Historic Environment Feature Management Report:

Pen Y Graig, Lime Kiln and Cottage

Customer Reference Number: A0024756

UID: 304,829 304,830

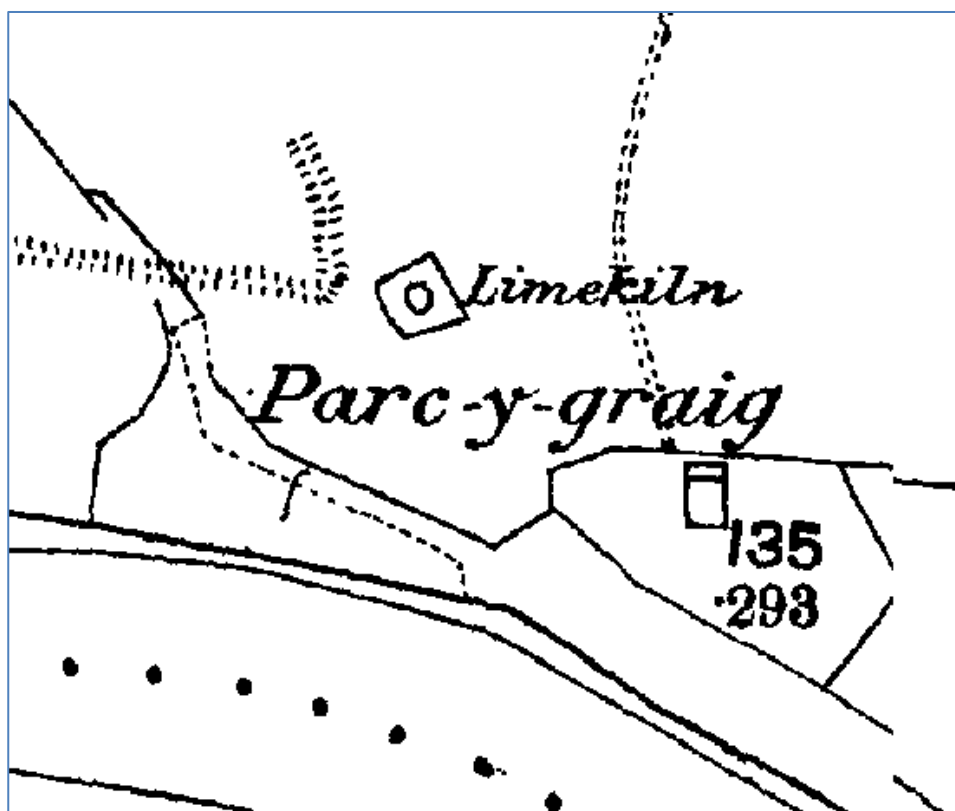
Detail from the Ordnance Survey 1st edition map (1888) © and database right Crown copyright and Landmark Information Group Ltd (All rights reserved 08/05/2012)

Site of lime kiln marked on 1st edition OS map. It is depicted as a circular structure in a square enclosure. It is located by the left bank of the River Taf upstream of the estuary mouth at Laugharne. This suggests that river transport may have been used to bring in raw materials or take away processed lime. By the second edition OS map of 1908 it is marked as Old Lime Kiln showing it had been abandoned by this date. The adjacent cottage Parc Y Graig (PRN 22782) may have been associated with workings of the kiln. The riverside location is low lying and embankments shown on the maps suggest it was prone to flooding suggesting a poor location for an agricultural dwelling. The footprint of the kiln is shown on recent mapping (Mastermap, 2011) and described elsewhere as Limekiln (disused) which indicates that remains still survive. Recent aerial photographs show the kiln site obscured by vegetation so its current condition is unclear.

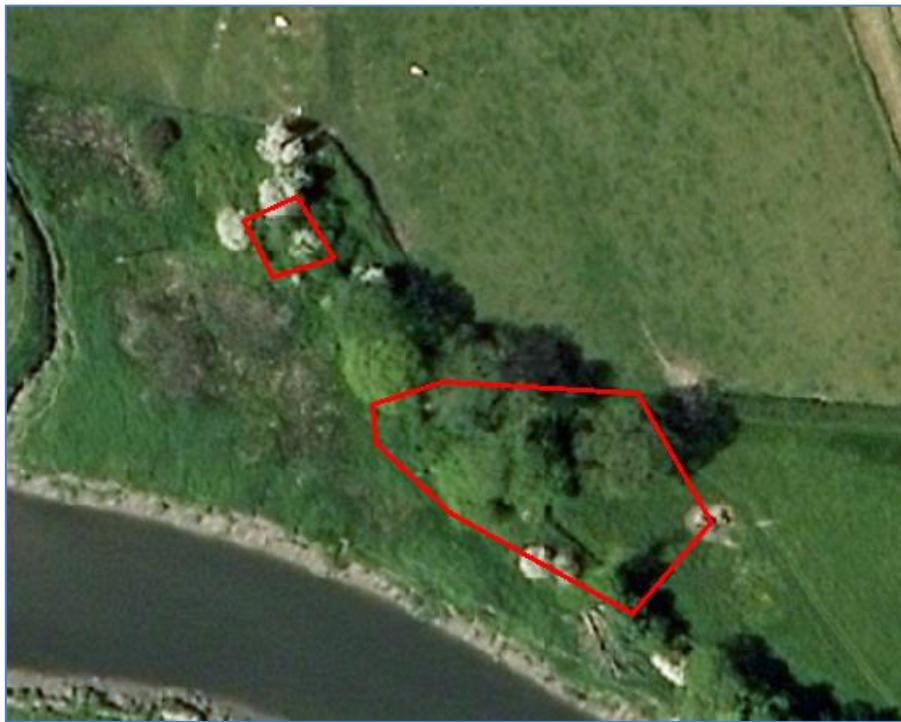
AERIAL PHOTOGRAPH

the cottage is shown on the recent mapping (Mastermap, 2011) which indicates that remains still survive. Recent aerial photographs show the kiln site obscured by vegetation so its current condition is unclear. (H.Pritchard, 2014).

- Remove by hand any vegetation growing on the remains.
- Cut back by hand any unwanted vegetation encroaching on the remains
- Spot treat with a suitable herbicide if required if required
