# Plas Crûg Primary School, Aberystwyth, Ceredigion

## Archaeological watching brief

**February 2011**

A report for Ceredigion County Council  
by Ellie Graham BA AIfA

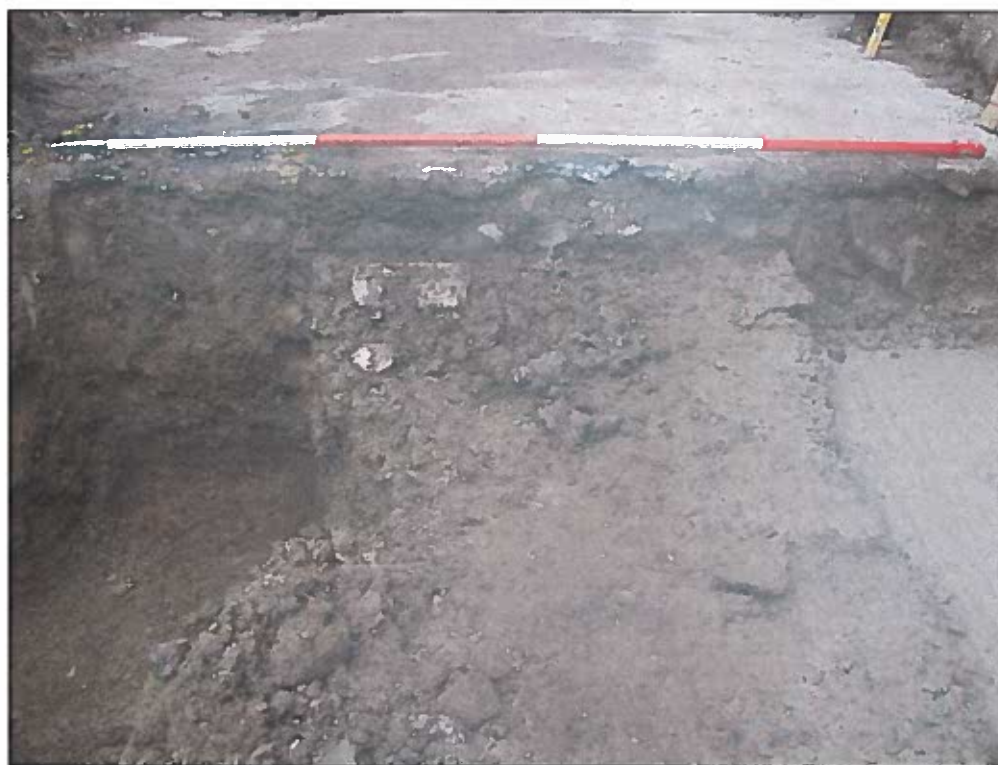
**Plate 1. Concrete slab 306, cobbles 308 and natural deposits, looking east ©GGAT**

The basal deposit encountered in all parts of the eastern area was a natural yellow-orange silty clay (307/319), which contained occasional sub-angular to sub-rounded stones, including some pieces of ironstone, with frequent iron panning. This deposit was excavated to a maximum of 0.6m, but was not bottomed. In the corridor area, this was overlain by cobble layer (308), which consisted of rounded cobbles up to c.0.2m contained within a grey silty clay matrix. This layer appeared to be formed of a single course of cobbles, laid on edge, between 0.4m and 0.5m deep. This was overlain by concrete slab (306), which measured 3.5m square and was 0.1m thick, and which abutted the walls of building 309 (Plate 1).

All of these walls were butted by the concrete slab floor, 306, which was 0.1m thick and square, measuring 3.5m north-south by 3.5m east-west. Sitting on top of this flooring was an area of burning approximately 1.5m square, centred on an iron pot-bellied stove, or boiler (315). It was located in the northeast corner of the building, although there was no evidence of a chimney (Plate 7). Boiler 315 consisted of a square iron stand with rounded corners, 0.5m square, tapering to 0.3m square towards the middle and splaying out at the top, although the upper section was badly fragmented. Within the rectangular box were several firebricks, and sitting on top was a large iron pot, 0.6m in diameter. The lid of the boiler was found next to the main body. It appears to have been used in this part of the room, as there was significant evidence of burning, but it had certainly been moved from its original position, as the door of the stove faced directly towards wall 313.

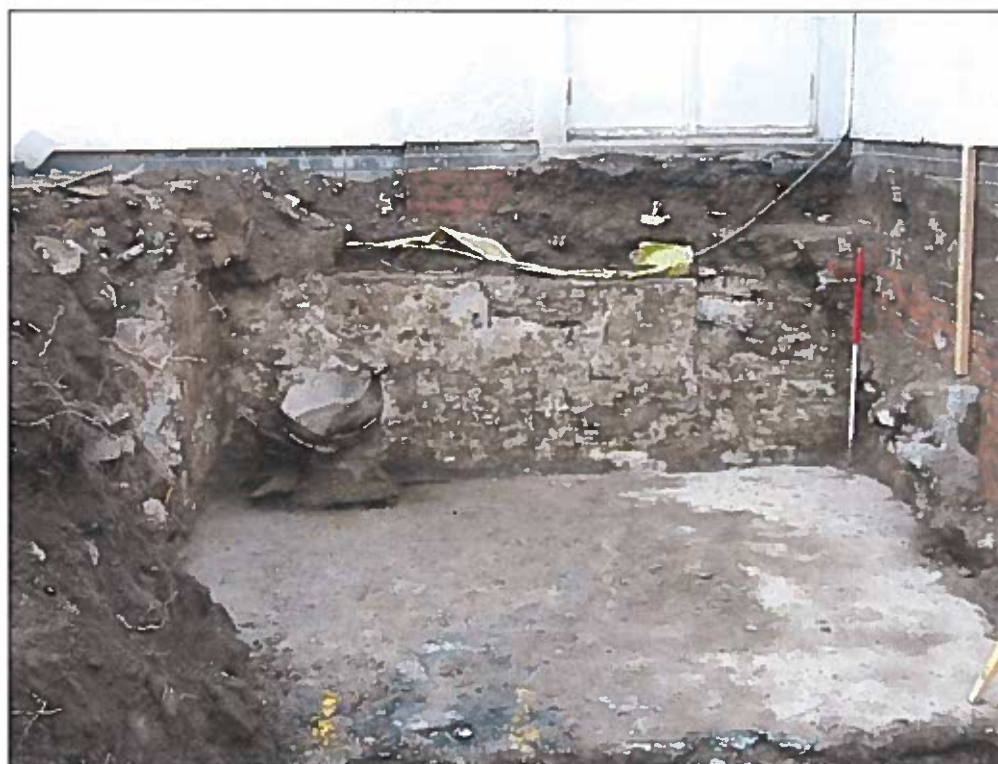
**Plate 2. Building 309, looking east ©GGAT**

The building (309) consisted of four main walls, 310, 311, 313 and 314, forming the east, south and north sides, with a fifth, 312, representing the later blocking of an east-facing opening in 310 (Plate 2). Wall 310 was constructed of squared stone blocks bonded with mortar, with a layer of whitewash visible underneath a later layer of lime plaster (Plate 3). It ran for a length of 3.5m on a north-south alignment, and survived to a height of between 1m and 1.2m. Its exposed width was at least 0.3m, but the full width could not be established due to the presence of a concrete-capped electricity cable trench and the foundations of the modern school building. It survived to approximately twelve rough courses, but this was difficult to establish with certainty as much of the structure was obscured by the later render. The stones used appeared to be up to c.0.3m long and c.0.1m thick, with a single brick included in the construction. There was originally an opening at the south end of the wall, but this had been blocked (312) at a later date.

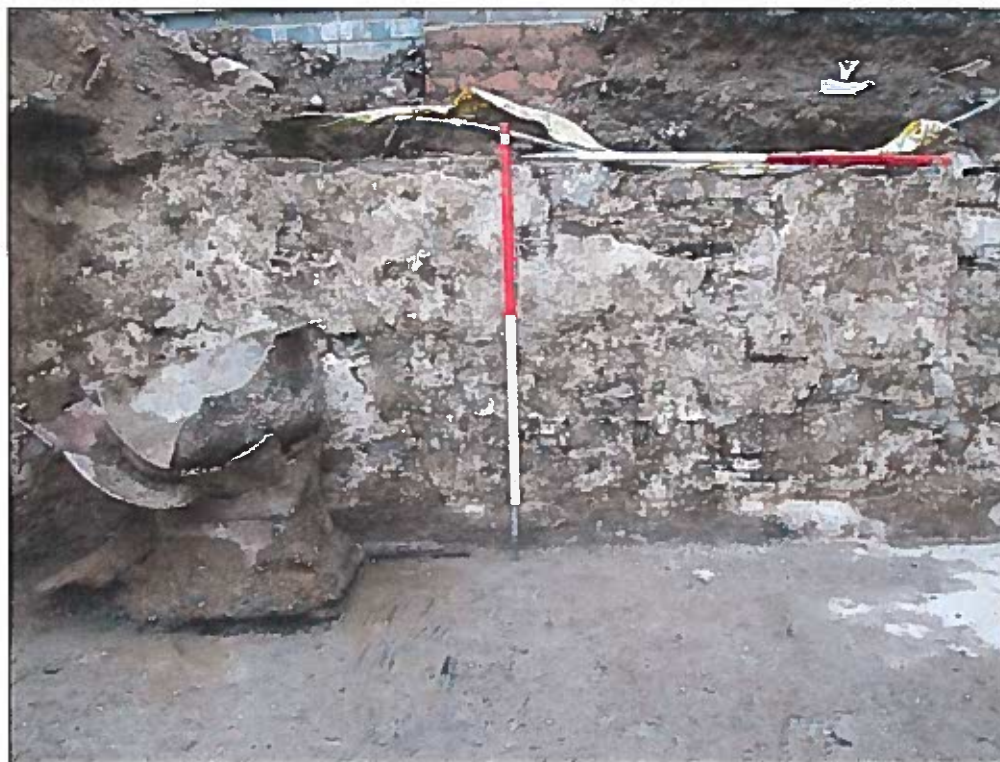
Plate 3. Wall 310, looking east ©GGAT

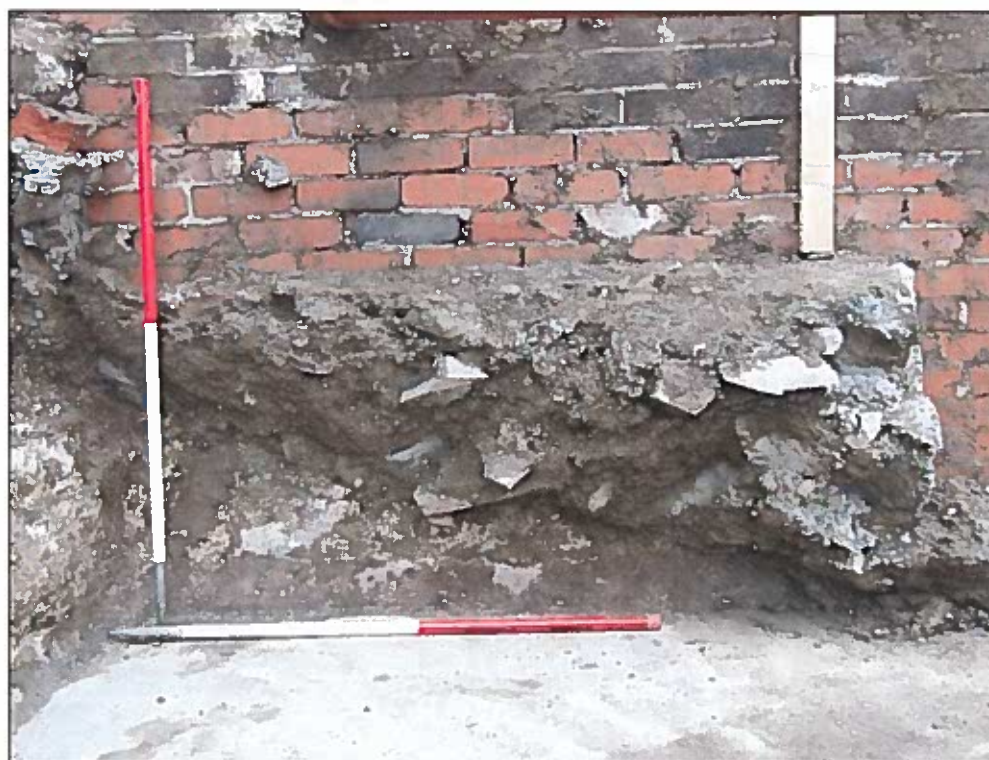
Plate 4. Wall 311, looking south ©GGAT

The south side of the building was formed by wall 311, aligned east-west. It also appears to have been constructed of roughly-shaped stone blocks of similar dimensions to those of 310, but again this was difficult to ascertain as the face of the wall was largely covered in plaster. Little of this wall survived; it stood to 0.55m at the east end, and dropped to the level of the concrete slab to the west after a length of 1.5m, where the concrete foundations of the modern school building directly overlay it (Plate 4).

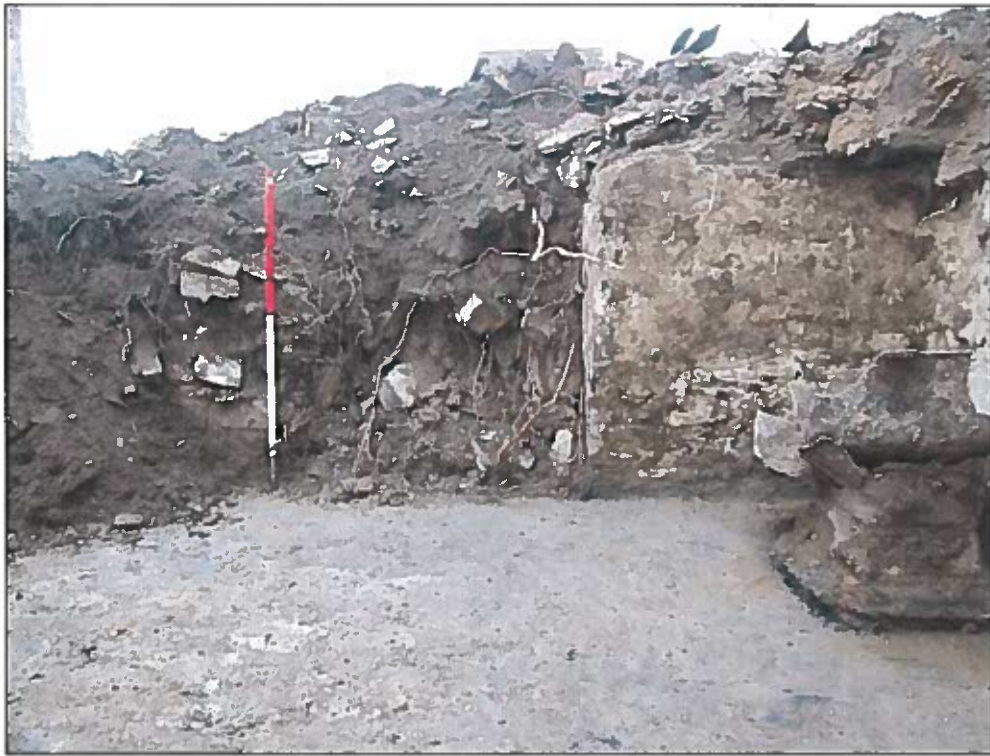
Plate 5. Wall 314, infill layer 305 and wall 313, with boiler 315 to right, looking north ©GGAT

The east-west aligned walls 313 and 314 formed the north side of the building. Wall 313 represented the return of 310 and survived to approximately thirteen rough courses, standing up to 1.25m high, 1.1m long east-west and 0.82m thick. The construction was similar to that of 310; the larger facing stones had dimensions of up to 0.5m by 0.3m by 0.1m, and the core was of rubble, but again the plaster largely obscured the face of the wall. Wall 310 was mortar-bonded, with several different types of mortar visible in its construction, both at its core and face, though there were also traces of clay bonding between some of the stones. Its west end terminated at a north-facing doorway, 1.1m wide. On the west side of the doorway, wall 314 continued along the same alignment. It survived to a height of 0.8m and 0.55m was exposed of its length. The wall survived to nine courses, but the uppermost had been heavily disturbed by tree-root activity. It appeared to have been roughly coursed and constructed of stones generally slightly smaller than the other walls of this building,

with maximum dimensions of 0.3m by 0.1m. There were traces of plaster around the base of the wall, though it did not survive as well as on walls 310, 311, 312 or 313, probably owing to the damage caused by tree roots. The construction of this wall generally appeared to be rougher than that of the others, but this might also be the result of the destructive action of tree roots. From its external appearance, the stones of the wall seemed to have been bonded with mortar, though there also appeared to have been some elements that were clay-bonded. At the north-facing doorway, the structure formed a splayed entrance on the west side, unlike the east side, which was straight.

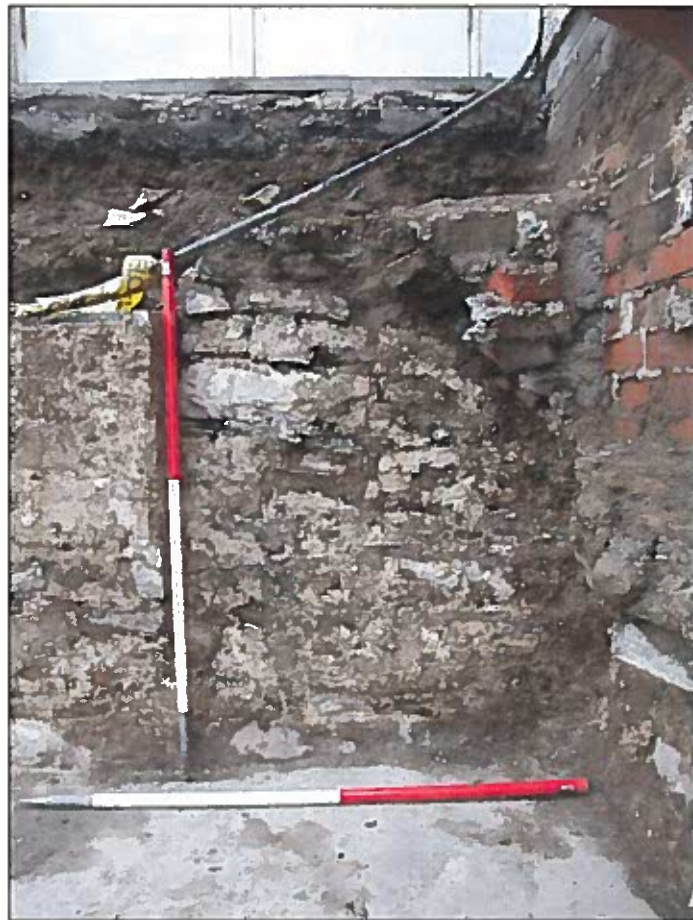
Plate 6. Wall 312, junction with 311, looking east ©GGAT

The latest element in the sequence of this structure appears to have been wall 312, which blocked the former east-facing opening in wall 310 (Plate 6). The doorway was 1m wide, and the blocking survived to a height of 1.1m, was composed of approximately twelve courses, and constructed of mortar-bonded, roughly-squared stone blocks of up to 0.45m in length by 0.18m thick. Like wall 310, the structure appears to have been covered in plaster, with a thick coating of paint prior to this. It was slightly battered, so that at the base it was level with wall 310 but at the top was set back by 0.18m.

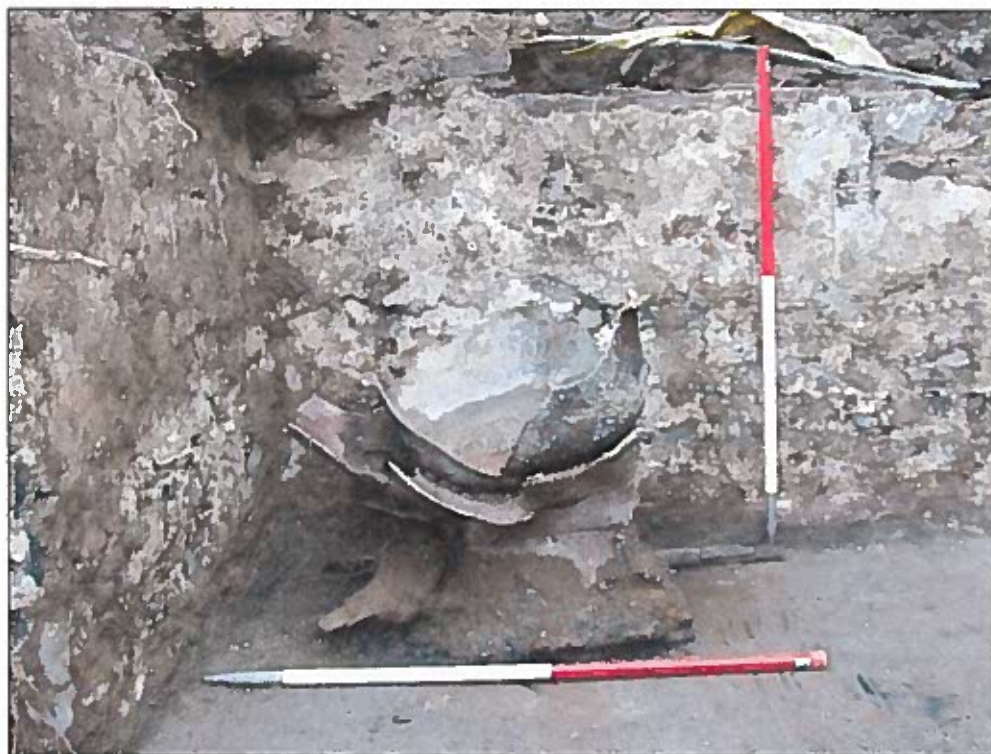
**Plate 7. Boiler 315, walls 313 and 310, looking east ©GGAT**

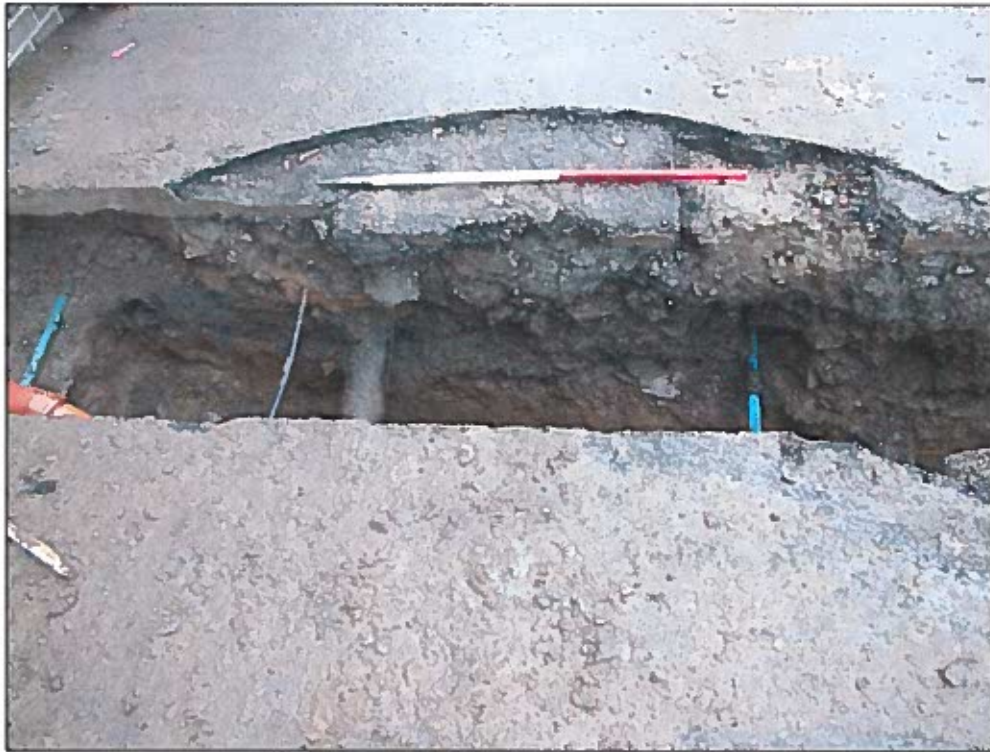
**Plate 9. North-facing section of foundation trench 1, showing service trenches 320, 325, 327 and 331, looking south ©GGAT**

Deposit 317 was also cut by service trench 327, a foul-water drain, which ran north-south. It measured 0.4m in width and 0.7m in depth. The fill (328) was a yellow-grey silty sand with frequent angular stone chippings, and pockets of redeposited natural (Plate 9). Service trench 331 also cut 317, forming a vertical trench, 0.5m in width and 0.5m in depth. It was aligned north-south, and ran alongside the wall of the school building, overlaying the concrete foundations of the wall. The fill (330) consisted of a brown-grey sand, containing moderate angular stone chippings. Deposit 317 underlay the tarmac (300).

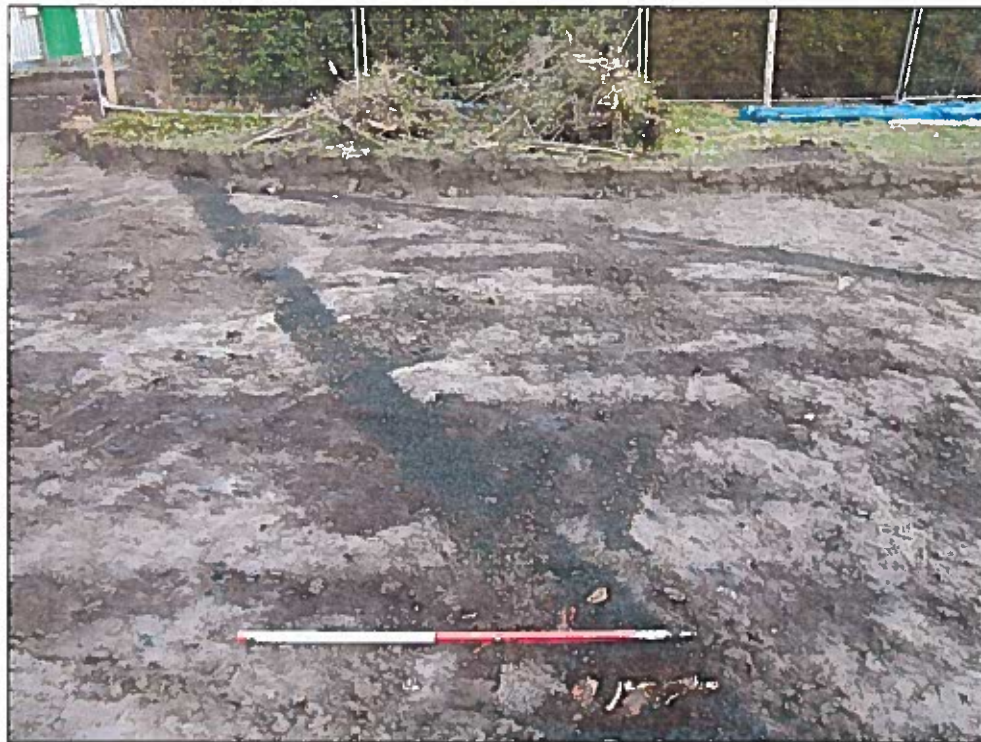
**Plate 10. Western area showing features 412 and service trenches 414 and 416, upper right, looking south southwest ©GGAT**

The subsoil (401) was also cut by a series of ten, roughly parallel, linear features (412). They generally measured c.0.3m to 0.4m in width and between 1.2m and 2.5m in length, all aligned east-west. They were on average set between 0.4m and 0.5m apart, generally broader to the east and tapering to the west, and covered an area 4m east-west by 3m north-south. They were not fully excavated, but appeared to be quite shallow, and contained fill 413 a compacted deposit of dark purple-red sand containing frequent angular fragments of stone, tarmac, coal and substantial quantities of late Post-medieval and Modern pottery and glass.

The linear features (412) were truncated by service trenches 414 and 416 (Plate 10). Pipe trench 414 was aligned north-south and measured 0.35m in width. It was part of the same network of services as 402 and 416. The fill of the trench (415), was identical material to deposit 411, and contained pieces of the fragmented narrow red ceramic pipe that formed the service pipe. Trench 416 was also 0.35m wide and
