Louise Mees.
October 2010.

Tairheol. Level 3 building survey of an early 19th
century lead miners' cottage, Cilycwm,
Carmarthenshire

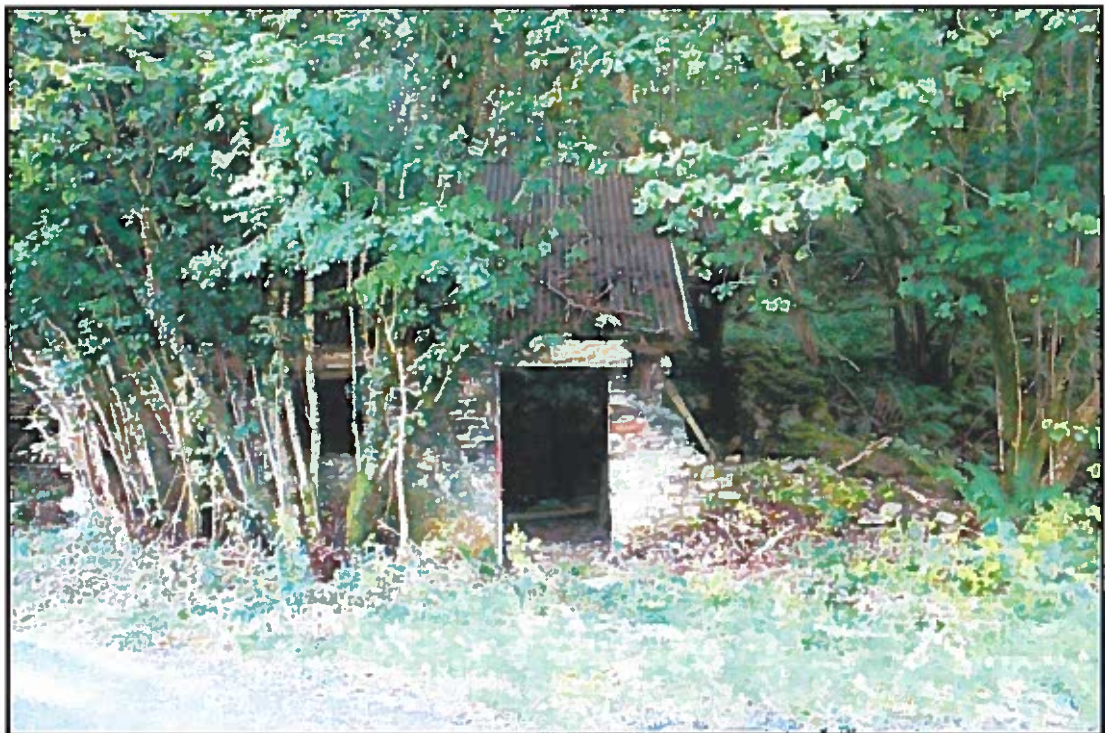
1.2.1 The northern gable and the northern end of the front elevation have collapsed (see figure 2). Though not at risk of demolition, the vacant building is clearly at 'extreme risk' according to the 'Critical Element Factor' (CEF) system of recording building condition, developed by the Handley Partnership and used to assess the condition of listed buildings in Wales (Cadw, 2009: 3) (buildingsatrisk.com, 2011).

Figure 2. Tairheol: collapse of northern elevation and northern part of front elevation.

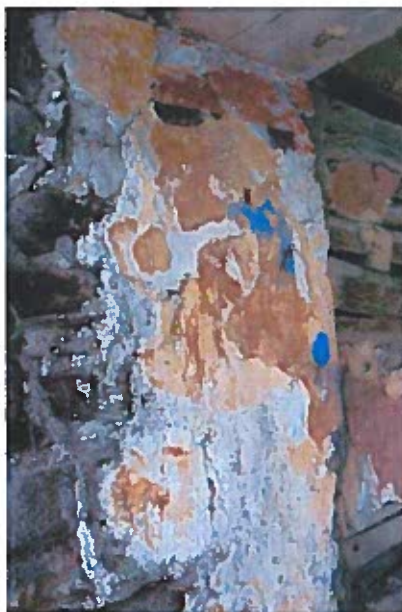
The remains of the most recent coat of lime-wash on the building show that the front elevation had been coloured red and the south-east gable had been coloured white. Other pigments can also be seen underneath the final wash: yellow, orange and blue in the doorway; and red, pink and yellow on the front elevation (figure 4).

Figure 4. Tairheol: variety of lime-wash pigments.

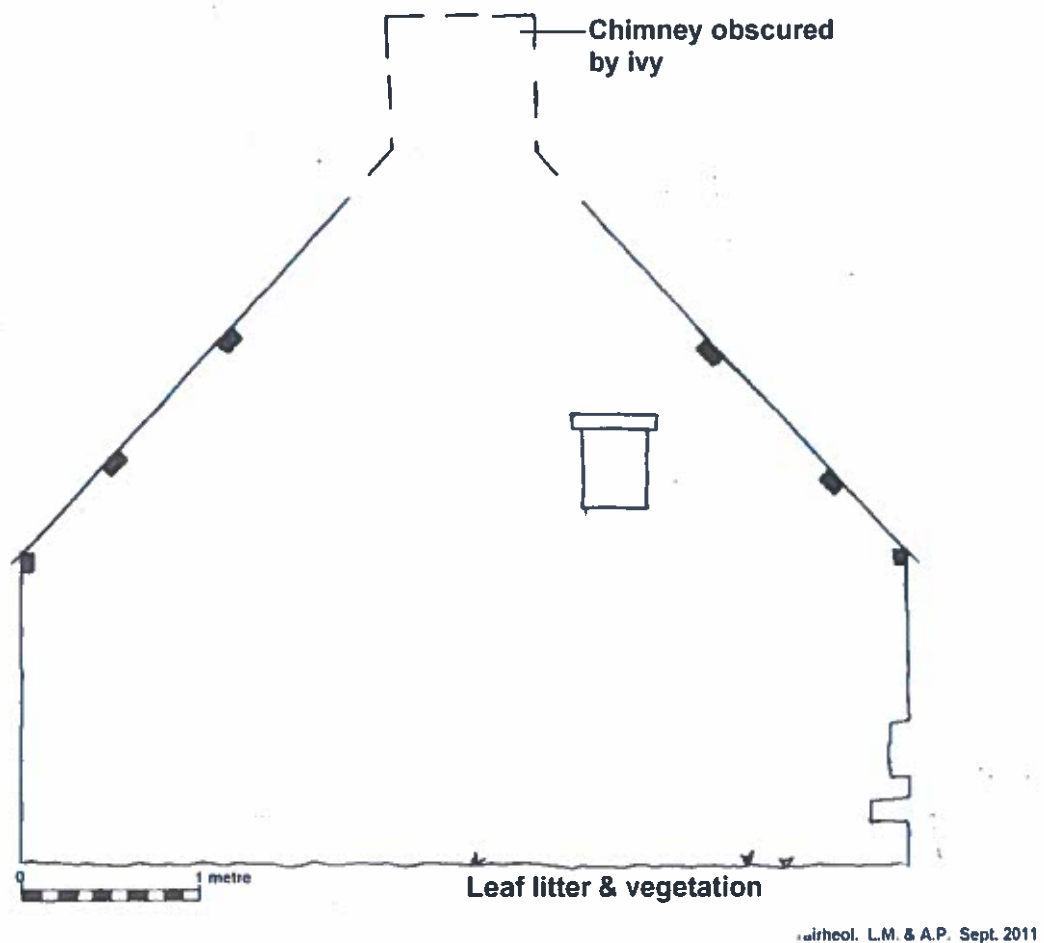
The window recess to the left hand side of the doorway, c. 0.5m high x 0.75m wide (measurements to stone rubble jambs and wooden lintel), has a painted, beaded, soft-wood timber frame, with a central socket in the upper section. The glazing is missing. The window was constructed without a stone or timber sill: the rubble stone sill was lime rendered. The window to the right-hand side of the door, in the section of collapsed wall, is only evident as a surviving fragment of the lower left-hand side of the window recess. The loft was lit by a small, four-pane glazed frame in a 0.4m square window recess, with timber lintel, in the south east gable end wall (figure 6).

Figure 6. Tairheol: south-east gable.

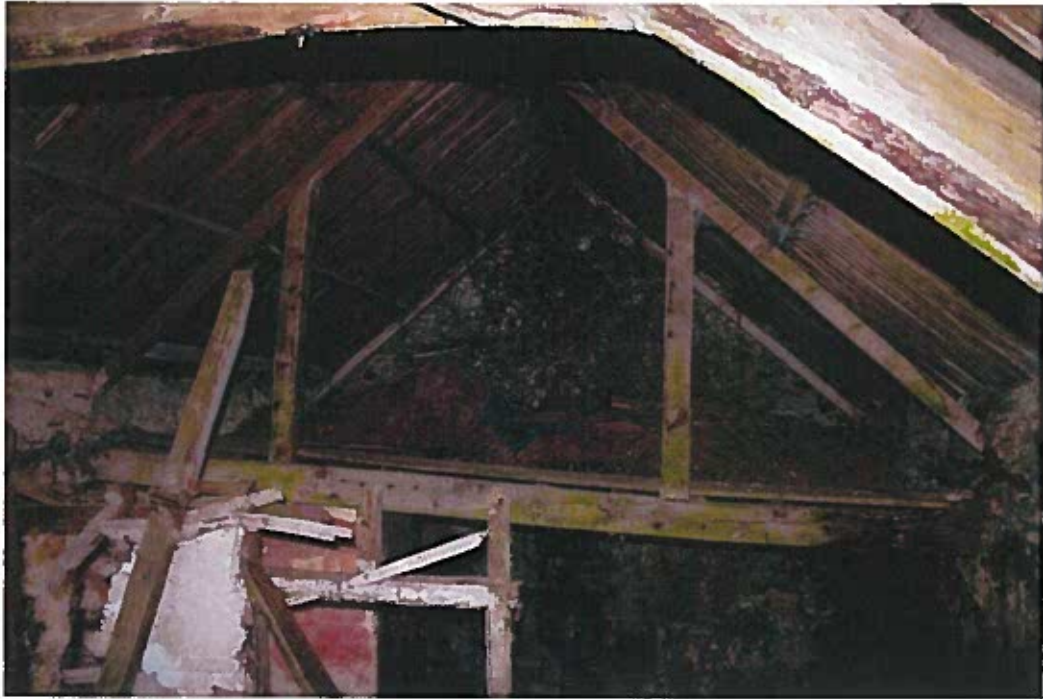
Over the central and south-east part of the building tin-sheet, underlain by tongue-and-groove timber, is set upon a light-weight timber truss roof. A sawn timber ridge piece is supported by sawn timber principal rafters (fixed by iron bolts), a double row of sawn timber purlins and sawn timber wall plates (figure 7). A central tie beam, supporting two sawn timber queen post struts, extends through the front elevation so that its end is flush with the external face of the wall. The gap between the wall tops and the underside of the roof is in-filled by rubble stone work: 0.6m high and only a single stone in width (figure 8).

Figure 7. Tairheol: roof structure, central and southern section of building.

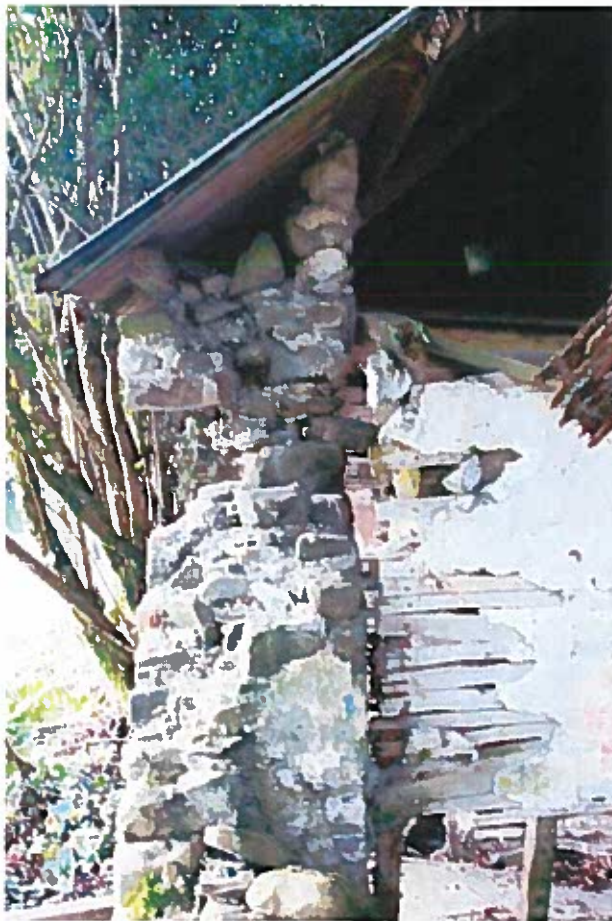
Figure 8. Tairheol: infill between wall top and underside of roof.

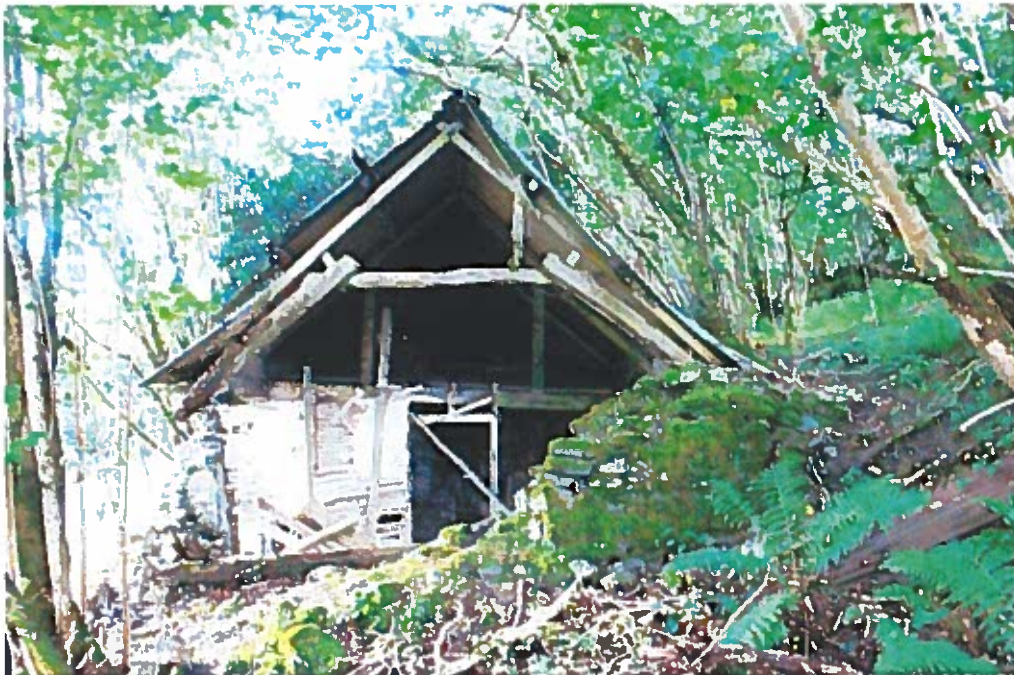
The north-west end of the roof has the remnants of a different structure: an un-sawn, half-round timber truss roof with two principal rafters (their ends cut off), a collar and a queen strut join the structure to a principal rafter of the sawn-timber roof structure (figure 9). The front principal rafter is hanging above the collapsed section of the front elevation. The rear principal rafter is set onto a pad-stone in the rear wall (figure 10).

Figure 9. Tairheol: roof structure at the northern end of the building.

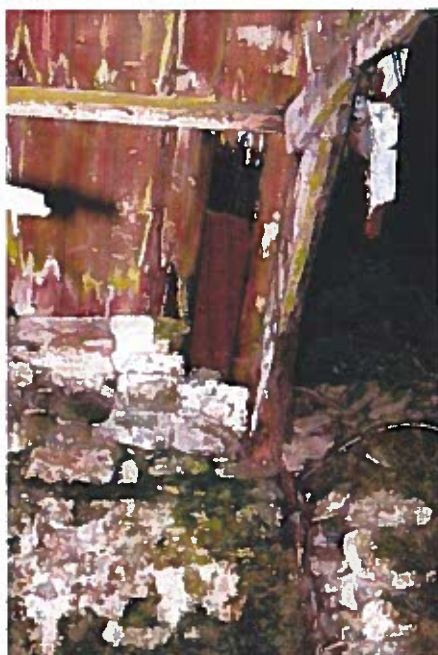
Figure 10. Tairheol: truss on pad stone.

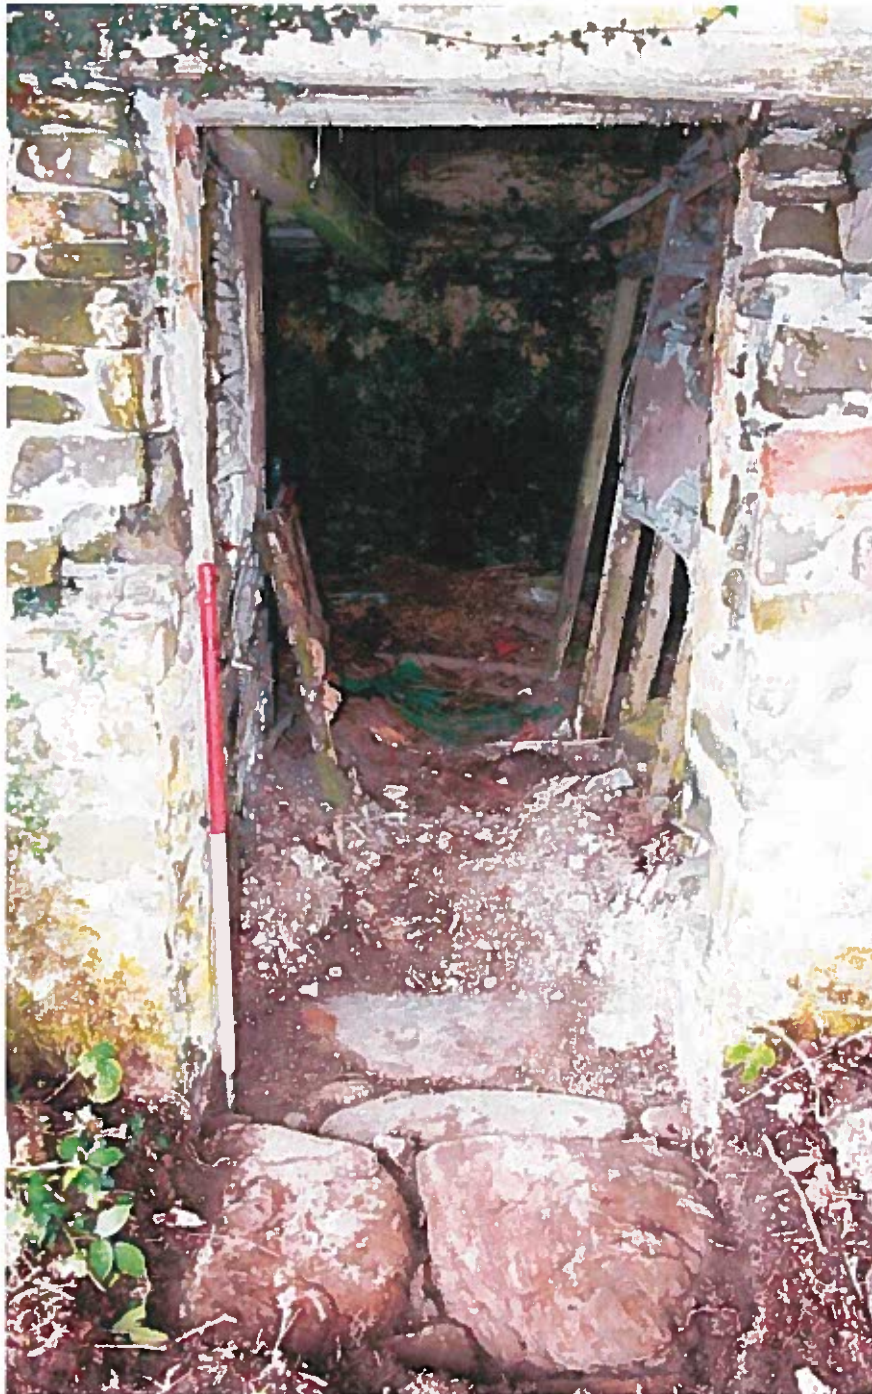
The cottage is entered through the front doorway: stepping over the stone-paved doorstep (figure 11), which led into the lath and plaster lined passage. The left-hand side partition is shorter in length than the right-hand side partition.

Figure 11. Tairheol: entrance into partitioned hall-way.

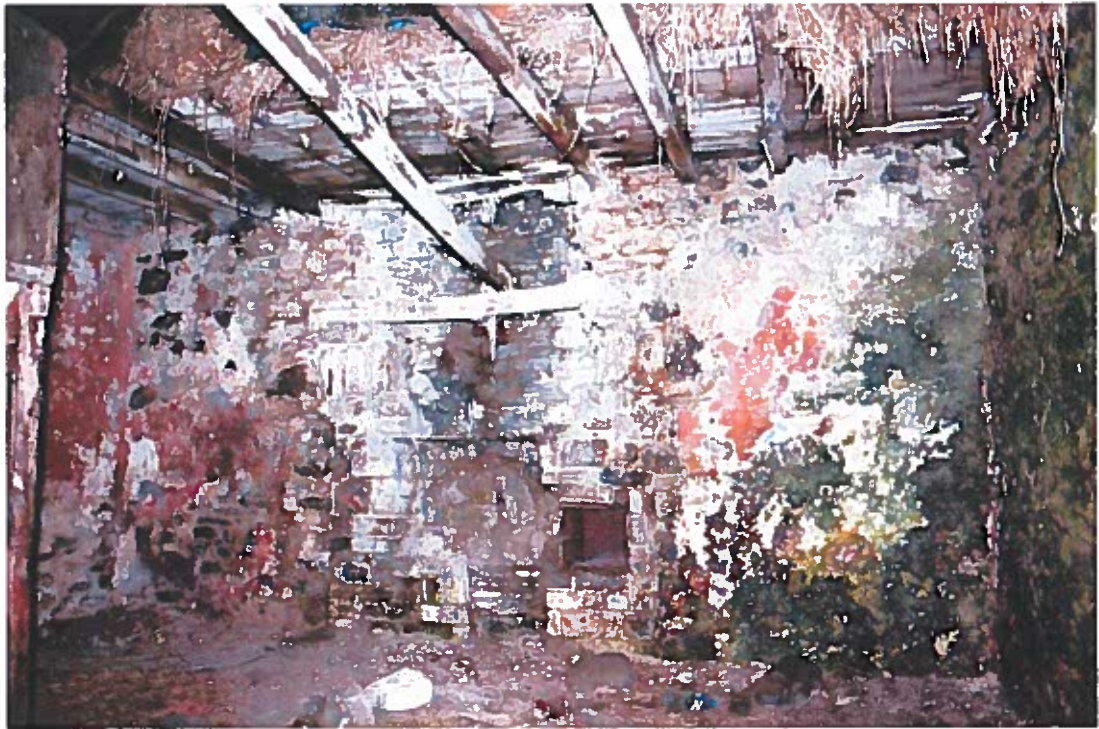
The passage leads directly into the larger room on the left-hand side of the cottage. This room was heated by a fireplace, central to and set flush against the south-east gable wall. The stone and brick built fireplace has a cast-iron bread oven to the right-hand side of a central iron grate. Above the main fire setting is an iron bar lintel. Five stones of an earlier stone archway survive two courses of stone above the iron lintel: three stones on the left-hand side and two stones on the right-hand side. A wooden lintel is set one course of stone above the stone arch. The central portion of the chimney breast, above the iron bar and up to loft height, has collapsed (figure 12).

Figure 12. Tairheol: fireplace in south-east gable.

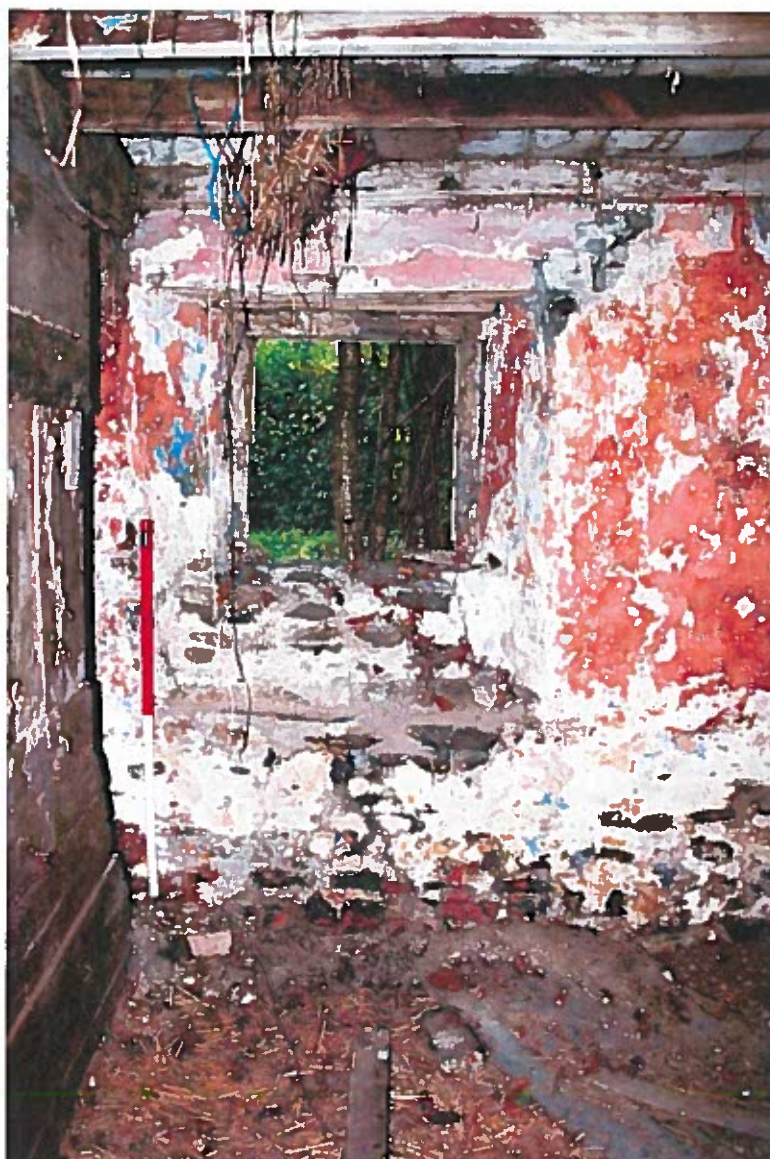
Natural light for the room was provided by the window in the front elevation. The window sill has been raised: an in-fill of rubble stone has been built over a lower stone sill, which is set at c.1m from the floor level of the cottage (figure 13).

Figure 13. Tairheol: rubble stone in-fill above window sill.

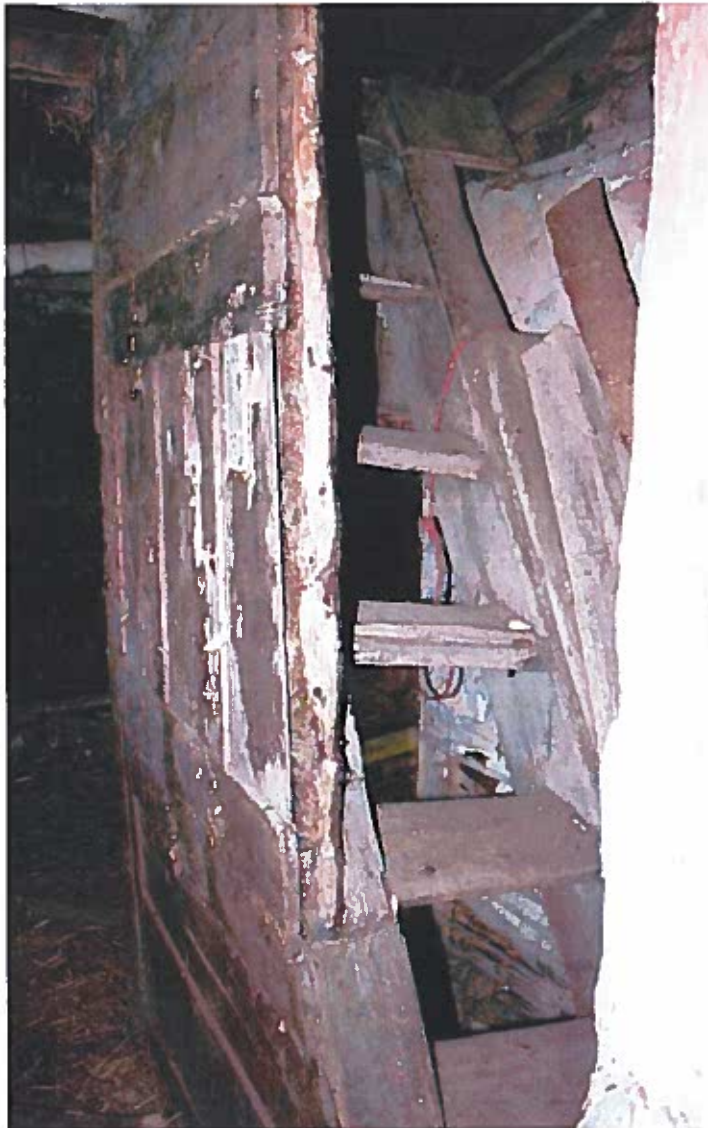
Sawn timber joists, running from the central tie beam into the south-east gable wall, support the floor boards of the loft. The loft boarding extends over half of the roof space of the kitchen-living room, the other half of which is open to the roof, though a full loft is evidence by fallen joists above the right-hand room and sockets in the central tie beam (see figure 9). The loft is accessed by a narrow single flight of seven steps (the bottom of which is missing), not much more than ladder, boxed in by timber boarding. The stairwell is partially lit by natural light from the window in the front elevation.

Figure 14. Tairheol: stairwell, viewed from window.

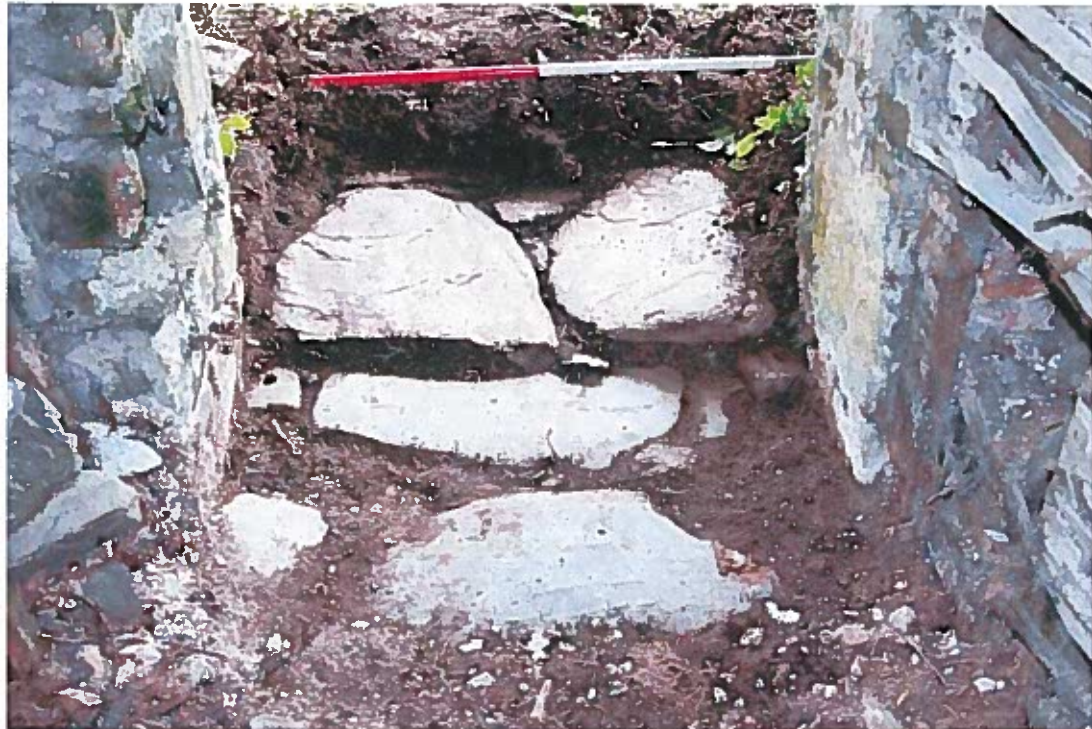
The internal walls show traces of lime render and lime-wash, colours of which include white, yellow, orange, red, pink and blue. The stone-paving on the door-step and inside the doorway were exposed when an Acrow-prop had to be inserted to stabilise the building. Clearance of debris from the floor revealed two sockets, one on either side of the entrance (figure 15).

Figure 15. Tairheol: stone paving and door frame sockets (pivot stones for a harr hung door?) in entrance.

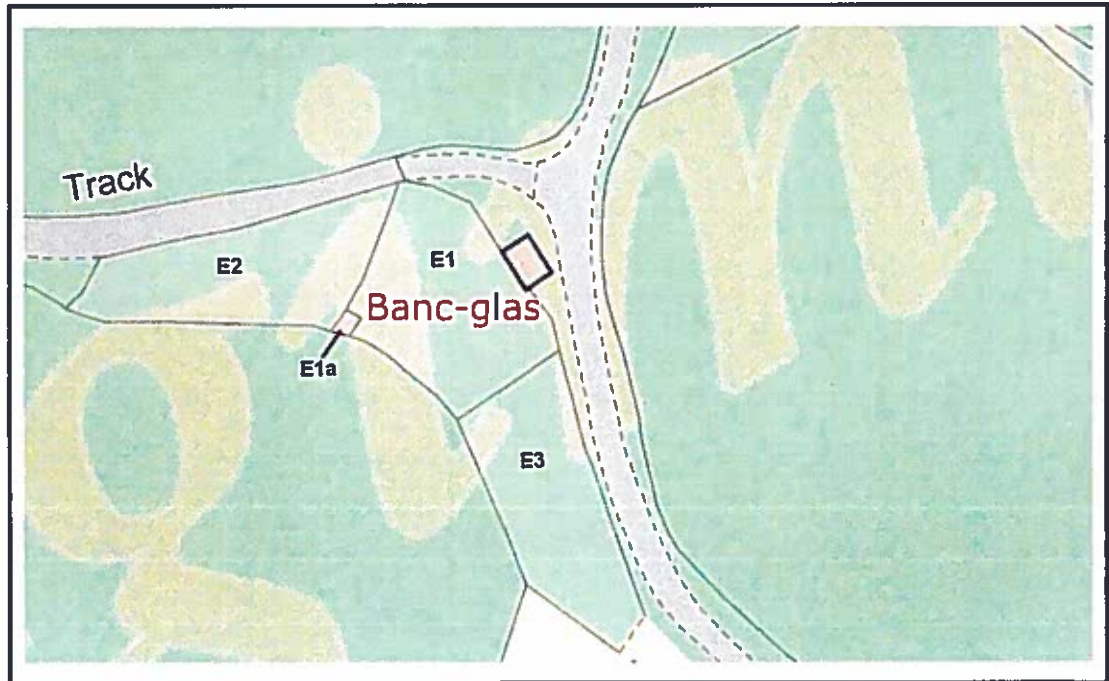
The OS Mastermap (Edina, 2011) shows a single cottage, identified as 'Banc-glas', at the exact location of Tairheol (see figure 16). The building is set on the same orientation as Tairheol, alongside the minor road.

Figure 16: 1970 Banc-glas, with annotations for enclosures and associated building (after 1970 O.S. Master Map) (Edina, 2011).

Three enclosures lie to the west of the building, for the purposes of this study they have been numbered 1 – 3. The southwest elevation of the property is set against a small enclosure (E1), which has a small structure in the southwest corner (E1a). There are two additional enclosures: one adjacent to the NW boundary of the enclosure (E2); and one adjacent to the SE boundary of the enclosure (E3).

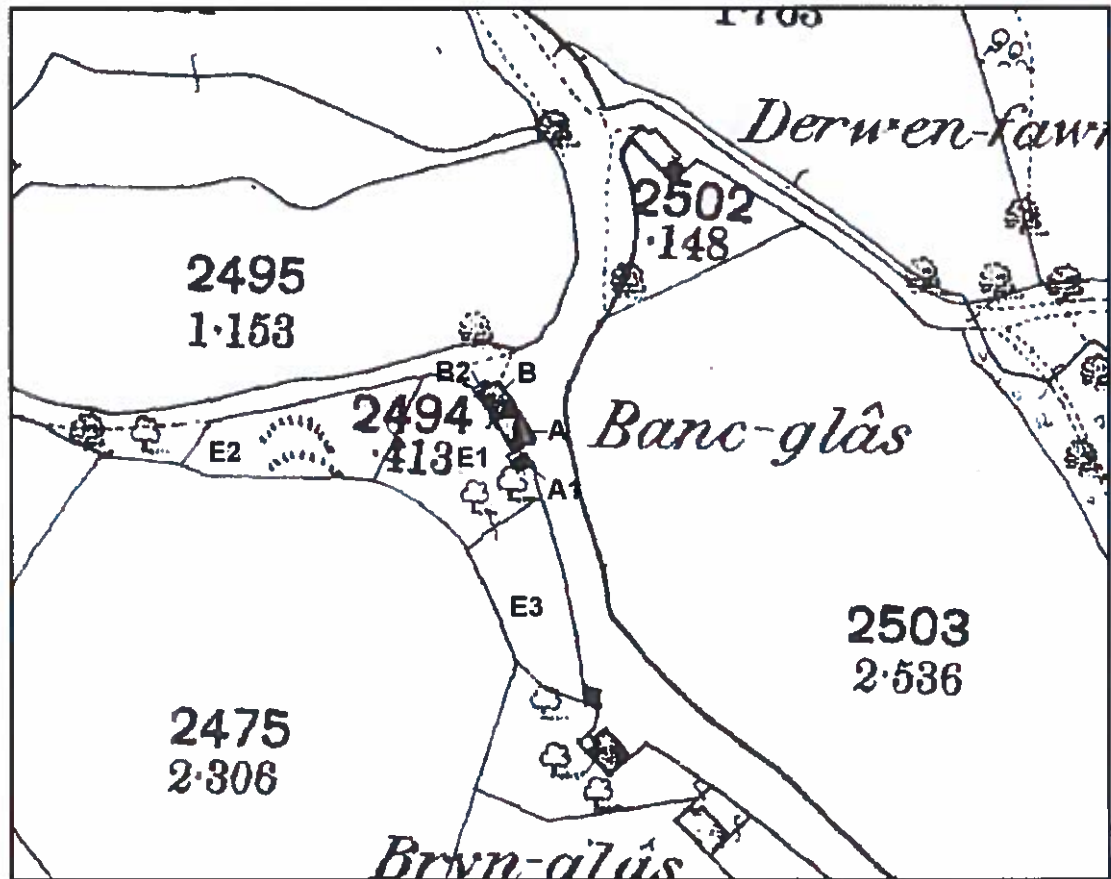
The Ordnance Survey 1st edition 1:2500 map (Carmarthenshire, 1888, sheet SN74) shows buildings A, A1, B and B1 identified as Banc-glas (see figure 18). Building A2 is not present.

The three enclosures, E1, E2 and E3, are depicted as associated with Banc-glâs. Buildings E1a and E3a are not present.

Figure 18. 1888, Banc-glas, with annotations for enclosures and associated buildings (after 1888 revised O.S. 1st edition map) (Edina, 2011).

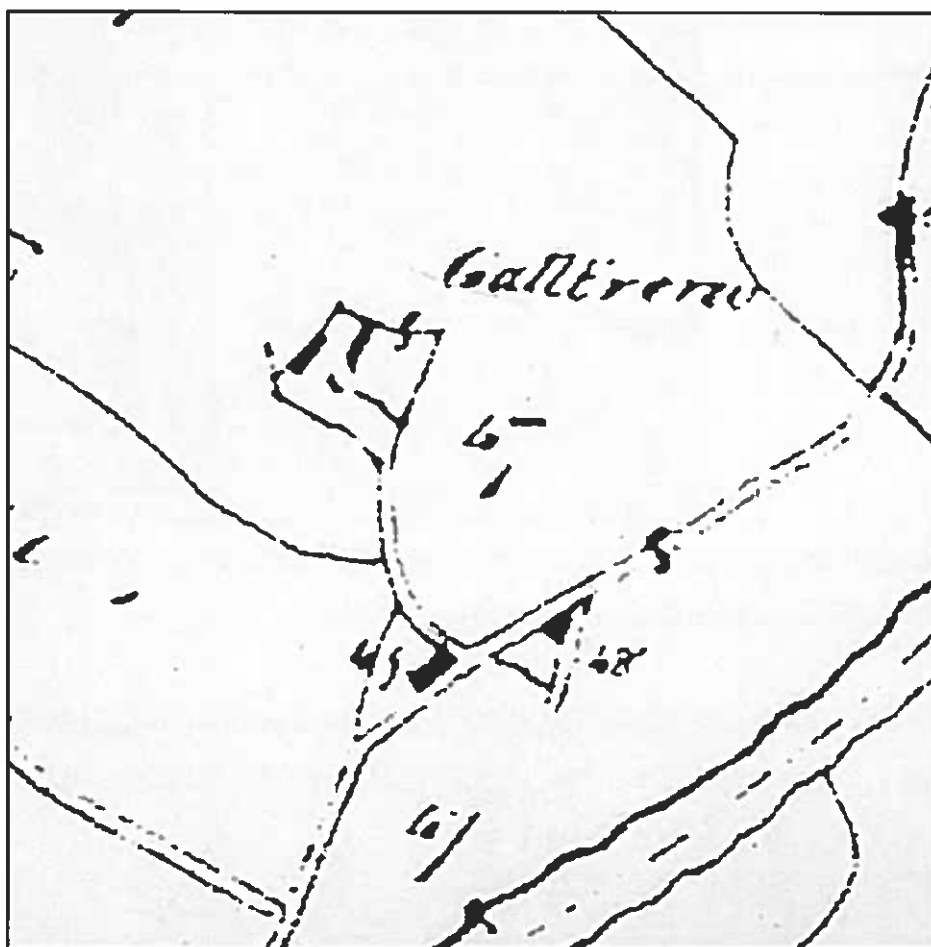
The tithe map and apportionment recorded on the 30th January 1843 for the parish of Cilycwm (CAO, 2011a), in the County of Carmarthenshire, includes an entry for Evenezer Davies, tenant of John Frederick Campbell, Earl of Cawdor, at Galltyrerw. In addition to the house and lands of Galltyrerw, the entry for Evenezer Davies also includes two records of 'House and Gardens, part of ditto', numbered 48 and 49 on the tithe plan (figure 19). Property number 49 relates to Banc-glâs, shown on the later Ordnance Survey maps.

Property number 48 relates to Derwen-fawr, also shown on the later Ordnance Survey maps.

Figure 19: Extract from 1843 tithe, Tairheol shown as no. 49 (after 1843 Tithe Apportionment) (CAO, 2011a)

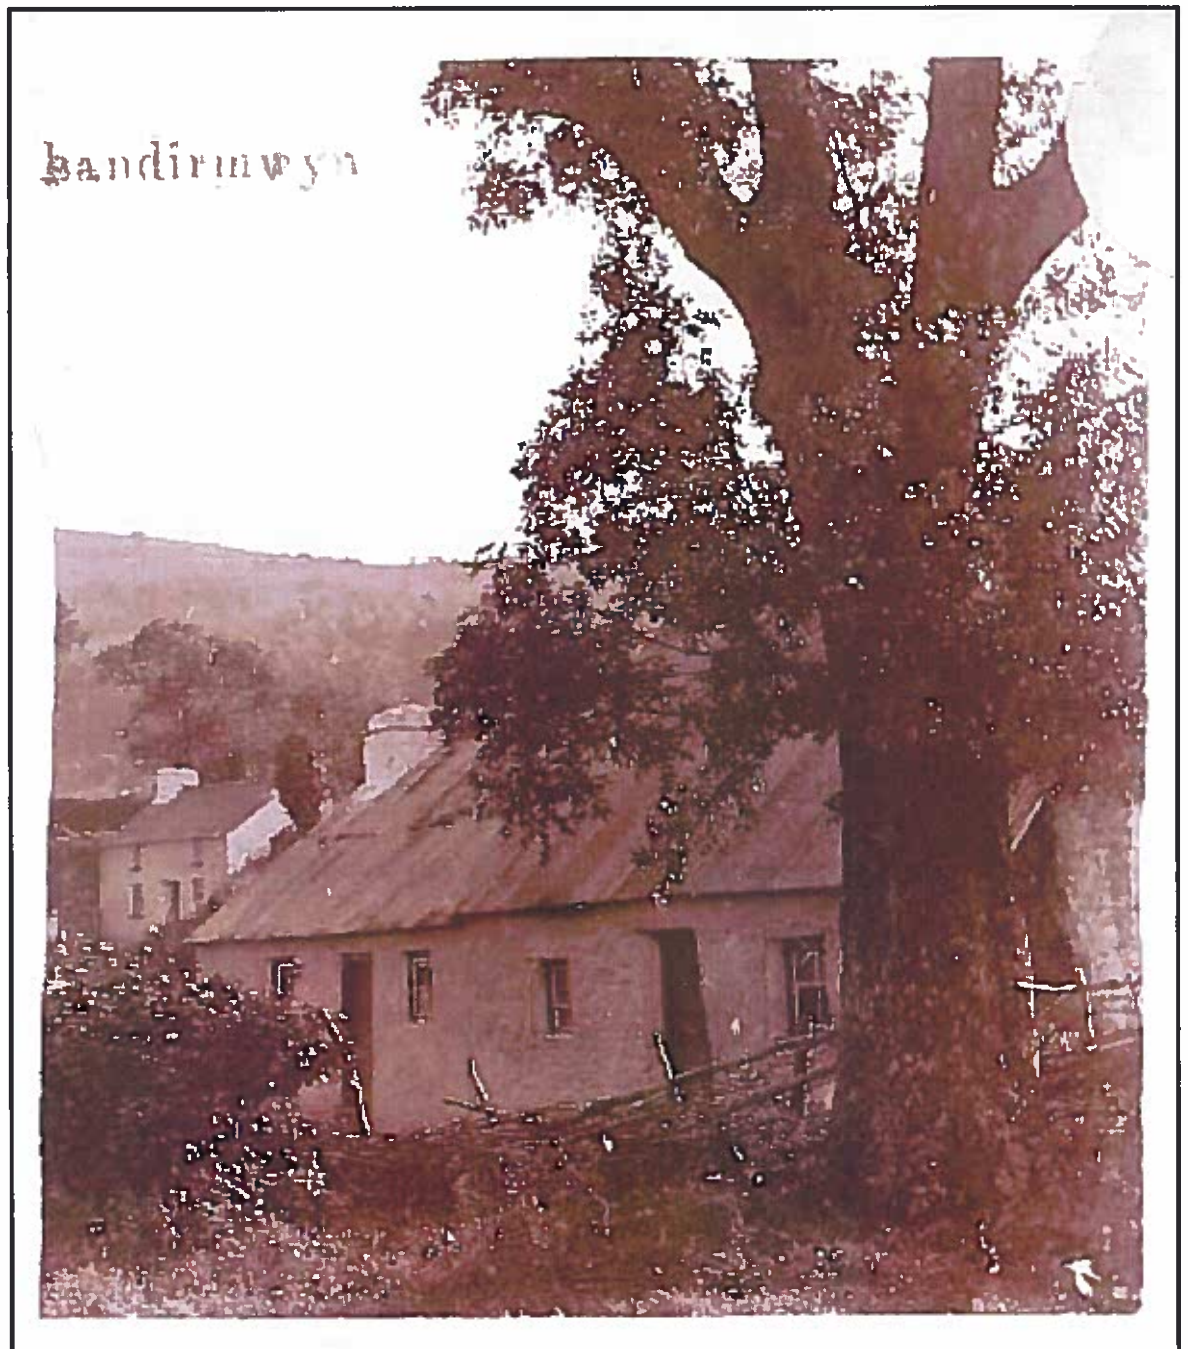
A hedge, laid in the Carmarthenshire style, runs along the front of the two cottages. The photograph appears to have been taken from the field opposite the properties, to enable the image to include both cottages. In which case, the laid hedge is on the eastern side of the road (which is obscured from view).

Figure 22: Tairheol c.1900, photograph by Thomas Lewis, reproduced with the kind permission of Mr. A. Jones.

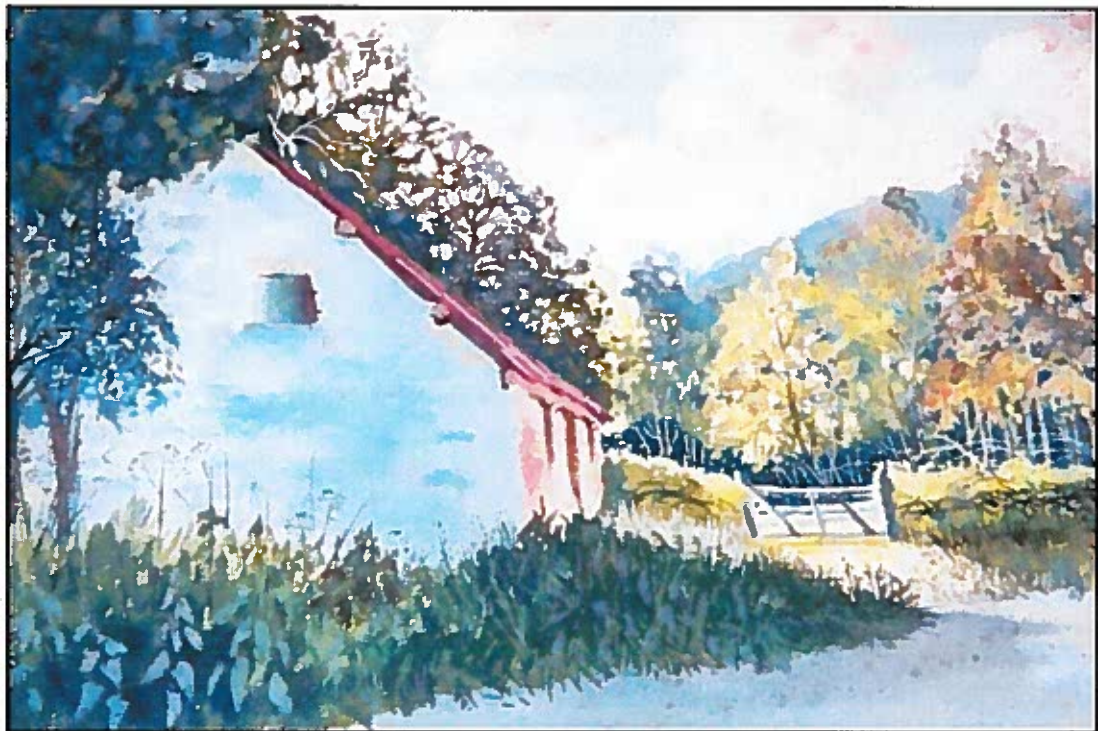
Monica Barnes (daughter of Thomas Lewis, photographer) painted Tairheol c. 1960 (figure 23). The painting records a view of the cottage from the southeast: showing a partial view of the southeast gable wall, front elevation and roof. The window to light the loft is shown in the southeast gable wall, which is lime-washed white. The front elevation is lime-washed in pink.

Figure 23: Tairheol in the 1960's, painting by Monica Barnes, reproduced with the kind permission of Mr. A. Jones.

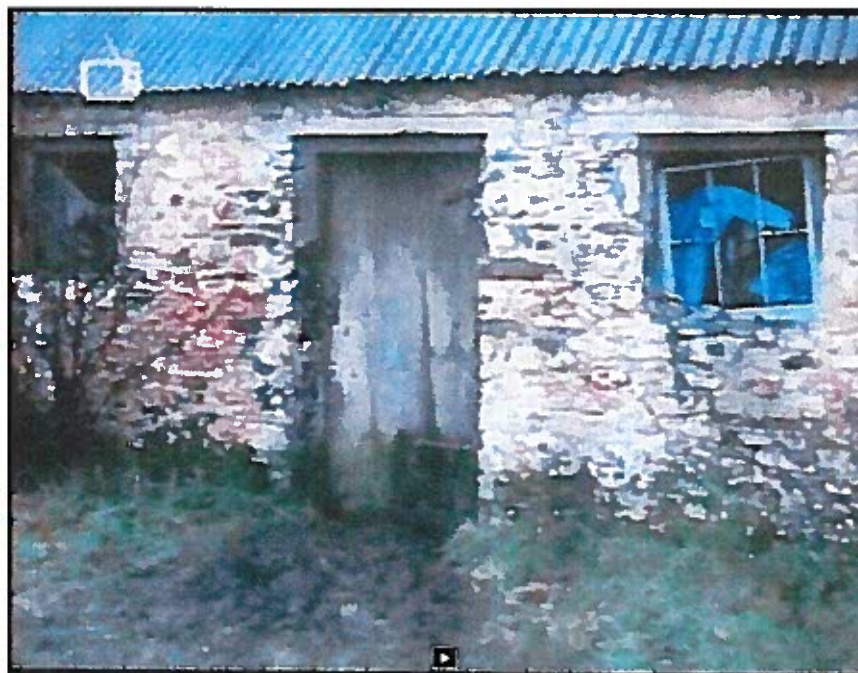
The last resident of Tairheol was a steer, reared by Dan Theophilus of Alltyrwrw. The cottage briefly features in an episode of Cefn Gwlad filmed in 1983, which shows Mr. Theophilus feeding the steer inside the cottage and then loading it into a trailer. The brief, tantalising, clips of film do show some features of the cottage, such as glazing, which have since been lost (figure 26).

Figure 26. Tairheol: 1982. Showing glazing (Griffiths, 1983).

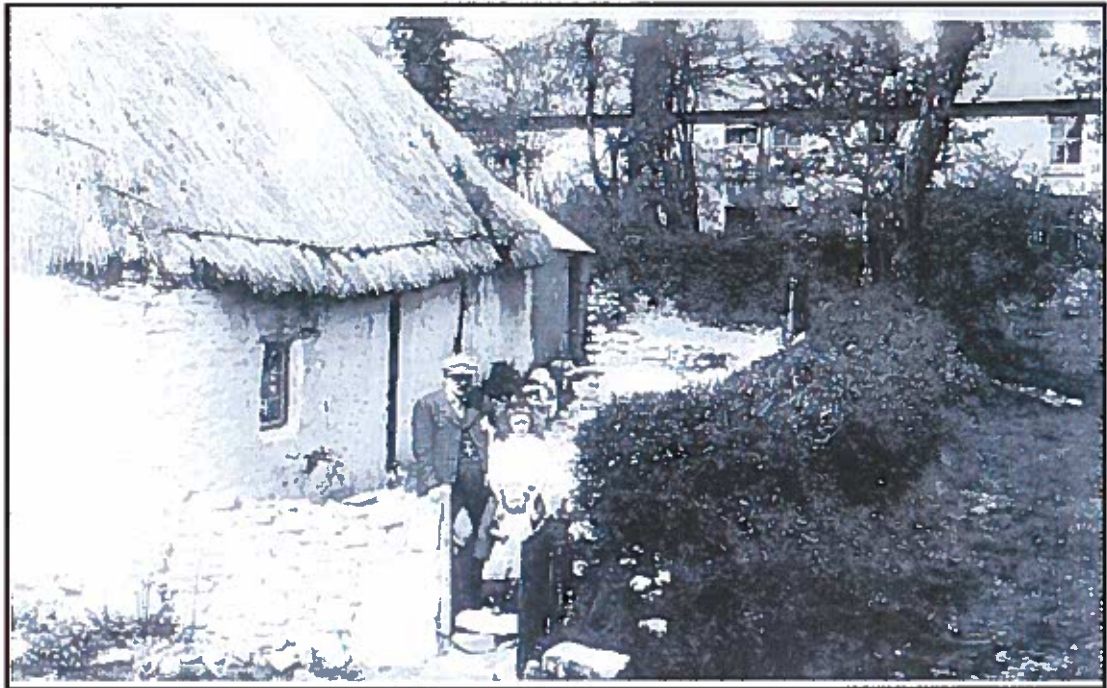
The draught-proofing modification is associated with alterations to the roof: the addition of the sawn timber structure overlain by tongue and groove panelling and tin-sheet. This later roof replaced an earlier timber structure, in which the trusses were set upon pad-stones, rather than a wall-plate, and the profile of which indicates a lower ridge height. The addition of the new roof involved the heightening of the rear wall by 0.3m. The former structure, built when tin-sheet was not available, would have been covered in thatch as seen in other local cottages of the period (figure 27).

Figure 27. Pentwyn, Rhandirmwyn, 1912, photograph by Thomas Lewis, reproduced with the kind permission of Mr. A. Jones. NB: Nantymwyn Terrace (built 1892), in the background.

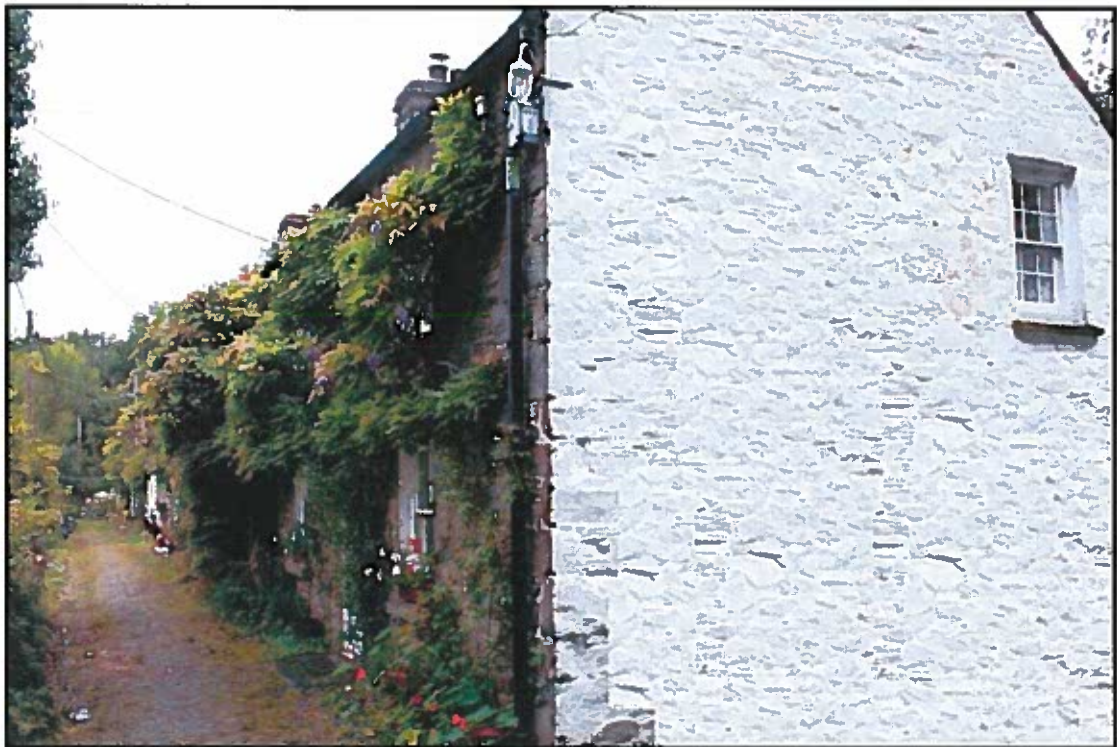
Considering the construction date of Tairheol, at the beginning of the nineteenth century, it may originally have been constructed as a single storey, thatched, croglift cottage. The building was certainly not as substantial as later examples of industrial housing constructed in Rhandirmwyn: Pannau Street, built c.1850 (figure 28); and Nantymwyn Terrace, built 1912 (see figure 27).

Figure 28. Pannau Street, Rhandirmwyn: industrial workers' housing constructed c. 1850.
