EXPLORATION OF ROMAN ROUTE FROM CAE GAER TO TRAWSCOED

MARTIN DAVIES
19/11/14

PRN
106535

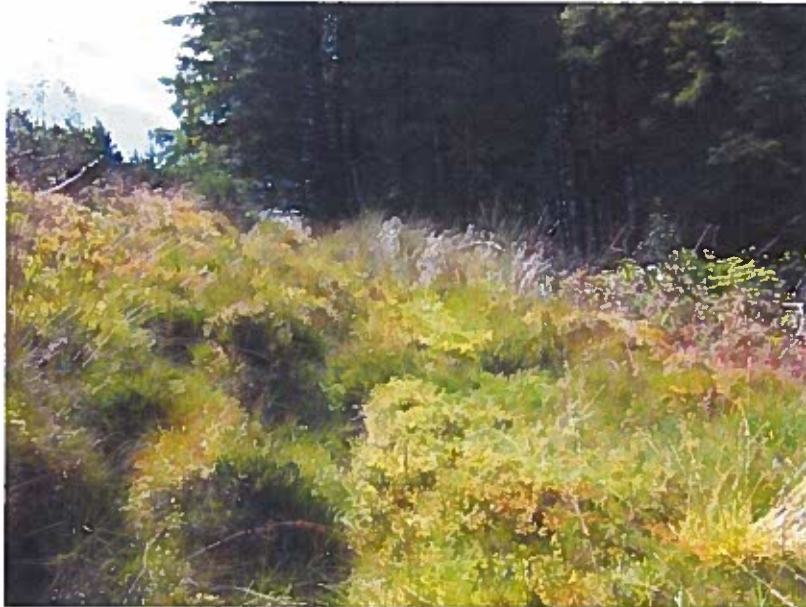
1. CAE GAER CUTTING

Apart from new Forestry tracks, there is only one old track in the vicinity of Cae Gaer fort, going past it from the NE, then climbing the hill to the SW, heading directly for Trawscoed. It is shown on the old OS maps as a footpath. The absence of other roads and the orientation make this highly likely to be a Roman road. Much of the cutting on the hillside lies under a deep peaty layer and has suffered from a varying degree of landslip. The photo looks SW.

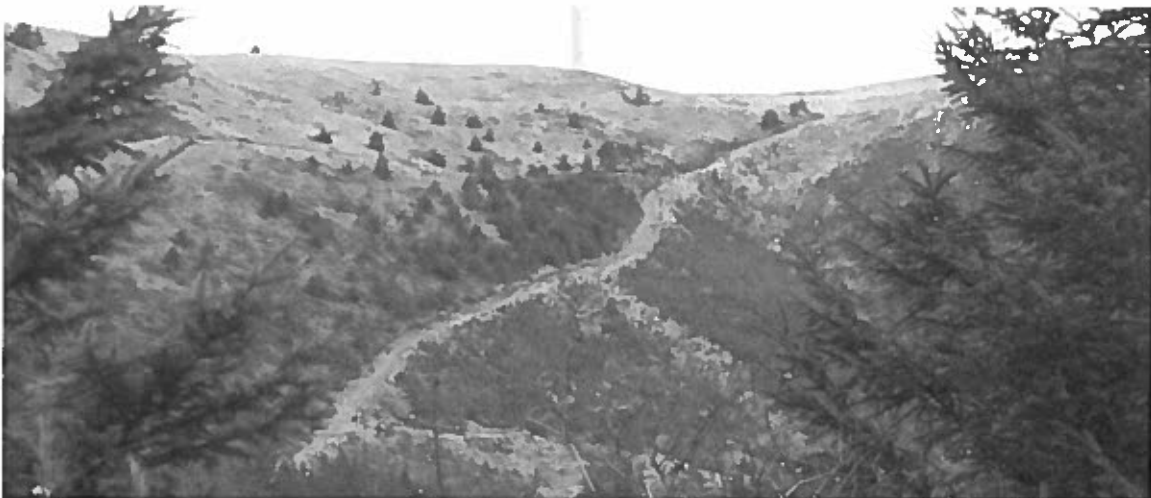
Rhiw'r Ordd from the SW

The name Rhiw'r Ordd (sledgehammer hill) is of some concern because it is contemporary spoken Welsh and so would hardly be the observation of those watching its construction in Roman times. If it is a metaphor for the punishing climb heading NE, it is apt. Another possibility is that it is derived from imagining its construction. But there is one further possibility: at the top of the cutting is a decidedly non-Roman deviation, which has been dug out of the rock, presumably to by-pass what was an unacceptably steep section. If this was dug out (some time before the old OS) without the benefit of blasting, it would have involved hard work for several people with sledgehammers and bars: in this uneventful place, an event worth recording.

In its favour, Rhiw'r Ordd heads directly towards Trawscoed, in a direction re-calculated from the top of the hill. Also in its favour is that there is no other track heading straight down into the valley. There are other cuttings above to specific ventures but it is clear that they have simply used an existing route to their advantage rather than creating it.

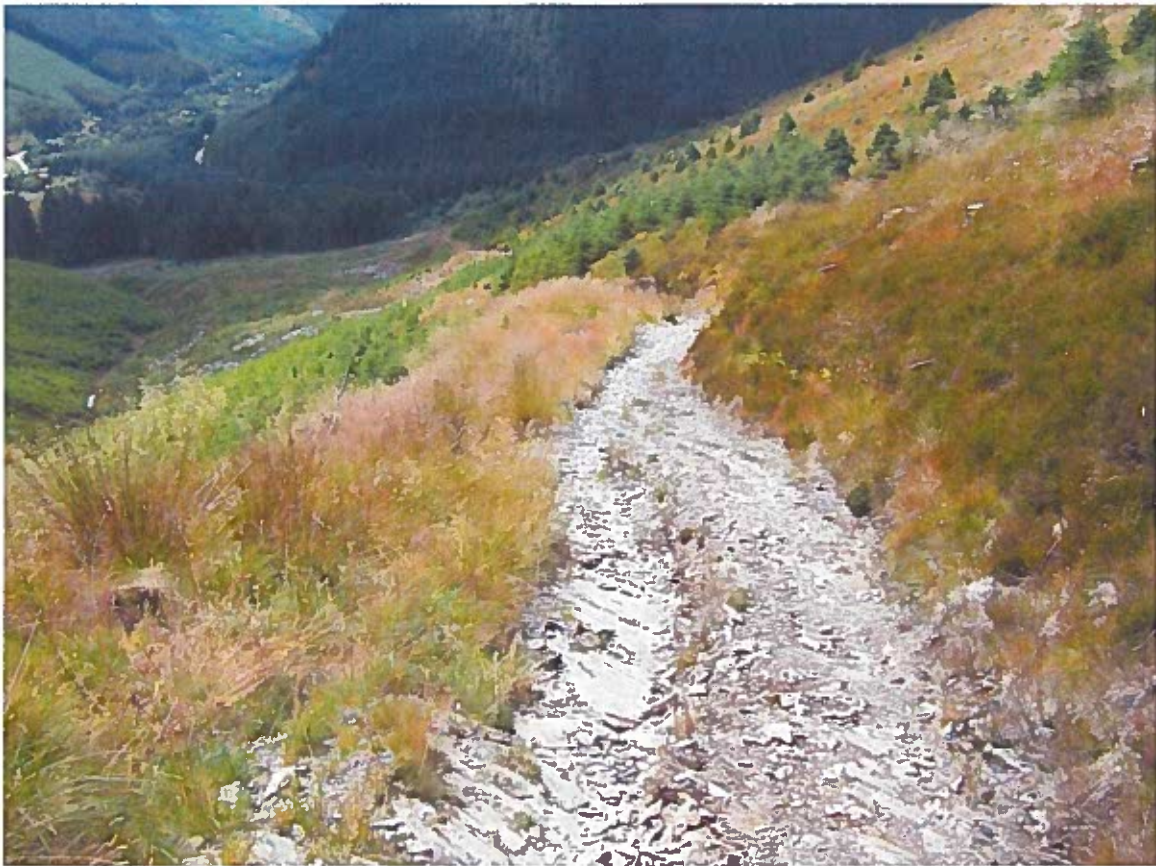
RHIW'R ORDD CONT'D

photo descending from the NE and section below from same direction

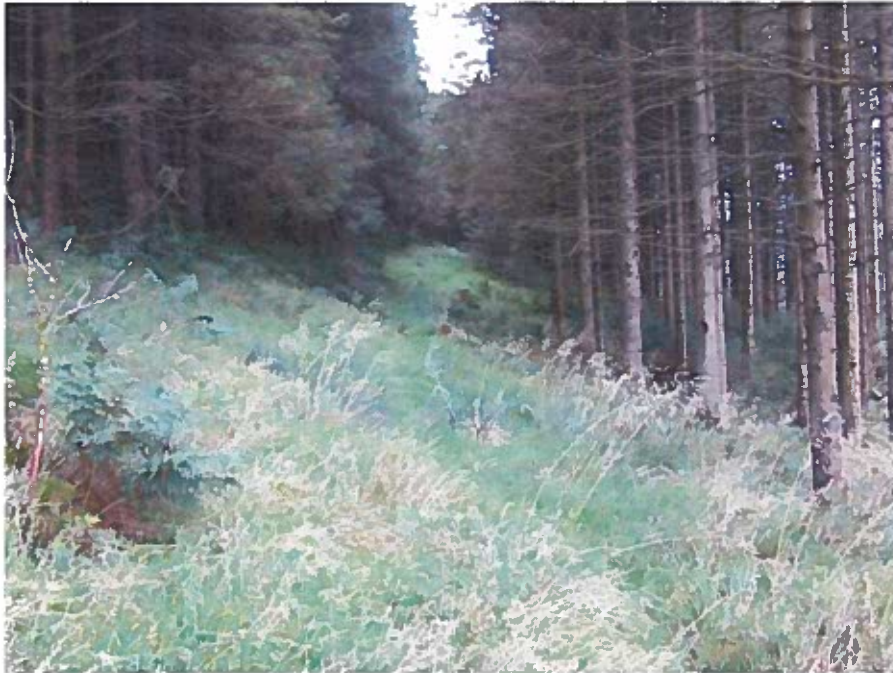
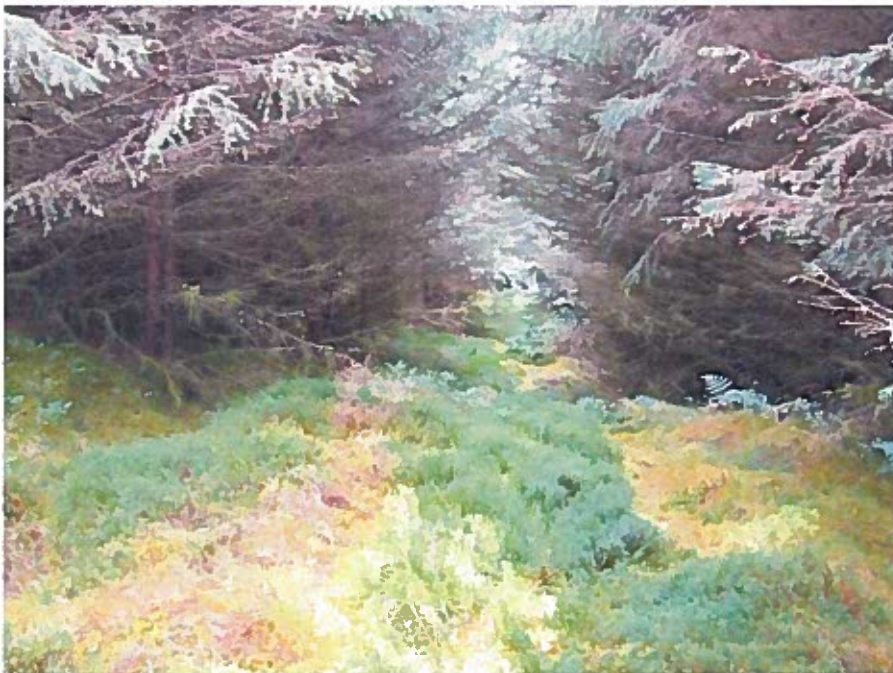
Point 4. looking west and below, 5, looking NE

The cutting to and over the top of Banc Dolwen was pretty much the only route on the old OS and is clearly visible on the RAF verticals. Since the land has been taken over by forestry, a myriad of tracks have appeared. The old route, however, has evidently been identified and made into a public footpath. The high point is at Dolwen itself, and the road round was a compromise between gradient and economy of length.

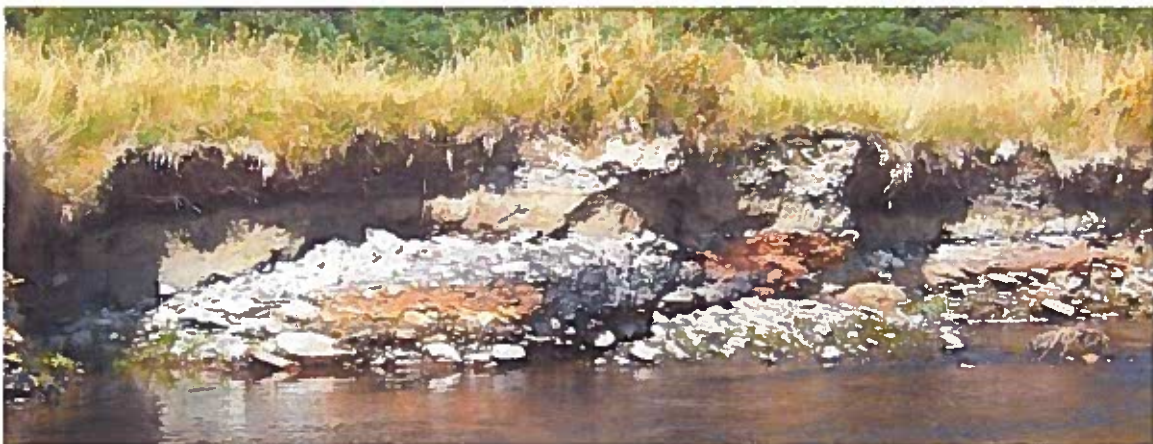
9. Having initially favoured the route N of the waterfall past Llaneithyr, I noticed a familiar (?) clay concrete in the river bank, which I have seen at other Roman river sections. This stretches possibly for 35 metres, and as at other sites, the river eats away the silt above it and the river pebbles below, leaving the slabs hanging until they eventually snap off. Also familiar was the orange clay (much of it stained black) where one would not expect clay to occur naturally. I found a few lumps under water which must have been there for a considerable time. Although the Bodcoll mine is nearby, there is no record of any industrial activity here. I saw no similar concrete elsewhere on the river.

'concreted' slabs which break off as they are worn under.

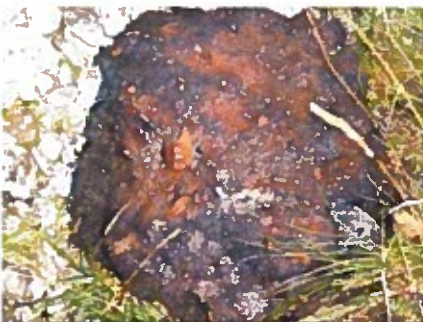
one of several lumps found in the river

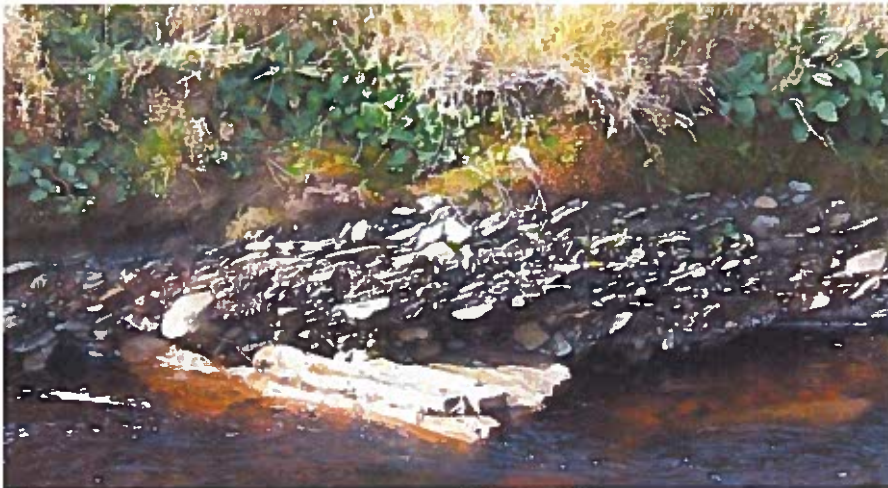
false road section

It is worth showing here a false road section, which looked convincing from a distance, but when tested for its concrete qualities, its cohesion was so weak that the stones simply crumbled apart and would not hold together. This was a clear demonstration of the marked difference between stones loosely held together by organic matter and the solid concreted material found up river, which needed a large stone to break it apart.

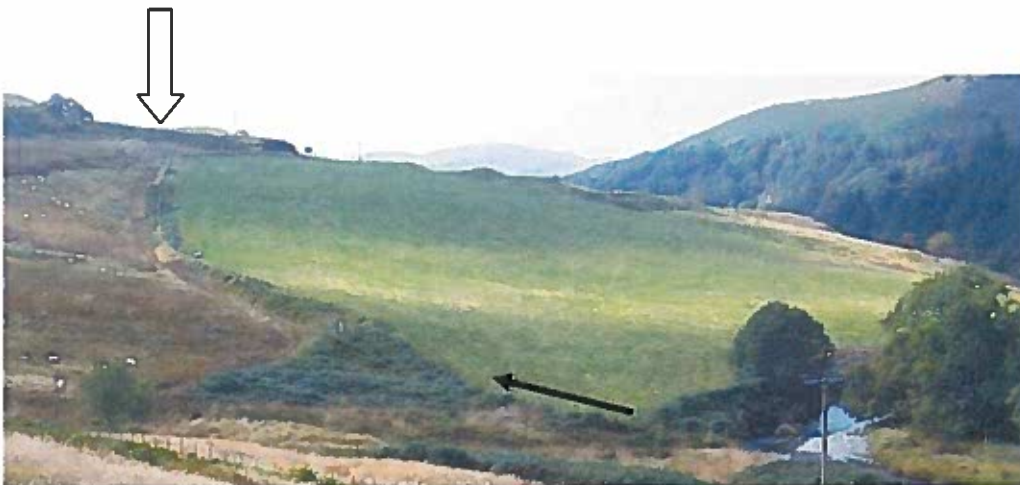
11. E to F BODCOLL MINE CUTTING

This cutting heads roughly towards Trawscoed, but at the top, there are offsets where it meets both the lower and higher routes which made no sense. Why not head straight for the bend? Lidar, however, revealed an old direct route, a small pass through to the higher road which made perfect sense, see arrow and 12 below.

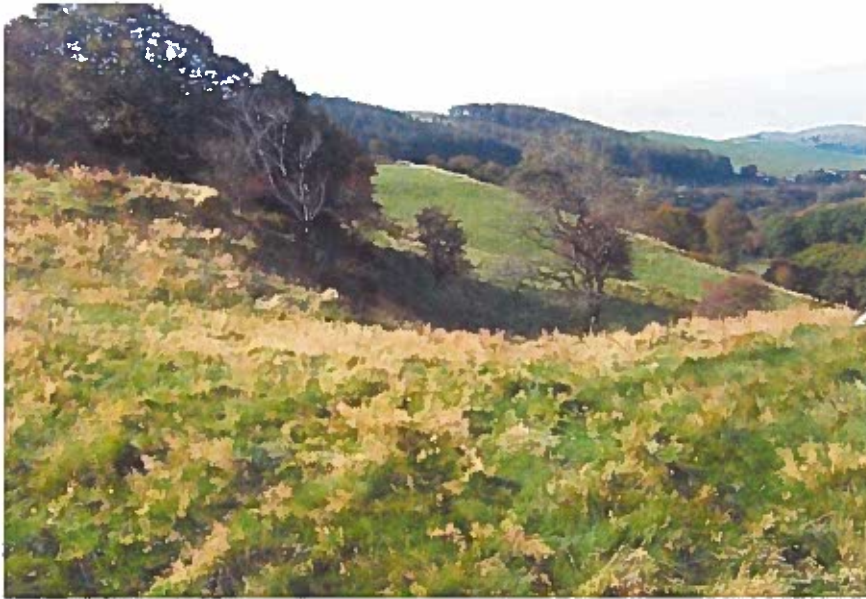
12. pass to higher road, looking SW.

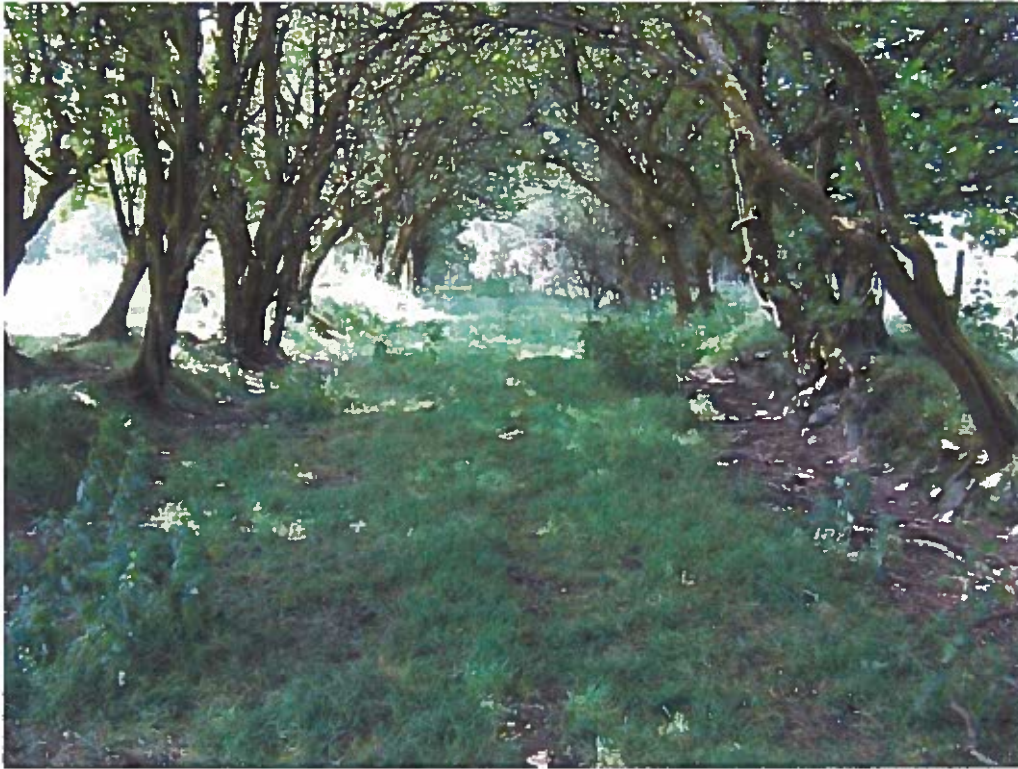
14. ABER BODCOLL WIDE SECTION

The typical increase in width where there is no cutting is shown here on the only visible bit of virtually un-cut road apart from a stretch of possible agger near Trawscoed, which compares favourably in width. The photo looks east, as does the section.

At the west end of this wide section the road changes direction and becomes a narrower cutting as it descends to the Aber Bodcoll ford. A possible reason for this change in direction would be the impassable canyon waterfall it is headed for; another, a reduction in cutting.

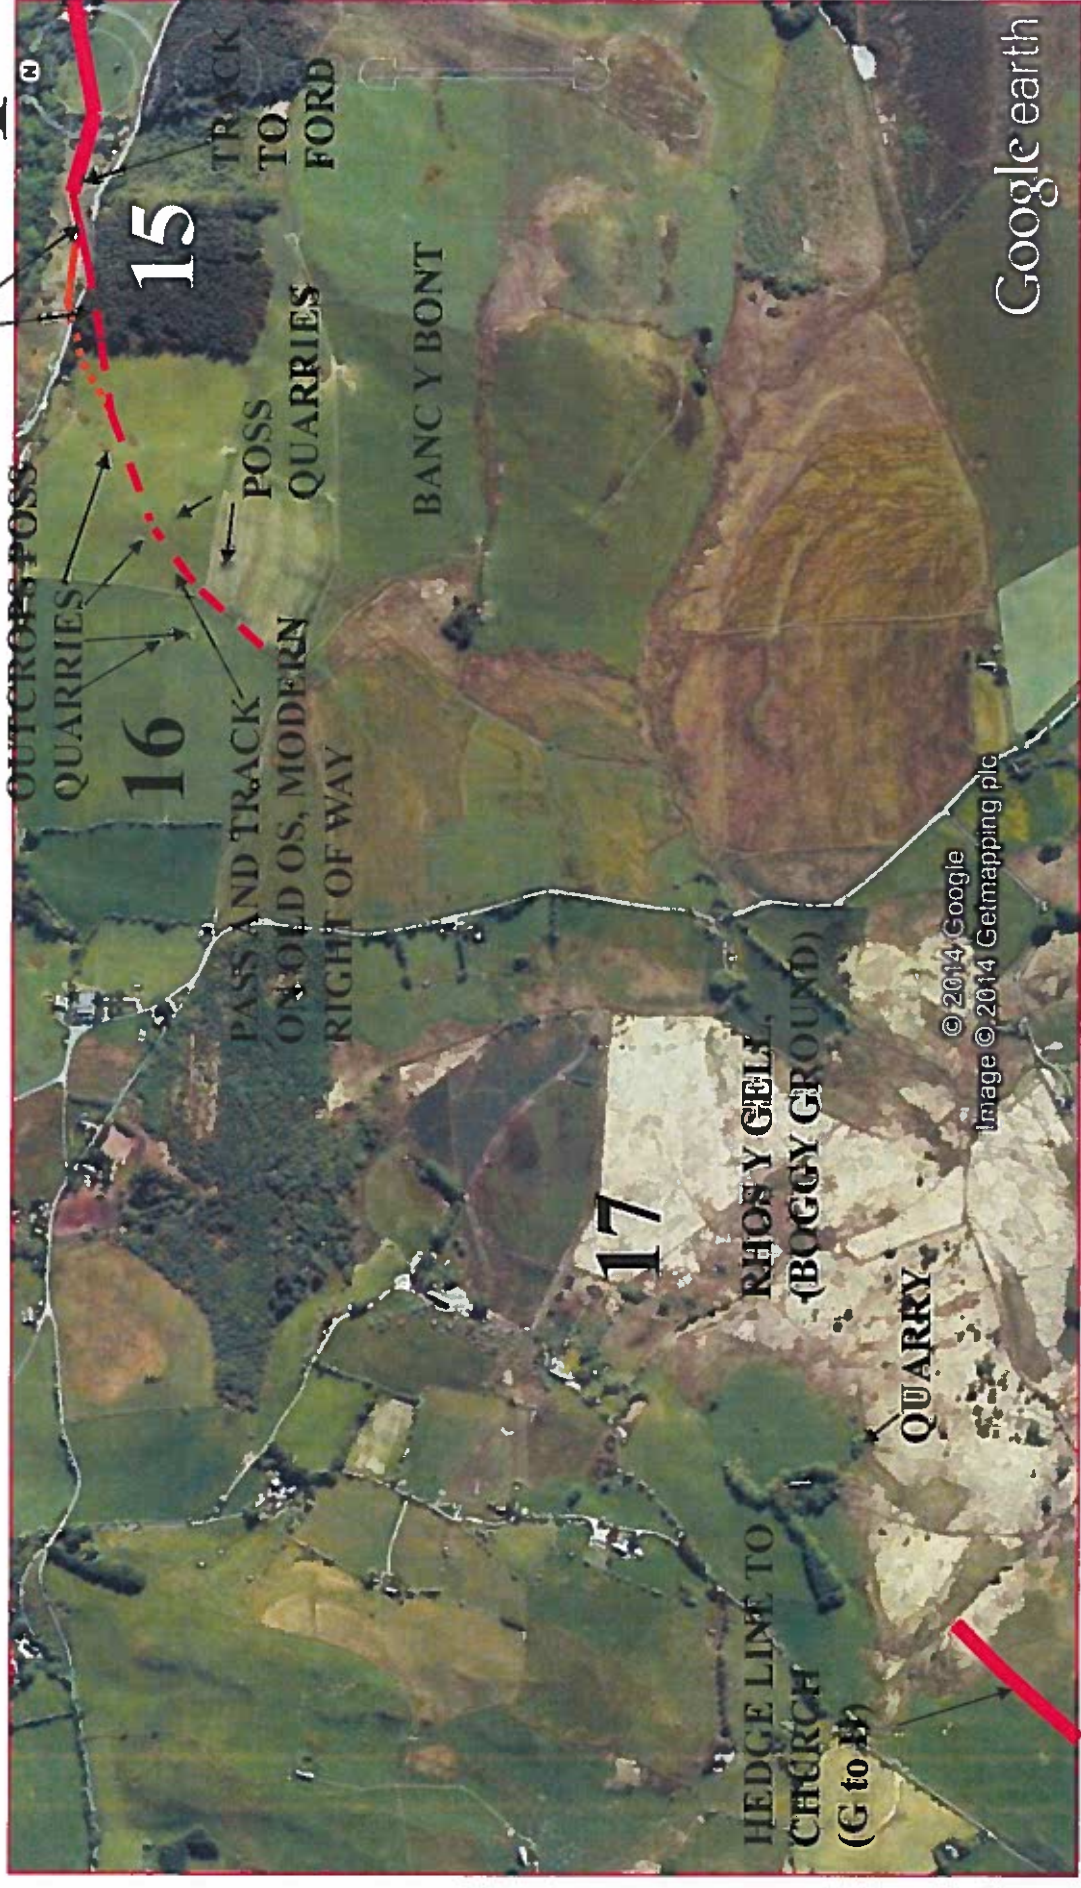
15. F to G. Cuttings each side of B4574

The lane up from Aber Bodcoll meeting the main road from the east seemed to veer too far to the north-west; this was when two old cuttings were discovered, apparently long-abandoned, each side of the road in the same line. Below: looking east towards Aber Bodcoll, track beyond far cutting arrowed.

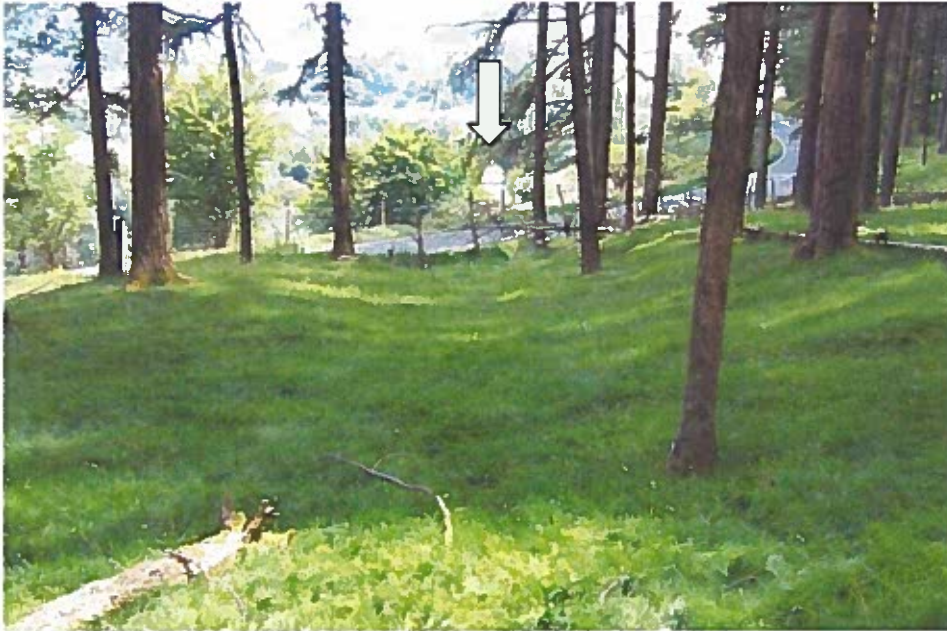
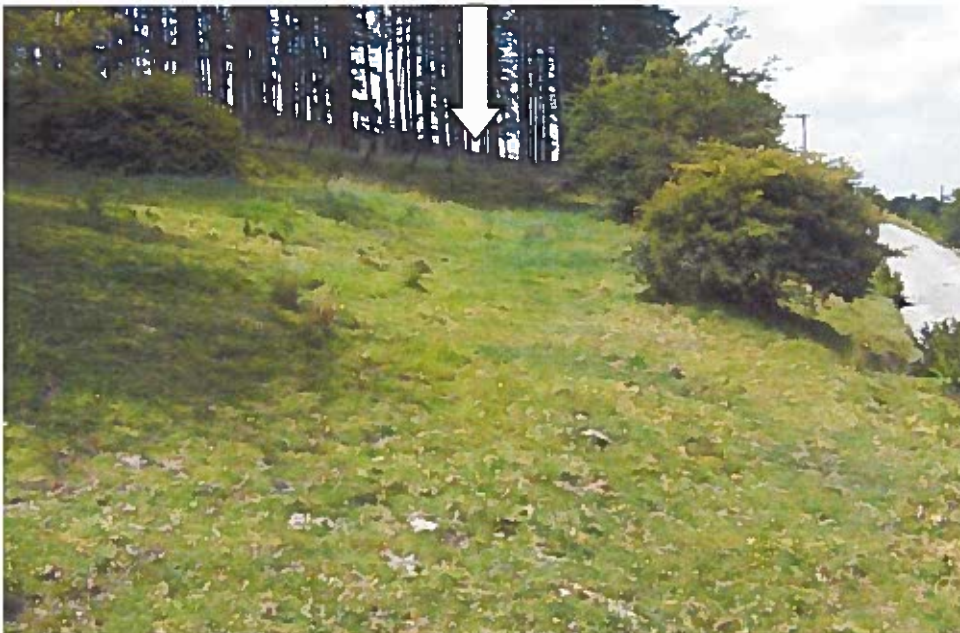
Cutting to left heading for B4574 looking west; modern track to right.

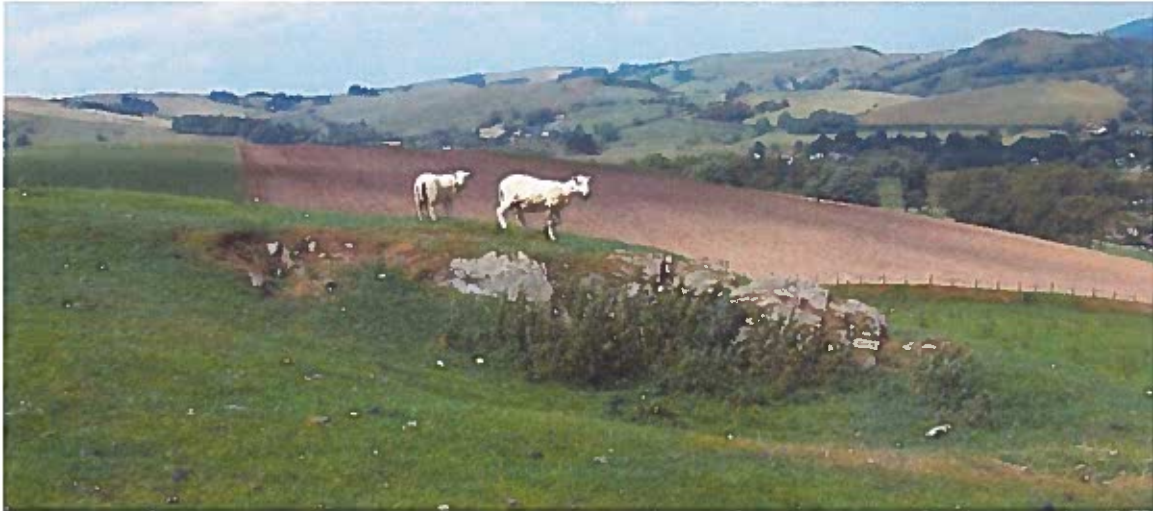
16. BANC Y BONT

Several outcrops exist in close proximity to the old track, now a public right of way over the top of Banc Y Bont, which look as though they might have been quarried.

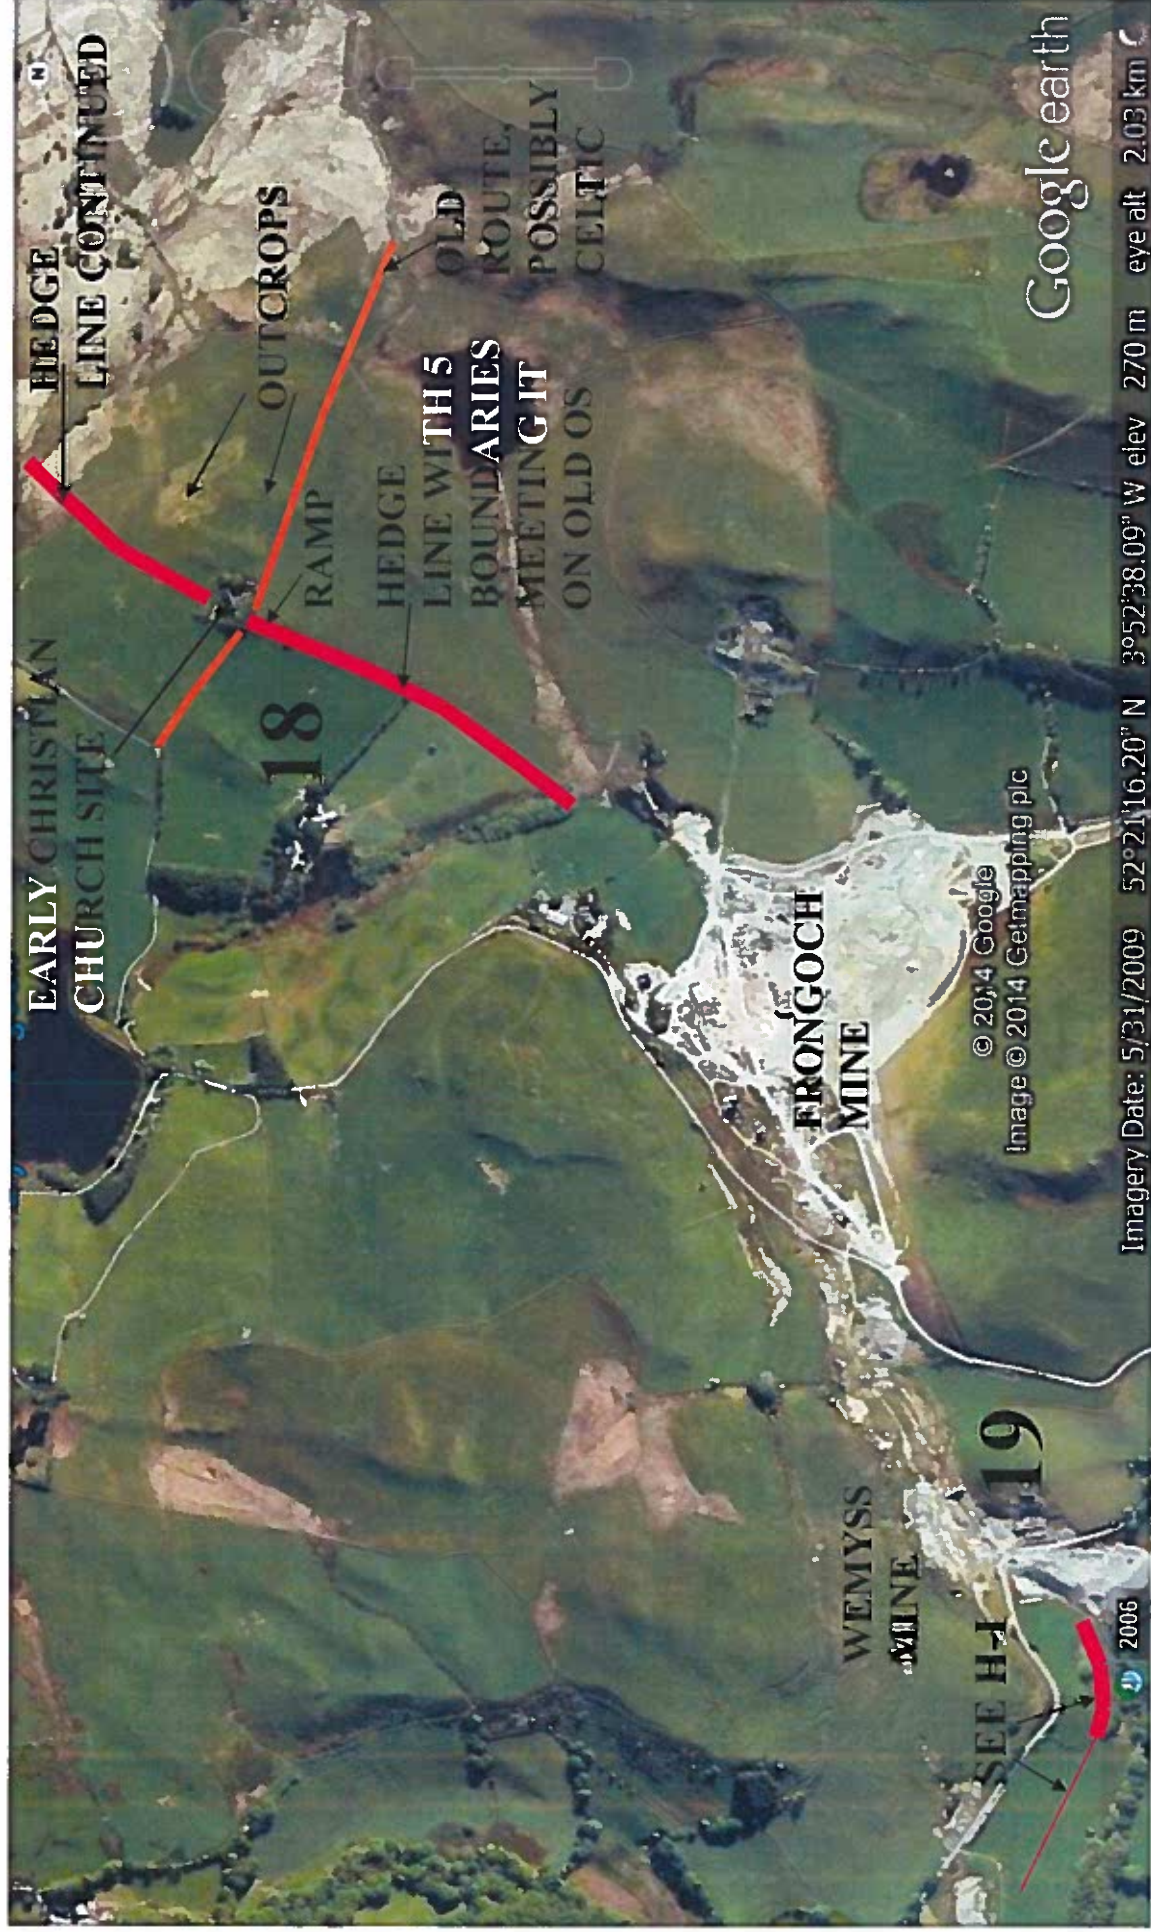
G to H. 18. LLANTRISANT HEDGE LINE

The name of the neighbouring farm, Blaen Pentre, points to the existence of a settlement here and makes the cross-roads more likely. Markings in relief, possible traces of a road associated with the hedge line are found on aerial views both north and south of the church.

Above: looking NE from east of centre boundary, below ditto from west of it. Note bank to west of ramp apparently carved or worn down into the rock.

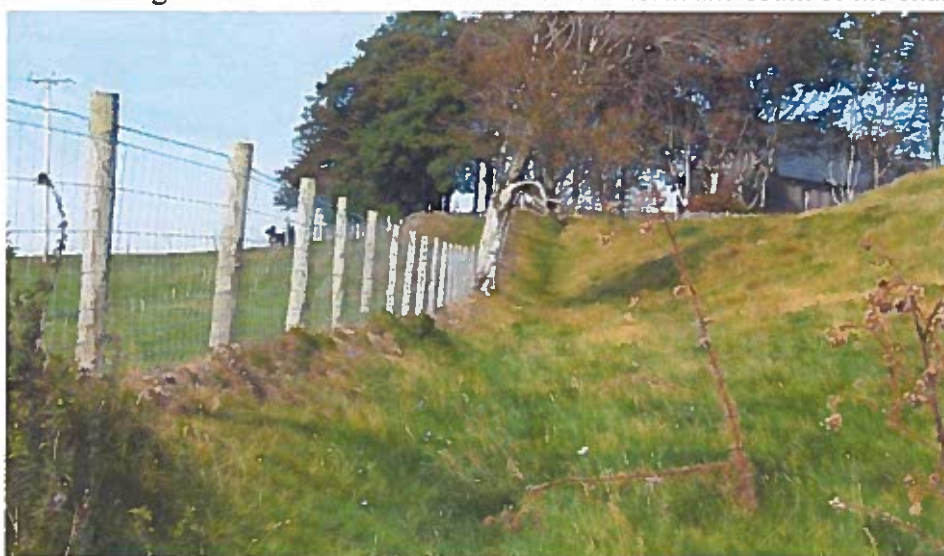
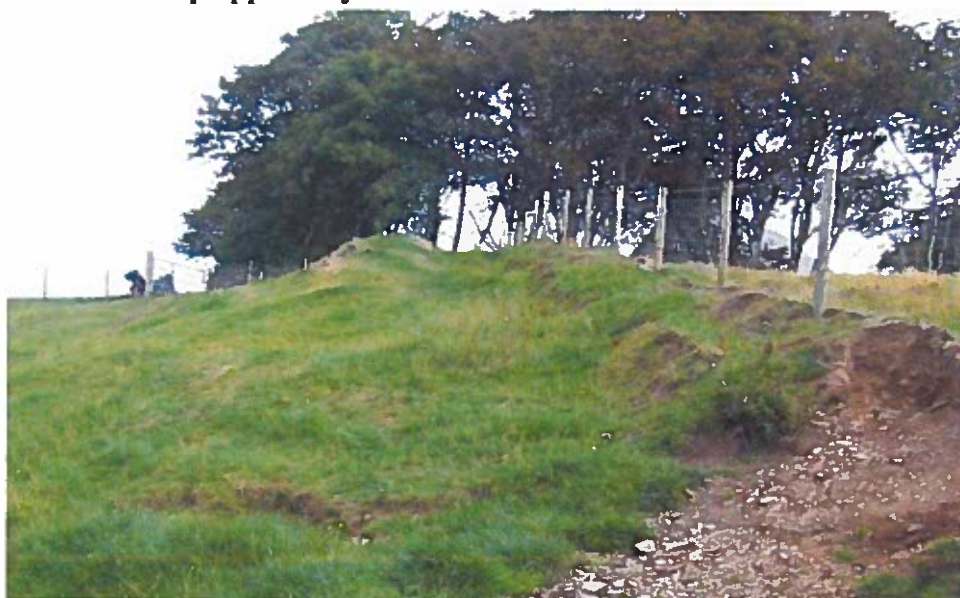
Llantrisant church was rebuilt in 1883 on an Early Christian site. Three Dark-Age crosses were dug up here in 1970. The hedge line which leads up to the church had (on old OS) two boundaries meeting it on one side and three the other, signs of a possible road. Where the hedge-line meets the church site is a rocky ramp with the boundary apparently in the centre, suggesting that the land of the redundant road was shared amongst two neighbouring owners. Both photos look up NE towards the ramp.

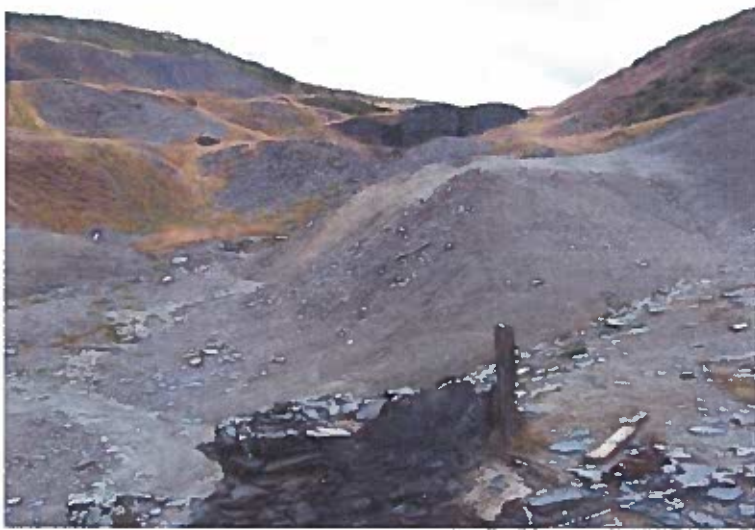
Although there is a route going in the right direction through the old Frongoch workings and the Wemyss mine complex, (see photo of pass above, 19) any actual tracks cannot be considered because the sites have undergone too much upheaval.

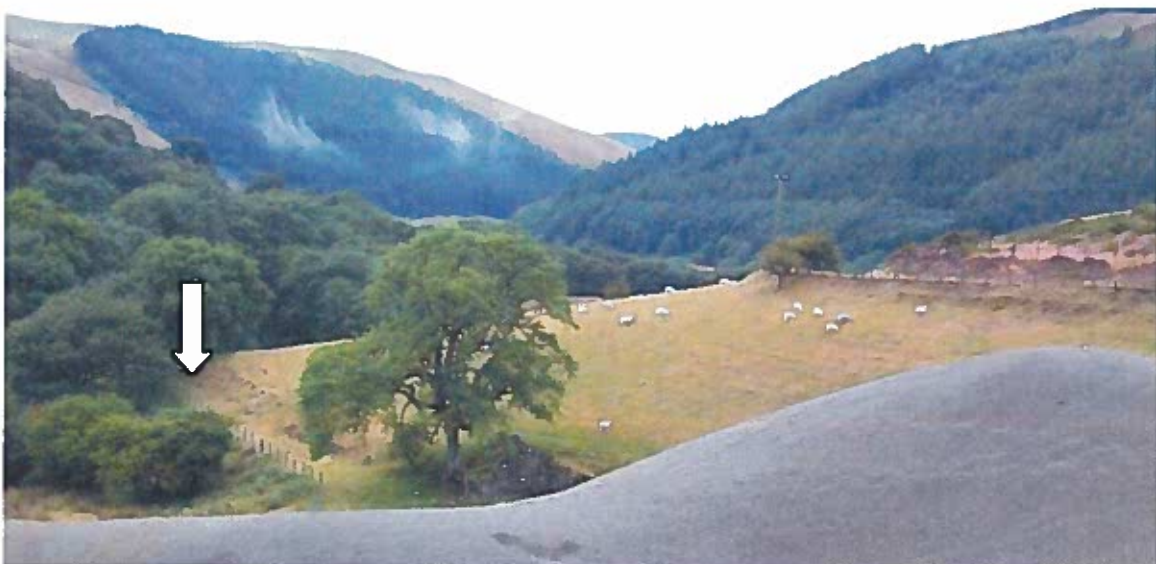
H to I. Wemyss mine cutting

The cutting shown at 20, however, is clear of this, and is significant, because due to its width, it confirms the existence of a bottom road leading into the Cwmnewyddion valley. The tithe map shows an L-shaped access from the upper road down to a (now ruined) house on this road (foreground L of centre) It is likely that this access was made when the Wemyss mine tip needed to block the route down from the east. The cutting has been built up and fenced in more recent times for agricultural access to the area below the tip.

Modern road middle right; old road cutting bottom left (arrowed) and spoil tip in foreground. Cross-section below towards NE.

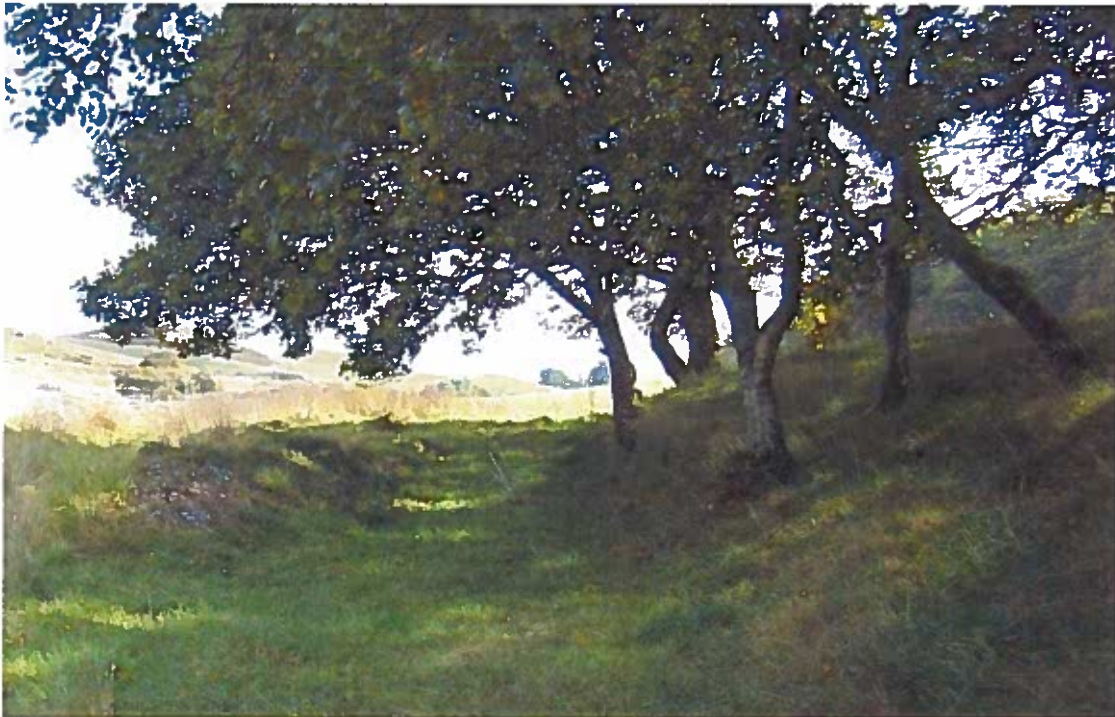
21. FALSE CUTTING AT CWMNEWYDION UCHAF FORD

There is a clear line on Lidar from the Wemyss Mine cutting across the field to the end of a raised promontory which was too much of an obstacle to go through. The projected route goes round the end of this, but so did a tramline in Victorian times, shown on the 1st Edition OS. The cutting shown, with the spoil forming a bank the other side of where the tramline was, may or may not have been modified from a Roman cutting.

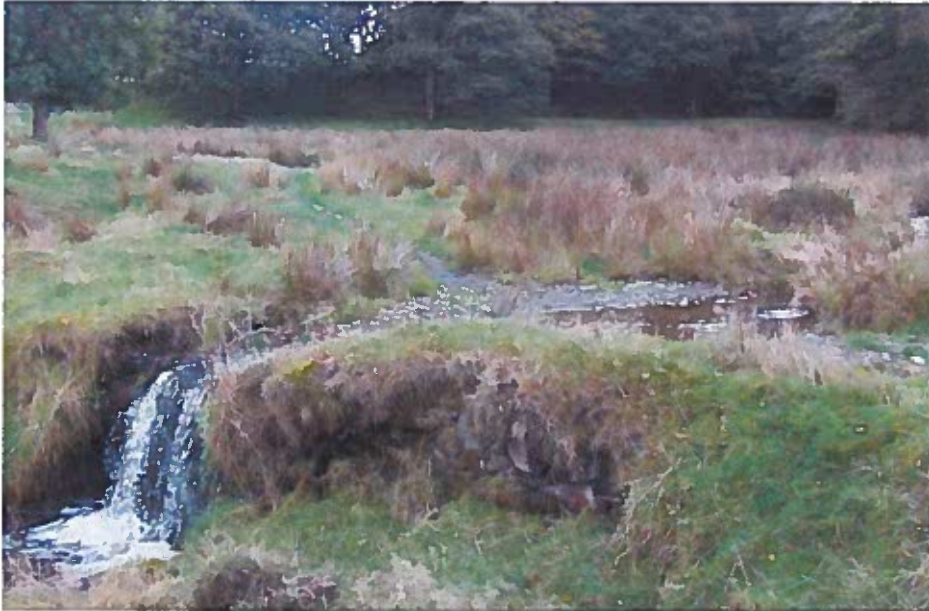
22. CWMNEWYDION UCHAF FORD

This coincides with a continuation of the old bottom road. To mitigate the steep and narrow descent in to the stream, a retaining wall was built at some stage so that the river could be filled and a level ford created which then had plenty of flood storage to keep it shallow. The picture looks east, with the obstacle of the promontory in the background.

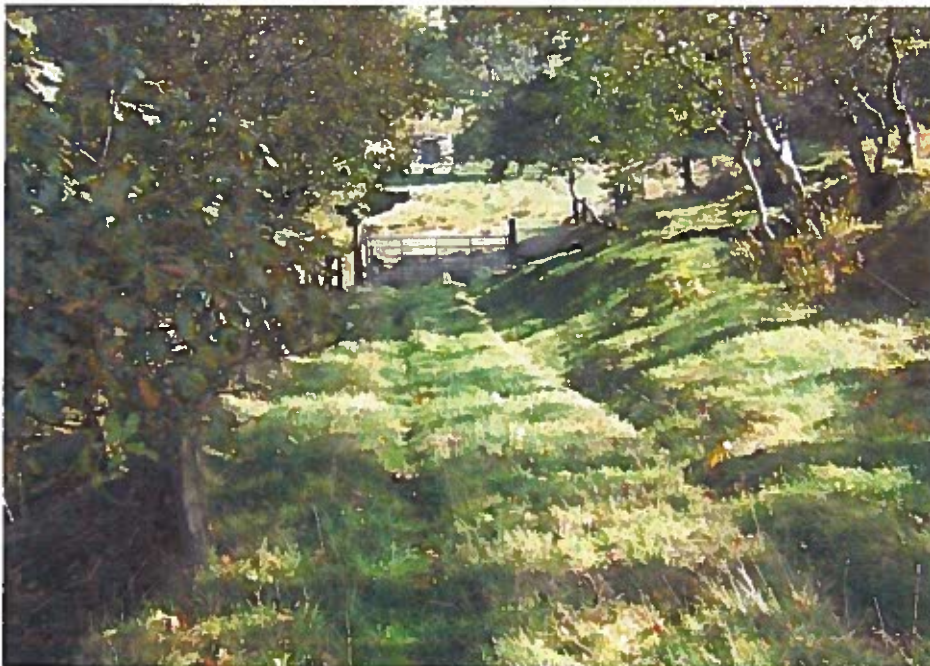
After the ford, the road cuts through a second promontory and heads across the fields to the Red Rock mine. The photo below looks east. The cover photo looks west along the same cutting towards the Red Rock mine and Cwmnewydion cutting (23) in the distance.

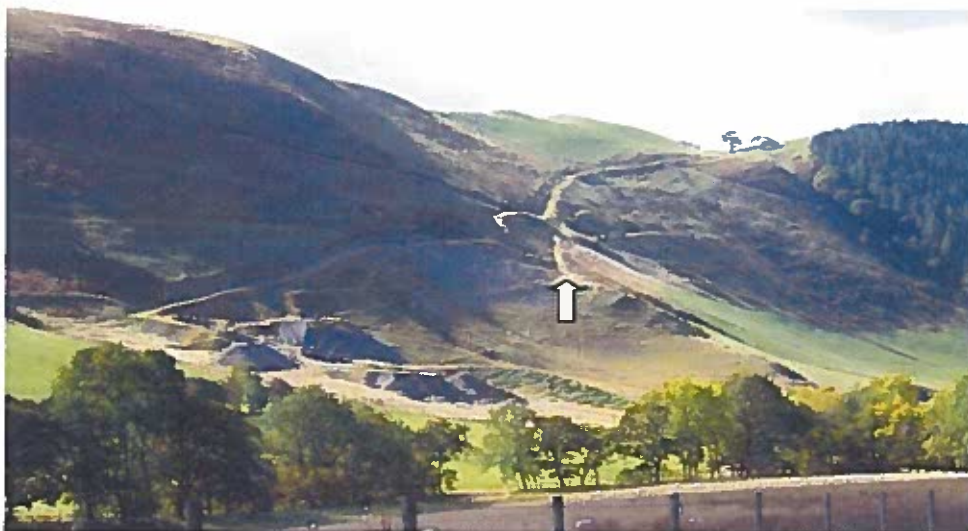
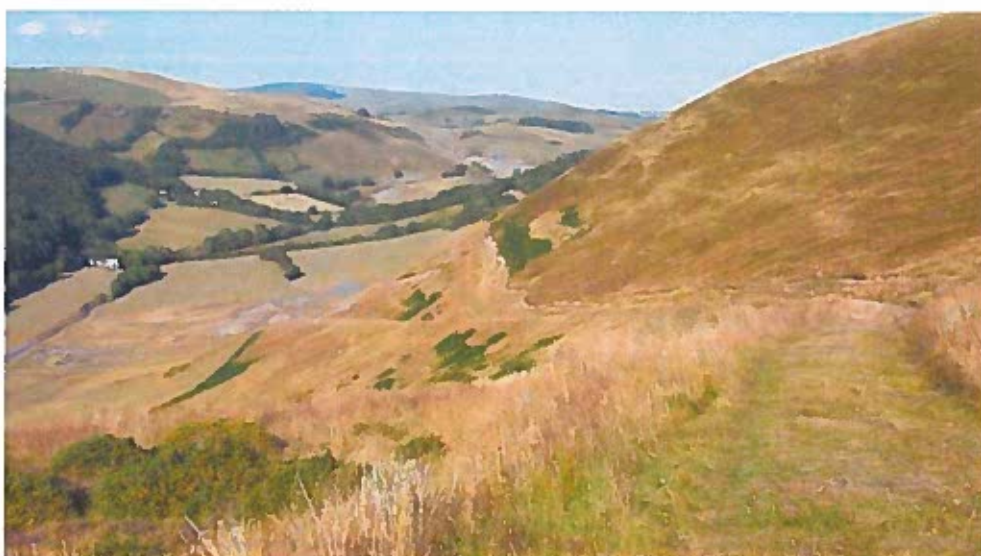
I to J 23. CWMNEWYDION CUTTING

This is an impressive and dramatic descending hillside cutting which unfortunately appears to have been 'tidied up' for occasional access up to the top fields, though without losing its impact. It can be seen on the 1st Edition OS but not the second, presumably because it was no longer a footpath. It is currently a permissive path, accessed through the ruins of the Red Rock mine and via one of the mine cuttings whose formation drowned the bottom part of it, proving that the road came first. Traces of it continue down to the mine buildings, where it is finally totally obliterated.

Branch cuttings headed west show a lack of co-operation; one actually cuts through another leaving it stranded 8' in the air! The T-junction to this steep branch has a 'slip-road' from both directions, suggesting that the main route was live in both directions when it was formed. It is clear, as at Rhiw'r Ordd, that these small ventures were not responsible for the very directional main route.

View towards SW. The lowest visible length (arrowed) descends almost directly towards the viewer. The cutting coming from the left is related to mining. Below looking E.

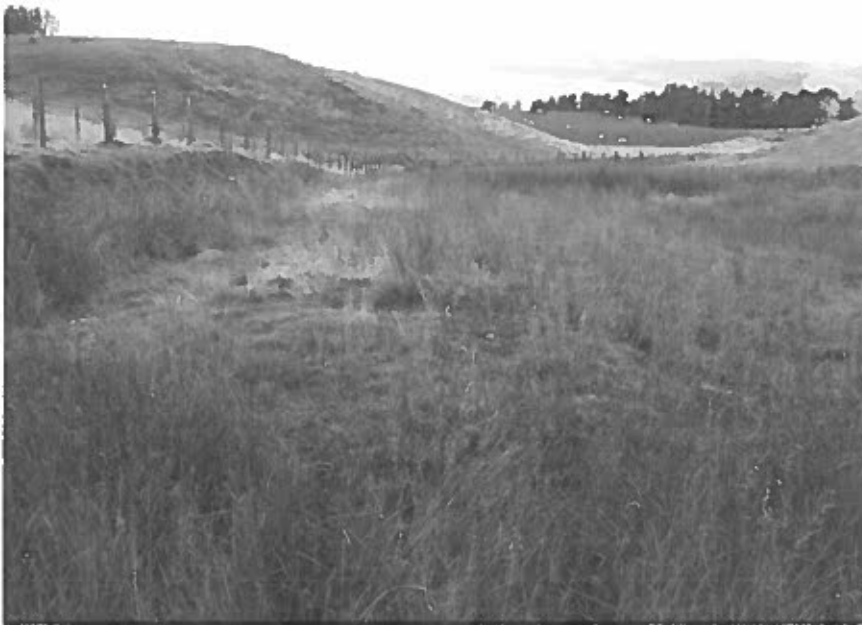
24. AGGER WEST OF BANC CWMNEWYDION

This line of suspected agger heads straight for Trawscoed fort and is in boggy ground. It has become misshapen, apparently collapsed, in some areas, which could mean that it is built off a timber corduroy on boggy ground. I have seen false agger created from the spoil thrown by digging two parallel ditches 6m apart, forming a convincing stone build-up; but in this case there is only one (probably post-Roman) ditch, and the spoil appears to have been used to form the hedgebank. A dig here might well prove the existence of a Roman road and confirm its route.

Photo taken towards Trawscoed. Cross section below drawn looking NE.

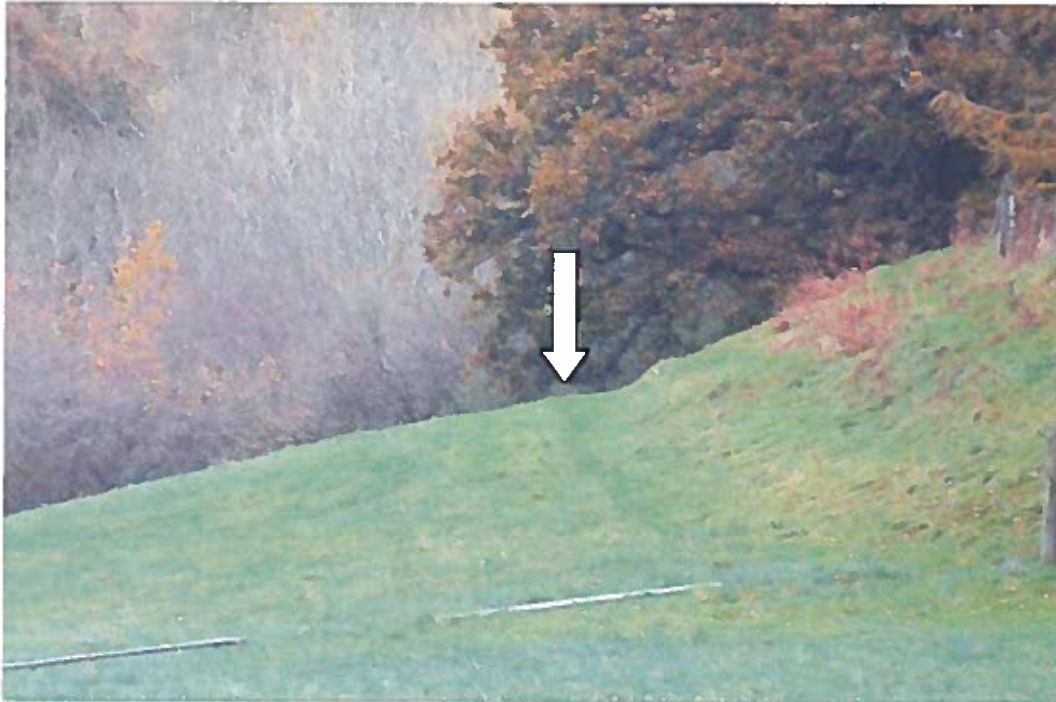
The line at 25 is visible on the ground as well as on aerial views. A straight descent is possible through the wood at this point (avoiding a knoll to the south) to the existing spinal forestry track which runs through it. At the bottom of the track, the present public footpath is un-convincing, being too narrow, but leading off it and roughly parallel to it is an old cutting which runs down until the last point arrowed in the field.

The drawn section was measured in the woodland further to the east. The photo (from west) shows the west end of the cutting in profile against the woodland. Both looking NE.
