St Dogmaels Abbey, Pembrokeshire

Archaeological Evaluation and Excavation

Report No. 1202

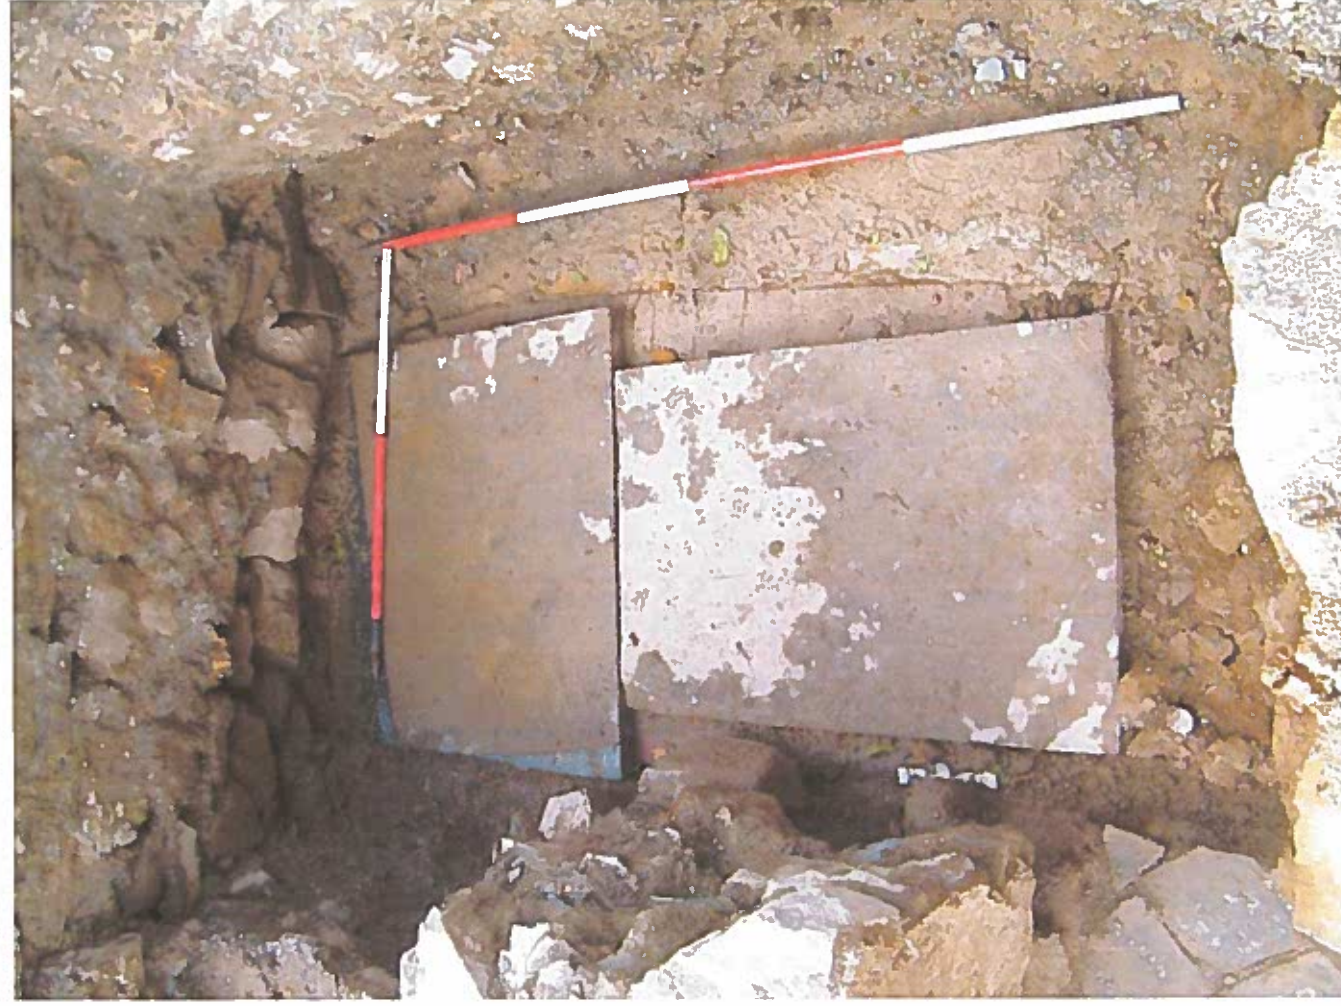
Fig. 12
Brick lined grave
at the base of grave
{115}

Looking west

Scale = 1m and 2m

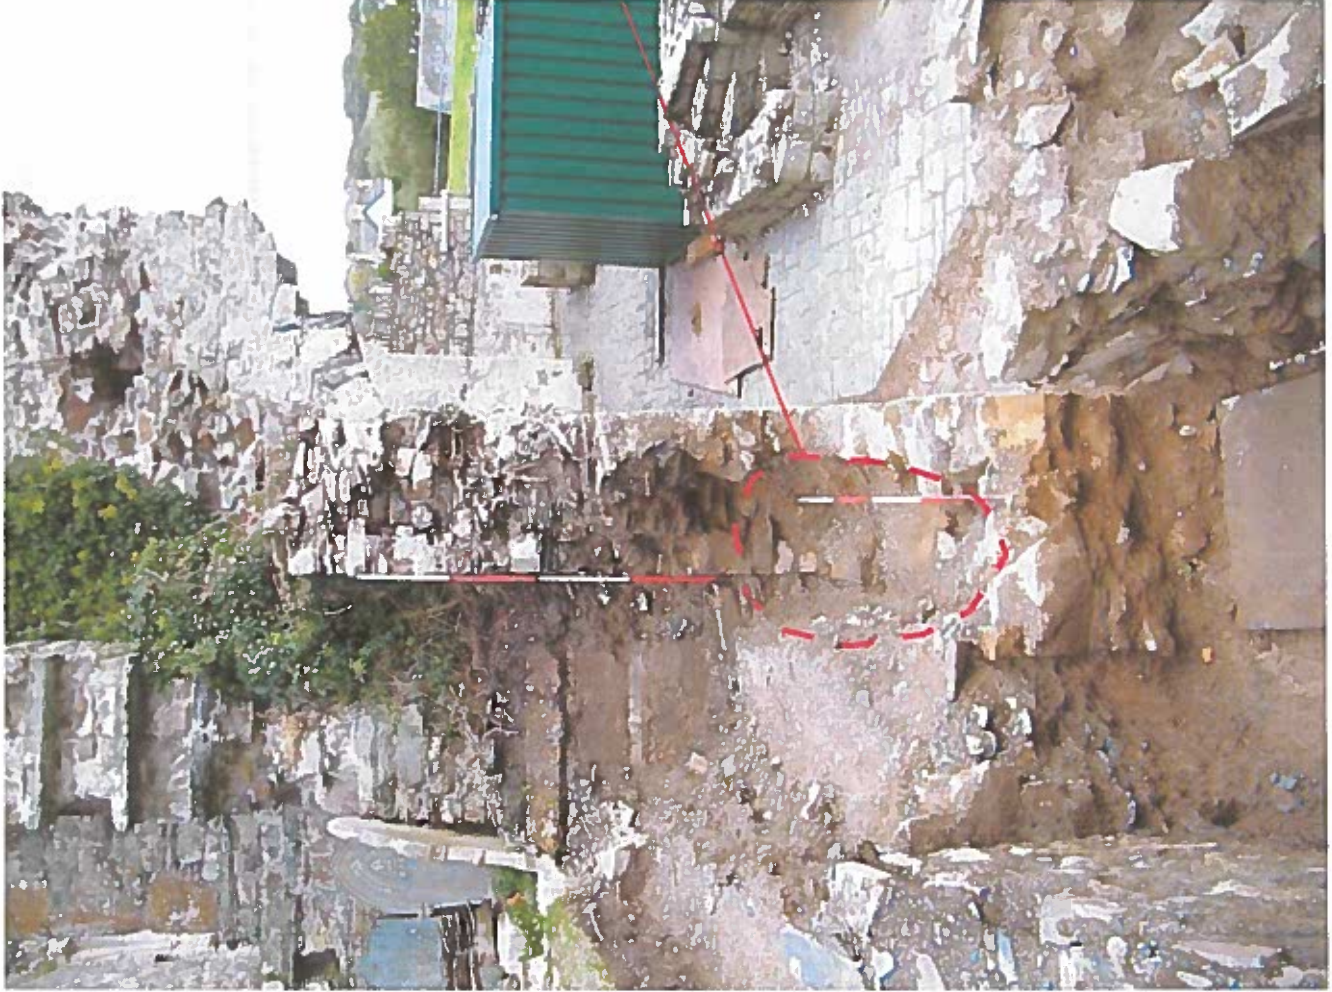
Fig. 14
Location of burial
(117) cut into the top
of the medieval wall
and detail in plan

Looking east

Scale = 2m

nails, and three metal coffin handles were also recovered. The body is thought to be that of Thomas Lewis who was buried in this location in 1822, according to the plan of the graveyard supplied by the Church Warden. The remains were lifted and carefully stored prior to reburial.

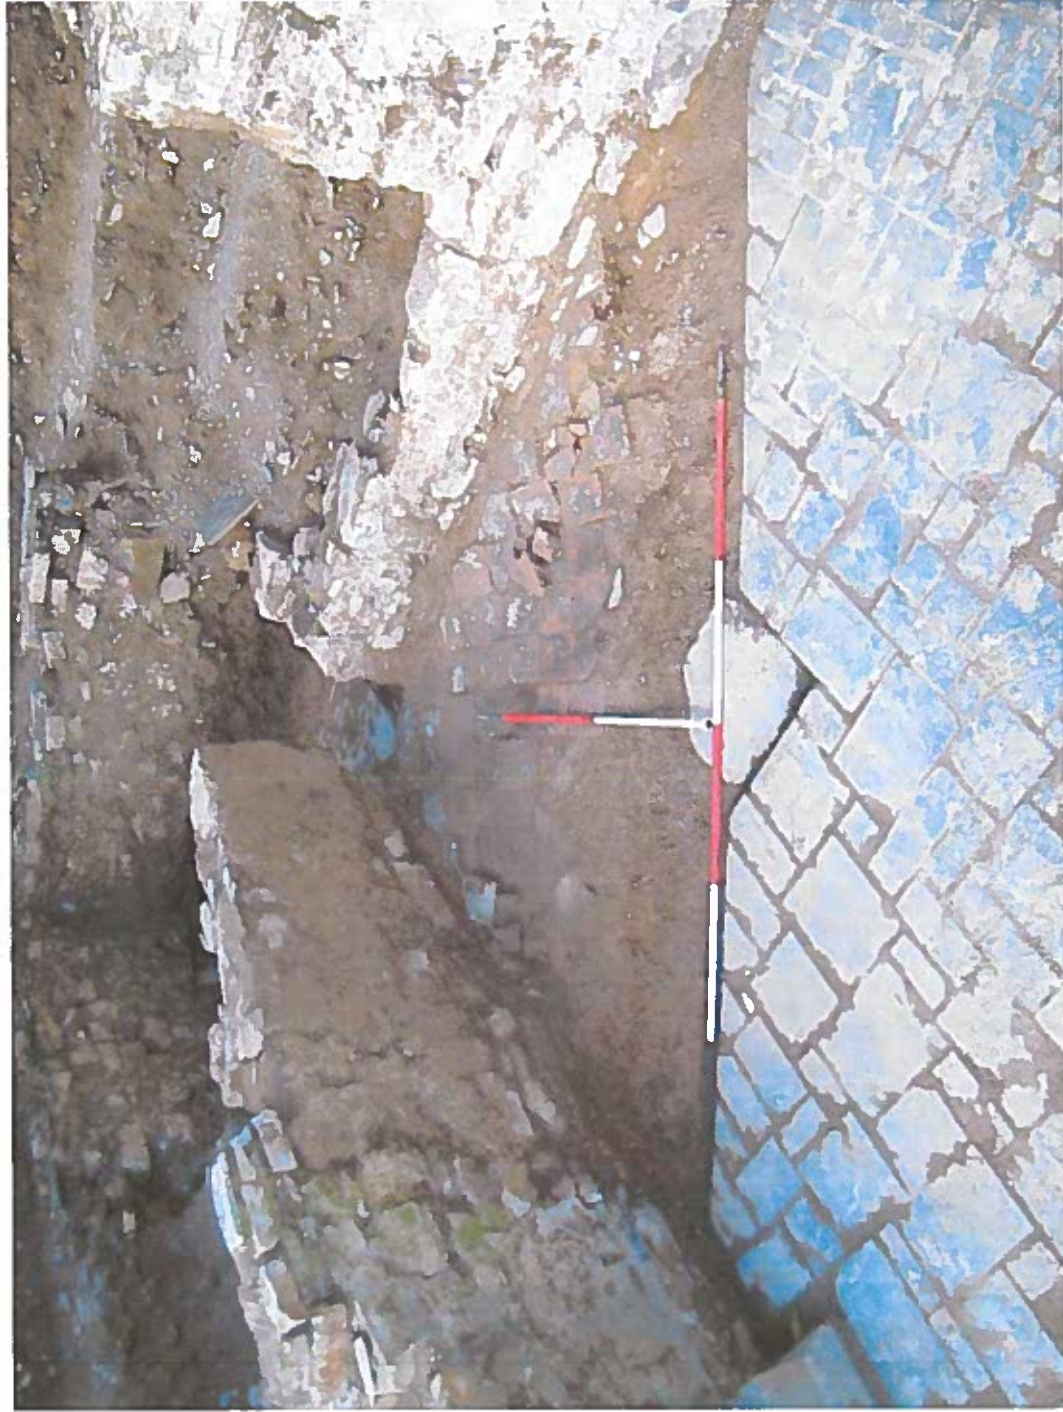
Fig. 16
Medieval floor tiles
in situ in the corner
of the nave

Looking north-west

Scale = 1m and 2m

In the triangular shaped area between the two medieval walls and the line of the diagonal graveyard wall a layer of in situ medieval floor tiles was found below the deposit of made ground (fig. 16). These would have lain inside the nave of the medieval church. The tiles were square, measuring 0.2m by 0.2m and had green glaze on their upper surface. They were set in a diamond pattern, similar to that seen elsewhere in the church. The tiles were set in a layer of lime mortar and were well preserved. A noticeable depression in the centre of the tiled area, orientated east/west, could mark the location of a burial, although there was nothing to confirm this on the surface. The tiles were left in situ, protected from the building work, and will hopefully be preserved.
