Kidwelly Castle, Kidwelly, Carmarthenshire

Archaeological Watching Brief and Evaluation

Report No. 1197

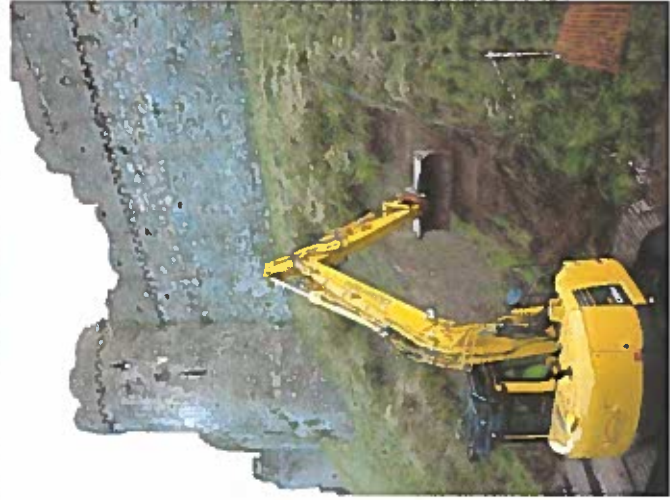
b. Landslip area under excavation

Prior to the creation of the platform, a 0.4m wide trench was excavated through the slumped material to a depth of 0.3m to ensure that the surface of the moat was not disturbed. This revealed that the slumped material comprised a mix of dark brown, silty loam topsoil and brown silty clay. A pipe was installed within the trench to aid drainage and then covered over with the original excavated slump material. A terram sheet was laid over the top of the spoil and railway sleepers placed above that in order to preserve the moat base and sides.

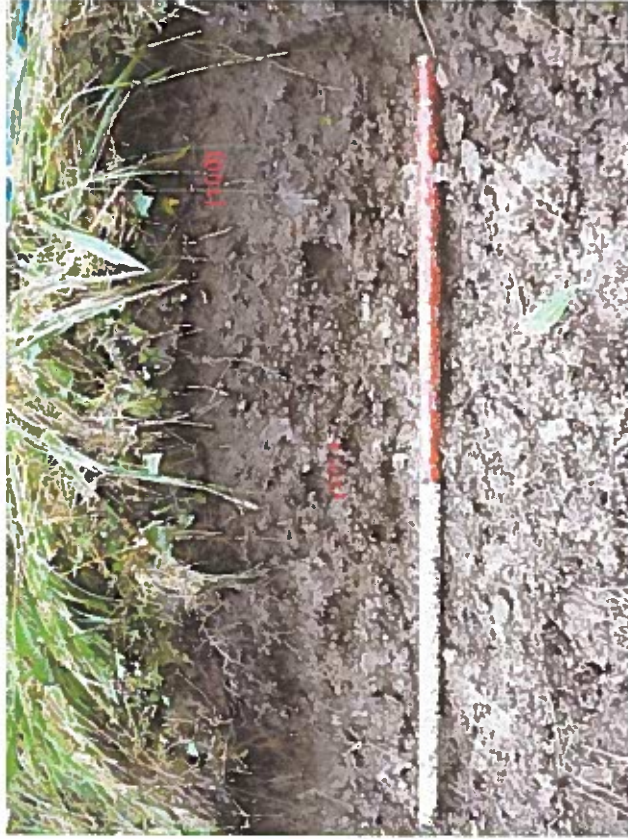
Fig. 3
Landslip area

The excavation of the site of the Motte mound revealed that it comprised a dark brown silty loam topsoil (100), 0.2m deep, directly below the turf. This overlay a mid-brown silty clay (101) that was tentatively identified as the up cast spoil from the creation of the castle moat and was excavated to a depth of 0.12m (fig. 3).

c. Section through exposed Motte. Scale = 1m

The slumped area of the castle mound revealed a 0.2m thick band of silty loam topsoil (100) that extended throughout the monitored area. This lay directly above a mid-brown silty clay (101), a deliberate dump deposit of up cast material from the construction of the moat. This deposit makes up some of the artificial mound that Kidwelly Castle was built upon. The extent of the slumping has only had a minor impact upon this silty clay deposit (101), removing the upper surface but leaving the remainder, which is compact and stable, in situ. No finds were recovered during the excavation of the slumped Motte material and no dating evidence found. A modern clay drain pipe was discovered in the northeast corner of the working area on the castle mound, but did not extend down the bank.
