Ystwyth Hydro-Power Scheme

Archaeological Assessment

Report No. 366

Prepared for Shawater Ltd.

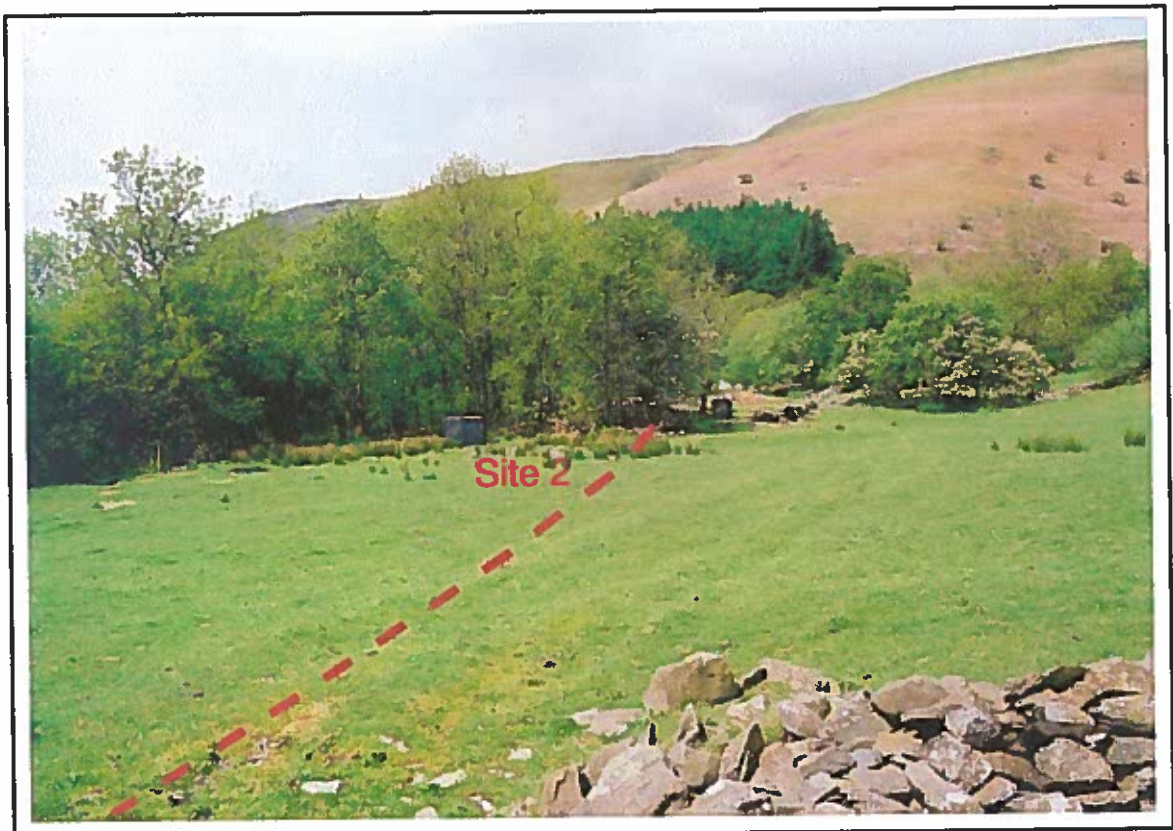
Immediately east and partly overlain by the upstanding remains of Troed-y-rhiw are the remains of a rectangular structure, surviving as partially grassed over stony banks <0.25m high, associated with other, slighter linear features to north and west. The structure, some 10m x 4m overall, appears to be sub-divided internally. It is scarped into what appears to be a lynchet running across the gentle south-facing slope, and forms part of a curving bank around its north-west corner.

Despite its proximity to the other remains at this location the structure is provisionally interpreted as a long hut of the medieval period, situated within an area of relict fields.

Figure 1: Showing site 2 - rectangular structure east of Troed-y-rhiw and the proposed route of the pipeline.

Recommendations for mitigatory measures: Avoid

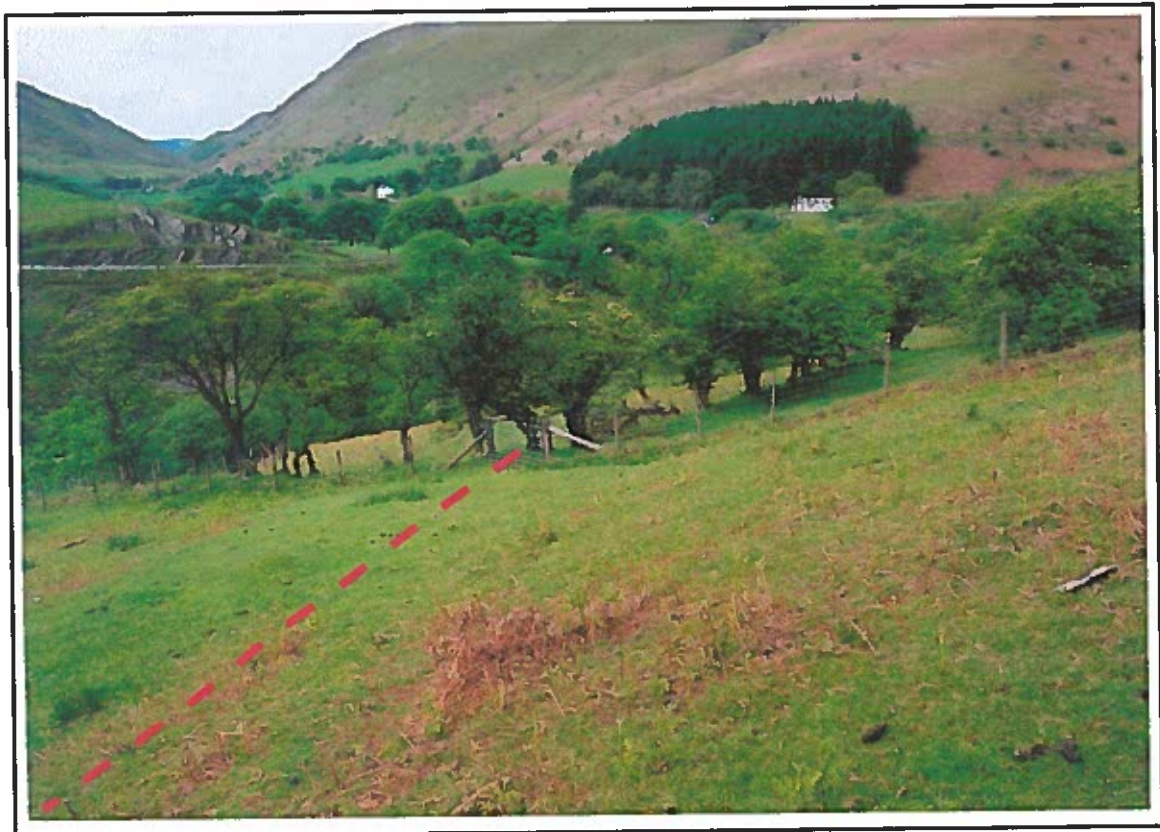
Figure 2: Showing the proposed route of the pipeline east of Troed-y-rhiw.

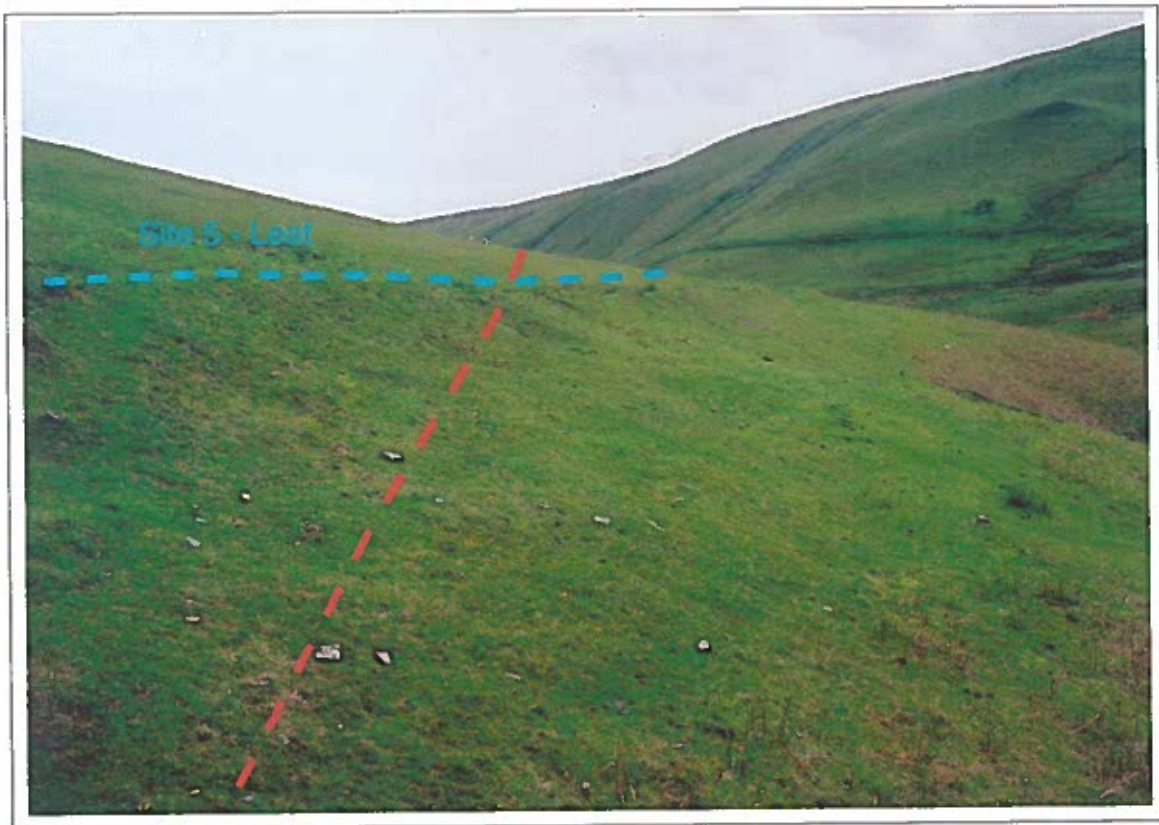
Within the study area the leat winds across the lower slopes of Yr Allt, above the *Afon Ystwyth*, between the 330m (see feature 9) and contours 300m (this location), approximately. For much of its length the leat is simply scarped into the south-facing slope, with a retaining bank up to 2.5m wide at the base, downslope. On steeper ground the bank is stone faced and built up. The channel survives between 1.6m - 2m wide, and is on average 0.7m deep. The leat once carried water to power the lead mills below *Bryn Copa* at SN 805 747.

Figure 3: Showing the proposed route of the pipeline and site 5 - leat.

Recommendations for mitigatory measures: Basic recording

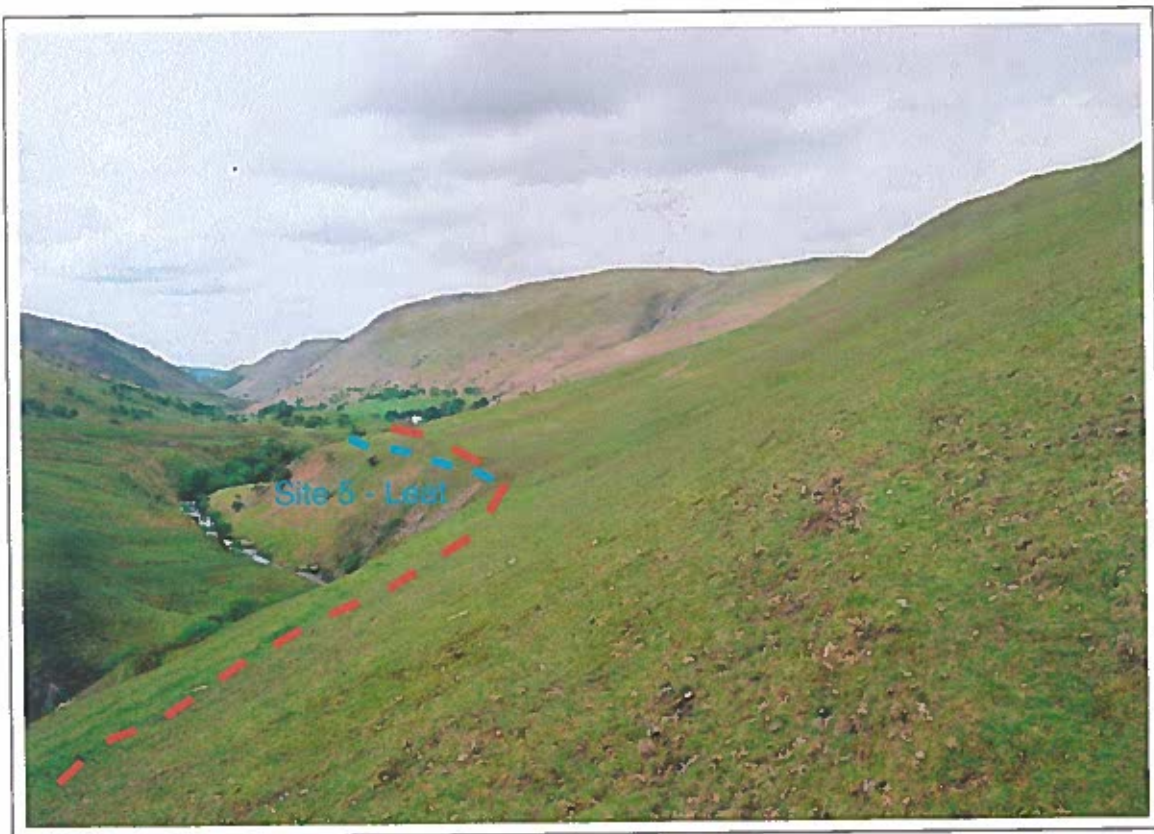
Figure 4: Showing the route of the proposed pipeline along Yr Allt.

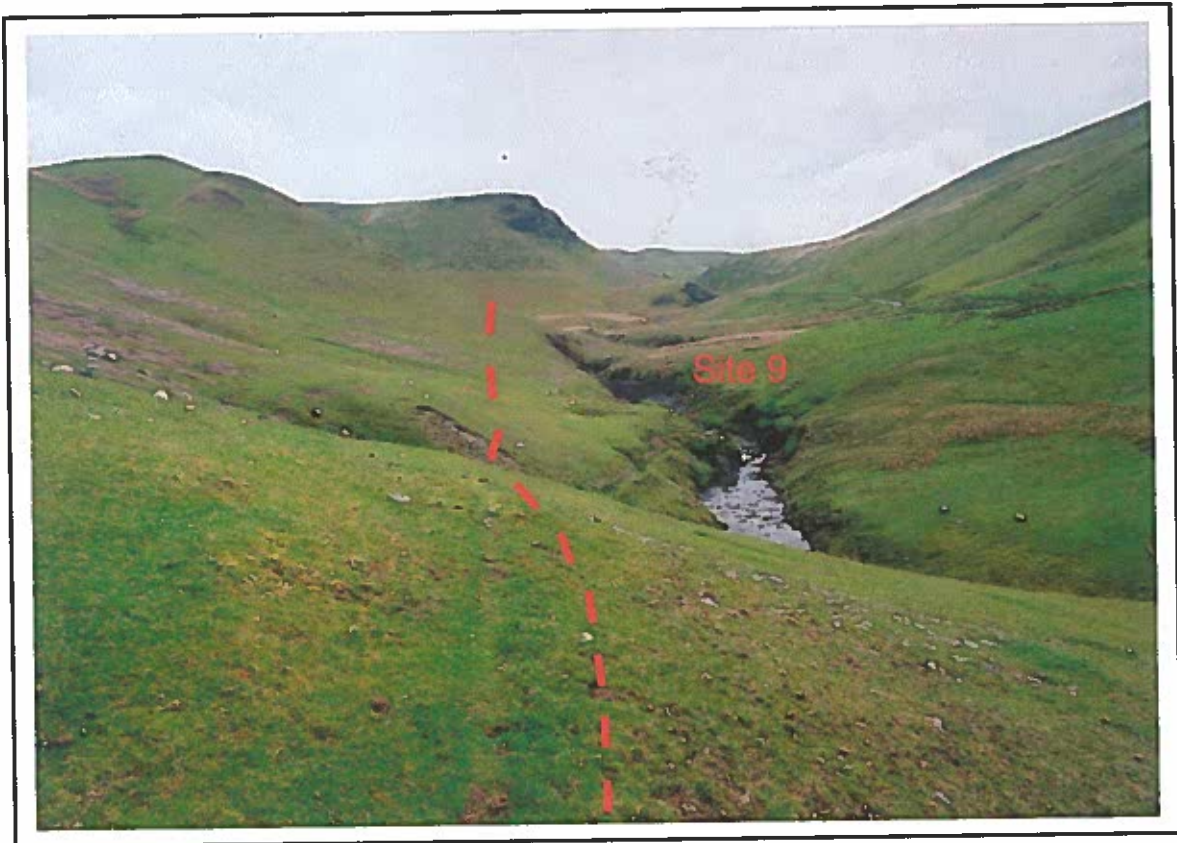
Constructed of mortar bonded stone, this feature is the intake point for the leat (3). The feature spans the width of the Afon Ystwyth, being some 25m across, the river being channelled through a bridge arch at the south-south east end of the bridge/weir. The span of the bridge and the weir wall are on slightly different alignments, being bonded via a buttress situated on a prominent outcrop in the river, and presumably being the reason for the siting of the bridge in the first place. The masonry of the present structure evidences two distinct phases of construction, that of the weir wall and of the bridge arch itself.

Figure 5: Showing the route of the proposed pipeline and site 9 - bridge and weir.

Recommendations for mitigatory measures: Avoid

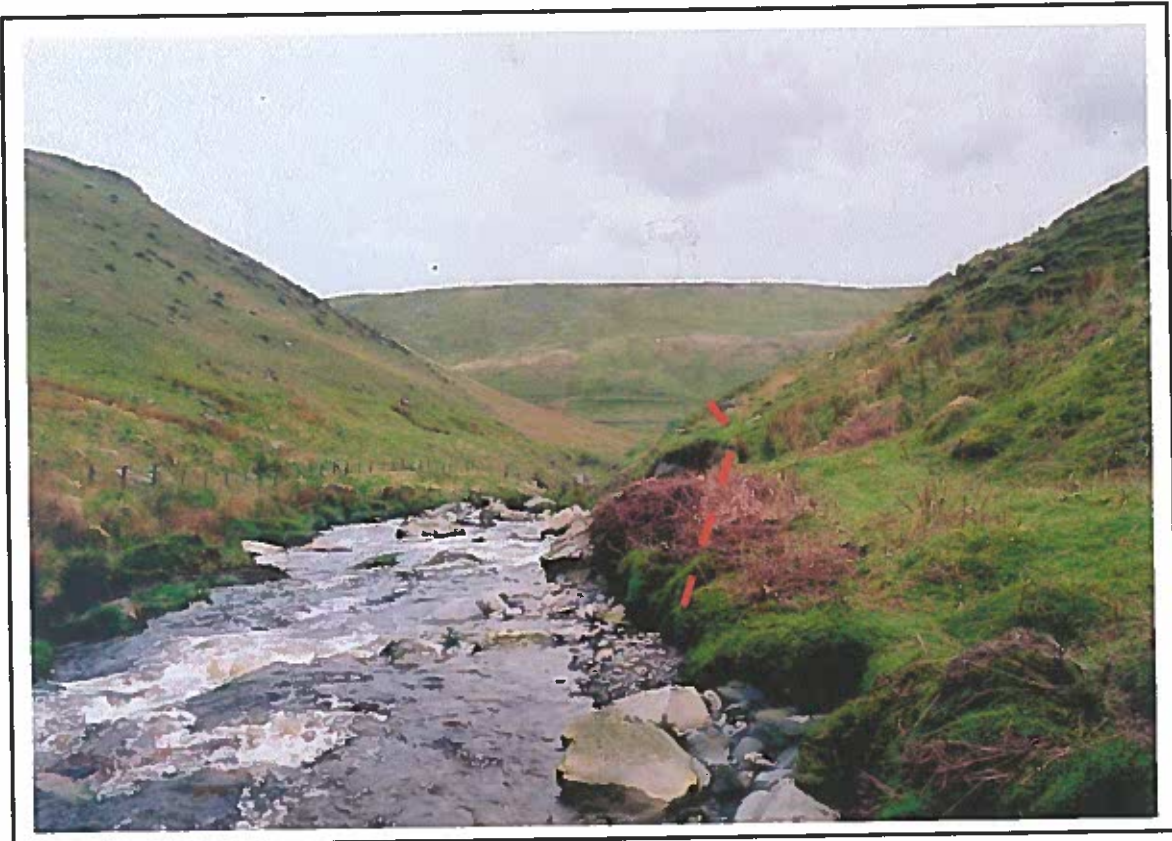
Figure 6: Showing the route of the proposed pipeline and the location of the proposed intake.

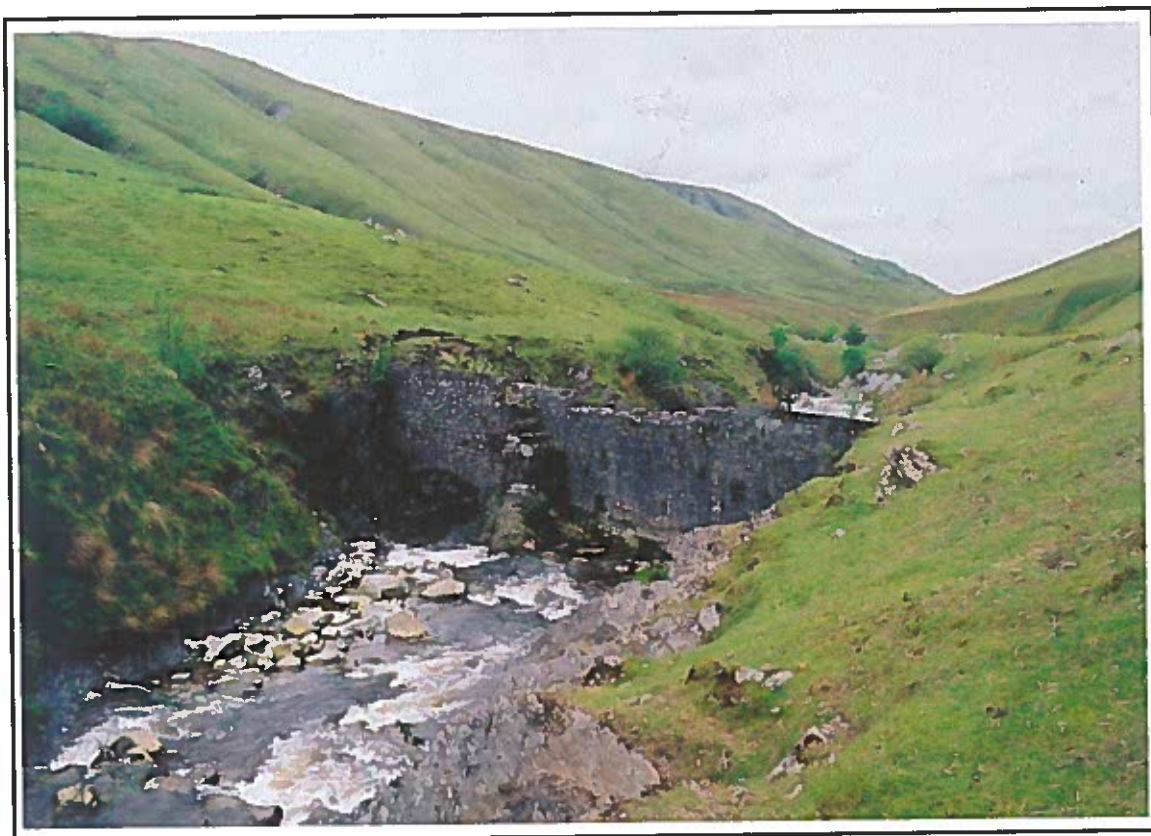
The weir wall has three distinct openings in it, each below mid-height, two being square, although of differing sizes, and one consisting of an arrangement of four iron pipes grouped together at the north end of the wall, close to the bank. This latter arrangement originally supplied the leat at this location, the other openings being interpreted as sluices. Both weir and bridge are some 5.5m high and 1m wide, with a walkway along the top.

Figure 7: Showing site 9 - bridge and weir over the Afon Ystwyth.

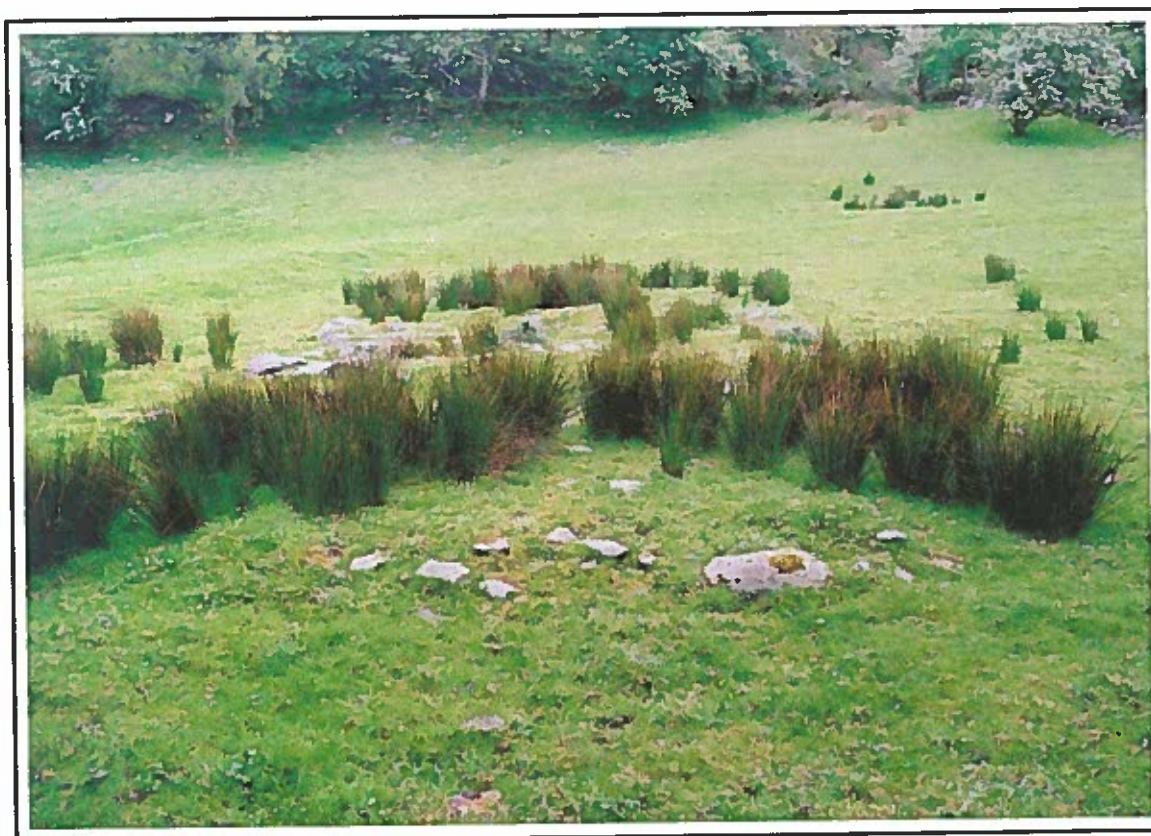
Figure 8: Showing site 2 - rectangular structure, east of Troed-y-rhiw
