Access for All 2000 Project  
Tenby Museum & Art Gallery  
Castle Hill, Tenby, Pembrokeshire

## Watching Brief

Deborah-Anne Wildgust BA (Hons) PIFA  
August 2000

**Watching brief for work on  
Access for All 2000 Project  
Tenby Museum & Art Gallery, Tenby, Pembrokeshire**

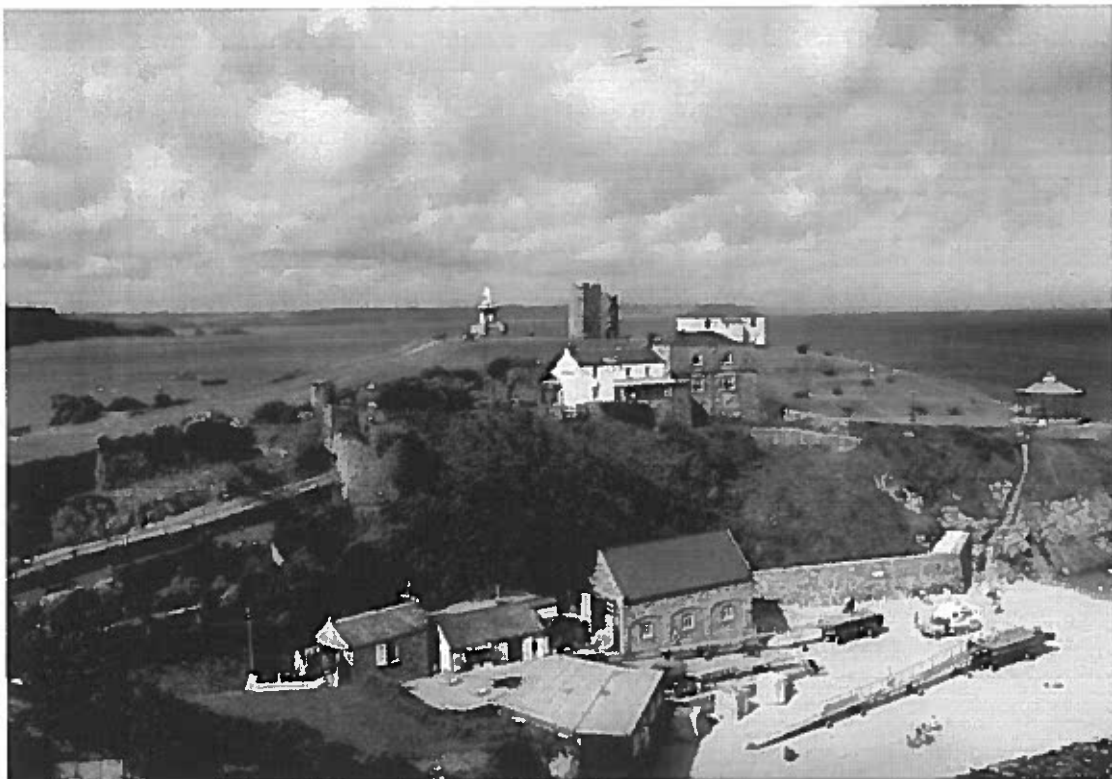
1. Tenby Museum & Art Gallery and Castle Hill, 1994  
Showing majority of extant remains of Tenby Castle  
TM&AG archive collection

Tenby Museum & Art Gallery is situated on the Castle Hill which forms the promontory divide between the south and north parts of the ancient walled port and town of Tenby. (**illustration 1**) It is possibly the site of an Iron Age promontory fort and the site of an early Welsh stronghold of the Princes of Dyfed. The site of Dinbych-y-Pysgod (Fort of the Fishes) is mentioned in a ninth century poem in The Book of the Taliesin which described the funerary feast of one of the Princes killed in battle. Castle Hill has always been assumed to have been the site of this 'Fortress above the Sea' described in the poem.

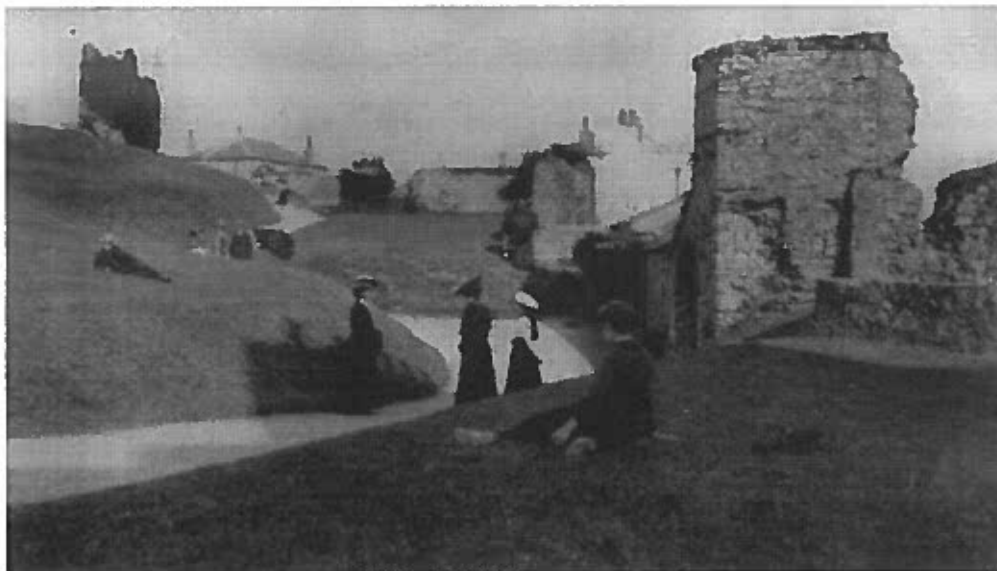
5. Old Castle walls to the rear (north) of the museum building, cottage & public toilets, c.1900  
TM&AG archive collection

By 1878 the National School had moved to the south of the town walls and a local committee sub-leased the school site from the leaseholders (the Philipps family of Picton Castle) for the Tenby Local Museum. The museum has occupied the site since that date but has been refurbished and extended several times (**illus. 4, 5**).

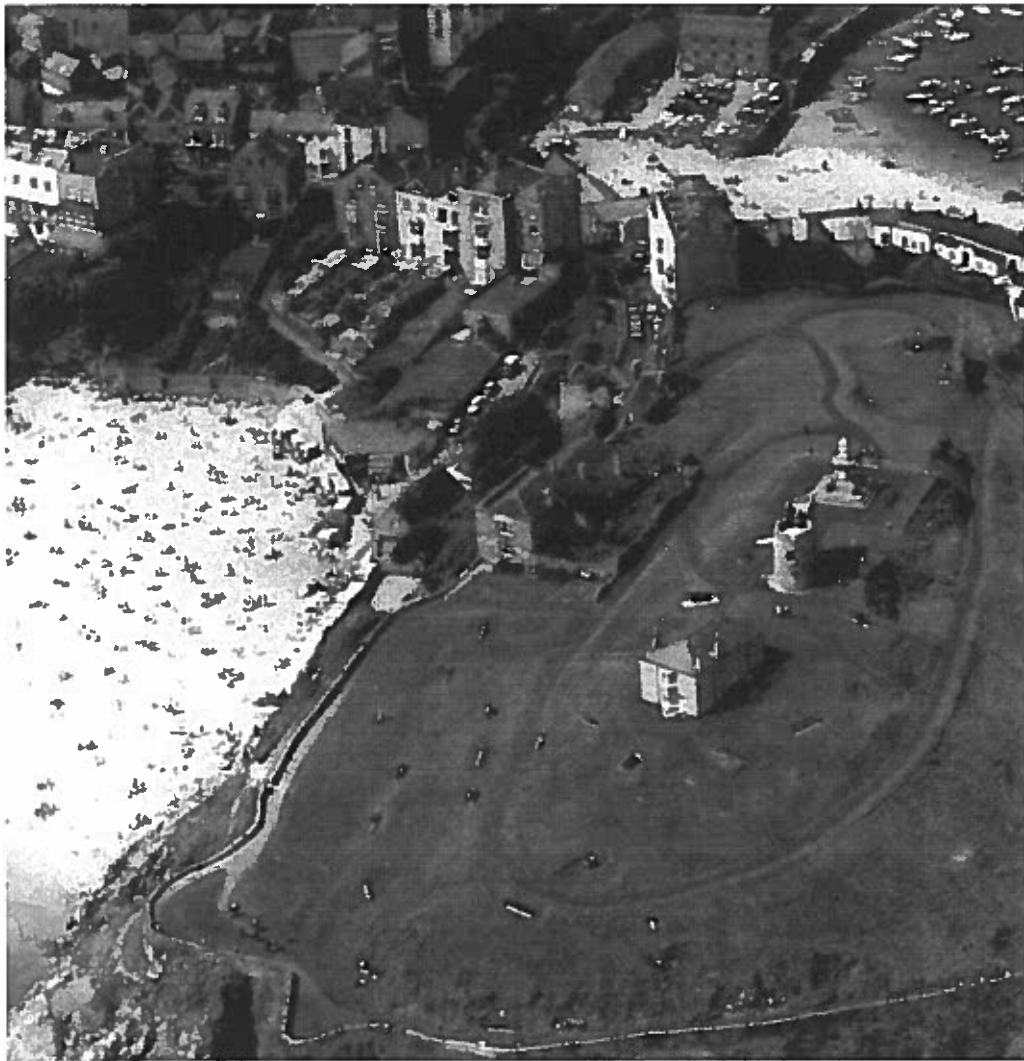
6. Castle Hill and beach, c. 1970  
Before museum art gallery extensions  
Tenby Museum & Art Gallery archive collection

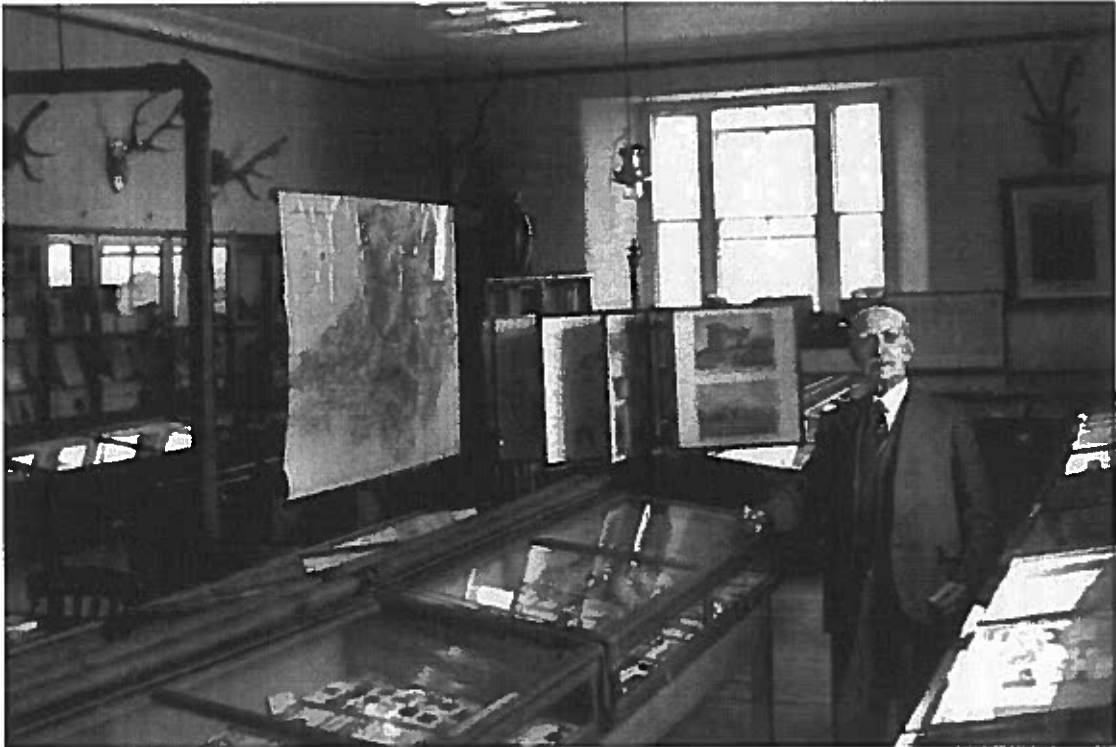
7. Lower Gallery with J Arnett, Hon. Curator, 1930  
TM&AG archive collection

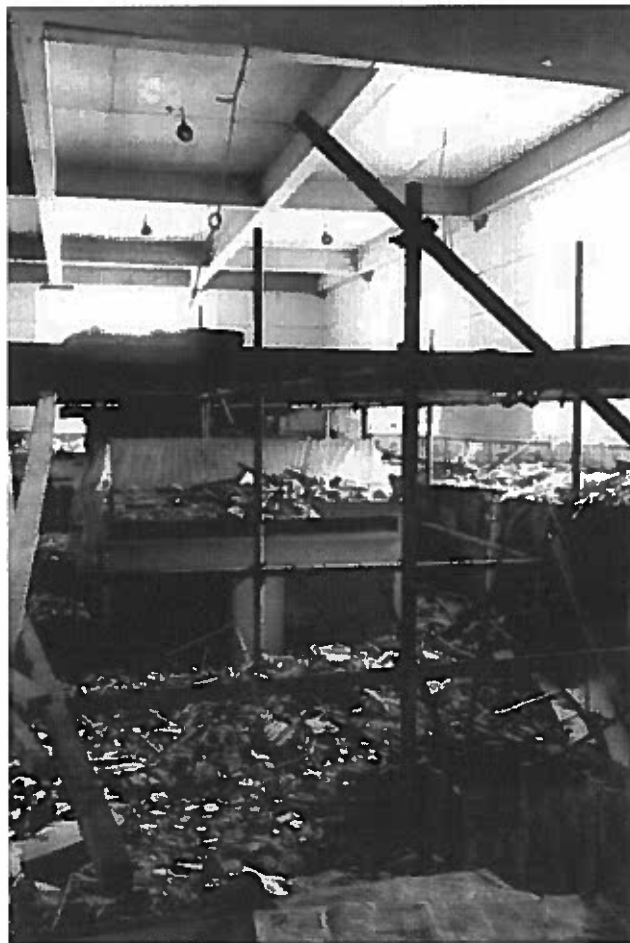
8. Lower Gallery being refurbished, 1967  
TM&AG archive collection

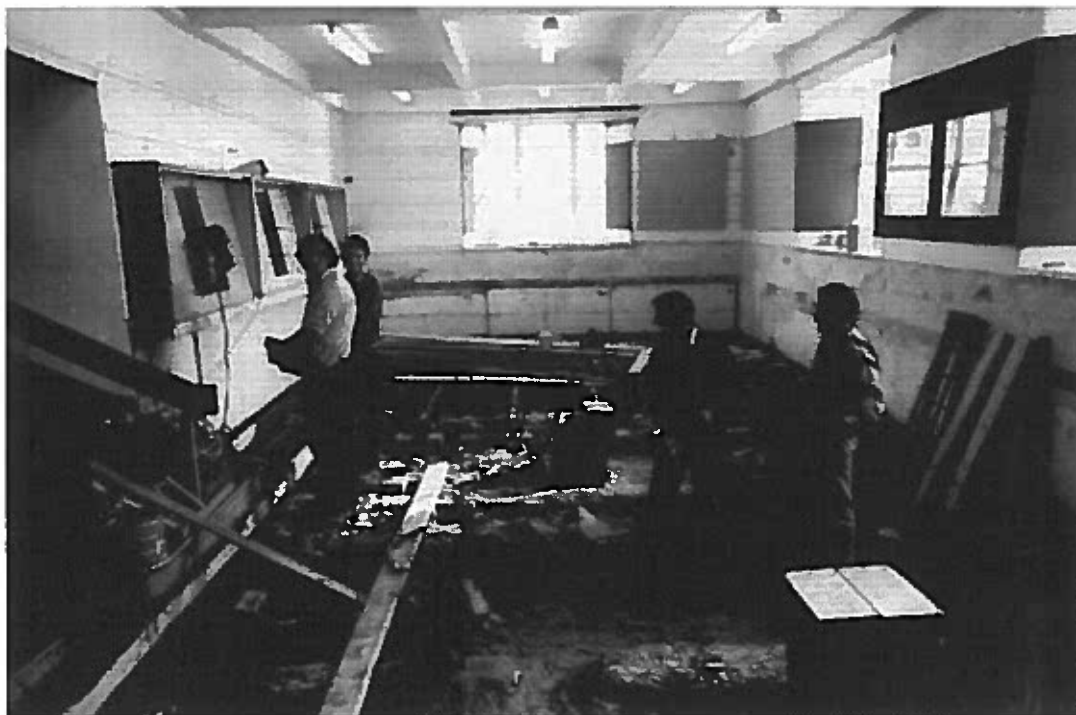
9. Lower Gallery, floor removed for lowering, 1987  
TM&AG archive collection

The Lower Gallery was the C19th National School's girls' classroom. At that time the gallery had a single door entrance at the front of the building, now closed over and used as a showcase for museum display. It presumably had also a single door exit/entrance onto the rear of the building and to the staircase which led to the boy's classroom above, on the north wall. The extant staircase and stair rail is mid-nineteenth century in design (Frans Nicholas, HLF Conservation Architect, pers. comm., 2000) and is presumably therefore the original, in its original location. Although the Lower Gallery walls are the same as the former classroom (*illus. 7*), there was a new ceiling installed in 1967 (*illus. 8*), the stairways and entrances to the mezzanine level and shop areas have been widened considerably during the C20th and the floor was replaced and lowered in 1987 (*illus 9*).

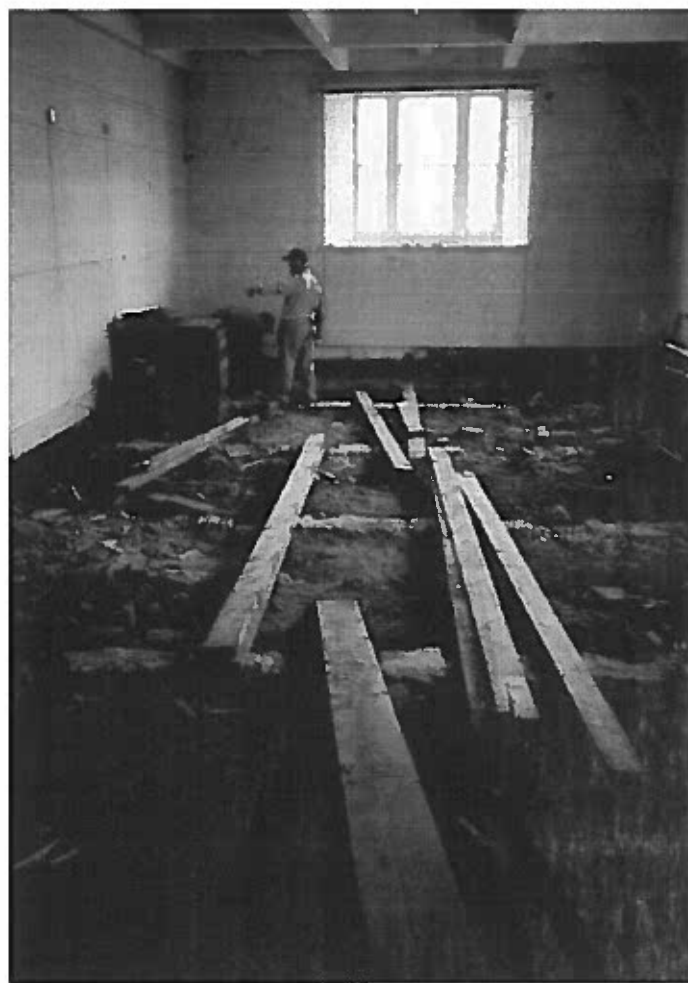
10. The Lower Gallery, floor removed before raising, April 2000  
TM&AG archive collection

During April 2000 this floor was completely removed and thus allowed the examination of the Victorian schoolroom floor and footings (*illus. 10*). The dwarf walls for the classroom floor were still partially intact, having been worked around by the contractors during the 1980s. These walls were plotted prior to consolidation and re-use by the present contractors; they were made of the same stone as the main castle fabric indicating they were probably rubble / reclaimed stone from the castle ruins.

The earthen floor between the dwarf walls, although very compacted, appeared to be of some depth, upto c.45 cm in some areas. There was much insect and snail activity as well as evidence of rodent intrusion around the south wall air vents.

Beneath the former floor level the walls were not plastered and enabled examination to show that all four walls were of the original castle building at that lower level, not a Victorian re-build. Examination of the wall section through the open vents under the south wall windows showed that the wall did not appear to have been re-faced. However it would appear from examination of prints in the museum archive and from testing of the wall fabric, that the upper part of the north wall, in the upstairs galleries, is a Victorian re-build on top of the ruined north wall of the castle apartments (*illus. 3*).

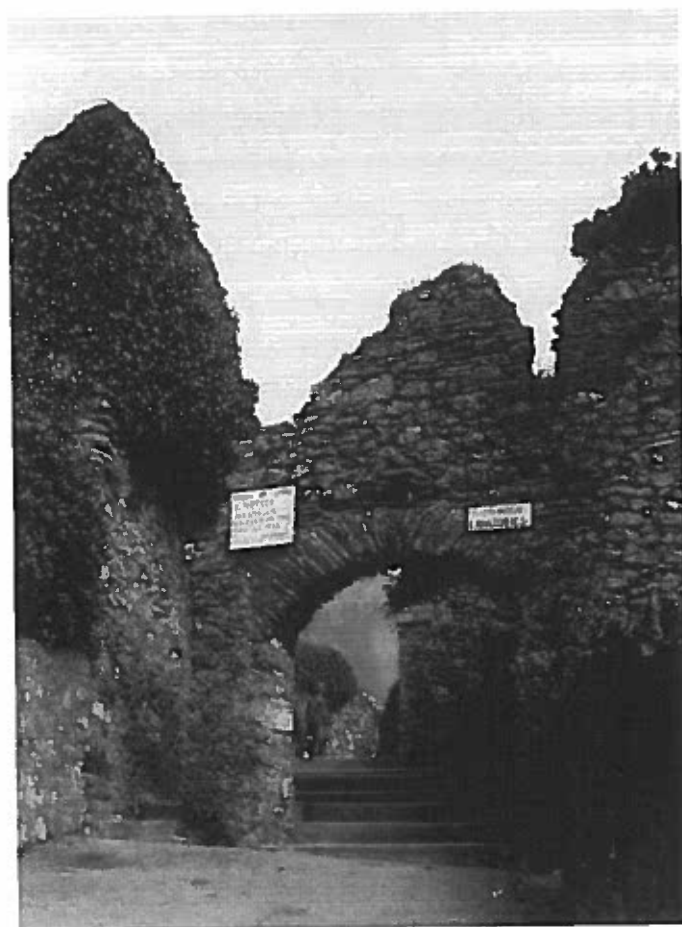
12. Portcullis Gateway, c. 1920  
TM&AG archive collection

The portcullis gateway steps were also levelled in order to enable an easier gradient for wheelchair / pushchair access (*illus. 12,13,15*). Again, smaller pieces of rubble mixed with loam and the ubiquitous oyster shells constituted the context – although the deposits here were much shallower (bedrock only c.10cm down in places) (*illus. 14*).

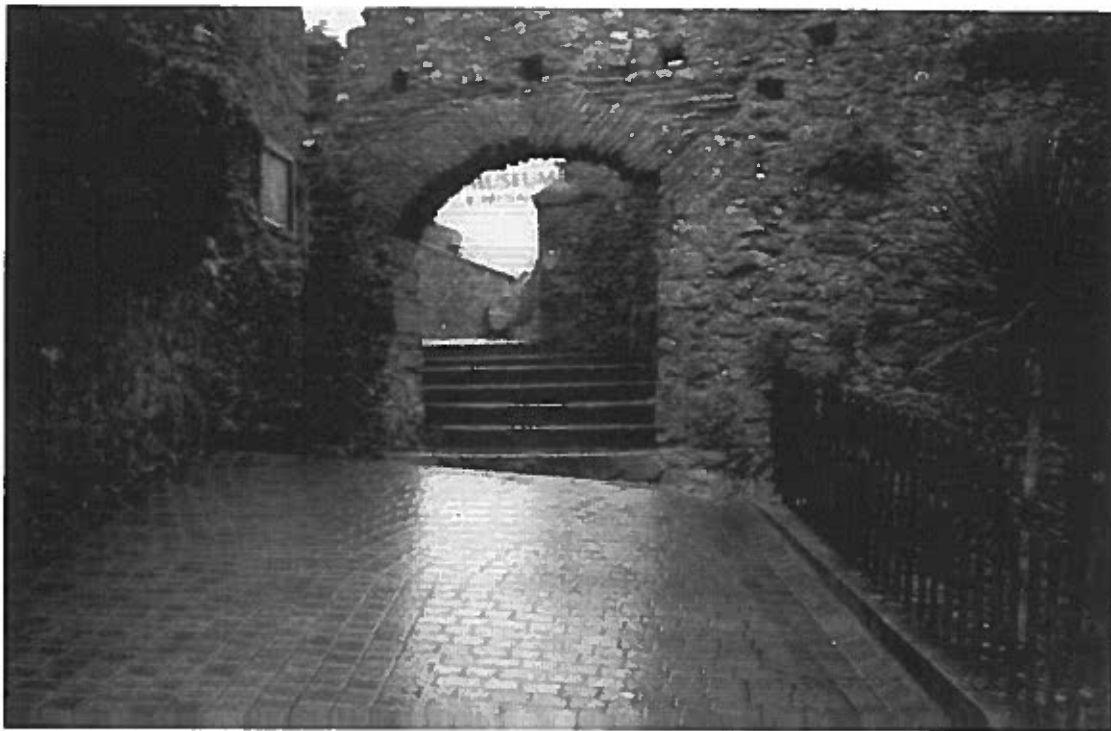
13. portcullis gateway, 1999

The original curtain wall to the castle has been lowered and iron railings installed  
TM&AG archive collection

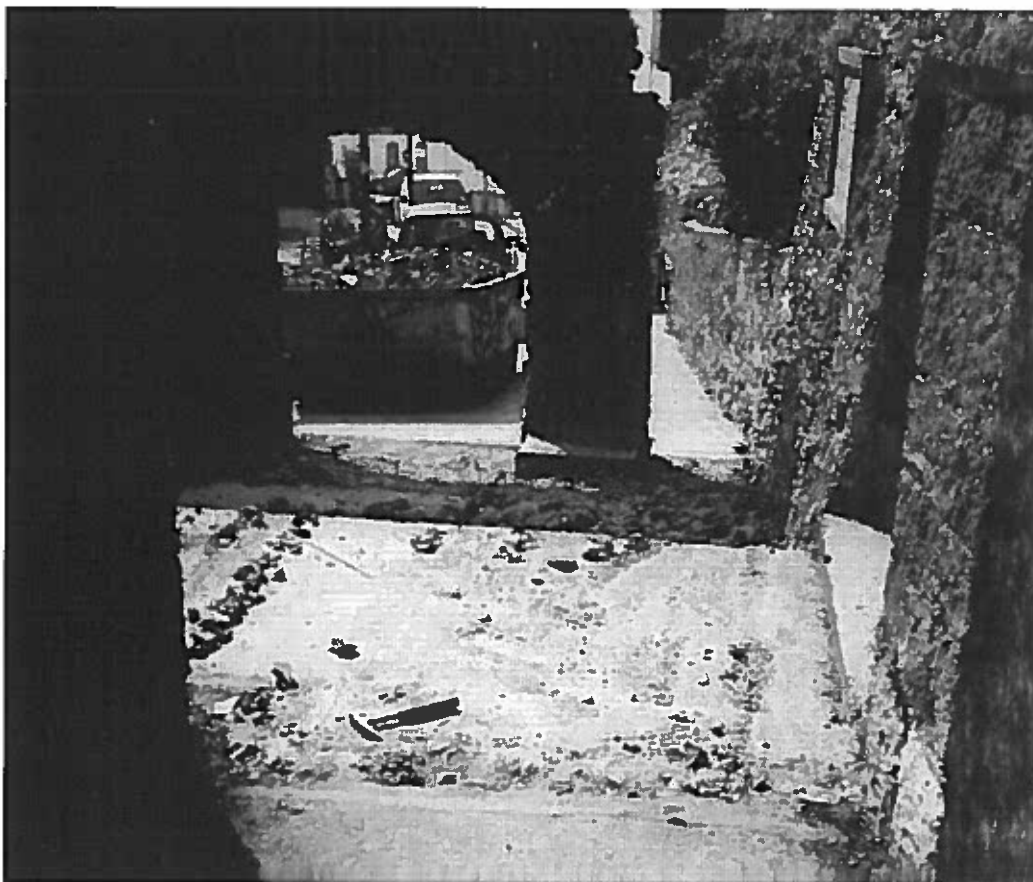
14. portcullis gateway during removal of steps prior to re-surfacing, June 2000

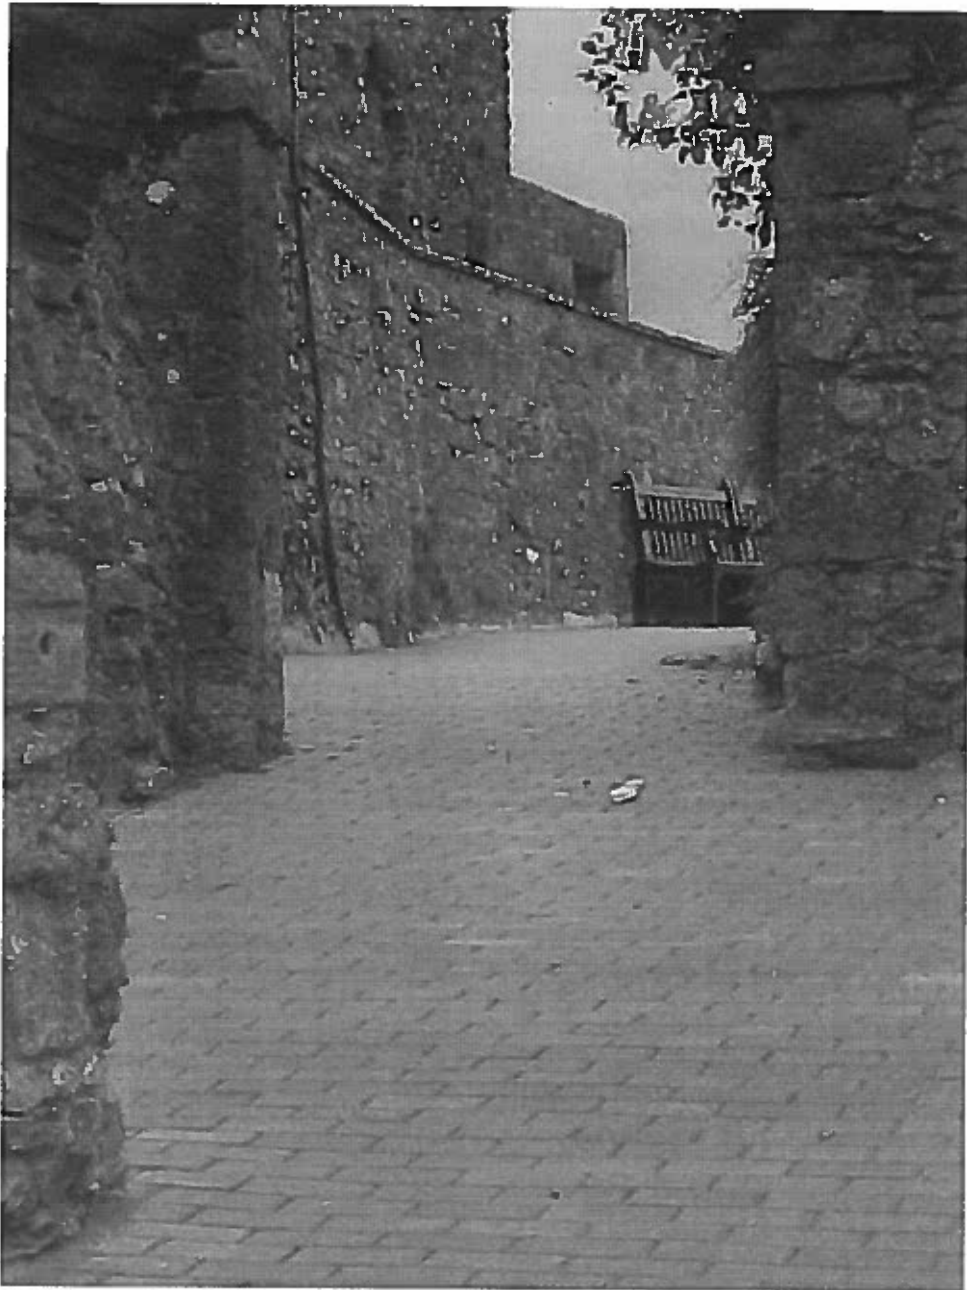
15. The portcullis gateway and upper approach after re-surfacing, July 2000

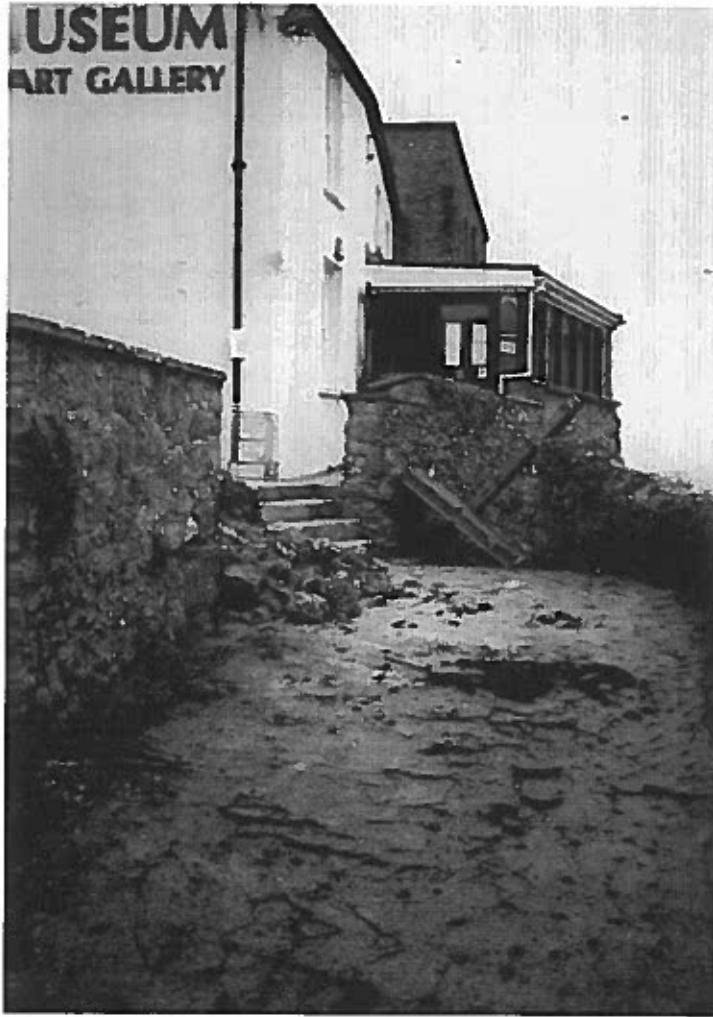
16. Upper approach before re-surfacing, June 2000  
TM&AG archive collection

During June 2000 a trench was dug by the contractors, from the gateway up to the steps onto the museum terrace (*illus. 16, 17*), in order to replace lead water pipes. The trench was cut by mechanical digger to a depth of c.90cm in places and revealed a considerable depth of rubble and loam. Within this context were found sherds of early modern pottery (mostly blue and white ceramic) probably rubbish accumulated from the cottages, schoolroom and early museum. The spoil consisted of a high proportion of oyster shells.

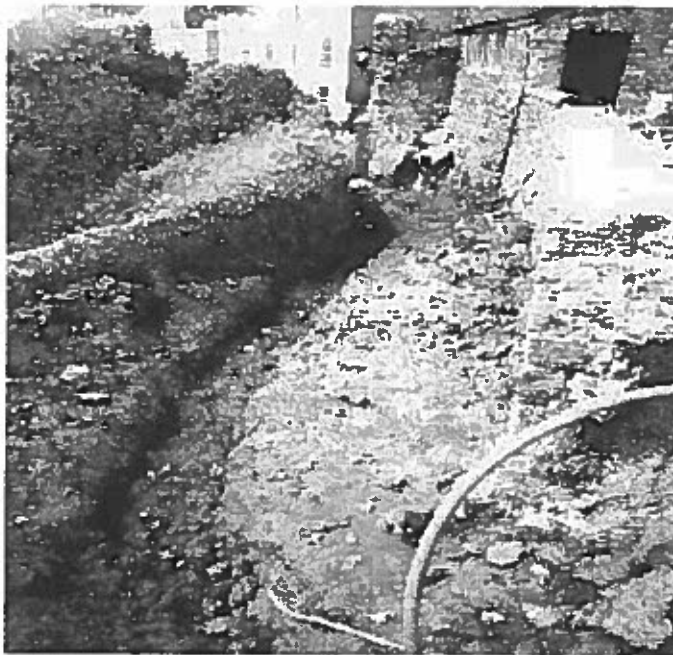
17. Upper approach (refilling) pipe trench, June 2000  
TM&AG archive collection

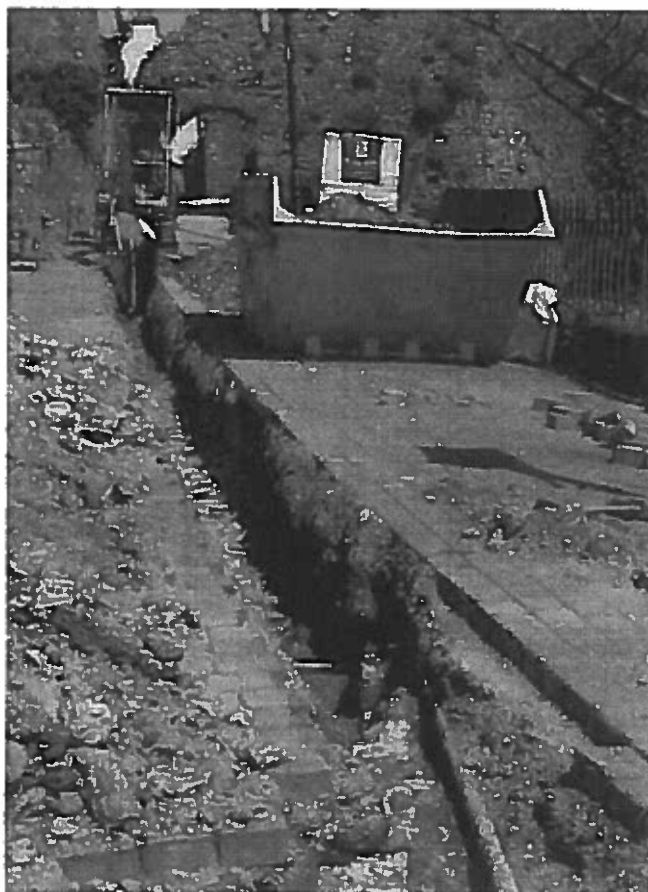
**18. Pipe trench, lower approach, Castle Hill, June 2000**

The wall foundations are mid front of the photograph, running off in a south easterly direction  
TM&AG archive collection

The trench dug for the laying of the water pipes was extended from the portcullis gateway down the lower approach of Castle Hill to a point outside 2, St Catherine's Terrace (**illus. 18**).

Photographs taken of this trench and partial wall again highlight the proliferation of oyster shells in these deposits (**illus. 18, 19, 20, 21**).

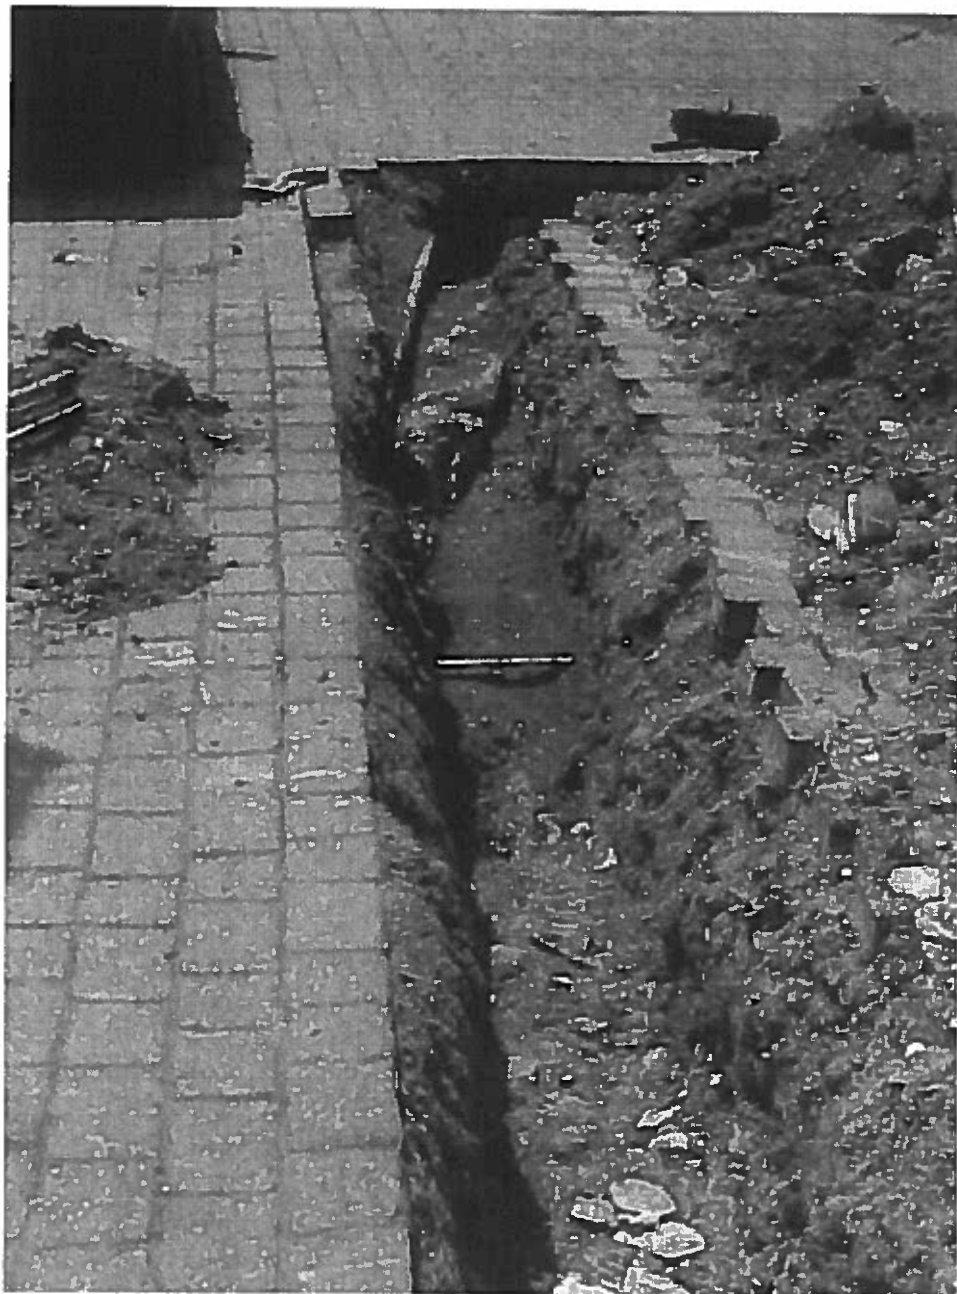
19. Wall foundations found in pipe trench, June 2000  
TM&AG archive collection

During the digging of the pipe trench, the foundations of a large, blocked wall were revealed by the contractors (**illus.19**). Two of the limestone blocks in the partial wall revealed were of over 60cm in length (**illus. 20, 21**) and were thus presumably incorporated to uphold a large or heavy structure. The wall appeared to run in a NW – SE direction. If the present small, railed wall of the Rotary Gardens is the remainder of the original curtain wall, it maybe that the wall revealed could have been a structure backing onto it or may have been connected to an initial castle gateway.

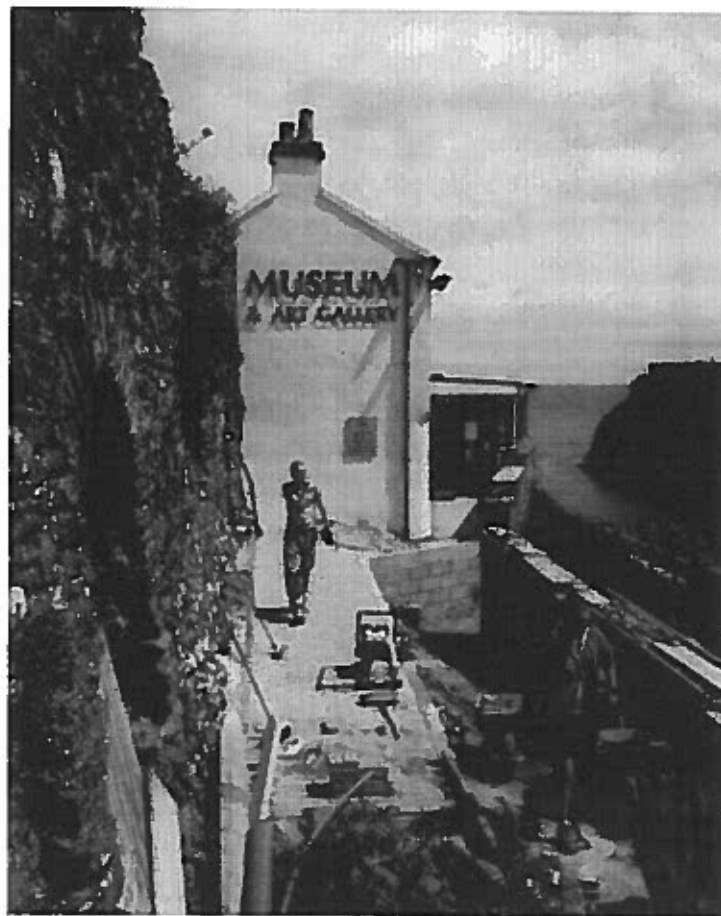
24. Museum terrace, surfacing the ramps, July 2000  
TM& AG archive collection

The concrete terrace between the museum and the former Victorian toilet block was cut away in order to incorporate ramped access to both museum entrances. The higher level of ramping, aligned against the extant castle hall walls, remained at the same level and was designed not to disturb any of the SAM (illus.24).

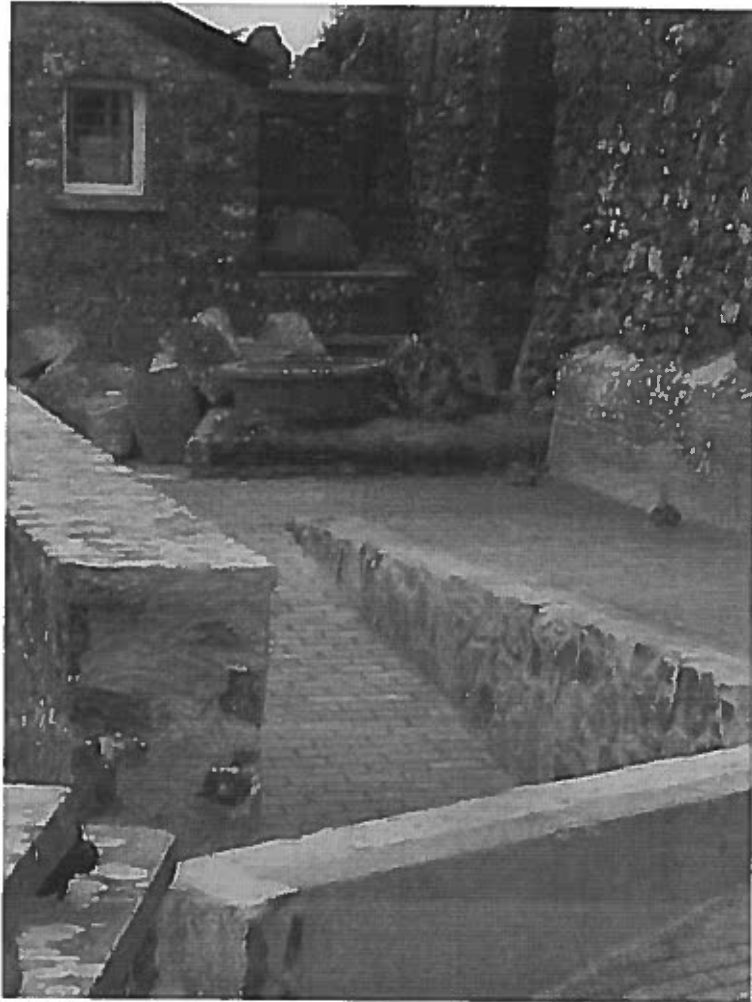
25. Museum terrace with ramps in place, July 2000  
TM&AG archive collection

The contractors dug a test pit alongside the castle walls to investigate the depth and nature of the deposits. It was supposed that the level of deposition on the terrace would be to several metres, as the adjacent part of the museum building, housing the museum library, had the original castle flooring beneath its current floor level, to a depth of 2 metres. The test pit, and subsequent excavation of the lower ramps, revealed under the 12 cm of 1960s concrete were several metres of rubble, loam and oyster shells. There was no bedrock nor floor level revealed, indicating a build up of rubble and rubbish over several centuries (illus. 25).
