Cwmbryno Mine Leat

Archaeological Watching Brief

**Report No. 101
August 1999**

Report commissioned by Forest Enterprise: Canolbarth District

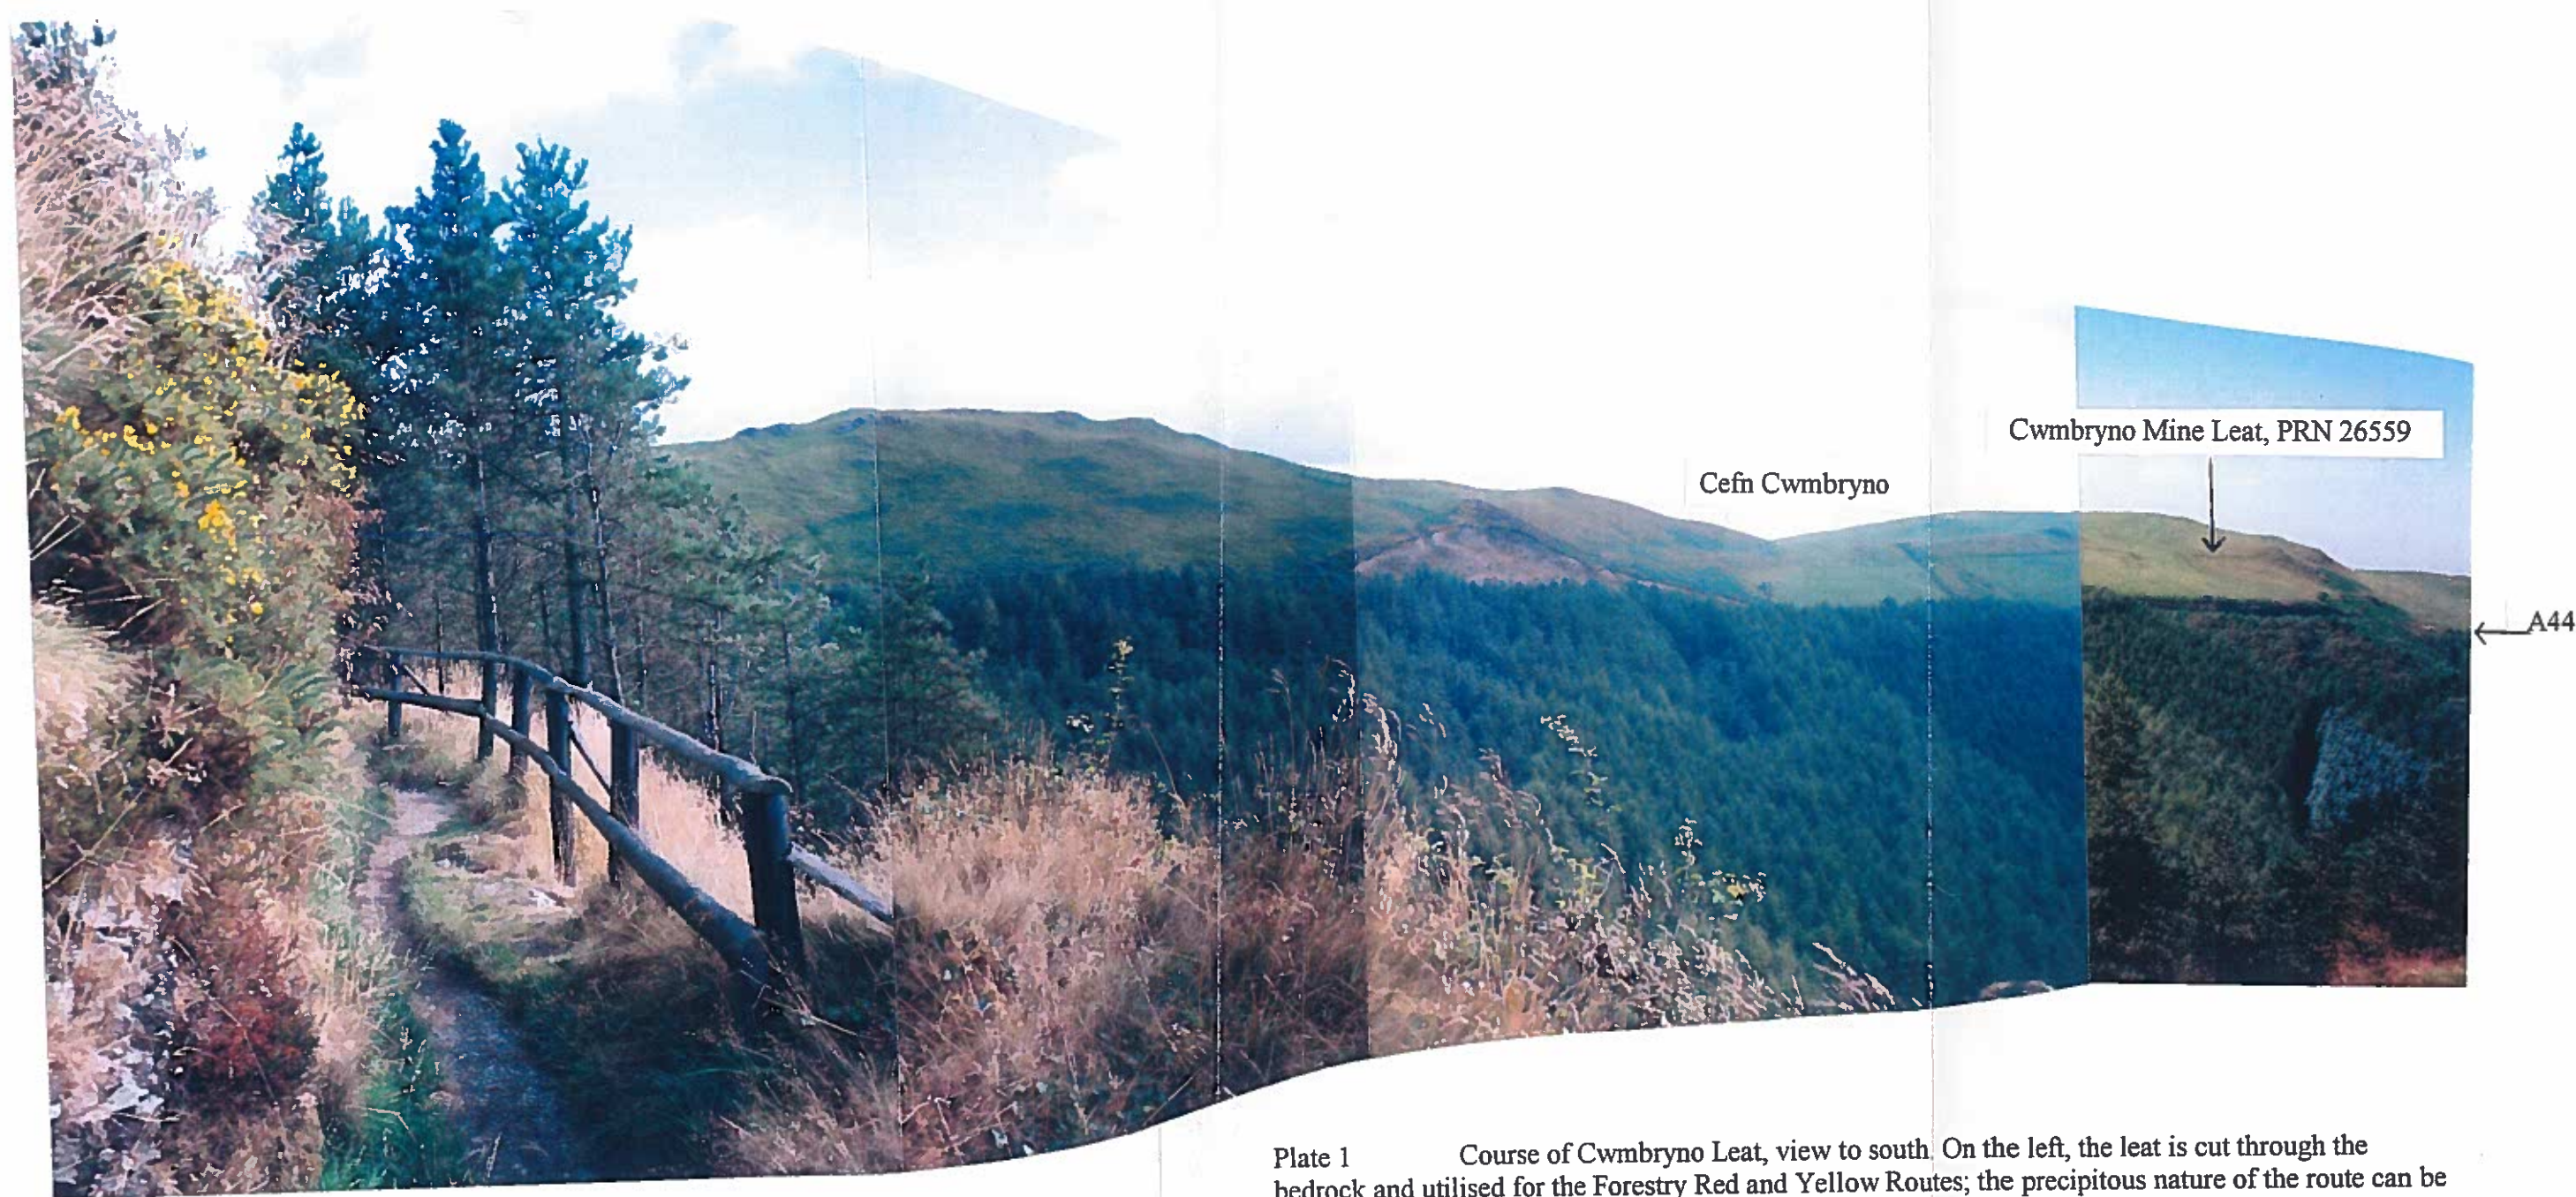
Plate 1 Course of Cwmbryno Leat, view to south. On the left, the leat is cut through the bedrock and utilised for the Forestry Red and Yellow Routes; the precipitous nature of the route can be seen by the construction of the wooden barrier, at a point where the leat falls steeply down to the Nant-yr-Arian valley.

In the background, the leat can be traced as it follows the c.320m contour, above the A44 trunk road. The leat can be seen curving south around Cefn Cwmbryno, to Cwmbryno Mine Site, south of the hill.

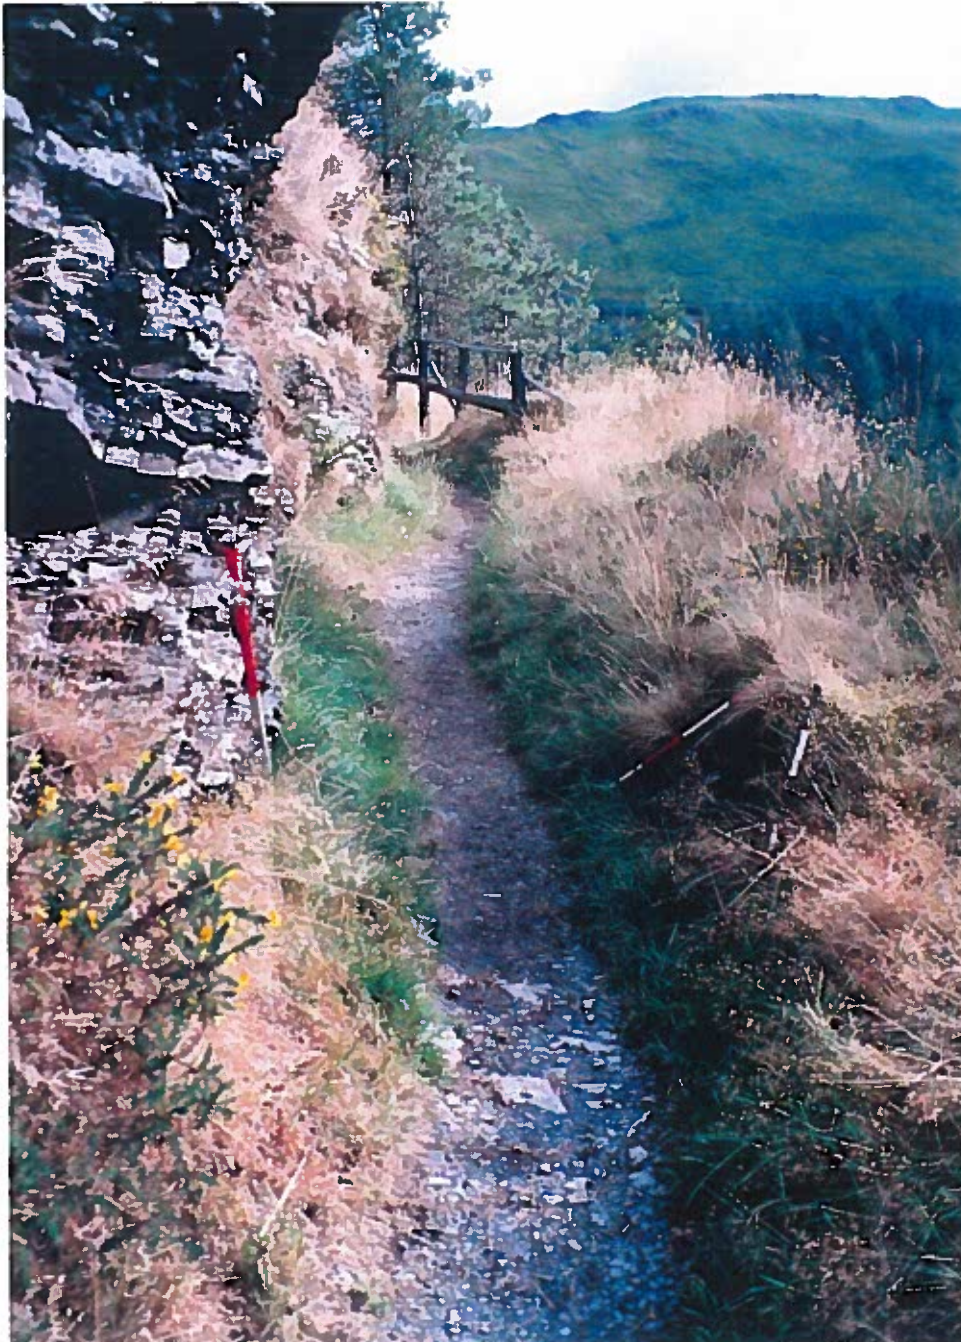
Plate 2.

View to South of
rock cut section
of leat.

Course of leat has
been through the
N/S dipping shales
(as indicated by
scales). The steep
rock cut on the
east side rises to
*c.*2m and the
shales on the
western embanked
side are *c.*0.15m
above the 1m wide
leat section. The
western shales
rock cut is
surmounted by a
made-up earth and
stone bank, now
grass covered.

This section of the
leat path was
undisturbed during
the present works.

4.3 On the southernmost section of the path, as it leaves the Forestry Offices, the leat is almost entirely rock-cut (*Plate 2*); this section was undisturbed during the present works, apart from the clearing out of existent drainage gulleys to *c.0.3m* max. width, which all showed evidence of the leat being cut through the bedrock. As illustrated in *Plate 2*, the floor of the leat is cut to bedrock surviving *1m* wide and the outer bank of bedrock shales stands *c. 0.15m* above the leat floor. The bank is composed of earth and stone matrix above the bedrock shales, under grass cover. The steep rock face drops west below the outer bank down to the Nant-yr-Arian valley.

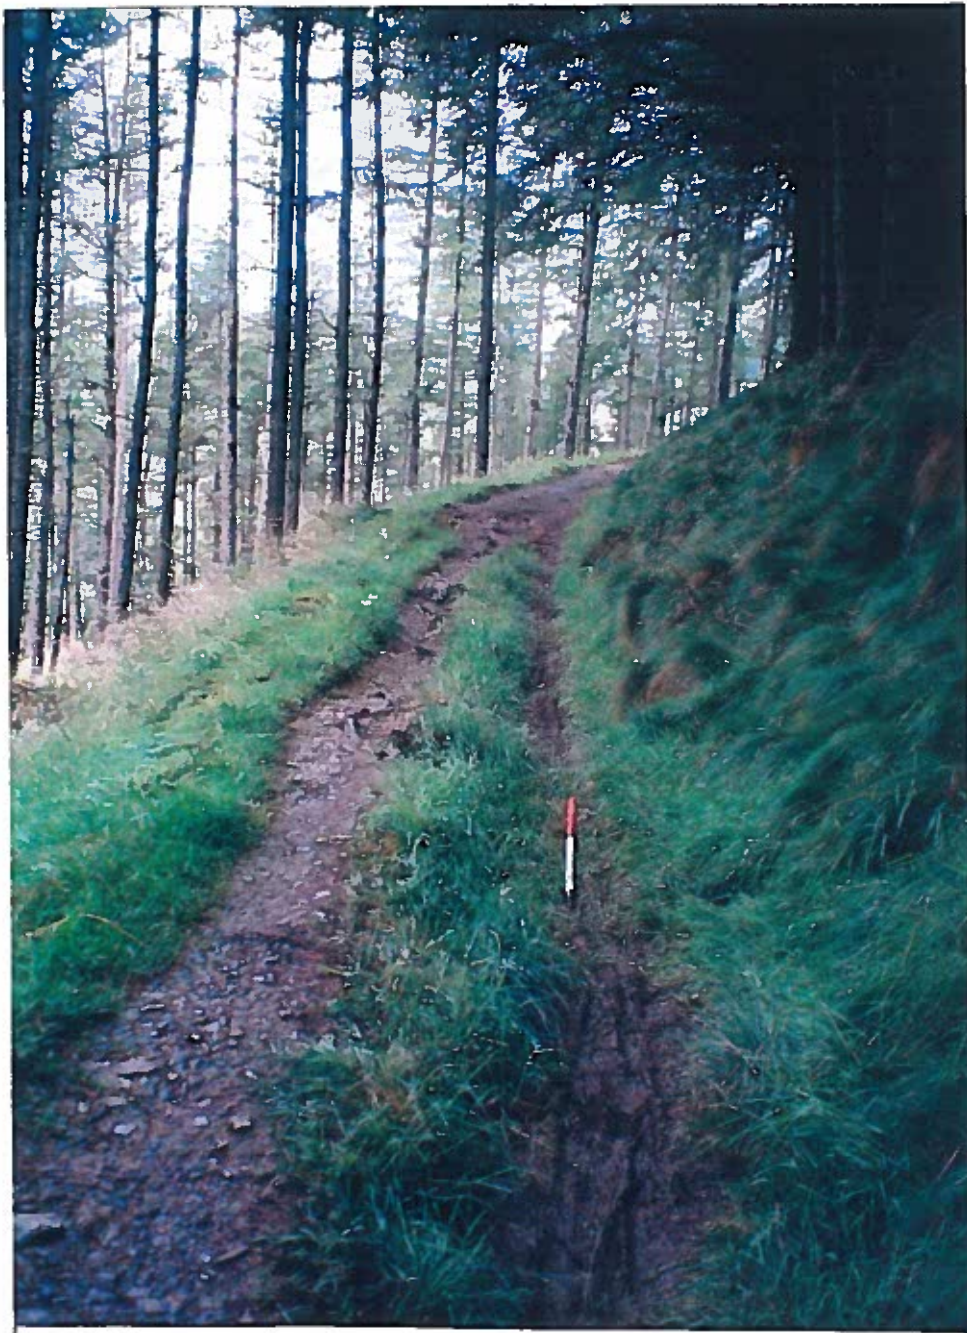
Plate 3 Section through conifer crop showing much disturbed section of leat, prior to work being undertaken. The spread of the outer bank inwards has included total removal of the topsoil and the leat is seen to be extremely silted-up.

4.8 During the removal of overburden and the uncovering of the base of the leat along certain sections, it became apparent that the outer bank had spread inwards over half of the leat's width. In parts of the section through the conifers crop, only c.0.5m of the real floor of the leat was uncovered, while the remaining 0.5m presumably lay under the flattened outer bank (*Plates 3 & 4, overleaf*). Along this section, the east side of the leat is cut into a loose shale bank, which has already been much disturbed.

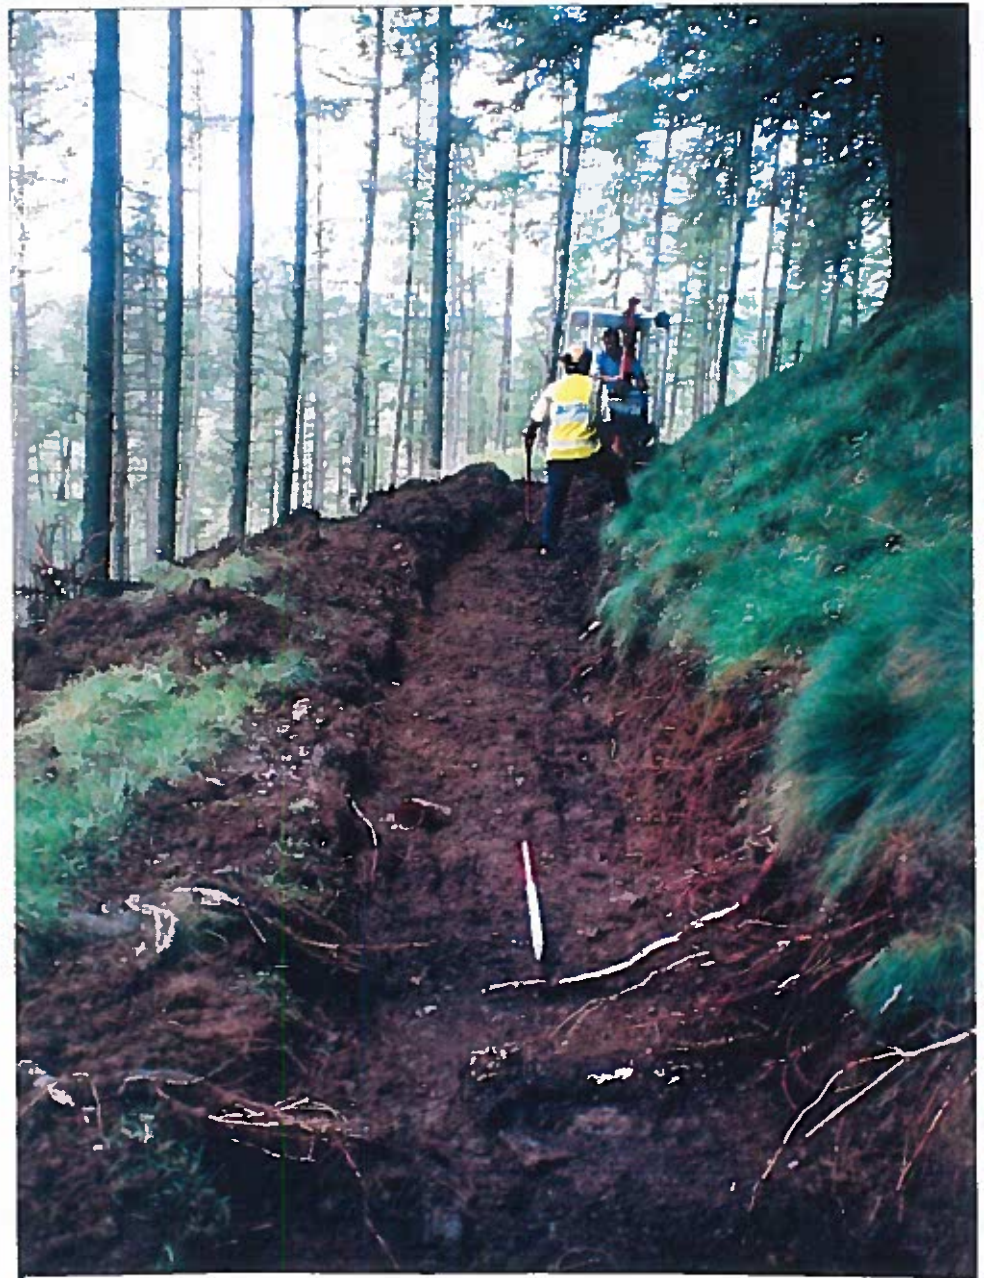
Plate 4 Section through conifer crop as Plate 3, following excavation. Ranging pole marks distinction between true surface of the leat c.0.5m wide; remainder presumably survives under spread of bank. The width of the footpath has been delineated by removing the overburden from against the east bank, which in this section is not the true cut for the leat.

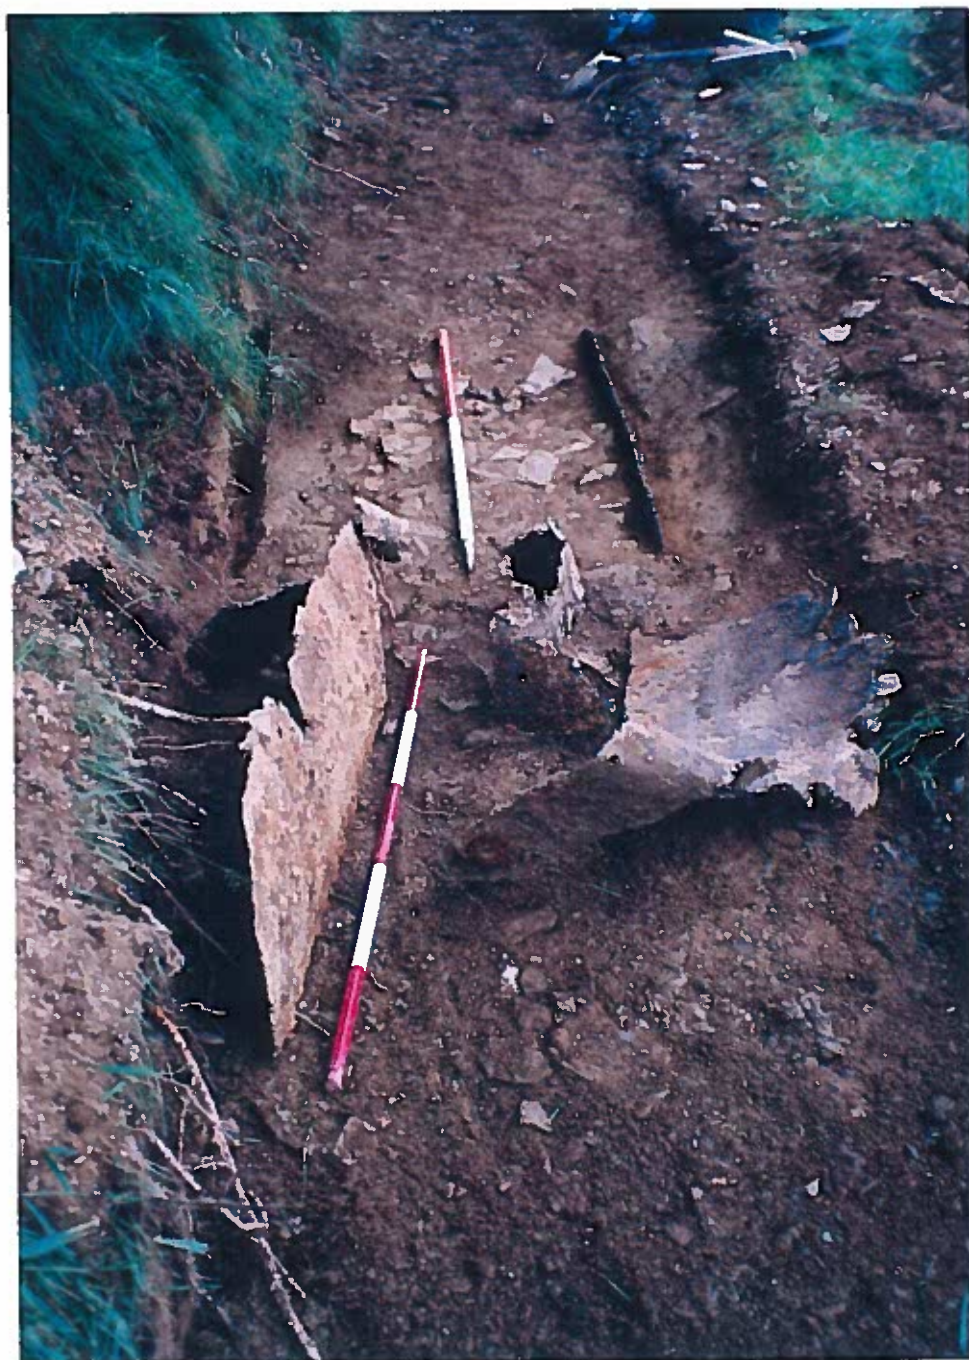
Plate 5 Sections of Iron "launder" .

4.10 Towards the north side of the section through the conifer crop, parallel sections of an iron "launder" were uncovered c.0.15m below the footpath. The cast iron sections were presumably inserted against the east side cut and the outer bank of the leat to prevent silting up from the looseness of the sides. The ironwork had been bent-over and flattened presumably during the establishment of the footpath or earlier forestry management. The bent-over sections (*Plate 6*) broke away immediately from their base which remained in situ (*Plates 5 & 6*).

4.11 The ironwork survived c.0.16m deep by 1.22m in length, being an imperial measurement of 4ft. The parallel sides enclosed a channel 0.765m wide, being an imperial measurement of 2ft 6". The cast ironwork measured 50mm thick and the mutilated sides appear to have been c.0.34m deep.

The base of the "launder" is visible in situ in the background, and the mangled sides, which broke away have been replaced on leat path for photographic purposes only.

4.12 Due to the fragile nature of the ironwork, the in situ metalwork was only excavated to verify that it formed a parallel revetment to the leat as opposed to an iron launder box to convey the water. Having partially excavated the metalwork, the feature was photographed and fully recorded by scaled drawings (*Plates 5 & 6; Archive Plan & Section*), then the in situ metalwork was re-buried under a matrix of loose brown loamy soil and shales. The mangled pieces of metalwork were removed for safety.

Following recording of the feature, the ironwork was reburied and the mangled metalwork removed for safety.

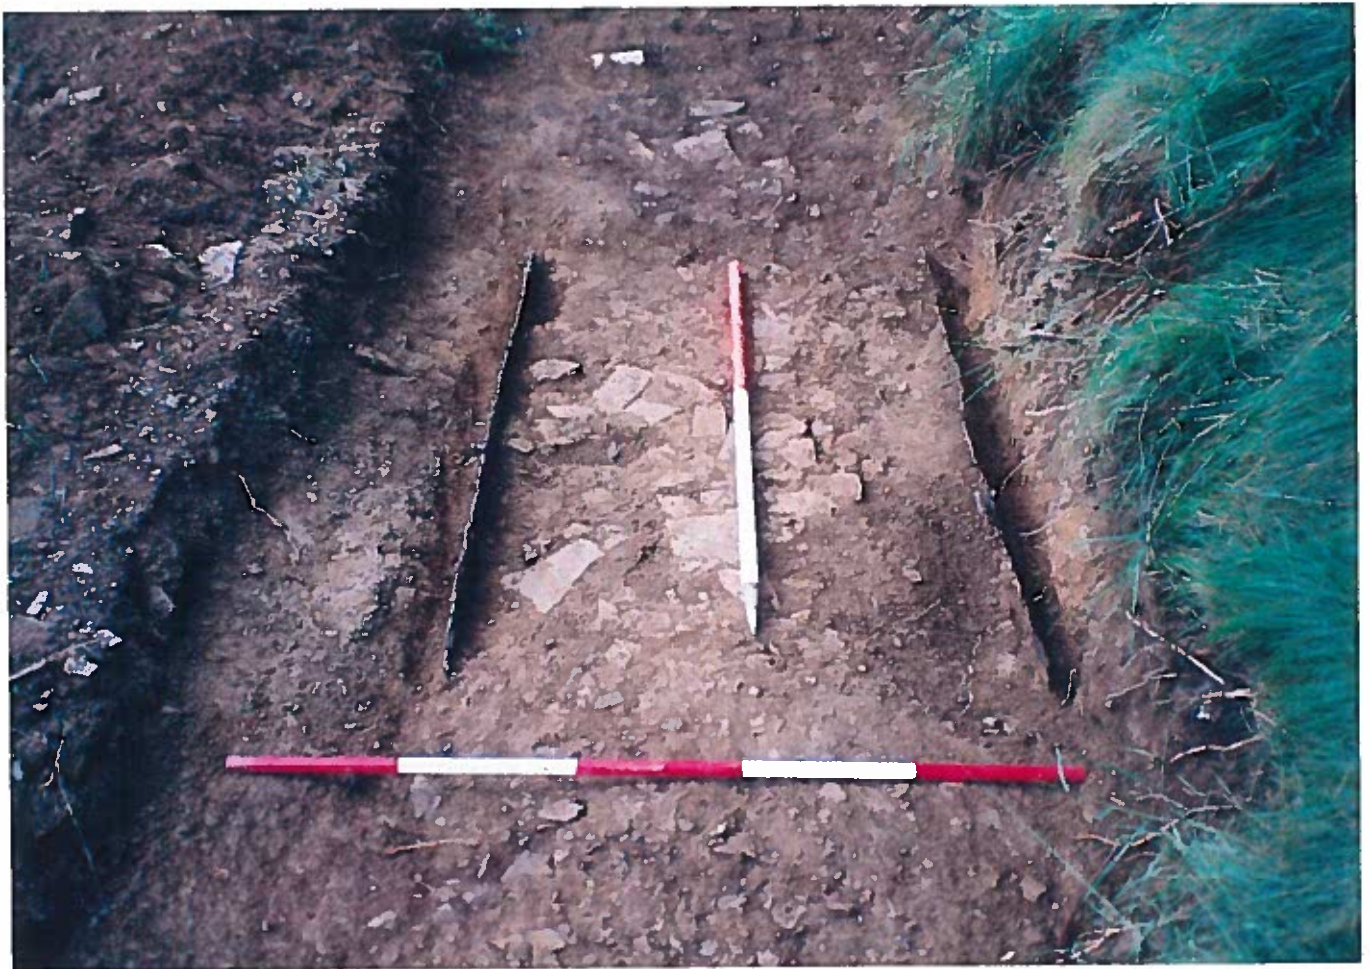
4.13 The base of the leat as it was conveyed through the metalwork comprised loose layers of shale, similar composition to the subsoil of the east section (*Plate 6, below*). The east section of the leat at this juncture showed signs of iron staining caused by the metalwork (*Deposited Archive Section Drawing*).

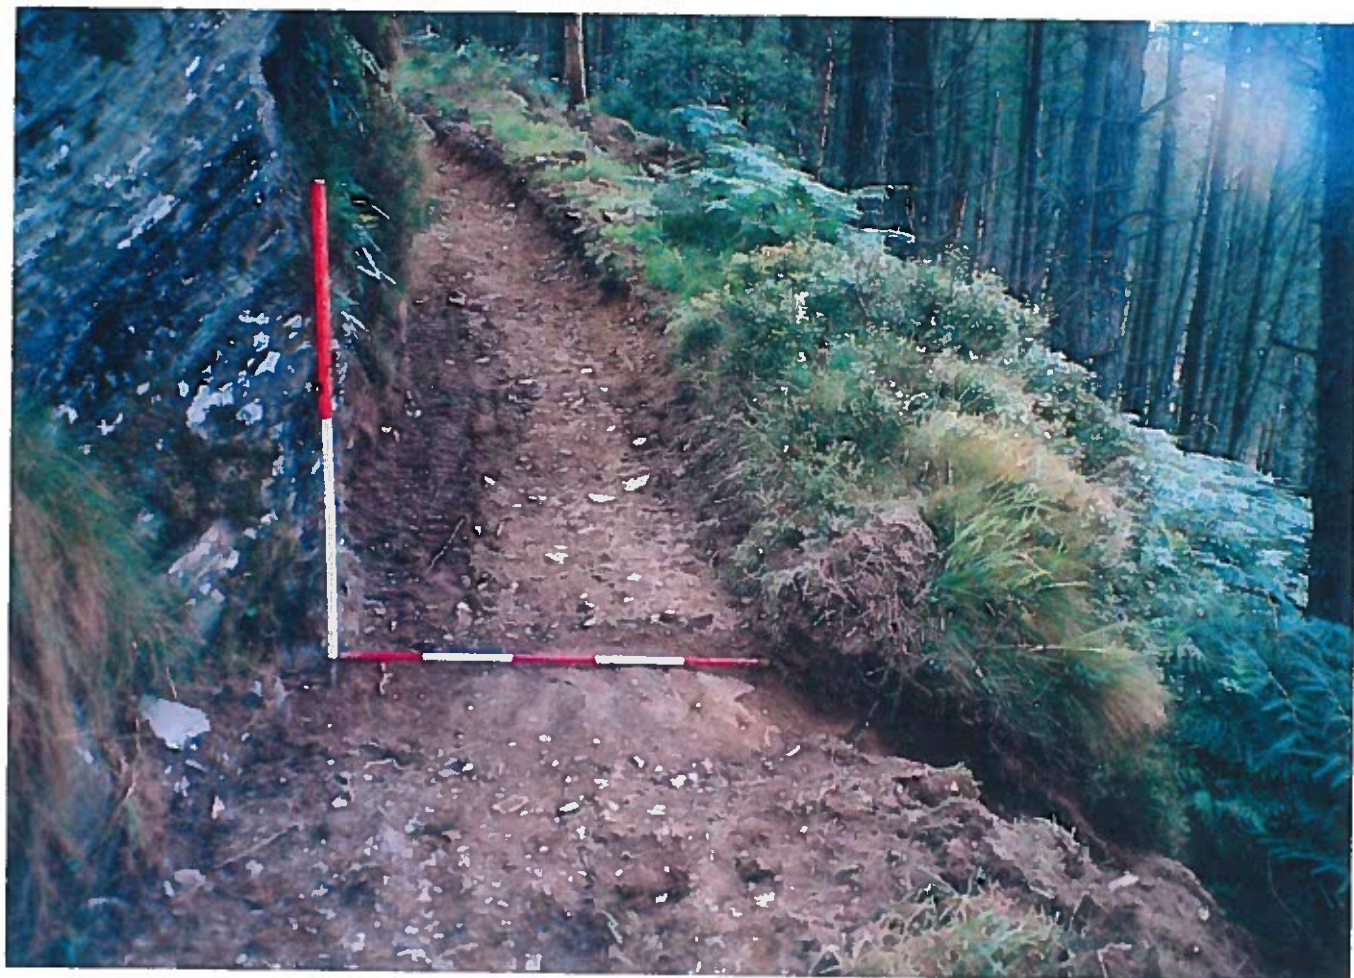
4.14 To the north of this section, in the section between the marker post and the steps that define the divergence of the yellow from the red route, the leat curves in a "S" shape. Part of the leat is unused as the footpath in this section, while the footpath is maintained close to the present east bank. In this section entire rock cuts are encountered (*Plate 7; Deposited Archive Section Drawing*) and the base of the leat is again cut to bedrock.

Plate 7 Rock-cut section following removal of overburden and clearance of the drainage gully. View from north, as recorded in Archive Section (*Fig. 3*).

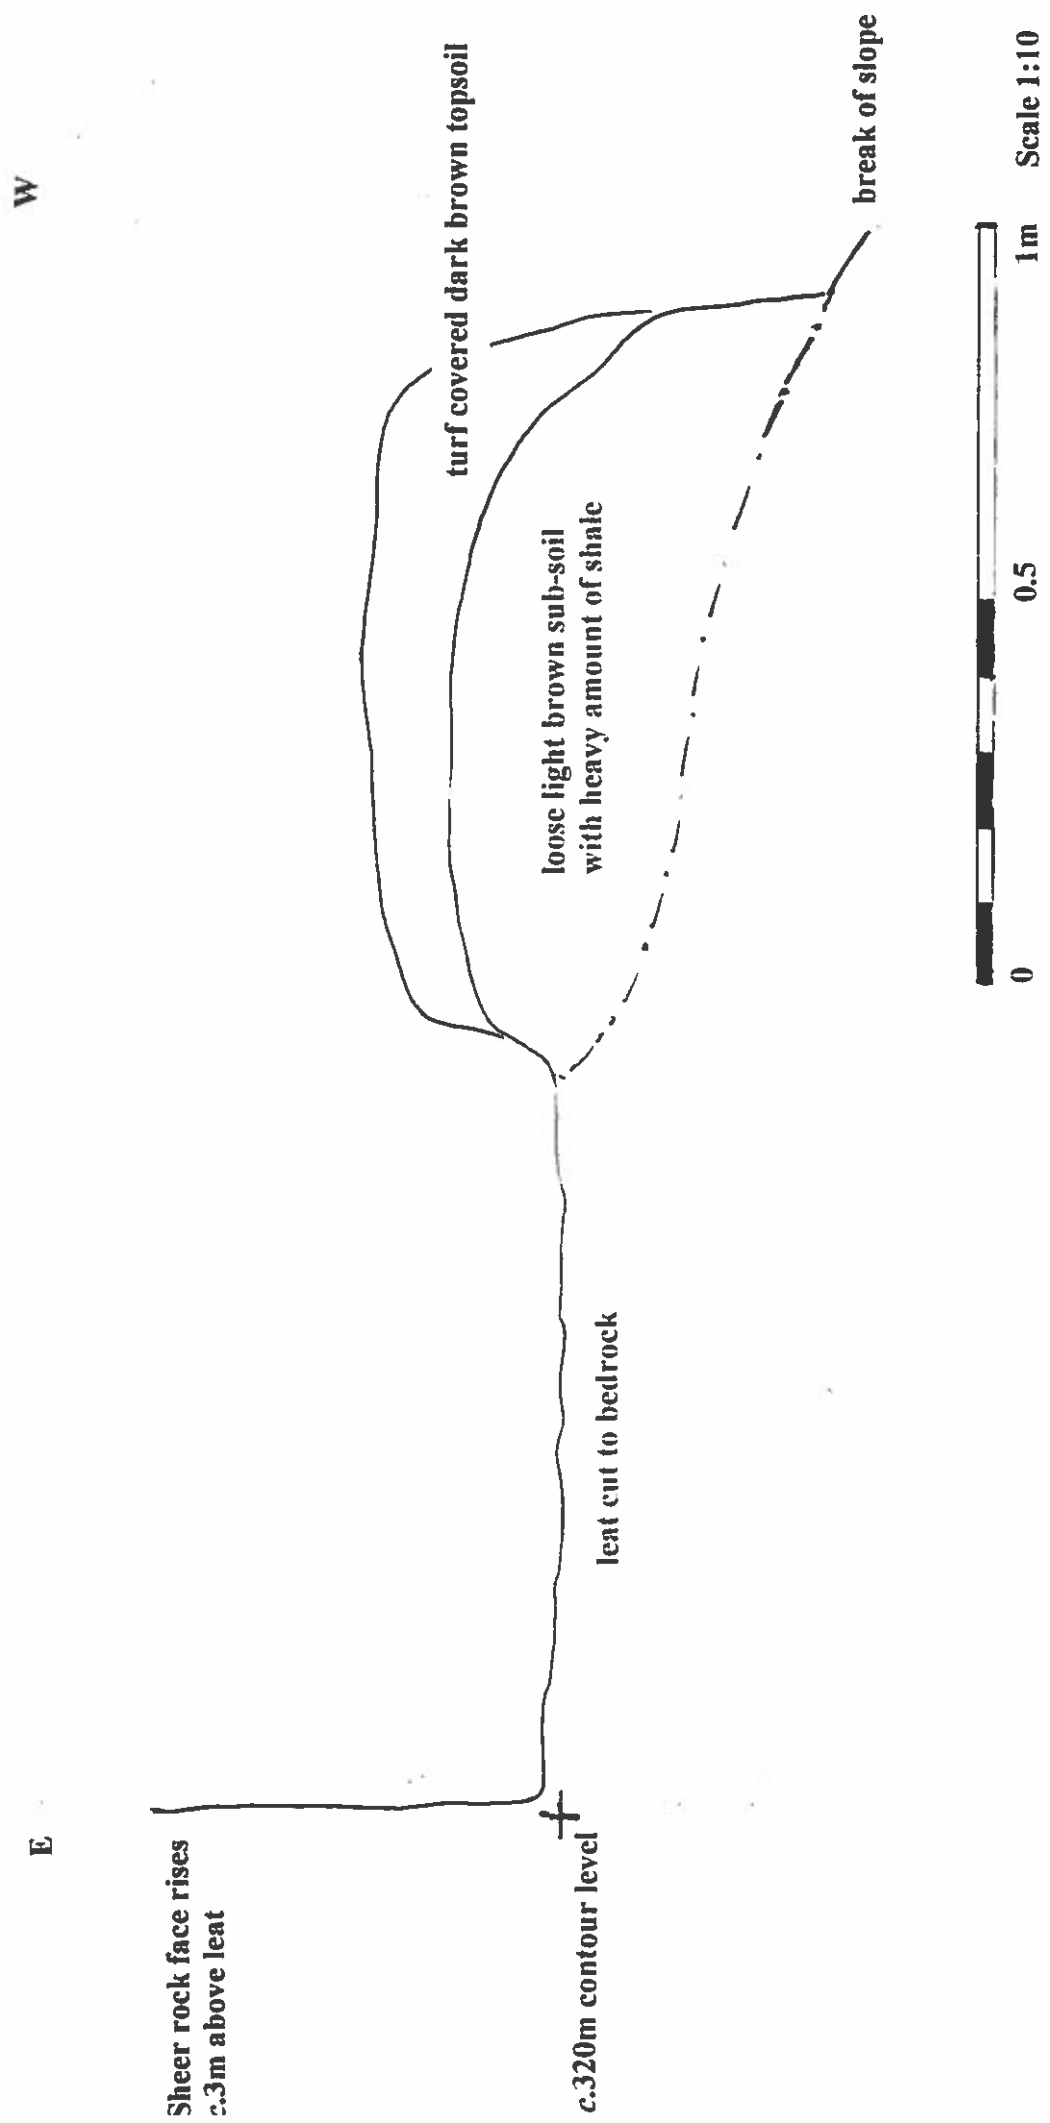
Fig. 3 Sample East/West section through Cwmbryno Leat, facilitated by cutting of drainage gully, during improvements to Forest Walks.

Section shows steep rock face cut on east side, leat cut along c.320m contour embanked on the outer west side by a matrix of shale and light brown sub-soil. The outer bank has been relatively undisturbed along this section.
