Peach House Excavations 2001, National Botanic Garden of Wales, Carmarthenshire

Archaeological Excavation

CAP Report No. 194

Date: October 2001

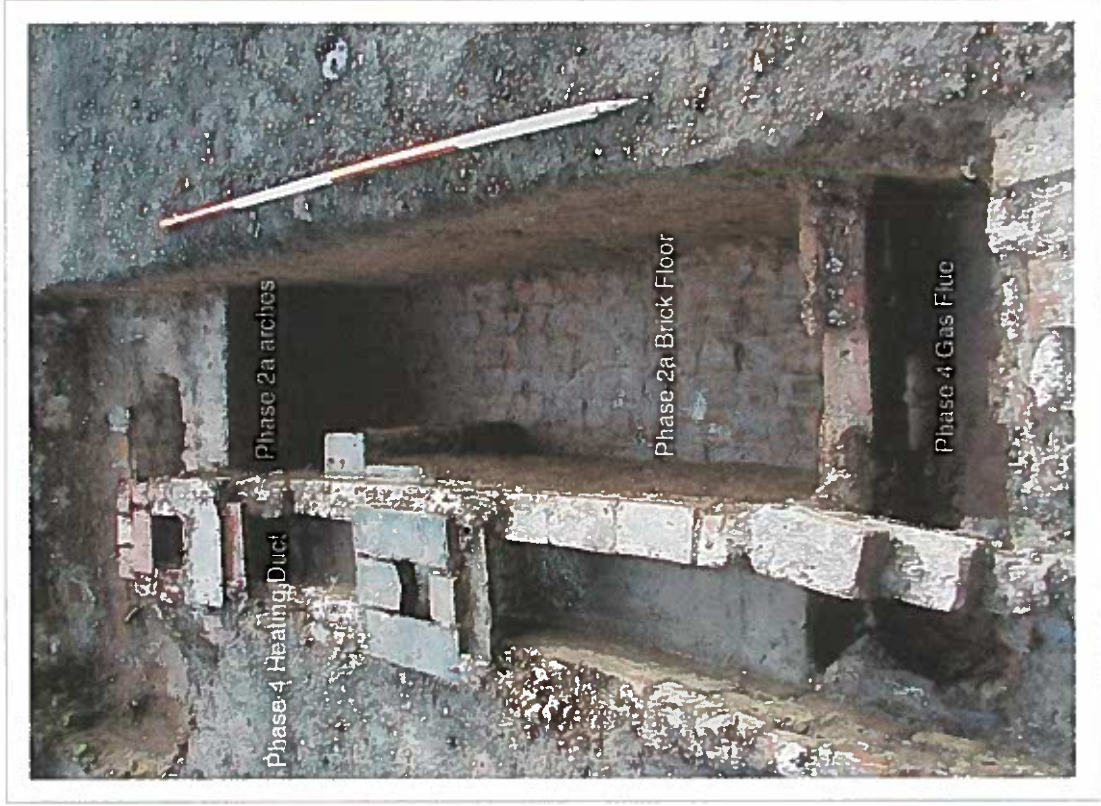
Plate 2: Phase 4 heating duct and gas flue, as revealed during 2000 excavations. (Scale 2m. looking east)

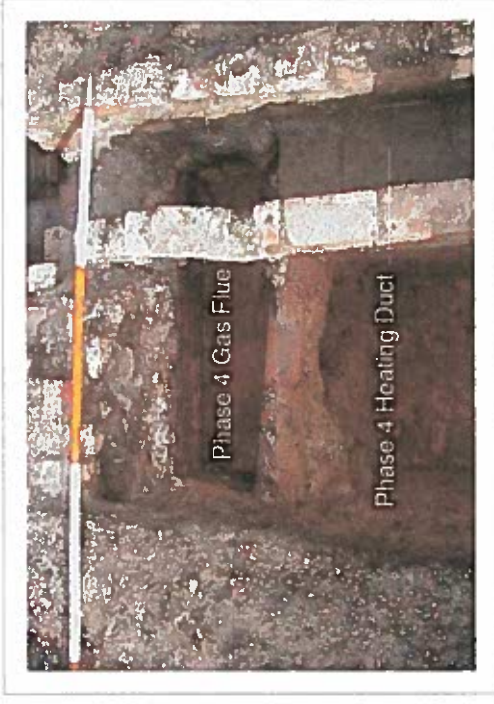
Plate 3: Detail of hot air and gas vents, revealed during 2000 excavations. (Scale 2m. looking west)

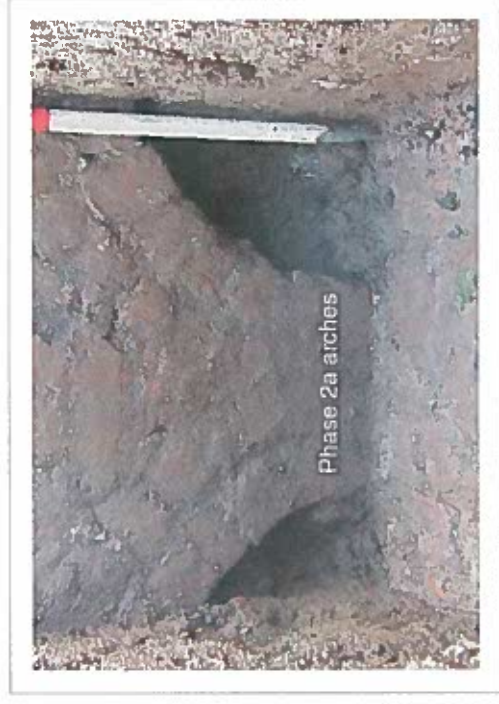
Plate 4: Detail of phase 2a arches, revealed in trench 37 during 2000 excavations. (Scale 2m. looking east)

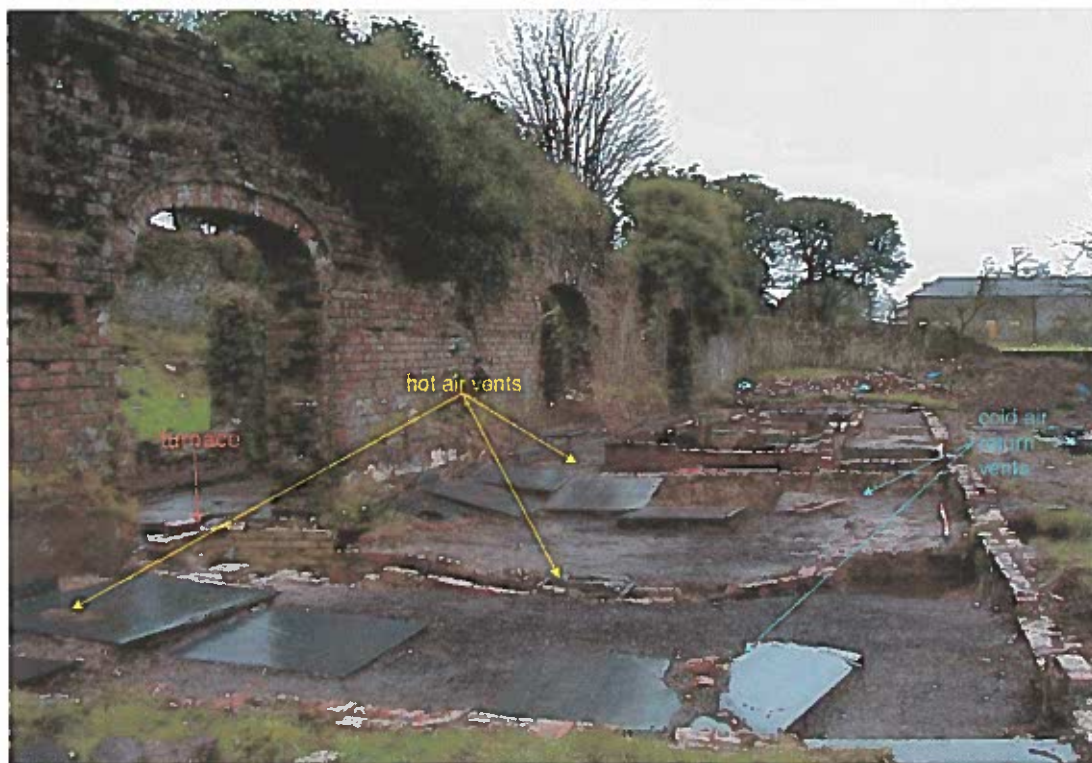
Plate 5: Overview of southern room of Glasshouse, showing principal features of the phase 4 heating system revealed during 2000 excavations. (Scales 1 and 2m. looking north)

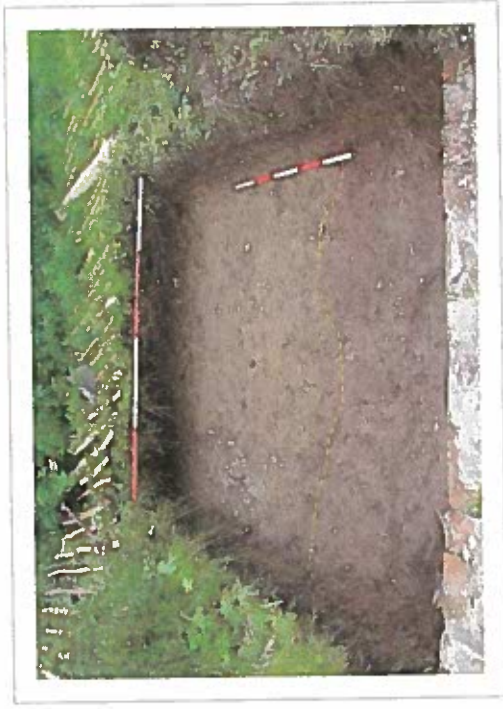
Plate 6: Trench 1, showing position of cut (highlighted) for eastern culvert. (Scales 2 x 1 m. looking east)

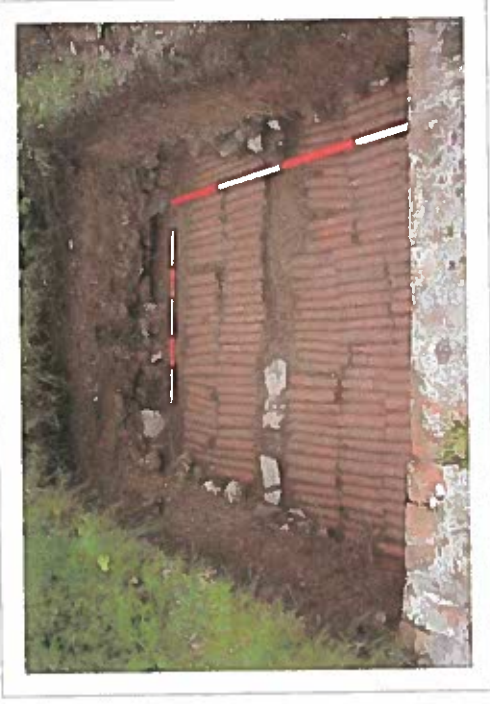
Plate 7: Trench 1, showing layer of ceramic field drains. (Scales 1 x 2 m. looking east)

After removal of the ceramic drainpipes (8), located during the previous excavation, a deposit of large angular stones was uncovered (4), which filled the entire trench. This deposit was c.0.4m deep and another layer of ceramic drainpipes (8) was located directly beneath deposit 4. After the removal of the drainpipes a north/south cut (12) was visible occupying the full width of the trench. This cut was filled by a yellow compact clay (13) with a rough stone and broken brick culvert (15) located at its base. Further excavation of the western side of the trench revealed another stone culvert (16) 0.1m from the east wall of the Peach House at the same depth as culvert.

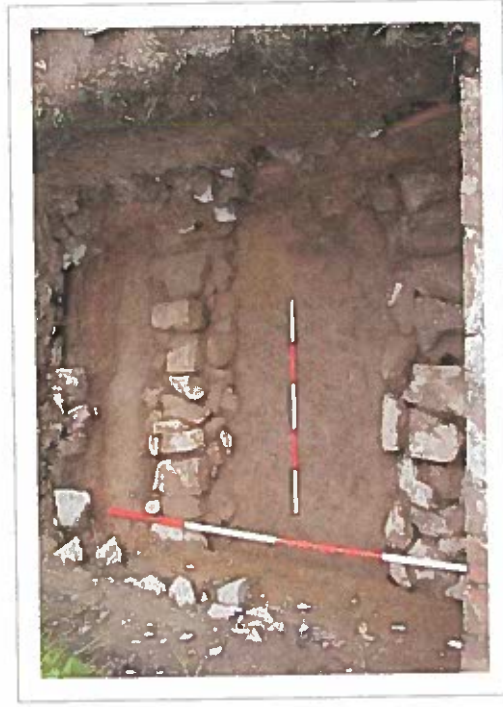
Plate 8: Trench 1, showing N - S culverts (15) and (16). (Scales 1 x 2 m. looking east)

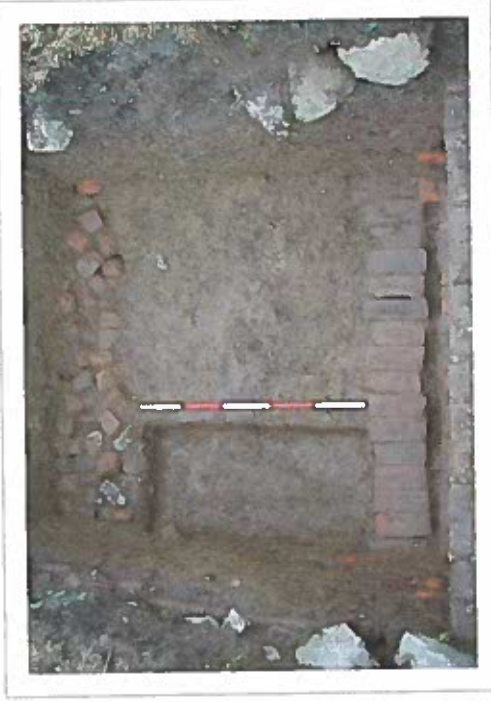
Plate 9: Trench 2, showing N - S culverts (27) and (29). (Scales 1 m. looking east)

Excavation of this trench revealed a very similar sequence of deposits to that found in Trench 1. However, the culvert (27) nearest the eastern wall of the Peach House was neatly constructed of red bricks and lay directly beneath the level of a red brick floor surface (62) which projected 0.1m out beneath the eastern wall of the Peach House.

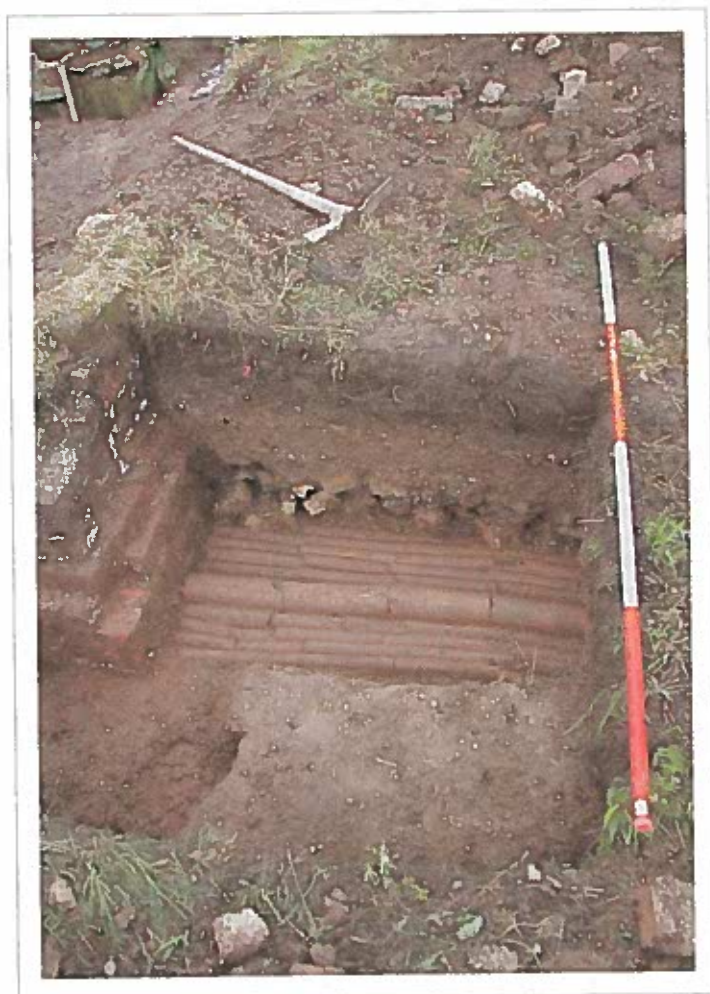
Plate 10: Trench 3, showing ceramic pipes (35) and cut (39)
(Scale 2m. looking north).

The uppermost deposits within this trench were similar to those located in Trenches 1 and 2. However, the large angular stone deposit and ceramic drainpipes terminated c. 1m from the northern section of the trench where a cut (39) for their deposition was clearly visible.

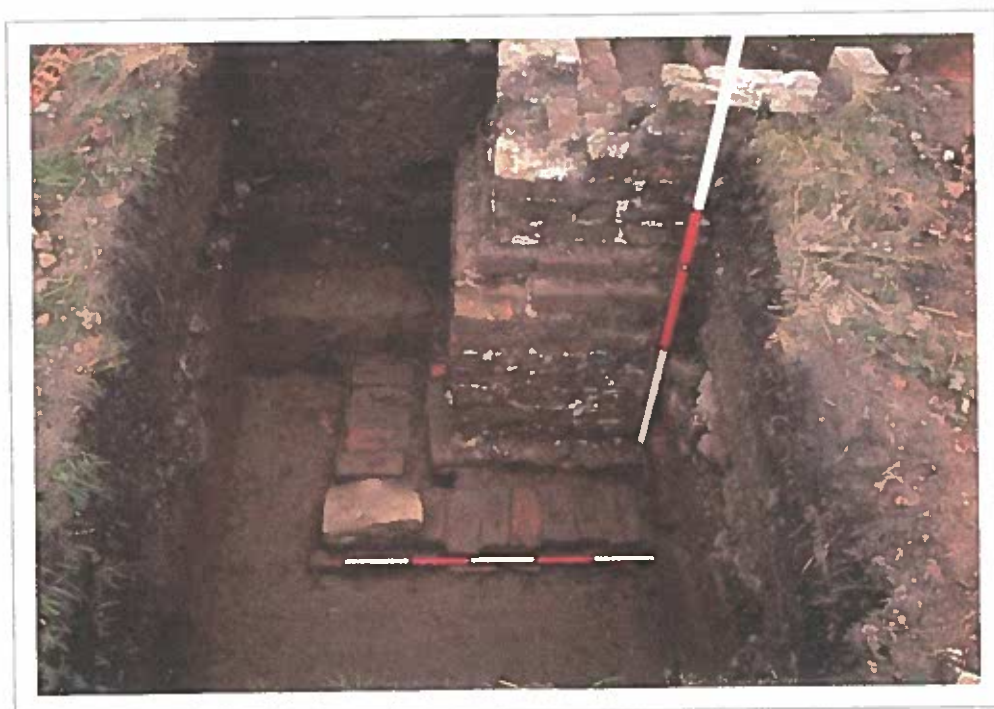
Plate 11: Trench 3, showing culvert (38)
(Scales 1 x 2m. looking west)

A red brick culvert (38) was located at the base of the eastern wall of the Glasshouse in alignment, and at the same depth as the culvert in Trench 2. The culvert continued at a right angle corresponding with the corner of the Glasshouse and ran towards the inner western wall of the garden, rising slightly to the west.

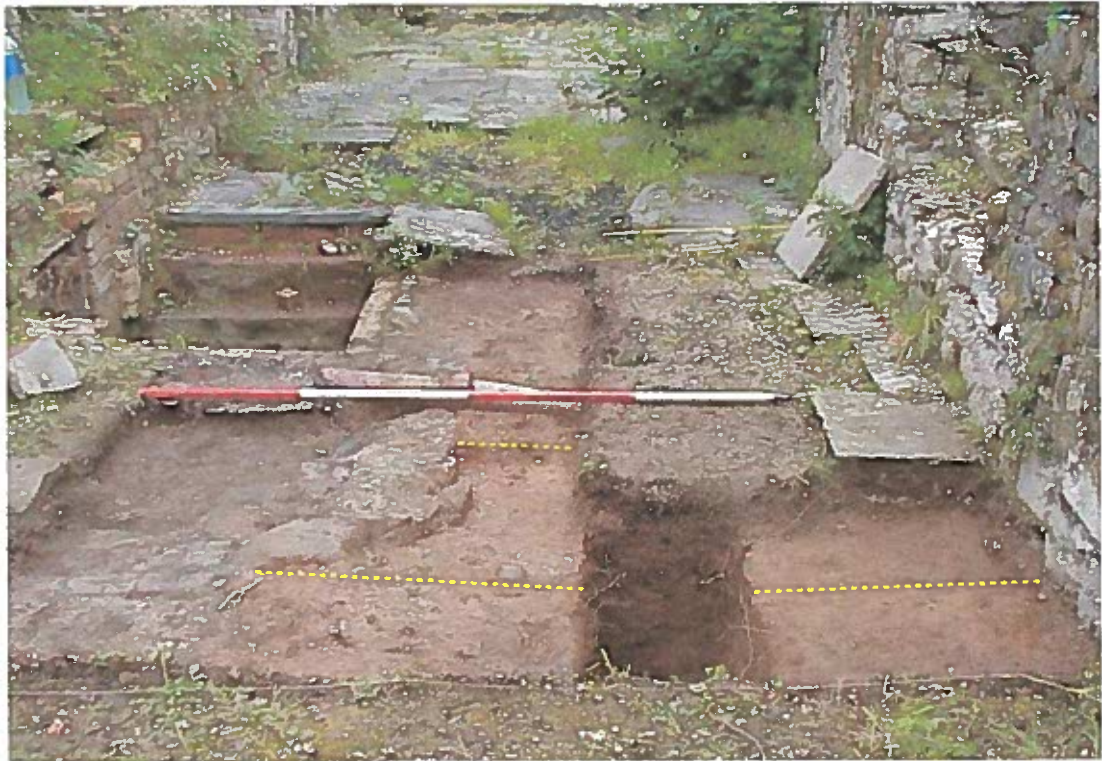
Plate 12: Trench 4, showing robber trench (cut highlighted) for southern wall of Phase 1 'cottage'.
(Scale 2m. looking south)

A trench was excavated within Room 2 of the Stokehouse in order to attempt to locate the return/southern wall of the original Phase 1 'cottage' building. Excavation revealed a cut (42) 0.6m in width running at right angles from the butt joint in the western wall of the Stokehouse at the southern point of Room 2. At the eastern end of the trench, possible foundation remains (43) were located in this cut.

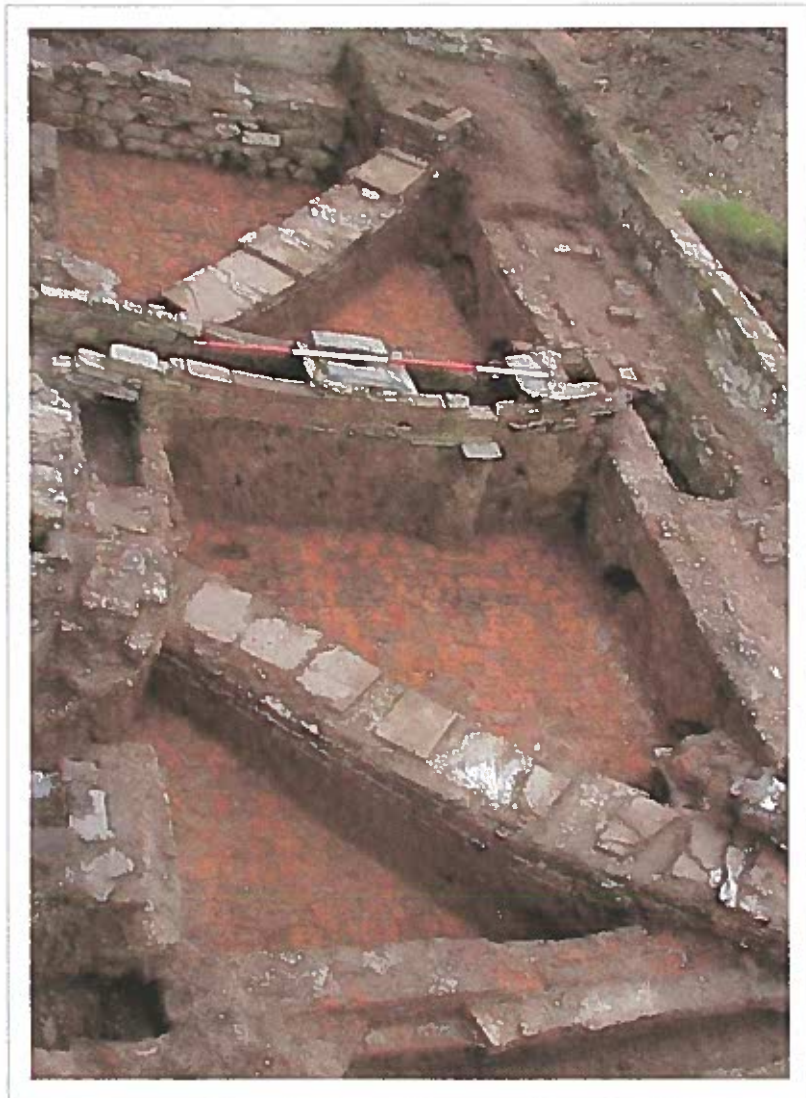
Plate 13: Overview of phase 3 - 4 heating system in southern room of Glasshouse, with phase 2a floor and walls beneath.
(Scale 2m. looking north oblique)

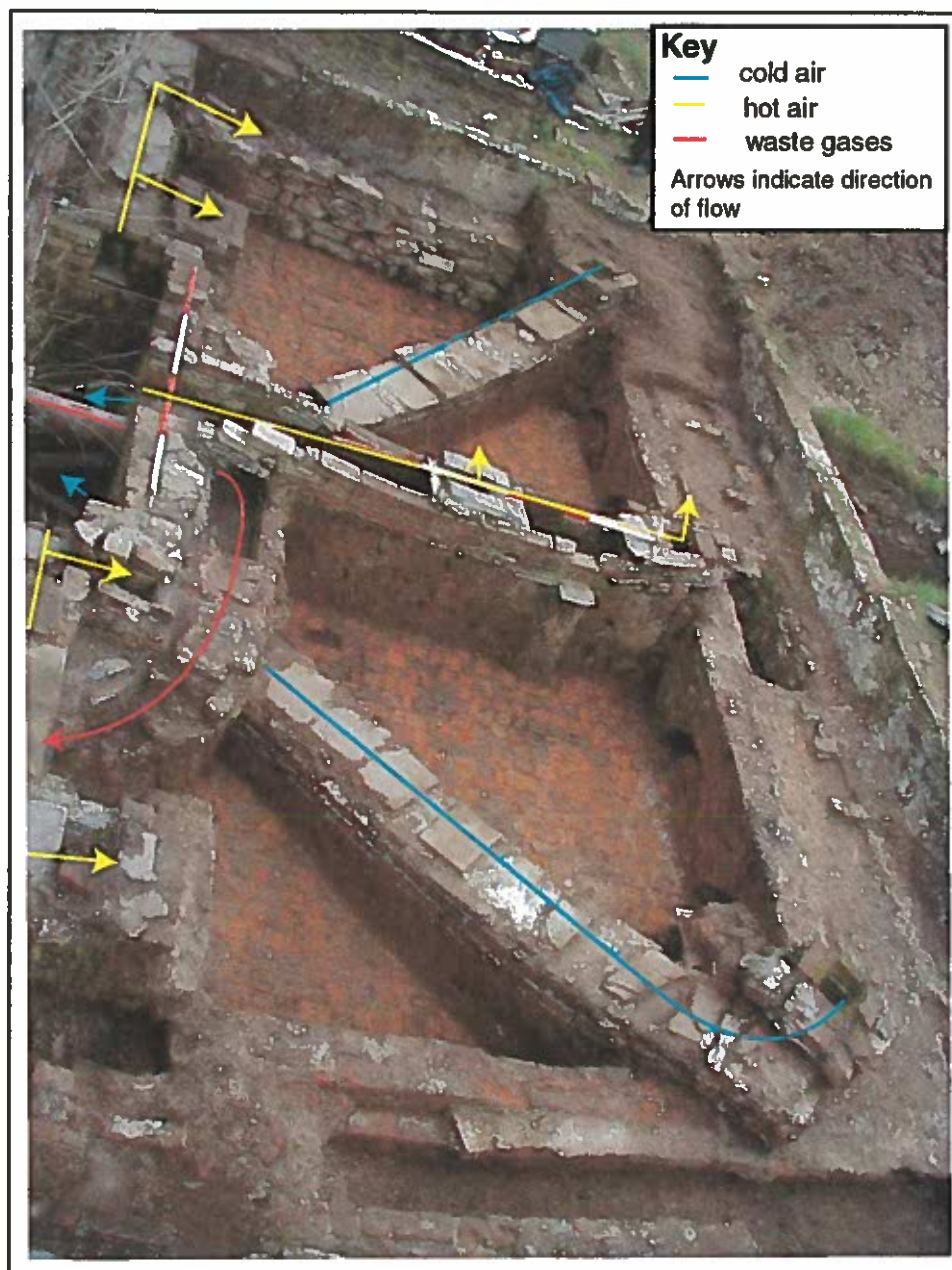
Plate 14: Overview of heating systems in South Room, with illustrations of air flow and gas flow through flues.
(Scale 2m, looking north oblique)

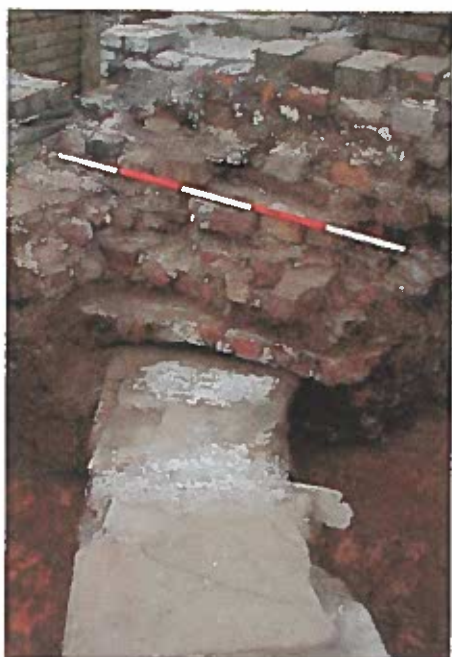
Plate 15: Cold air return flue *with* capping, entering hot air chamber of southern furnace. (Scale 1m. looking west)

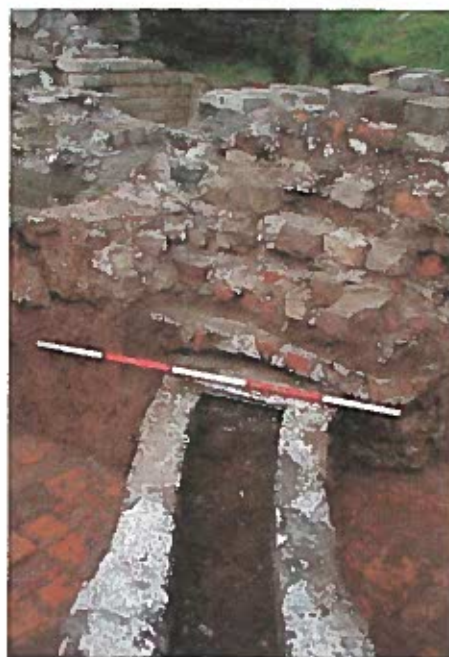
Plate 16: Cold air return with capping removed. (Scale 1m. looking west).

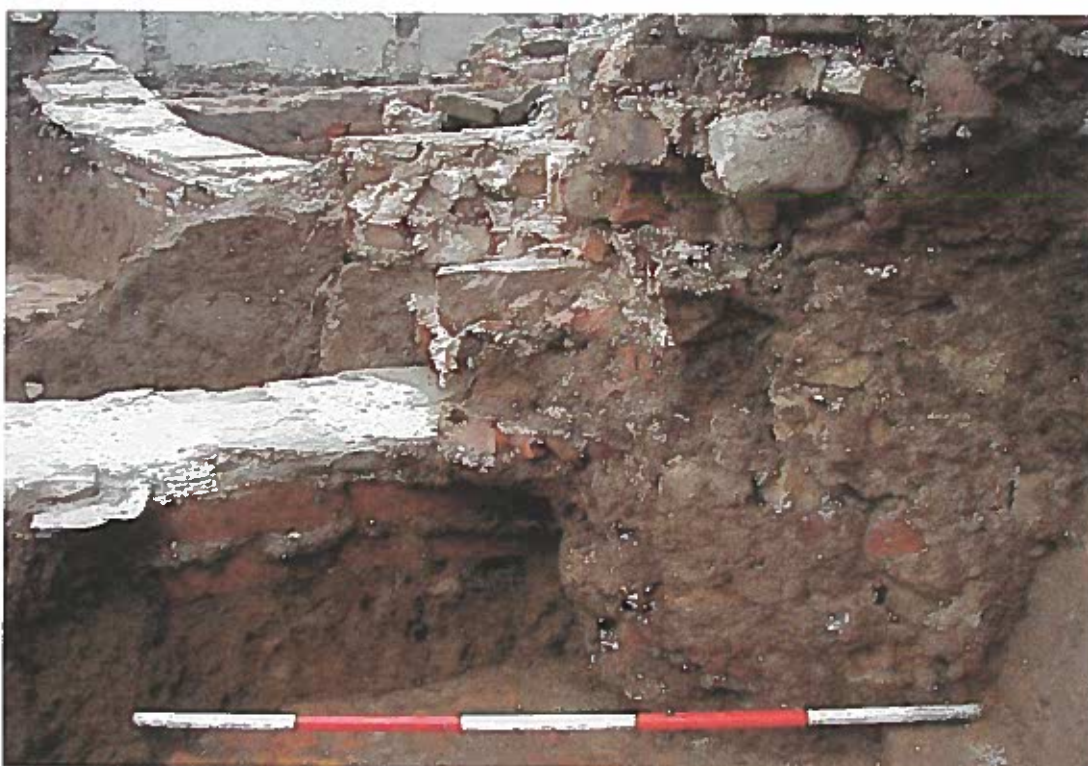
Plate 17: Cold air return flue entering hot air chamber of southern furnace. (Scale 1m. looking south)

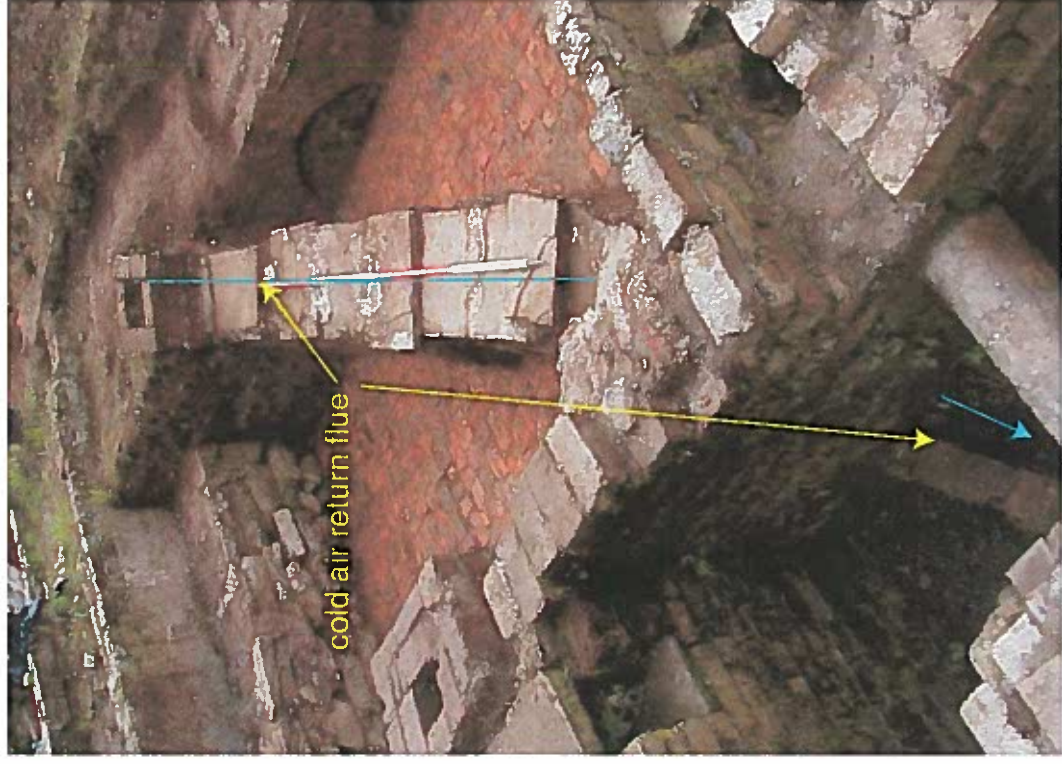
Plate 18: Northern cold air return flue with air flow illustrated.
(Scale 2m. looking north-east)

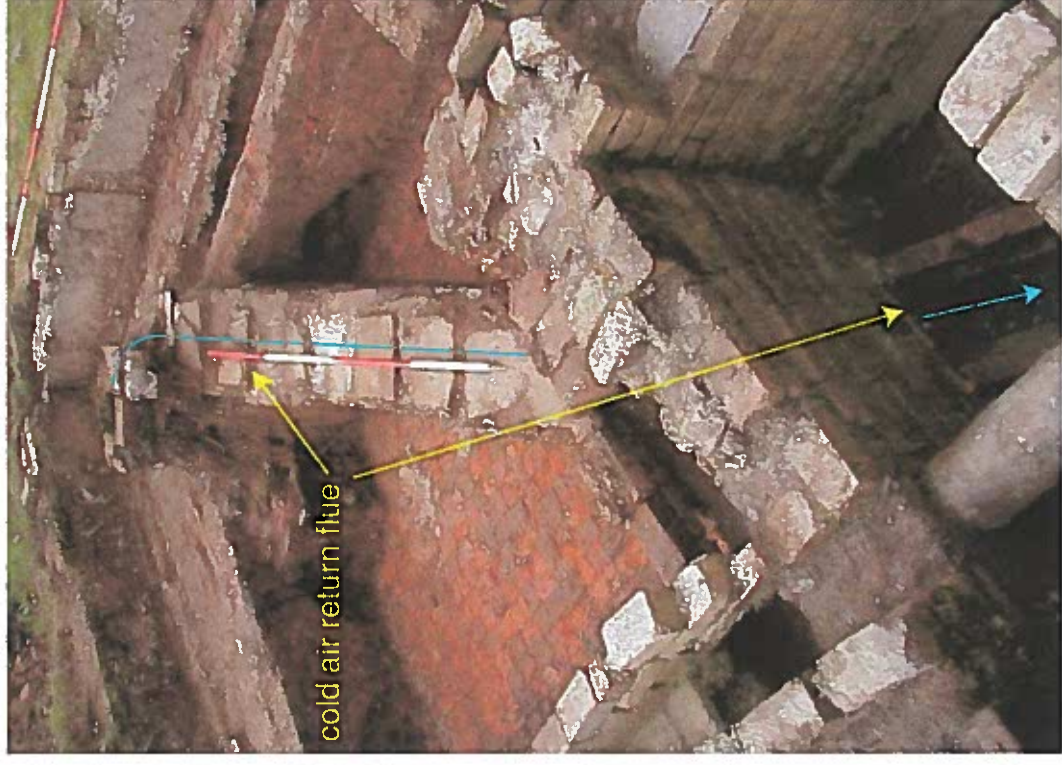
Plate 19: Southern cold air return flue with air flow illustrated.
(Scale 2m. looking south-east)

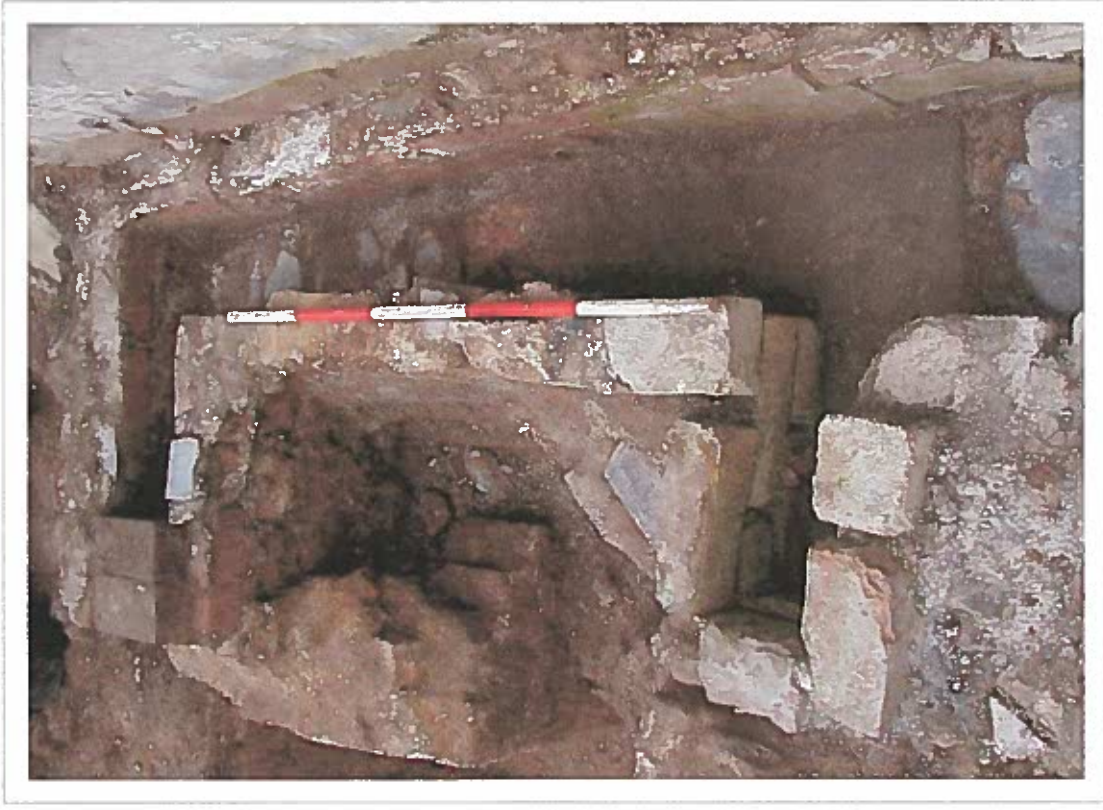
Plate 20: Southern hot air flue uncovered.
(Scale 1m. looking south)

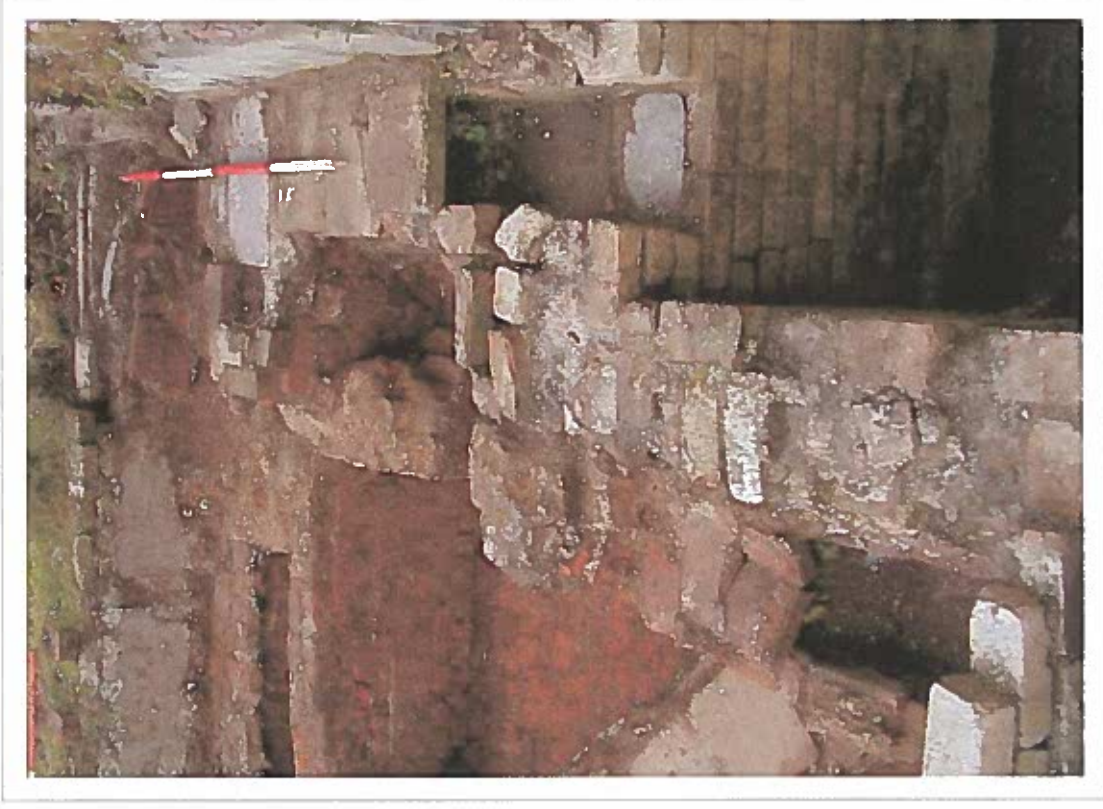
Plate 21: Southern hot air flue covered.
(Scale 1m. looking south)

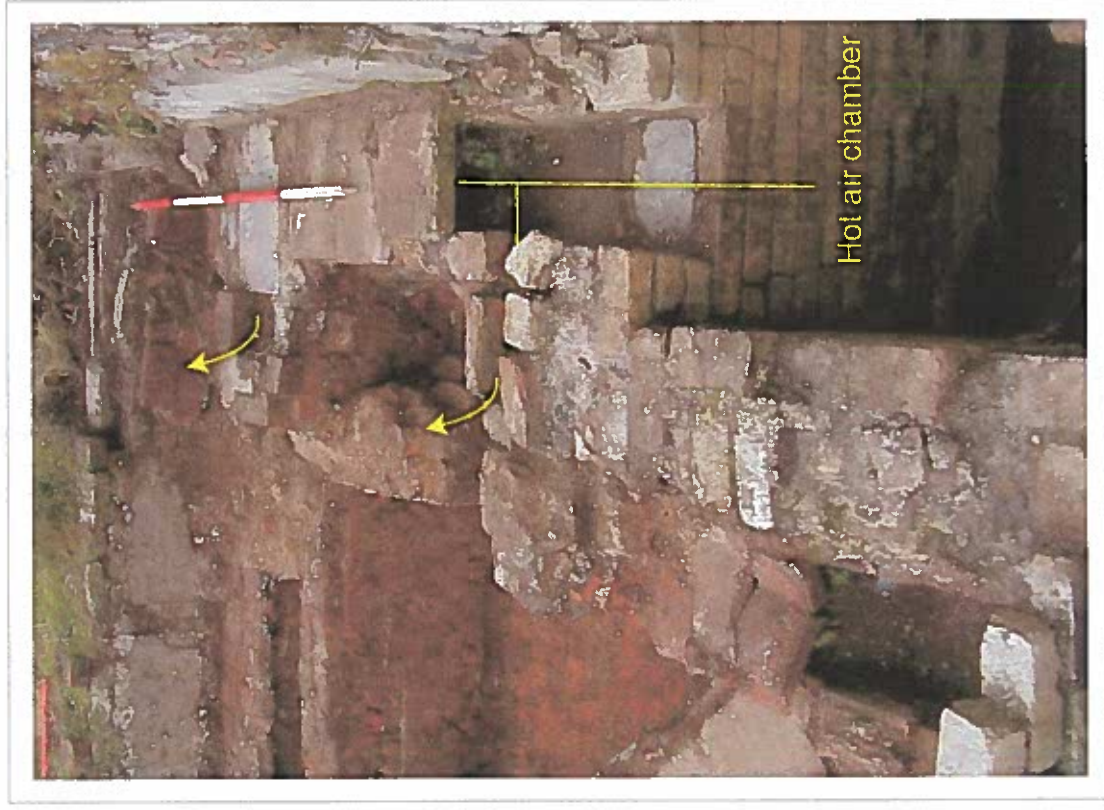
Plate 22: Southern hot air flue with air flow illustrated.
(Scale 2m. looking south)

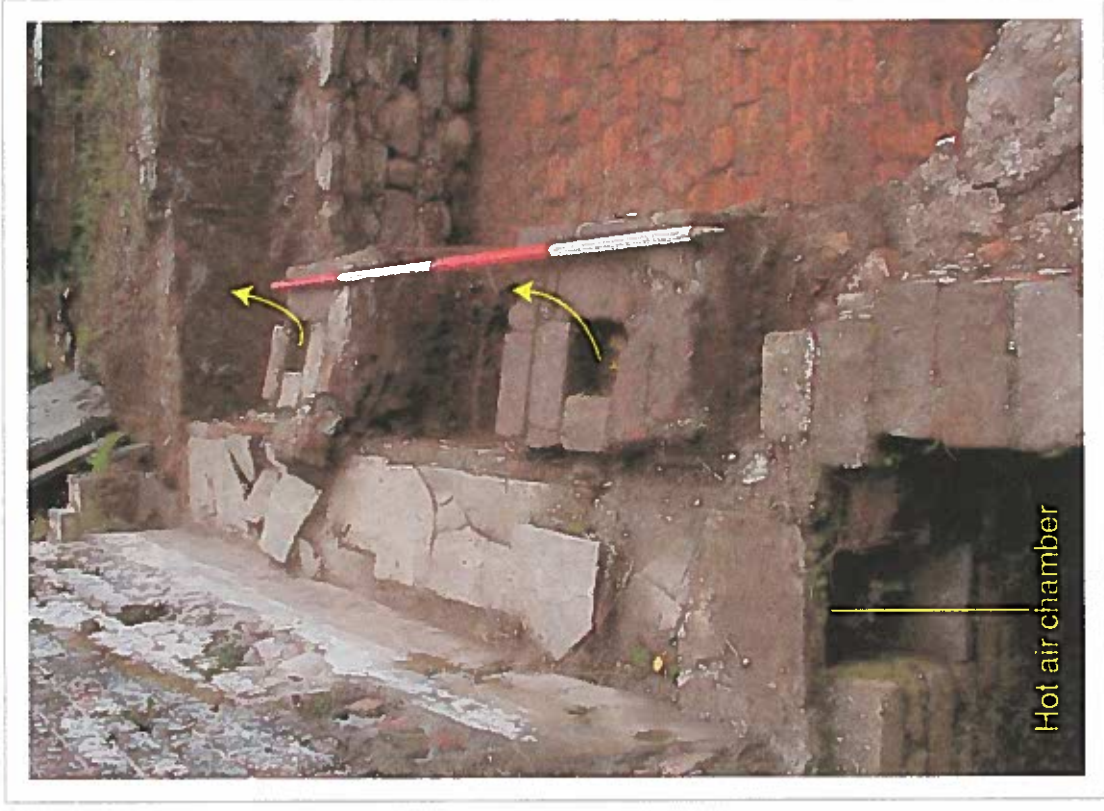
Plate 23: Northern hot air flue with air flow illustrated.
(Scale 2m. looking north)

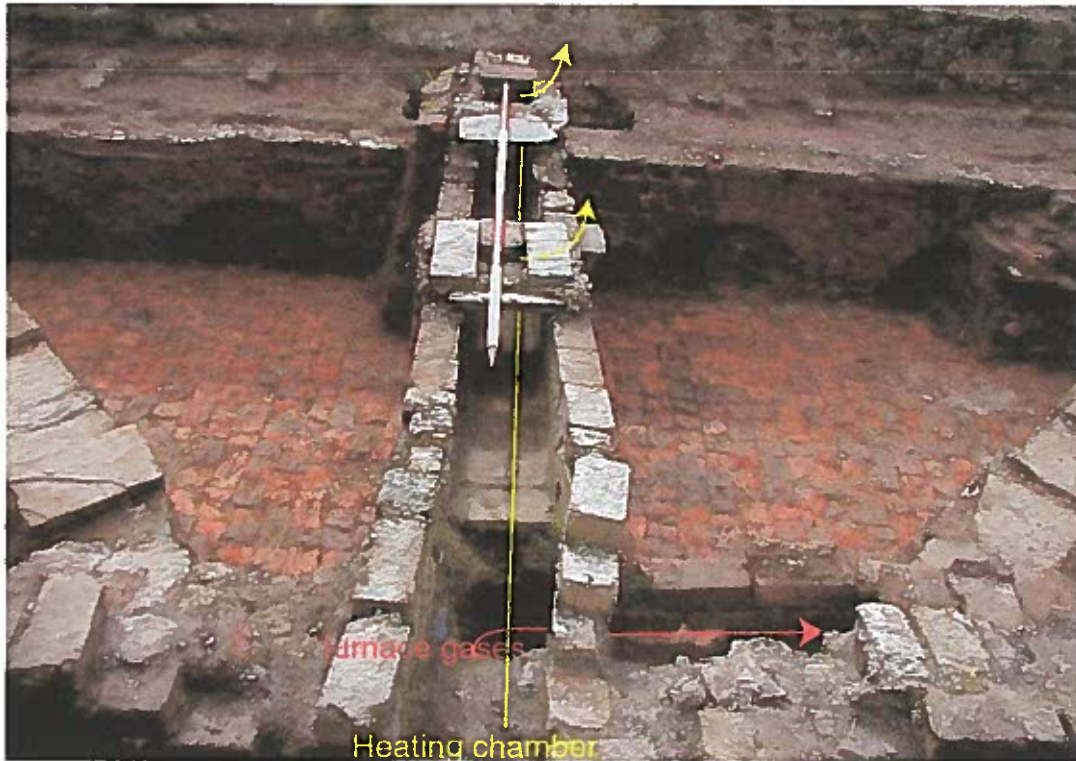
Plate 24: Central hot air flue and furnace gas flue, with flow directions illustrated.
(Scale 2m. looking east)

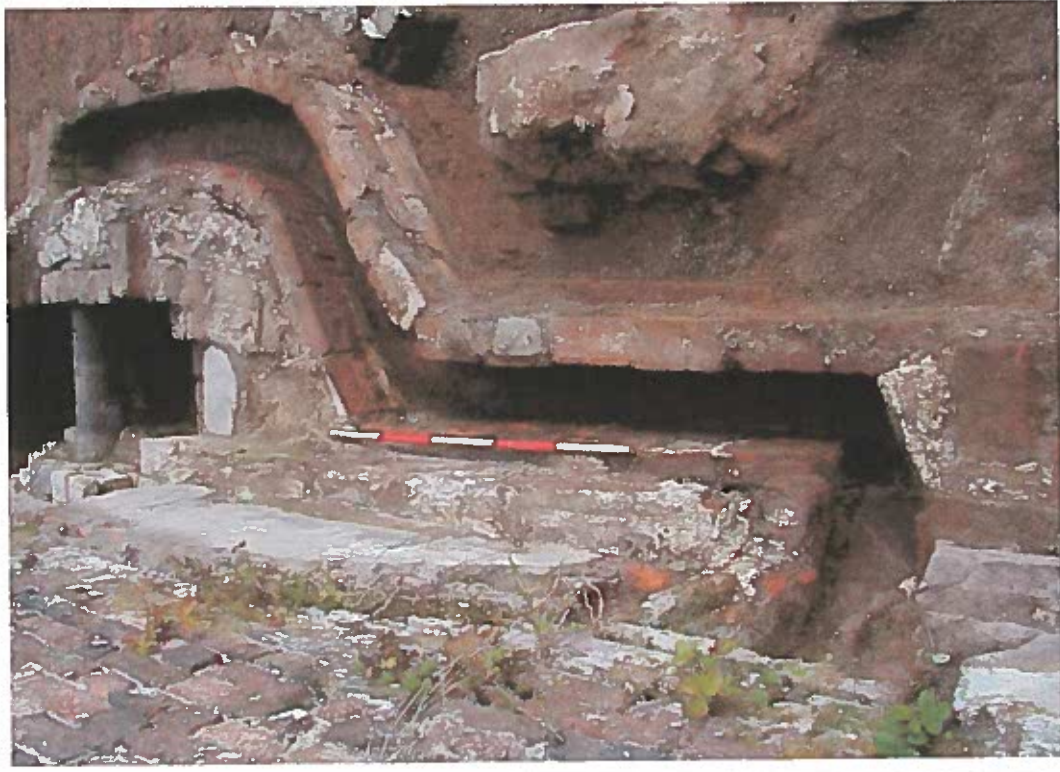
Plate 26: Gas Flue for Southern Furnace with capping removed.
(Scale 1m. looking north)

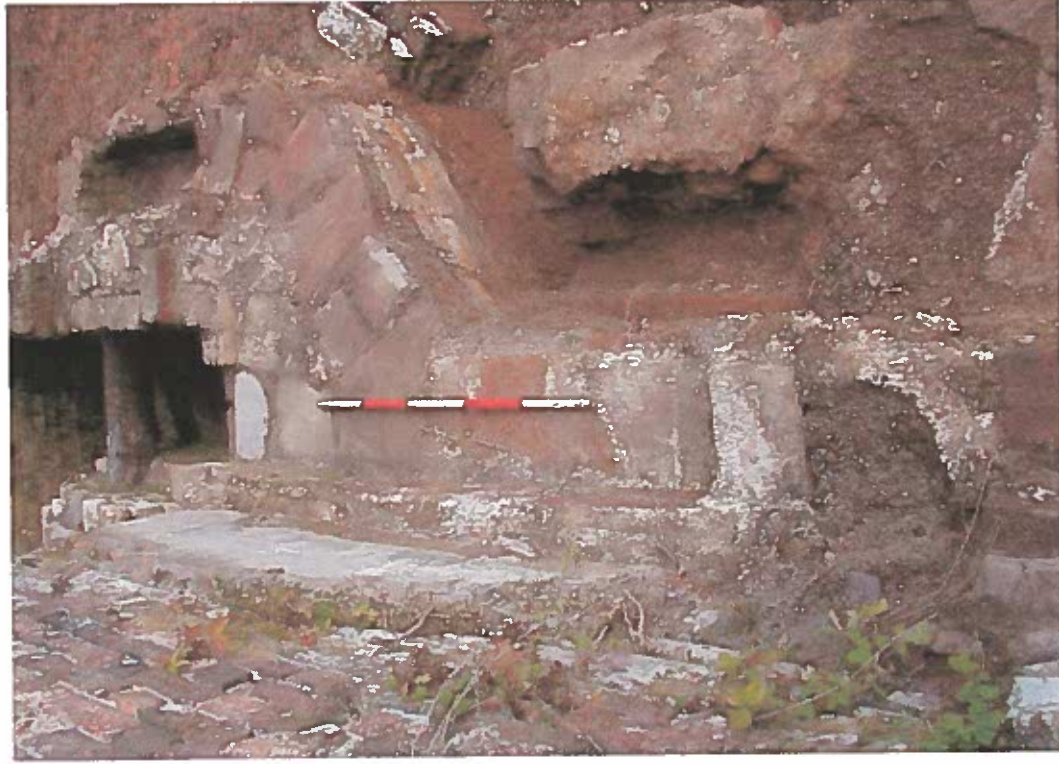
Plate 25: Gas Flue for Southern Furnace with capping intact.
(Scale 1m. looking north)

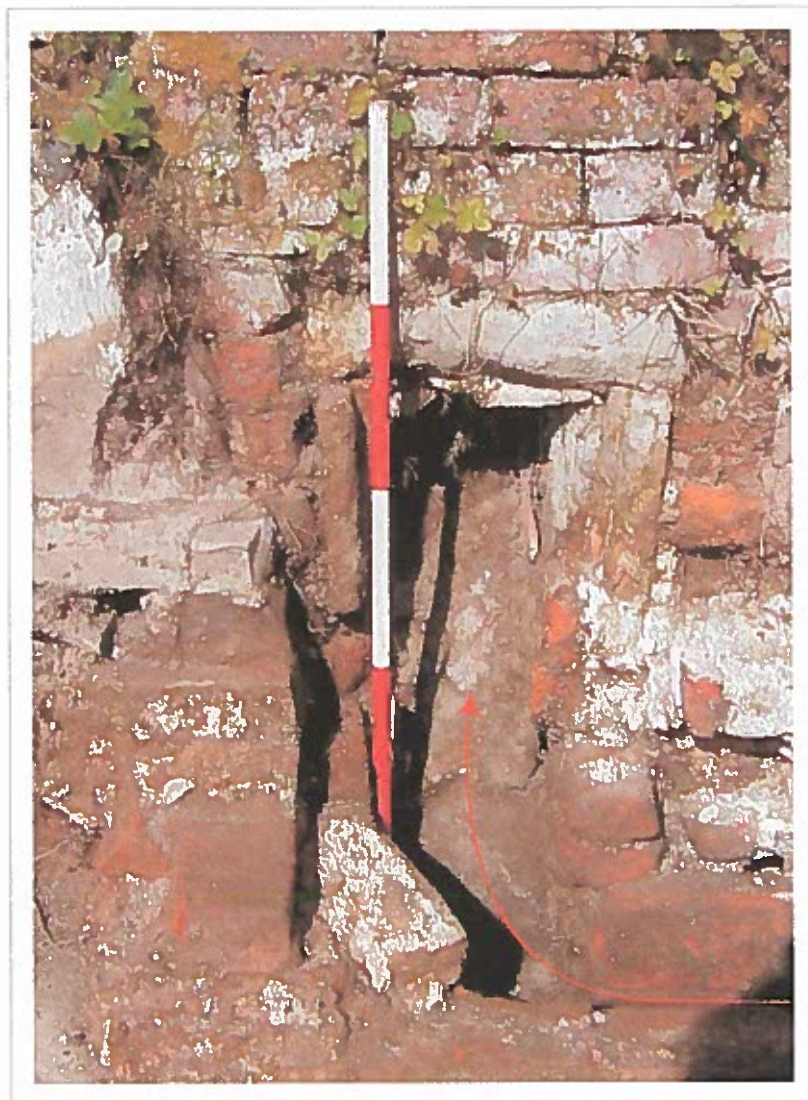
Plate 27: Wall Flue taking furnace gases out of Glass House.
(Scale 1m. looking west)

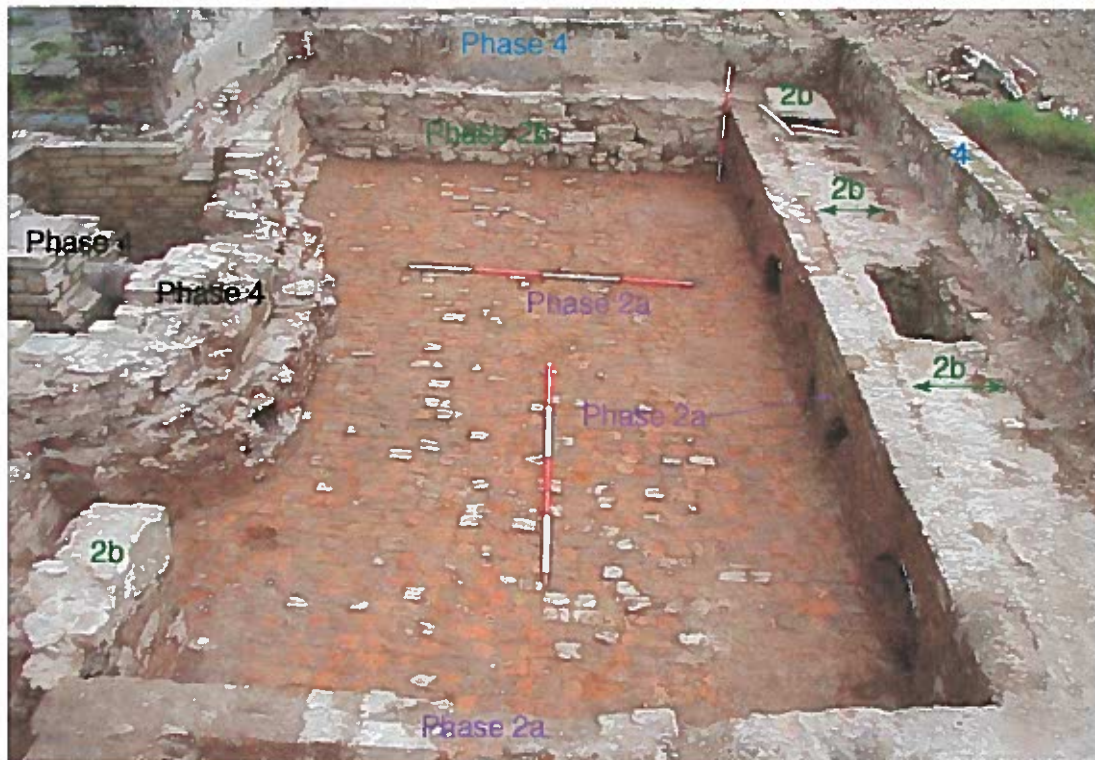
Plate 28: Overview of South Room after excavation showing suggested phasing of structural elements.
(Scales: 1m, 2m . looking north)

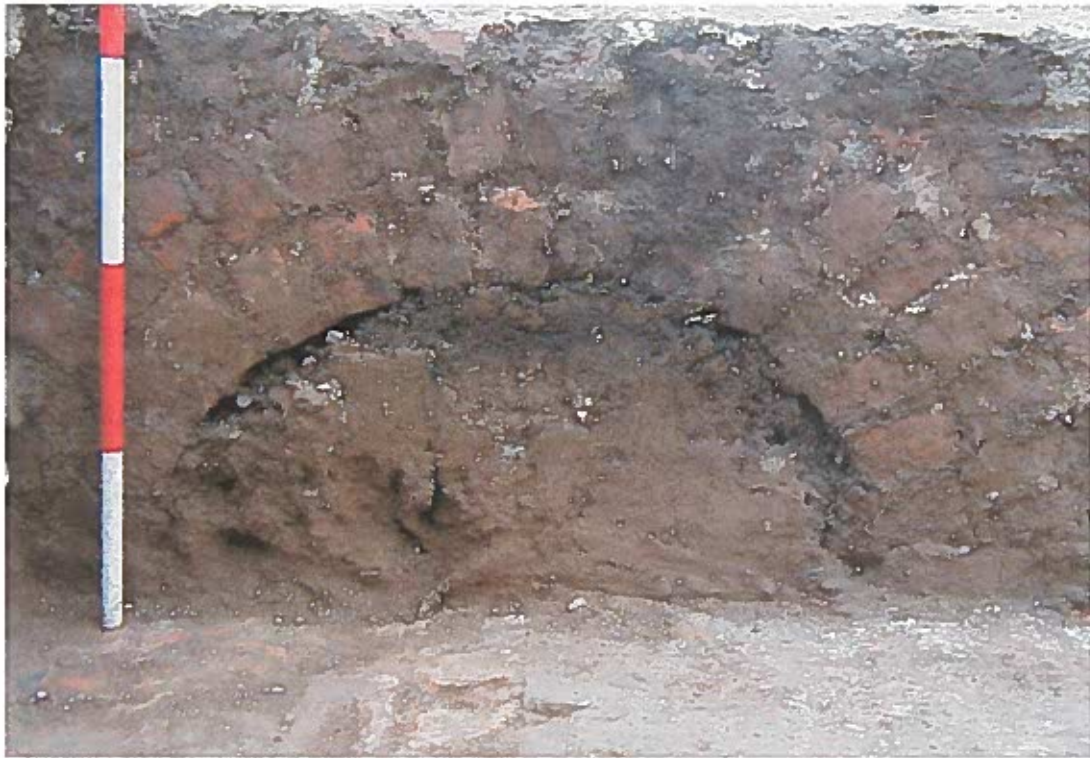
Plate 29: Detail of arches in eastern inner wall of south room.
(Scale 1m. looking east)

Excavation of the southern room of the Glasshouse revealed that the double brick walls with archways (64) continued along the entire length of the eastern side of the Glasshouse. In the Southern Room the inner eastern wall had six arches, and in the areas where the central slot could be fully excavated, each arch had a corresponding arch on the external wall. A double wall (65) was also exposed running along the southern side of the building, with a single arch centrally located in both walls. This wall terminated 1.1m from the western wall of the Glasshouse. Scarring on the western end of the southern wall (Plate. 33), and mortar patches on the red brick floor (which covered the entire building) suggests that another arched wall ran north/south along the western side of the building at this point (Fig. 16). Another similar feature at the eastern end of the southern wall (Plate. 34) would appear to be a scar from wooden beam or other structural fastening. The western wall of the Glasshouse forms part of the inner wall of the garden, and is constructed in the same manner as the rest of the inner wall i.e red brick wall with stone foundation. However, within the southern room of the Glasshouse the stone foundation is covered with a red brick batter (Plate. 35), which has a red brick culvert (66), similar to that located in Trenches 2 and 3, forming a base beneath the batter (Plates. 31-32).

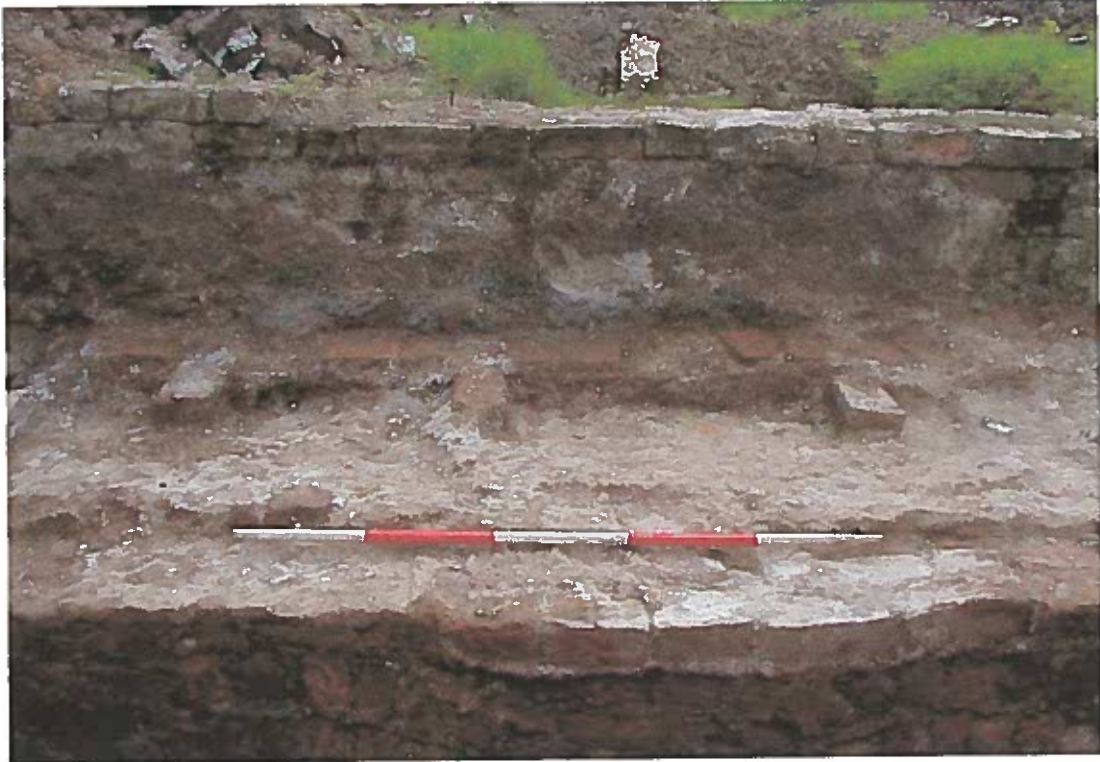
Plate 30: Detail of floor joist slots on east side of Southern Room.
(Scale 1m. looking east)

Excavations revealed that the gap between the double arched walls and the interior of the building was backfilled with a mid brown/yellow clay deposit (67) between the time when the manure heating system was in use and the construction of the furnace heating system. During this phase the gap between the two arched walls, on the eastern and southern sides of the building, were capped with bricks and sealed with mortar. Resting on this mortar spread, bricks placed at regularly spaced intervals appear to form beam supports for a wooden floor (Plate.30). At this time two drains were also created over the gap in the arches, one at the northern end of the eastern wall, which still has its flagstone capping, and the other half way along the same wall (Plate. 37). During this phase it would appear that the building of phase 2 was divided, with the insertion of a stone wall at the northern end of the South Room This again has regularly spaced
