Peach House Excavations 2001, National Botanic Garden of Wales, Carmarthenshire

Archaeological Excavation

CAP Report No. 194

Date: October 2001

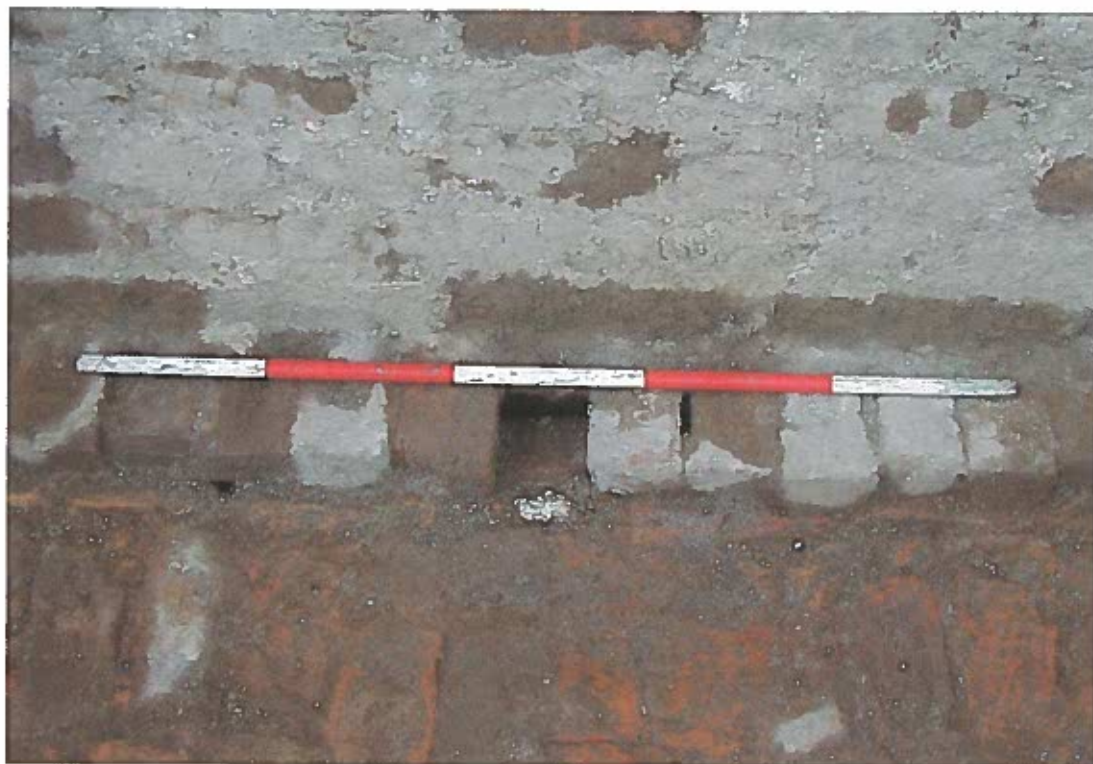
Plate 31: Brick culvert at base of west wall, southern room of Glass House.
(Scale 1m. looking west)

Excavation of the southern room of the Glasshouse revealed that the double brick walls with archways (64) continued along the entire length of the eastern side of the Glasshouse. In the Southern Room the inner eastern wall had six arches, and in the areas where the central slot could be fully excavated, each arch had a corresponding arch on the external wall. A double wall (65) was also exposed running along the southern side of the building, with a single arch centrally located in both walls. This wall terminated 1.1m from the western wall of the Glasshouse. Scarring on the western end of the southern wall (Plate. 33), and mortar patches on the red brick floor (which covered the entire building) suggests that another arched wall ran north/south along the western side of the building at this point (Fig. 16). Another similar feature at the eastern end of the southern wall (Plate. 34) would appear to be a scar from wooden beam or other structural fastening. The western wall of the Glasshouse forms part of the inner wall of the garden, and is constructed in the same manner as the rest of the inner wall i.e red brick wall with stone foundation. However, within the southern room of the Glasshouse the stone foundation is covered with a red brick batter (Plate. 35), which has a red brick culvert (66), similar to that located in Trenches 2 and 3, forming a base beneath the batter (Plates. 31-32).

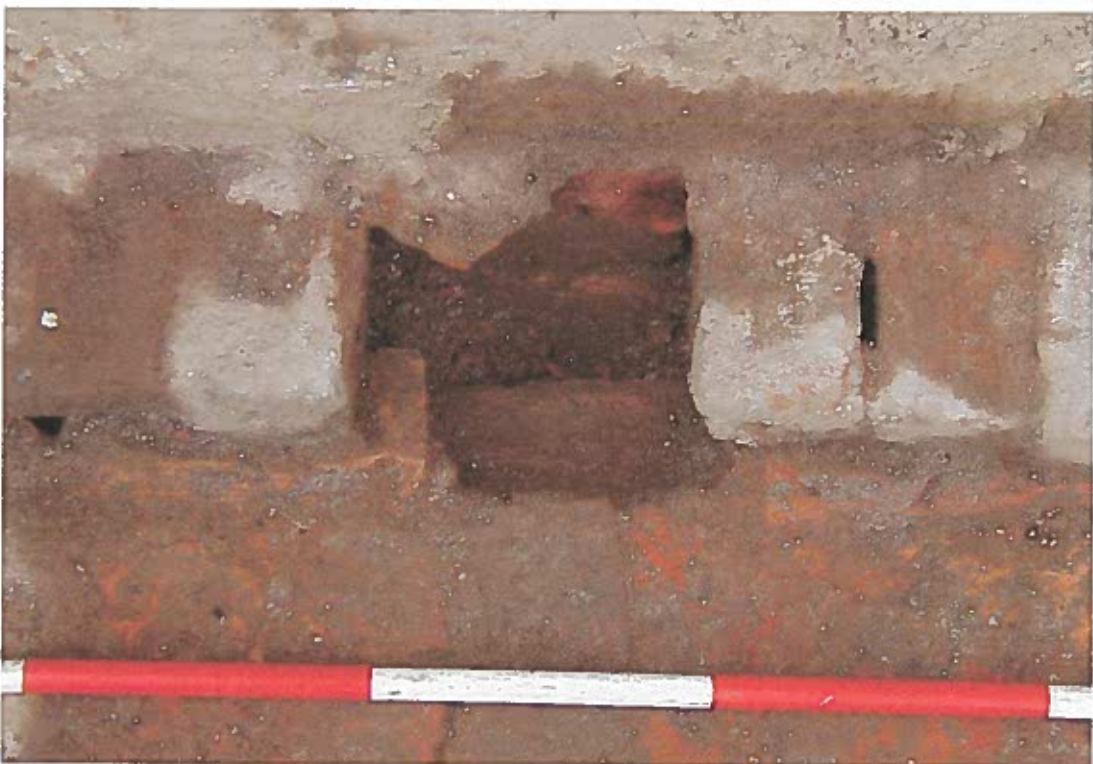
Plate 32: Detail of brick culvert (as above) after removal of capping.
(Scale 1m. looking west)

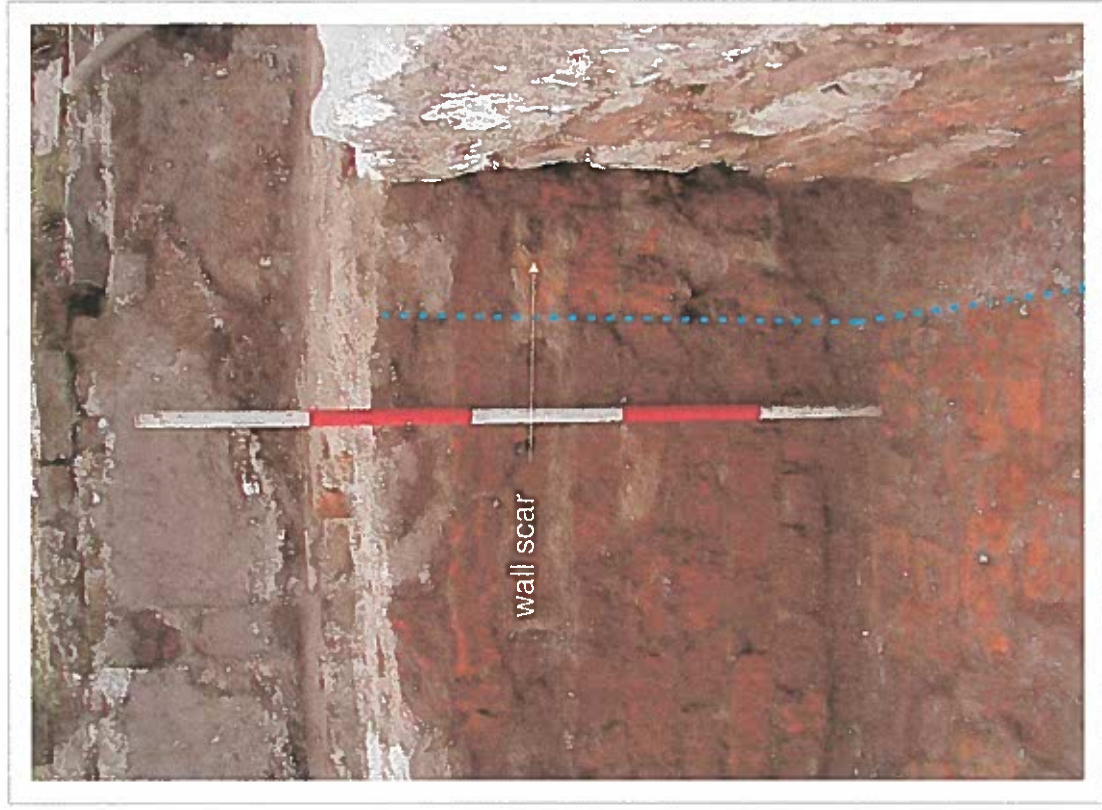
Plate 33: Detail of west end of inner southern arched wall, showing scarring from pre-existing N - S wall. (Edge of scarring is highlighted) (Scale 1m. looking south)

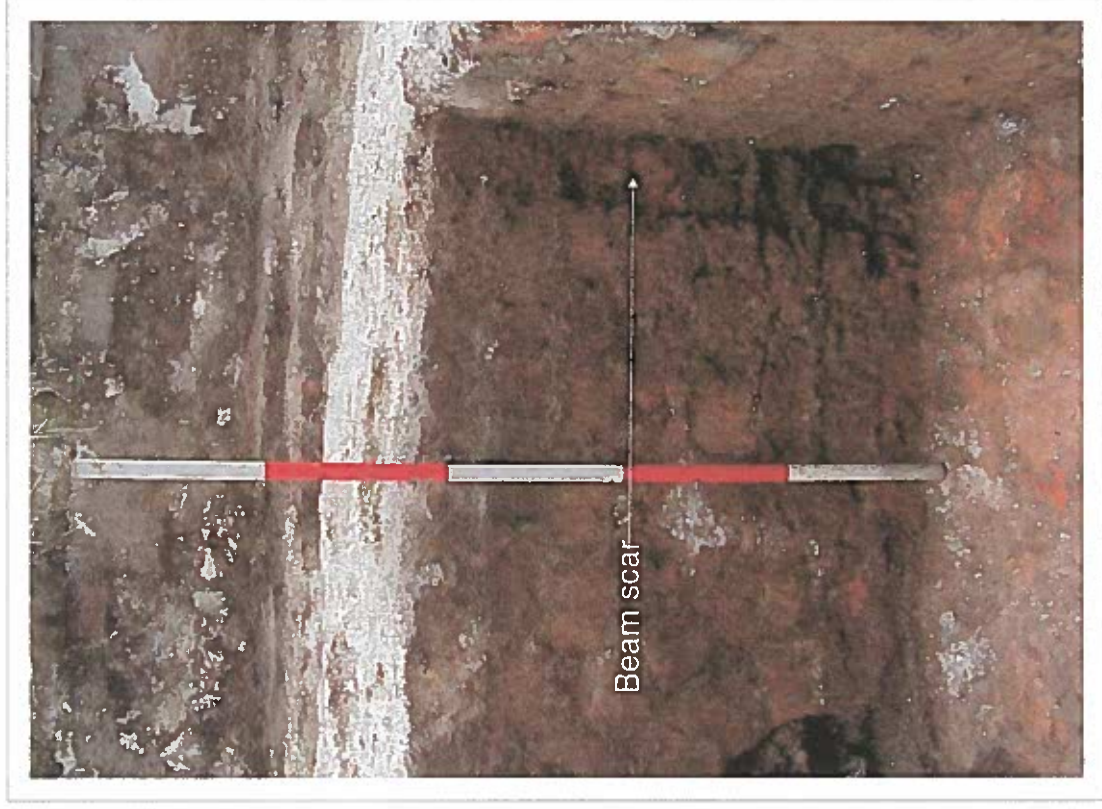
Plate 34: Detail of interface between inner eastern/ southern walls of south room, showing scarring on brickwork, probably caused by a beam. (Scale 1m. looking east)

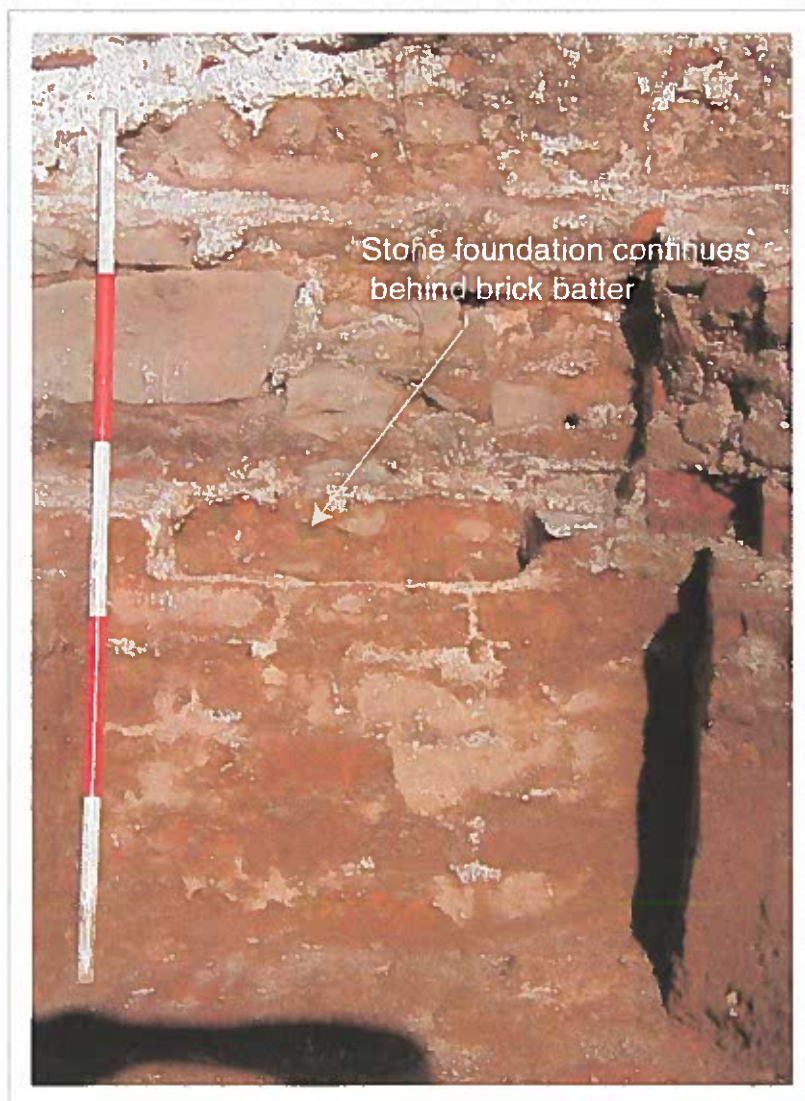
Plate 35: Detail of west wall foundations of Glass House, showing brick batter on stone foundations.
(Scale 1m. looking west)

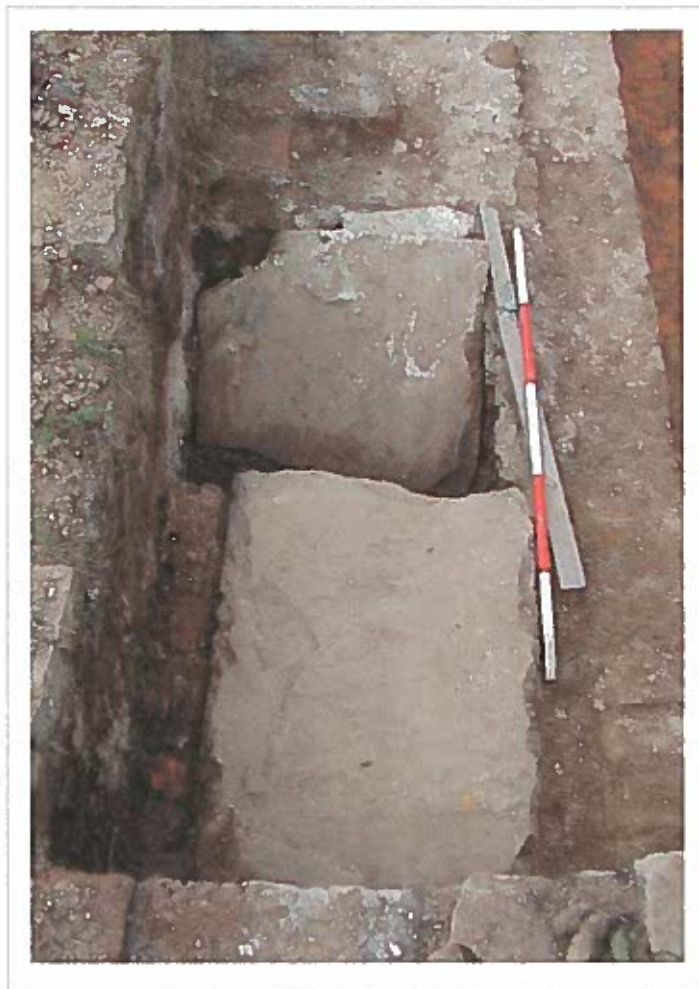
Plate 36: Drain capping, phase 2b. (Scale 1m. looking south)

Excavations revealed that the gap between the double arched walls and the interior of the building was backfilled with a mid brown/yellow clay deposit (67) between the time when the manure heating system was in use and the construction of the furnace heating system. During this phase the gap between the two arched walls, on the eastern and southern sides of the building, were capped with bricks and sealed with mortar. Resting on this mortar spread, bricks placed at regularly spaced intervals appear to form beam supports for a wooden floor (Plate.30). At this time two drains were also created over the gap in the arches, one at the northern end of the eastern wall, which still has its flagstone capping, and the other half way along the same wall (Plate. 37). During this phase it would appear that the building of phase 2 was divided, with the insertion of a stone wall at the northern end of the South Room This again has regularly spaced

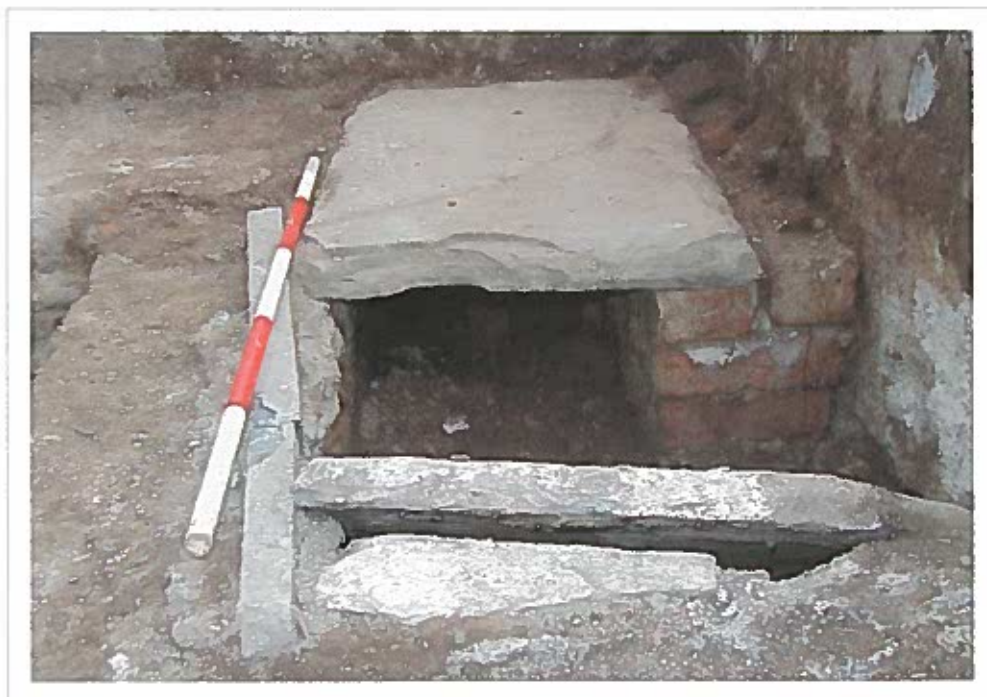
Plate 37: Detail of phase 2b drain viewed from the south. (Scale 1m. looking north)

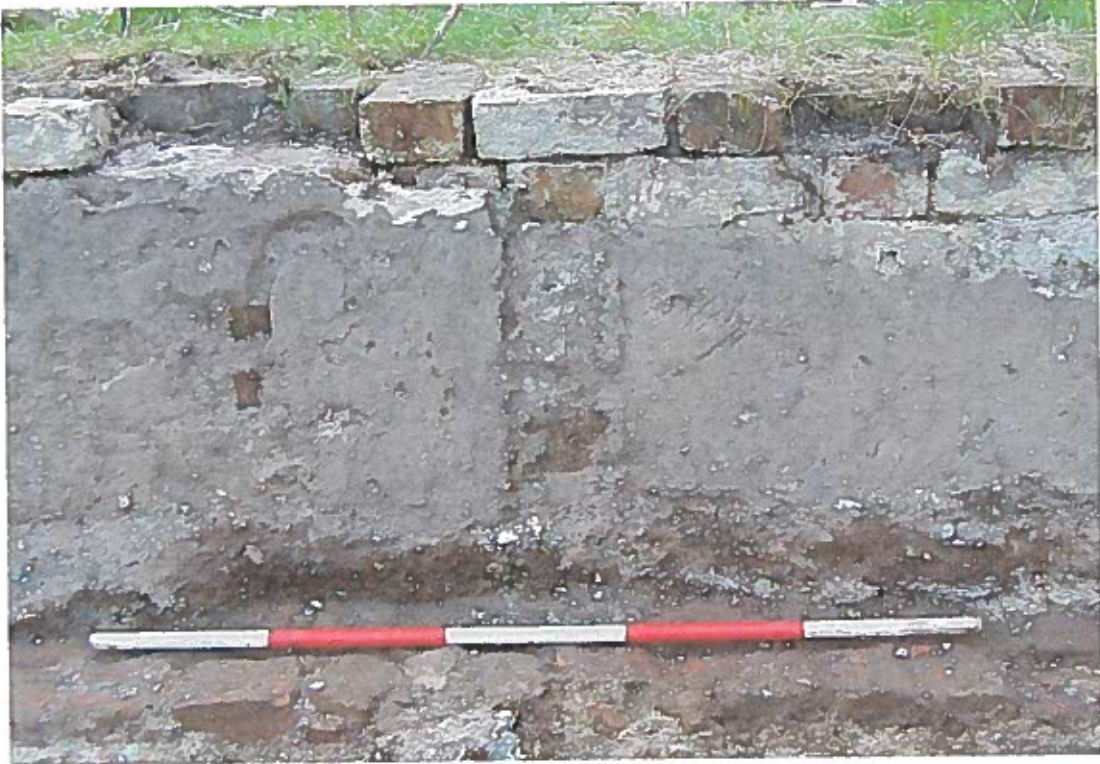
Plate 38: Detail of upper south wall of southern room (phase 4) showing upright beam impression in mortar.
(Scale 1m. looking south)
