HAFOD CHAIN BRIDGE EXCAVATION 1998

An archaeological investigation carried out
and written and compiled by:

Salvatore Garfi BA MA AIS MIFA - **Archaeologist**

30 September 1998

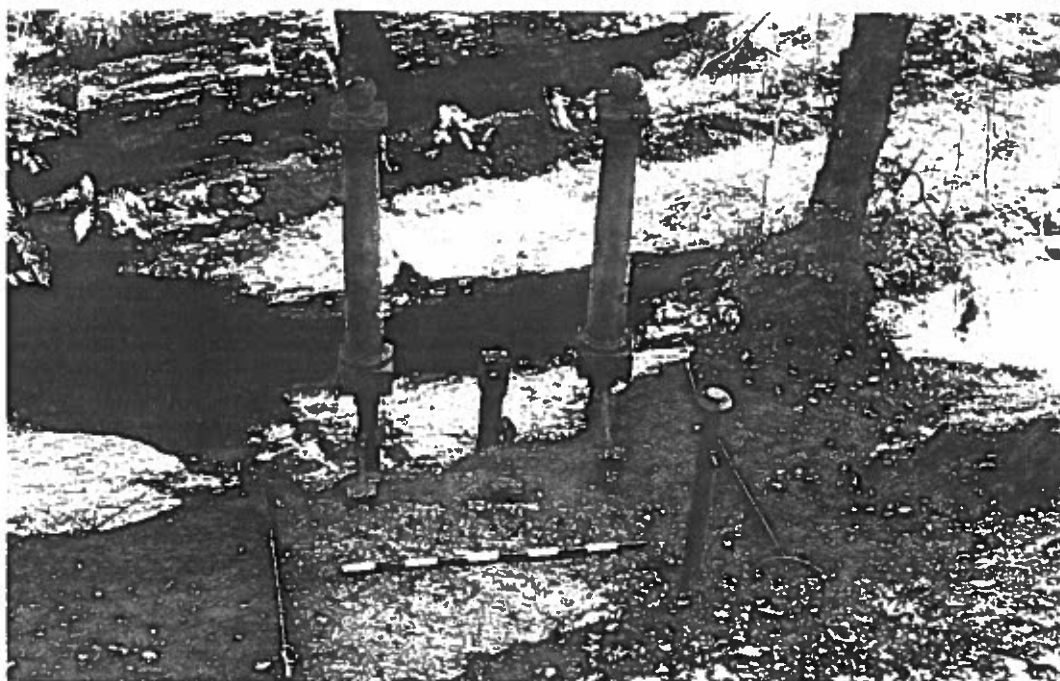
3/9a South excavation trench with the clay dumps of context [3] exposed, looking north.

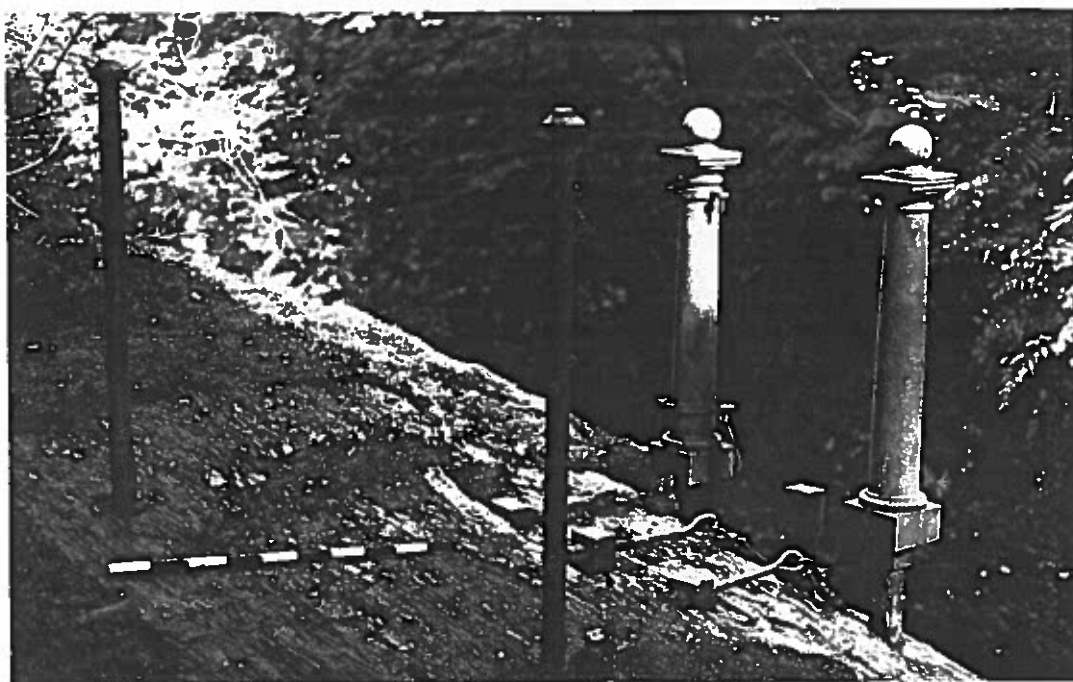
3/20a North excavation trench with humic layer of turf and moss (context [4]) removed, and with bedrock and bridge fittings exposed. Also visible is the cut in the bedrock delineating the path to the bridge. Looking east.

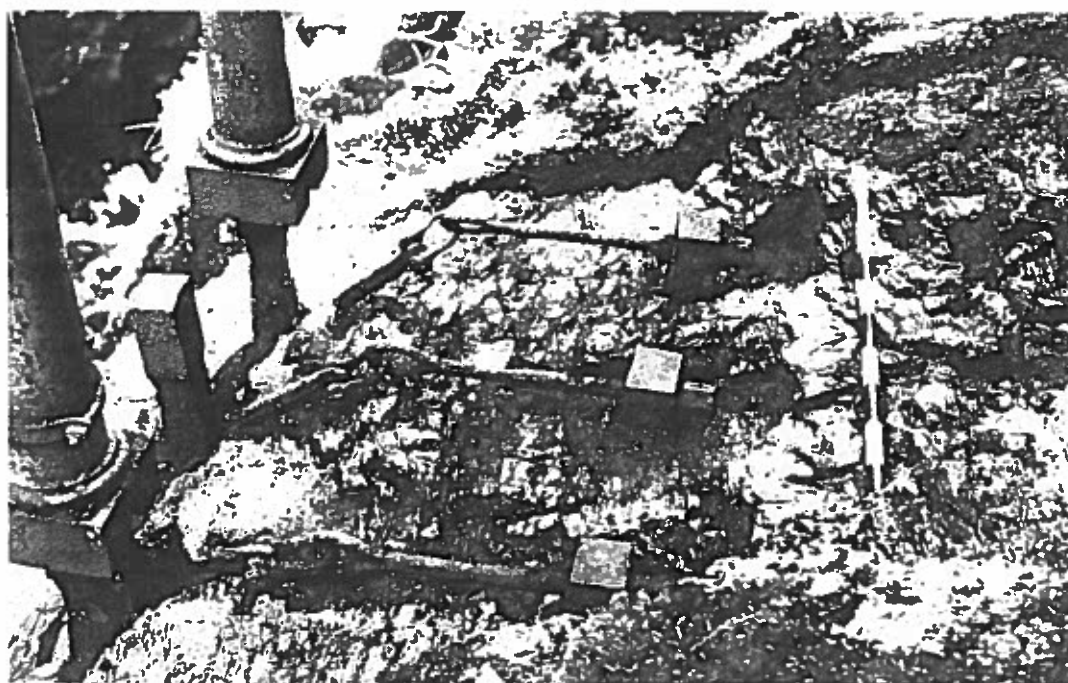
- 27a to
28a North excavation trench. View of the anchor pins, anchor rods and bolts, cable stirrups, corroded ends of cables which supported the bridge gangway, and the guide pins and columns. Also the cuts in the bedrock to accommodate the anchor pin heads and rods. Looking west.

23 North excavation trench. View of the anchor pins, anchor rods and bolts, cable stirrups, corroded ends of cables which supported the bridge gangway, and the guide pins and columns. Also the cuts in the bedrock to accommodate the anchor pin heads and rods. Looking west.

3/28a North excavation trench. View of the anchor pins, anchor rods and bolts, cable stirrups, corroded ends of cables which supported the bridge gangway, and the guide pins and columns. Also cuts in the bedrock to accommodate the anchor pin heads and rods. Looking west.
