# Archaeological Observation on works carried out by Morcon (Dyfed) Ltd in Roman Road, Llangunnor, Carmarthen (November 2002 to February 2003)

Report No: 2003-06-01

### Archaeological Observation on works carried out by Morcon (Dyfed) Ltd in Roman Road, Llangunnor, Carmarthen

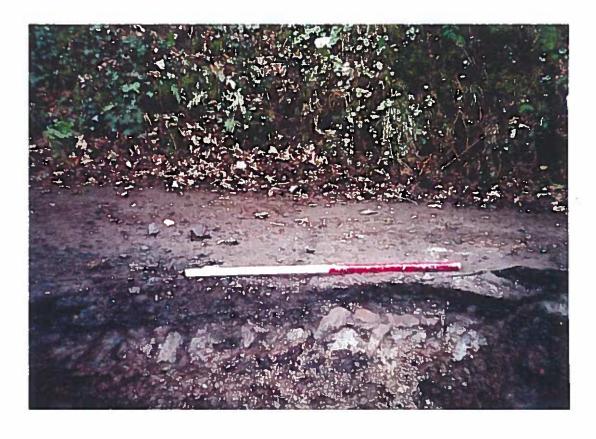
- 5.7 Within (004) a fragmented cobbled road surface (006) was identified at 7.03m (SN 41328 19206). The stones were small and rounded to well rounded, measuring approximately 60mm x 40mm. The cobbles were intermittent up to 11.52m (SN 41333 19202). Most seemed to have been disturbed.

Plate 1 North-east facing section showing cobblestones within (004)

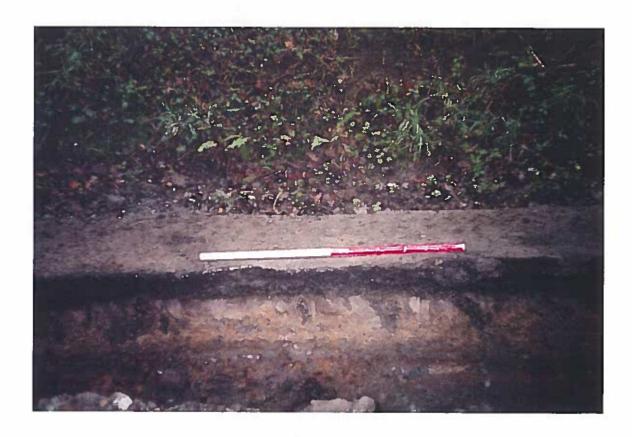
- 5.10 The more substantial stones continued in section to 26.21m. At 26.24m (004) ended abruptly. A loosely-compacted, yellow-brown, slate/shale and clay (011) continued along the trench to 30.86m where it ended gradually. The cobbles continued in (011) to its end, but again were intermittent, except for a tightly compacted row of smaller cobbles from 26.69m-27.68m.

Plate 2 North-east facing section showing cobblestones within (011)

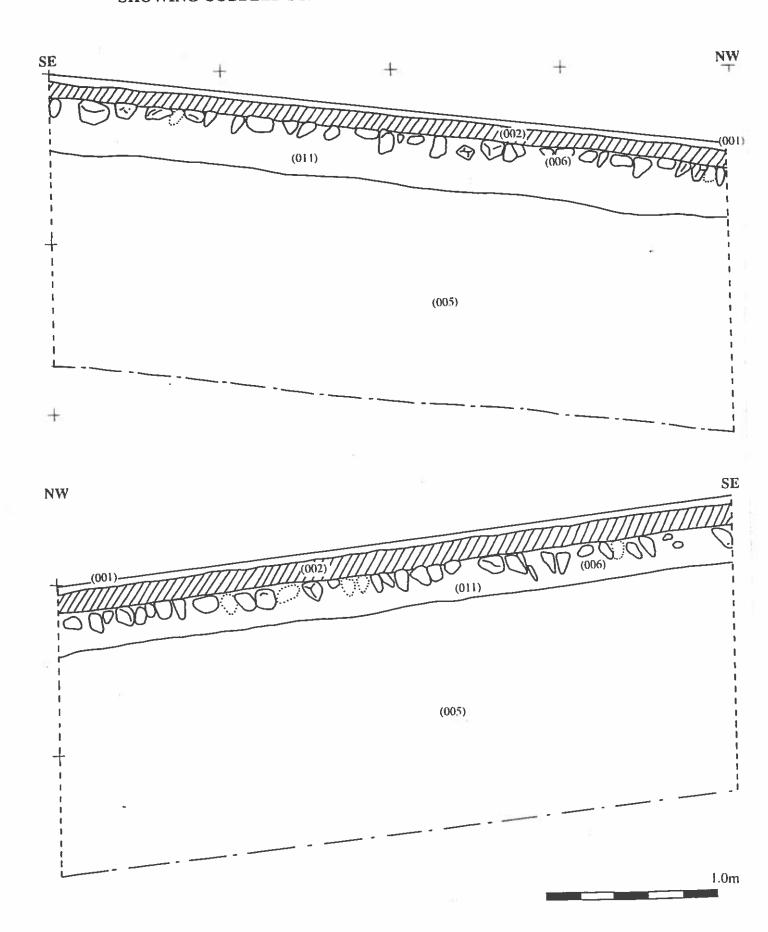
## FIGURES 2 & 3 NORTH-EAST & SOUTH-WEST FACING SECTIONS SHOWING COBBLED SURFACE WITHIN CONTEXT (011)
