**Report on former Tabernacle Chapel, (PRN 25712)
18/19 High Street Lampeter, Ceredigion**

**Zoë Crossland
David Austin**
Department of Archaeology
University of Wales Lampeter

Planning application number: A001000

Listed Building application number: A000999LB

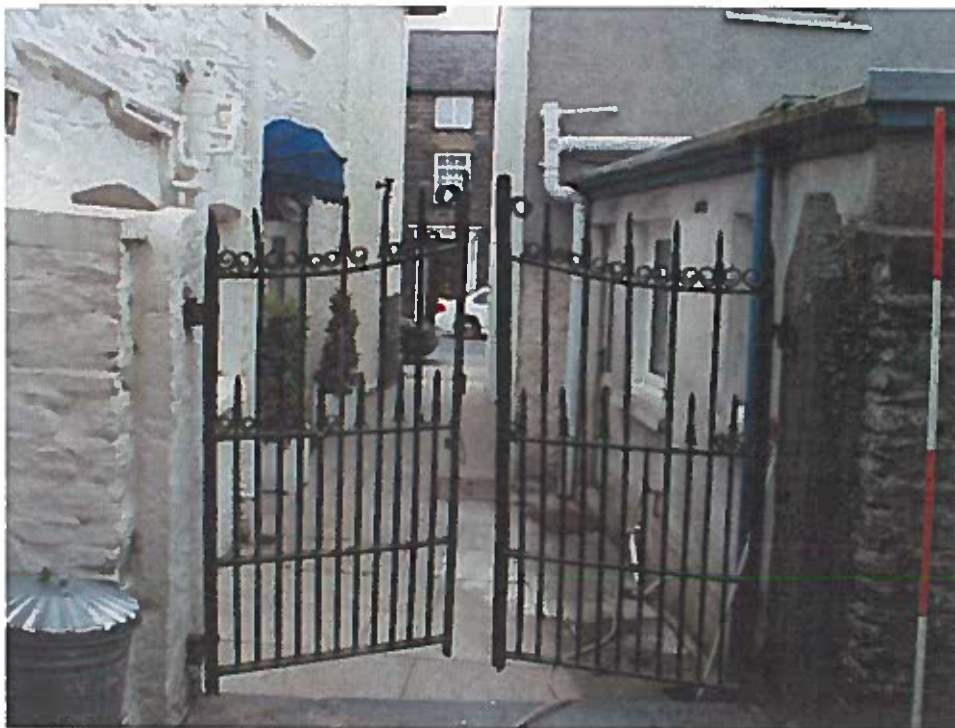
Fig. 1. Gate on north side of chapel

“The gates have uprights with spiked and scroll finials rising alternatively above top and lock rails, each top rail set on an upward curve towards the centre.”

The gates are set in two stone posts, the west of which has a round head and is whitewashed. The east post is made of slate with a pointed head, and has probably been reused as it has small holes where a previous gate has hung (see Fig. 2).

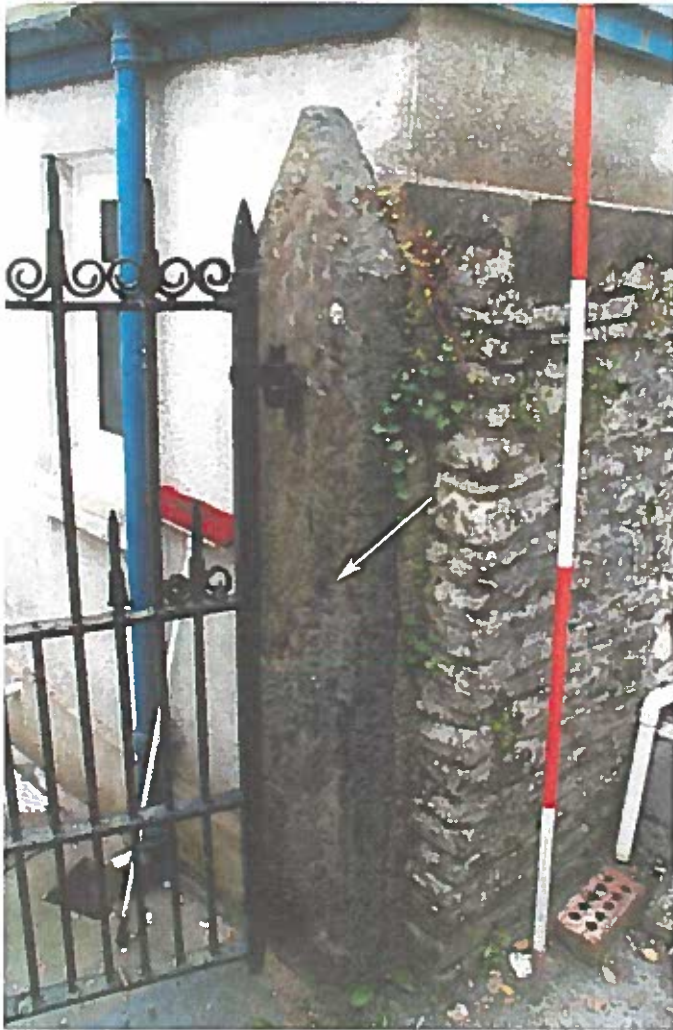
Fig. 2. Showing hole where another gate has been hung

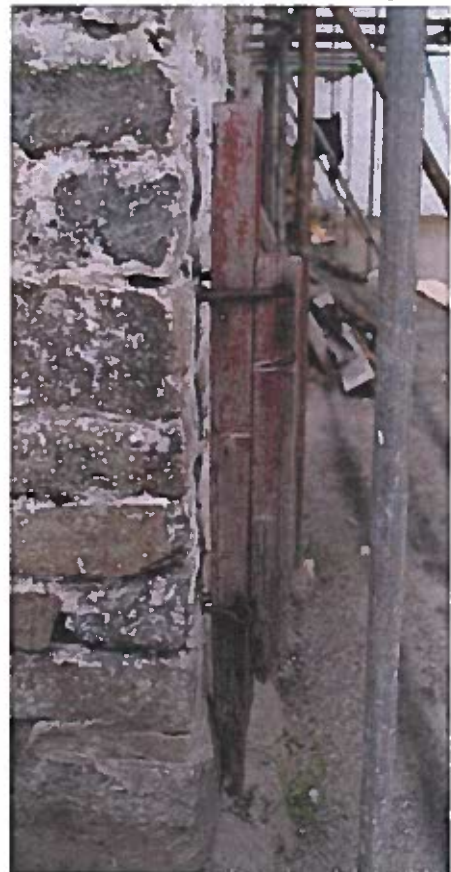
Fig. 3. Gatepost on North wall

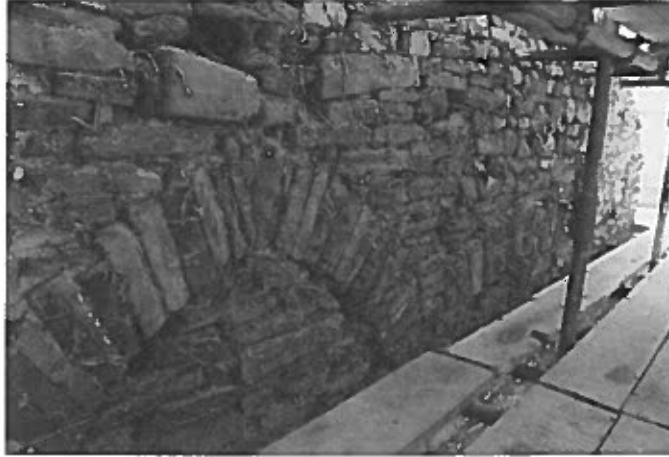
Fig. 4. Exterior of west wall, showing blocked windows

openings on the rear elevation, and the west front entrance) was also located on the south side of the central window on the west wall. This had lead flashing above it. Fig. 4 shows the heads of these blocked windows, visible from the exterior. Figure 20.2 shows them from the interior. The stones around and above the blocked window with cambered head are more rounded than those above the semi-circular headed window, which are more

rectangular (see figure 4). The interior wall also indicates a rebuilding of the wall above the semi-circular headed window, as there were no traces of plaster adhering to the wall in this area (see figure 5). This may date to the later insertion of a chimney.

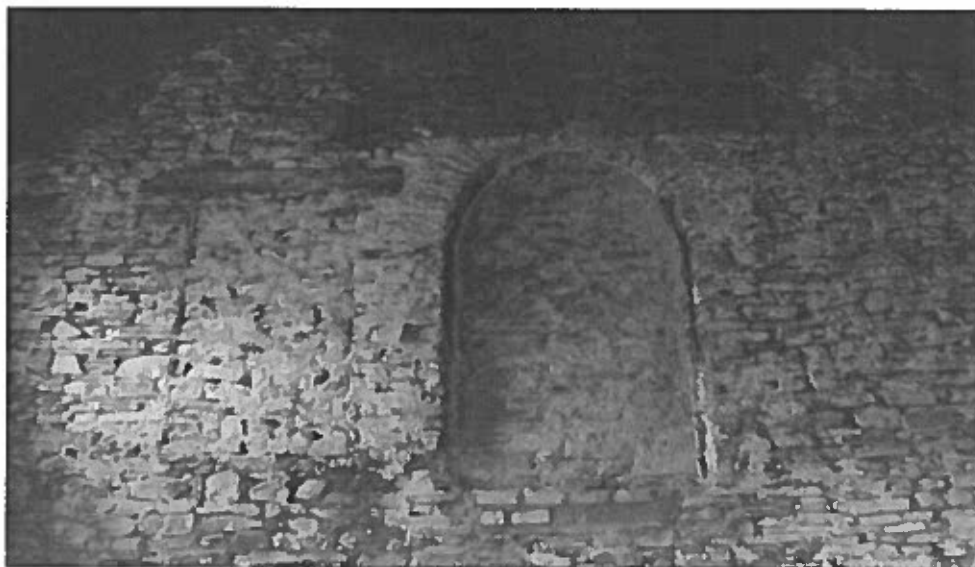
Fig. 5. Interior of west wall, when plaster was removed, showing two blocked openings. White shows location of plaster.

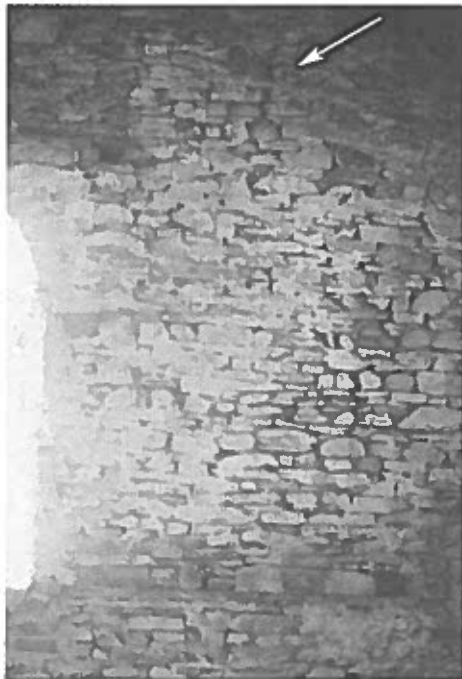
The east wall may have had a small window in a similar location to the south of the central window, indicated by a possible change in the stonework (see Fig. 6). However, there was no trace of voussoirs, and no clear line marking the window edge. The semicircular-headed window in the east wall also had lead flashing lying in a horizontal line above the window/

Fig. 6. Possible window in east wall. Arrow indicates line of previous gable

The walls showed traces of an earlier gable line lying just below the current roof line. These traces were visible on the exterior walls where larger, rough hammer dressed stones were still visible forming a clear edge within the present stonework (see figures 20.1, 22.1). On the interior, white plaster still adhered to the walls following the line of the previous gable (figures 20.2, 22.2). When the plaster was removed lines of larger roughly dressed stones were also visible from the interior (see figures 6 and 8)

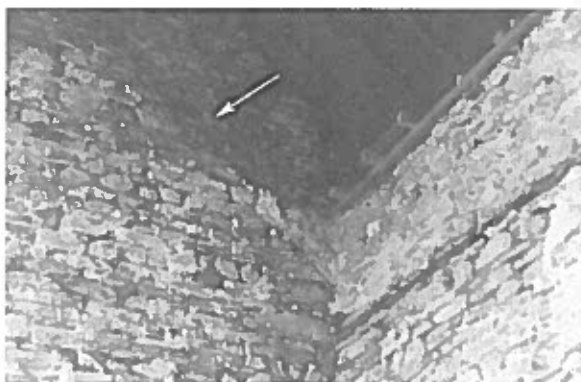
Fig. 8. Interior of west wall after removal of plaster. Arrow indicates previous line of gable.

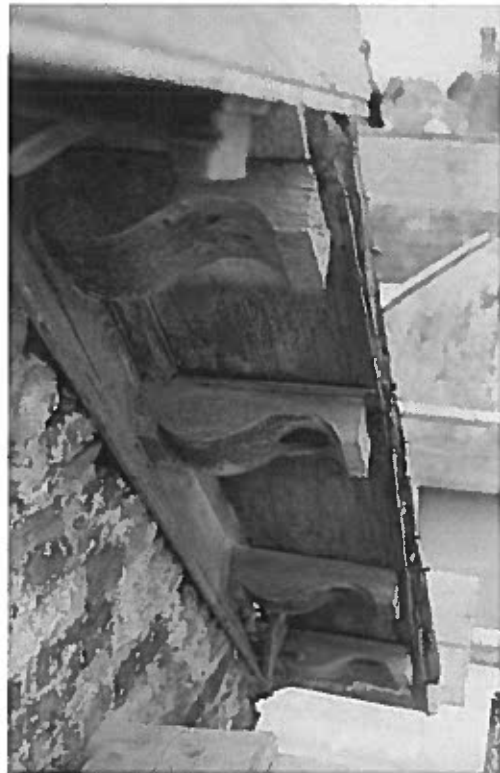
The roof is half hipped, with projecting decorative bracket eaves on the north and east elevations (see Figures 7 and 23.3). These were not present on the south elevation, (the rear of the building), where

Fig. 7. Northeast projecting bracket eaves cornice.

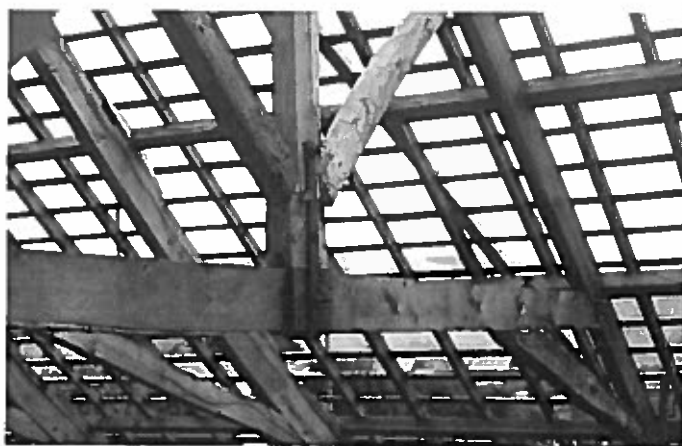
Fig. 9. King post of roof tree

The roof tree (figures 9 and 23) is constructed of five pegged king-post trusses with central iron braces on each king-post. The five machine-cut cross beams that span the chapel were probably added later, presumably when the roof was raised. These were unpegged and probably were inserted to hold a suspended plaster ceiling.

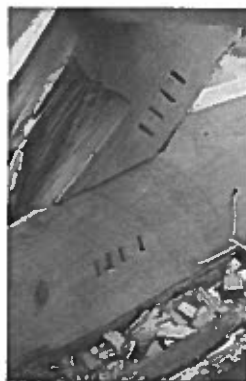
Fig. 10. Details of carpenter's marks on tie beam and cross beam.

Carpenters marks number these cross beams I to V (figure 10). One of the tie beams was also numbered (figure 10). The earlier pegged roof tree was probably contemporaneous with the previous gabled roof, and would have been visible by the congregation from the chapel below.

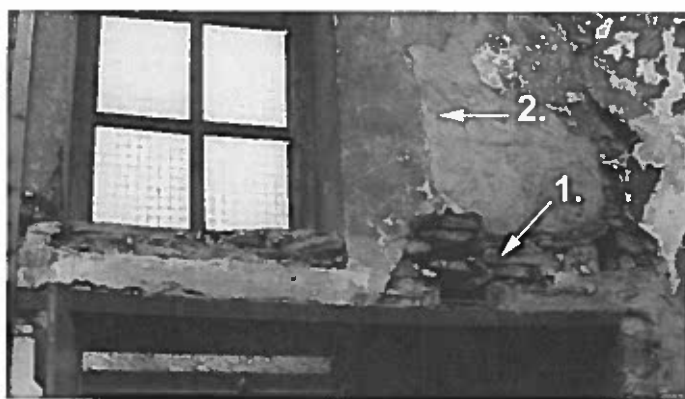
The present day entrance to the chapel is through the east door, which has been widened and a metal girder inserted. Visible above this is a shorter wooden lintel with a mortice cut in it (see fig. 11.1). A similar lintel with mortice cut is visible above the west door in the same wall. These were presumably to support beams for a gallery that

Fig. 11 Shows mortice cut beam (1), replaced by later iron girder, and probable line of gallery balustrade (2).

ran around the east, south and west sides of the interior, c 2.5m above the floor. Also visible above the mortices, above both east and west doors were two linear features that were probably traces of the railing or balustrade that edged the gallery (see fig. 11.2). Much of the interior was still plastered when we recorded the chapel, and some of the paint and the plaster gave an indication of the location of previous

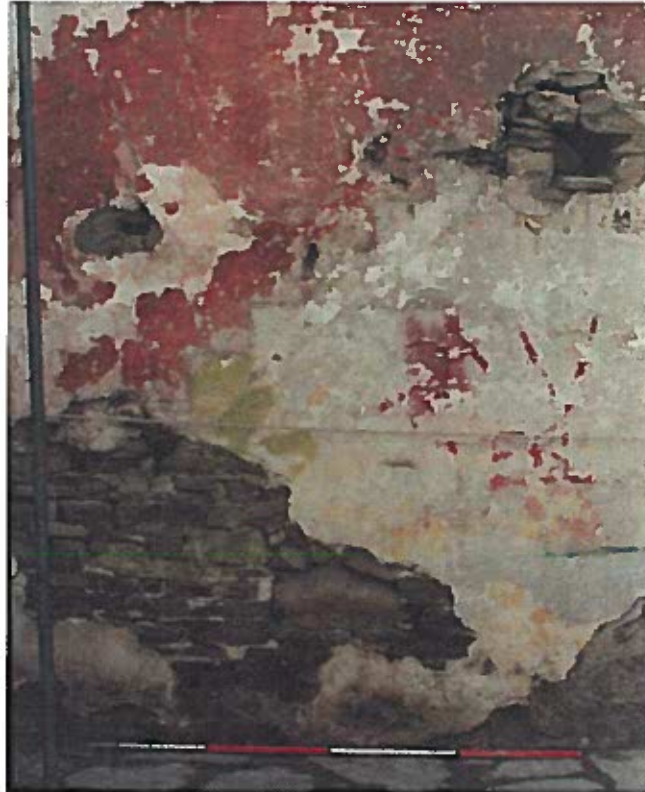
interior walls and staircases. Visible on the northeast and southeast walls were traces of steps leading up to the gallery (see Figures 12.1, 12.2, 19.2 and 22.2), indicating that the stairs began just inside the two entrances, turned, and ascended along the West and East walls.

**12.1 Traces left by paint
on East wall, showing
previous line of stairway**

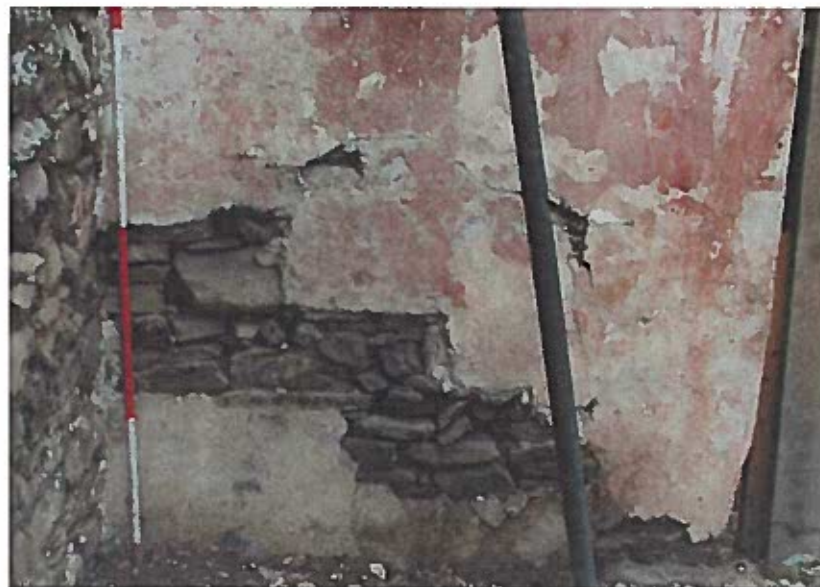
**12.2 Traces of base of stairs on west end
of North wall, shown by absence of plaster.**

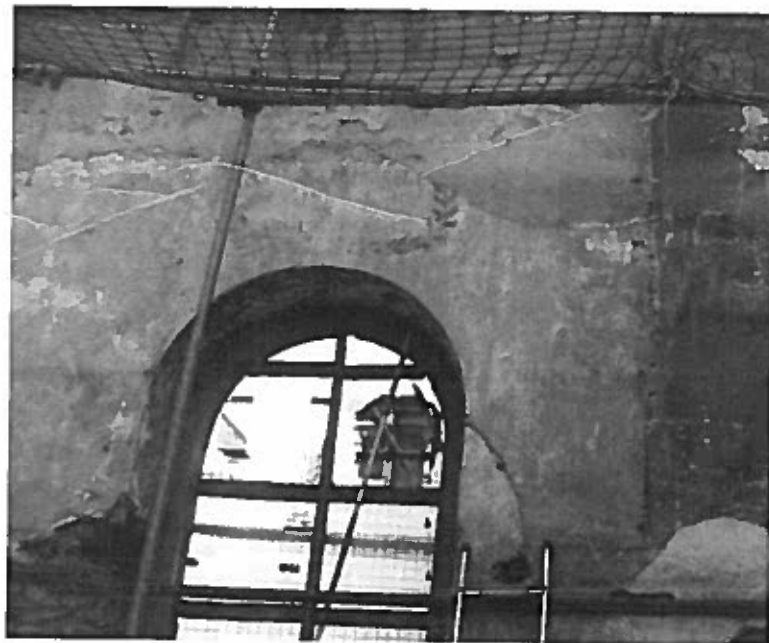
Fig 13.1
View of inscription above
central window

On the north wall, over the central window were the traces of two successive inscriptions, one partially overlying the other (see fig. 24). Both apparently read:

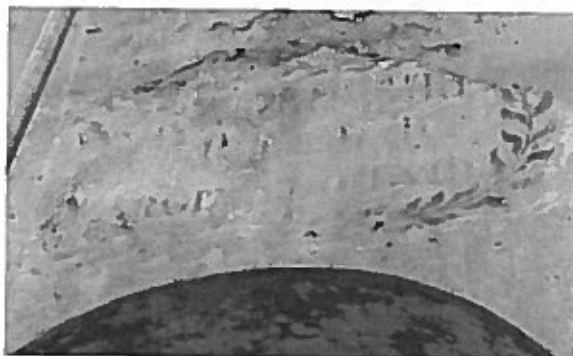
Fig 13.2
Close view of inscription

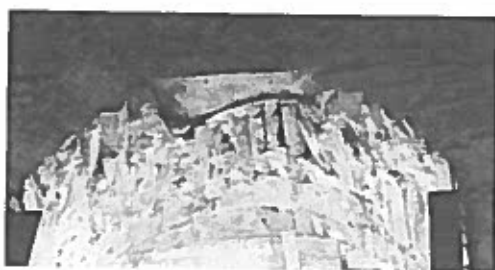
The plaster above the inscription was cracked along almost the entire length of the wall. When the plaster was removed, an interior timber plate was visible below the crack. This wall plate cut the top of the east window head on the North wall (fig. 14), and ran just above the west window (fig. 19.2).

Fig. 14. Interior wall plate, cutting east window on North wall

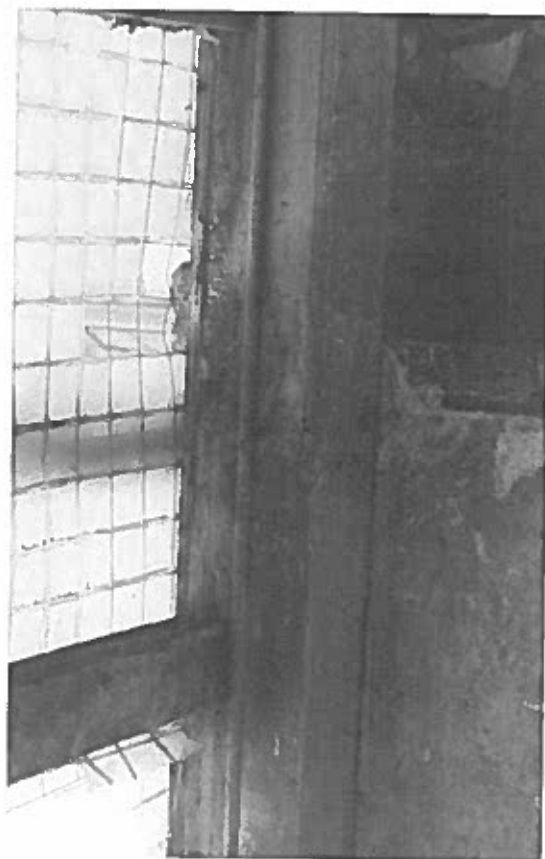
The windows on the North wall were plastered on the interior with red painted wooden reveals with beaded jambs (see figure 15 and student illustrations). Traces of vertical sash frames were visible. The east and west windows both appear to have raked sills. The sill of the central window was destroyed by the later insertion of the small entrance beneath it.

Fig. 15. Beaded jamb on central window, North wall.

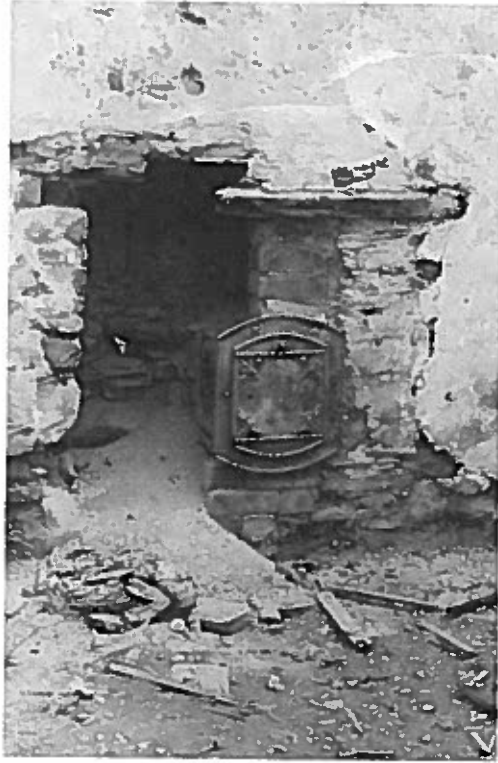
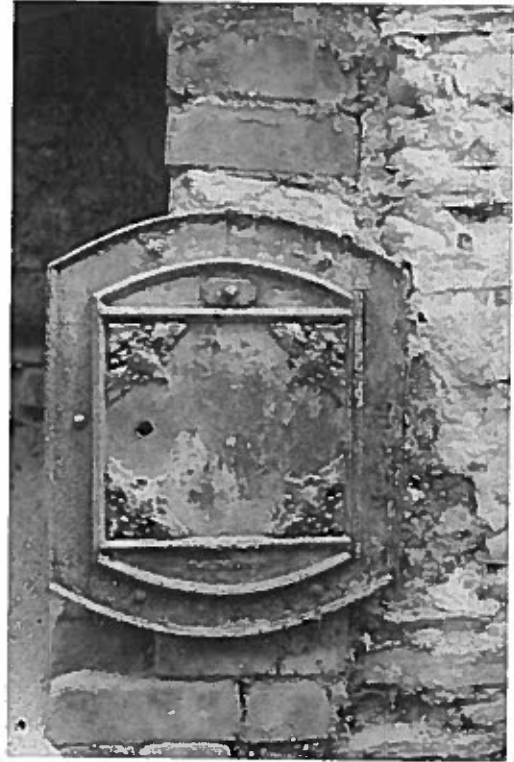
The east wall also had a completely blocked window (figure 22) c.3m above the ground. Directly beneath this was a later oven that had been inserted with its chimney running through the blocked window. As mentioned previously, there was some evidence that there may have been a second square headed window to the south of the central round headed window (see figs. 4 and 5). Visible on the East wall were traces of the gallery stairs (fig.12.1).

Fig. 16 Oven and inserted chimney in the East wall

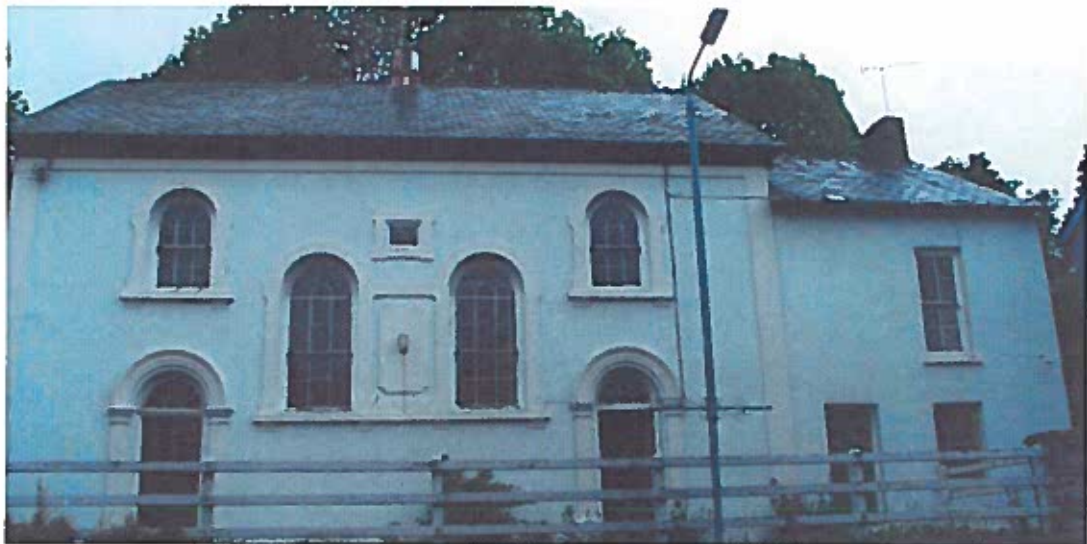
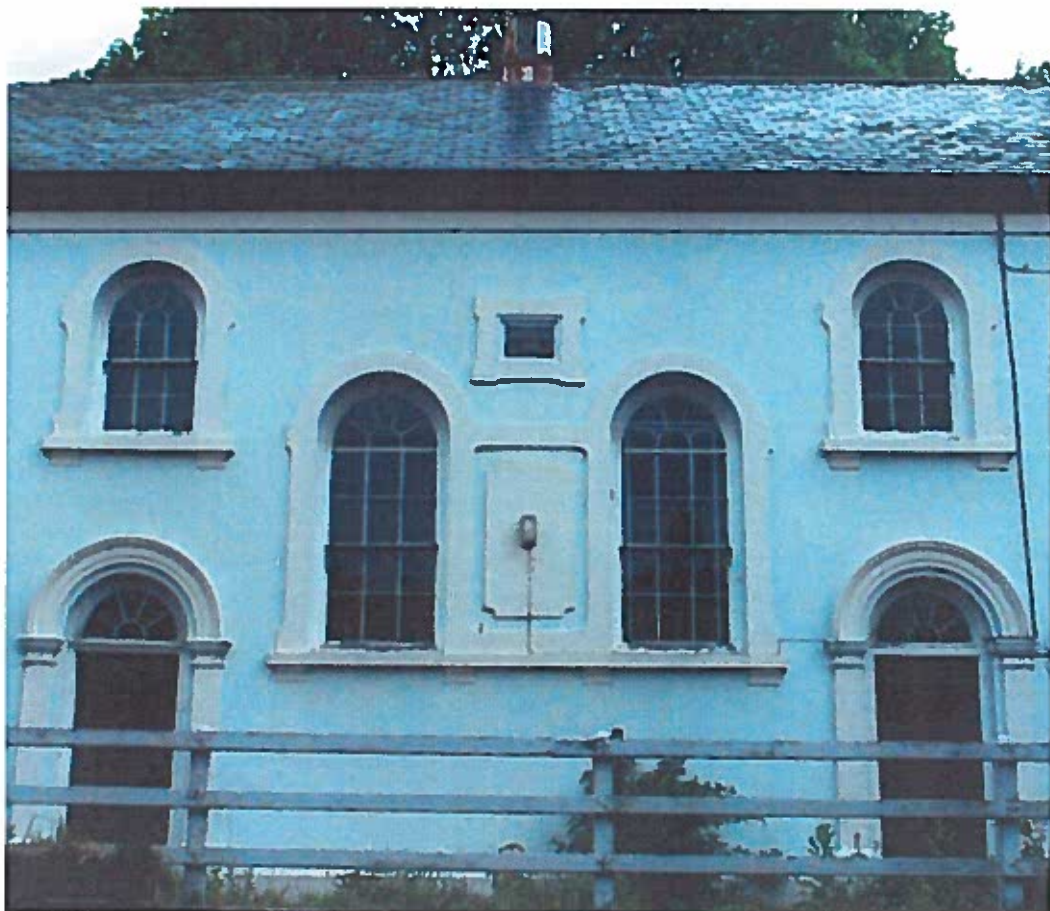
Fig. 17.
Calvinist Methodist Tabernacl in Llandysul

The Calvinist Methodist Tabernacl chapel at Llandysul (SN41554044; NPRN: 7286) proved to be of limited use as a comparison as we were refused access by the present owner. The RCAHMW record of the chapel at Llandysul records that it was built in 1832. The external front elevation has some similarities to the Lampeter Tabernacl (figure 17). There are two central semi-circular headed windows in the centre of the exterior and two semicircular headed doors at either end. In contrast to the Lampeter Tabernacl, the front elevation also possesses two smaller windows at a higher level. The building as a whole is higher than the Lampeter Tabernacl, and would appear to provide more room for the gallery. There is no record of it being extended, and it seems probable that the Llandysul Tabernacl was probably designed as a chapel, with a gallery within it. In contrast to the Lampeter Tabernacl it is clearly visible from the street, lying slightly set back on the northwest side of the A486.

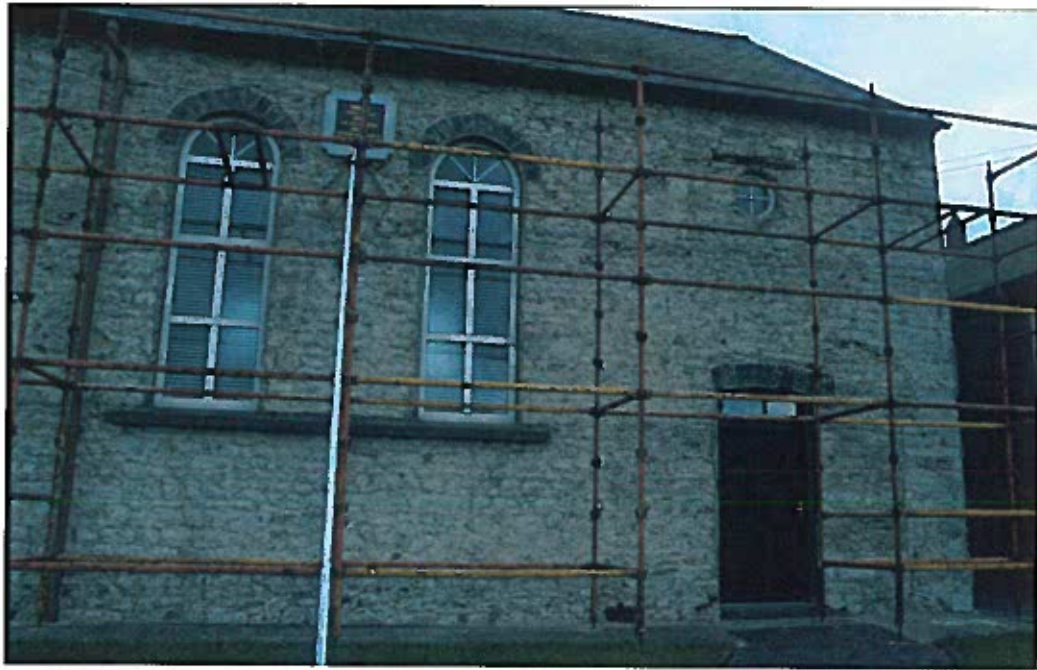
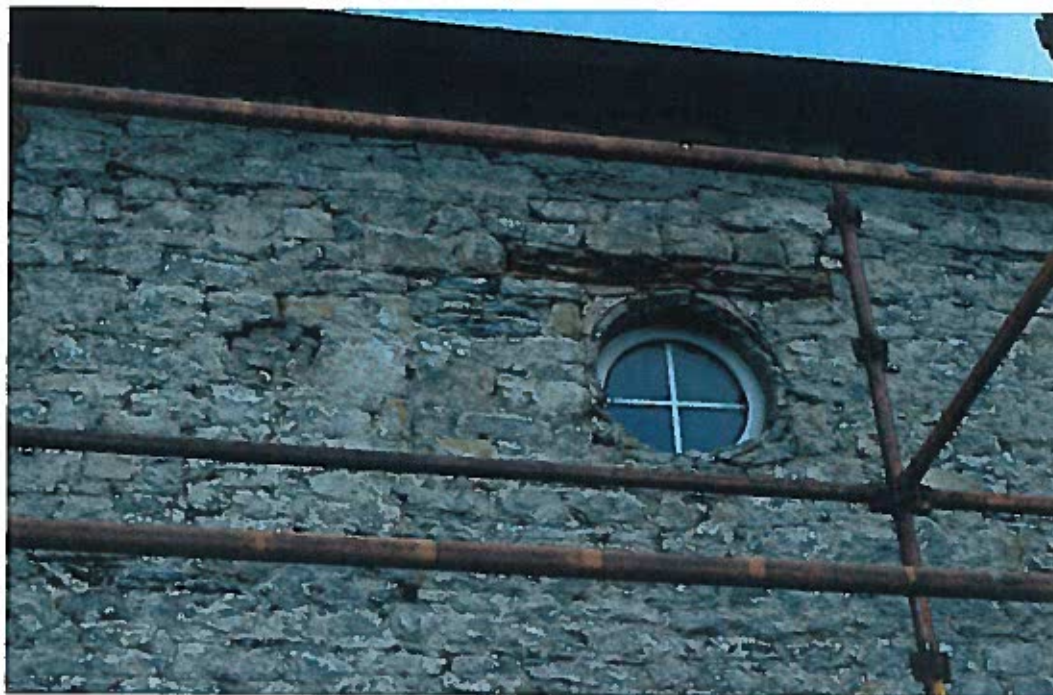
Fig. 18. Chapel at Horeb

The Independent or Congregational chapel at Horeb, Ceredigion provided a better comparison to the Tabernacl. The chapel at Horeb is also located facing the street, on the north side of the A475, in the parish of Llandysul (SN39434250; NPRN: 7283). It has been recorded by Cambria Archaeology (Dyfed Archaeological Trust). It was being re-rendered in August 2001 when the photographs shown in figure 18 were taken, exposing the stone wall of the front façade. It is of a similar date to the Tabernacl, Lampeter. A plaque outside records that it was built in 1784, then rebuilt twice, in 1826 and 1879:

The RCAHMW Chapels database also records that it was enlarged in 1832. It is a gable-ended chapel with an interior gallery still present. This was visible from the exterior, apparently wrapping around three sides of the building. The traces of two semi-circular headed doors were clearly visible at either end of the front façade (figure 18). These have been replaced by smaller doors with cambered segmental heads. It is probable that the doors were moved in order to accommodate the gallery.

A pair of long windows with semi-circular heads are located in the centre of the front façade, between the two doors. To either side of the central windows are two small round windows. All are probably later additions, as they appear to have replaced a row of three small square windows, now blocked (figure 18b). Also visible above the line of the windows is a change in the stonework, suggesting that the wall was extended in order to raise the roof, as at the Tabernacl, Lampeter.

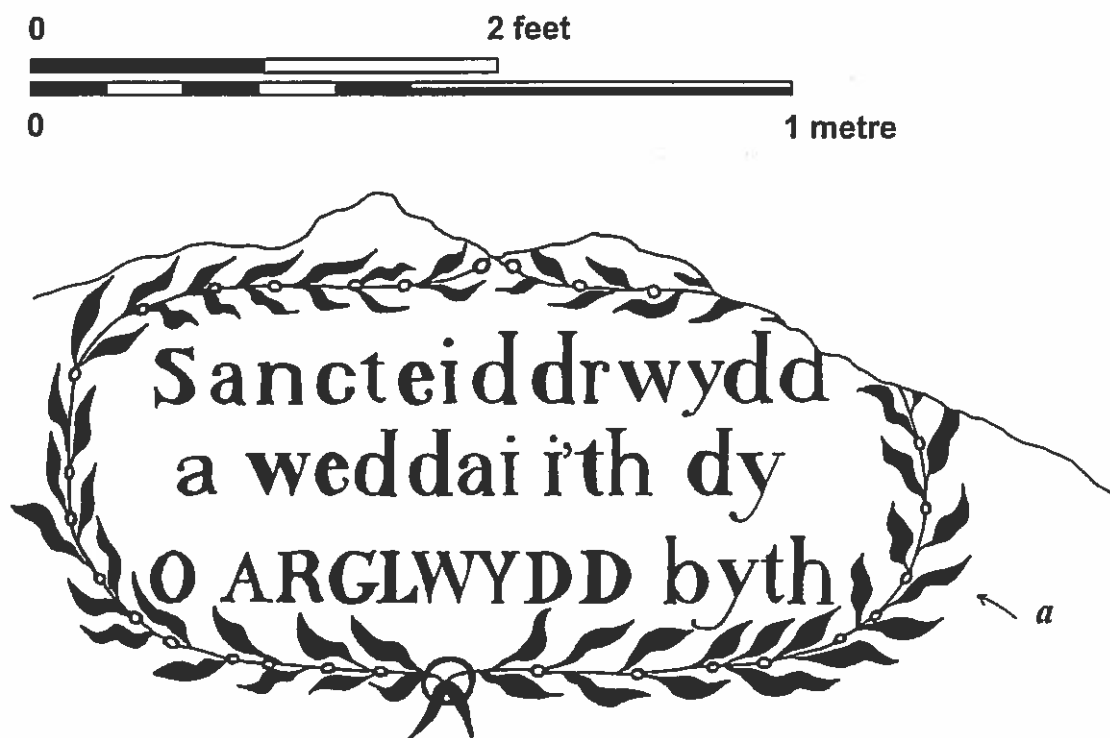
Fig. 24.1

The earlier inscription (figure 24.1) appears to be most complete. Close inspection showed that it was first painted entirely in black, with the lettering encircled by a border of leaves, also painted in black. The leaves were later painted over in dark green and small pink and blue 'knots' (figure 24.2) were added.

Earliest visible inscription, located in the centre of North wall.

Originally painted black, with no 'knots' between leaves. Subsequently, leaves and stem painted over in dark green and oval pink and blue 'knots' added (see 24.2)

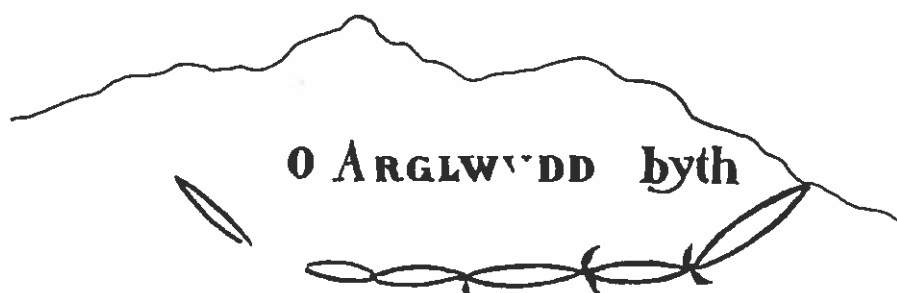
Fig. 24.3

This inscription was subsequently painted over in white, and replaced with a second, smaller inscription located higher up on the wall above the window (figure 24.3). Only a fragment of this second inscription was still visible.

Later inscription, painted over 24.1
 Drawn scale 1:10
 Black paint on white background

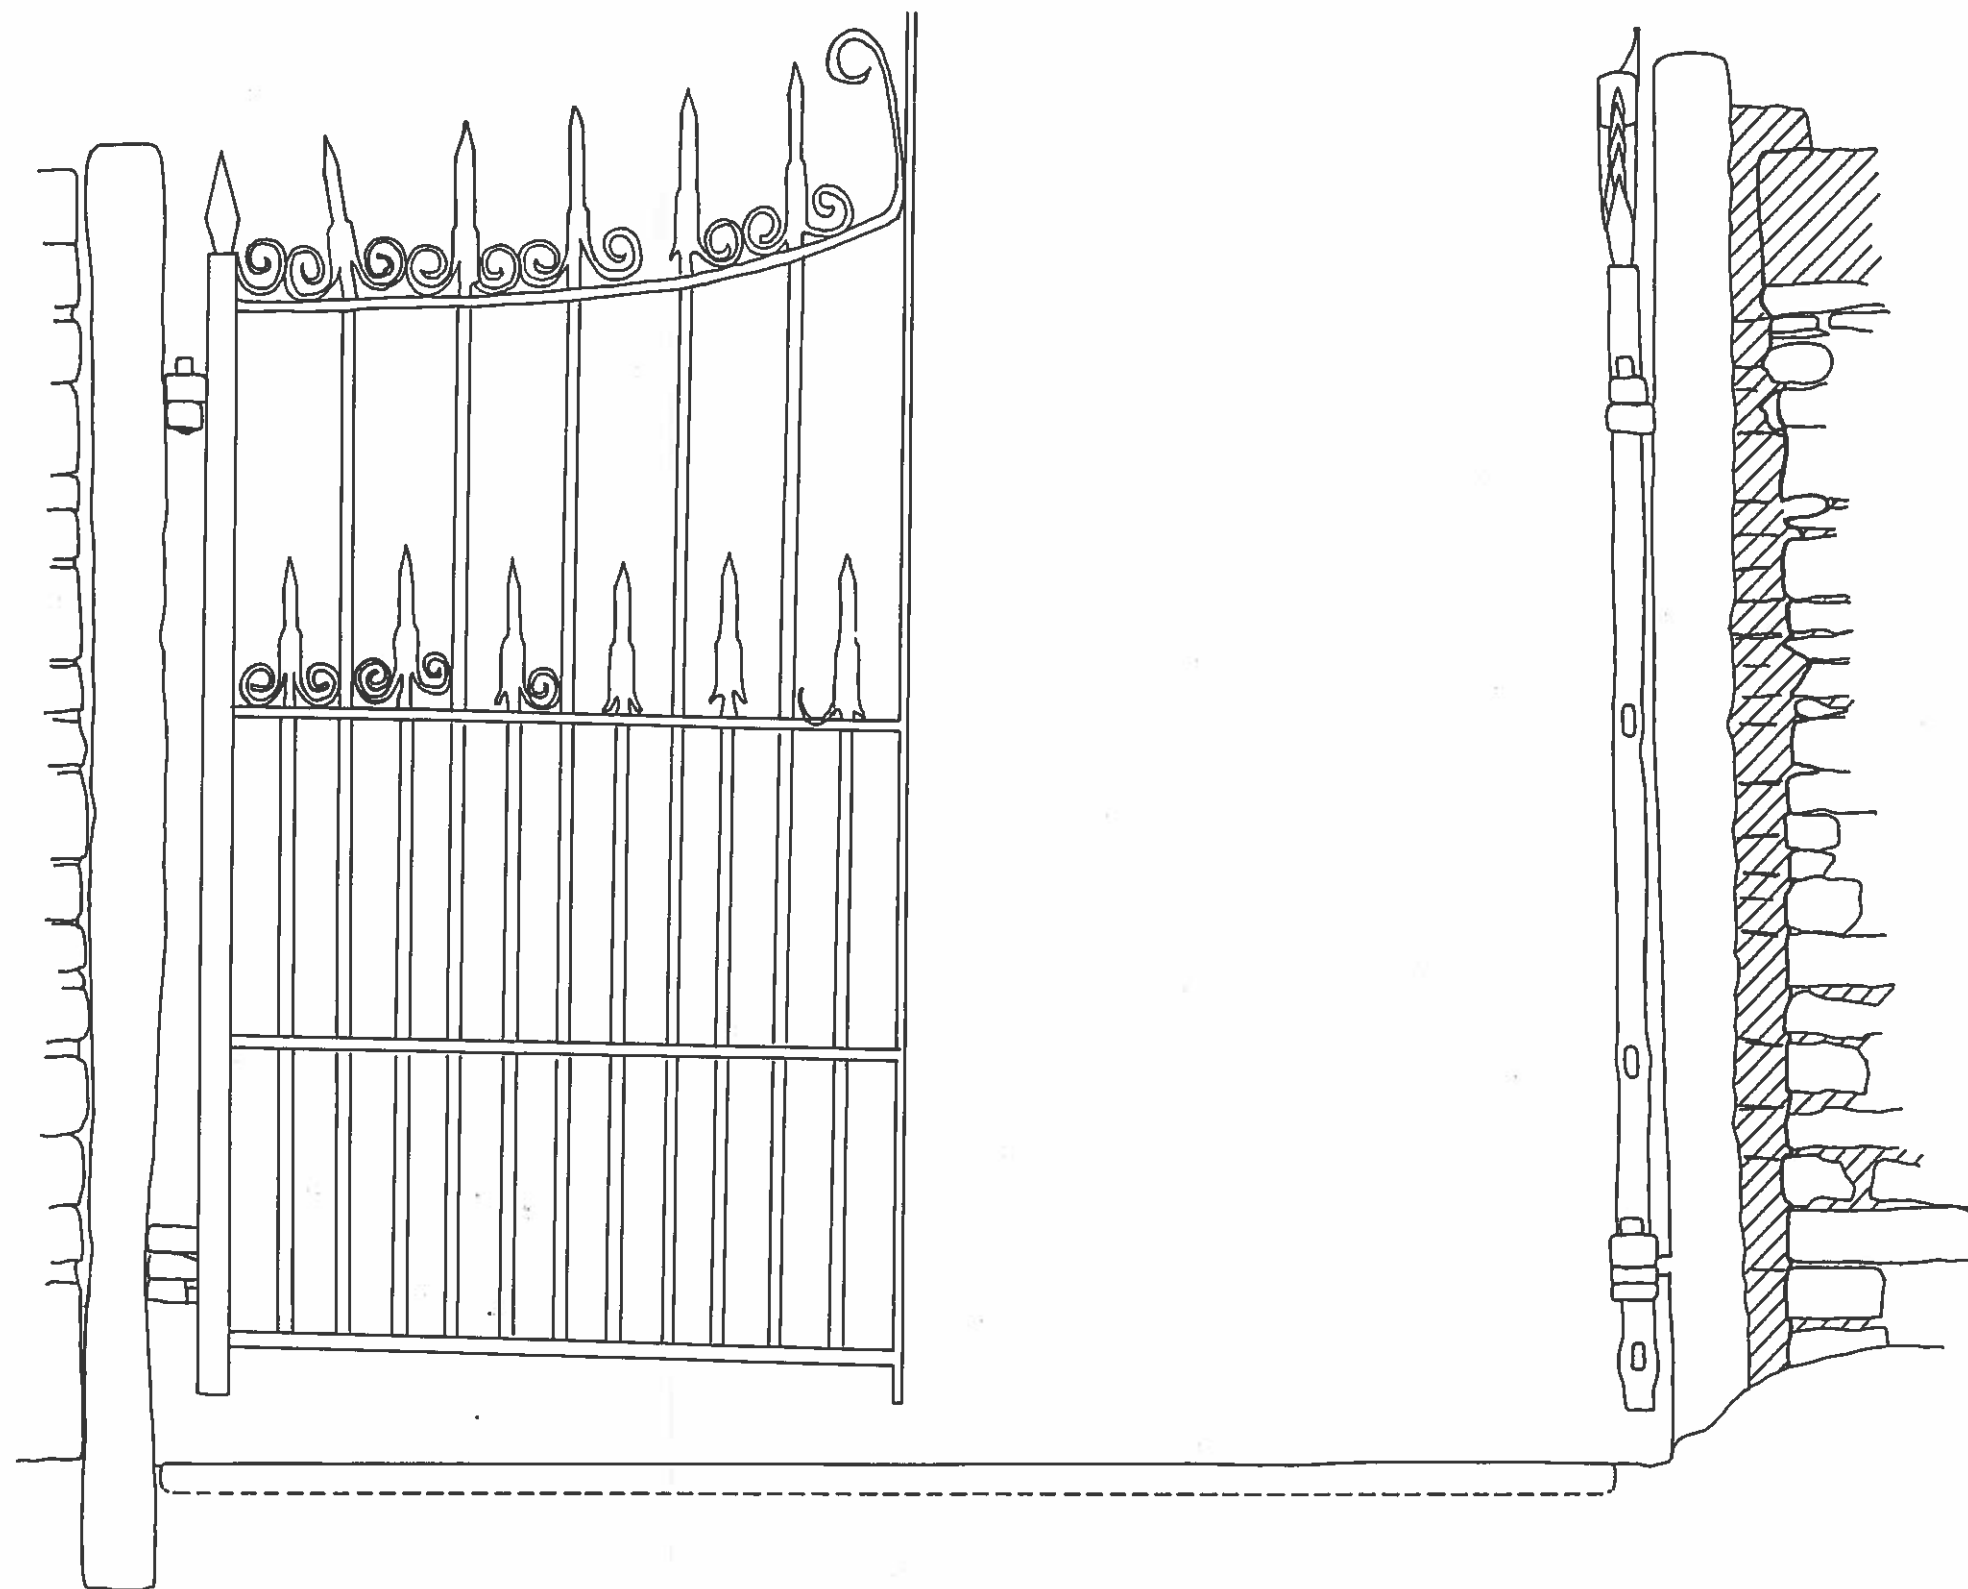
Fig. 27
Gate on north side of Tabernacl Chapel, Lampeter
NGR SSN 5755 4809
Recorded June 2001
Drawn scale 1:10
Recorded by CG, ZC
