**Slebech Park, Haverfordwest,
Pembrokeshire**

Archaeological Desk-based Assessment,
Field Evaluation
and
Standing Building Recording

CAP Report No. 233

Date: January 2003

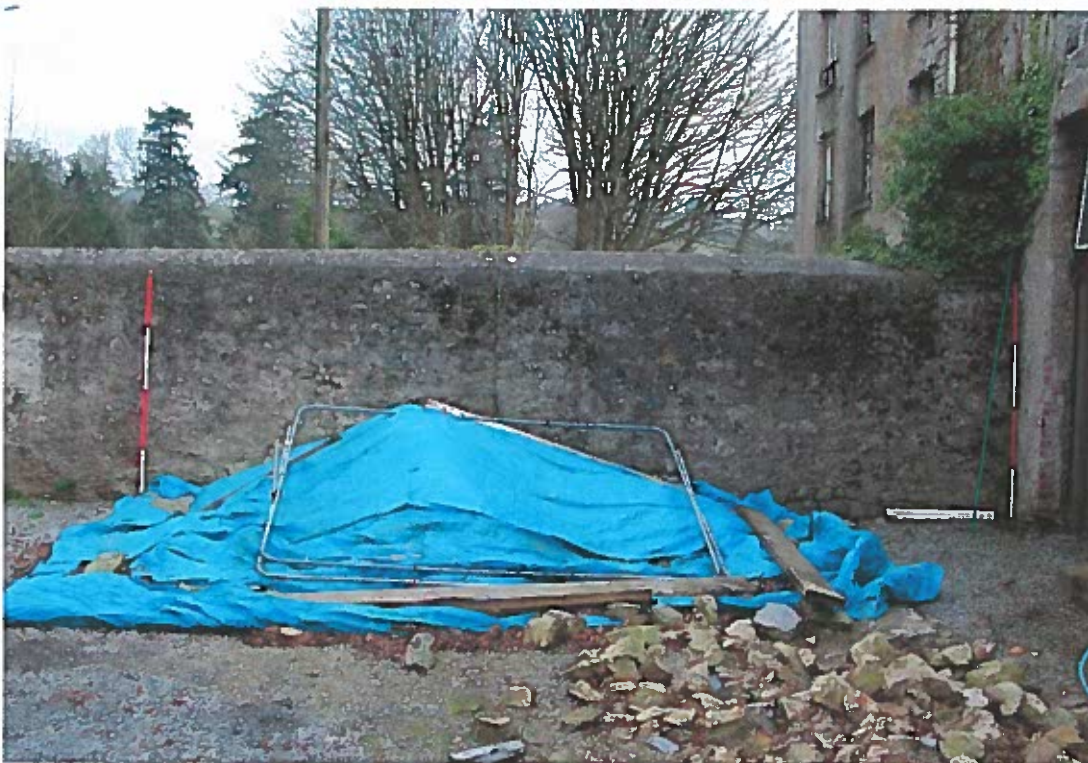
Plate CY3: Wall A, east section, looking north. Scales 2m

Wall A was clearly built in two main phases, and had undergone a number of alterations during its lifetime. The earliest section is a 0.8m long length against the east wing of the stable block (Plate CY3 and CY7). At this point the wall is 4.9m tall on the north side. This section is probably bonded to the east wing, rather than built up against it with a butt joint. Unfortunately, the mortar is abundant at this point and the detail is uncertain. It is recommended that the joint be checked (by an archaeologist) during demolition of the wall and further records of the joint made.

The second phase of Wall A, butting up to the earlier phase, comprises the remainder of the wall (Plates CY4, CY5, and CY8). At a point 3m west of the eastern end of the wall are two vertical joints (Plate CY3 and CY8). It is uncertain what these represent. It is recommended that these are investigated in more detail (by an archaeologist) when the wall is demolished and further detailed records made.

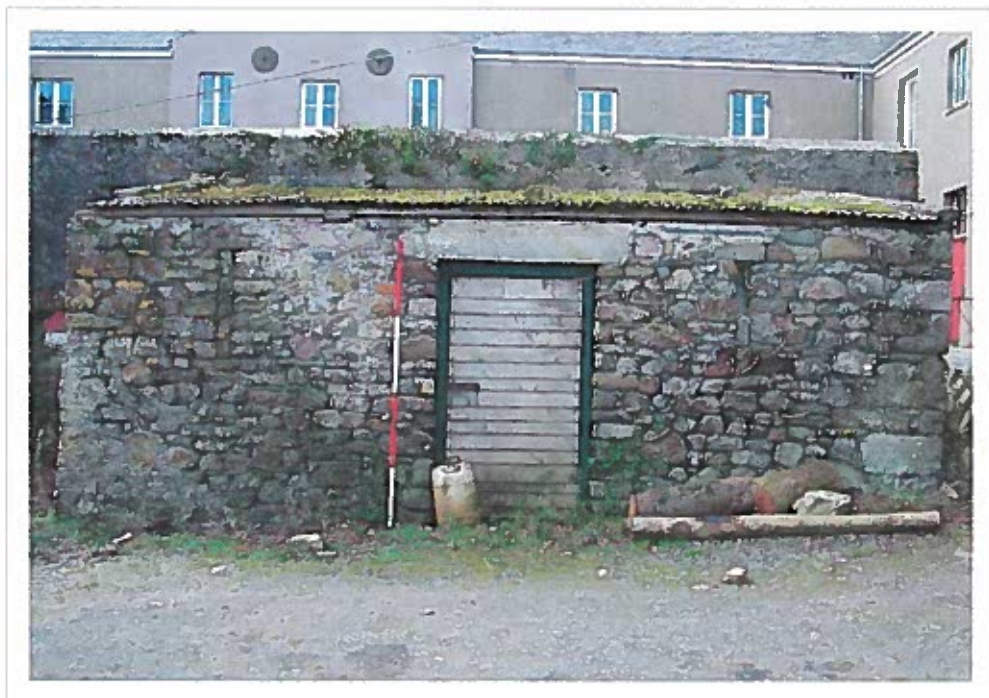
Plate CY12: Building C, north elevation. Scale 2m

The front (north) elevation has two similar narrow windows and a 1m wide doorway, the head of which has been replaced with a concrete lintel (Plate CY12).

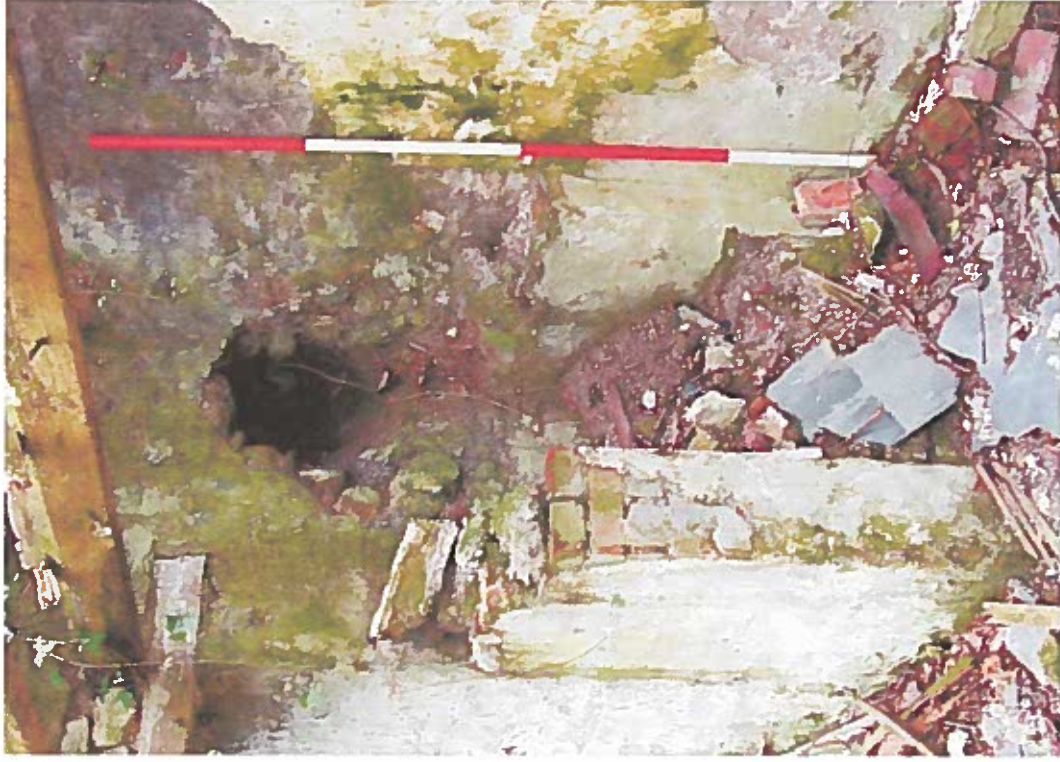
Plate K11: Detail of fireplace in 'kitchen', looking south-east.
Note chimney flue in the corner. Scale 2m
