Archaeological Watching Brief

CAP Report No. 261

**Richmond Park,
Carmarthen**

Prepared for:
Carmarthen Football Club

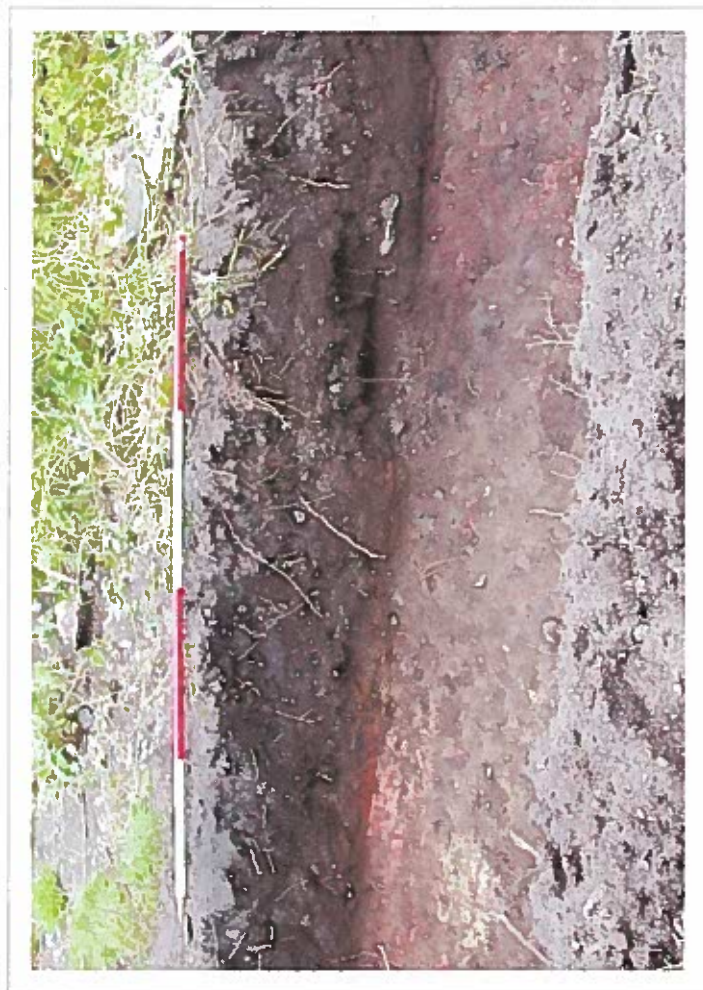
Plate 2: Detail of section in Trench 1, west end. Scale 2m, looking north

- 4.3.1 The overburden was removed revealing a number of distinct features (Contexts 1-10):. From west to east the following contexts were recorded:
 - Context 1, mid brown loam with patches of yellow clay and tile fragments. Interpretation: Roman occupation layer (similar to Context 15 in Trench 3).

- Context 2, fine grey loam with charcoal flecks. Interpretation: Roman occupation layer.
 - Context 3, red sandstone chippings, burnt in-situ. Interpretation: probable Roman floor surface.

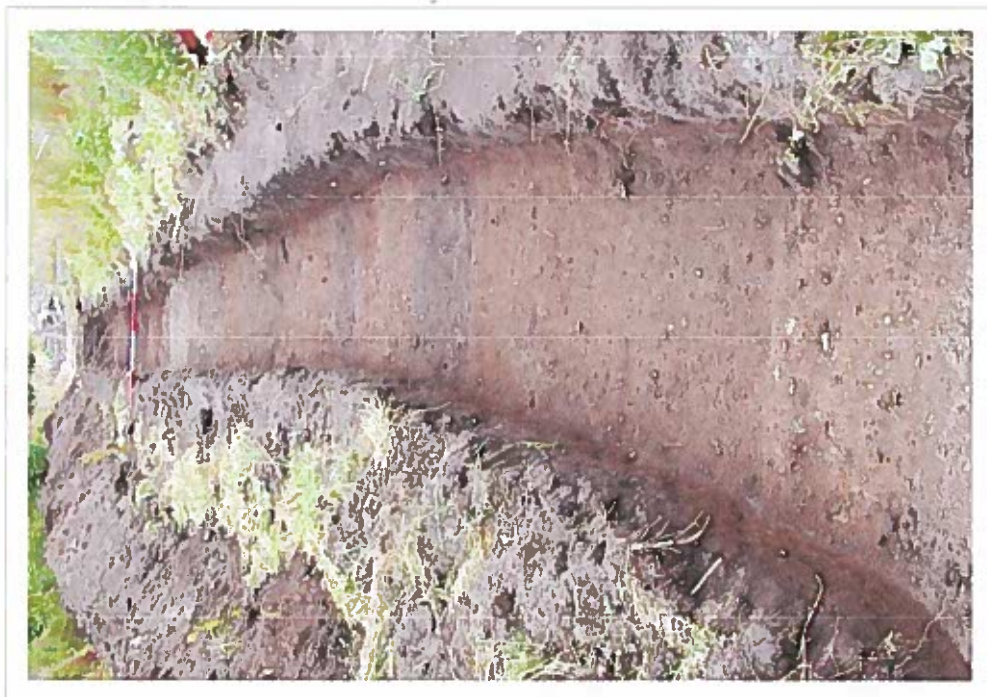
Plate 1: General view along Trench 1. Scale 2m, looking west

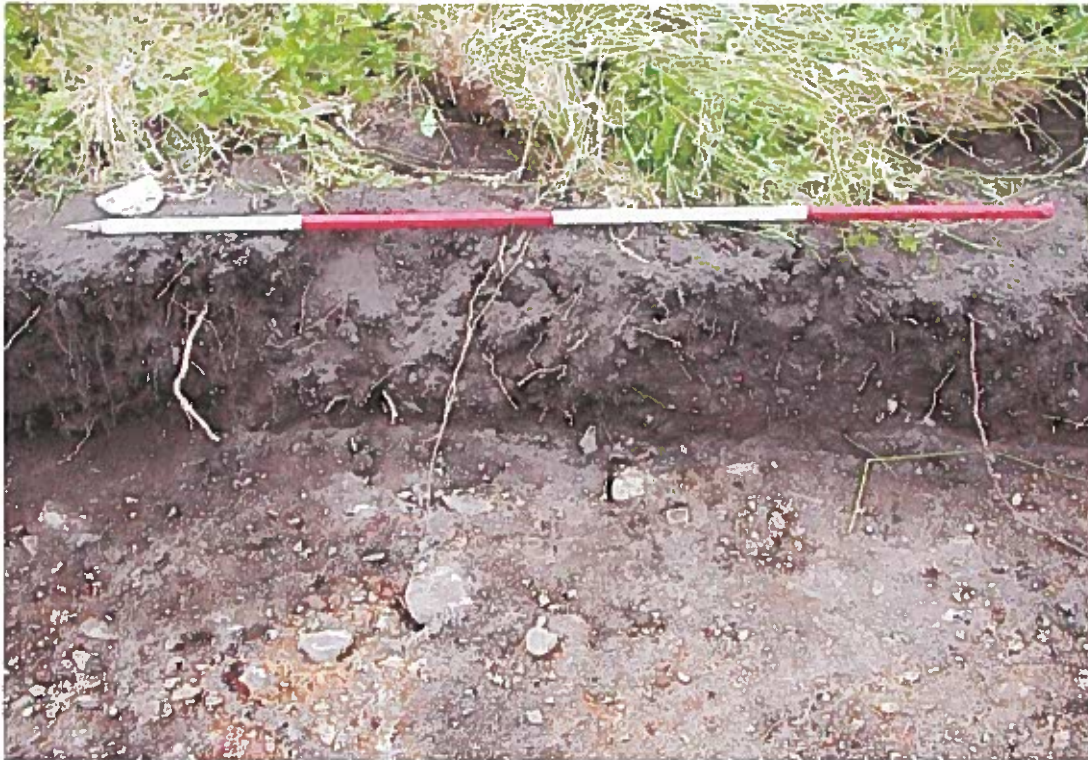
Plate 3: Detail of section, Trench 1, Roman road. Scale 2m, looking north

- 4.2.1 The Roman archaeological levels were uncovered in all three trenches and were cut by a number of more recent features. The top of the archaeological levels varied in depth from the surface. In most places the overburden was 0.6m deep, with areas being 0.55m below the surface. The Roman road, however, survived to within 0.4m of the surface.

- Context 6, layer of cobbling with camber west and east. Interpretation: Roman road.
 - Context 7, fine mid brown loam with charcoal flecks. Interpretation: general Roman layer (similar to Context 13 in Trench 2).

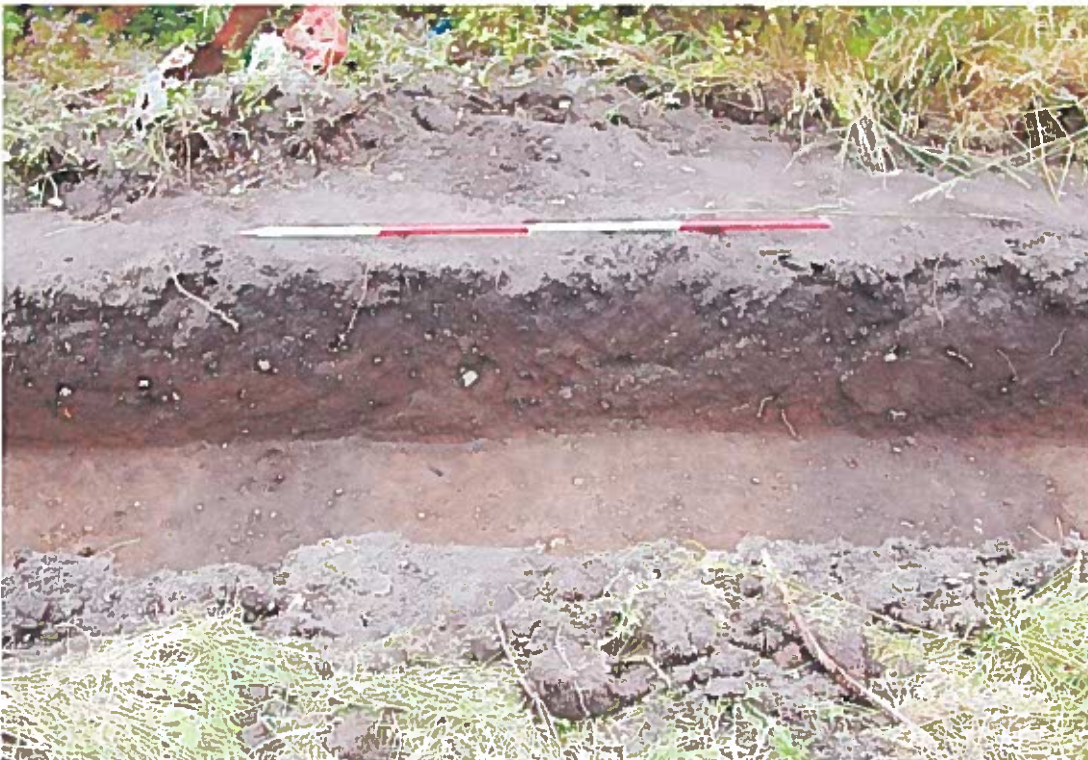
Plate 4: Detail of section, Trench 1, east end, looking north

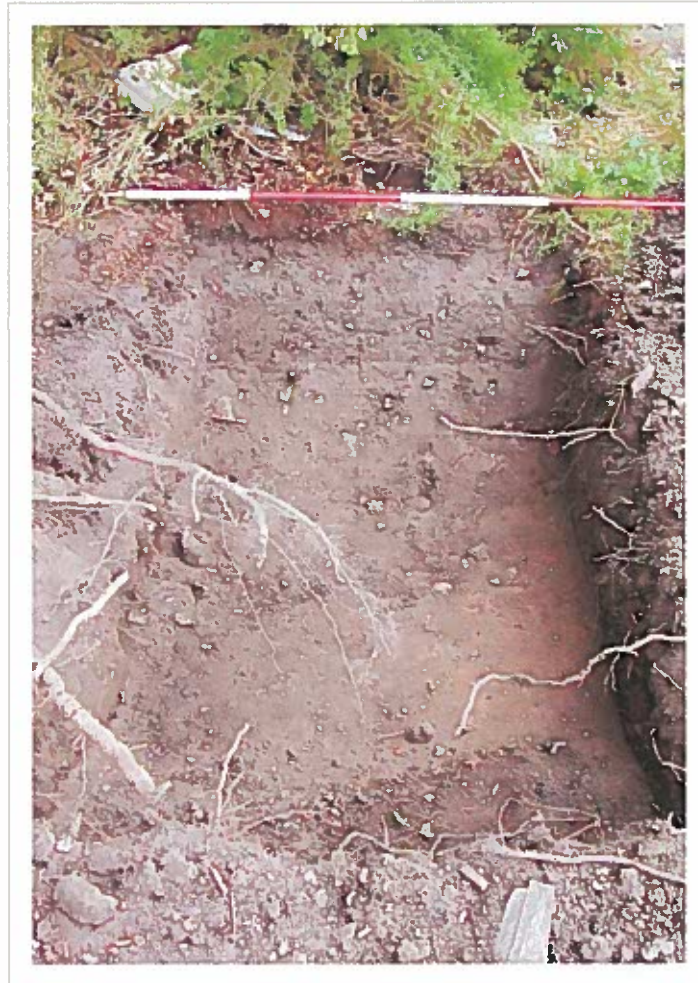
Plate 5: General view of Trench 2. Scale 2m, looking west

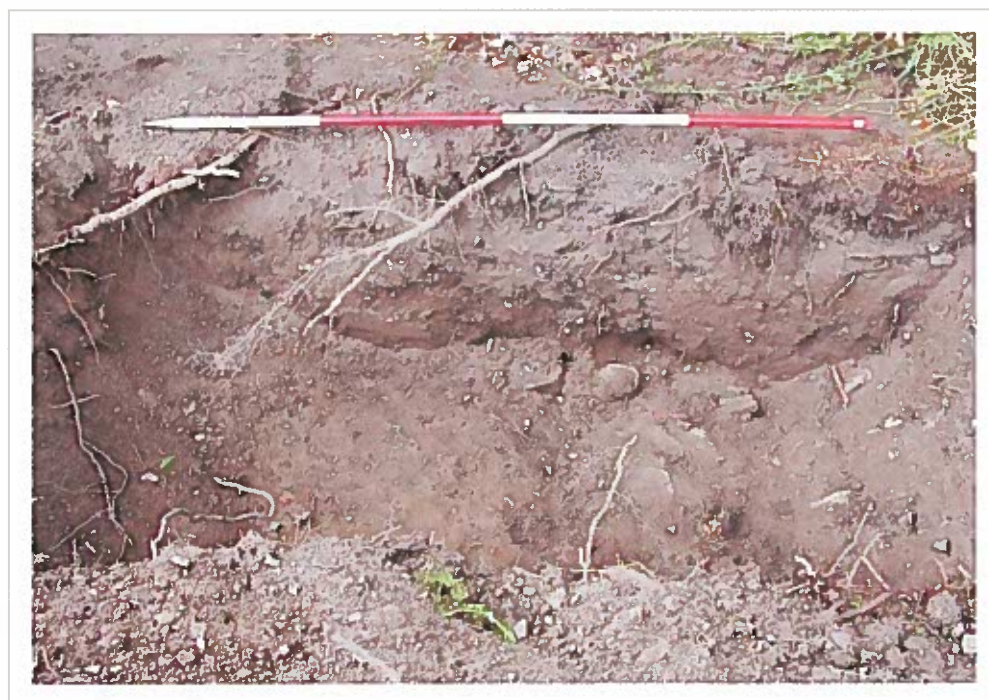
Plate 6: Section of Trench 2. Scale 2m, looking south

Context 11, compact layer of shale chippings. Interpretation: a Roman deposit, perhaps part of a floor or yard surface.

Context 12, mid grey silty loam. Interpretation: Roman silt layer below the shale chippings (11).

Context 13, fine mid brown loam with charcoal flecks. Interpretation: general Roman deposit (similar to Context 7 in Trench 1).

Context 14, edge of linear feature with dark brown loam fill. Interpretation: modern field drain.

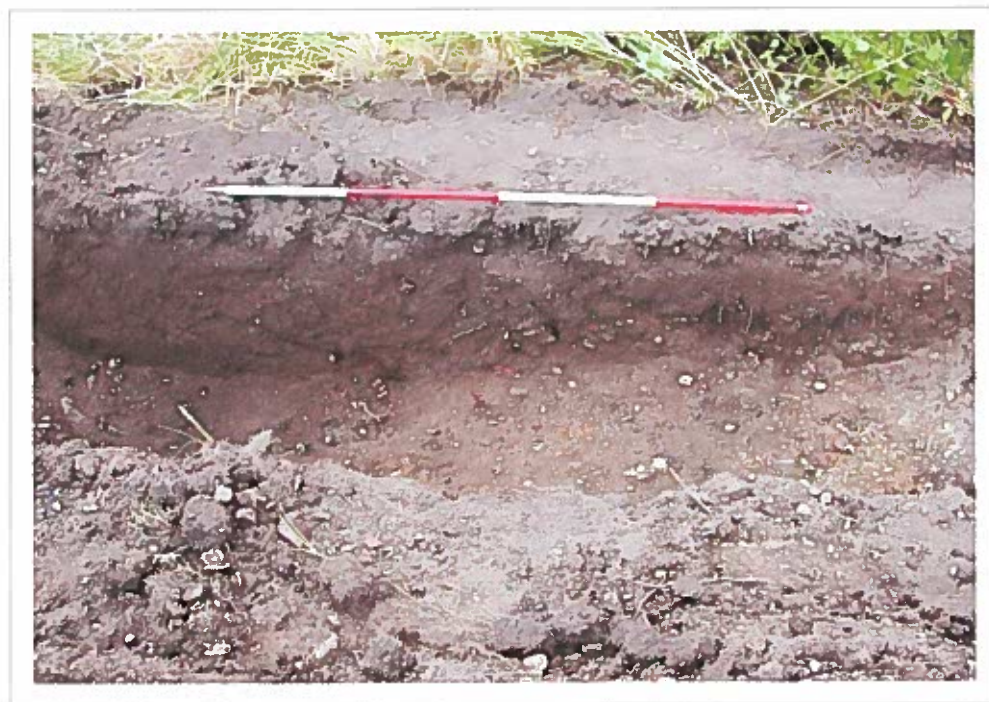
Plate 8: Section of Trench 3. Scale 2m, looking south

Context 15, mid brown loam with patches of yellow clay and tile fragments. Interpretation: Roman occupation layer (similar to Context 1 in Trench 1).

Context 16, linear feature with dark brown loam fill. Interpretation: modern field drain.
