Aberglasney Mansion, Llangathen, Carmarthenshire

Archaeological Evaluation

CAP Report No. 312

Date: May 2004

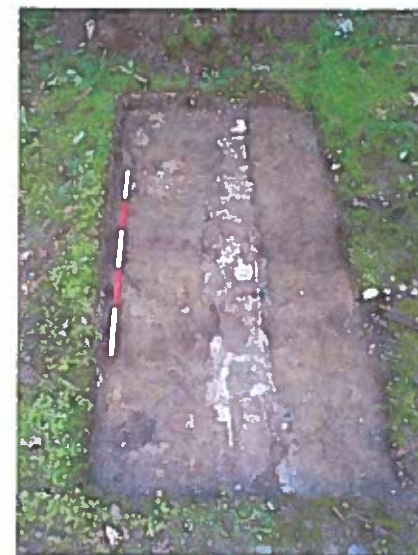
Figure 03: Trench 1 Illustration

Plate 1: Trench 1, scale 1m
looking south

Trench 1 (Fig. 3, Plate.1)

This trench measured 2m by 1m and was excavated to a maximum depth of 0.1m. After the removal of the overburden (1.1) the foundations of a 19th century partition wall (1.2) were located running in a north/south direction in the centre of the trench. This wall probably relates to the later 19th century partitioning of the earlier open courtyard. To either side of the wall the natural clay (1.3) was revealed directly beneath the overburden. A small pit filled with masonry waste (1.4/1.5) was located cut into the natural clay in the southeast corner of the trench.

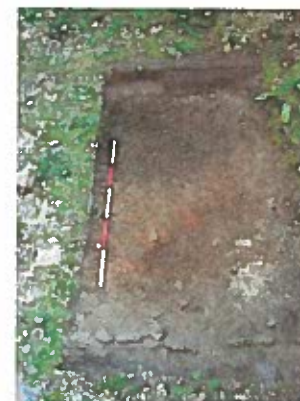
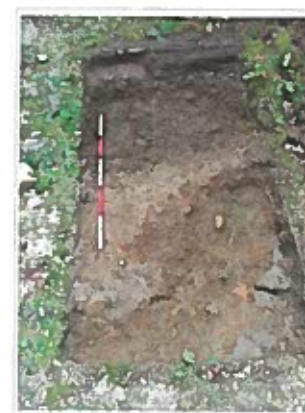
Fig 04: Plan and Plate of Trench 2

Plate 02: Trench 2 after initial excavation detailing cobbled surfaces and masonry waste pits. 1m scale looking south

Plate 03: Trench 2 after final excavation, scale 1m looking south

Trench 2 (Fig. 4, Plates. 2 & 3)

This trench measured 2m by 1m and was excavated to a maximum depth of 0.2m. Two rough pitched stone cobbled surfaces (2.2 & 2.3) were located directly beneath the overburden (2.1) at the northern and southern ends of the trench. A wooden beam was revealed abutting the northern set of cobbles in alignment with the northern edge of the doorway to the east, this beam is probably the remains of the staircase depicted in Area 6 – Blockley/Halfpenney 2002 (Fig. 2). To the south of the wooden beam two shallow pits (2.4/2.5 & 2.6/2.7) filled with masonry waste were revealed. Both of the pits contained pottery dating to the late 19th/early 20th century.

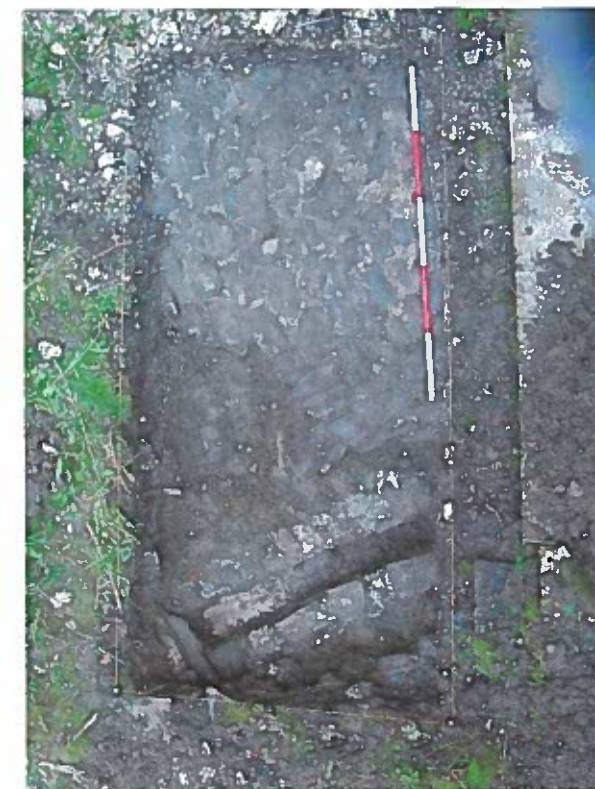
Plate 04: Trench 3 after initial excavation, scale 1m

This trench measured 2m by 1m and was excavated to a maximum depth of 0.5m. After the removal of the overburden (3.1) a rough pitch stone cobbled surface (3.2) was revealed. Excavation of a small section of the cobbles located a fragment of 17th/18th century pottery (North Devon Gravel Tempered Ware) within the bedding material for the cobbles (3.3). The natural clay (3.4) was located directly beneath the cobble bedding medium. At the western end of the trench the cobbled surface and natural clay had been cut (3.6) through and a stone culvert(3.7), dating to the 19th century, constructed at a depth of 0.3m below the present ground surface.

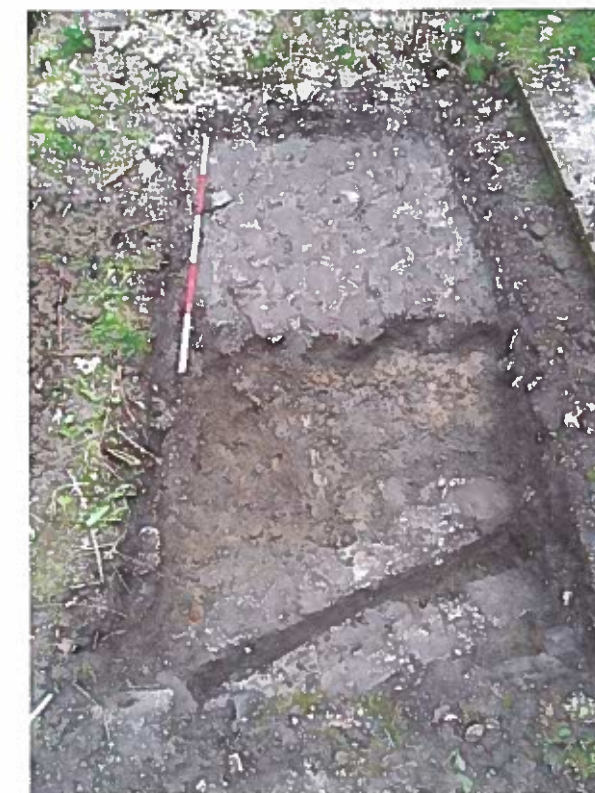
Plate 05: Trench 3 after final excavation, scale 1m looking East

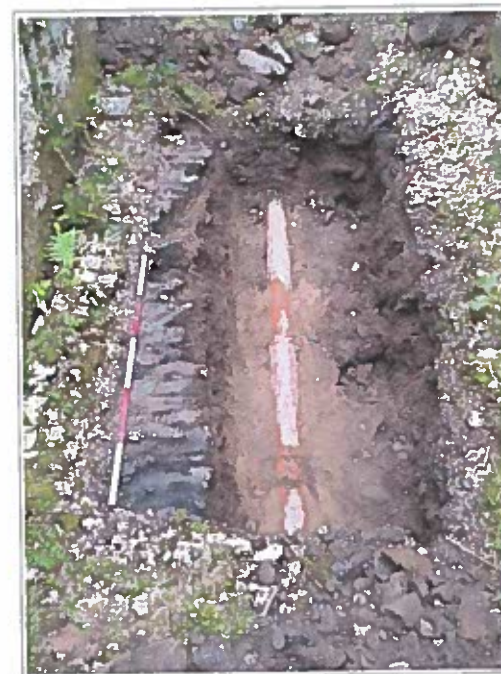
Fig 06: Trench 4 Illustration

Plate 06: Trench 4 after final excavation, scale 1m, looking north

Trench 4 (Fig. 6, Plate. 6)

This trench measured 2m by 1m and was excavated to a maximum depth of 0.4m. After the removal of the overburden (4.1) a small area of rough pitch stone cobbling (4.2) was revealed along the western side of the trench which is at the same height and of the same style as the cobbles revealed in Trench 3. To the east of the cobbled surface a cut for a modern service trench (4.5) (excavated during archaeological watching brief in 1999) was revealed. Excavation of cut (4.5) revealed that the cobbled surface (4.2) sat directly above the natural yellow clay (4.3) which in turn lay directly above the natural shale bedrock (4.6).

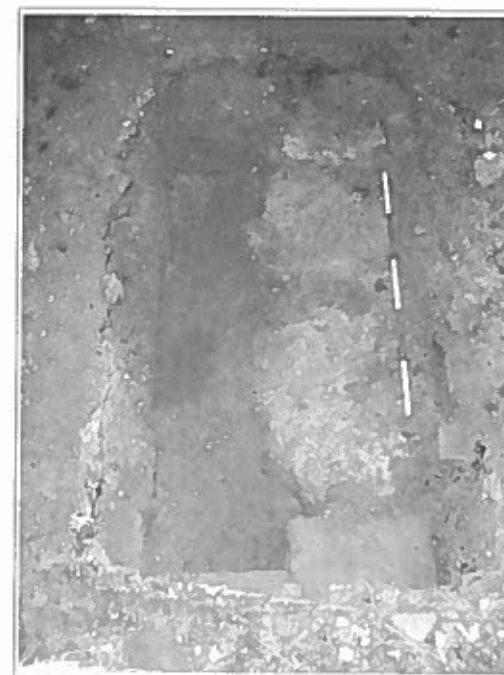
Fig 07: Trench 5 Plan and Plate

Plate 07: Trench 5 after final excavation, 1m scale looking north

Trench 5 (Fig. 7, Plate. 7)

This trench measured 2m by 1m and was excavated to a maximum depth of 0.4m. After the removal of the overburden (5.1) a deposit of loose brown/black silty clay with masonry waste inclusions (5.2) was revealed. To the north of the trench a slate flagstone floor slab was visible sat directly on deposit (5.2) indicating that it was probably laid as a hardcore makeup/leveling deposit for the latest floor surface within the room. Excavation of deposit (5.2) revealed three further slate flagstone floor slabs (5.3) in the southern section of the trench 0.2m below the present ground surface. Lying directly beneath the flagstones (5.3) the foundation remains of an earlier wall (5.5) were located on the eastern side of the trench which in turn sat directly on the natural clay (5.6). Patches of charcoal rich mortar (5.4), typical of the 19th century, were located on the upper surface of the foundations (5.5) indicating a 19th century date for the lower set of flagstones (5.3). The foundations (5.5) were composed of large stone slabs covered in a white/pink lime mortar and ran in a north/south direction along the eastern side of the trench. The location of the wall foundations within the area of the original courtyard (prior to its later subdivision), suggests a probable pre-19th century date, without further excavation it is not possible to ascertain the exact extent, nature and date of the wall foundations. On the western side of the trench deposit (5.2) continued to a depth of 0.4m where the natural clay (5.6) was located.

It is recommended that any areas of the proposed development that will affect the cobbled surfaces in the South Wing should only be undertaken after recording of the surfaces by either photographic and/or drawn records. Any works undertaken on the wall in Trench 5, along with any work to the north and south where the wall may continue, should be undertaken under archaeological supervision so that more details regarding the extent, date and function of the wall can be established.

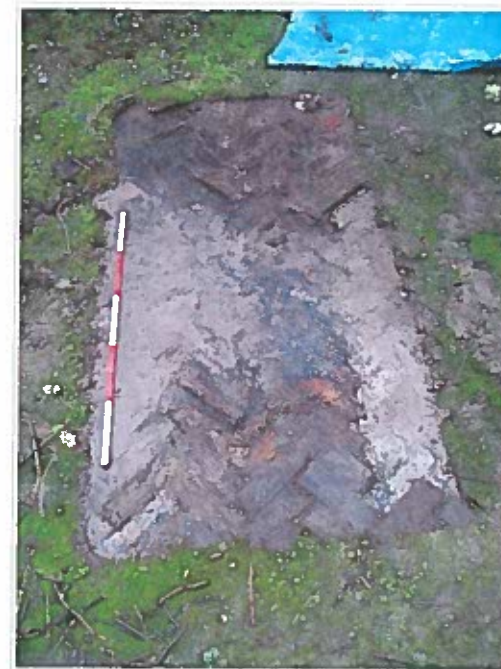
Fig 08: Trench 6 Plan and Plate

Plate 08: Trench 6 after initial excavation, scale 1m looking south

Trench 6 (Fig. 8, Plate. 8)

This trench measured 2m by 1m and was excavated to a maximum depth of 0.4m. After the removal of the overburden (6.1) a surface of concrete with par-ky wooden floor segments was revealed covering the whole of the excavation area. A small slot (0.2m wide by 1m long) was excavated through the concrete to a depth of 0.4m. A deposit of masonry waste (6.2) dating to the 19th century was revealed directly beneath the concrete. This deposit extended to a depth of 0.35m where a deposit of dark brown silty clay (6.3) was encountered. No archaeological features or dating evidence was revealed during the excavation of deposit (6.3) which in turn lay directly above the natural yellow clay (6.4).

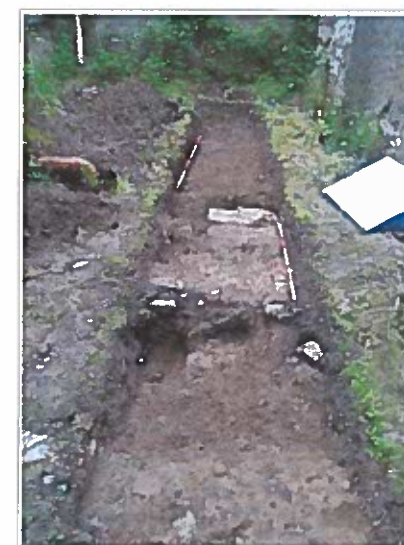
Plate 9: Trench 7 After Final excavation, scales 1 & 2m looking North

This trench measured 7m by 1m and was excavated to a maximum depth of 0.5m. After the removal of the overburden (7.1) a linear cut feature (7.2/7.3) was located at the northern end of the trench. Excavation of (7.2/7.3) revealed two 19th century ceramic drain pipes running in a northeast/southwest direction, the natural clay (7.4) was also revealed at the base of the trench, 0.3m below the present ground surface. 3m to the north of the southern end of the trench the foundation remains of an east/west running wall (7.8) measuring 0.3m wide by 0.6m long and surviving to a depth of 0.5m was located. One fragment of 19th century pottery and a fragment of clay pipe stem were located in the fill (7.7) of the foundation trench for the wall indicating further possible partitioning of the courtyard in the 19th century. Immediately to the south of the wall an area of compact mortar (7.9), containing 2 fragments of late 19th century pottery, and fragmentary remains of a cobbled floor surface (7.5) were revealed. Deposit (7.9) continues beneath the cobbled surface (7.5) and is probably the bedding medium for the cobbled surface which has been largely robbed. Over the majority of the trench the natural clay (7.3) was located directly beneath the overburden suggesting that any courtyard surface that may have covered this area had been removed.

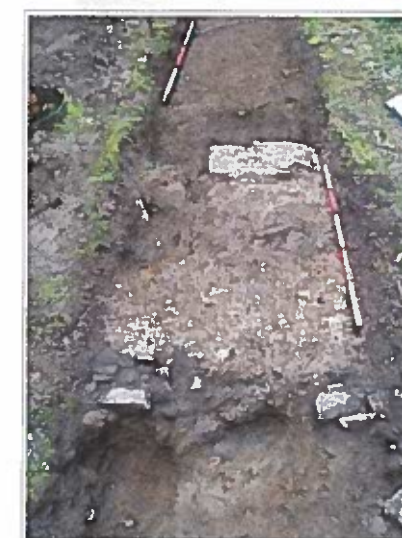
Plate 10: Detail of Stone wall and cobbled surface, scale 1m looking North

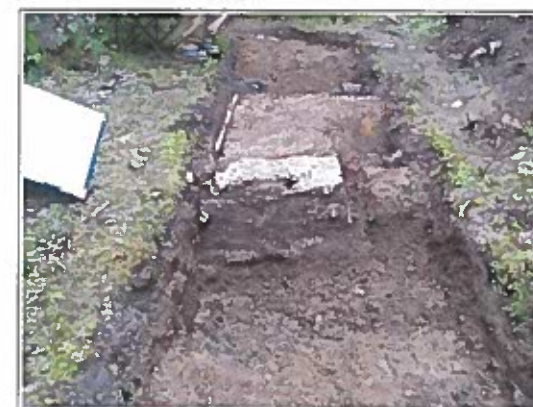
Plate 11: Detail of Stone wall and Foundation cut 7.7, scale 1m looking south
