Archaeological Observation Programme

**Land adjacent to Haverfordwest Priory,
Haverfordwest, Pembrokeshire**

Report No: 2003-07-09

Archaeological Observation of works carried out on land adjacent to Haverfordwest Priory, Haverfordwest, Pembrokeshire, by Laing Utilities for Dwr Cymru/Welsh Water

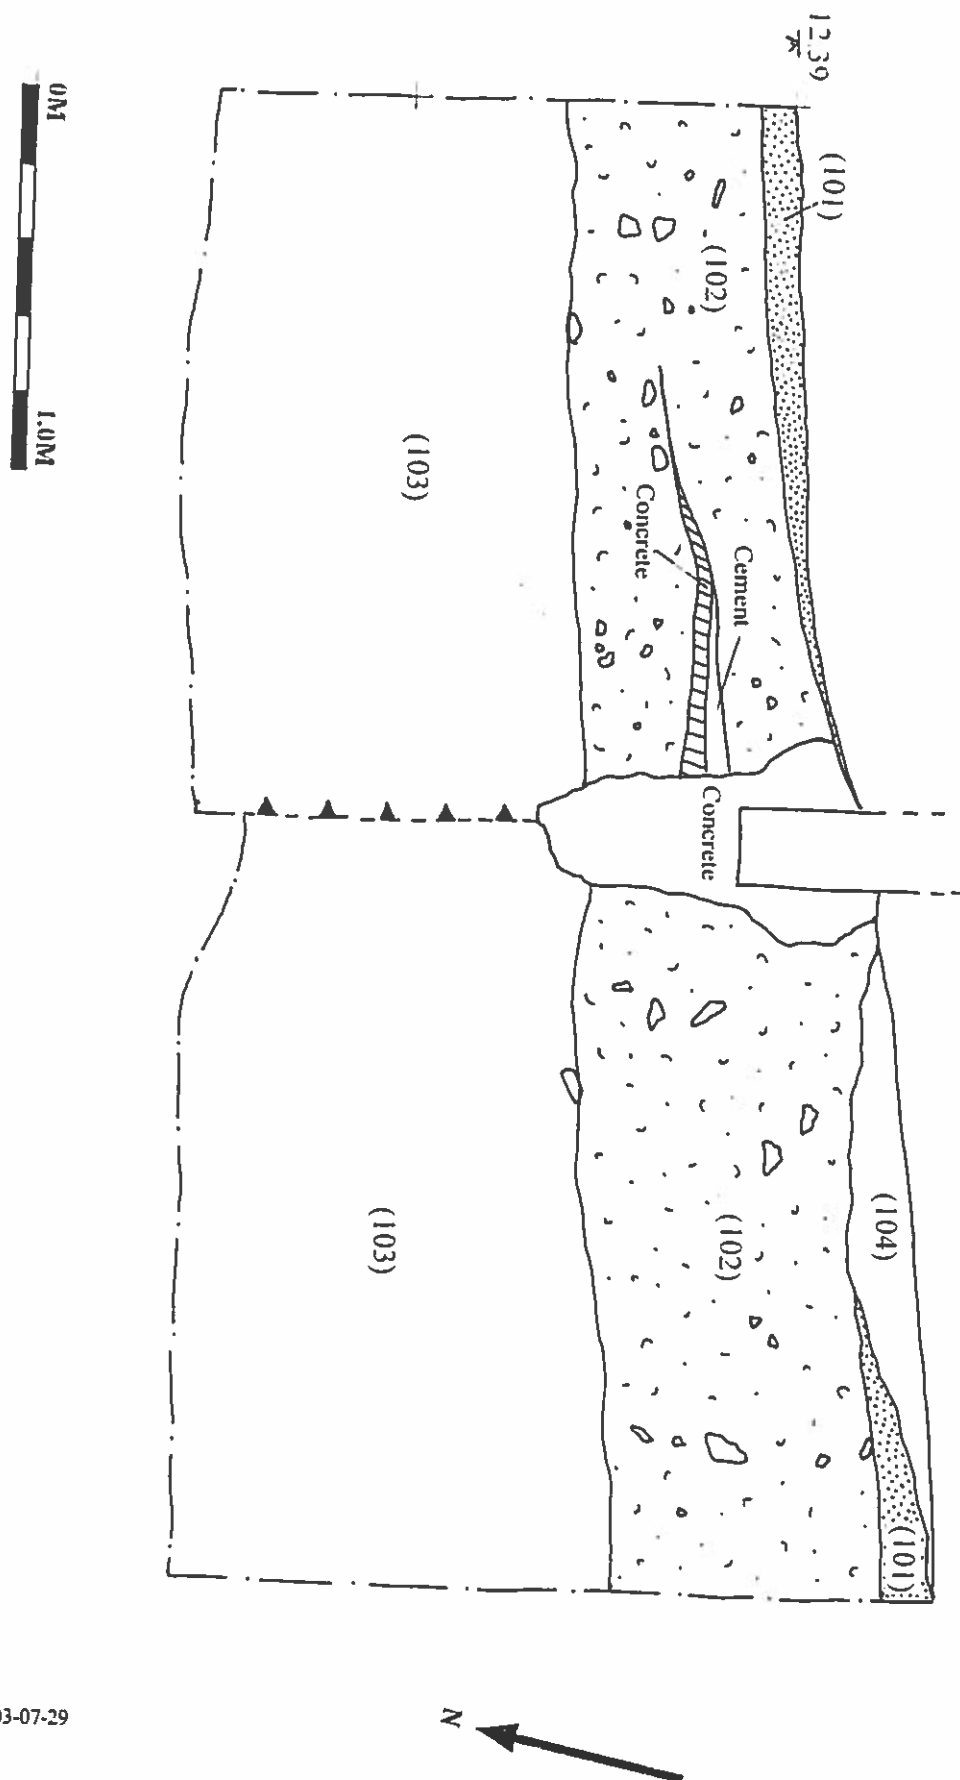
FIGURE 6. TRENCH 2 (SECTION)

- 5.9 Three contexts were identified. The first of these extended to a depth of 0.22m and comprised a loosely compacted, medium brown to dark brown, sandy turf layer (101) with occasional, small, angular stone inclusions. Underlying (101) to a depth of 0.84m was a moderately compacted, grey-brown, silty clay soil (102) with frequent small and occasional medium angular and sub-angular stone inclusions. Several 20th century ceramic utility pipe fragments were also identified. Underlying (102) to the trench base was a moderately compacted, orange-brown, sandy clay soil (103).

- 5.10 The stratigraphy was identical in all sections to the depths recorded, except for the west-facing section which comprised concrete blocks where the water main entered beneath the A4076.
