## **The Old Engine House, Llanfyrnach, Pembrokeshire.**

### **Archaeological Standing Building Recording**

**HRSW Report No: 102**

**Date: 1st September 2005**

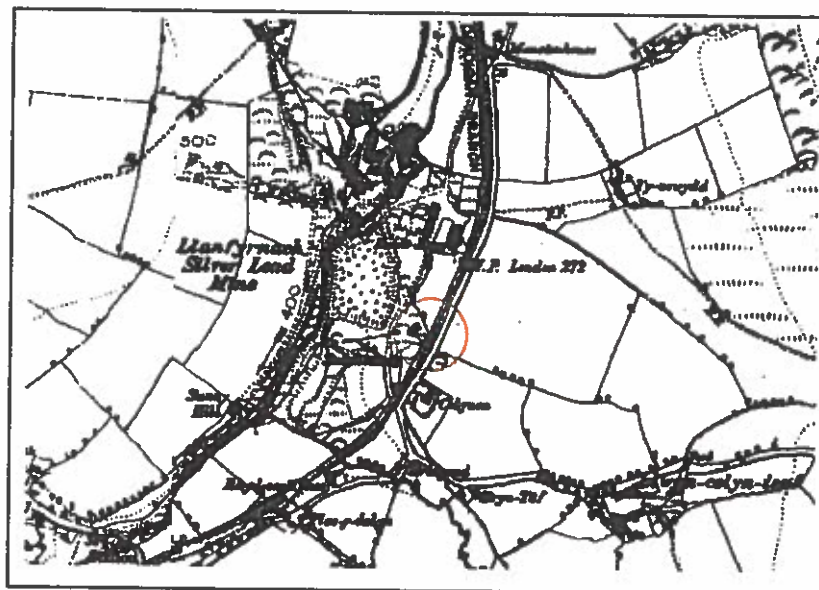
Figure 2. Portion of OS 1<sup>st</sup> edition map of 1898 showing Llanfymach Silver Lead Mine Complex (Old Boiler House highlighted in red).

4.24 For reference, a portion of the Ordnance Survey First Edition 6 inch map, dated 1898, showing Llanfymach Silver-Lead Mine has been included (see Fig ?). Also included is copy of a plan by Peter Claughton based on the same early OS map, but annotated with interpreted buildings of the former Llanfymach Mine Complex.

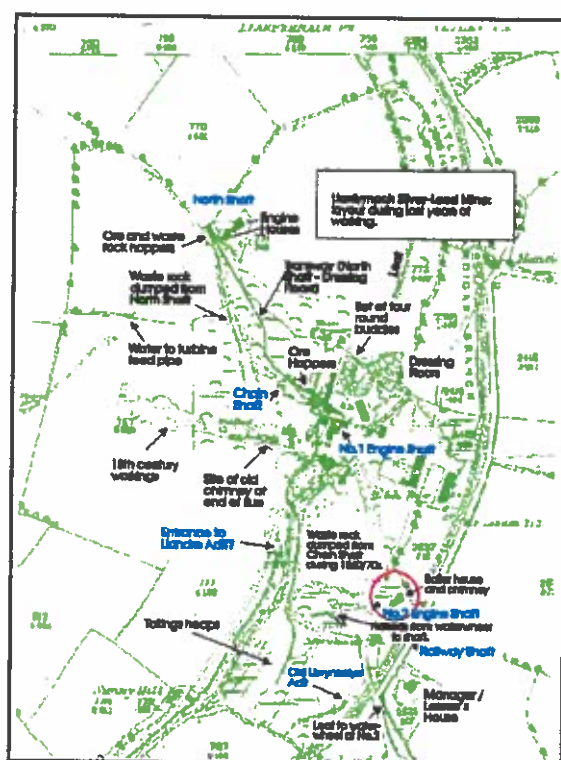
Figure 3. Peter Claughton annotated plan of Llanfymach Silver Lead Mine Complex. (Boiler House highlighted in red).

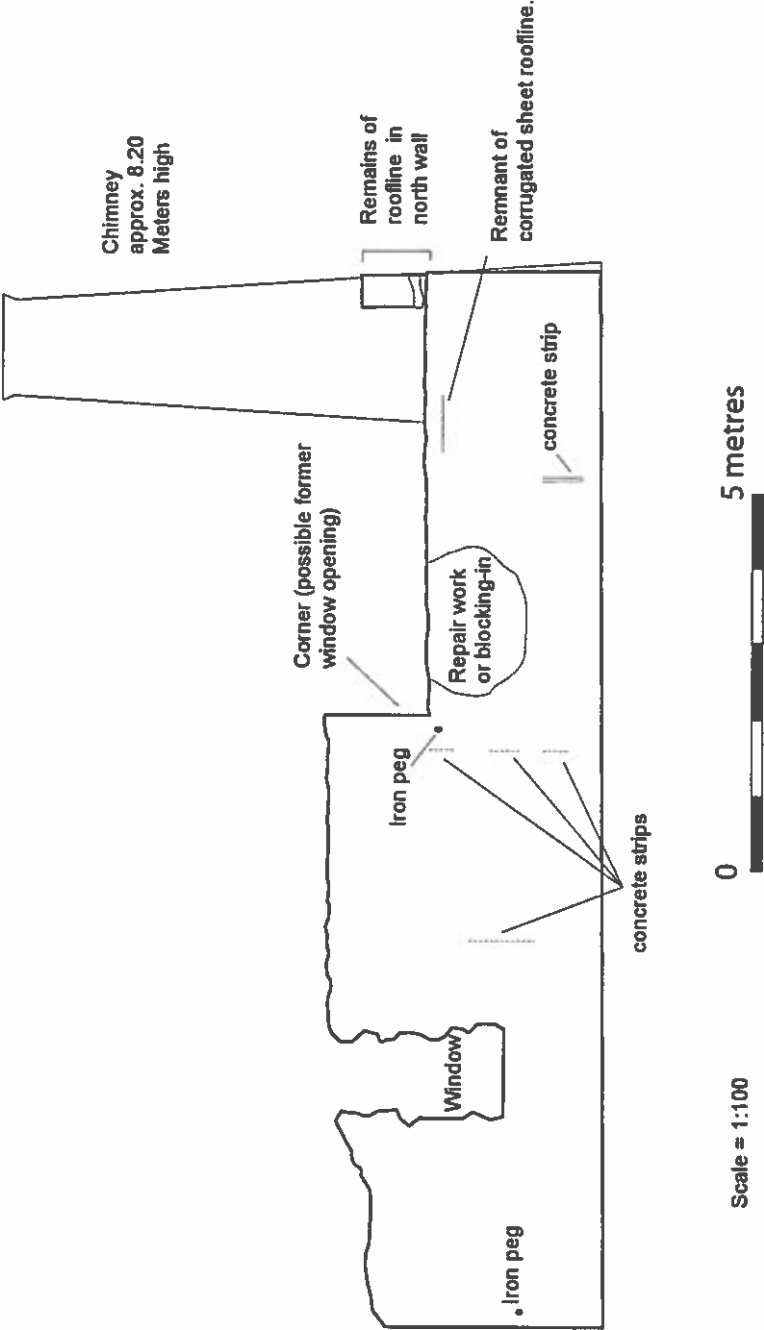
Figure 5. South facing elevation

#### 5.4 iii) *South-east facing elevation (Rear – exterior) (see Fig 5)*

Similar to the front north-west facing elevation, the south-east facing elevation is also approx. 13.5m in length x 4.2m in width. This wall is characterised by the remains of a window opening approx. 1.07m wide with the base of the sill approx. 1m from ground level. The standing remains of this wall vary in height from between 3m – 3.75m. Halfway along the length of the wall, the standing height alters to an average height of approx. 2.5m. This level begins at a point where part of the wall terminates in a corner face, as if evidence of a former opening that formerly ran the length of the upper wall from this point onwards. Added to this, central to this area of the wall, there is also potential evidence of a square opening having been blocked in. This is only evidenced however by an area in the wall that has either formerly collapsed at some stage and then rebuilt or the stones re-stacked or else the outline of stones marks a blocked in feature, possibly even a former window, that reflected in form, the window in the front north-west facing elevation.

Also noted within the fabric of this elevation two several iron pegs and a series of concrete fixing strips indicative of a former lean-to.

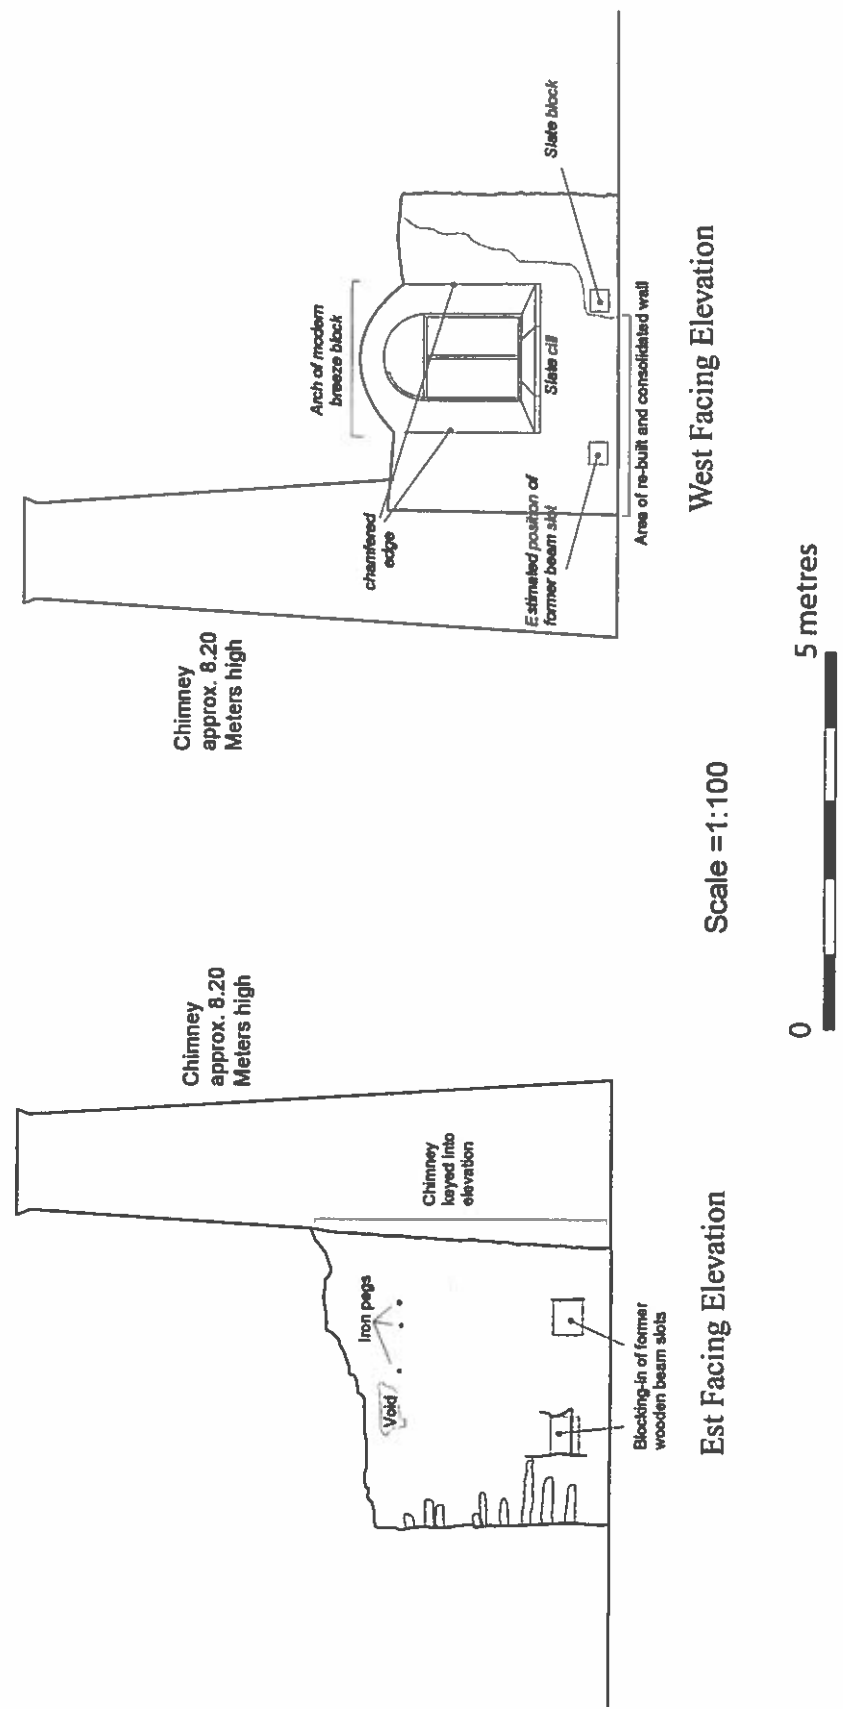
Figure 6. East and West Facing Elevations

#### 5.6 v) *South-west facing elevation (Side – exterior) (see Fig 6)*

The south-west facing side elevation is approx. 4.2m in width with standing remains reaching a maximum height of approx. 2.60m. This side elevation is characterised in the main by the remains of an arched window, approx.1.15m wide. The greater part of this side elevation has been rebuilt and the former standing remains have been consolidated. As well as recent re-pointing work, this recent repair work is evidenced by

the modern breeze block arch above the window opening, as well as the fact that the interior of the wall has also been *skinned* with modern breeze blocks. The only definite authentic feature within the fabric of this elevation is the remains of the slate sill and a blocked-in square feature located toward the lower southern corner of the wall. It appears that a wooden beam would once have been placed in this slot but has now been blocked in with a *friable* piece of slate. It is very likely that a similar wooden beam slot would also have been present in the lower northern side of this wall, but this is not present due to re-building work where the feature has been omitted.

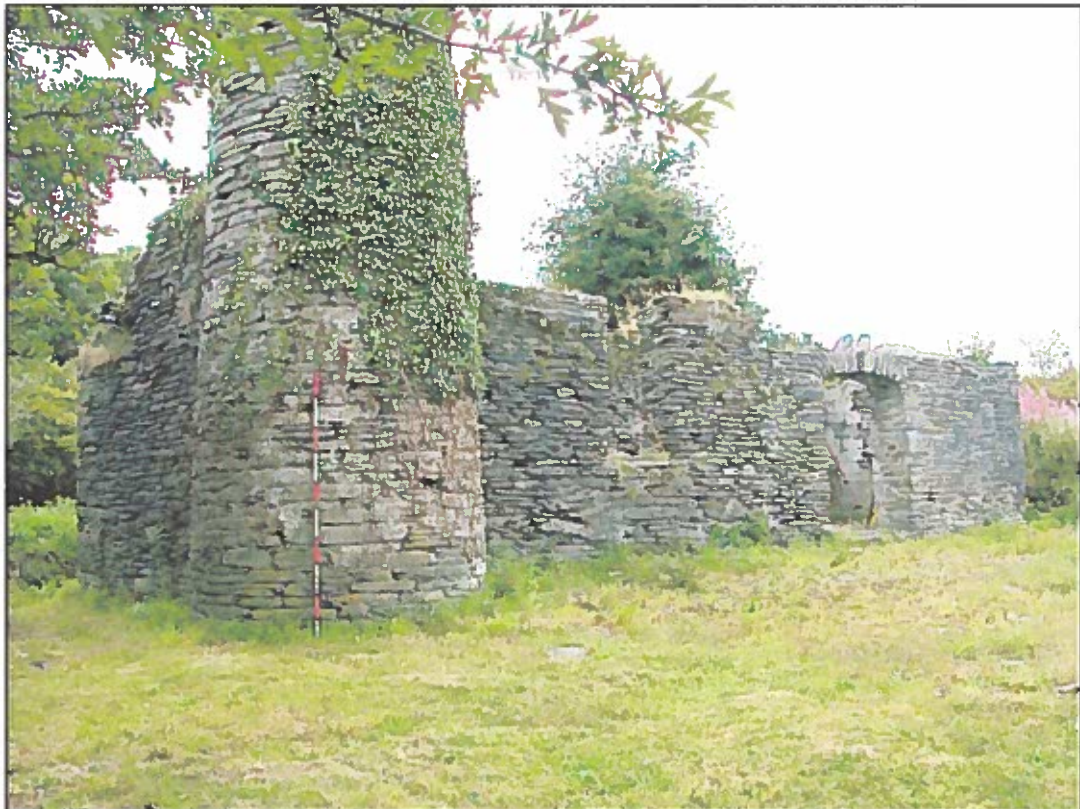
*Plate 2. North-west facing elevation and chimney.*

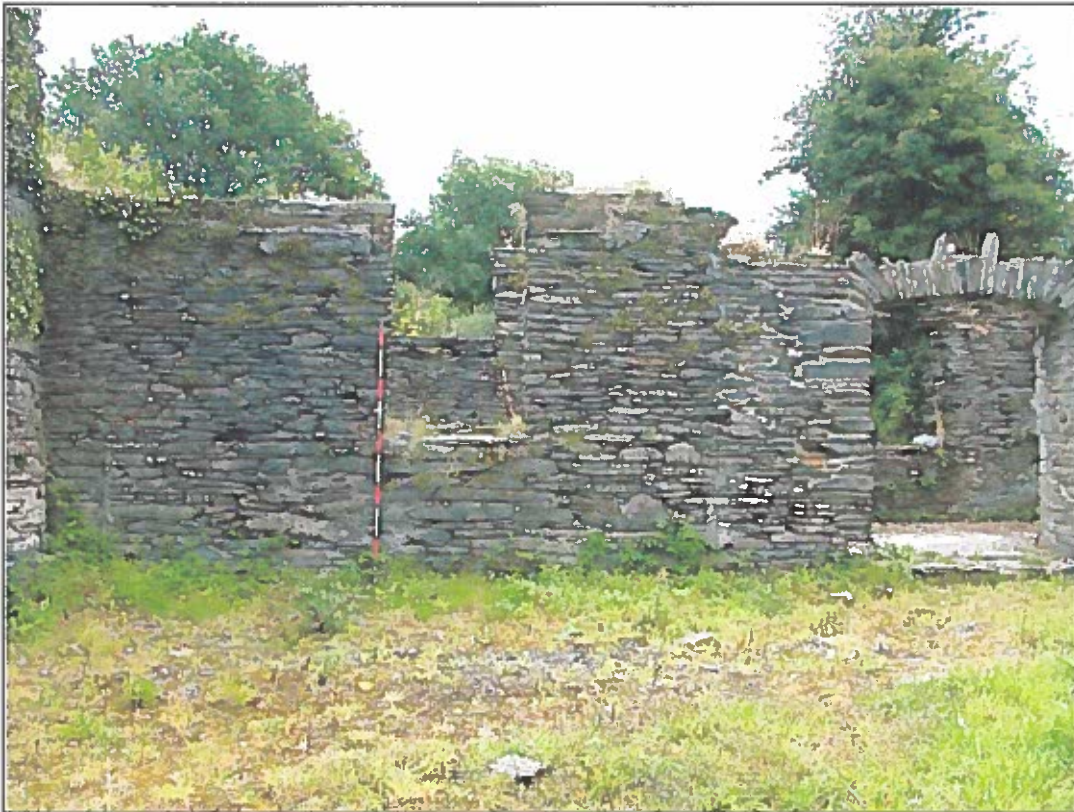
**Plate 3.** Northern end of north-west facing elevation.

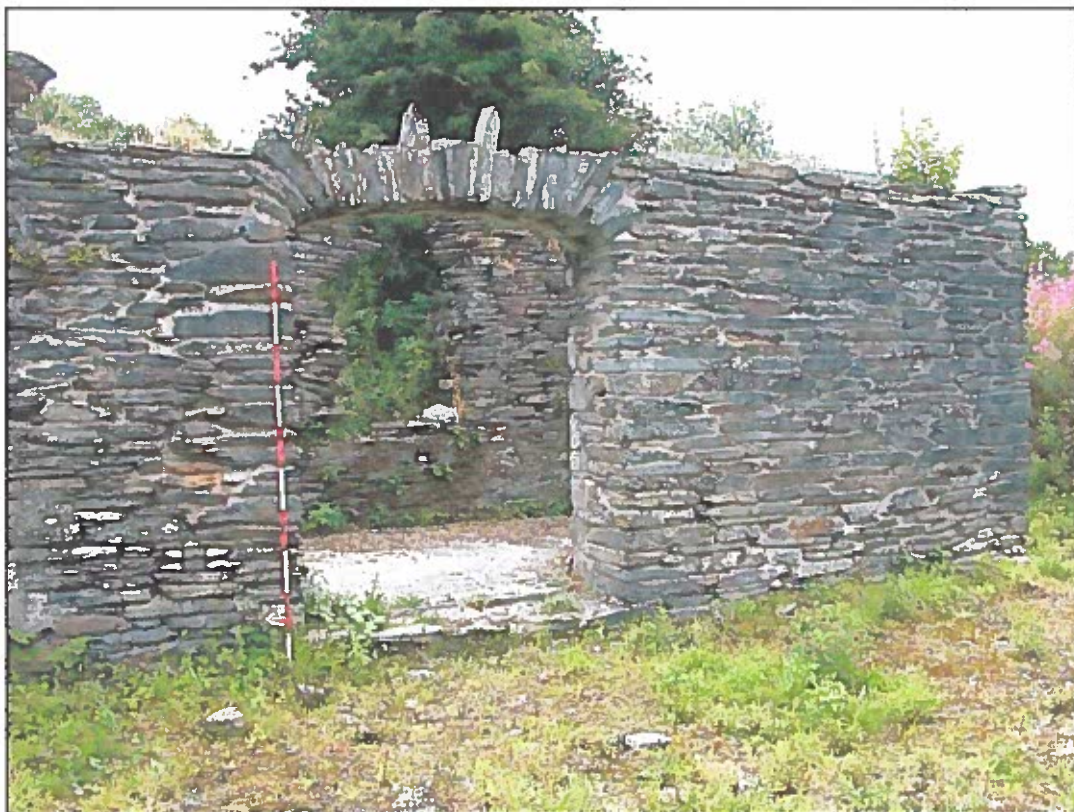
**Plate 4.** Southern end of north-west facing elevation.  
Area of repair work and consolidation

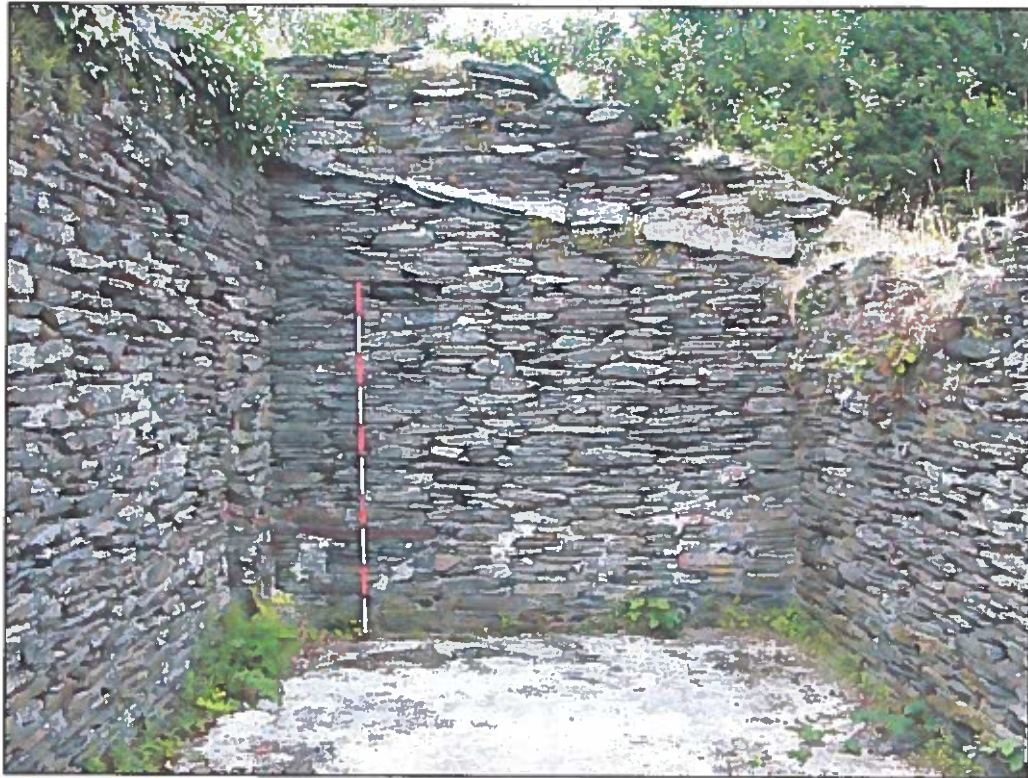
**Plate 13.** North-east wall interior. Note cast iron supporting plate at lower left hand corner.

Other than the features already mentioned within the exterior of this elevation, the investigation of the interior fabric noted no new features, apart from the remains of one rusting cast iron supporting plate in the lower left hand corner located above the blocked in beam slot. Worth mentioning is the remains of an old roof line, likely post dating the earlier roofline that appears to have been 1m above this roofline

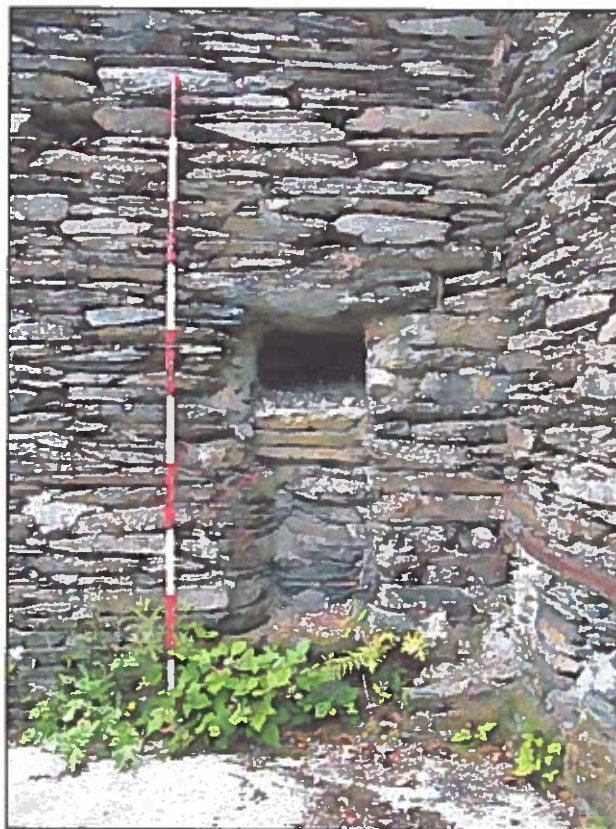
**Plate 14.** Chimney flue opening within north wall interior.

There are no further features visible on the interior of the north-west facing elevation that are not evident on the exterior of the wall, except for the small narrow opening to the chimney in the far northern corner of the wall. A description of this feature is included in the *Chimney* section below.

The stone chimney-stack is in a very well preserved condition. It is approx. 8.2m in height and tapers inwards from its approx. 2m wide diameter base. Investigation of the chimney itself noted the presence of a series of put-log holes located approx. 5-6m up the length of the chimney. Within the interior the opening for the chimney flue is located at the corner of the interior of the north-west facing elevation. The opening slot is approx. 1.30m in height with the flue opening only approx. 0.40m x 0.30m.
