Linney Head Promontory Fort Castlemartin Pembrokeshire

Archaeological Recording

April 2005

Issue N^O: 1 OA Job N^O: 2634

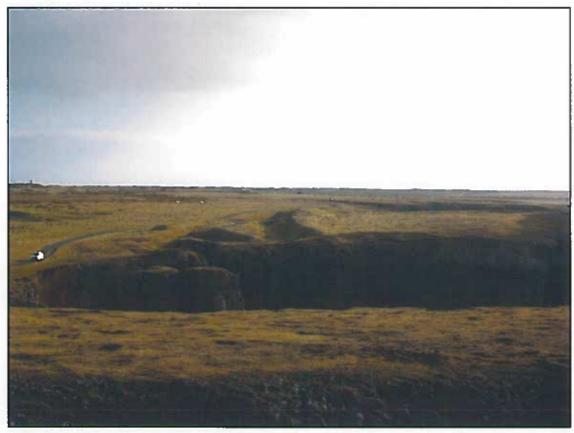
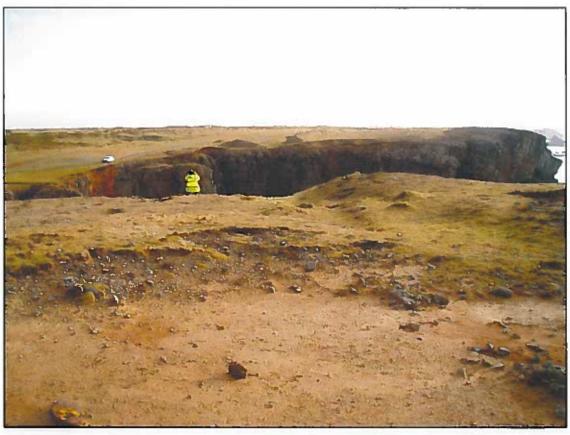
Figure 3: Linney Head fort, general site view

Linney Head main fort, outer ramparts (view to the east)

View to the east, with main ramparts in the foreground and the newly identified rampart in the foreground

3.2.1 The exposed section was recorded photographically, from the adjacent promontory to the west, as the section is unsafe to approach. Views were taken of the overall appearance of the structure, the area exposed by erosion, the section's relationship to its setting and particular structural and constructional details (figs 3-6).

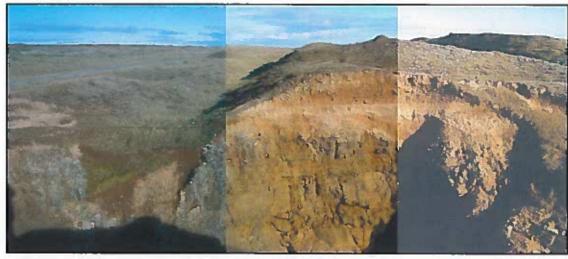
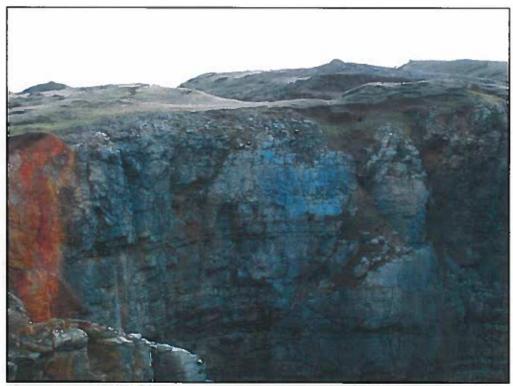
Figure 4: Close-up views of the eroded sections

4.2.1 The stratigraphy of the outer rampart of the fort was clearly exposed in section (fig.4). The rock-cut ditch has steep sides and a flat base. It is filled with reddish brown soil containing some medium to large stone inclusions. There are no obvious layer

Close-up of outermost rampart and eroded section, to the east

Close-up of inner rampart and eroded section, view to the SE

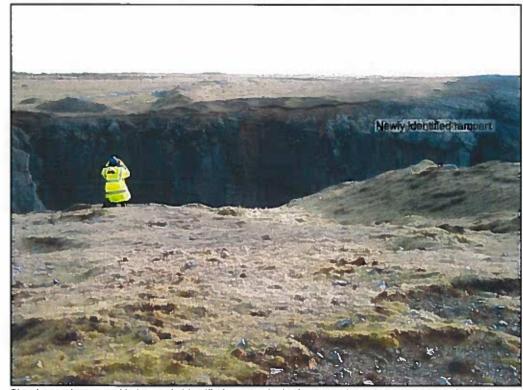
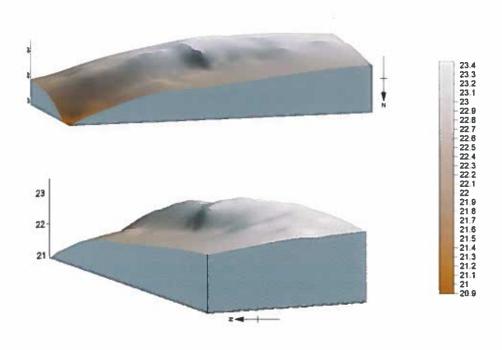
Figure 5: Newly identified rampart, photographed and rendered in 3D

4.1.1 The most significant result of the survey was the identification of an additional rampart on the promontory to the west of the scheduled area (fig. 5). This appears to represent an extension of the inner rampart of the fort, from which it has presumably been severed by coastal erosion. The inner rampart thus seems to have been at least 280m long in its original form, 100m longer than has previously been assumed.

Site view to the east, with the newly identified rampart in the foreground

3D models of the new rampart, results of the GPS survey

- 3.1.1 The field survey was carried out by members of OA's Geomatics Department. All survey was done using a Leica 1230 GPS rover and base unit.
- 3.1.2 The survey concentrated on geo-referencing the exposed rampart sections in advance of photographic rectification. A limited earthwork survey of the monument and the promontory to the west was also carried out. The survey results are presented in Figure 5.

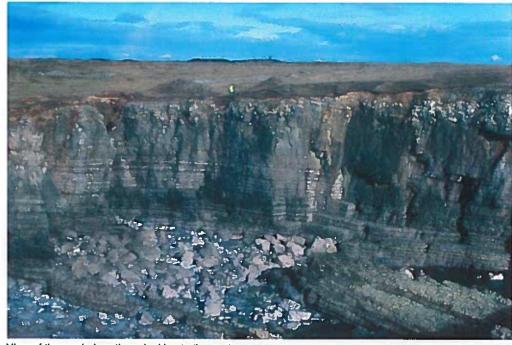
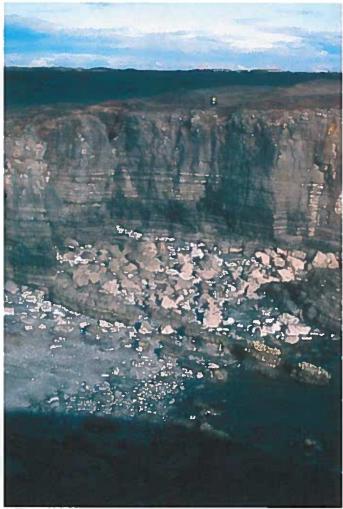
Figure 6: Panoramic view of the eroded sections, from neighbouring promontory

View of the eroded sections, looking to the east

View of the eroded sections, to the east.
