Archaeological Observation

**Eben's Lane  
Cardigan**

**Cardiganshire (Ceredigion)**

Laing O'Rourke for Dwr Cymru /  
Welsh Water

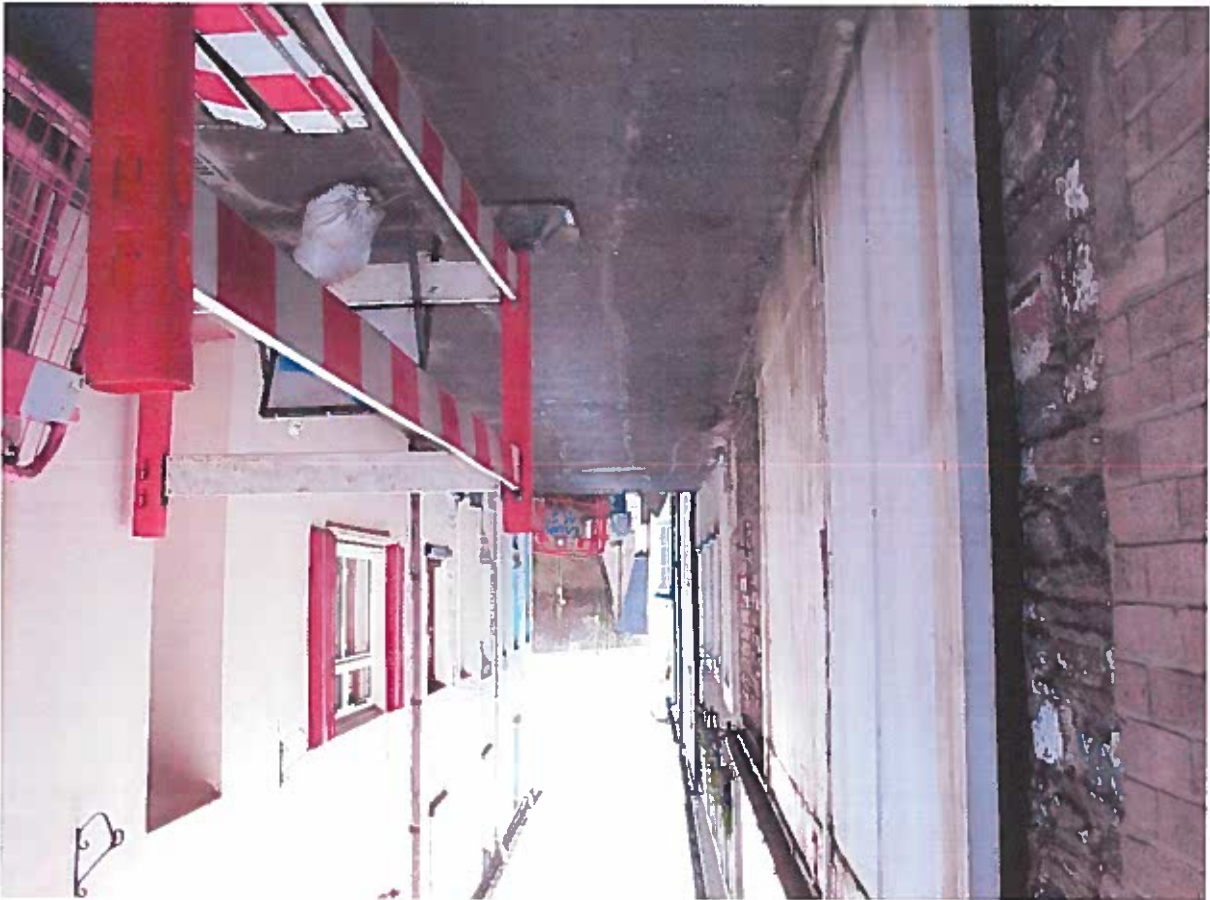
Plate 1: NW view along Eben's Lane

Eben's Lane is a narrow lane running approximately 100m in a E-W direction from Cardigan High Street to Lower Mwdan, within the historic core of the medieval town of Cardigan (Plate 1). The lane is first shown in detail on the 1839 tithe map of the parish of St Mary's Cardigan.

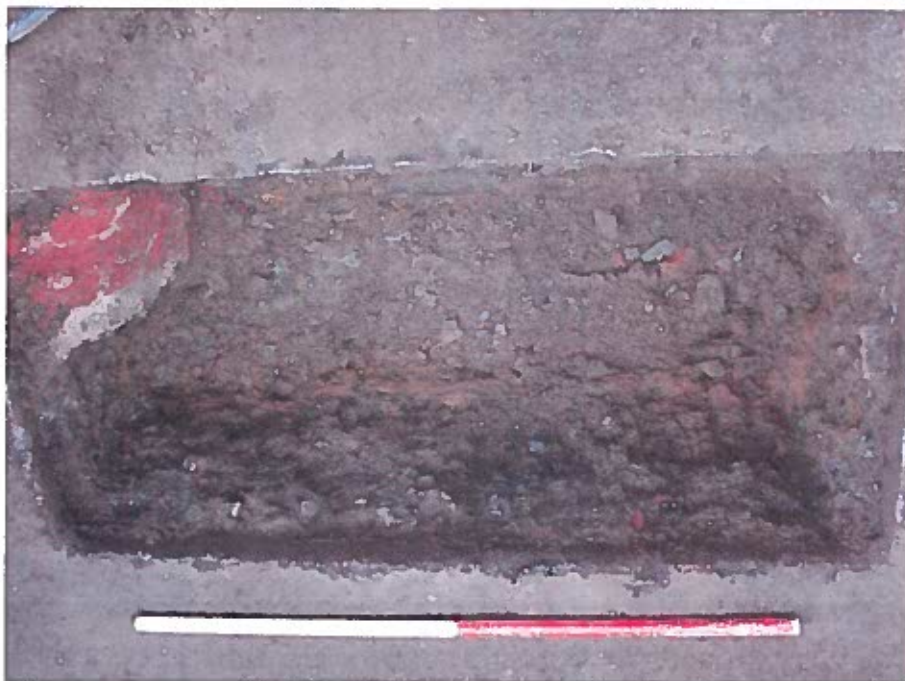
| Date | Grid Ref/Pit No | Location | Description | Results |
|---|---|---|---|---|
| 06/01/2005 | SN17721 46077<br>Pit E5 | o/s No. 21 | Tarmacadam path/road >> moderately compacted coarse orange sand mixed with gravel (50%) - redeposited backfill. | NAR |

Plate 3: SW-facing section of Pit E5

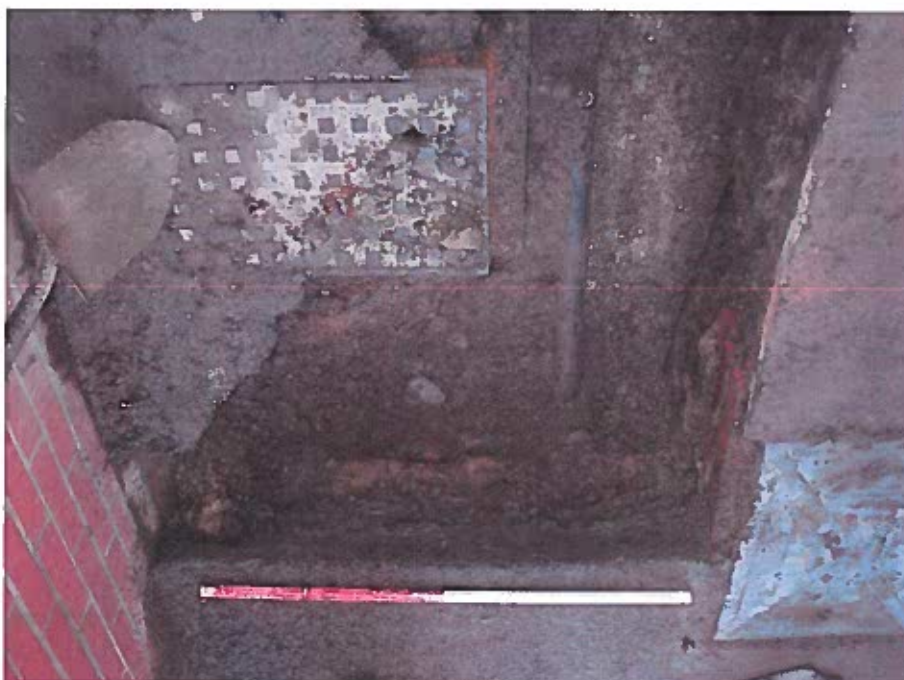
| Date | Grid Ref/Pit No | Location | Description | Results |
|---|---|---|---|---|
| 05/01/2005 | SN17704 46068<br>Pit E1 | o/s HSBC - NE-facing elevation | Tarmacadam path/road >> hardcore deposit of well - compacted grey clay and 60% small grey angular stones >> moderately compacted coarse orange sand >> dark grey/brown sandy silt loam with moderately frequent (15-20%) slate fragments and occasional (<10%) small subangular and well rounded stone inclusions - redeposited. Finds of C18th - C20th pottery fragments - 4 D43 ceramic rim; 5 brown internal salt glaze; 1 light brown internal glaze; 1 light brown and yellow pattern glaze; 1 C20th blue-and-white pattern glazed china; 1 ceramic unglazed. | NSA |

Plate 2: SE-facing section of Pit E1

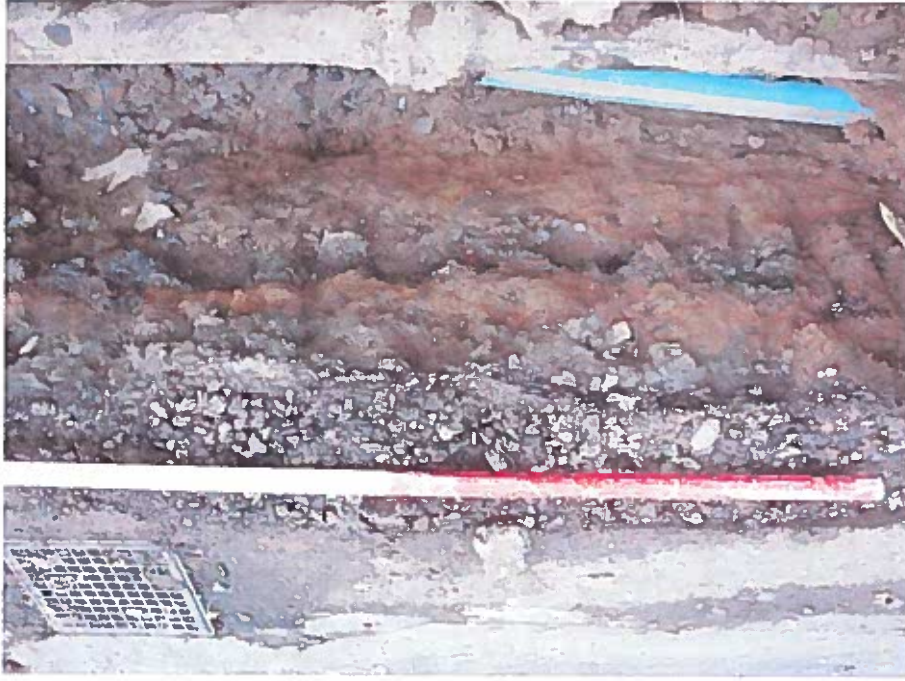
| Date | Grid Ref/Pit No | Location | Description | Results |
|---|---|---|---|---|
| 10/01/2005 | SN17707 46073<br>Pit E11 | o/s No. 18 | Tarmacadam path/road >> moderately compacted coarse orange sand mixed with gravel (50%) - redeposited backfill >> moderate to well compacted orange/brown sandy clay loam, with occasional (<10%) small subangular and rounded stone inclusions - disturbed natural | NAR |

Plate 5: SW-facing section of Pit E11

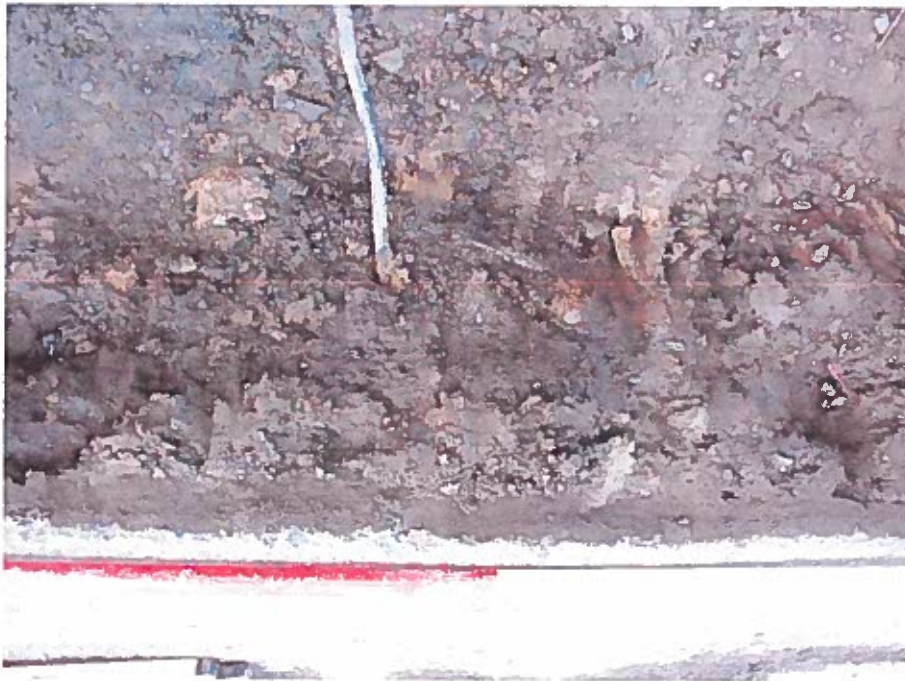
| Date | Grid Ref/Pit No | Location | Description | Results |
|---|---|---|---|---|
| 10/01/2005 | SN17716 46069<br>Pit E9 | o/s No. 20 - doorstep | Tarmacadam path/road >> moderate to well compacted mix of grey/brown sandy loam/grit/gravels, with orange sandy clay and very frequent (40%) small angular and subangular stones and slate fragments >> clay with very frequent (40%) small subangular stones and slate fragments - redeposited | NAR |

Plate 4: SW-facing section of Pit E9
