# Freemans View, Merlins Bridge Haverfordwest

Archaeological Evaluation

GAP Report No. 411

Date: 2 February 2006

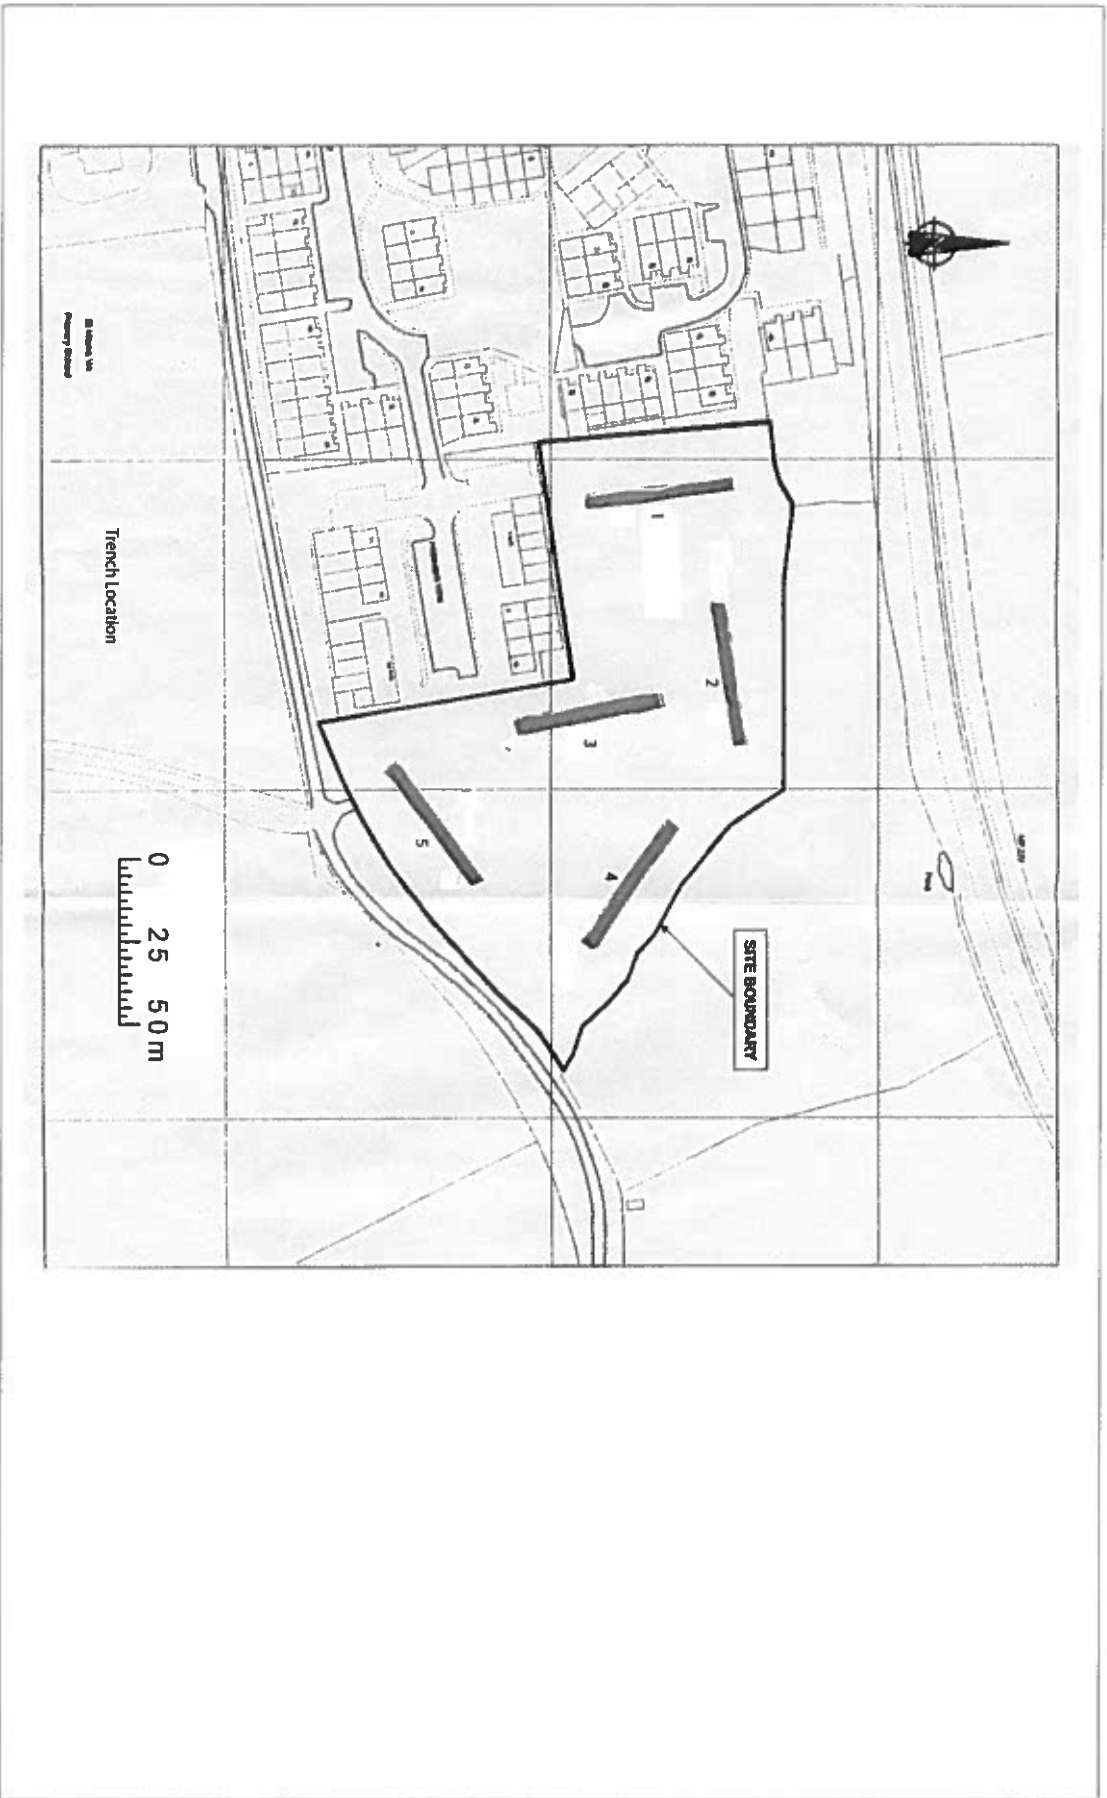
Fig2: Trench Location Plan

Five trenches were excavated, each 43m long and 2m wide – representing 2% of the overall development area. Each trench was initially stripped of topsoil and subsoil by a machine fitted with a toothless bucket – this was done under the close supervision of Cambrian Archaeological Projects staff. The trenches were then cleaned back by hand to reveal the surface of the natural and any features cut into it. Each trench was photographed, and context recording undertaken. Where features were revealed, these were photographed and drawn before being sectioned; finally, photographs and section drawings were undertaken.

In all cases, the trenches measured 43m in length by 2m wide, and were initially excavated to the upper level of the natural by machine.

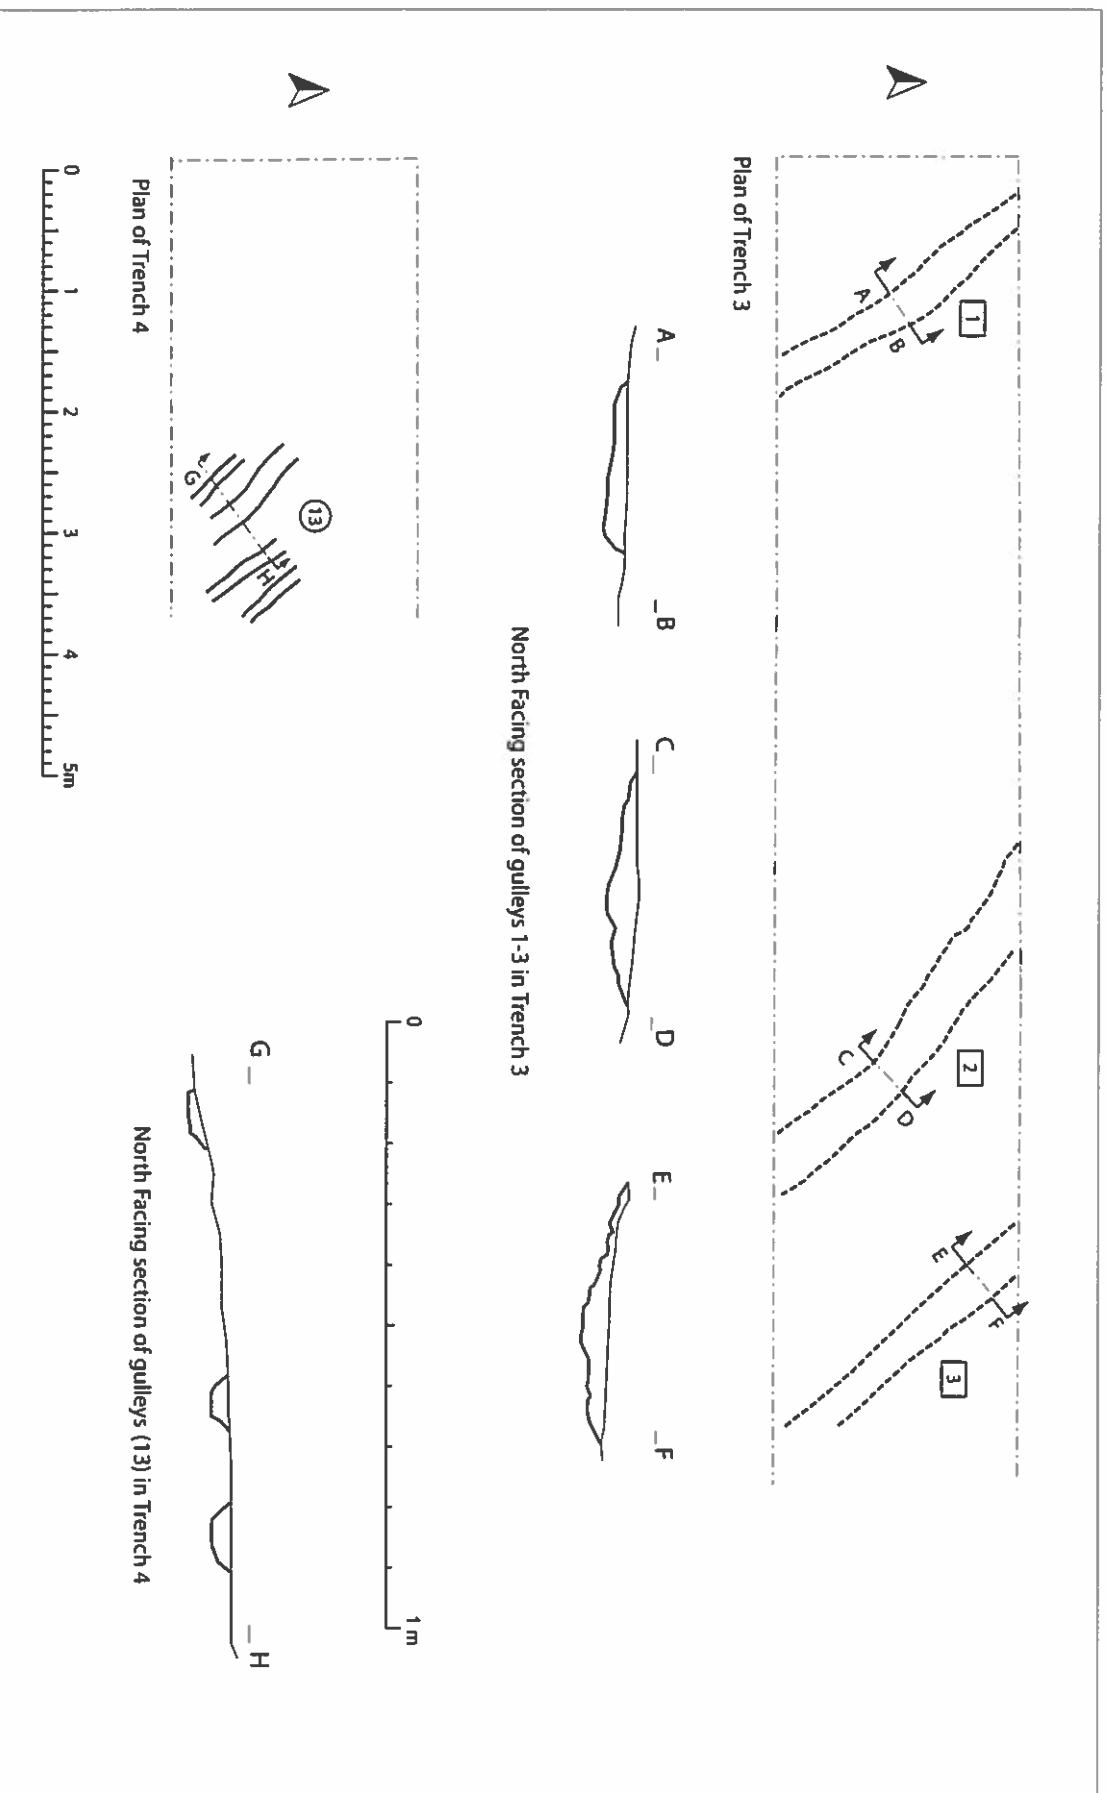
Fig 3: Detail of features in Trenches 3 and 4

Three linear features were identified running NE-SW across the central part of the trench. These were planned and sectioned. See Fig 3 and Plate 1.

Feature 1 was 0.35m wide and 0.03m deep, with a rounded base. It was cut into the bedrock and filled with dark brown loose silty clay

Feature 2 was 0.37m wide and 0.035m deep with a flattened base and rounded sides, cut into the natural. The soil fill was comparable to feature 1.

Feature 3 was 0.41m wide and 0.04m deep with an uneven base cut into the natural, and was filled with material comparable to feature 1.

Four possible plough marks (context 13) were identified towards the western end of the trench, running NW/SSE. All were very ephemeral and only a few mm deep. They were recorded and sectioned, and were all found to be filled by a loose brown clay soil. See Fig 3 and Plate 2.

The linear features identified in trench 3 remain ambiguous, although it is possible that they relate to possible ridge and furrow tentatively identified in the field. Their close spacing would perhaps discount this interpretation, although some hand dug rig can be very narrow.

The plough marks in trench 4 are likely to be ancient, due to the lack of signs of ploughing in the overlying subsoil. However, without dating evidence their significance cannot be ascertained.
