**ARCHAEOLOGICAL WATCHING BRIEF**

**"No:1 Robeston Hall,  
Robeston West, Milford Haven".**

**HRSW Report No: 107**

**Date: 30th August 2006**

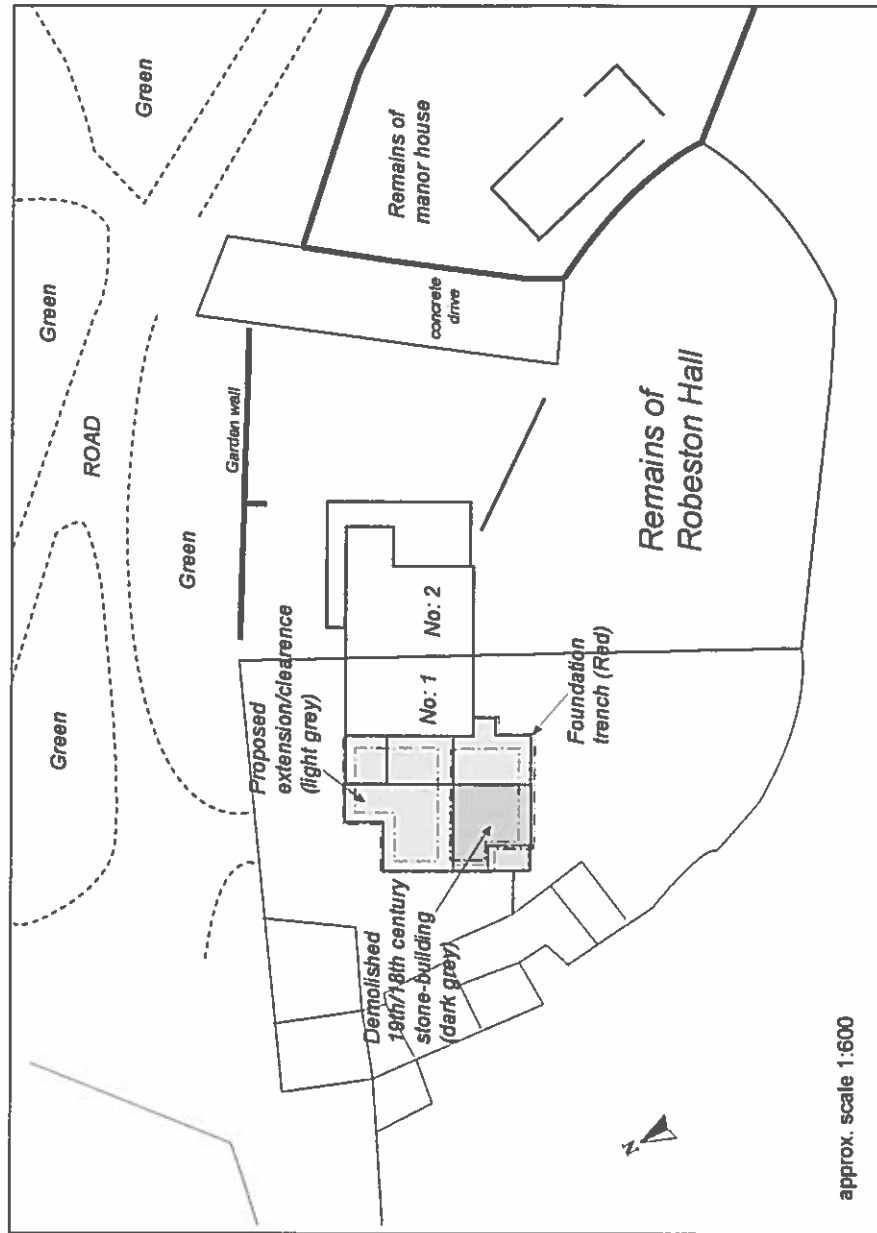
Figure 3. Site plan showing proposed extension and associated foundation trench (outlined in red).

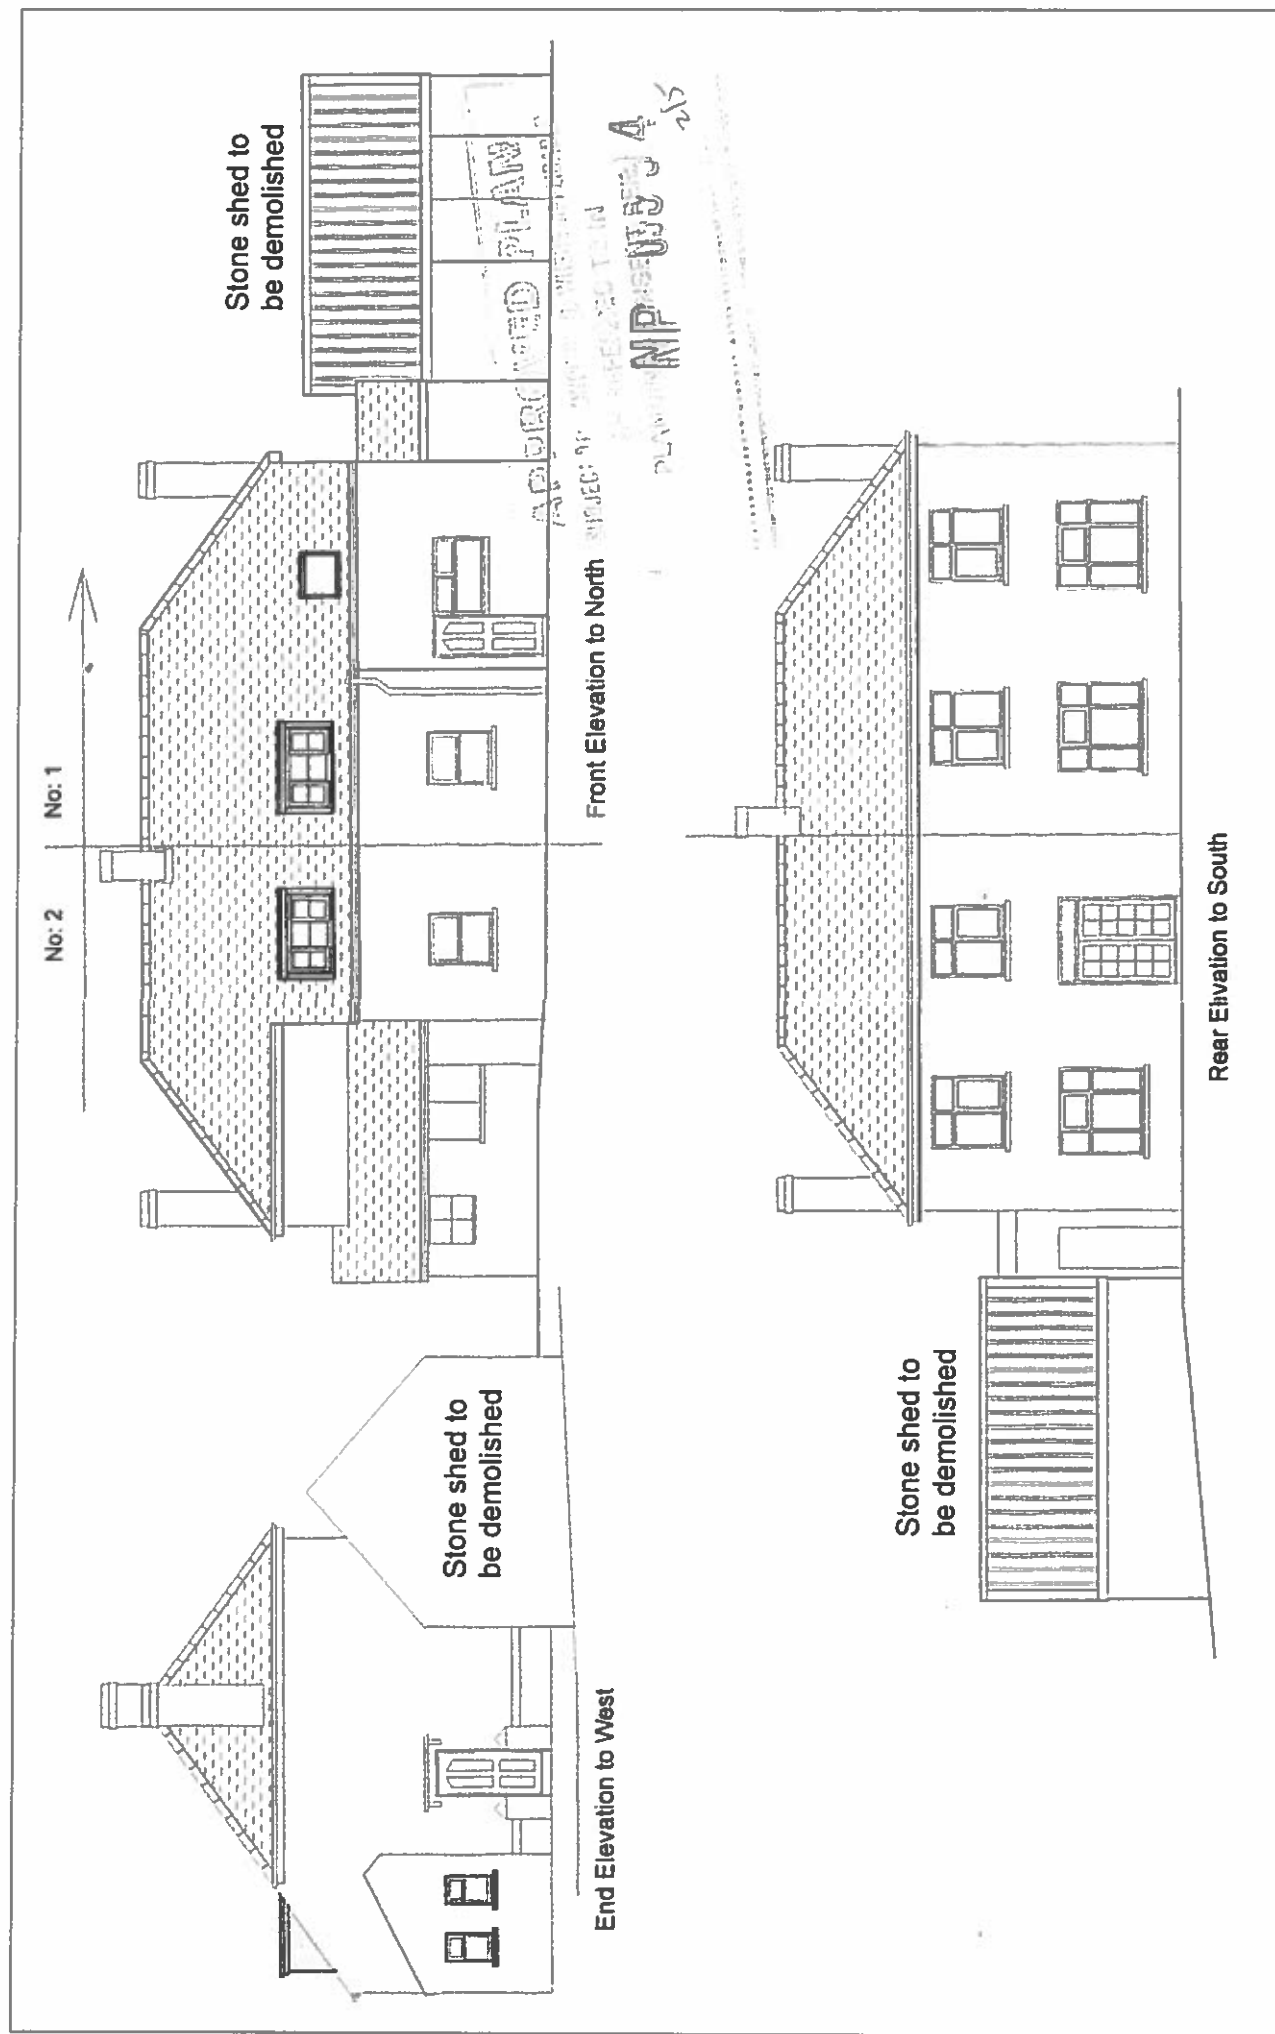
Figure 4. Existing elevations of No 1 Robeston Hall, Robeston West, Milford Haven.

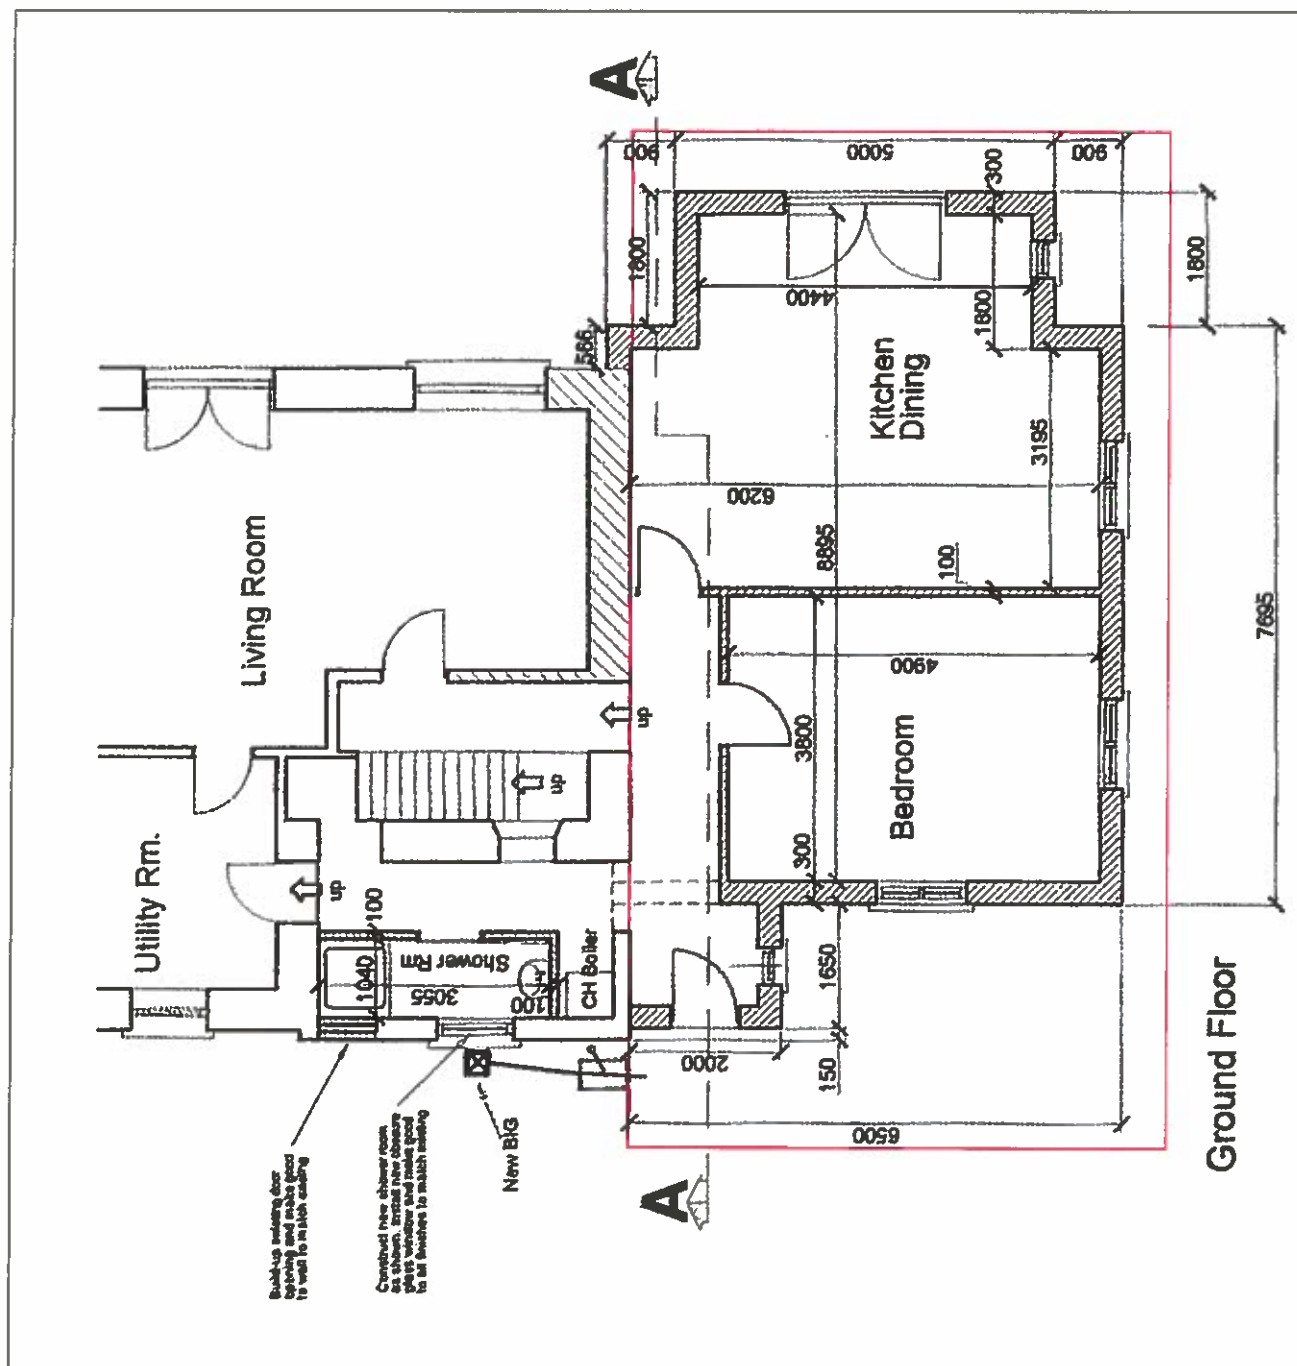
Figure 5. Proposed extension ground plan (area outlined in red).

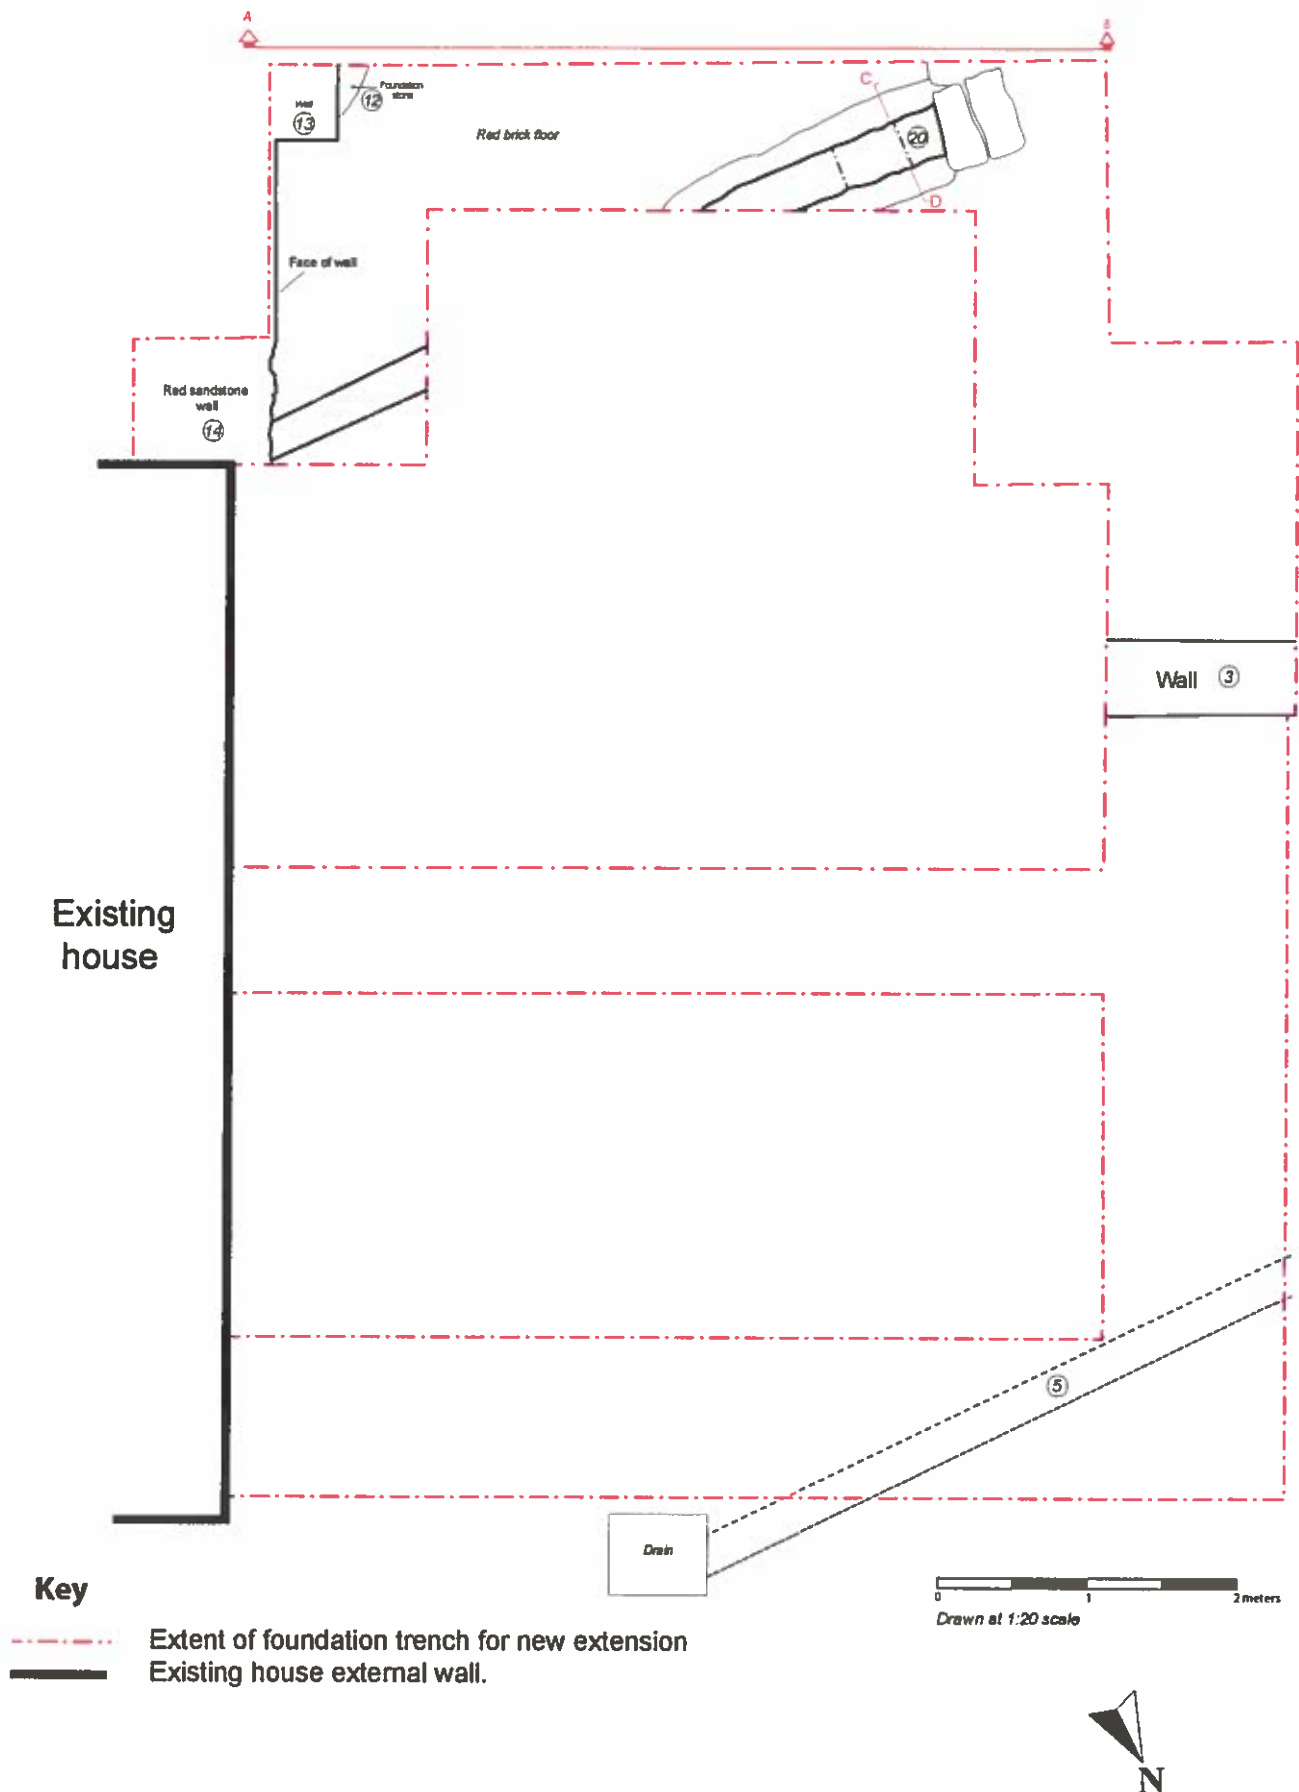
- 4.2 After demolition of the existing stone shed at the far southern end, the uppermost deposit that covered the entire site, both modern concrete (2) and tarmac(1) to a depth of approx. 12cm was removed., thereby exposing the surface below. Directly below these upper deposits was a gravel and rubble core (3). Directly below this was a demolition rubble deposit (3), which consisted of stone-work, plaster and general debris from former demolition and landscape work. This demolition deposit is likely the remains of the former mansion, demolished following the fire in 1921. Initially the plan had been to cut through this rubble deposit in the agreed foundation trench positions, however after careful inspection below this deposit, it was noted that there was both an earlier floor level within the demolished building that consisted of a red brick floor (7) and an extensive cobbled surface outside of the building within the courtyard area (6).

- 4.4 Clearance of the rubble deposit across the entire area exposed the foundation walls of the demolished building (9) which enclosed a rectangular room that had been divided by a red brick partition wall (8). The remnant of an iron peg was found at the front end of this wall, indicative of a former door hinge/peg (11). Abutting this partition wall to the west was a large red sandstone slab at floor level. At the far south west corner was found the remains of a small fireplace/hearth (15) delineated by a series of slate stone slabs. A further square stone slab (22) had also been inserted in the main part of the red brick floor. To the west of this stone was an area of concrete that had been laid out in an 'L' formation along the west and north wall (10). This area likely delineated a working area that may have held a table or tables at some time. Further removal of the demolition rubble exposed the fact that the demolished building had been much larger at some time or other. Whereas the demolished building had been almost square in form, the exposed floor surface indicated a rectangular building some 2 meters longer in length E-W. The entrance to the building had been from the courtyard area at the northern end across a stone threshold (21). Unfortunately the full width of this entrance could not be ascertained due to overburden covering.

**Figure 8.** Ground Plan of foundation trench outlined in red. Undertaken following recording of early floor surface.

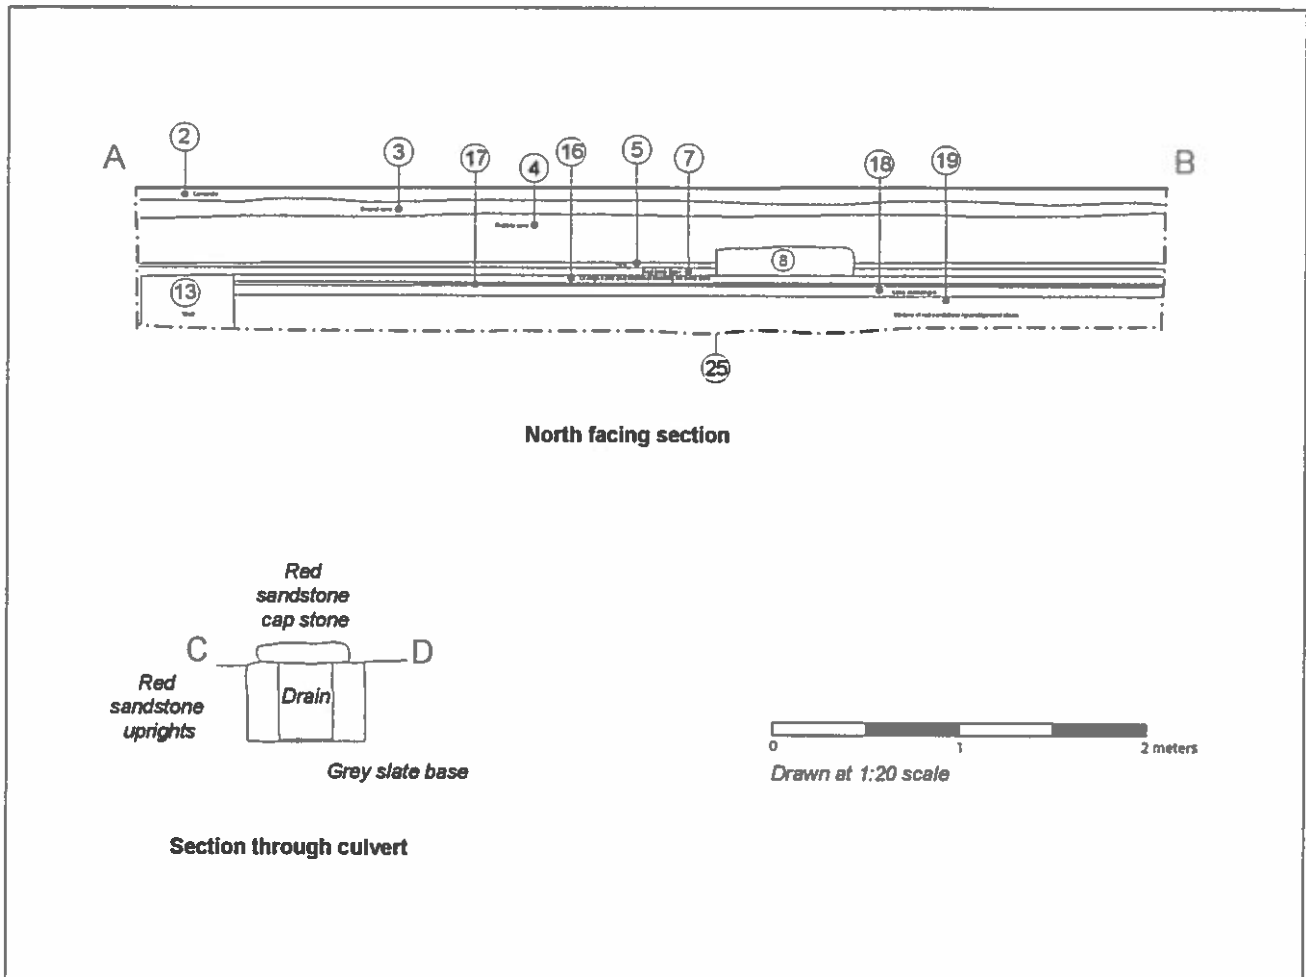
- 4.6 Following the recording of these floor surfaces the foundation trenches were dug, cutting through the exposed floor surfaces, the red brick floor and the cobbles. At the far southern corner of this building, cutting for the trench exposed what appeared to be a buttress or corner of an earlier wall incorporated into the building (13). This was located directly below the red brick floor surface. At the base of this corner/wall is what appeared to be an even earlier floor surface still (12). This was implied by the remains of a stone slab tucked up into the corner, possibly indicating that the floor surface at this time was flagged.

- 4.8 Another significant feature exposed during the cutting of the foundation trenches was the remains of an old culvert (20), which lay below the partition wall of the demolished building (8). The culvert consisted of a series of red sandstone capping stones, which covered a series of red sandstone uprights. Unfortunately, from the section of the culvert exposed, only two of the cap stones remained, the others having been removed or destroyed at an earlier date. This said however, the inside of the drain still had the contents of a 'sealed' deposit. For investigative reasons, so as to ascertain some dating material for the drain, a large section of the drain silt in-fill was removed. Within the silt was found predominantly 18<sup>th</sup> century material, consisting mostly of pottery fragments. These fragments included the remains of half an 18<sup>th</sup> century tea cup which had a hand painted decoration of flowers on its face. Also discovered was the remains of a 'souvenir' type plate from Malta, again likely 18<sup>th</sup> century in origin. Other fragments included sherds of plates, dishes, glasses etc, all 18<sup>th</sup> century in date.

**Figure 10.** North facing section of foundation trench at southern end and section through stone culvert.

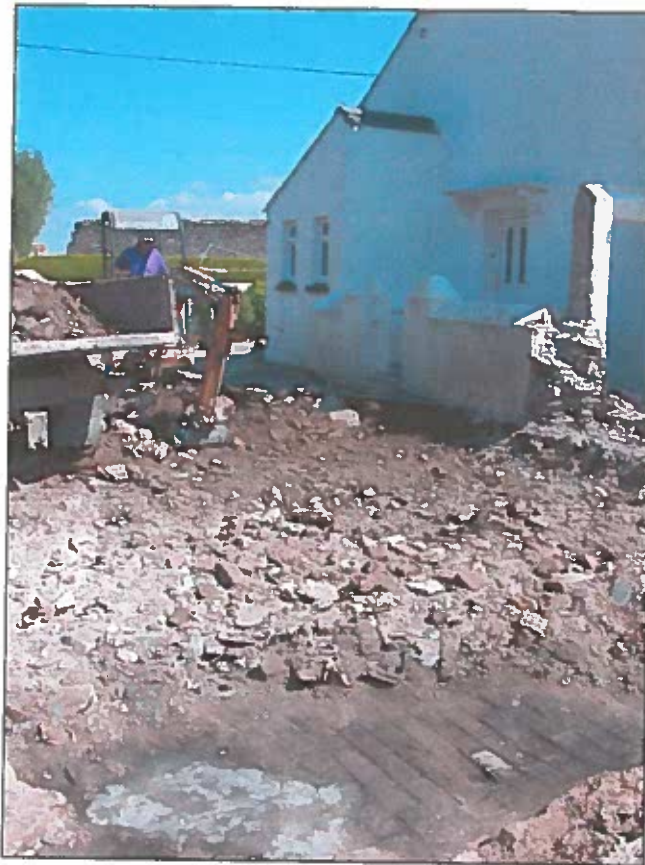
**Plate 3.** Early floor level exposed (foreground) following demolition of stone shed and concrete floor. Looking northward.

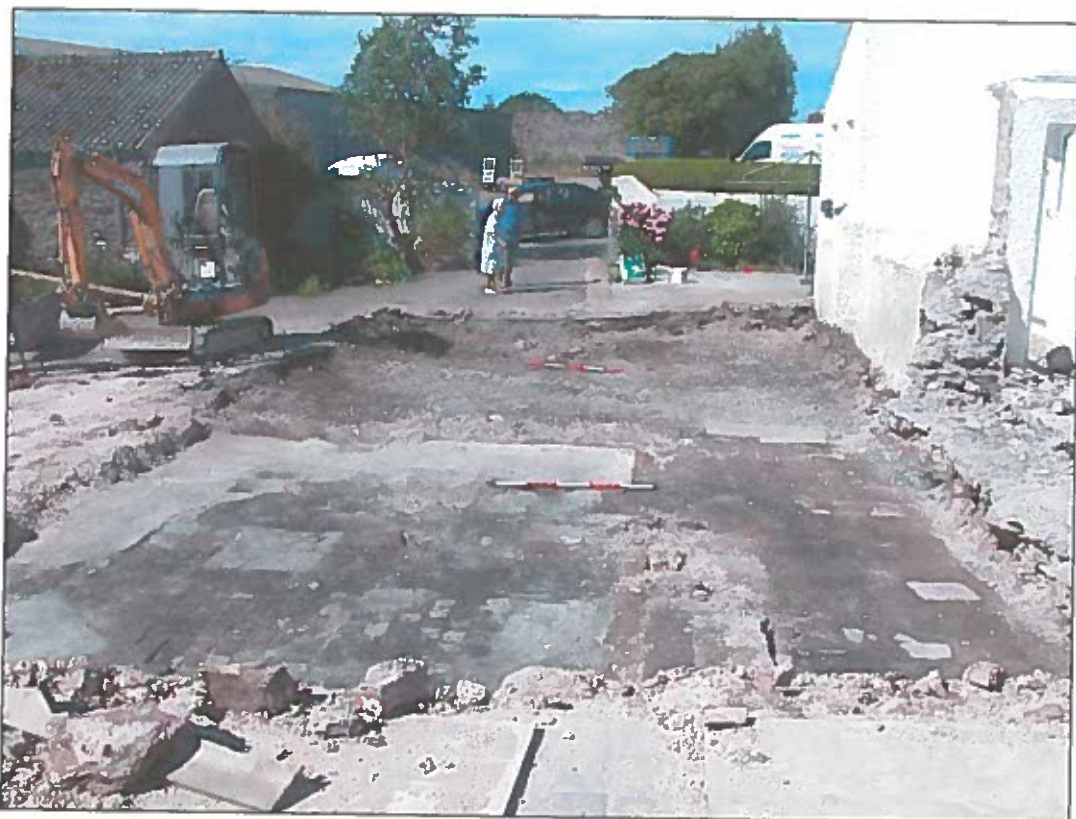
- 4.3 Because of the nature of these floor levels, in that they were very likely 18<sup>th</sup> century in origin, the decision was made to completely clear the entire development area of the rubble deposit (3), thereby exposing both the red brick floor (7) and the cobbled floor surface (6), so that it could be recorded and

**Plate 4.** 19th / 18th century floor level cleared and exposed as well as cobbled courtyard. Looking north.

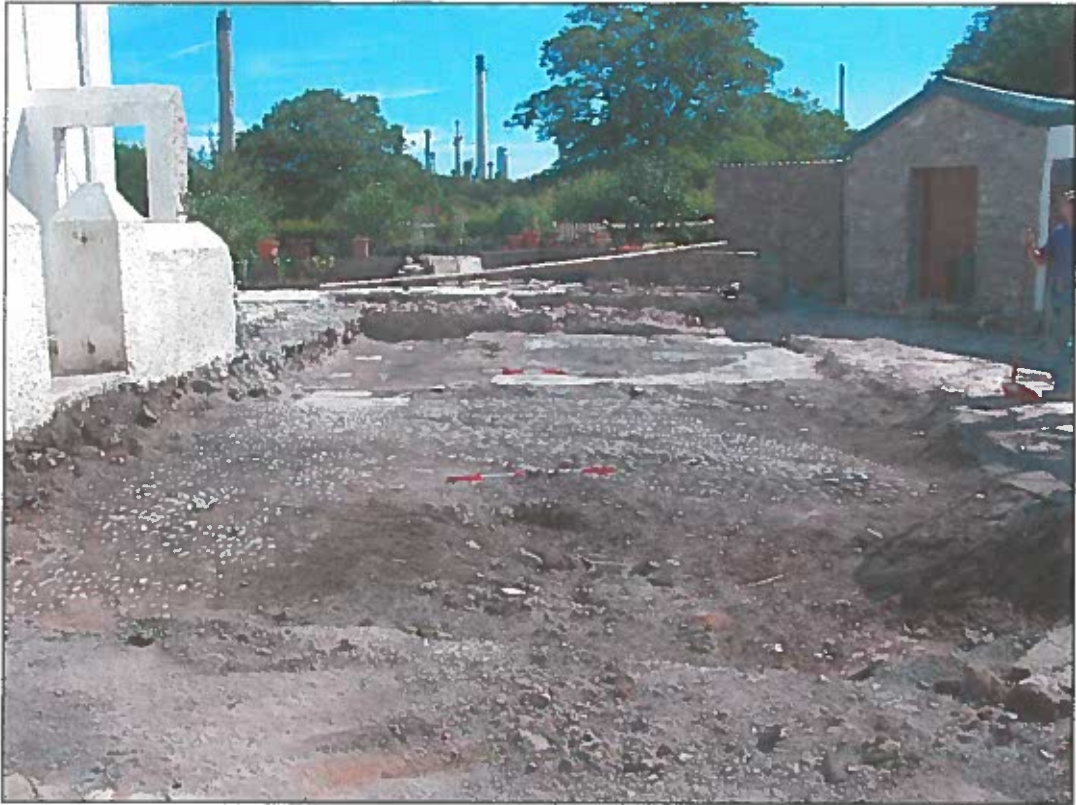
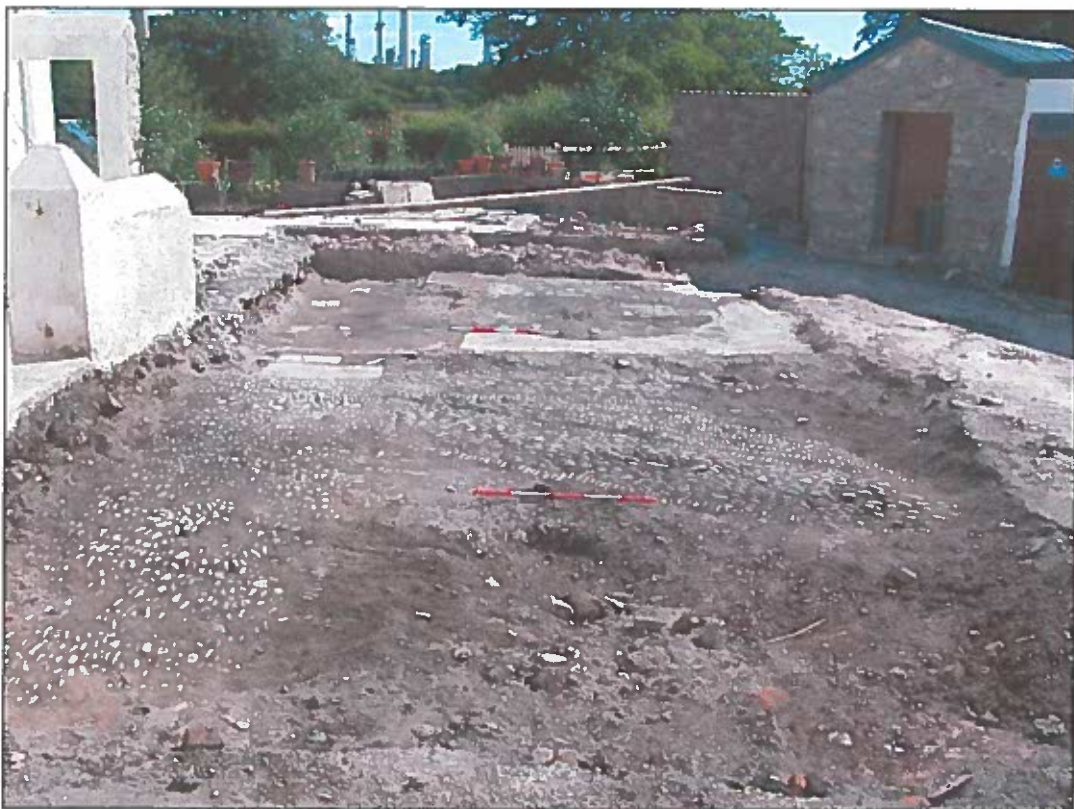
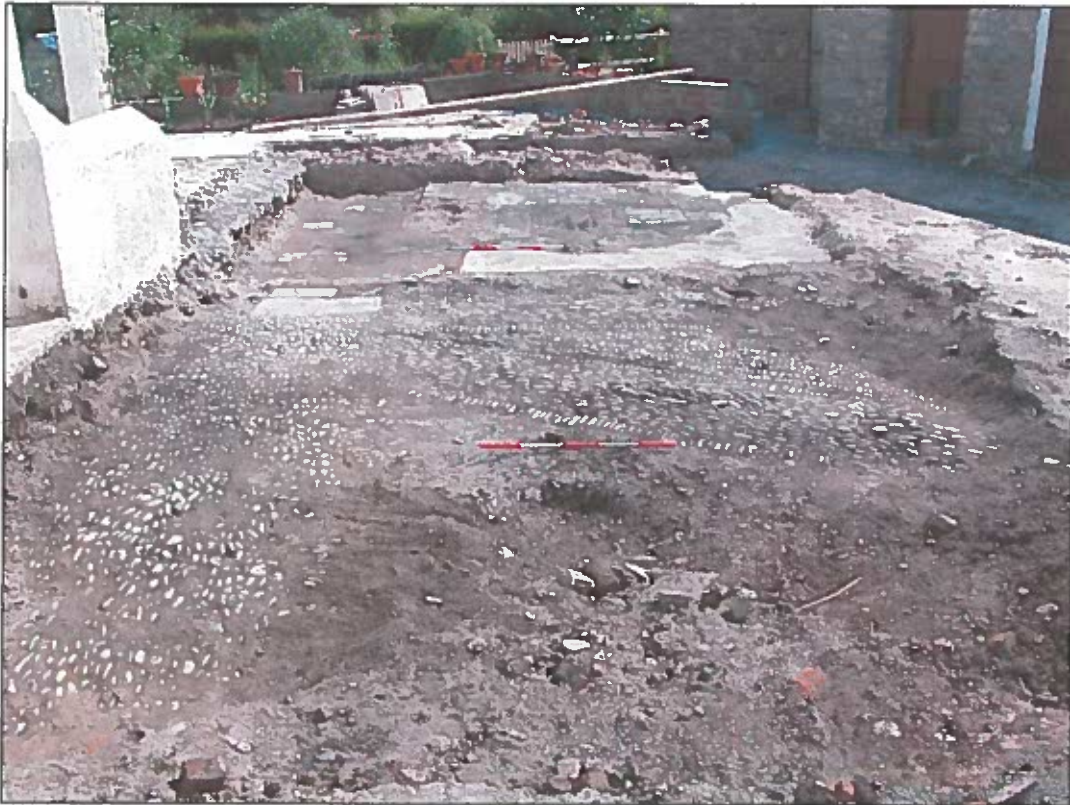
*Plate 5. 19th / 18th century cobbled courtyard exposed in area of development. Looking south.*

*Plate 6. 19th / 18th century cobbled courtyard exposed in area of development. Looking south.*

*Plate 7.* 19th / 18th century cobbled courtyard exposed in area of development. Looking south.

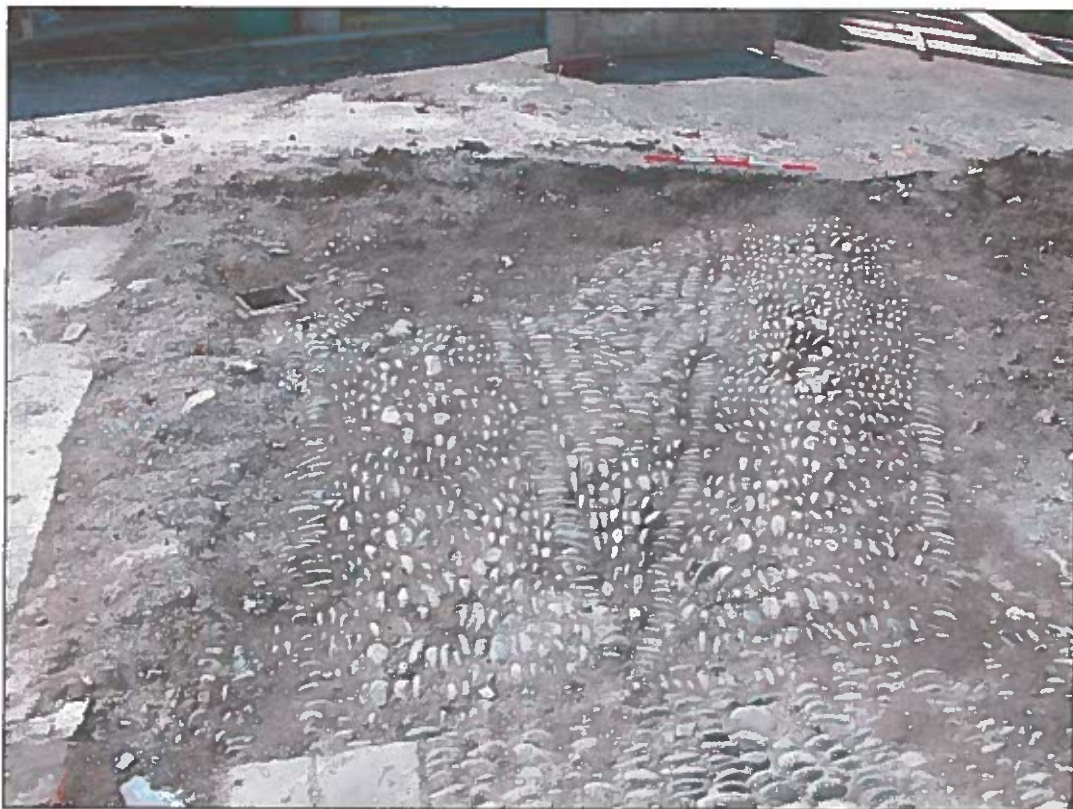
- 4.5 Outside of the building, the clearance had exposed a cobbled surface (6) in the courtyard area. Investigation of this area showed that the cobbles had been deliberately laid in alternating directions, a line of verticals followed by an in-fill of hap-hazard horizontals. Unfortunately much of the floor surface to the west and the north had been destroyed by earlier service trenches (23 + 24)

*Plate 8.* 19th / 18th century cobbled courtyard exposed in area of development. Detail of cobbling looking westward.

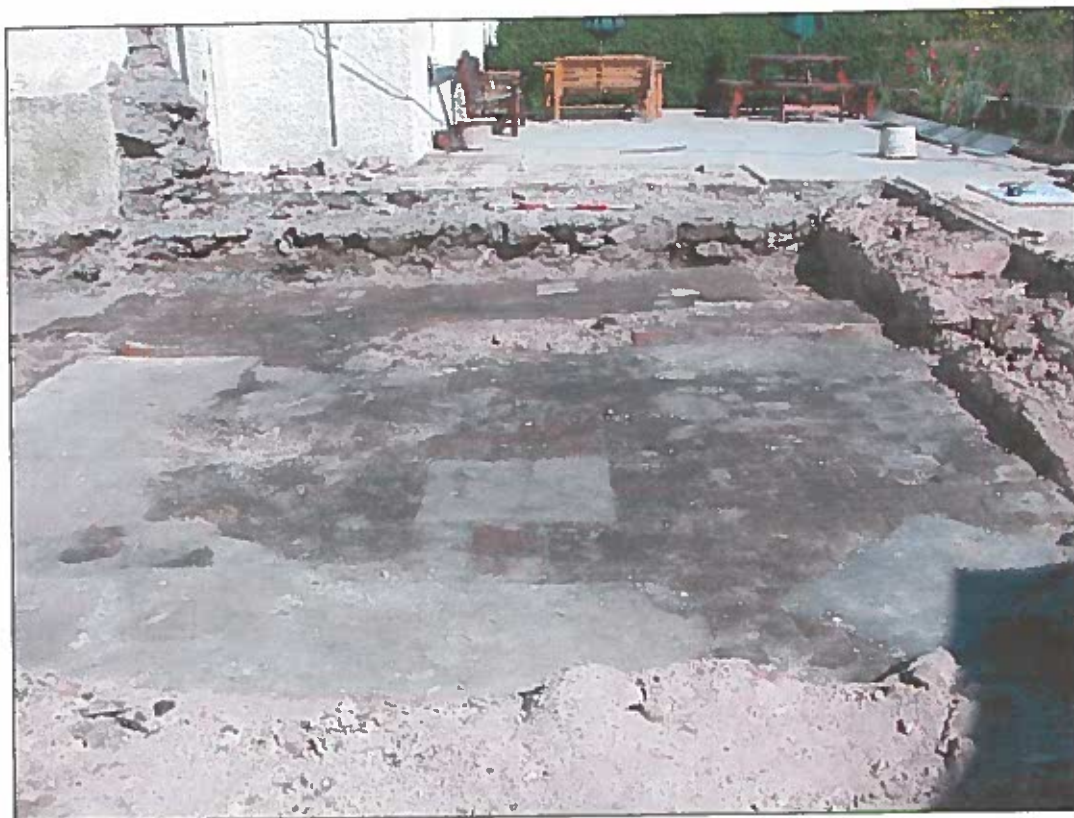
*Plate 9. Interior floor level of 19th / 18th century demolished stone shed structure. Looking east.*

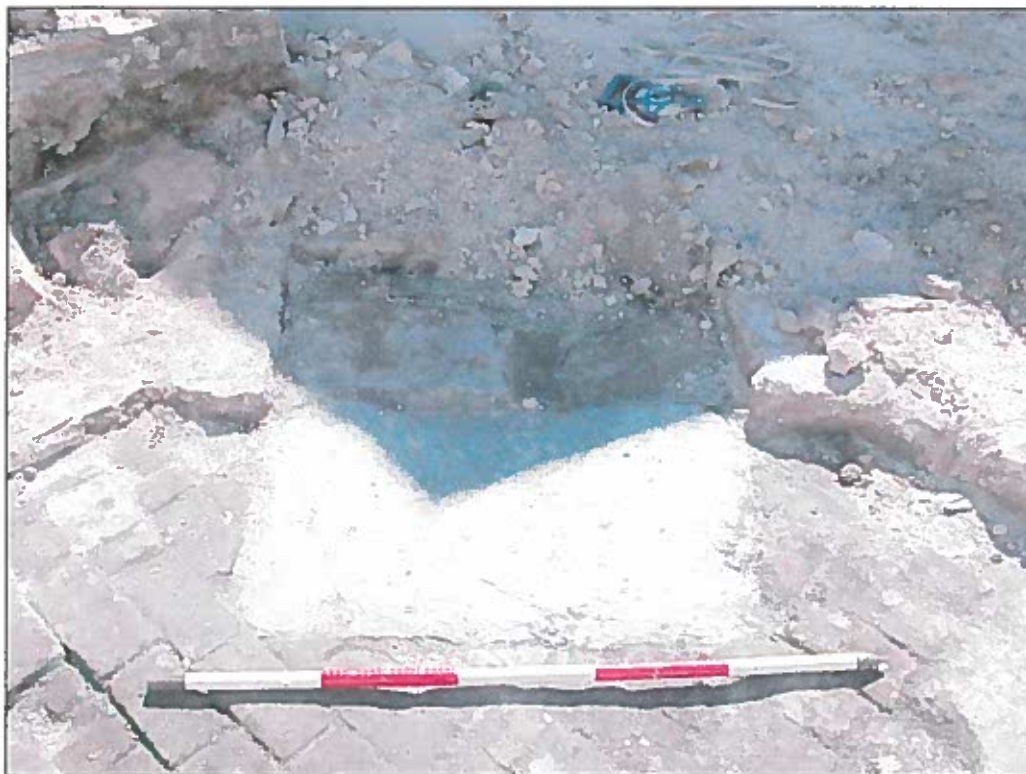
*Plate 12. Detail of hearth/fireplace in demolished stone structure. Looking south-west.*

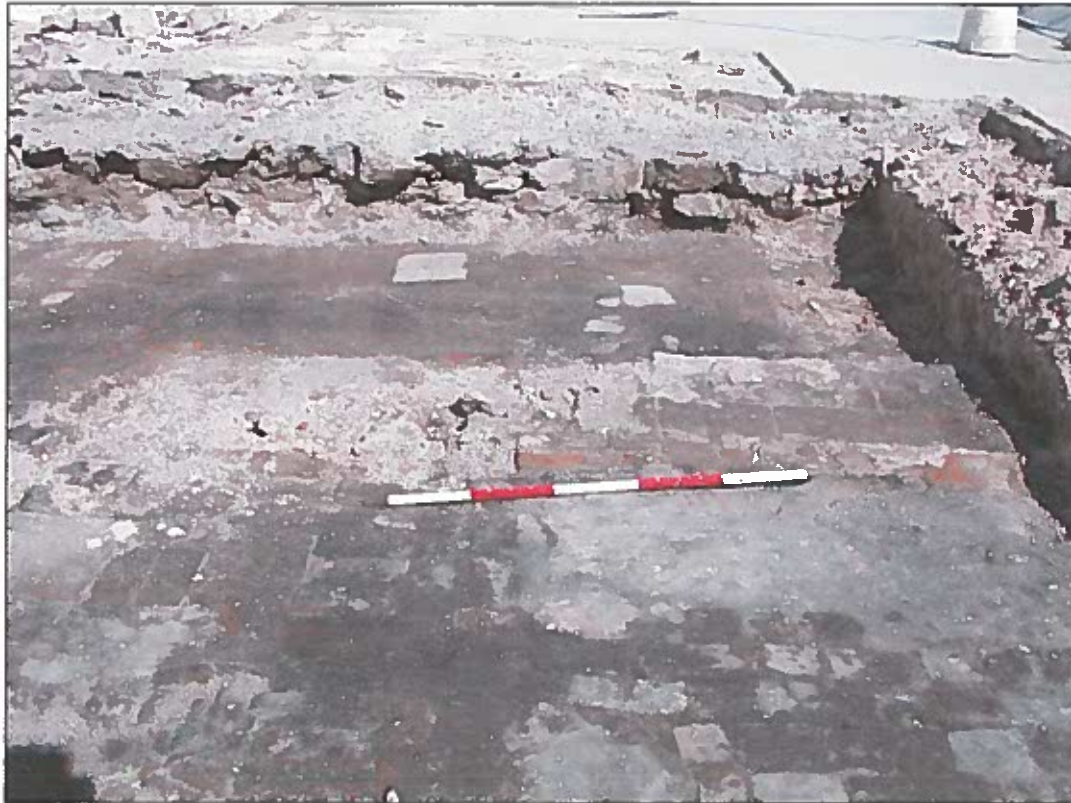
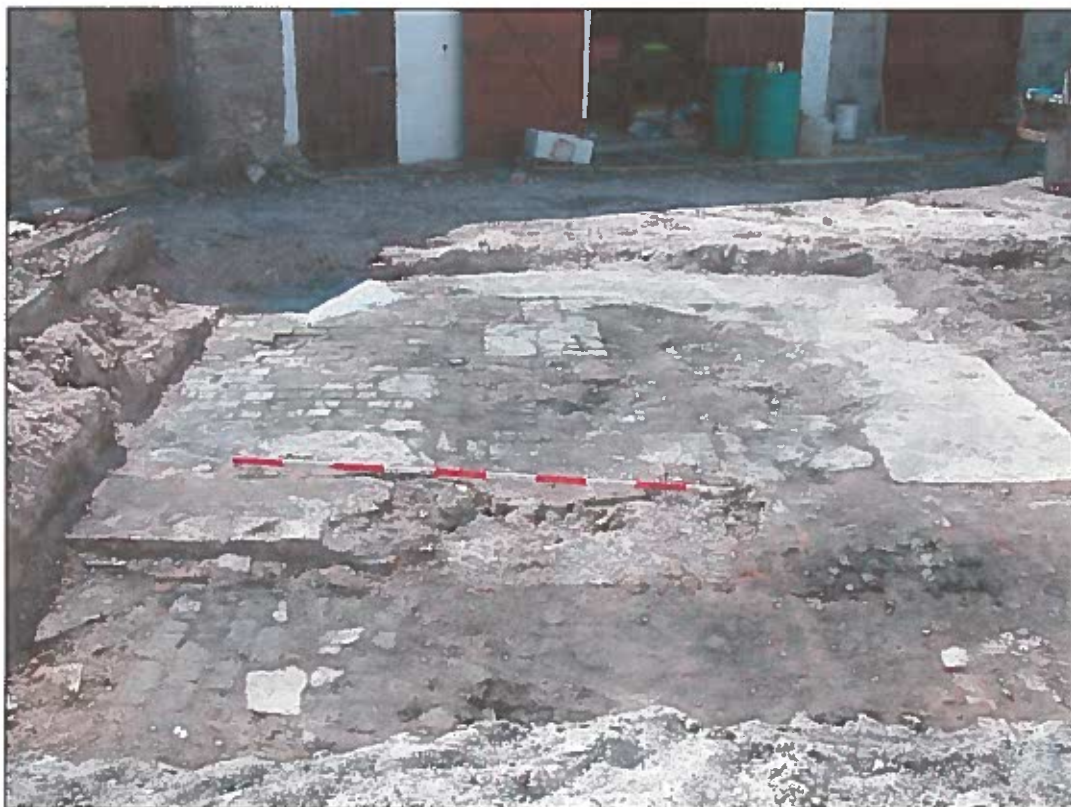
*Plate 12.* Red brick built partition wall within demolished building. Looking eastwards.

*Plate 13.* Red brick built partition wall within demolished building. Looking eastwards.

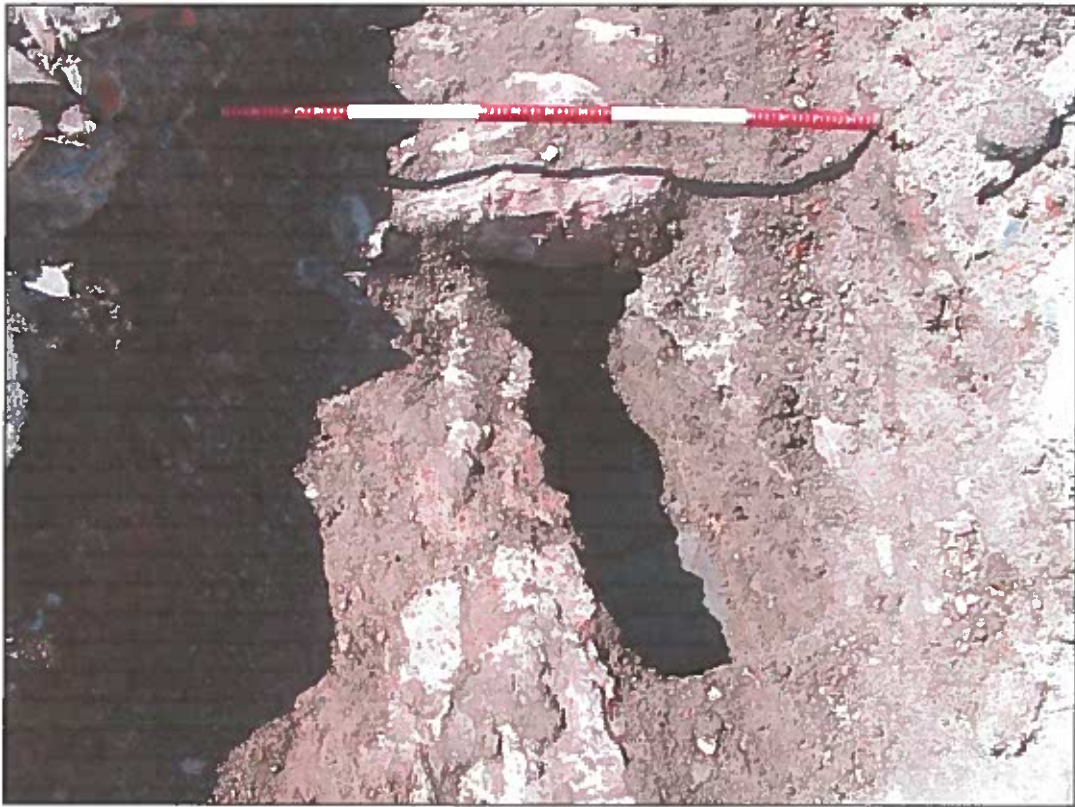
*Plate 15. New foundation trench, with exposed 18th century culvert remains at far west end of trench.*

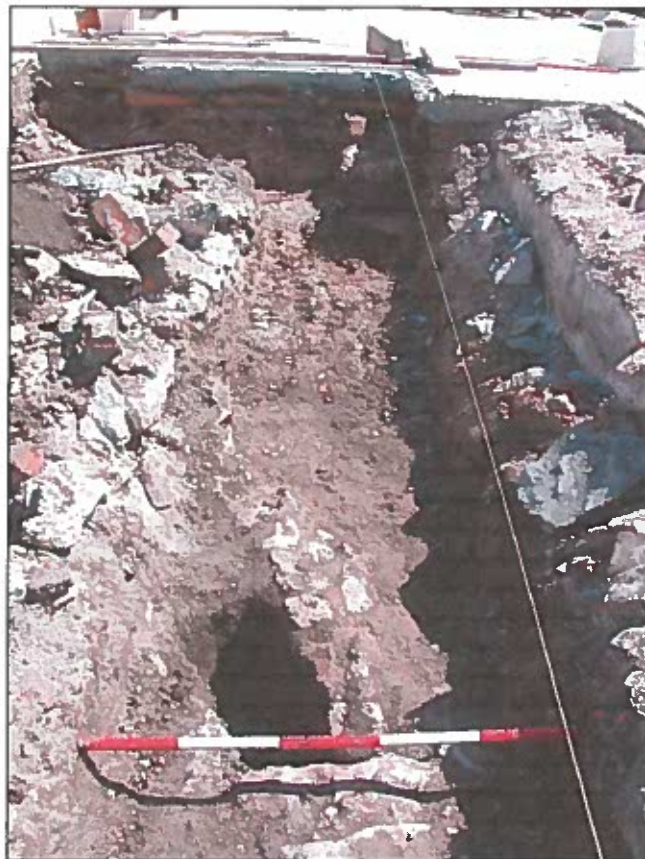
*Plate 16. Exposed 18th century culvert. Looking east.*
