Manor Farm, Llanllwch Carmarthenshire.

Archaeological Field Evaluation

HRSWales Report No: 108

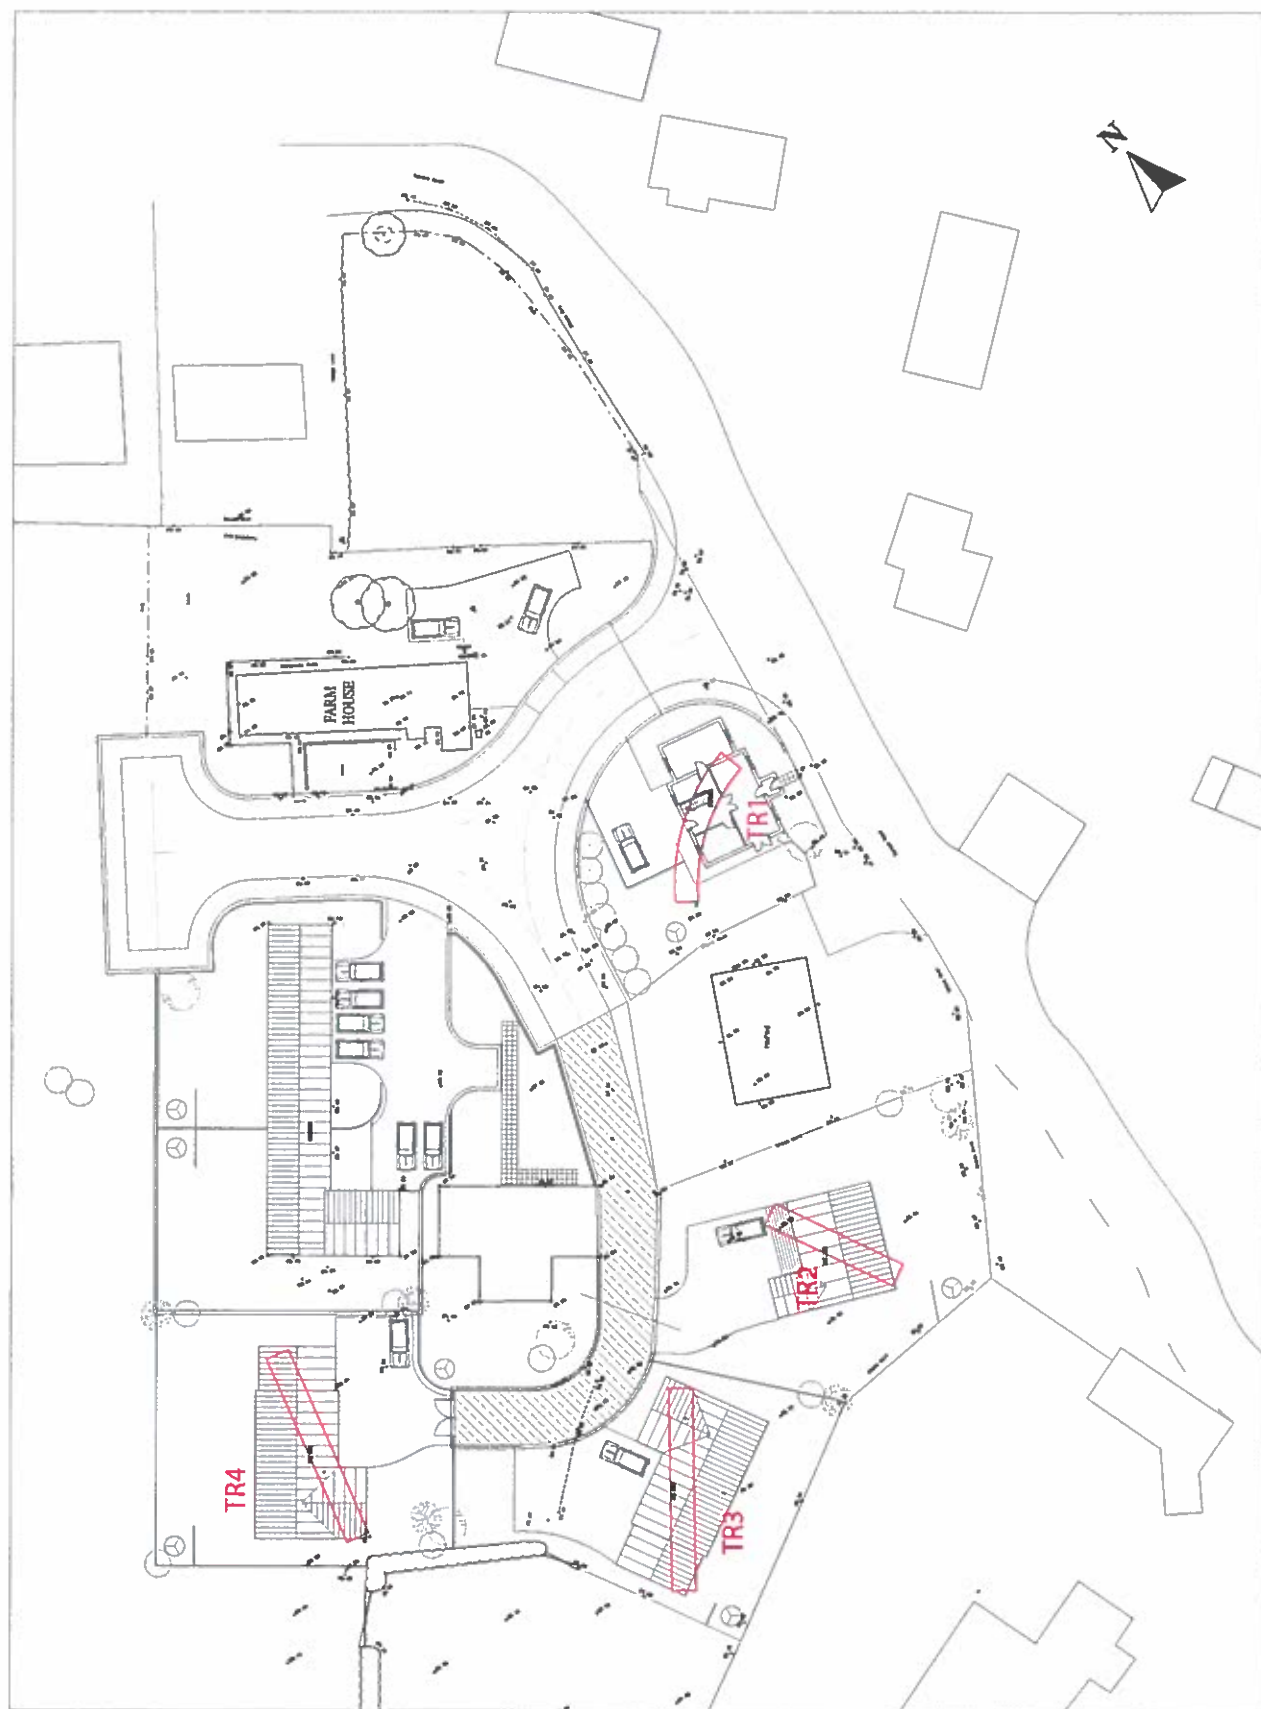
Figure 4. Proposed development with evaluation trenches high-lighted in red.

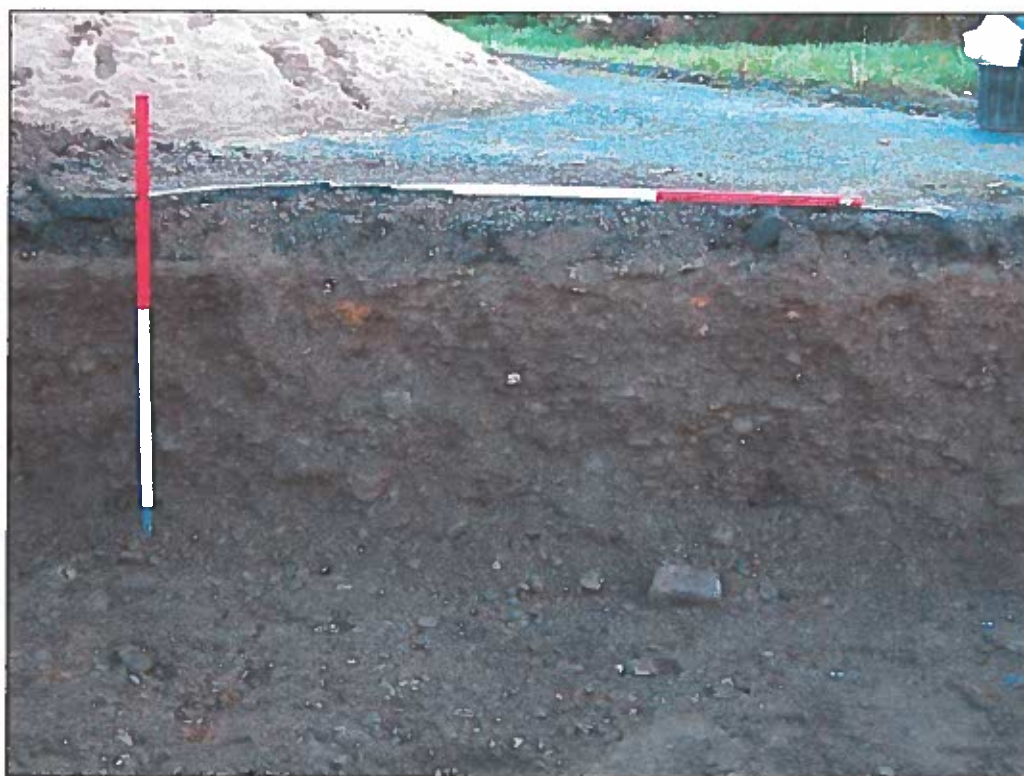
Plate 3. Trench 1. Typical section of trench 1. South facing.

- 4.2 Trench 1 was repositioned from its former position due to existing services. It measured approx. 11 meters long x 2 meters wide. The average depth of this trench was approx. 1m. The upper most deposit was tarmac (100). This was removed across the entire length of the trench to a depth of approx. 0.10m. Directly below this was a mid-brown silty sand and gravel deposit (101). This averaged a depth of approx. 0.60m. Below this was a natural mid/light brown sand, of which only 0.30m was exposed (103). No archaeological features nor any dateable material was recovered from this trench.

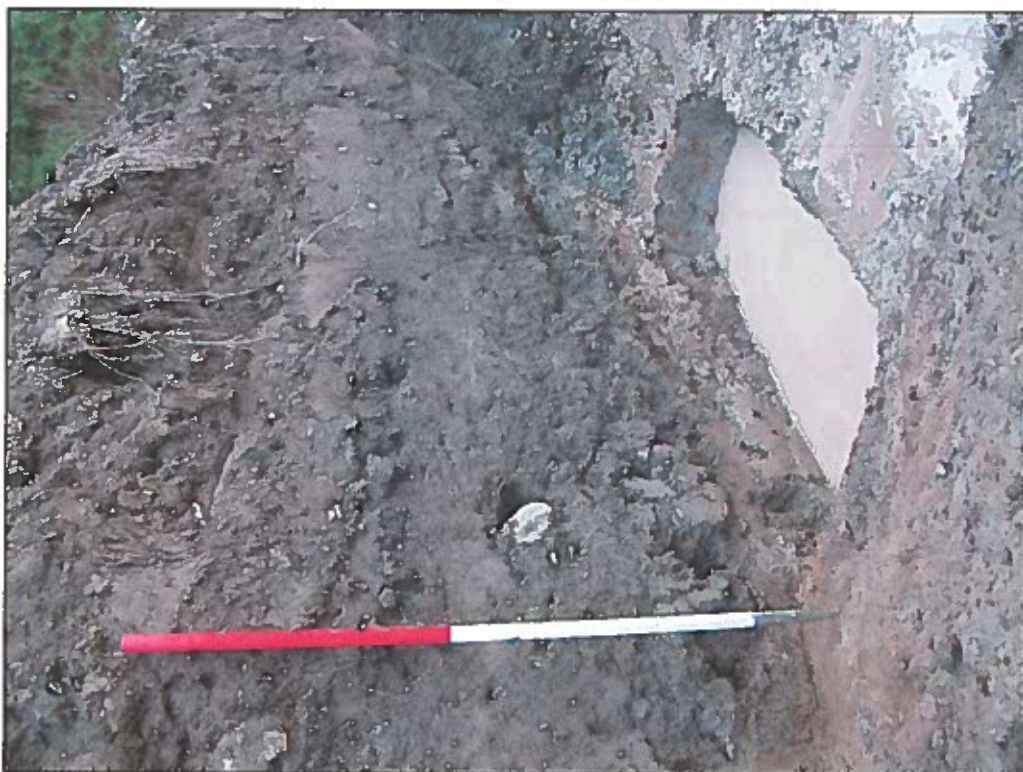
Plate 6. Trench 2. Detail showing remains of drainage ditch at base of trench. Looking southwards

- 4.4 On removal of this deposit excavation exposed the remains of a former cut feature (203) cutting into a natural grey clay deposit (205), which appeared to be an early drainage ditch or else the remains of an early mill leat. The feature ran diagonally across the trench orientated E-W. It was approx. 1.30m wide. It was filled by the overlying grey silty clay deposit (202) and its edges were defined by a thin dark orange band of leached iron/calcite deposit. A slot was put through this feature at its east end so as to ascertain the features depth so as to get a clearer understanding of its character and form as well as in the hope of recovering any dateable material. The base of the feature was reached at a depth of only 0.30m. The same hardened iron stained leached deposit was also found at the base of the feature. This deposit appeared to have been formed by iron deposits having percolated through the soil and settled onto the clay cut ditch or leat. The base of the ditch appeared to be fairly flat in character and the sides fairly steep in character. No small finds or any dateable material was recovered from the removed fill. Unfortunately it was not possible to fully remove the fill of the cut as rainwater from the heavy storm the night before was flooding through the soils into the trench and filling the leat at a rate quicker than it could be removed making excavation and interpretation impossible. However, these conditions did help with the interpretation of the feature nevertheless.

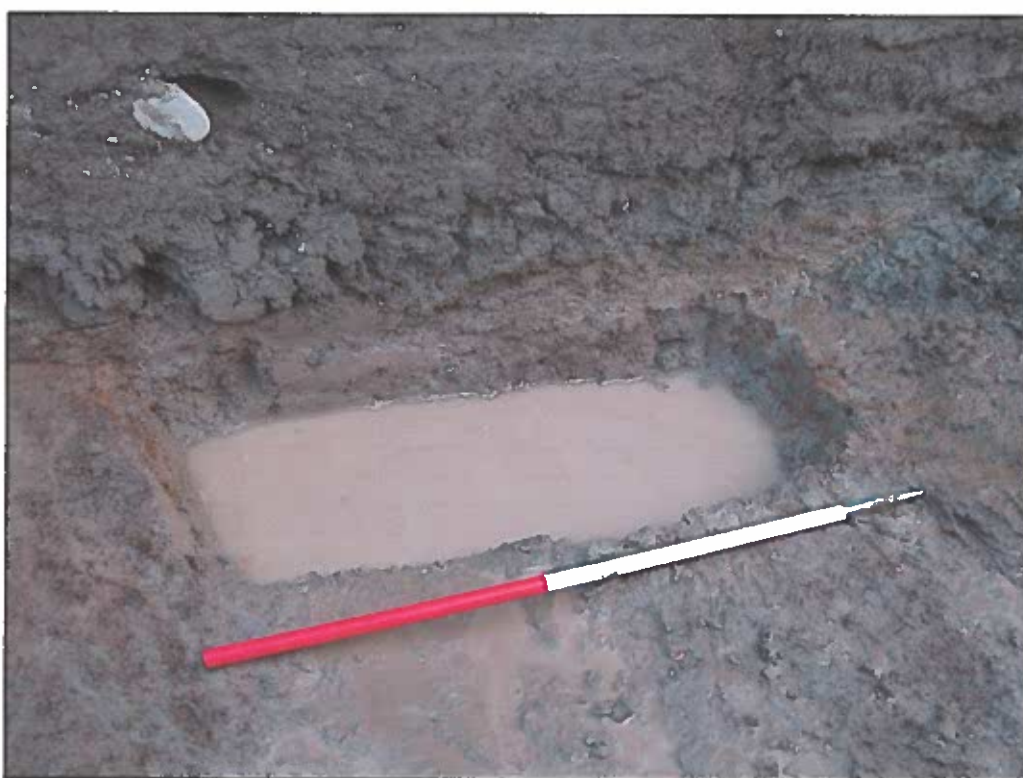
Plate 7. Trench 2. Detail showing remains of drainage ditch at base of trench. Looking eastwards.

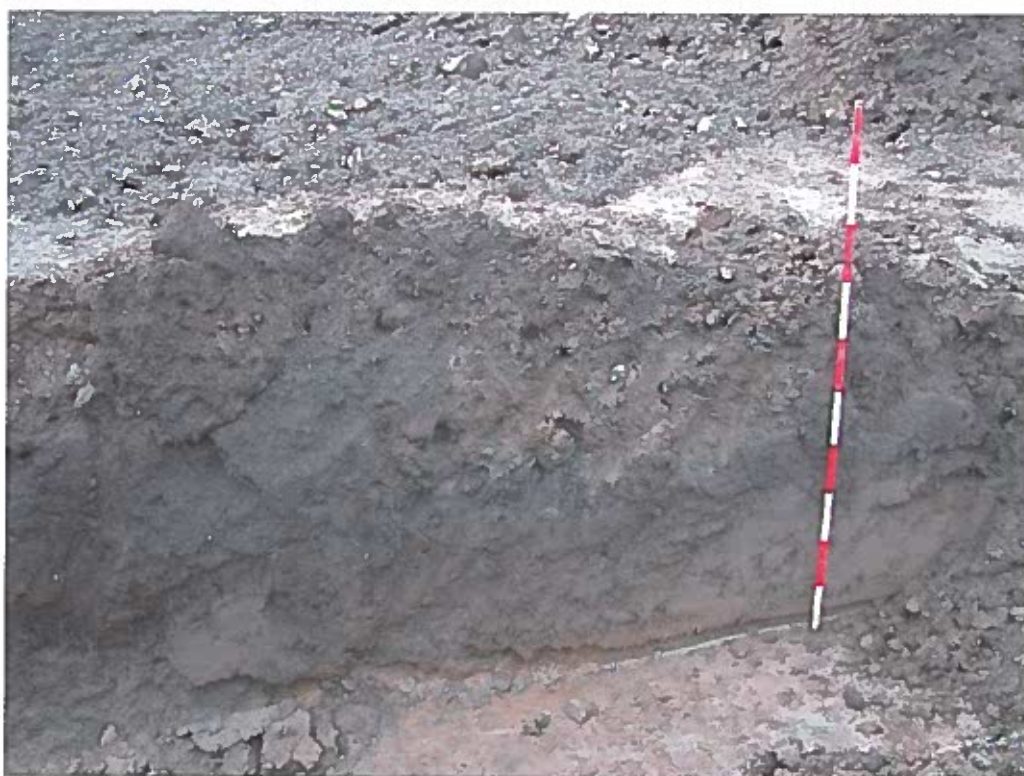
Plate 8. Trench 2. Typical section through trench 2. Looking westward.

- 4.3 Trench 2 measured approx. 10m long x 2m wide. It was orientated N-S within the area of the footprint of the proposed new dwelling. This trench averaged depths of 2m at the southern end and approx. 1m at the northern end. The position of this trench was sunk in the footprint of the proposed new dwelling. Much of the northern consisted of made up ground. Initially the overlying deposit was removed (200). This consisted of a mid-brown soil with small amounts of building stone, which appeared to have been imported from earlier construction work to build up the ground in this area. Directly below this was a mid-brown loam type soil with stone fragments, turf and roots from an earlier top soil now buried from imported soil (201). This reached an average depth of approx. 0.20-30m. Directly below this deposit was a grey-light brown silty clay (202). This reached a depth of approx. 0.60m. A fragment of North Devon Green Ware was recovered from this deposit.

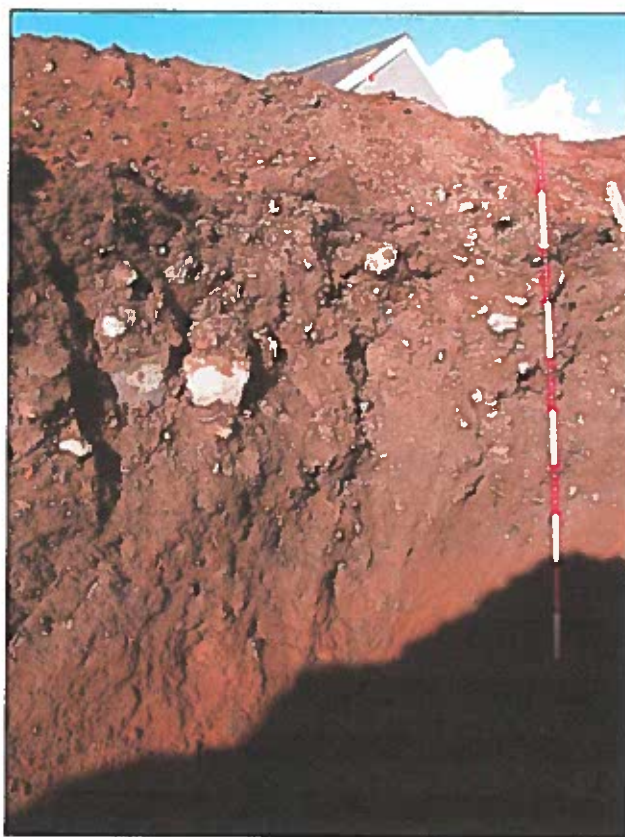
Plate 12. Trench 3. Typical section facing south.

- 4.6 Trench 3 measured approx. 19m long x 2m wide. It was orientated E-W. Its depth varied from 1m at the west end to 2m at the east end. Initially the overburden was removed which consisted of soil containing construction material such as pieces of stone, brick. All of this appeared to have been imported onto the site fairly recently during earlier construction work (300). This deposit reached an average depth of approx. 0.40m. Directly below this was a mid-brown loam type soil with stone inclusions indicative of an agricultural soil. This deposit reached a depth of approx. 0.30m (301). Below this layer was a natural

deposit of orange sandy clay. This was exposed only to a depth of approx. 0.30m at the west end and shallowing off at the east end (302). No archaeological features nor dateable material was recovered from this trench.
