Stag & Pheasant Public House, 34 Spilman Street, Carmarthen.

ARCHAEOLOGICAL WATCHING BRIEF

HRSWales Report No: 110
March 2007

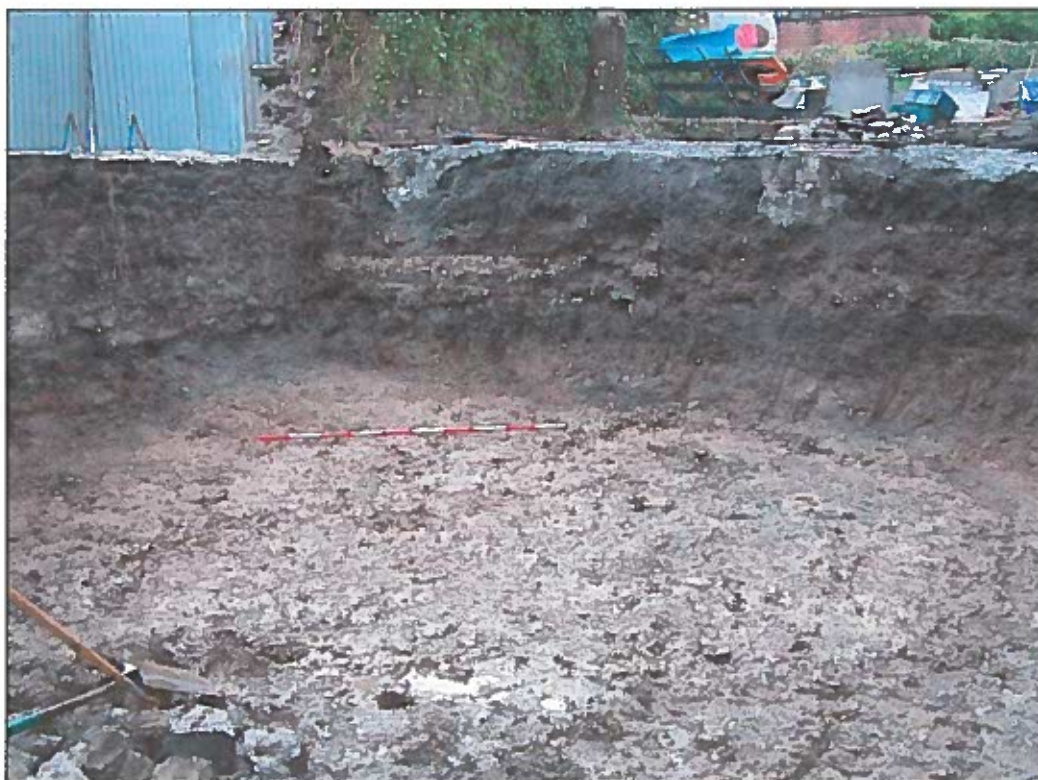
Plate 6. Ground level reduced exposing Roman deposits. Prior to clean-up. Looking north-west.

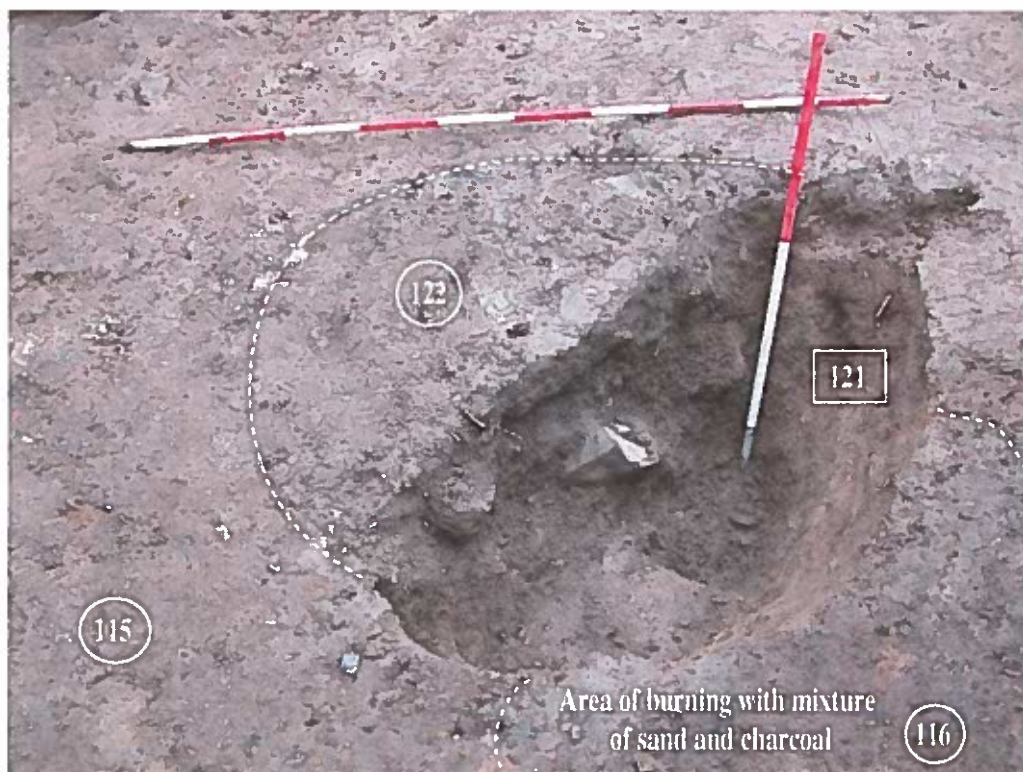
Plate 18. Half-sectioned post-medieval oval rubbish pit (121/122). Looking west.

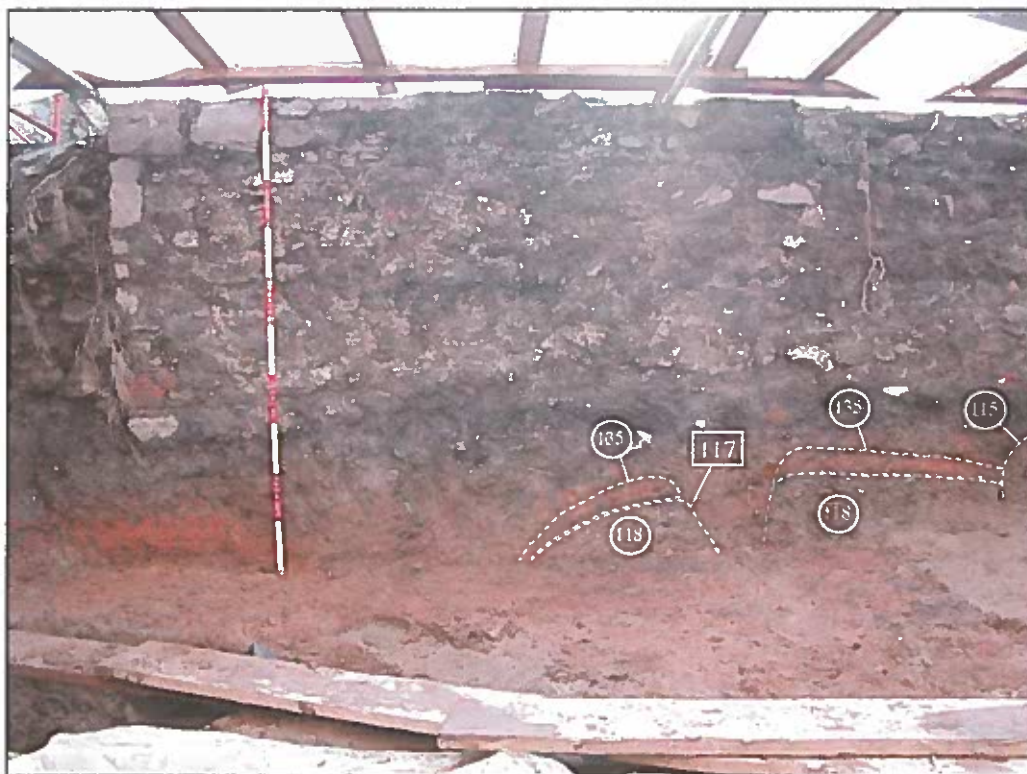
Plate 20. East facing section prior to stone wall removal. Showing gravel track 118, cut 117, compacted heated clay 135 and clay rampart 115. Looking west.

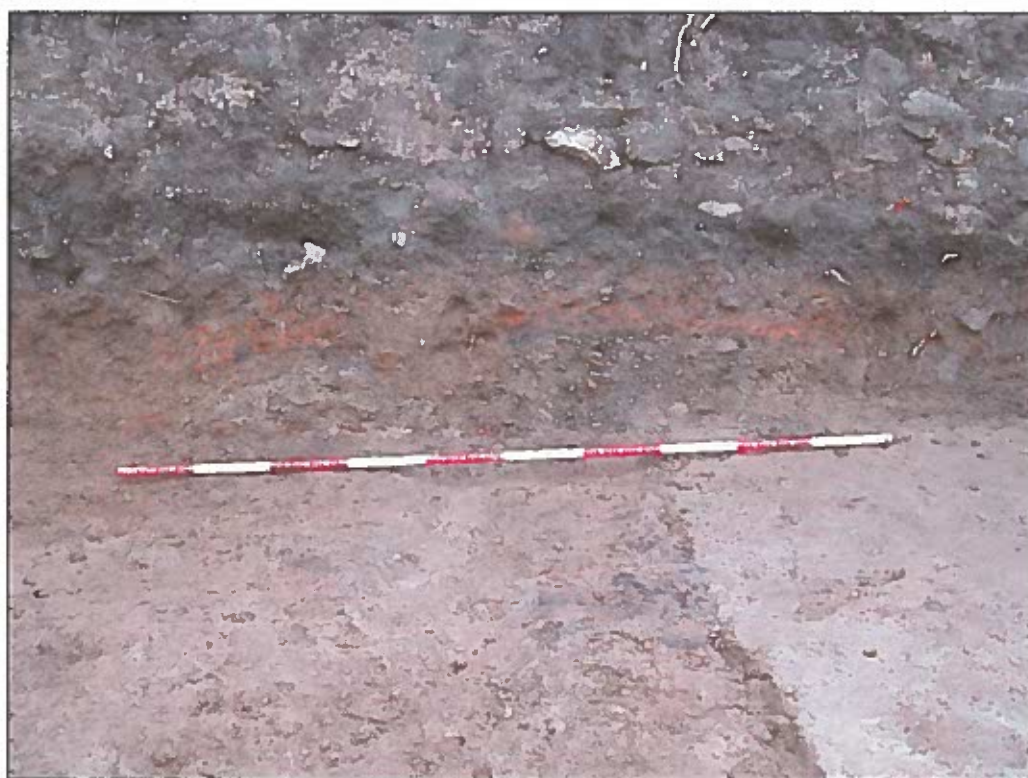
Plate 21. East facing section prior to stone wall removal. Showing gravel track 118, cut 117, compacted heated clay 135 and clay rampart 115.

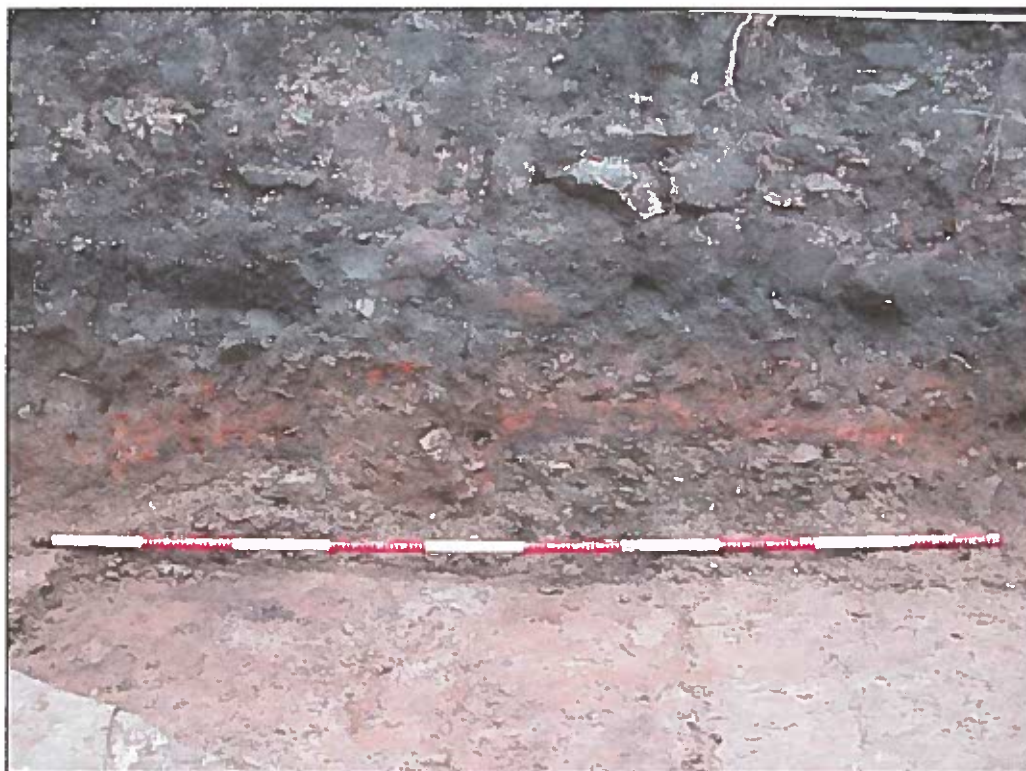
Plate 22. East facing section prior to stone wall removal. Showing gravel track 118, cut 117, charcoal deposit 134 and compacted heated clay 135 overlying. Looking west.

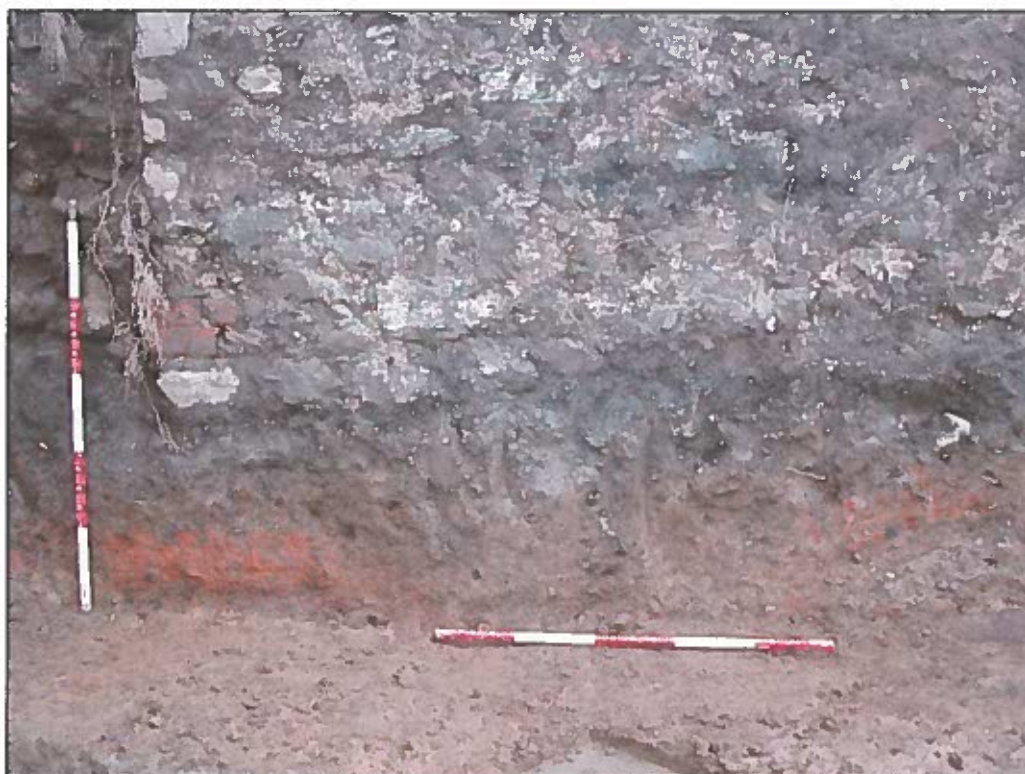
Plate 23. East facing section prior to stone wall removal. Southern end of section showing cut or channel 138 through compacted clay 135.

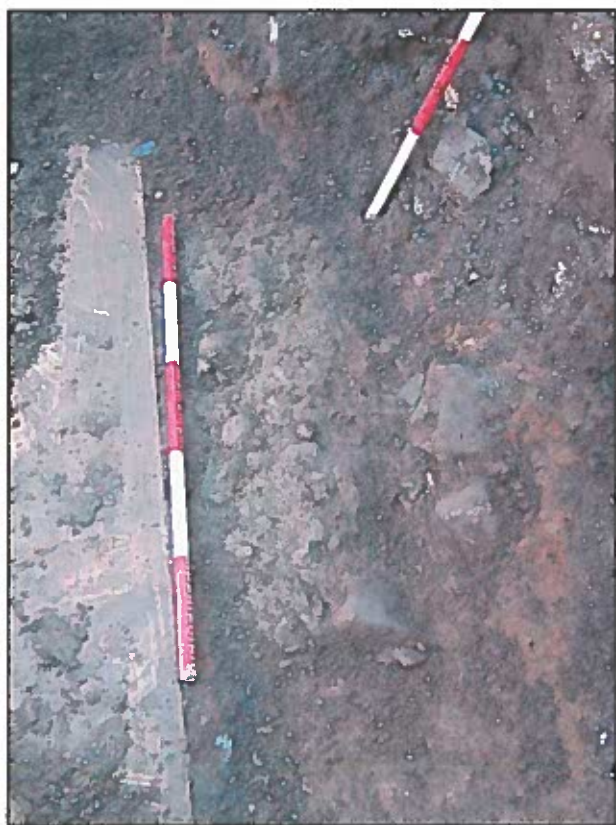
Plate 28. Top of gravel track (118) (intervallum) exposed once wall removed.

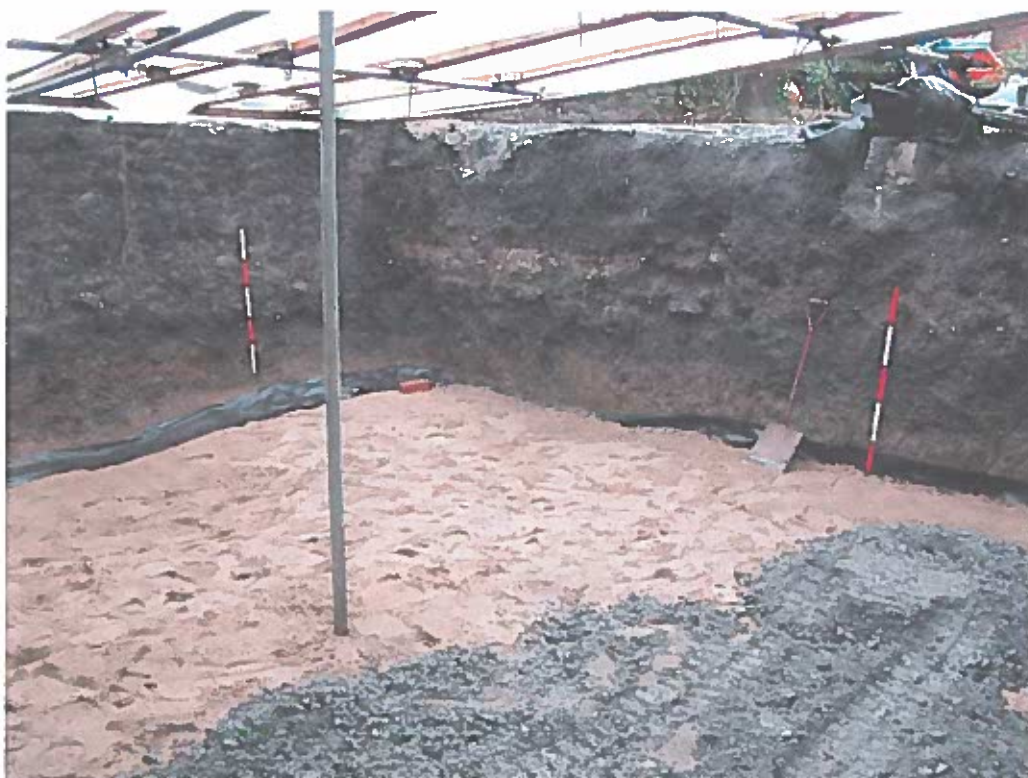
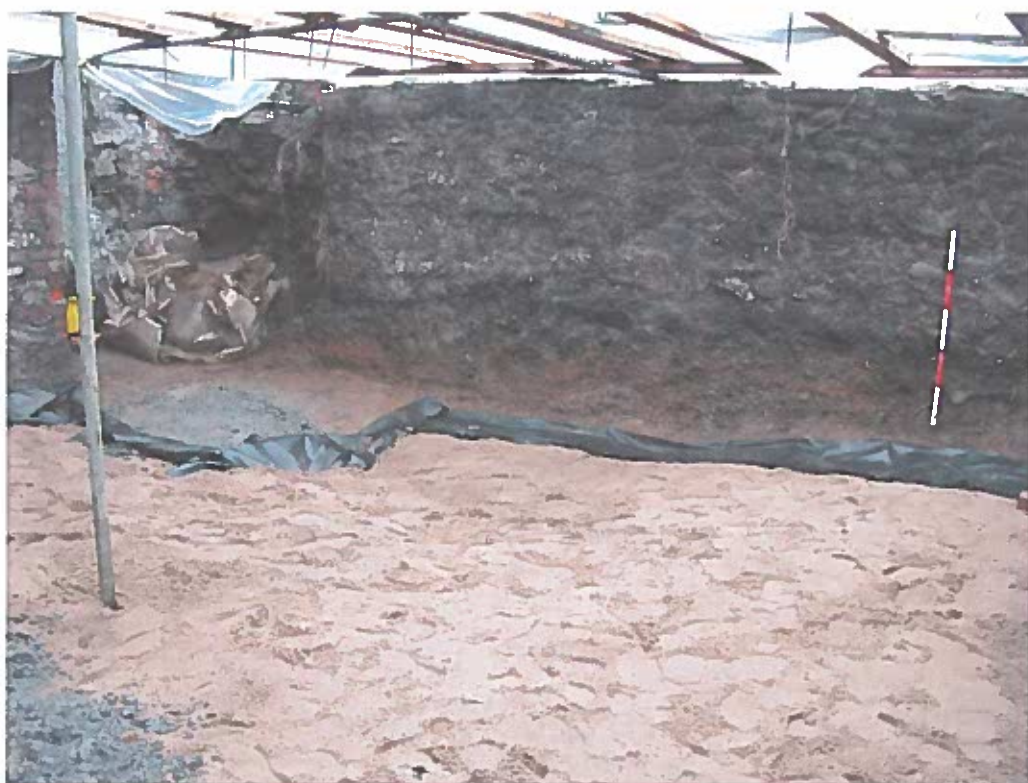
Plate 30. Area preserved in situ with protective terram sheeting and layer of sand. Looking north-west.

Plate 31. Area preserved in situ with protective terram sheeting and layer of sand. Looking south-west.

- 4.15 Due to the exposed Roman deposits, the initial development design of the proposed extension cooler room had to be redesigned, making sure that the exposed remains were *preserved in situ*. In order to do this it was decided that a floating concrete platform had to be constructed approx. 8 inches in depth, thereby creating a step up from the present ground level at street level. This new design also meant that the far west stone garden wall (128) also had to be removed, because it was unsafe, and a new wall built onto the base of the new concrete platform. Removal of this garden wall exposed a further 0.50m of excavated area, and of especial significance, the continuation of the gravel track (118) and cuts (117 and 138), which helped confirm their character and orientation.
