Glebe Farm, Llangun Coedbryn, Llandysul.

Archaeological Field Evaluation

HRSWales Report No: 111

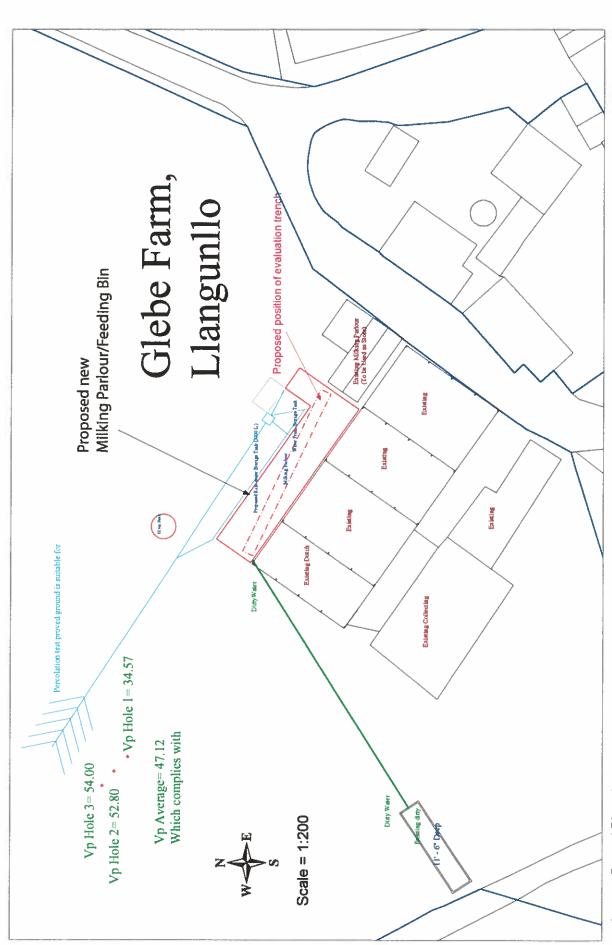
Figure 3. Ground Plan showing proposed new Milking Parlour and Feeding Bin at Glebe Farm, Llangunllo, with location of evaluation trench high-lighted.

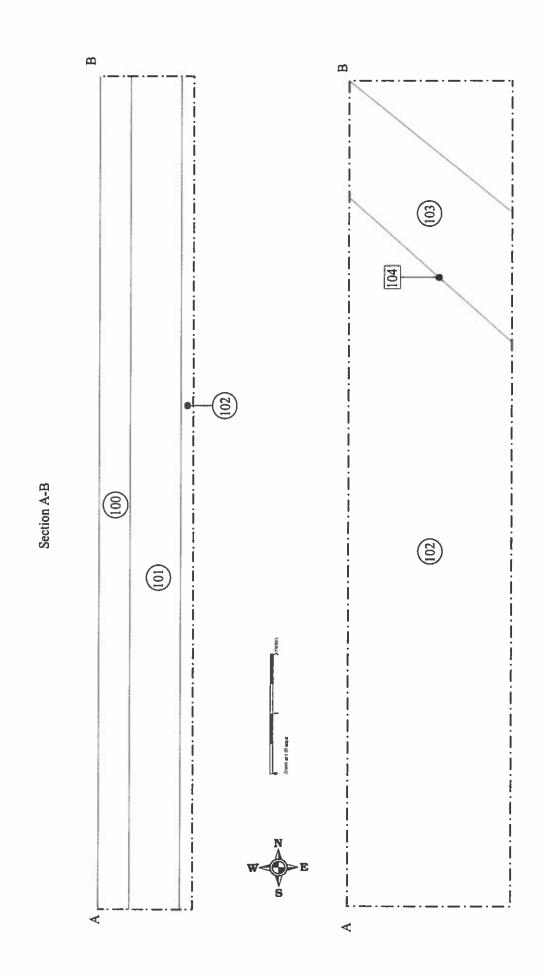
Figure 4. Trench 1 - Ground Plan and section A-B

4.2 Trench 1 was positioned at a diagonal within the footprint of the proposed new Milking Parlour. It measured approx. 13 meters long x 2 meters wide. The trench would have continued to the south but was terminated due to this area of ground having already been removed extensively several years ago. This former ground work had created a pit approx. 4 metres oval and had cut through the natural shale geology to a depth of approx. 2 metres. The average depth of this trench was approx. 0.75m. The upper most deposit approx. 0.25m in depth consisted of a mixture of top soil and general debris from farming activities (100). Dateable material from this deposit was generally late 20th century in date Directly below this deposit was a natural sand, gravel and shale mix(101). This averaged a depth of approx. 0.50m. Below this was a natural grey shale (102). The only feature that became exposed in the trench was a modern cut and fill for a water pipe (103 and 104) at the far north end of the trench. Other than this feature no archaeological features nor any dateable material earlier than the 19th century was recovered from this trench.

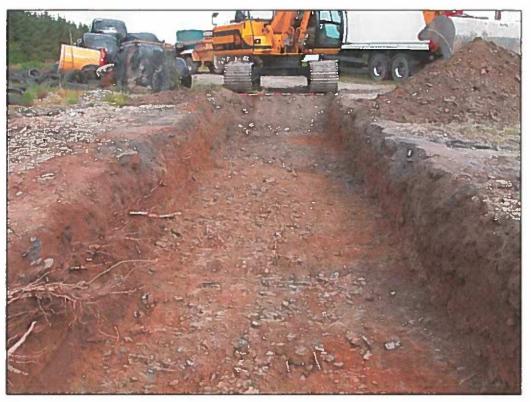
Plate 3. Trench 1. Looking north.

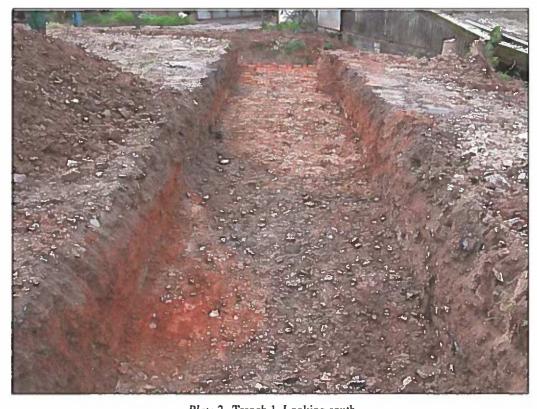
Plate 2. Trench 1. Looking south.

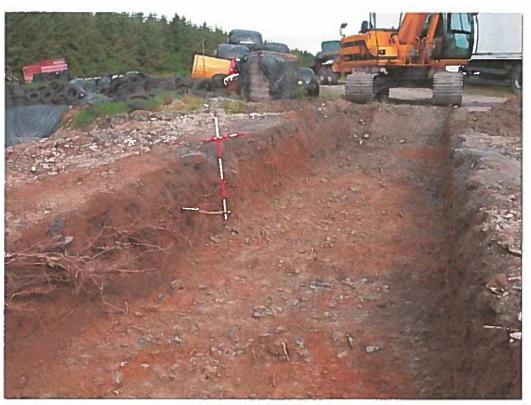
Plate 5. Trench 1. Looking northwards.

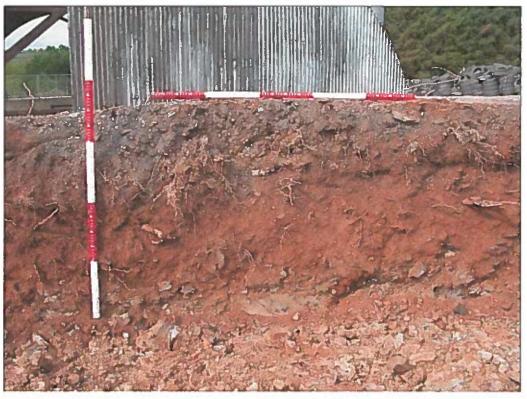
Plate 6. Trench 1. Typical section through trench 1. Looking west..

5.1 The evaluation trench at Glebe Farm, Llangunllo, for the development of the new Milking Parlour and Feeding Bin, did not expose any significant archaeology. No dateable material was recovered earlier than the 19th century. The area for the proposed development is to be sited onto a natural geology of grey shale bedrock. Which became fully exposed at a depth of approx. 0.40m.
