Archaeological Field Evaluation

HRSWales Report No: 112

Ty Gwyn, Llangybi, Ceredigion.

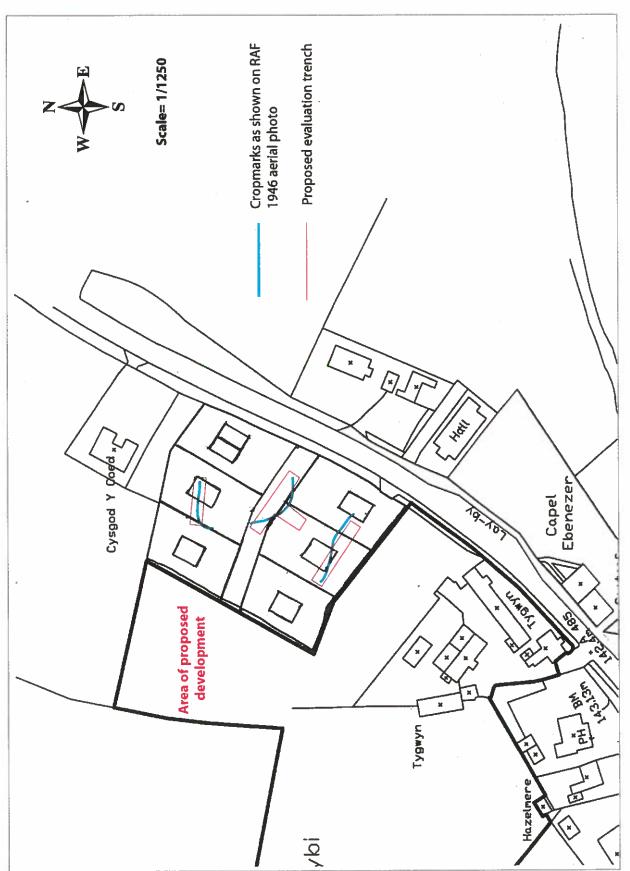
Figure 3. Preliminary site layout with positions of evaluation trenches positioned over possible cropmarks as interpreted from RAF aerial photo of 1951.

5.1 In the following, numbers contained within brackets (), refer to context numbers allocated during the watching brief. A detailed list of all contexts is given in Appendix III of this report. Three evaluation trenches were put in within the area of the development. Each trench was strategically placed across an area where there was a *potential* cropmark as shown on the RAF aerial photo of 1946.

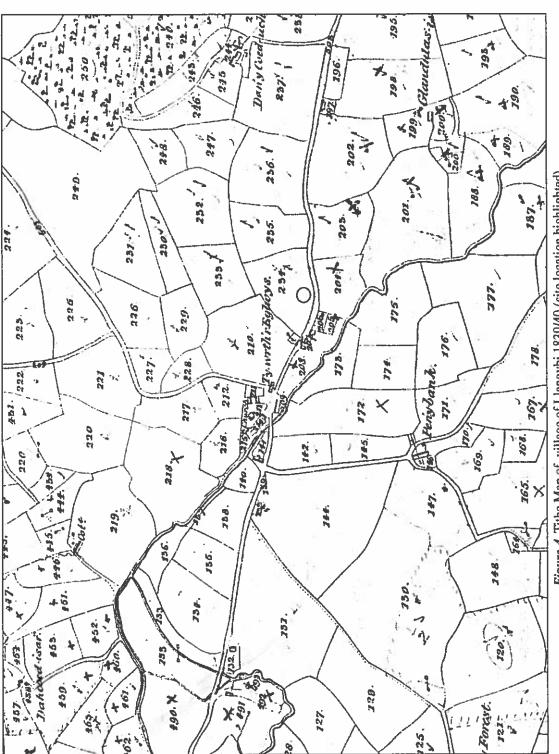
Figure 4. Tithe Map of village of Llangybi 1839/40 (site location highlighted).

4.2 Study of the Tithe Map of 1840 for the parish of Llangybi shows that there were no buildings or structures present within the area of the field proposed for development immediately north of Ty Gwyn.

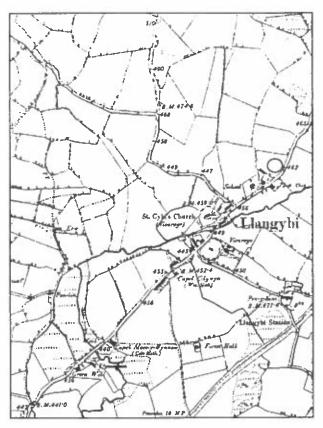
Figure 5. OS First Edition Map of 1887 (site location highlighted),

4.3 The Ordnance Survey First Edition map of 1887 shows no features within the area of the proposed development.

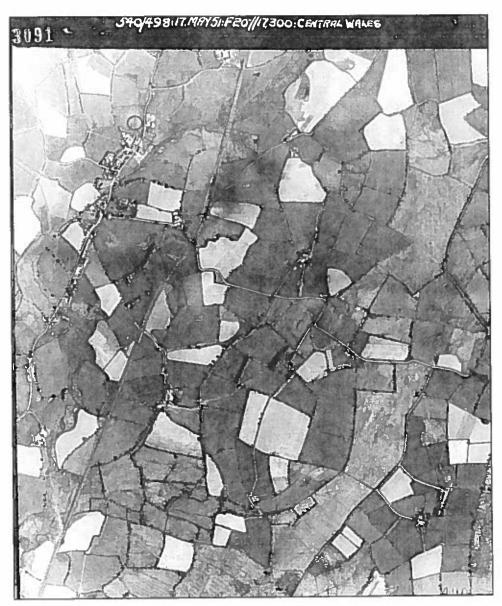
Figure 7. Aerial Photo of 1951 (site location highlighted).

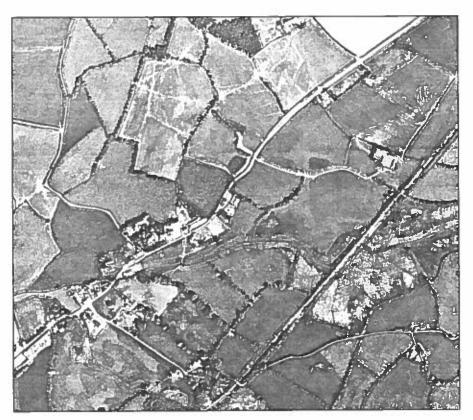
Figure 9. Aerial Photo of 1975.

4.6 No features or cropmarks are evident within the area of the proposed development on this aerial photo.

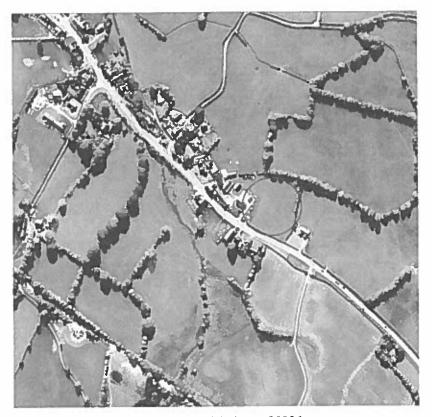
Figure 10. Aerial Photo of 2006.

4.8 No features or cropmarks are evident within the area of the proposed development on this aerial photo.

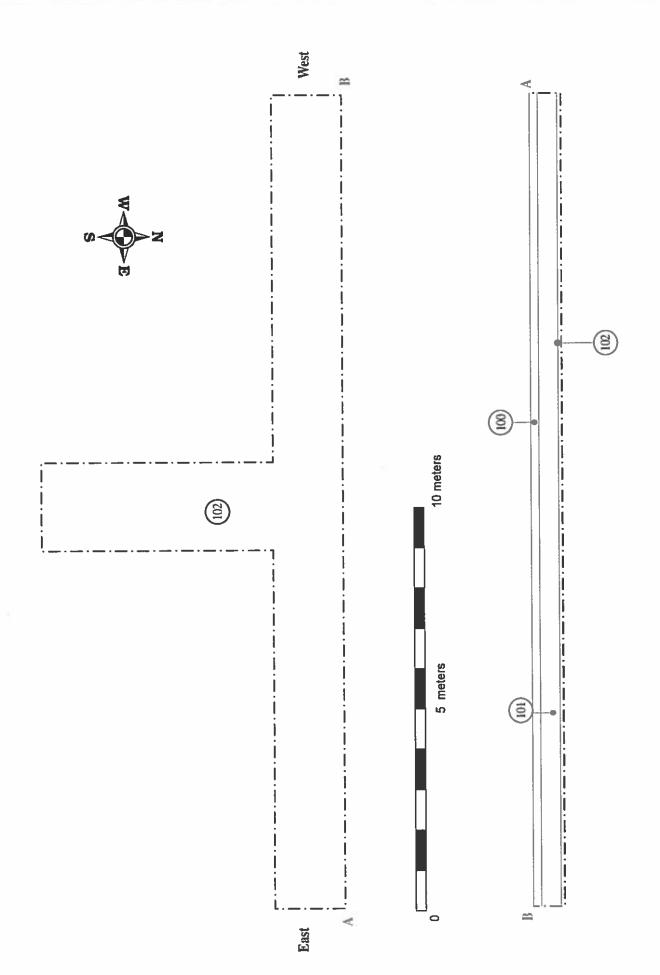
Figure 11. Trench 1 - Ground Plan and Section A-B.

Trench 1 measured approx. 20 metres in length x 1.75 metres in width and averaged a depth of approx. 5.2 0.60m and ran east-west. This trench was placed in the central area of the proposed development where a possible curvilinear cropmark was visible on the aerial photo of 1946. Once the top soil (100) was removed, which consisted of a mid-brown agricultural soil inter-mixed with stones of varying size, none no bigger than approx. 0.10m. This deposit averaged a depth of approx. 0.20m. Below this deposit was a mid-brown/orange sub soil (101) which was fairly sandy with occasional areas of clays and shale gravels. This averaged a depth of approx. 0.30m. No archaeological material was recovered or observed from this deposit and as such it appeared to be an untouched natural deposit. However, just to confirm this, this deposit was further removed to reveal a more convincing natural layer (102), which consisted of a mixture of sandy shale gravels and yellow clays with the occasional large rounded former river stones or glacial deposits averaging 0.20m - 0.40m in size. Once the trench had been dug both sections were inspected for possible evidence of former earthern banks or ditch features. None were present. Following the submitted project specification, a further transect trench was cut across the southern central section of the trench already dug, in order to confirm the non-existence of any features in this area. This trench measured approx. 8 metres in length x 1.75 metres wide. It averaged a depth of approx. 0.60m. No features were present in this transect trench and the exposed deposits mirrored those already exposed in the east-west trench.

- 100. Top soil
- 101. Mid-brown / orange sub soil
- 102. Sandy shale gravels inter-mixed with clays and other glacial deposits

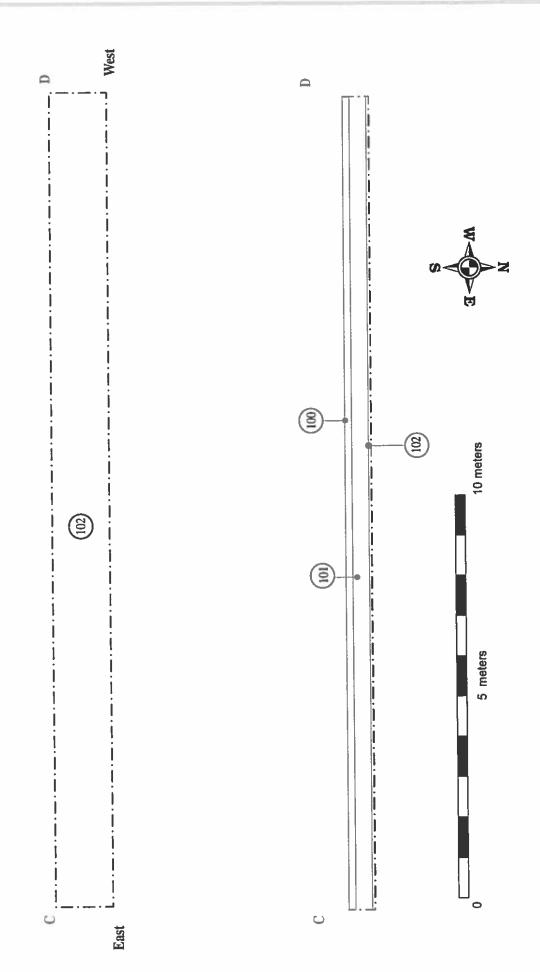
Figure 12, Trench 2 - Ground Plan and Section C-D.

5.3 Trench 2 measured approx. 20 metres in length x 1.75 metres in width and averaged a depth of approx. 0.60m and ran east-west. This trench was placed at the far northern end of the proposed development where a possible linear cropmark was visible on the aerial photo of 1946. Once the top soil (200) was

removed, which consisted of a mid-brown agricultural soil inter-mixed with stones of varying size, none no bigger than approx. 0.10m. This deposit averaged a depth of approx. 0.20m. Below this deposit was a mid-brown/orange sub soil (201) which was fairly sandy with occasional areas of clays and shale gravels. This averaged a depth of approx. 0.30m. No archaeological material was recovered or observed from this deposit and as such it appeared to be an *untouched* natural deposit. However, just to confirm this, as with Trench 1, this deposit was further removed to reveal a more convincing natural layer (202), which consisted of a mixture of sandy shale gravels and yellow clays with the occasional large rounded former river stones or glacial deposits averaging 0.20m - 0.40m in size. Once the trench had been dug both sections were inspected for possible evidence of former earthern banks or ditch features. None were present. No archaeological features or finds were exposed in this trench and the deposits mirrored those already exposed in Trench 1.

- 200. Top soil
- 201. Mid-brown / orange sub soil
- 202. Sandy shale gravels inter-mixed with clays and other glacial deposits

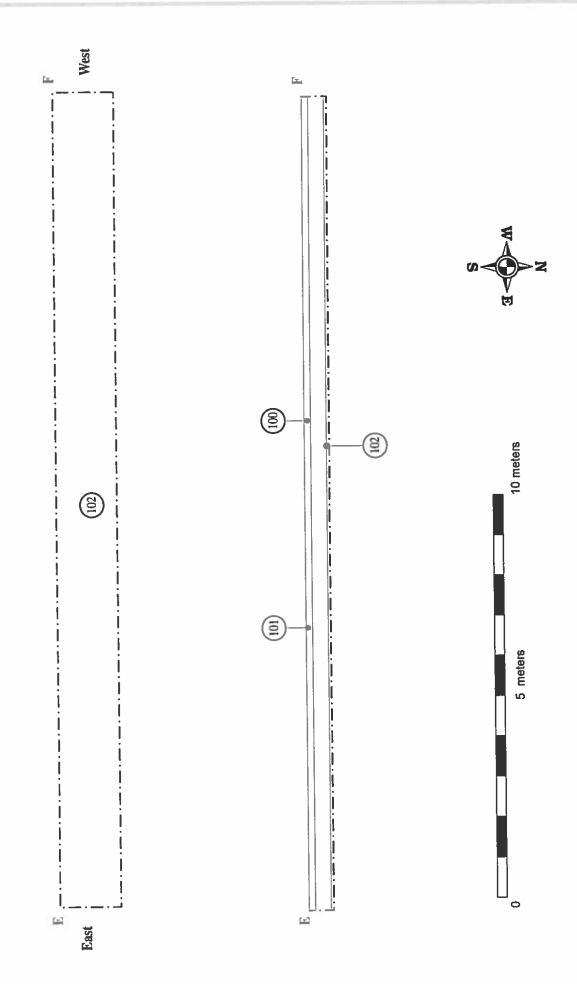
Figure 13. Trench 2 - Ground Plan and Section E-F

5.4 Trench 3 measured approx. 20 metres in length x 1.75 metres in width and averaged a depth of approx. 0.60m and ran east-west. This trench was placed in the far southern end of the proposed development where a possible linear crop-mark was visible on the aerial photo of 1946. Once the top soil (300) was removed, which consisted of a mid-brown agricultural soil inter-mixed with stones of varying size, none no bigger than approx. 0.10m. This deposit averaged a depth of approx. 0.20m. Below this deposit was a mid-brown/orange sub soil (301) which was fairly sandy with occasional areas of clays and shale gravels. This averaged a depth of approx. 0.30m. No archaeological material was recovered or observed from this deposit and as such it appeared to be an *untouched* natural deposit. However, just to confirm this, as with Trences 1 and 2, this deposit was further removed to reveal a more convincing *natural* layer (302), which consisted of a mixture of sandy shale gravels and yellow clays with the occasional large rounded former river stones or glacial deposits averaging 0.20m - 0.40m in size. Once the trench had been dug both exposed north and south facing sections were inspected for possible evidence of former earthern banks or ditch features. None were present. No archaeological features or finds were exposed in this trench and the deposits mirrored those already exposed in Trenches 1 and 2

- 300. Top soil
- 301. Mid-brown / orange sub soil
- 302. Sandy shale gravels inter-mixed with clays and other glacial deposits

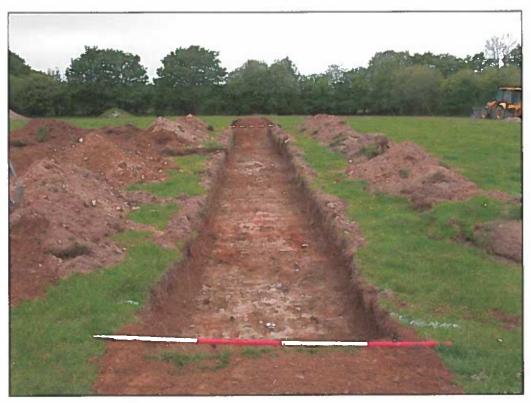
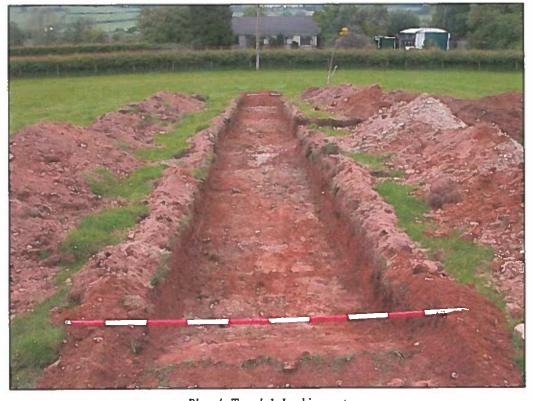
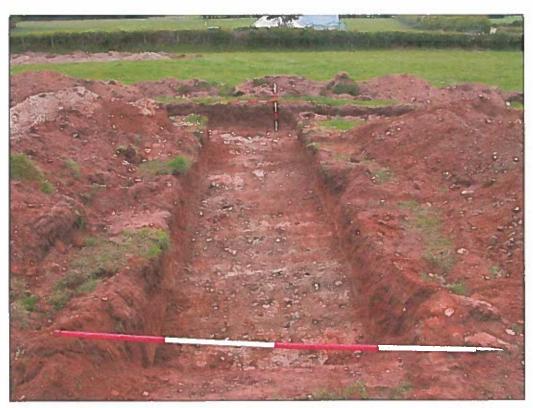
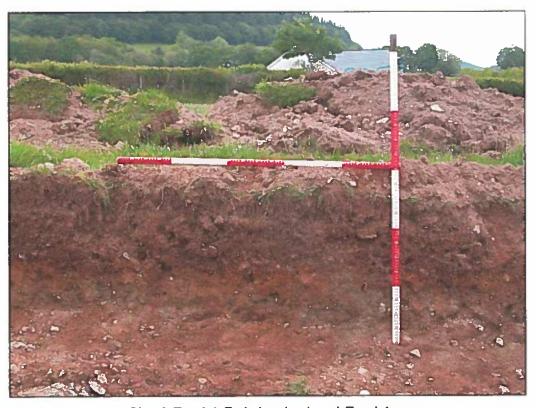
Plate 3. Trench 1. Looking west.

Plate 4. Trench 1. Looking east.

Plate 5. Trench 1. North-south transect.

Plate 6. Trench 1. Typical section through Trench 1.

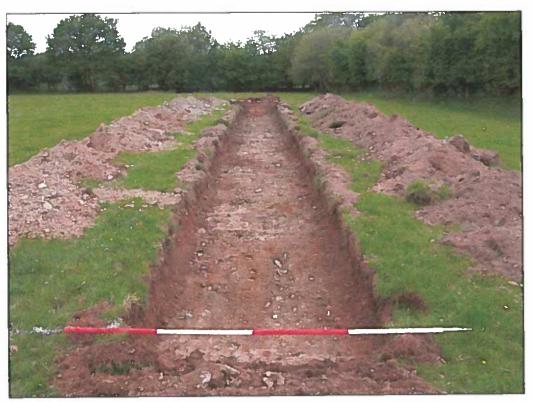
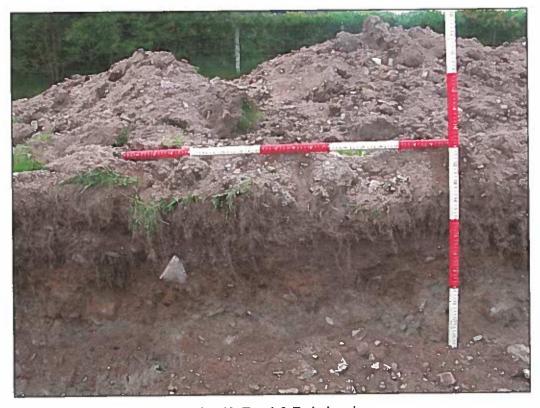
Plate 9. Trench 2. Looking west.

Plate 10. Trench 2. Typical section.

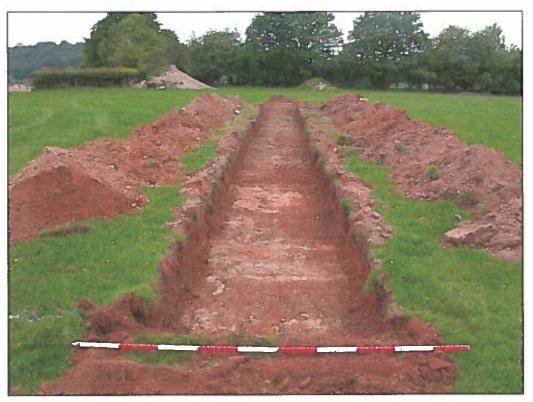
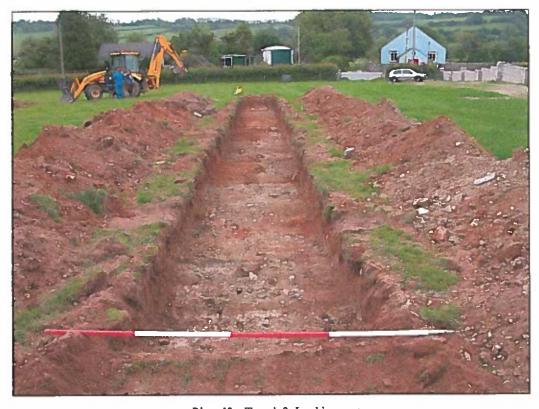
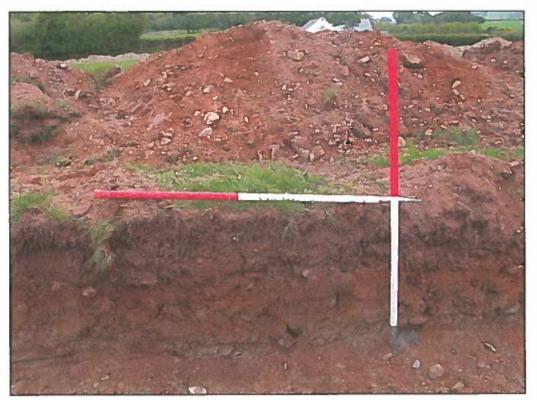
Plate 11. Trench 3. Looking west.

Plate 12.. Trench 3. Looking east.

Plate 13. Trench 3. Typical section.
