## **Nant Cwnlle Church, Bwlchllan, Ceredigion.**

### **Archaeological Watching Brief**

Date: January 2009

HRSW Report No: 117

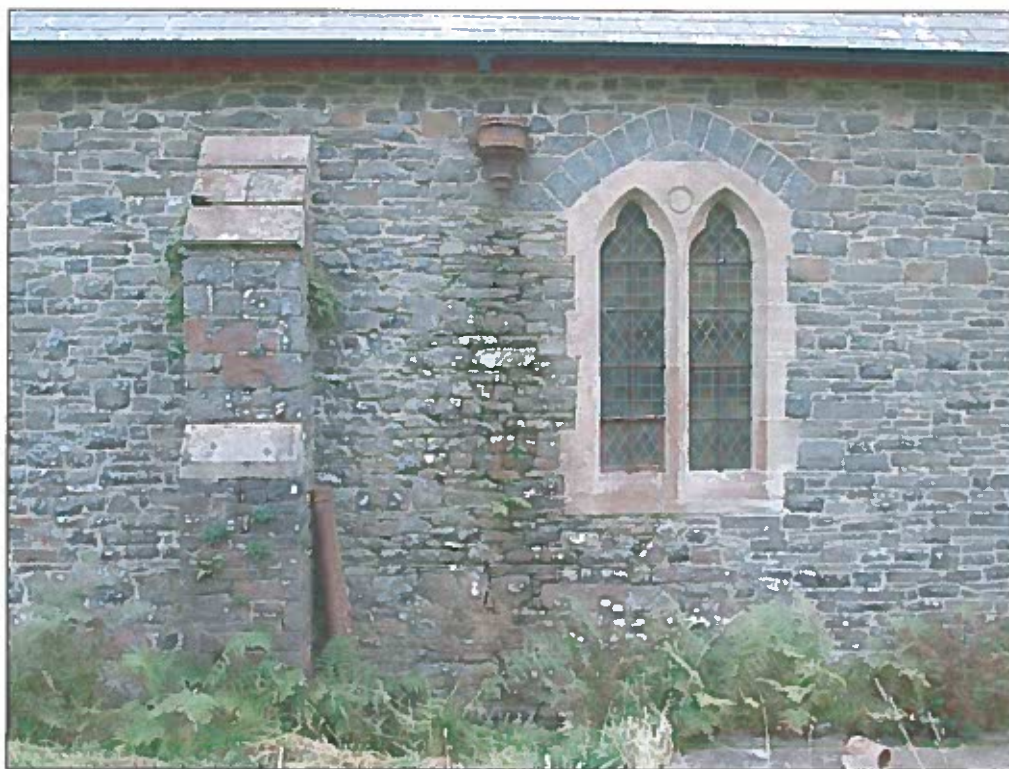
**Plate 11.** Nant Cwnlle Church. North facing elevation, west end showing area of 19th century extension. Note different mortar types. Looking south.

of the church's earlier foundation or else was a necessary requirement during construction of this elevation. Inspection of the mortars types used in both of these areas seem to imply the latter however, in that both mortar types are identical. However this could mean that the mortars are later re-pointing which gives the impression that the builds are contemporary. Without further investigation in the form of coring however this would be hard to come to any solid conclusion.

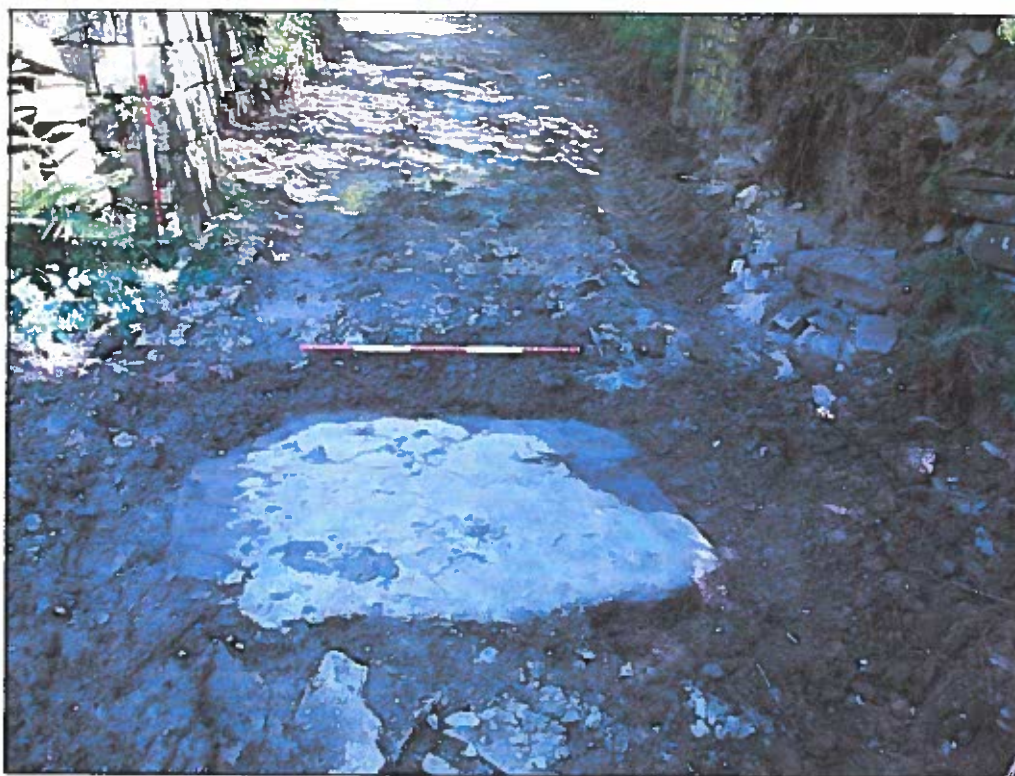
*Plate 18.* Large stone slab exposed at edge of former of well located at threshold between graveyard and entrance gate. Looking east.

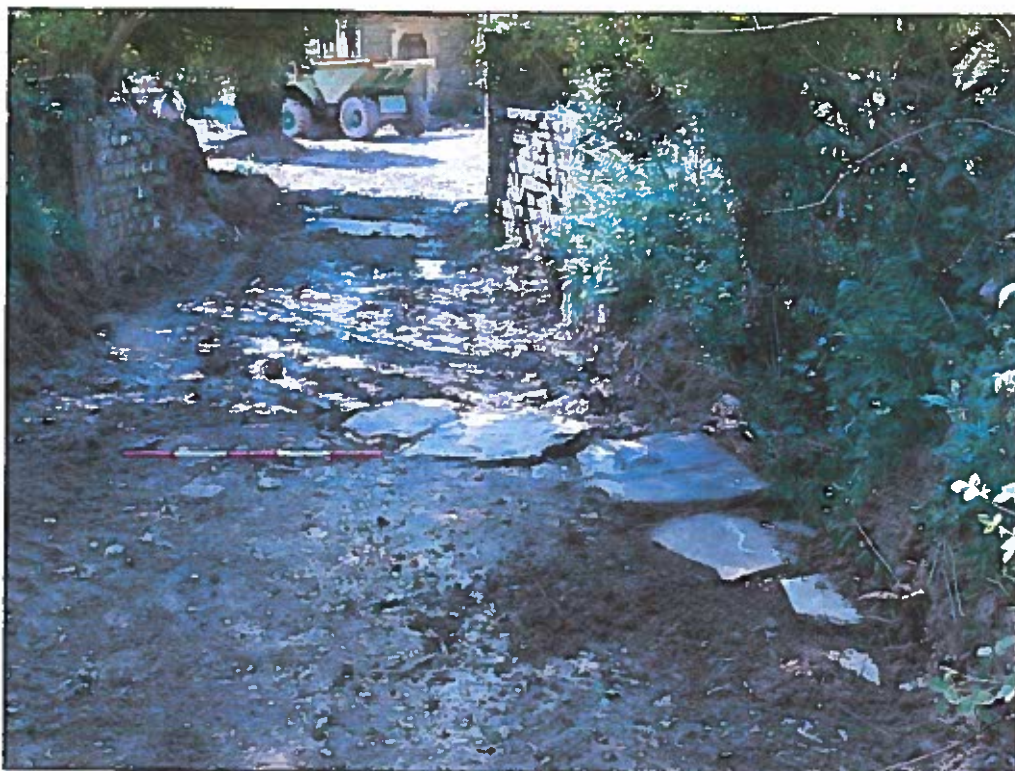
*Plate 19.* Exposed stone culvert running across church access track from natural spring by old school house. Looking west toward graveyard.

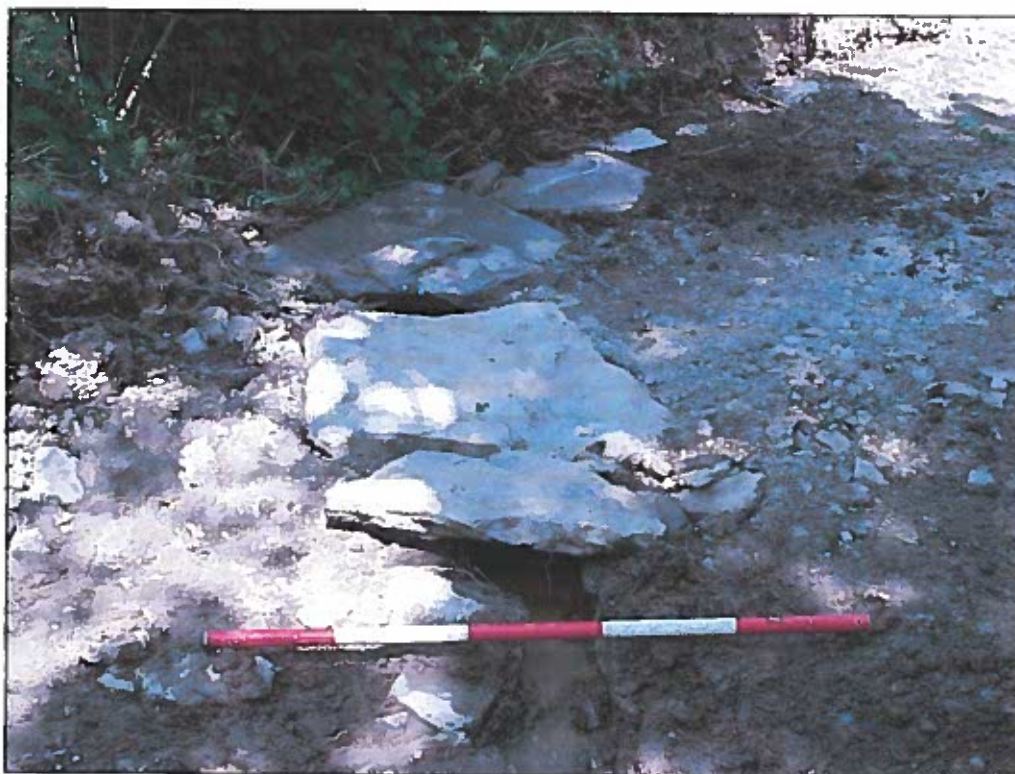
*Plate 20.* Exposed stone culvert running across church access track from natural spring by old school house. Looking northeast toward school house, source of spring.

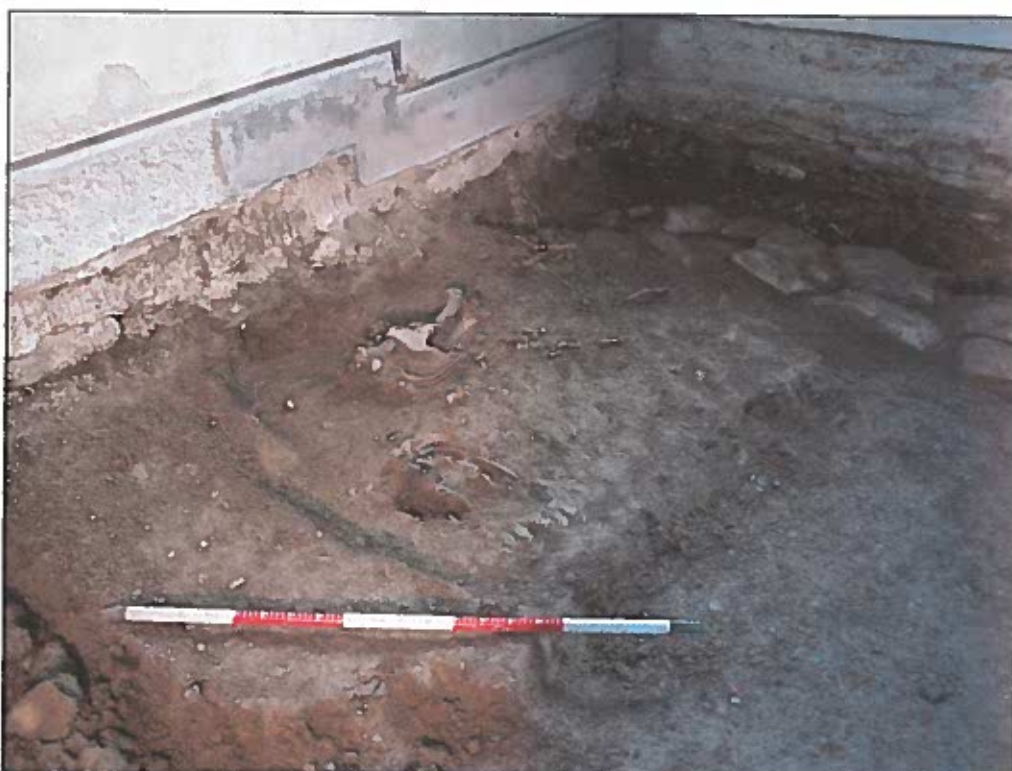
**Plate 34.** Partly dis-articulated remains of heavily disturbed burial at far end of Chancel with further burial marked by capping stones at rear of shot.. Looking south.

- 7.4 A further part burial was also exposed beneath the far Chancel east window, which was partially disarticulated. These remains appeared to have been very heavily disturbed at some time, likely when the chancel extension was built in the 18<sup>th</sup> century. The date of these remains must remain uncertain, however what is certain is that they pre-date the foundations of the chancel area of the chancel.

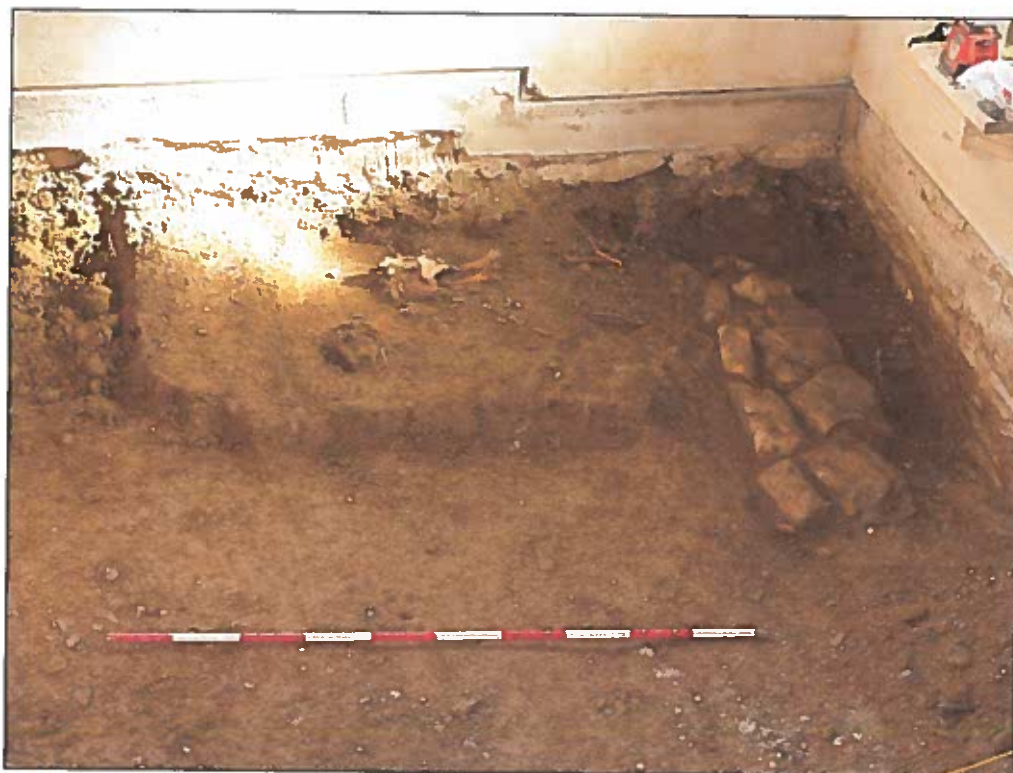
**Plate 35.** Burials 114 and 115 at far east end of Chancel. Looking east.

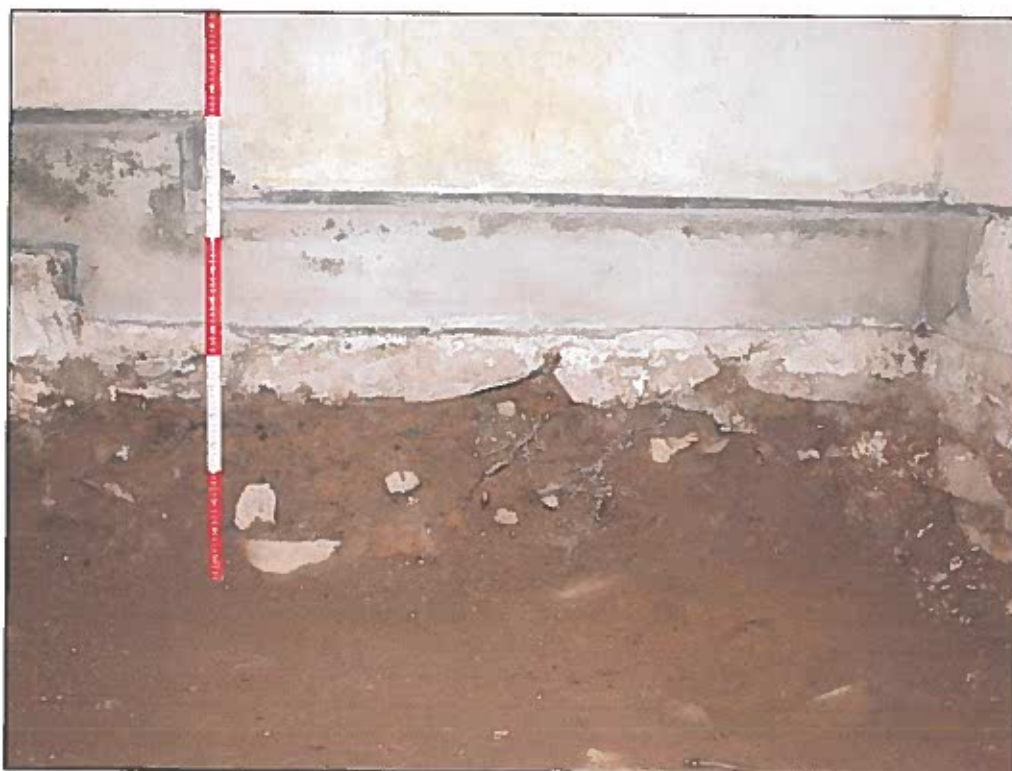
**Plate 40.** Exposed west facing section at base of wall foundation at far south-east end corner of Chancel.

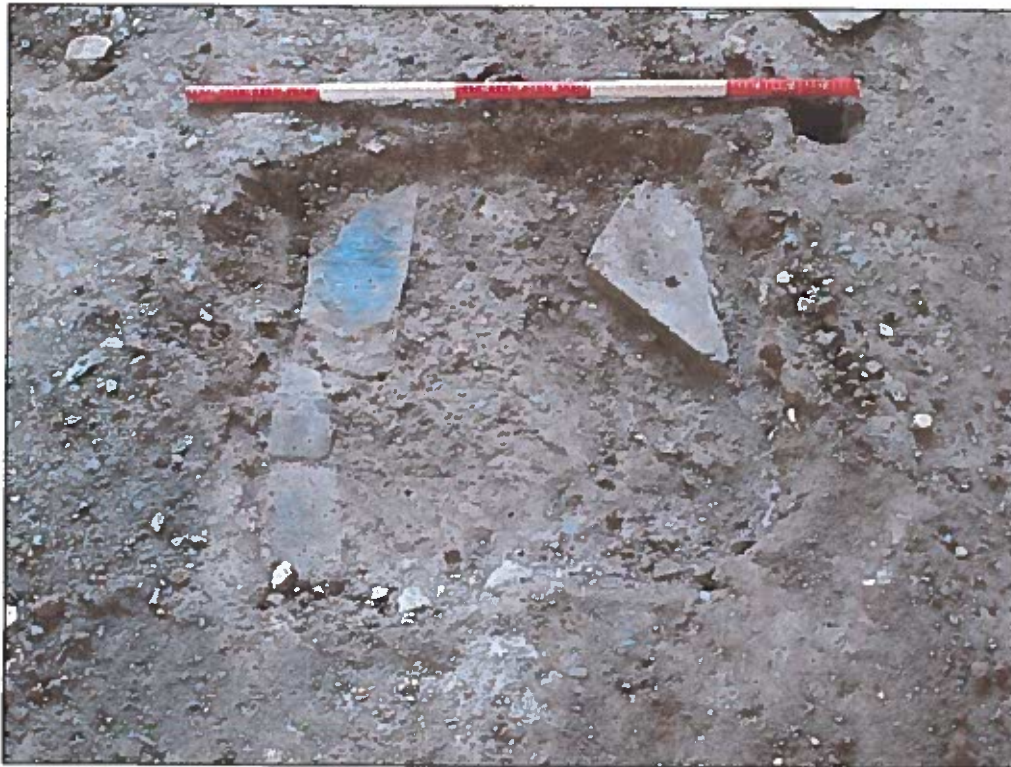
**Plate 42.** Excavated pier base for proposed stairwell support in Chancel area..

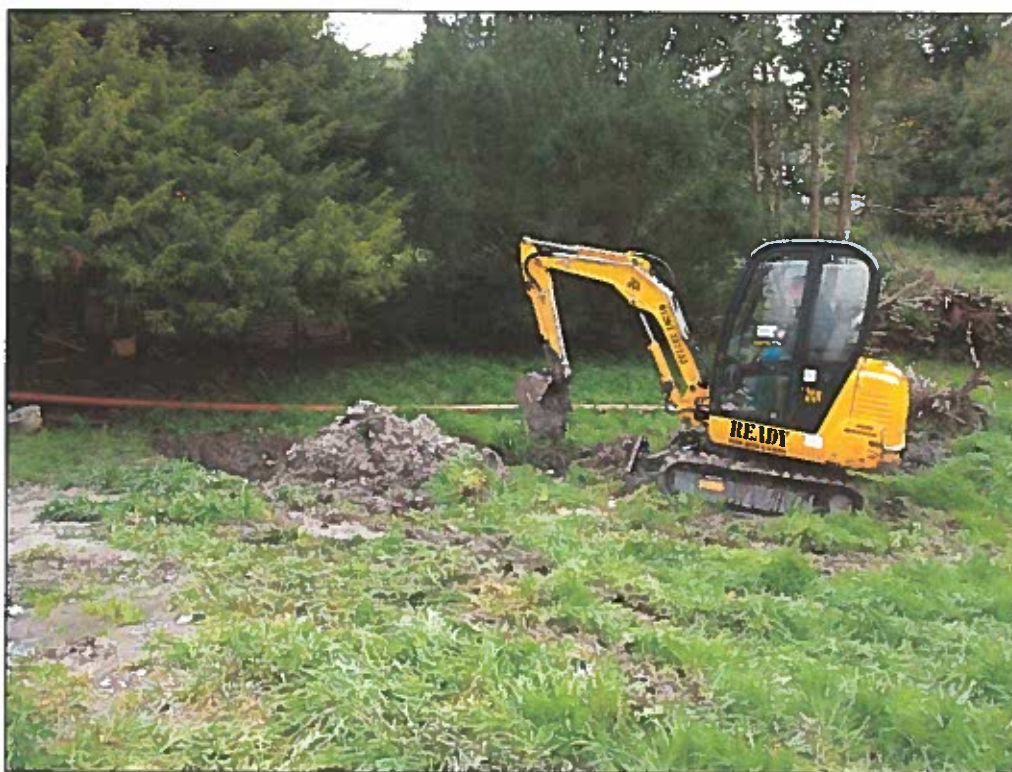
**Plate 49.** Working shot during groundwork for excavation of septic tank in graveyard area. Looking south.
