**Hen Eglwys Court Farm,
St Davids Road, Letterston,
Haverfordwest, Pembs.**

Archaeological Watching Brief

**HRSWales
Report No: 121**

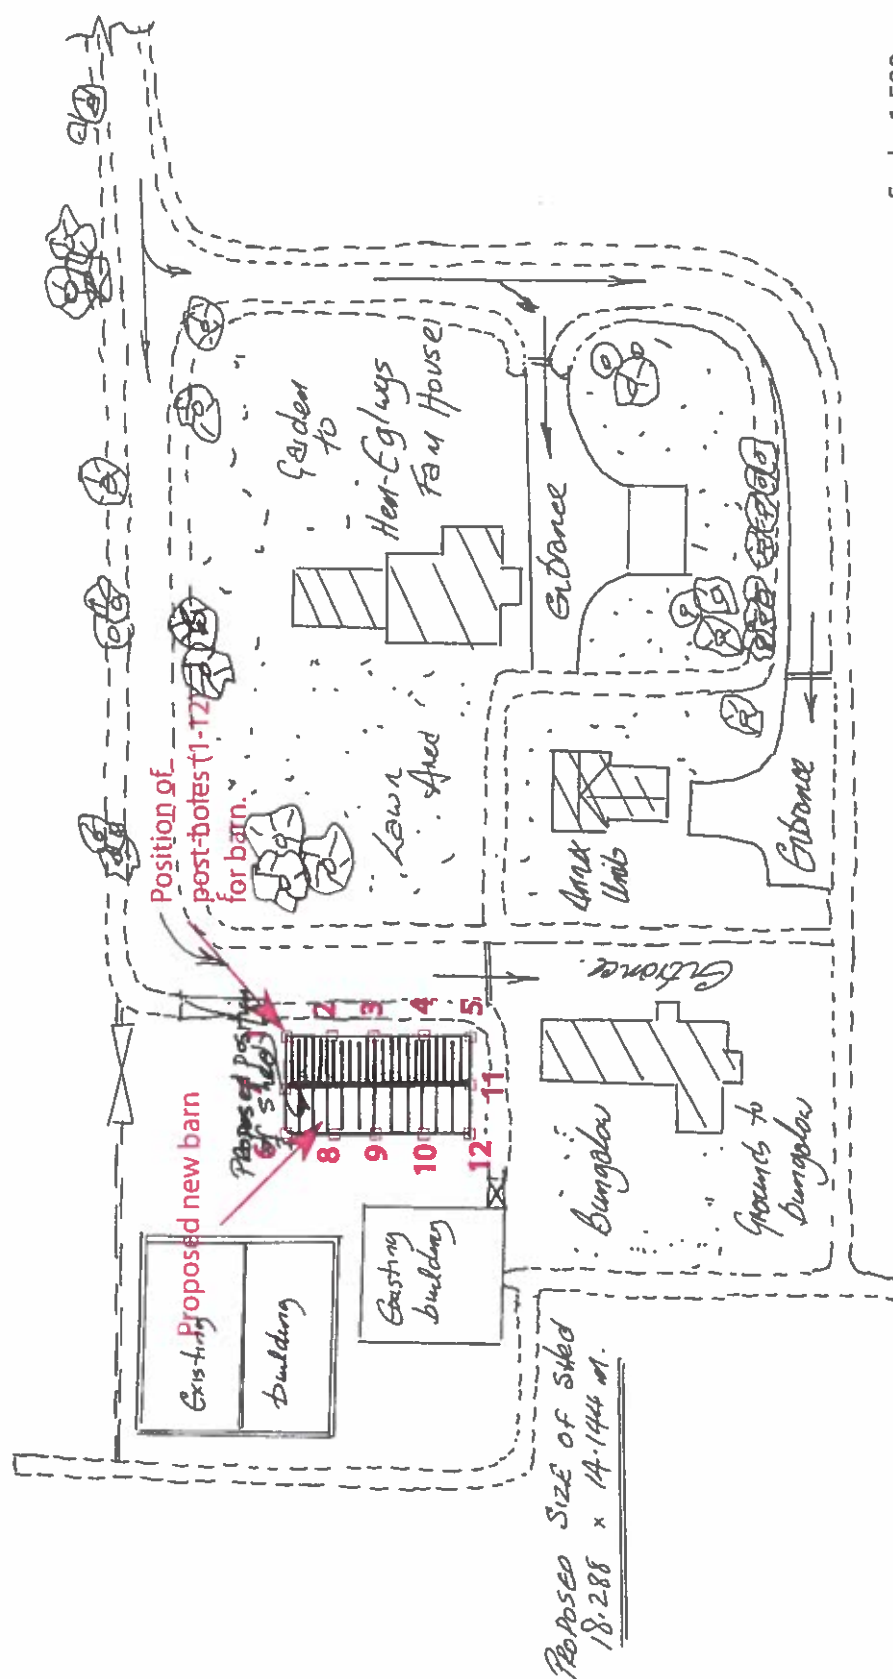
- 4.1 In the following, numbers contained within brackets (), refer to context numbers allocated to each posthole during the watching brief.
- 4.2 The area proposed for the erection of the new barn was clear of any obstruction and was centred on an open area only 100m west of Hen Eglwys Farm.
- 4.3 Each of the 12 postholes is described in sequence. Each measured approximately 1m in length x 0.50m wide and each reached on average between 0.40-0.50m in depth. For the location of each posthole please see Figure 6.

Figure 6. Site plan showing position of new barn with reference to position of proposed post-holes. Based on Architects ground plan.

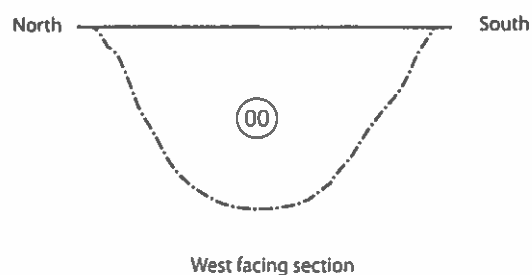
1.

- 4.4 This posthole exposed only one natural shale deposit (00)

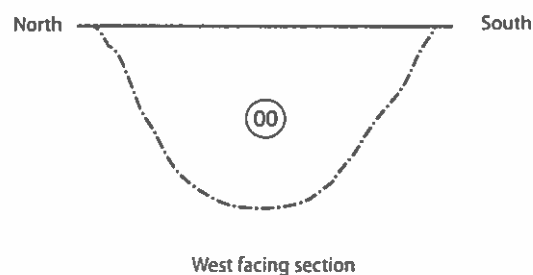
2.

- 4.5 This posthole exposed only one natural shale deposit (00)

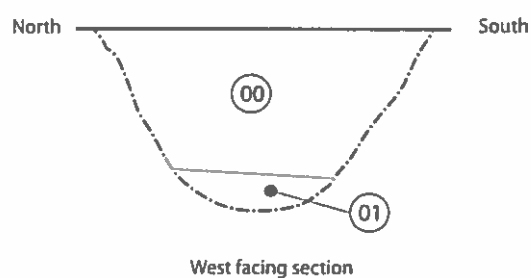
3.

- 4.6 The upper deposit for this posthole was of natural shale intermixed with grey/mid brown soil (00). Directly below this was a limestone rubble deposit (01) with pieces no larger than 0.20m in size. This

deposit was interpreted as a natural glacial deposit.

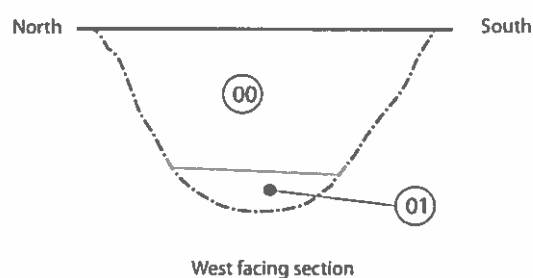
4.

- 4.7 The uppermost deposit for this posthole was of limestone rubble intermixed with shale. Within this deposit there was evidence of leaching in the lower levels of the deposit (00). This deposit was interpreted as a natural limestone glacial erratic.

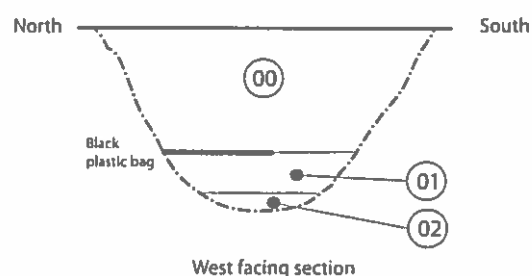
5.

- 4.8 The upper deposit of this posthole consisted of a limestone rubble layer (00) approximately 0.10-0.20m in size reaching a depth of approximately 0.40m. Directly below this deposit was part of a modern black polythene bag covering half of the trench. Directly below this was a loose stone (01) interpreted as stone for a soakaway for a septic tank located in the garden to the north for Hen Eglwys Court farmhouse. Directly below this was a natural limestone rubble fill intermixed with a natural shale (02).

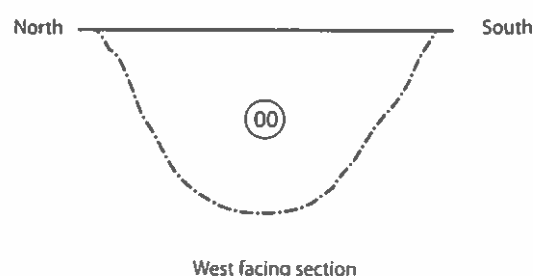
6.

- 4.9 This posthole was made up of only one natural shale deposit (00)

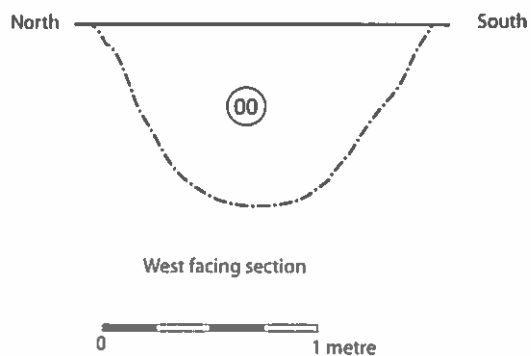
7.

- 4.10 This posthole was made up of only one natural shale deposit (00)

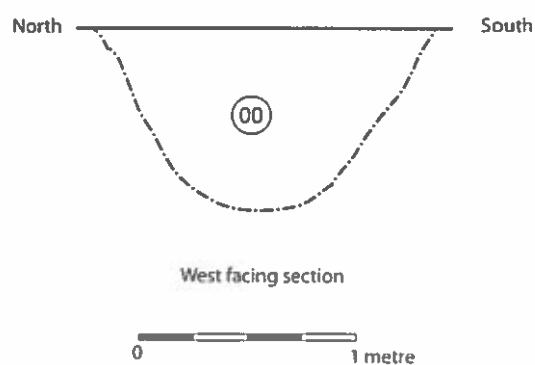
8.

- 4.11 This posthole was made up of only one natural shale deposit (00)

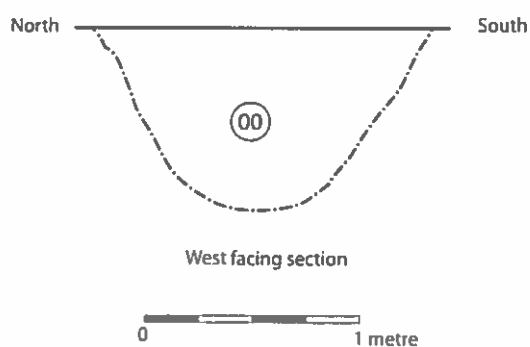
9.

- 4.12 This posthole was made up of only one natural shale deposit (00)

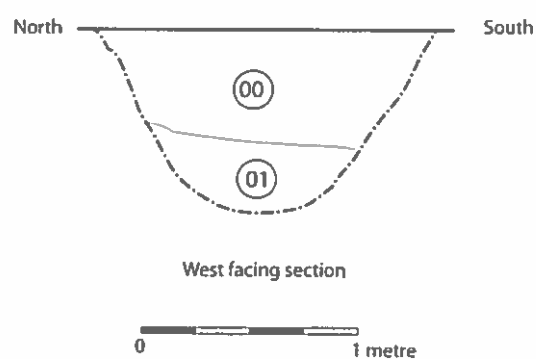
10.

- 4.13 This posthole consisted of shale across one side of the trench, tapering to a limestone rubble intermixed with soil and shale (00). This was interpreted as a natural deposit.

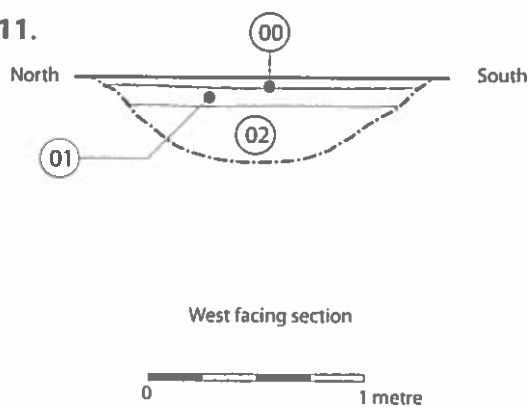
11.

- 4.14 The upper deposit for this posthole was a compact shale/soil (00) which reached a depth of only 0.05m. Below this was compact shale with iron stained sand (01). Below this was a limestone rubble deposit (02) intermixed with a grey/mid brown soil. All deposits were interpreted as natural shale deposits.

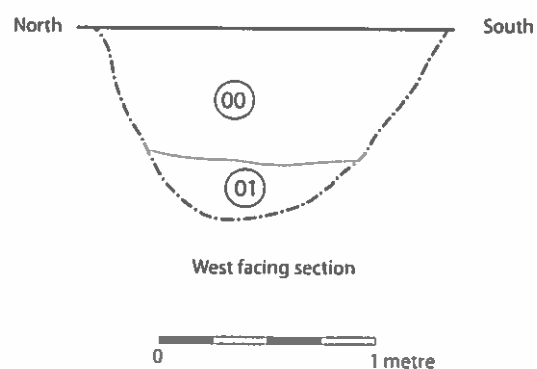
12.

- 4.15 The upper deposit for this posthole was a sandy/silt (00) and below this was a limestone rubble deposit (01) interpreted a natural deposit.

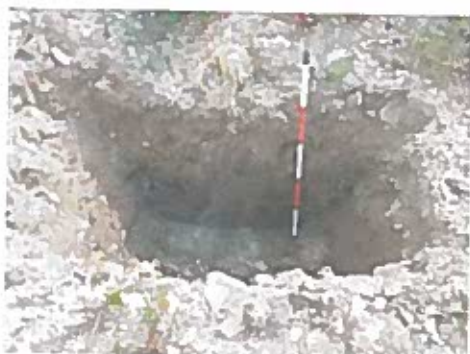
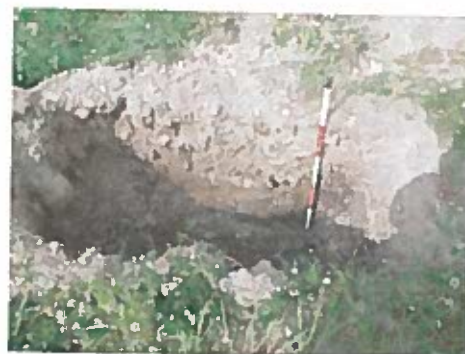
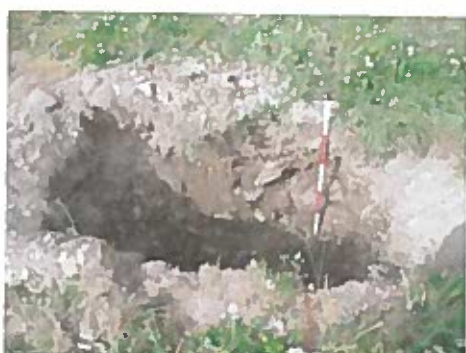
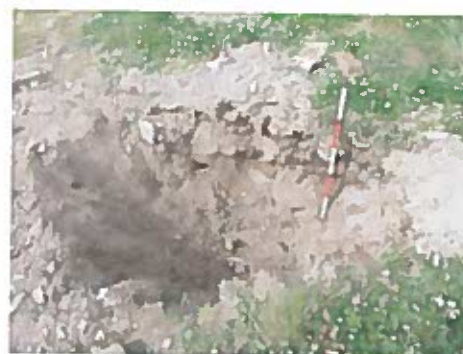
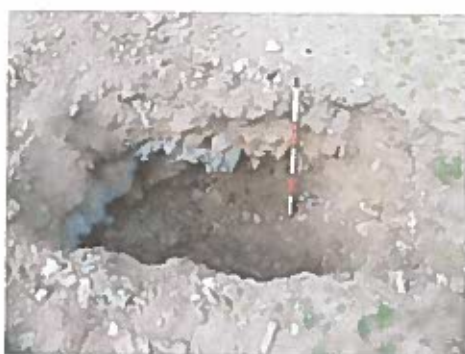
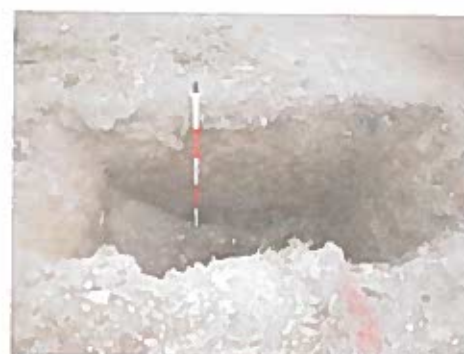
Plate 1. Post-holes 1-6

- 5.1 The watching brief at Hen Eglwys Court Farm, Letterston, exposed no significant archaeological deposits or finds in any of the excavated postholes. Each posthole apart from one, *Posthole 5*, exposed

natural geology in the form of natural shales and glacial limestone. *Posthole 5* exposed part of a 20th century septic tank soakaway drainage ditch.

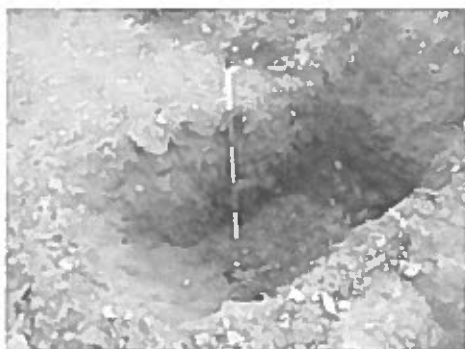
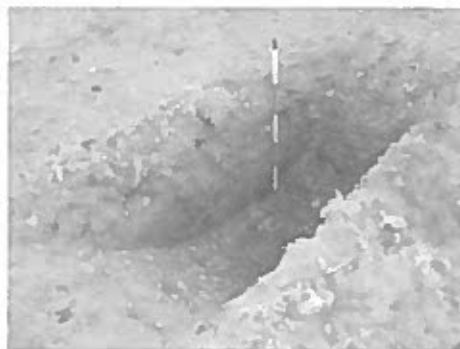
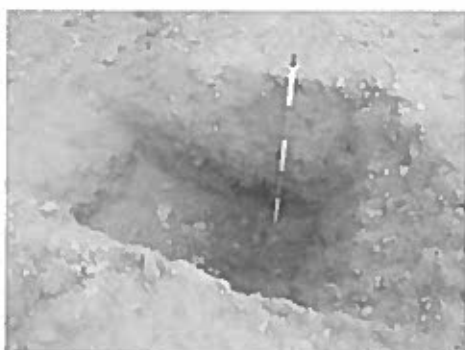
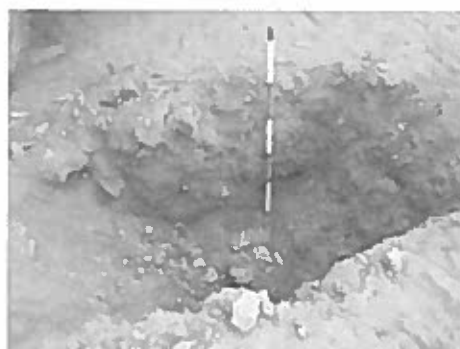
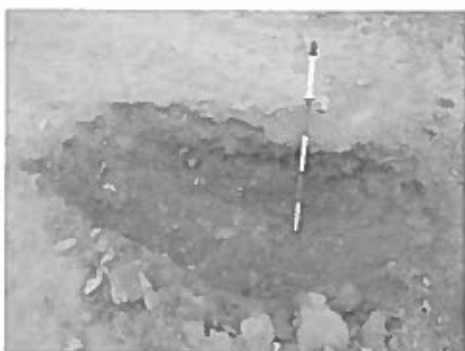
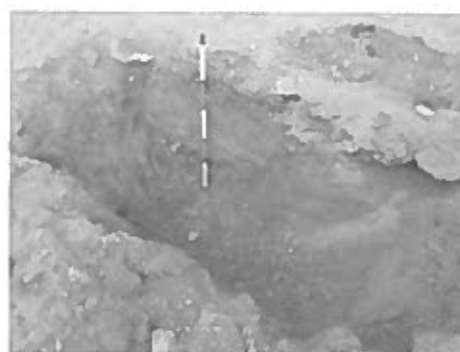
Plate 2. Post-holes 7-12

- 4.8 No features or finds were recorded in the ground work for the proposed new barn at Hen Eglwys Court Farm, Letterston. No archaeological deposits encountered were earlier than the late 20th century.
