Vicarage Bungalow Llanddeusant Watching Brief

Trysor Project No. 2009/141

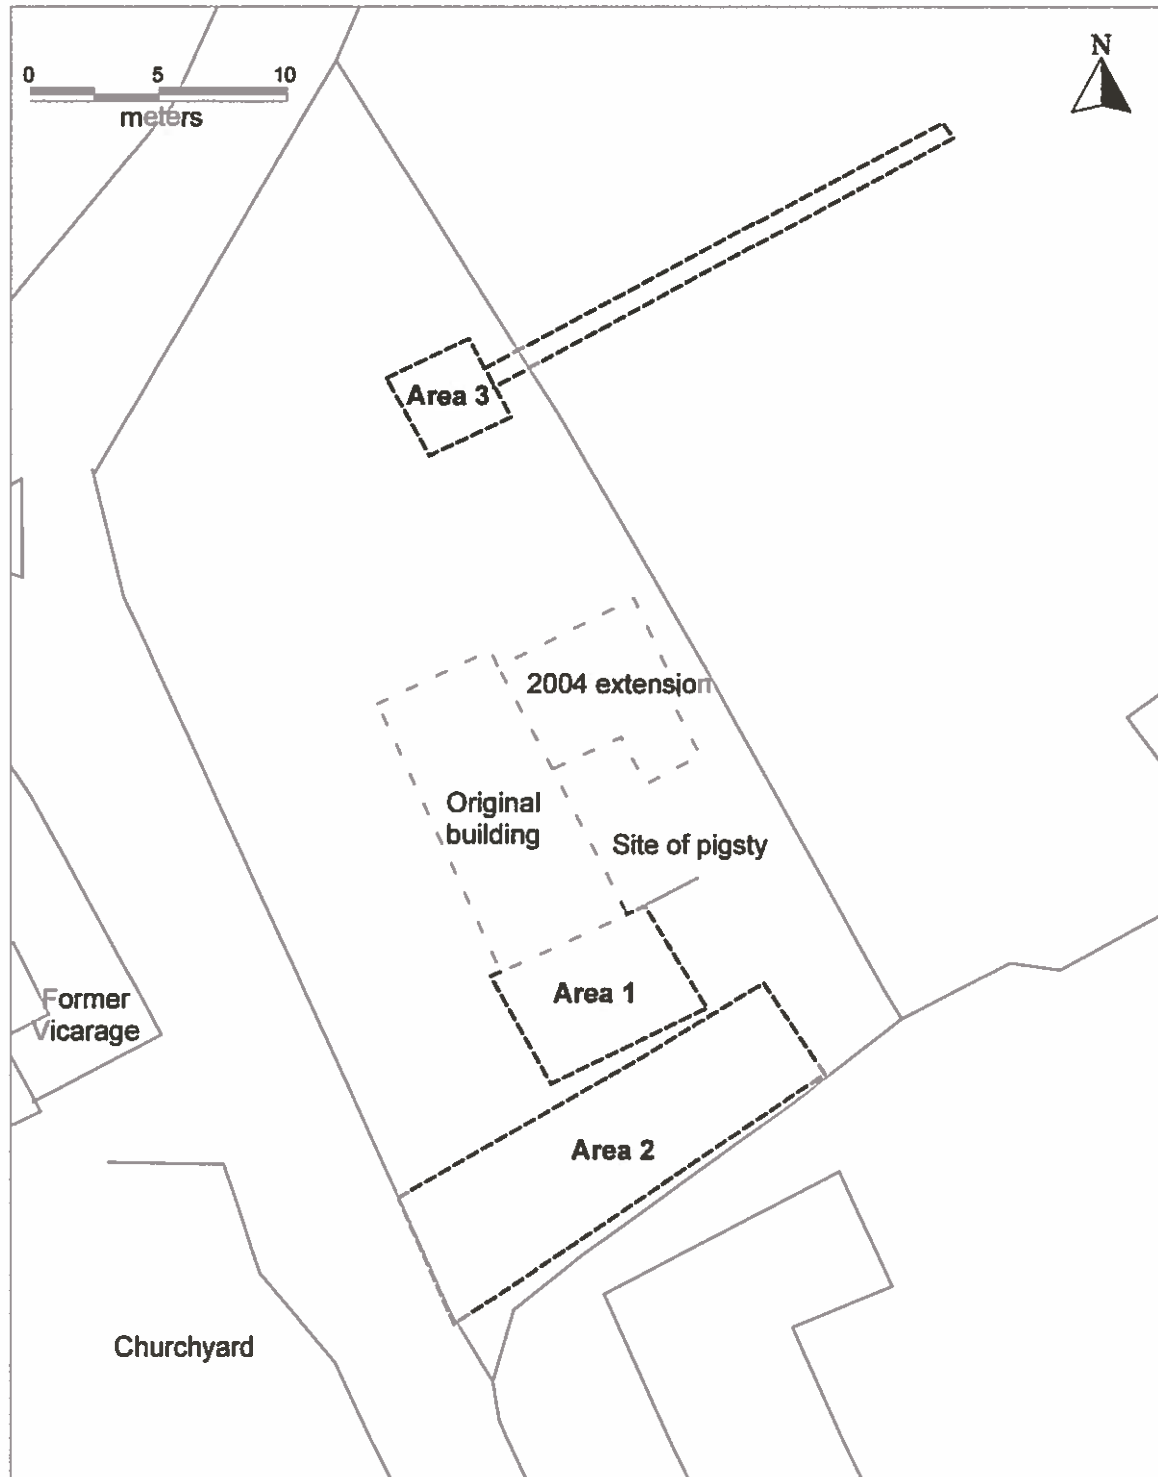
Figure 4: Location of the three areas mechanically excavated, based on clients plans and verified in the field.

Three separate areas were mechanically excavated for the development under archaeological observation, see figure 4. Area 1 was to the southeast end of the existing building for the bedroom extension. Area 2 was for the new driveway on the southeast edge of the plot. Area 3, for the septic tank and soakaway, lay to the north of the current building.

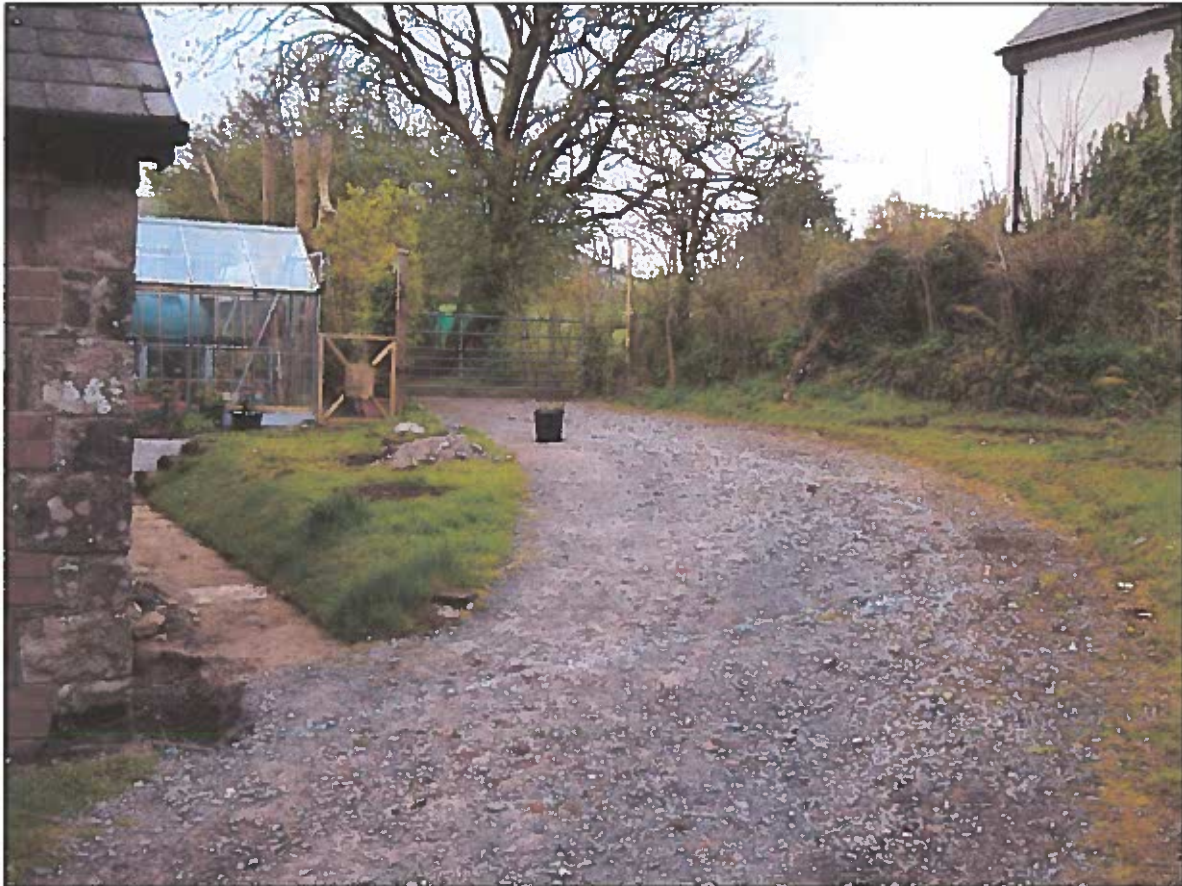
Plate 1: VB01 – Area 1, the extension, outlined on the ground, looking east.

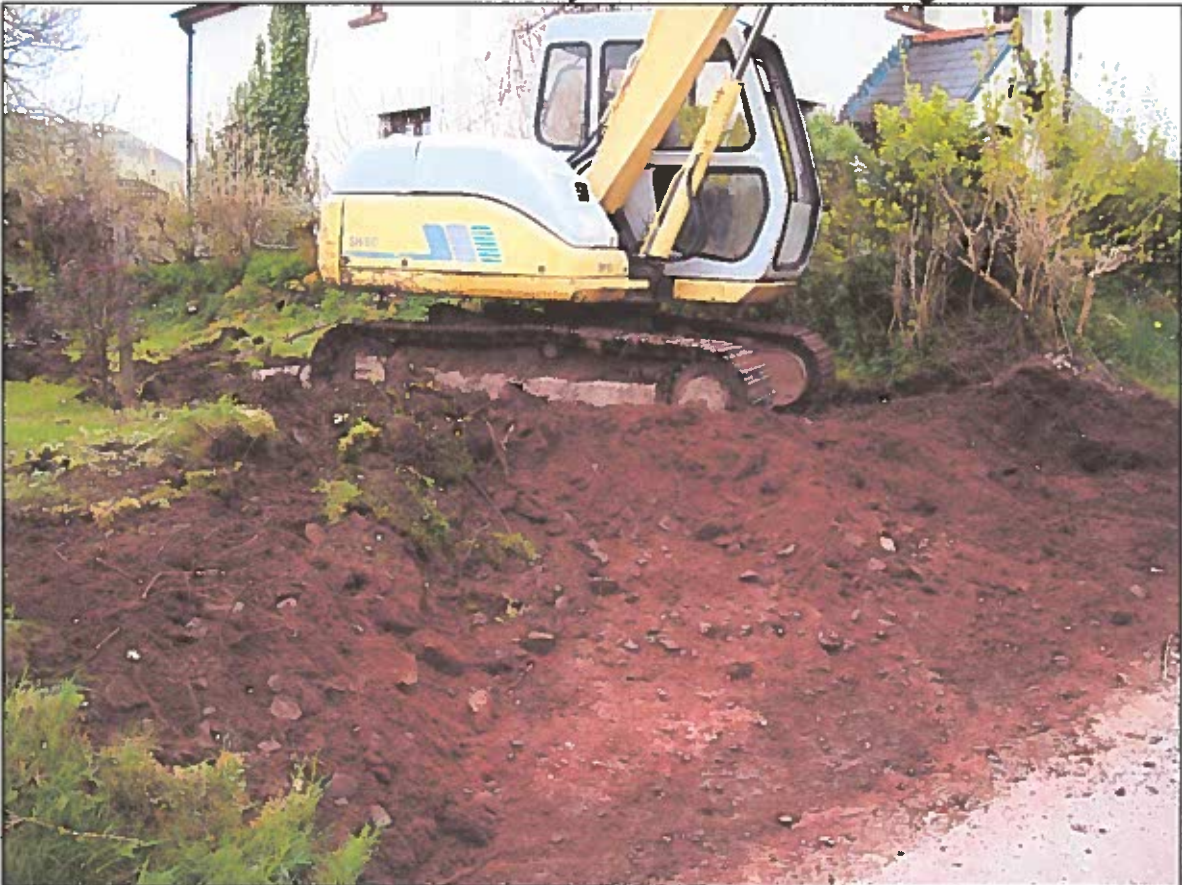
Plate 4: VB04 – Excavation of new driveway, Area 2, showing roadside ditch, looking east.

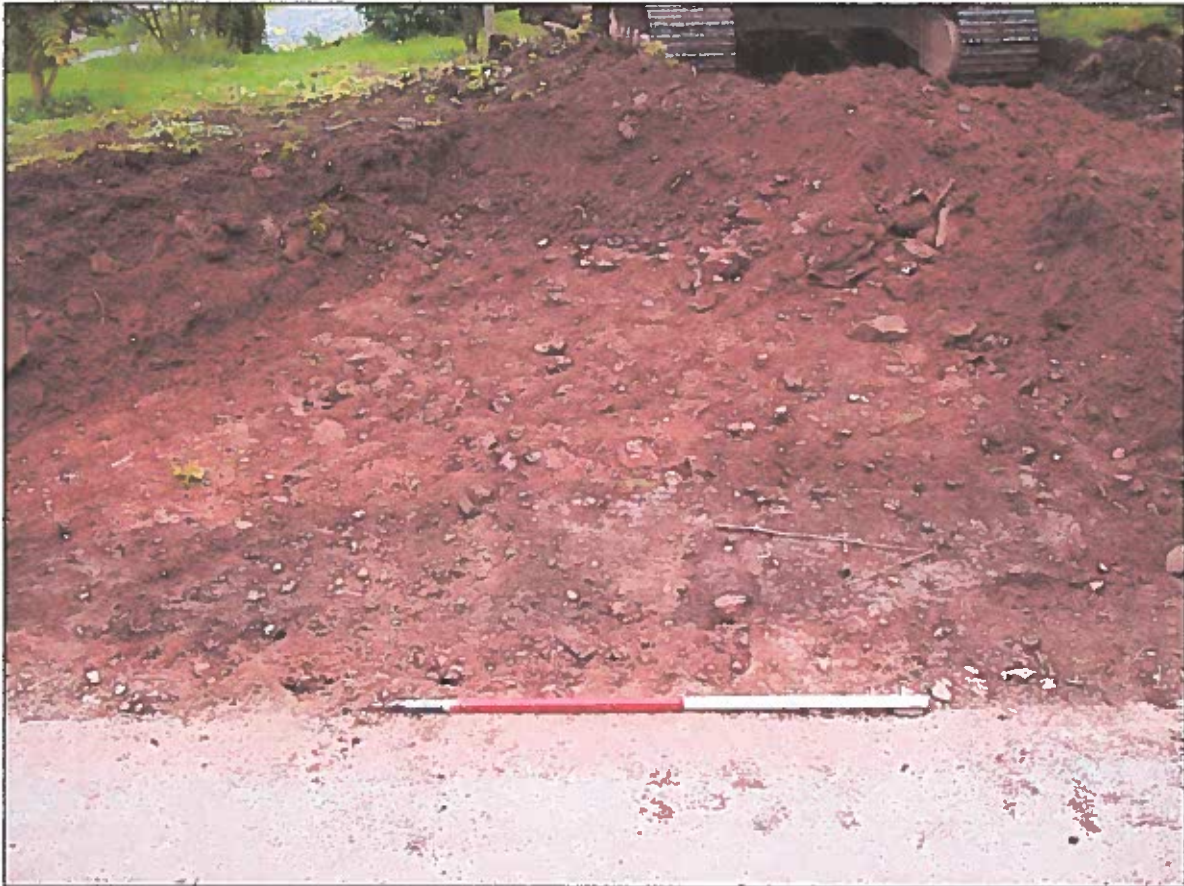
Plate 5: VB05 – The roadside ditch in Area 2, looking northeast

The development had no significant impact on the archaeological resource. All features recorded related to the 20th century with the possible exception of a roadside ditch of unknown date.

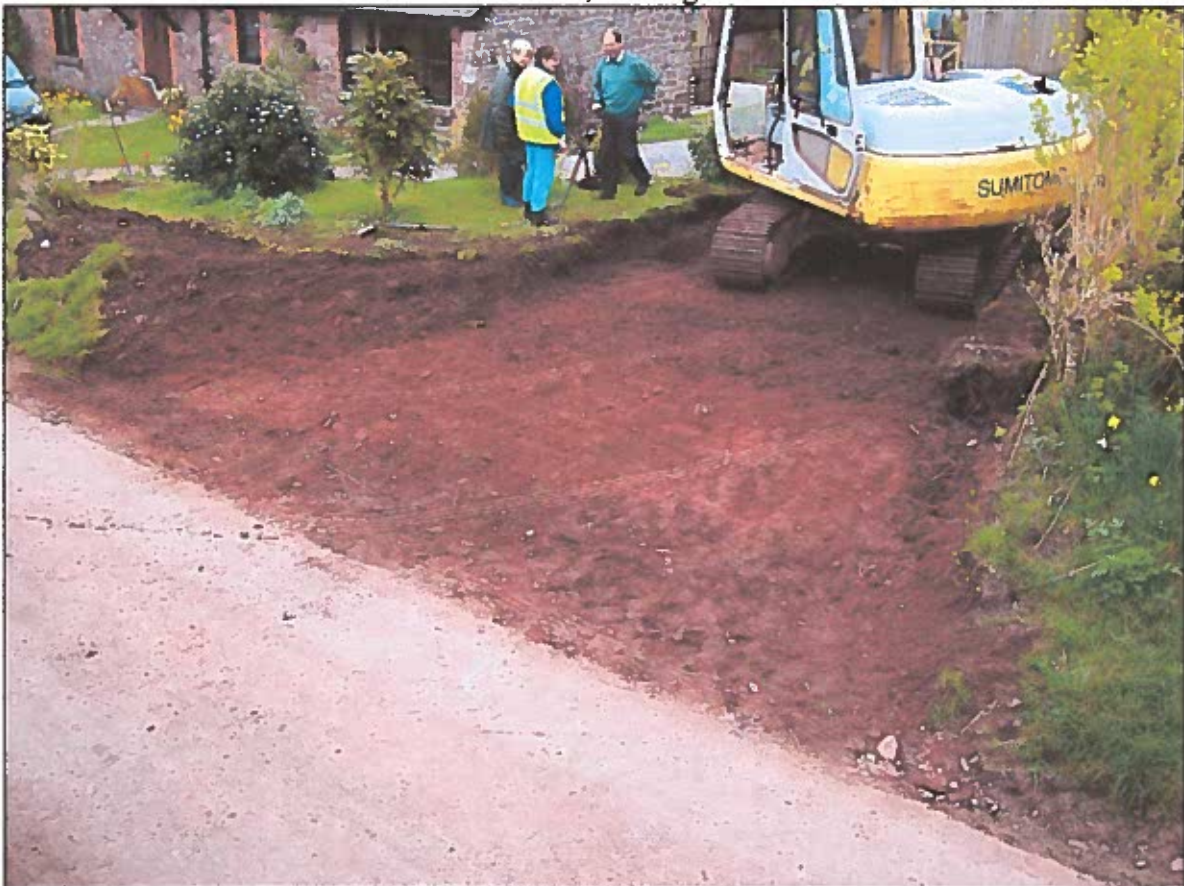
Plate 6: Final level of southwestern end of Area 2, showing roadside ditch, looking north.

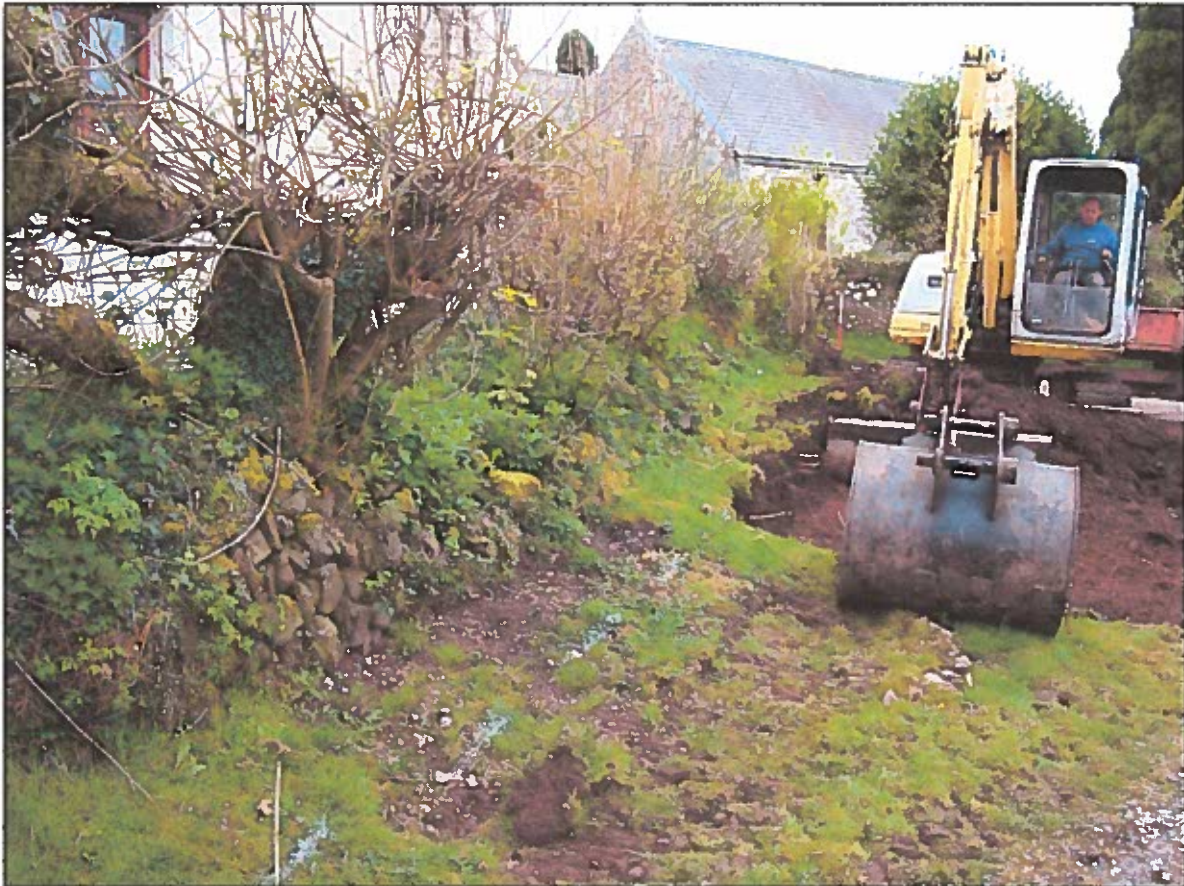
Plate 7: VB07 – Northeastern end of Area 2, showing boundary bank, looking southwest.

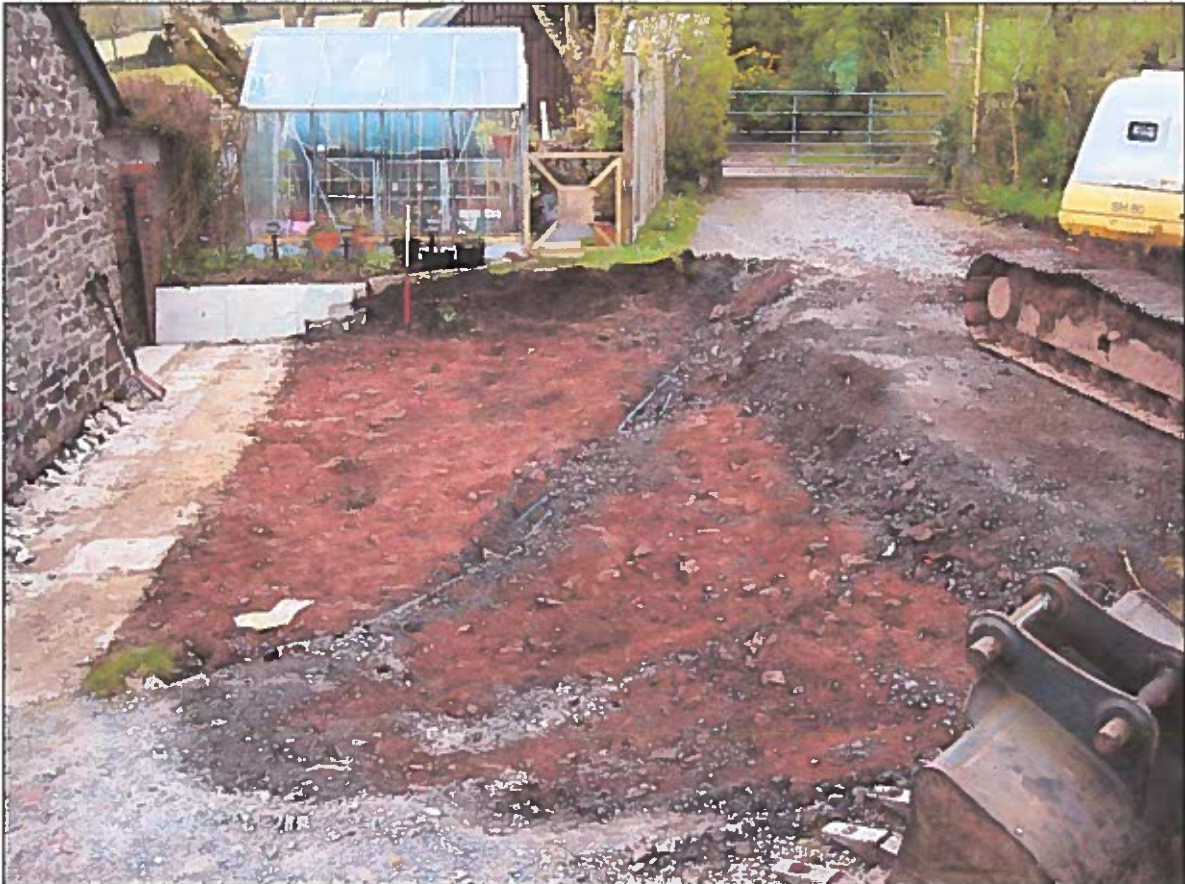
The area to be occupied by the bedroom extension was excavated to a depth of 0.50m down to the natural subsoil. Above this was a brown mixed loam soil containing 20th century debris including a small plastic bat or racquet. No features were seen within the soil, nor cutting the subsoil other than a service trench carrying water and electricity. The service trench had been created previously by the present owner. The present gravel track overlay the soil along the southeastern edge of the excavated area.

Plate 9: VB09 Final level of Area 1 showing service trench and driveway, looking northeast

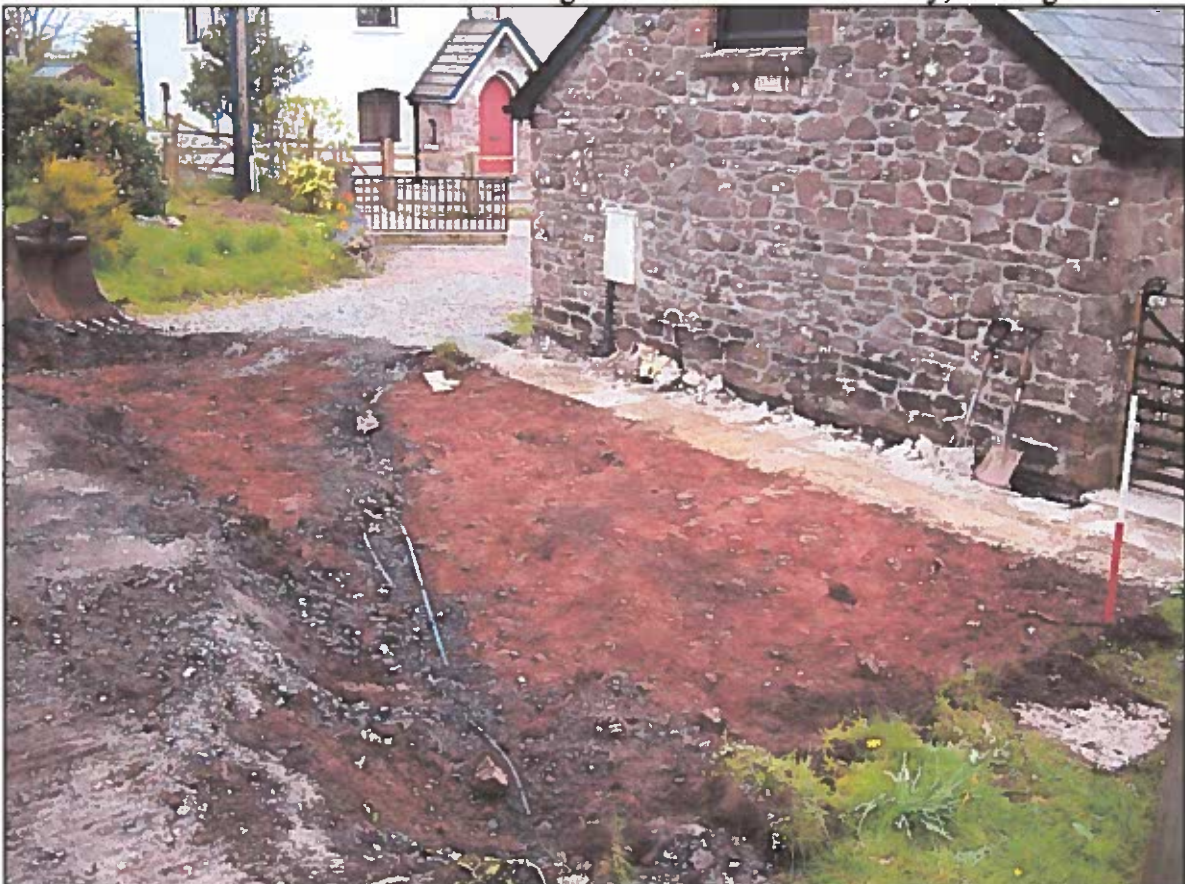
Plate 10: VB10 Final level of Area 1 with service trench and driveway, looking southwest

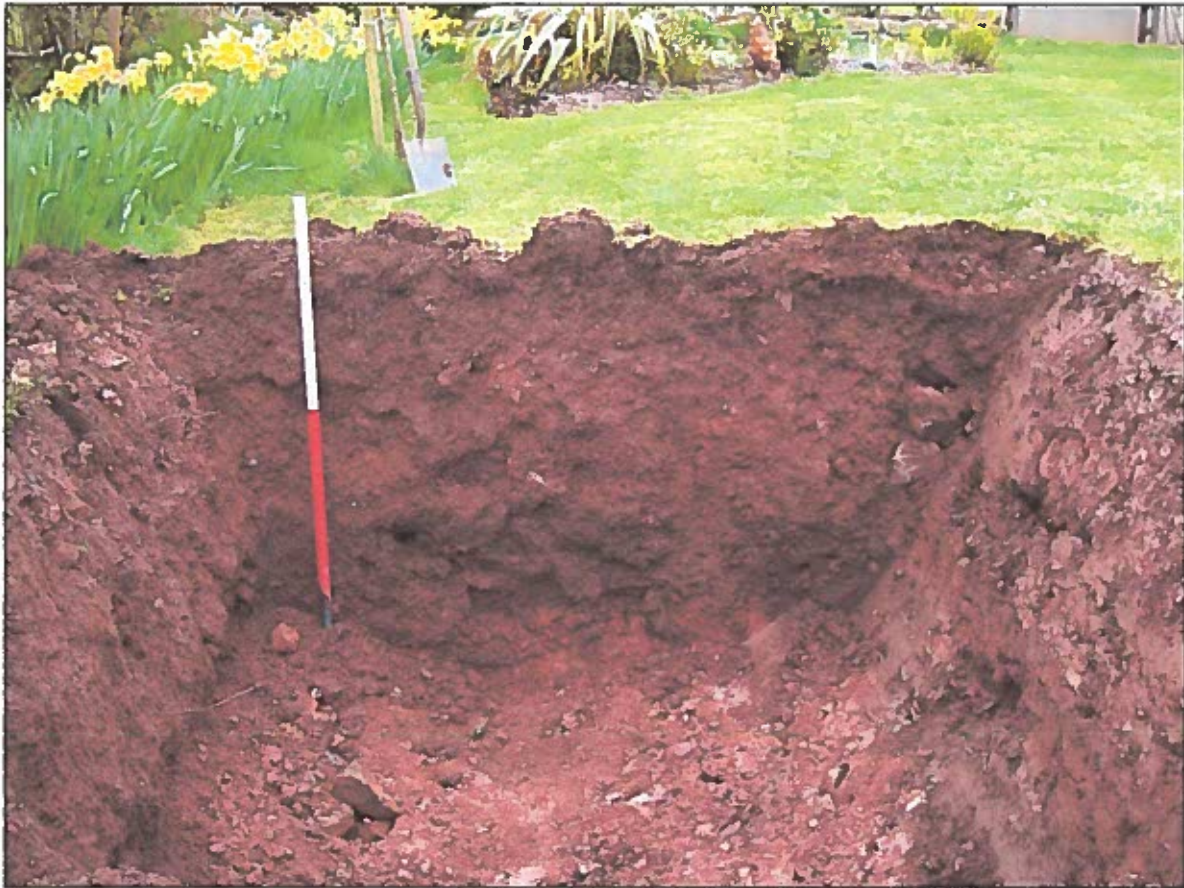
VB11	Excavation of Area 3 showing layer 014	22/04/2009	Looking southeast
VB12	GPO artefact from context 014 in Area 3	22/04/2009	
VB13	Close up of GPO artefact from context 014 in Area 3	22/04/2009	
VB14	Soak away trench in Area 3.	28/04/2009	Looking southwest
VB15	Soak away trench in Area 3.	28/04/2009	Looking northeast

Plate 11: VB11 – Excavation of Area 3 showing layer XX, looking southeast.

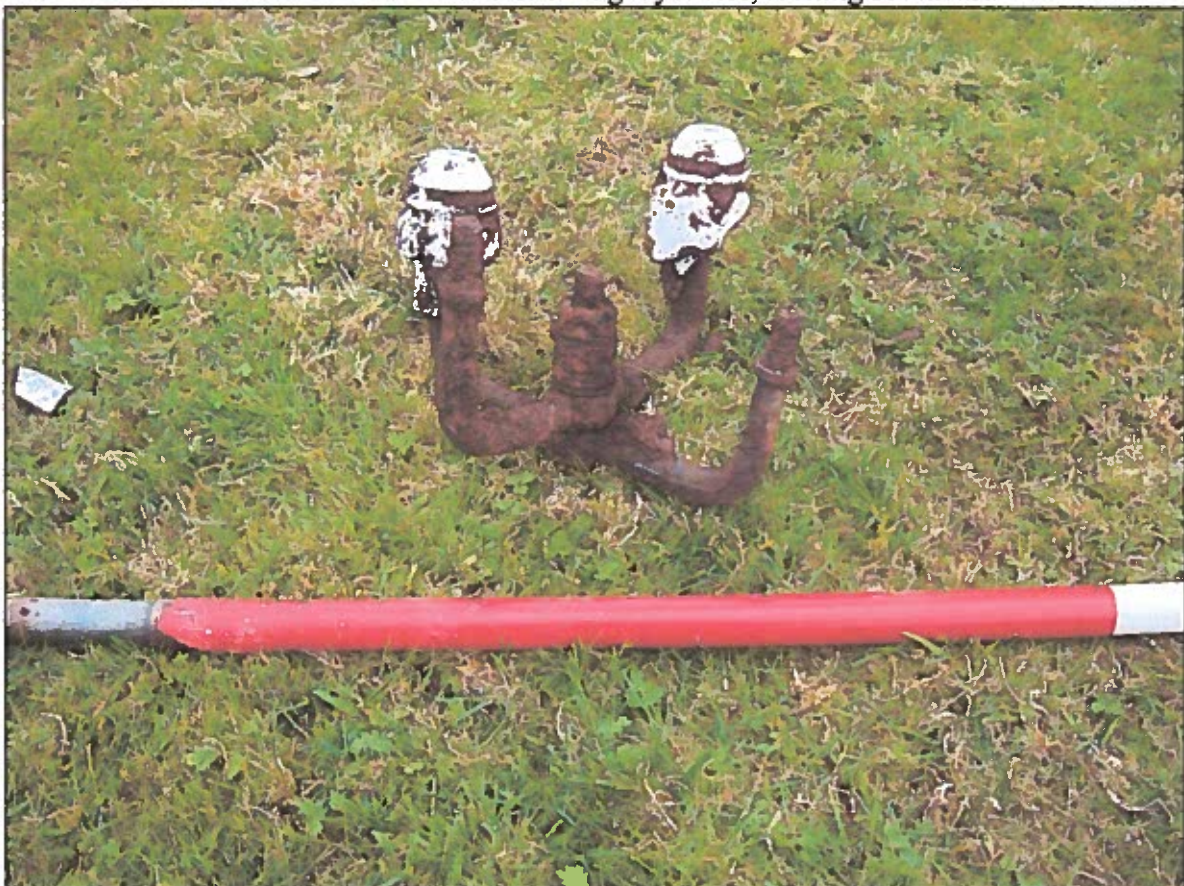
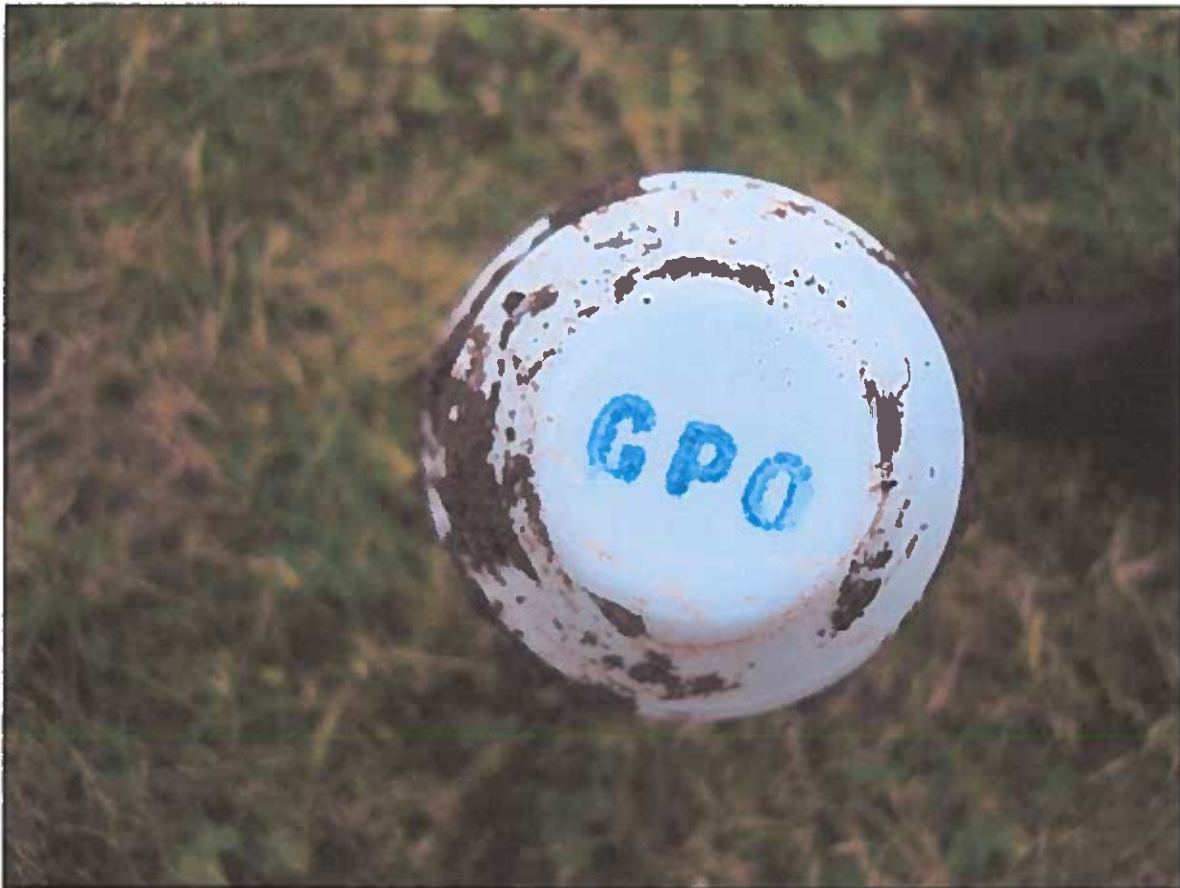
Plate 12: VB12 – GPO artefact from layer XX in Area 3

Plate 13: VB13 – Close up of GPO artefact from layer XX in Area 3

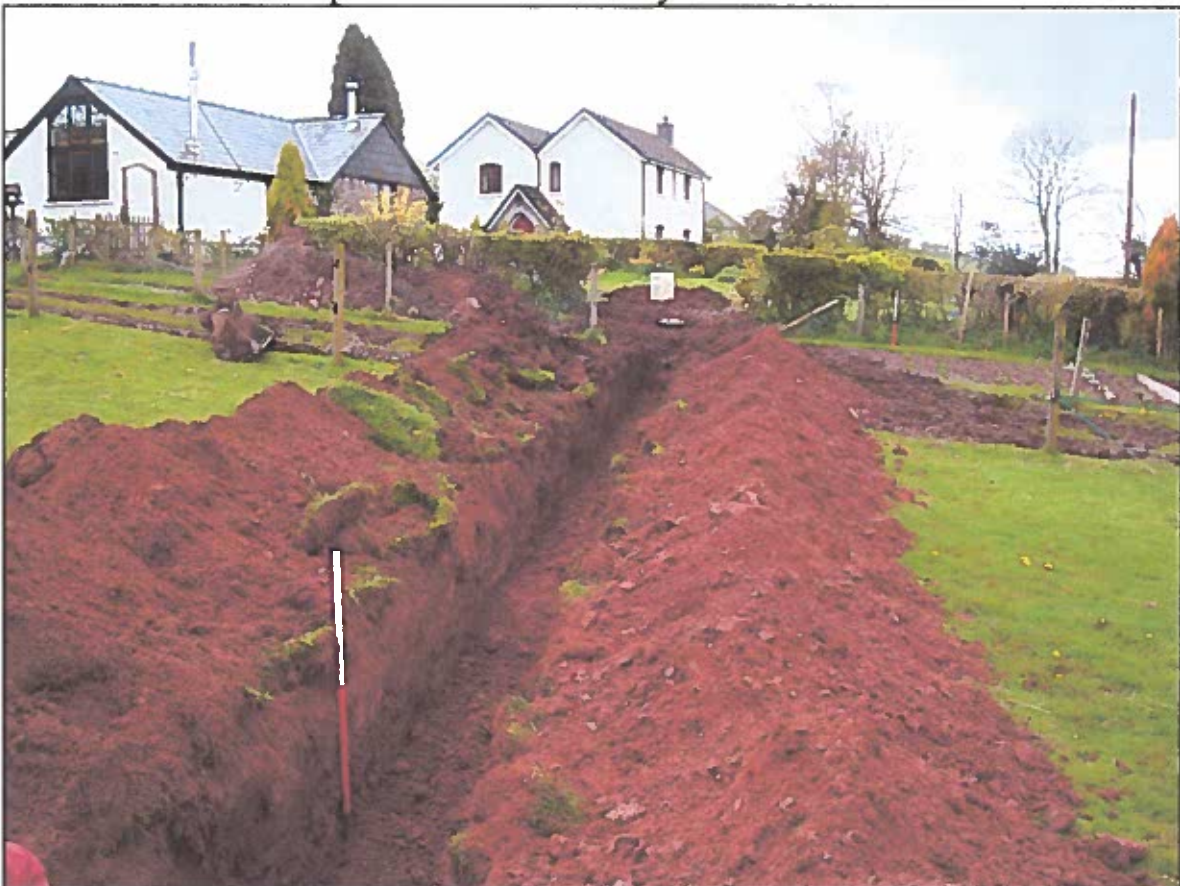
Context Number	Depth	Description	Interpretation
013	0.20-0.25m	Mixed brown loam with some small stones extending from the hedgeline for 5m.	Garden soil in area of field currently in use as a vegetable garden
005	-	Reddish brown with stones	Natural Subsoil
014	0.30m	Reddish brown clay/sand loam	Ploughsoil

Plate 14: VB14 – Soakaway trench in Area 3, looking southwest.

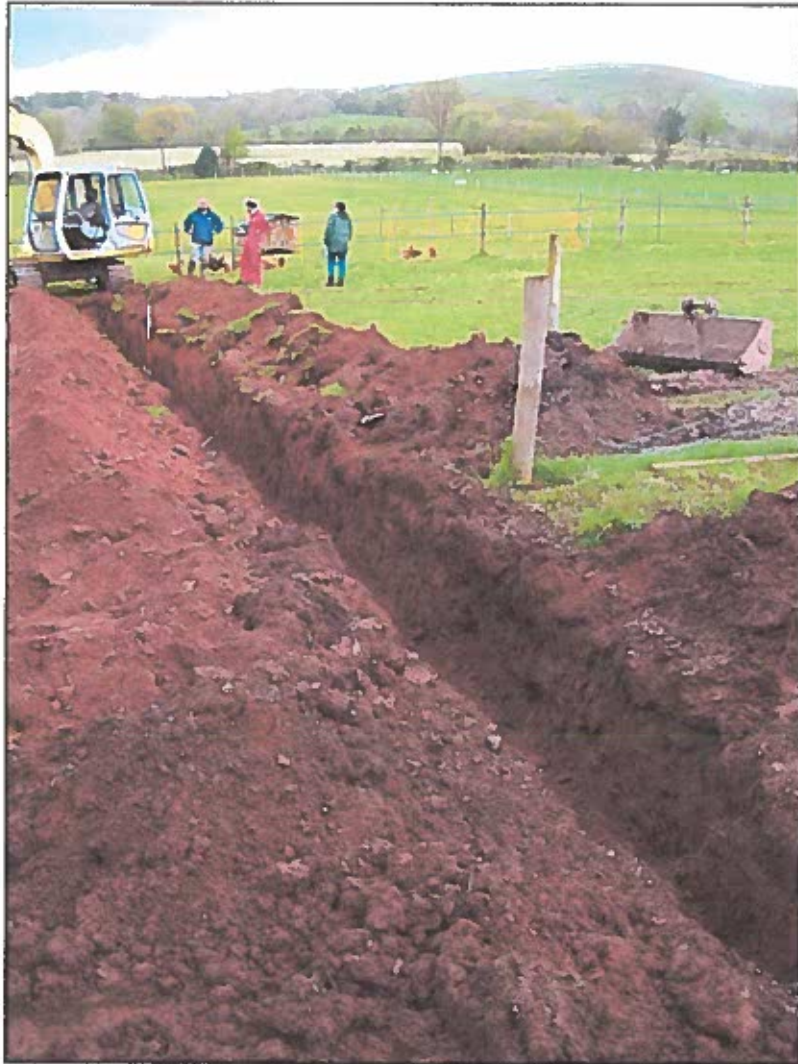
Plate 15: VB15 – Soakaway trench in Area 3, looking northeast.
