Allt Nant y Ci Archaeological Survey

November 2007

Trysor Project No. 2007/98

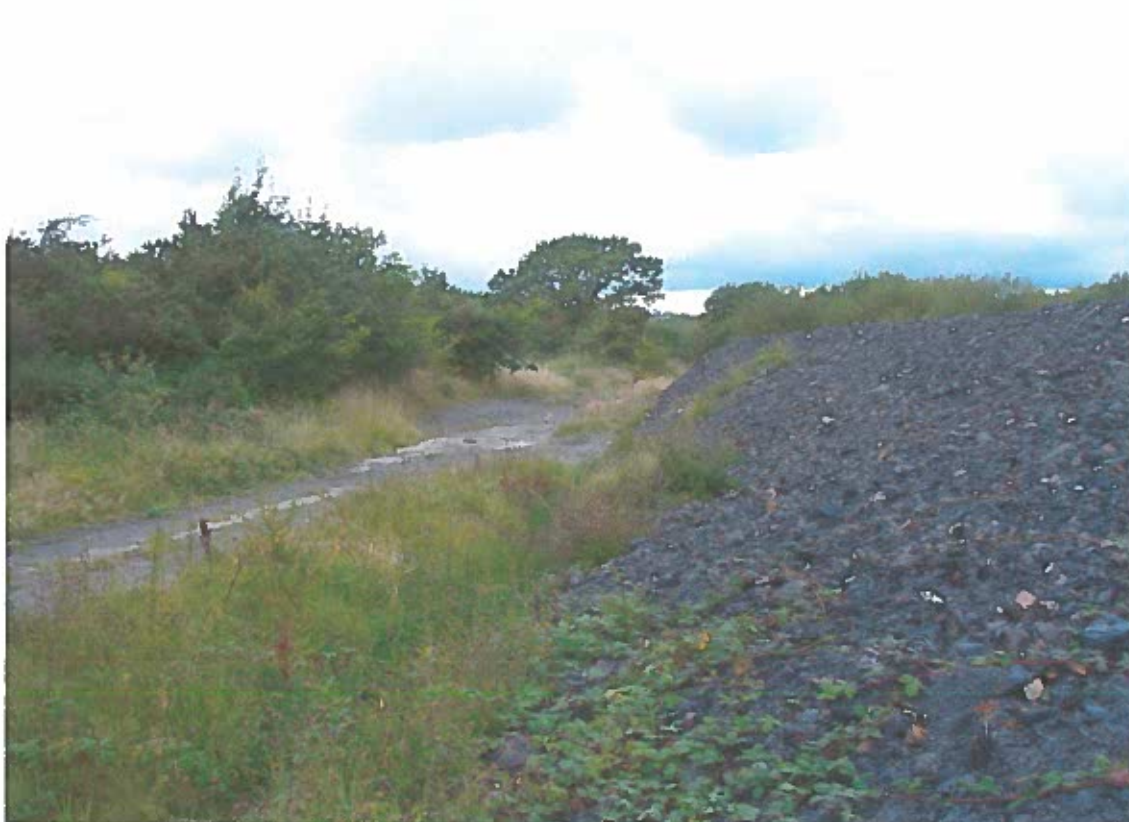
nantyci.011 Looking west at the edge of the main Park & Blaina coal tip 013

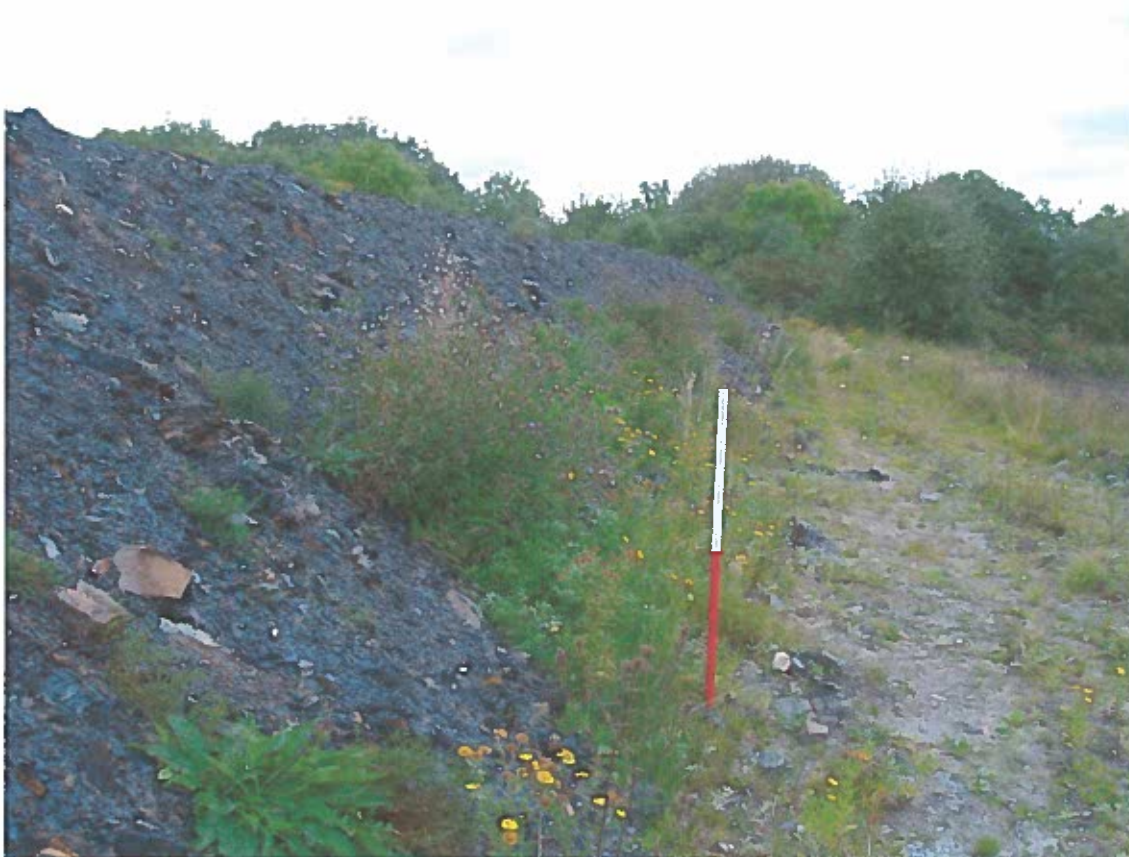
nantyci.012 Looking east at the edge of the main Park & Blaina coal tip 013

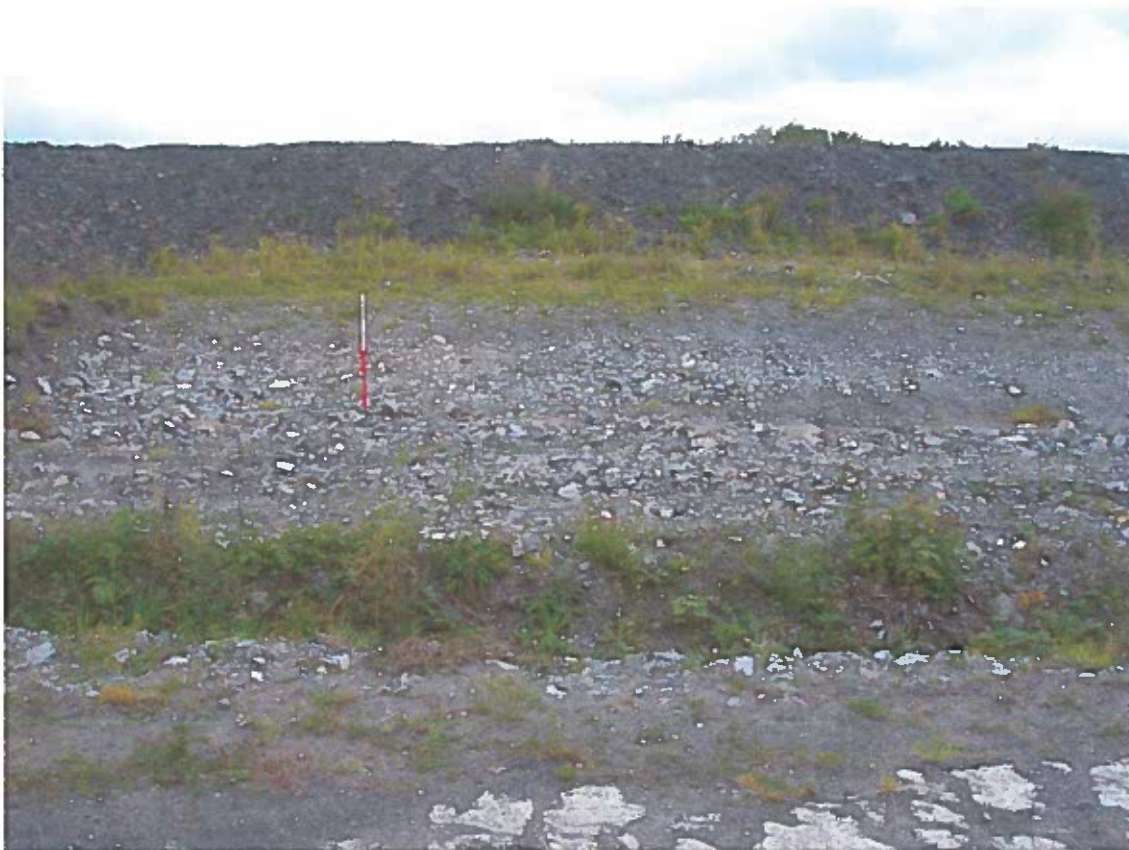
nantyci.013 Looking north at the main Park & Blaina coal tip 013

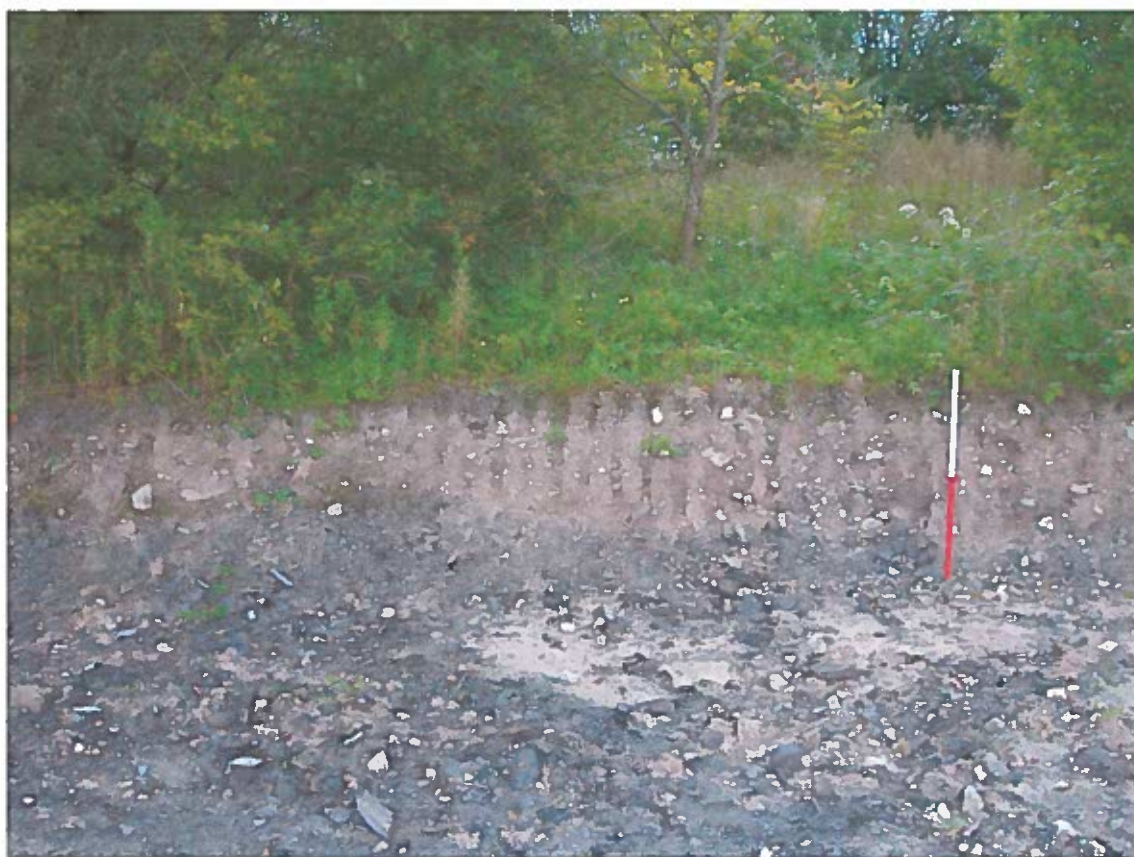
nantyci.015 Clay and coal spoil covering the heapstead area of the Park & Blaina colliery

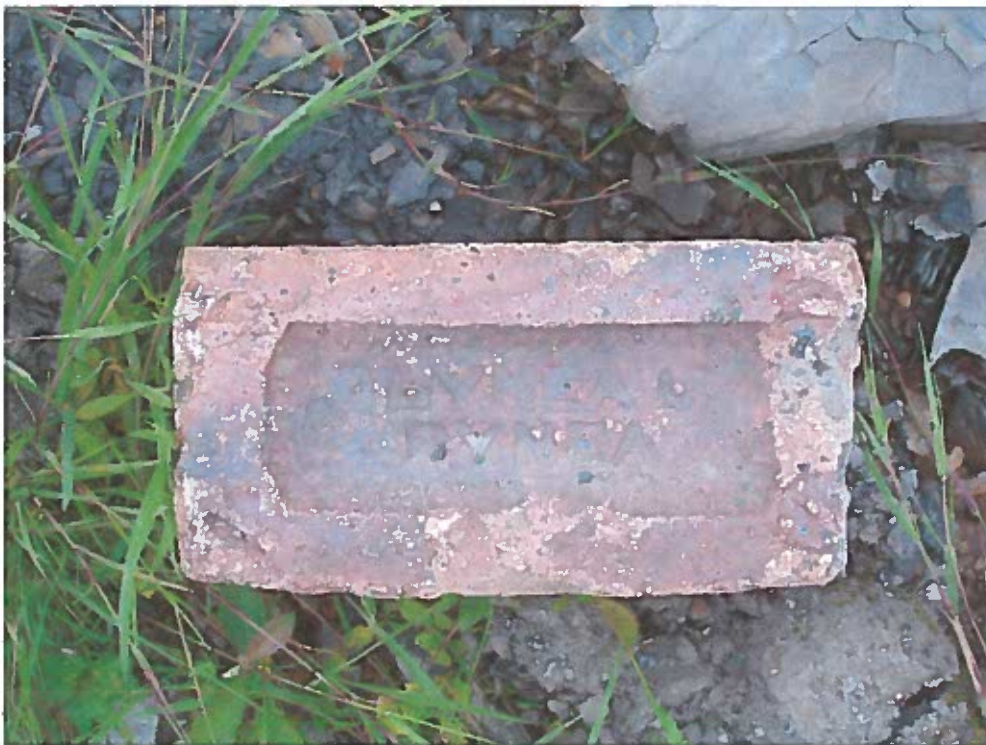
| Photo No. | Description | Date Taken | Direction |
|---|--|---|---|
| nantyci.017 | Detail of Glynea & Bynea brick found on coal tip 013 | 05/09/2007 | - |

nantyci.017 Detail of Glynea Bynea brick found on coal tip 013

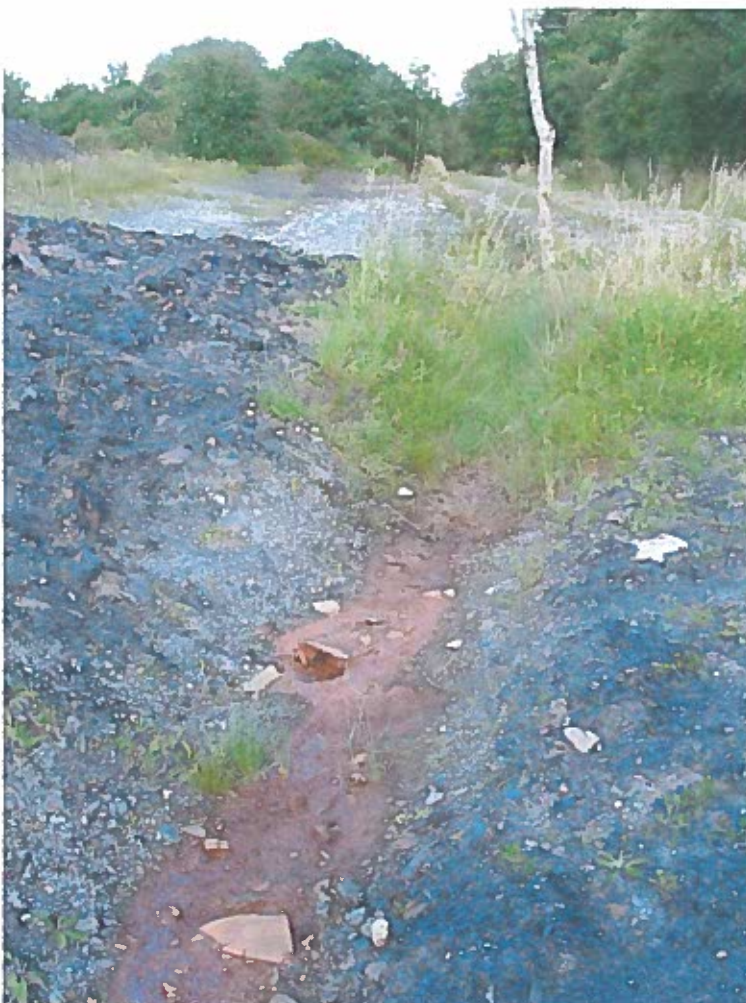
| Photo No. | Description | Date Taken | Direction |
|---|--|---|---|
| nantyci.018 | Showing iron-stained water in gully alongside coal tip 013 | 02/08/2007 | Looking east |

**nantyci.018 Iron stained
water flowing alongside
coal tip 013**

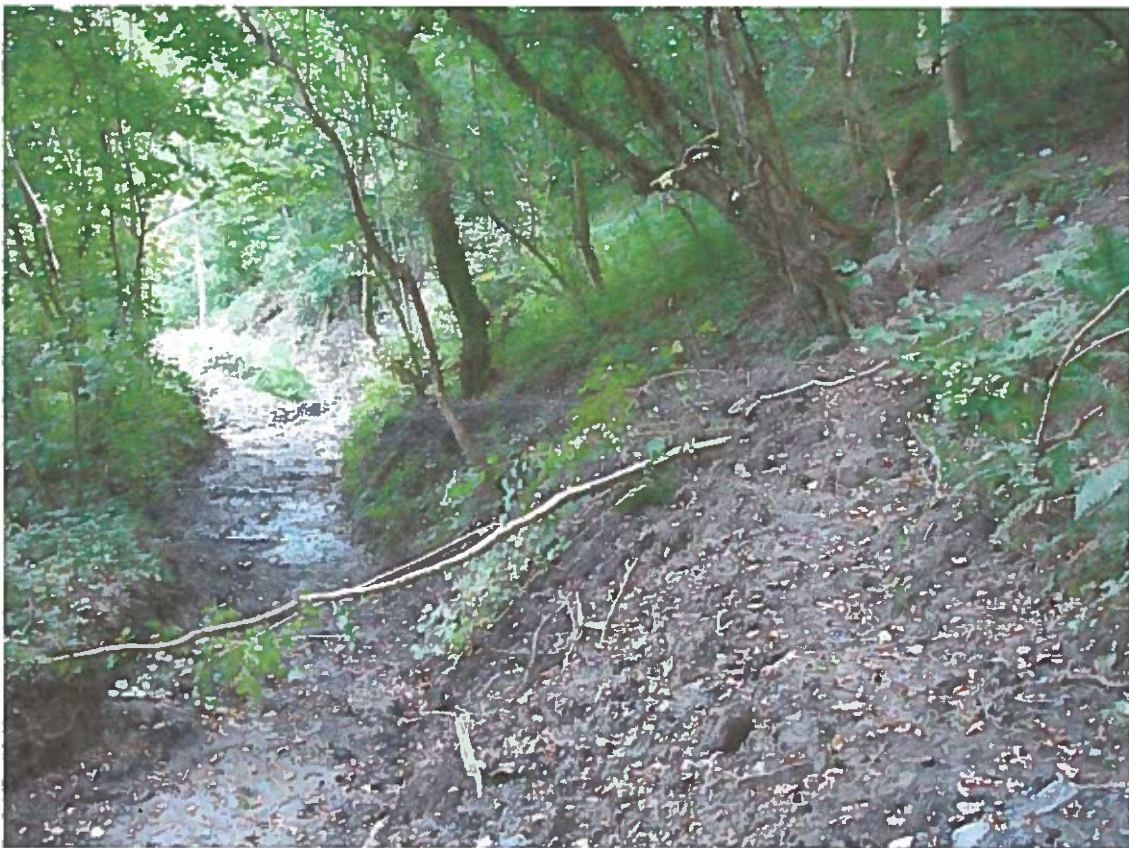
| Photo No. | Description | Date Taken | Direction |
|---|--|---|---|
| nantyci.020 | Recently excavated gully, adjacent to the Nantyci | 05/09/2007 | Looking east |

nantyci.020 A recently excavated gully adjacent to the Nantyci brook

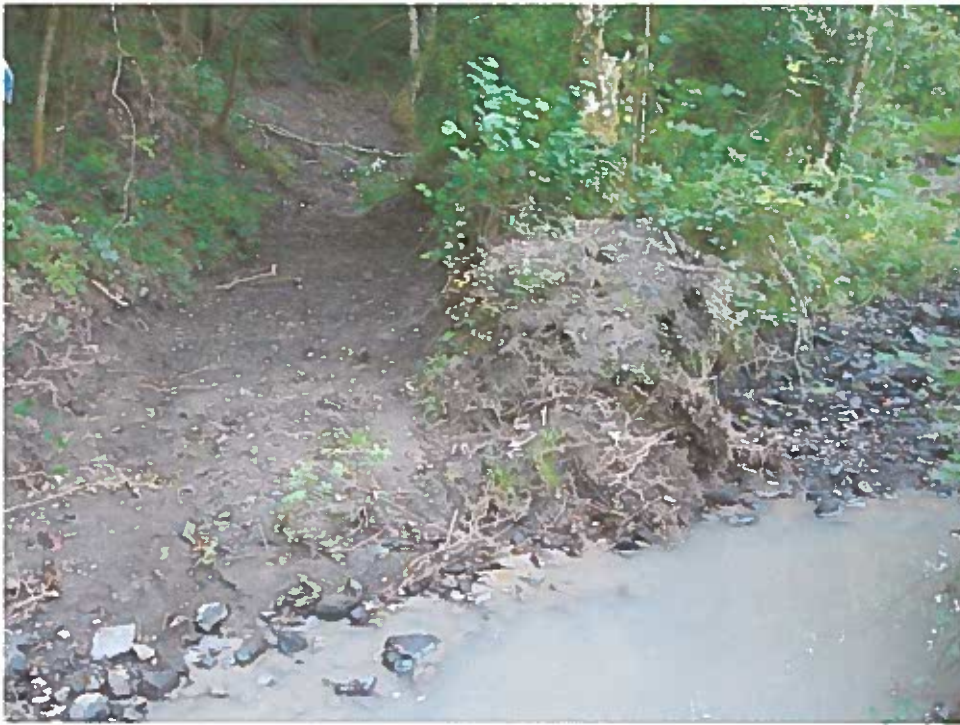
nantyci.021
Recently excavated
gully joining the
Nantyci brook

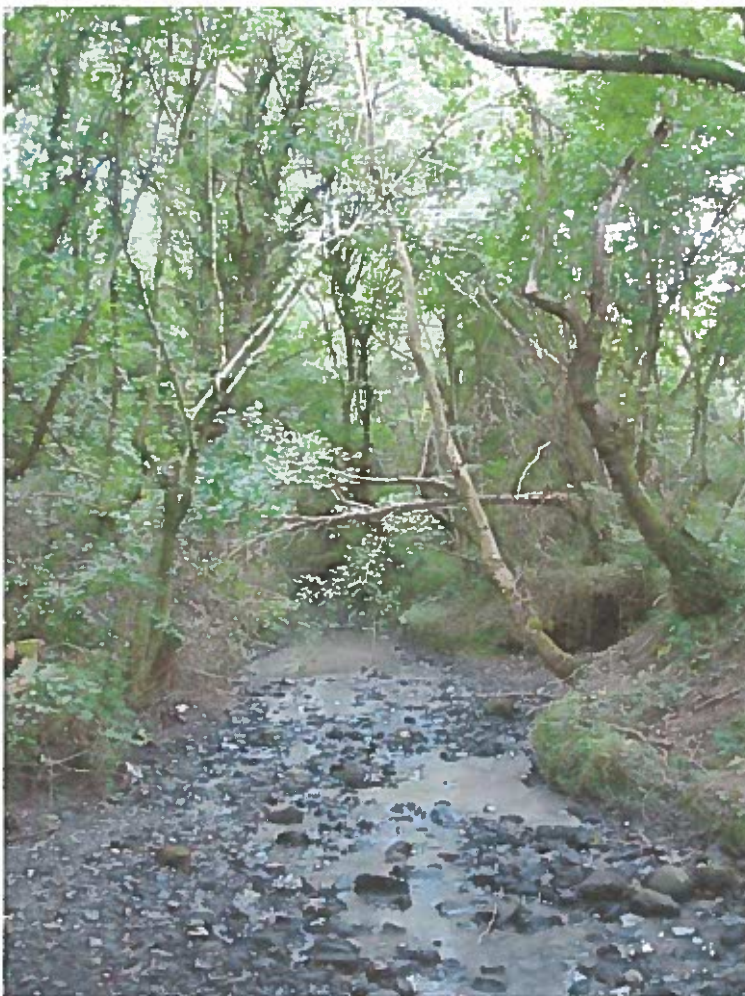
nantyci.022 The Nantyci
brook with a modern
drainage channel cut to
the right

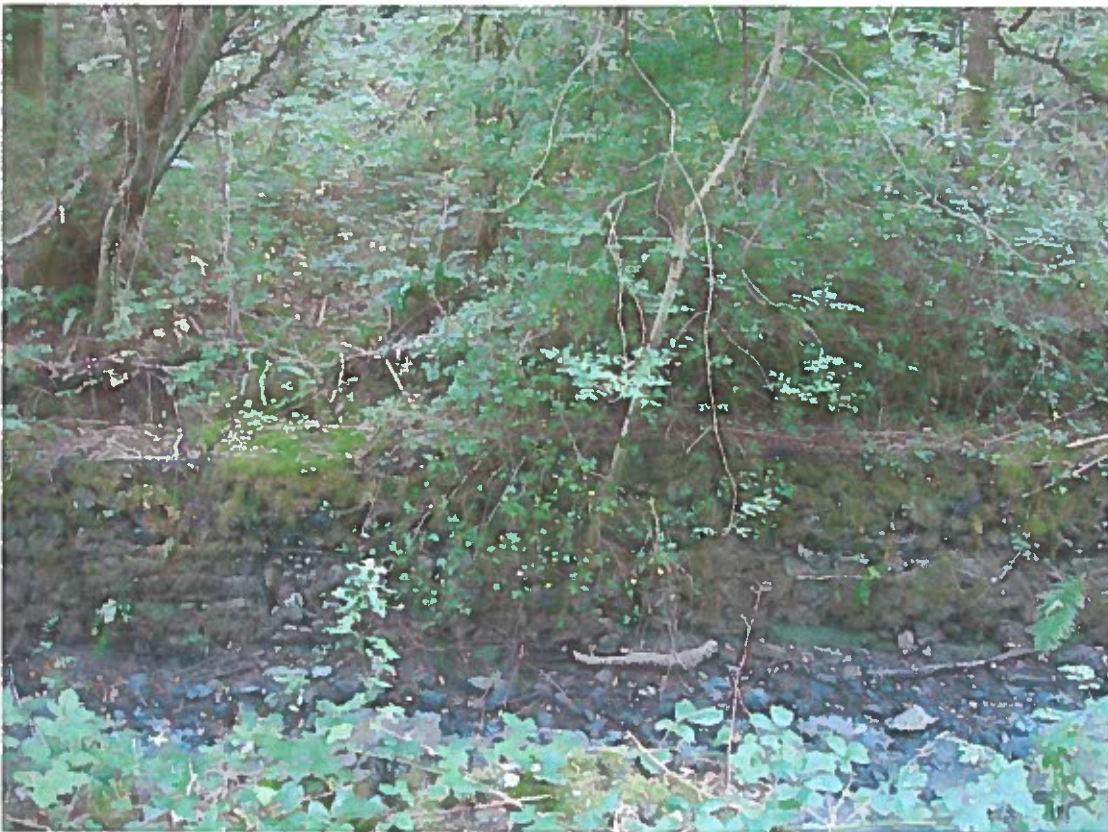
nantyci.024 Modern revetment along the south bank of the Nantyci brook

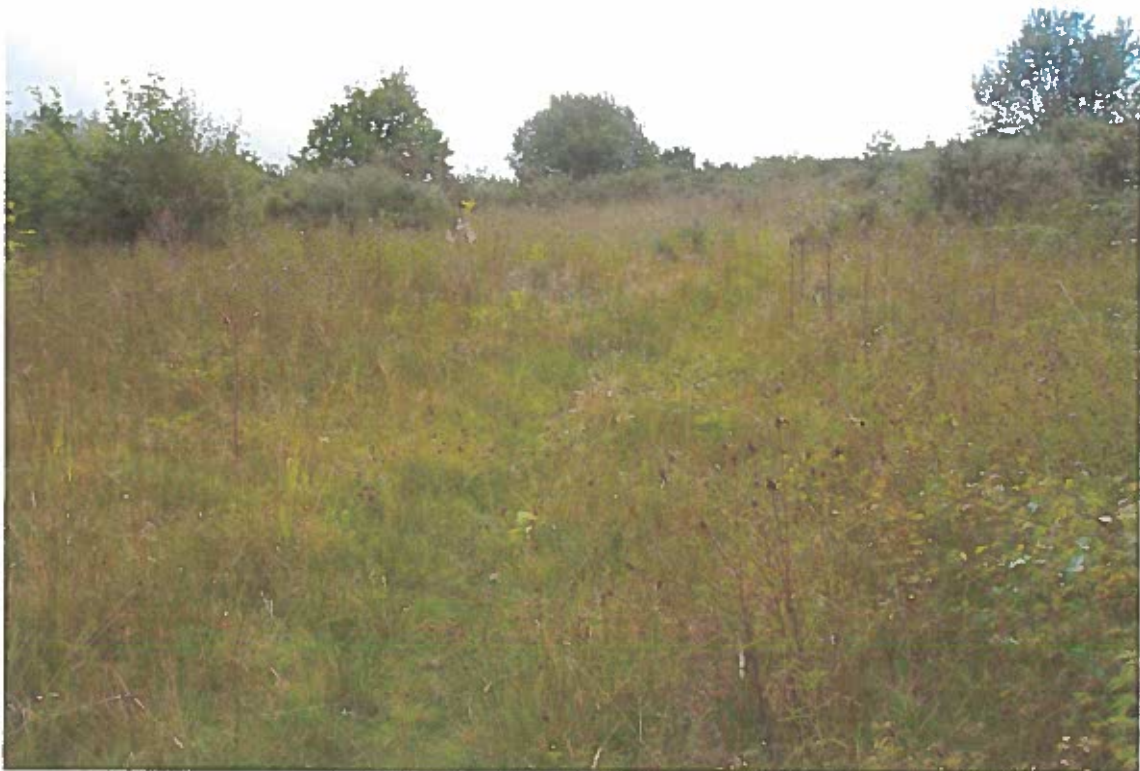
nantyci.025 Eastern edge of Cae Cwmffalde, the undisturbed field north of Nantyci brook

- The management of the undisturbed field (C) to the north of the Nantyci brook should reflect the fact that it has not been farmed for several decades and appears to be rich in plant and insect life. The field itself is a fragment of the pre-industrial landscape and as such should be retained.

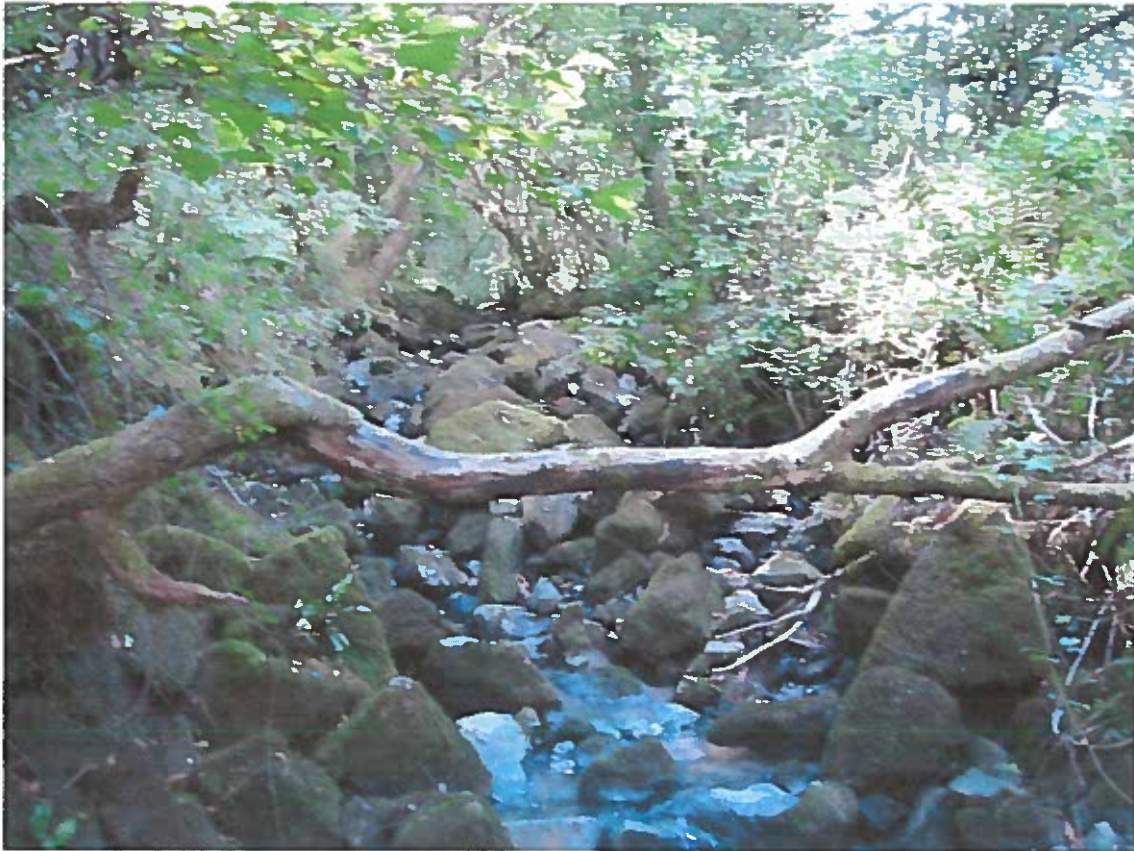
nanty-ci.027 Canalised stream joining the Nantyci brook

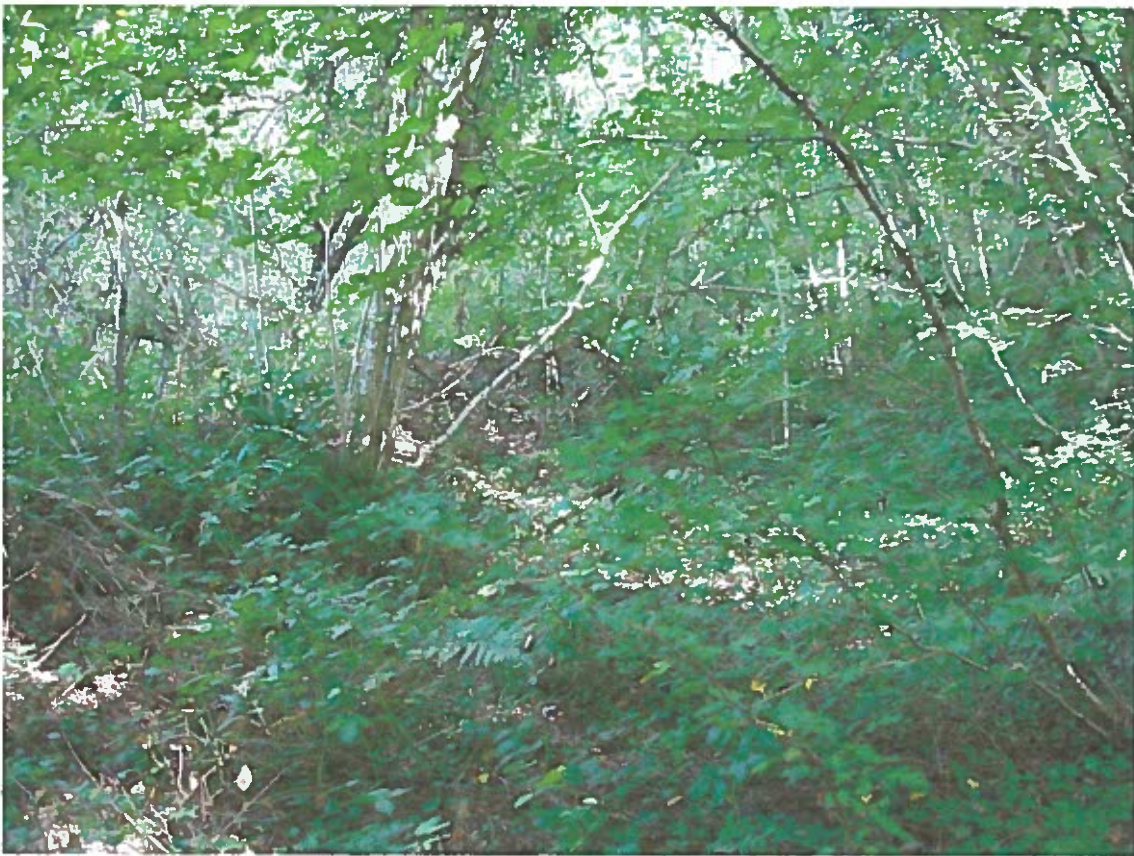
| Photo No. | Description | Date Taken | Direction |
|---|--|---|---|
| nantyci.028 | Line of former tramway bed serving the Saron Colliery? | 05/09/2007 | Looking east |

nanty-ci.028 Line of the former tramway bed to Saron Colliery

- The surviving section of the original tramway bed (A) connecting Saron Colliery to its colliery screens and the main railway line should not be disturbed by development work.
