Castlewood Leisure Park, Narberth Watching Brief

January 2008

Brookside, Narberth Watching Brief

Trysor Project No. 2007/97

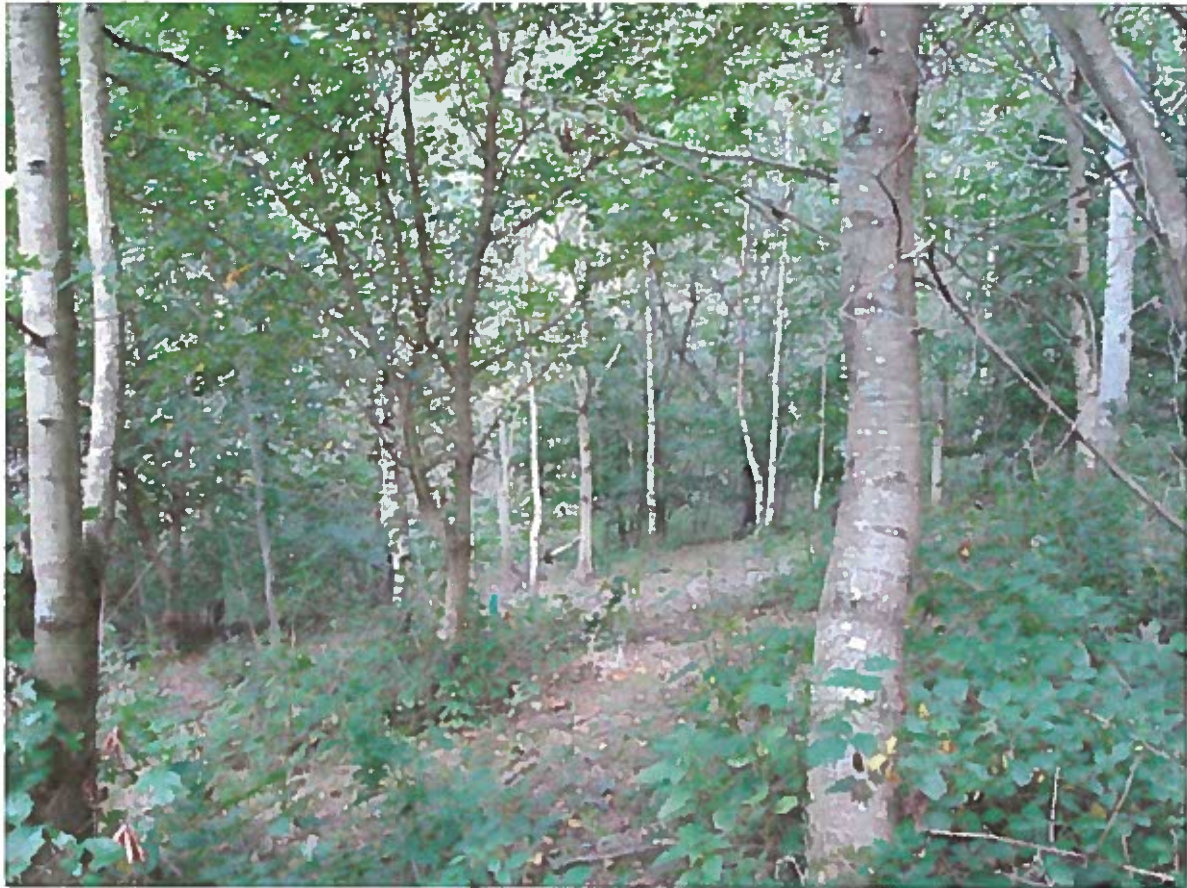
The development consists of 9 self catering holiday units, each measuring 20' x 40', with access roads, and parking for 20 cars. Service trenches and some landscaping accompanied the development. Prior to development, the land parcel was relatively thickly wooded with deciduous trees planted over 20 years previously. Most of these were removed in advance of groundwork beginning.

Plate 1: Castlewood Leisure Park Development Area prior to vegetation clearance, looking towards to the northern end of the site.

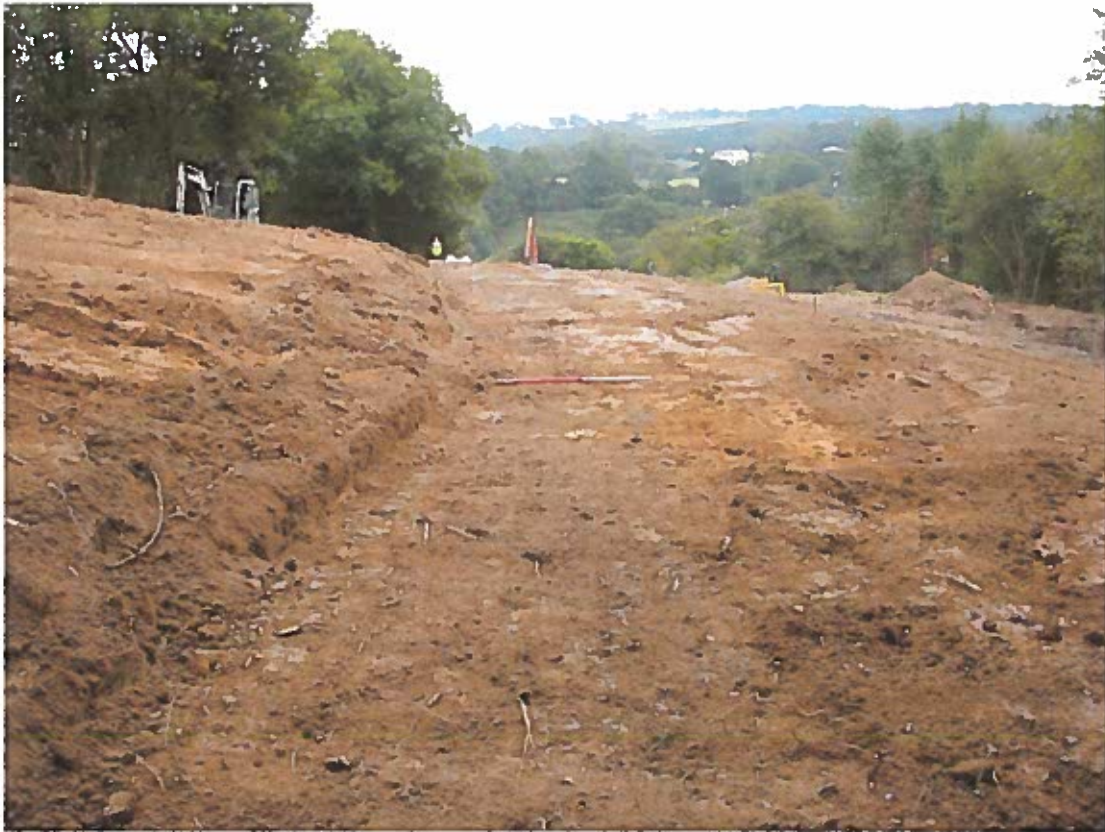
Plate 3: The line of the old trackway (Feature No. 022)

The watching brief found little of archaeological interest, although an old trackway underlying the post-mediaeval field system was noted. This pre-19th century trackway appeared to have been running southwards away from Narberth town towards the river valley below Narberth Castle. A 20th century chambered spring was also recorded, built from red bricks produced at the Goodwick Brickworks Ltd, which was operational between 1910 and 1969.

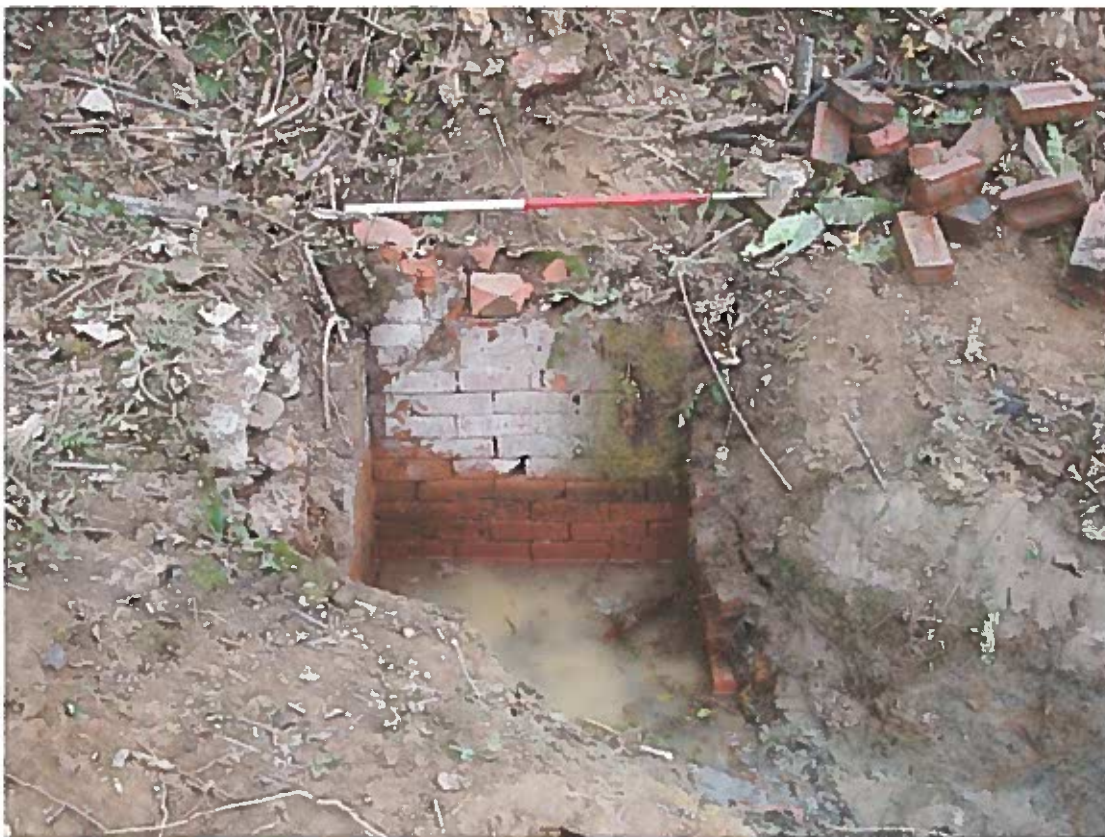
Plate 4: The brick-lined spring chamber (Feature No. 020)

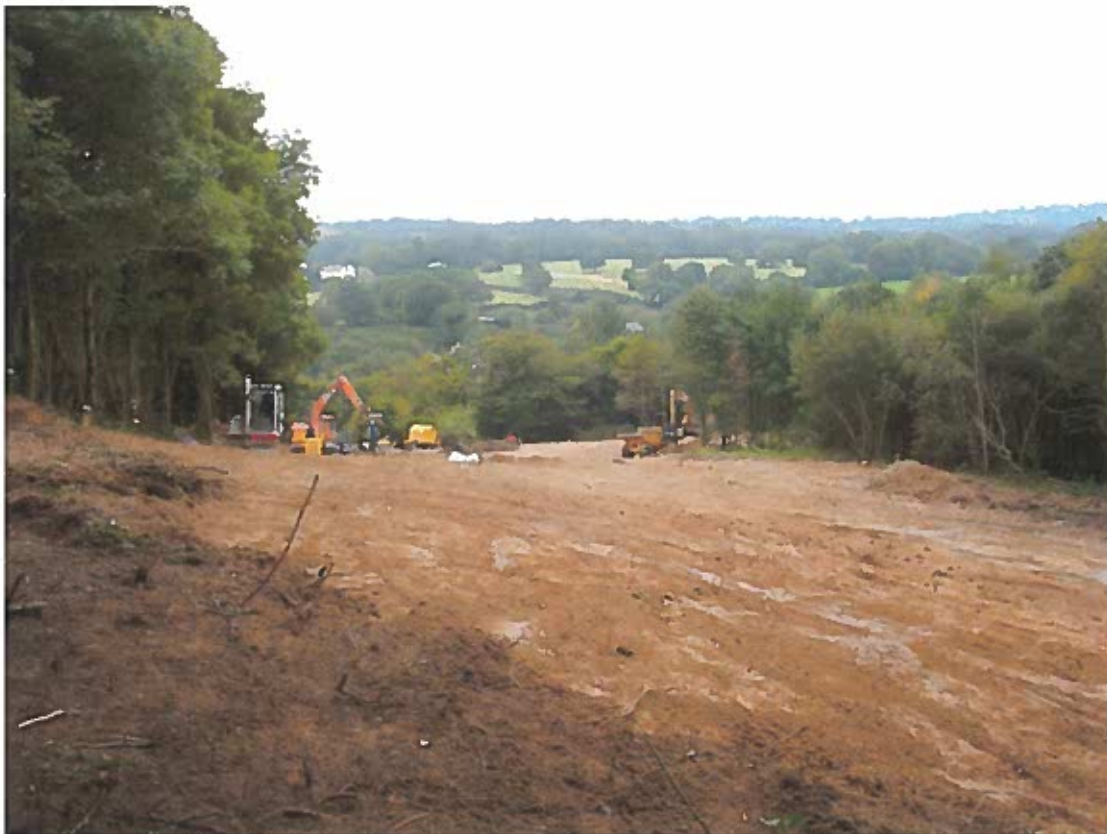
The site comprised of a parcel of former agricultural land that had been planted with deciduous trees some 20 years previously. Most of this woodland was removed by the development. This revealed a clayey surface, which was relatively wet, due to the presence of a spring line across the site. The original names of the two former field parcels incorporated into the development area were Lower Moor and Upper Moor, suggesting that this had not been prime agricultural land in earlier times. Indeed evidence of attempts to drain the land was found in the form of drainage ditches cut parallel to some of the field boundaries at the northern end of the development area.

Plate 5: Castlewood Leisure Park Development Area following the removal of trees and vegetation, looking southwards from the northern end of the site.
