Caerwedros, Ceredigion:

Archaeological Watching Brief

Report No. 625

Date: April 2010

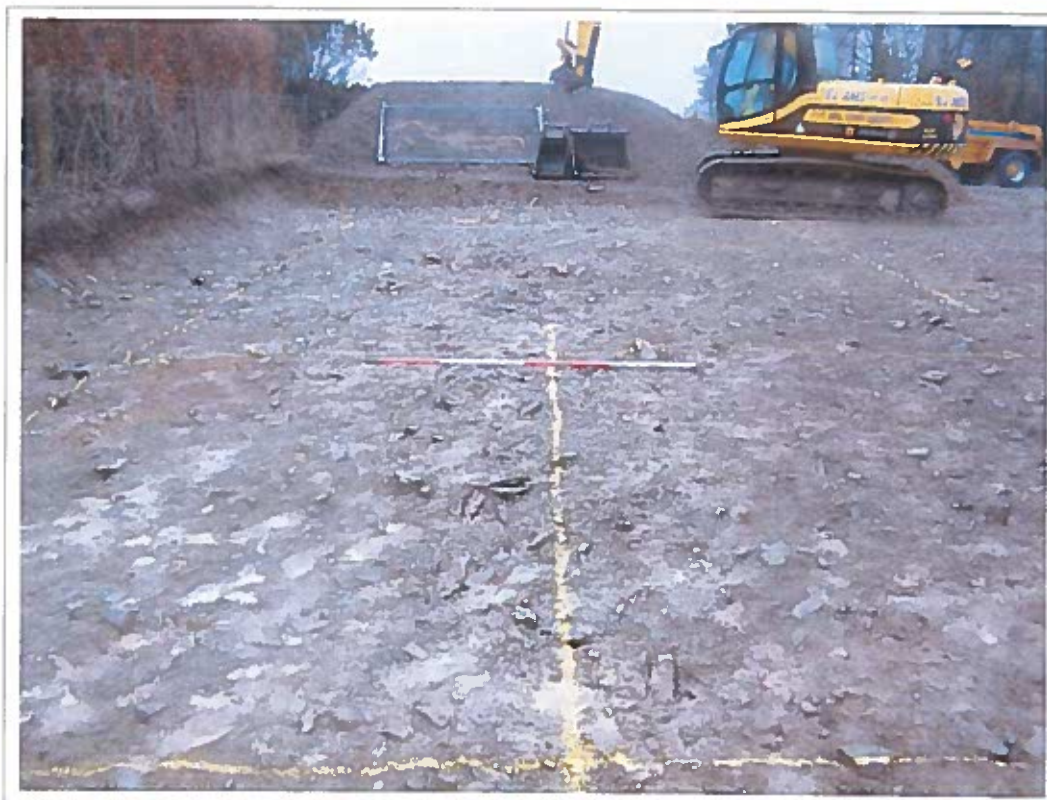
4.1.2 Topsoil and subsoil deposits were removed to a depth of 0.40m to 0.85m from within an 'L' shaped area measuring approximately 200m east to west by 175m north to south (Plates 1 to 3).

4.2.1 Topsoil was removed from the entire area. It varied in depth from 0.20m to 0.40m.

Plate 1: West end of site after removal of topsoil, looking north east. Scale 2m

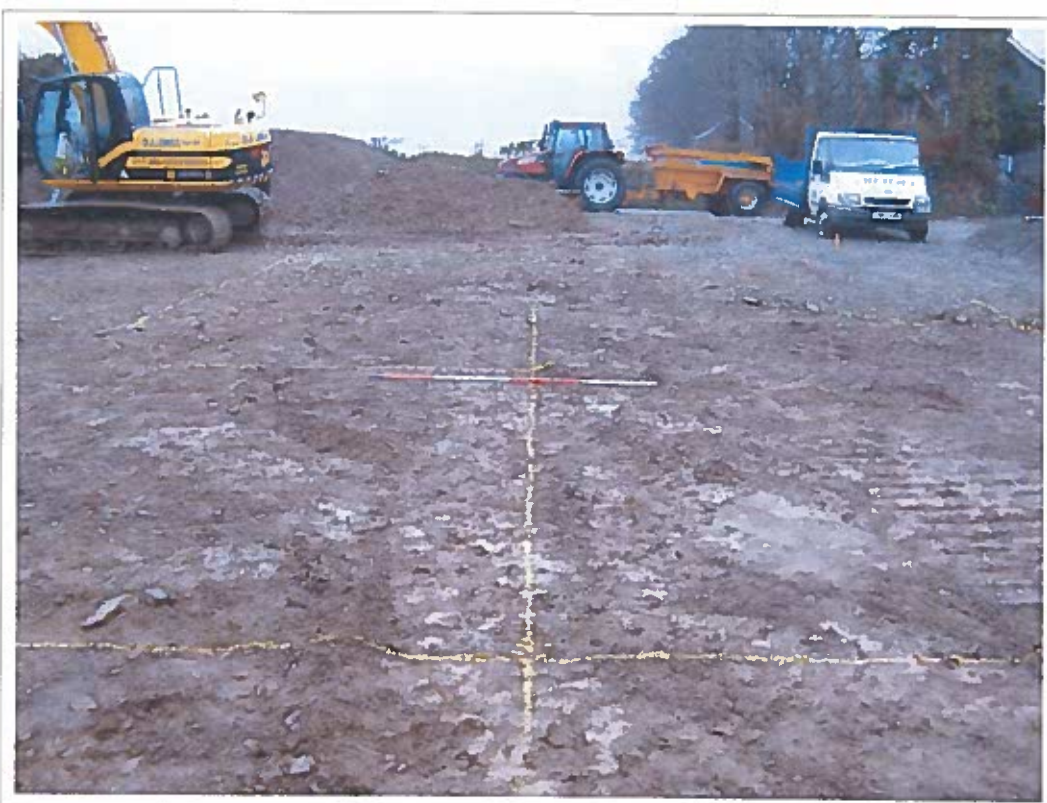
4.2.2 The subsoil consisted of mid brown, silty, clay mixed with moderate to frequent stone inclusions (weathered bedrock). It varied in depth from 0.20m to 0.30m. It was removed from the western and central parts of the site, but was only partially removed in the east.

Plate 2: East end of site after removal of topsoil, looking north east. Scale 2m

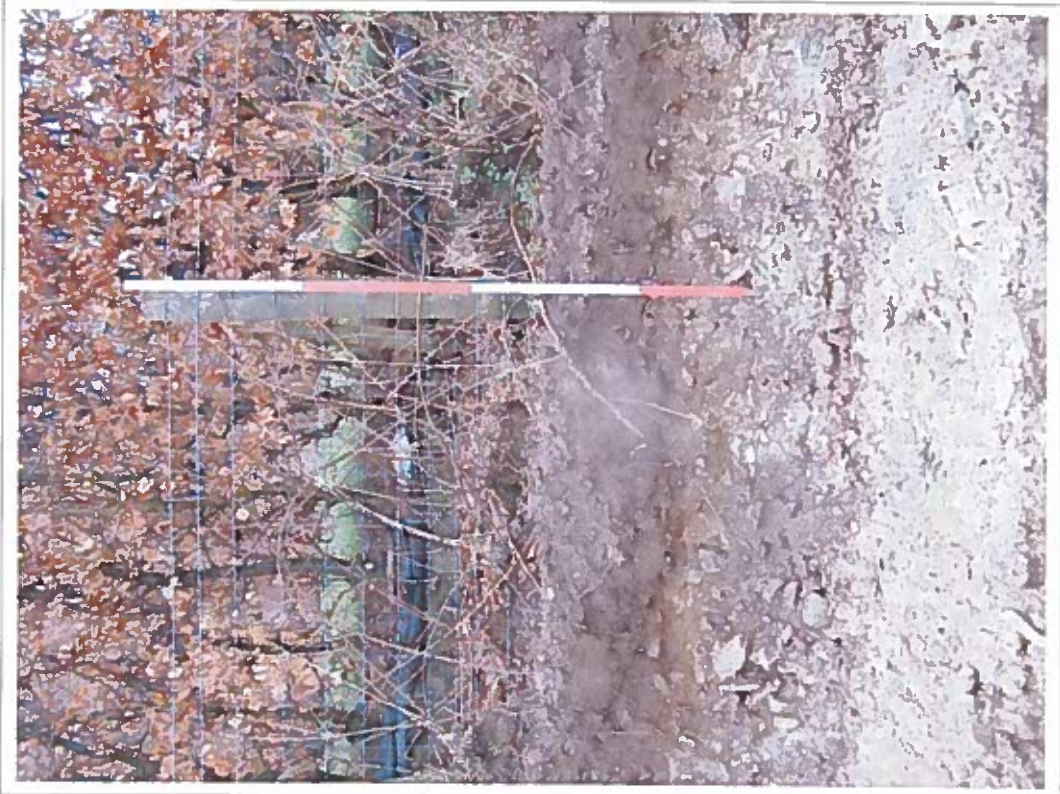
Plate 3: Detail of west section, looking west. Scale 2m

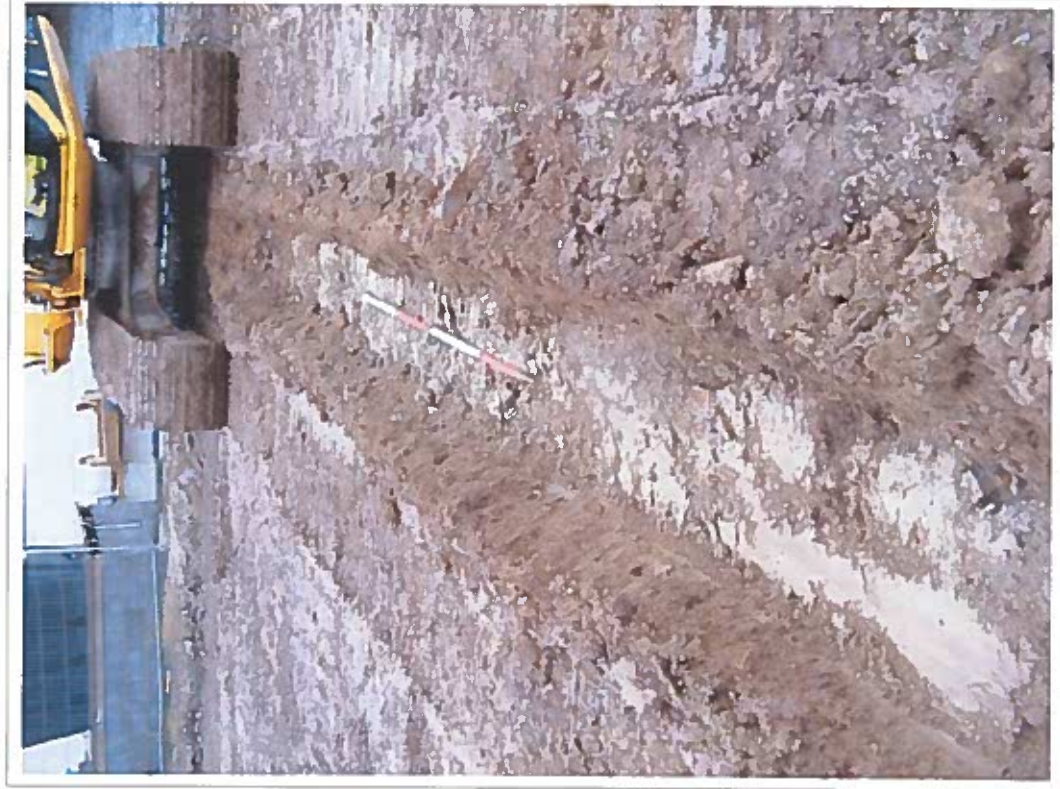
4.1.3 Subsequently, foundation trenches were cut into the base of the exposed horizon (Plate 4).

4.2.3 The natural ground surface consisted of mid yellow brown, silty, clay mixed with frequent stone inclusions (weathered bedrock). It was removed to a depth of up to 0.30m in the western part of the site, and was exposed in the central part.

Plate 4: Southern foundation trench, showing subsoil removed to the top of the natural, looking east. Scale 2m
