From: Alice Pyper
Sent: 16 December 2020 11:44
To: 'Permitting Consultations'
Subject: RE: PAN-012213 Request for comments on deployment application

DAT File No 14895

Deployment Reference Number:	PAN-012213
Permit Reference Number:	EPR-AB3891CX
Permit Holder:	Stepside Agri
Site address:	Rhosygadair Fach, Tremain, Cardigan, Ceredigion, SA43 1RP
Grid reference:	SN 23253 50212

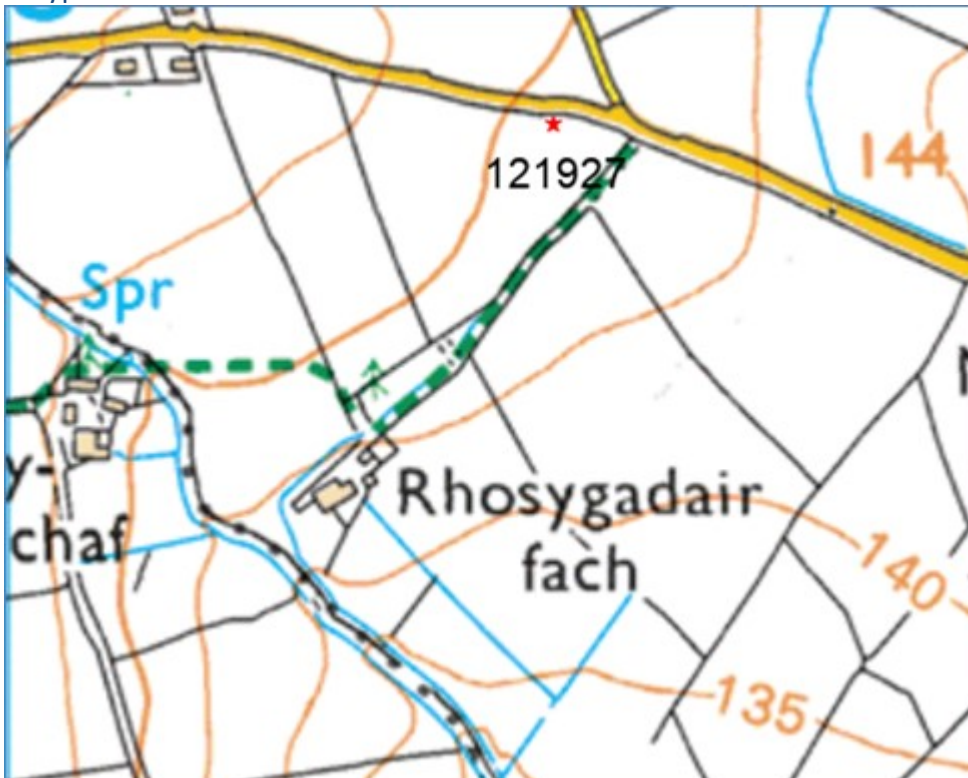
PRN 121927
PERIOD AND TYPE POST MEDIEVAL HOUSE
NGR SN23415051
SUMMARY

A small house called Ty-newydd is shown on the 1st edition OS map (1890), but is no longer shown on the 2nd edition (1905).

Having assessed the application, the proposals for land-spreading of waste should not have a detrimental impact on these features, which do not exhibit above-ground remains. However there may be archaeological deposits surviving below ground in those areas within the orange boundaries shown in the maps above, and we would recommend that these locations are not suitable for ground intrusive activities.

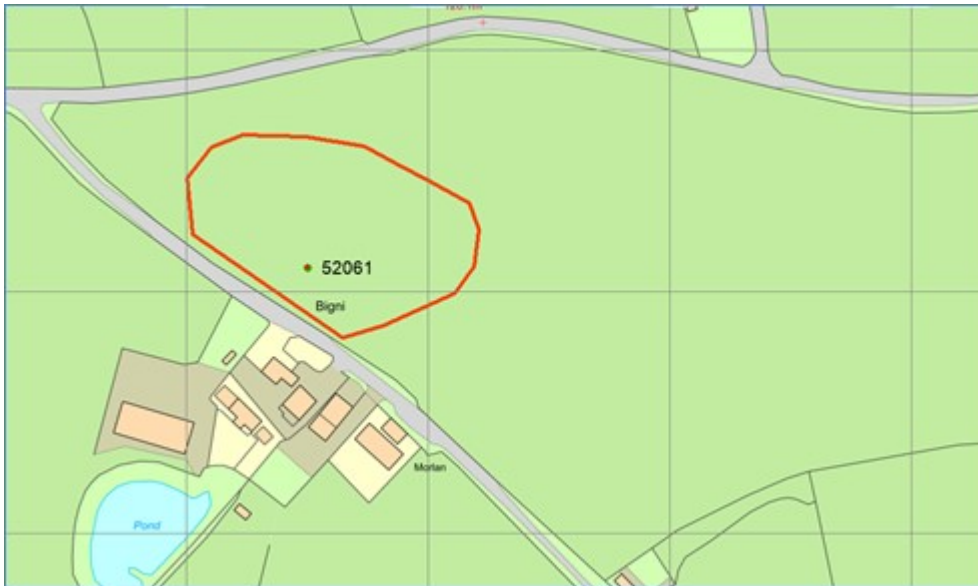
PRN 52061
PERIOD AND TYPE IRON AGE DEFENDED ENCLOSURE
NGR SN20755131
SUMMARY

A small cropmark enclosure lies on gentle northwest-facing coastal slope at 120m above sea level, with views over Cardigan Bay to the north. It is a cropmark site with no earthwork or other surface evidence. It is sub-rectangular in shape, approximately 40m northwest - southeast and 30m southwest - northeast, and defined by a cropmark ditch. The southwest side lies under a hedge-bank. There is no obvious entrance. In 2005, the site was under improved pasture. K Murphy 15 November 2005

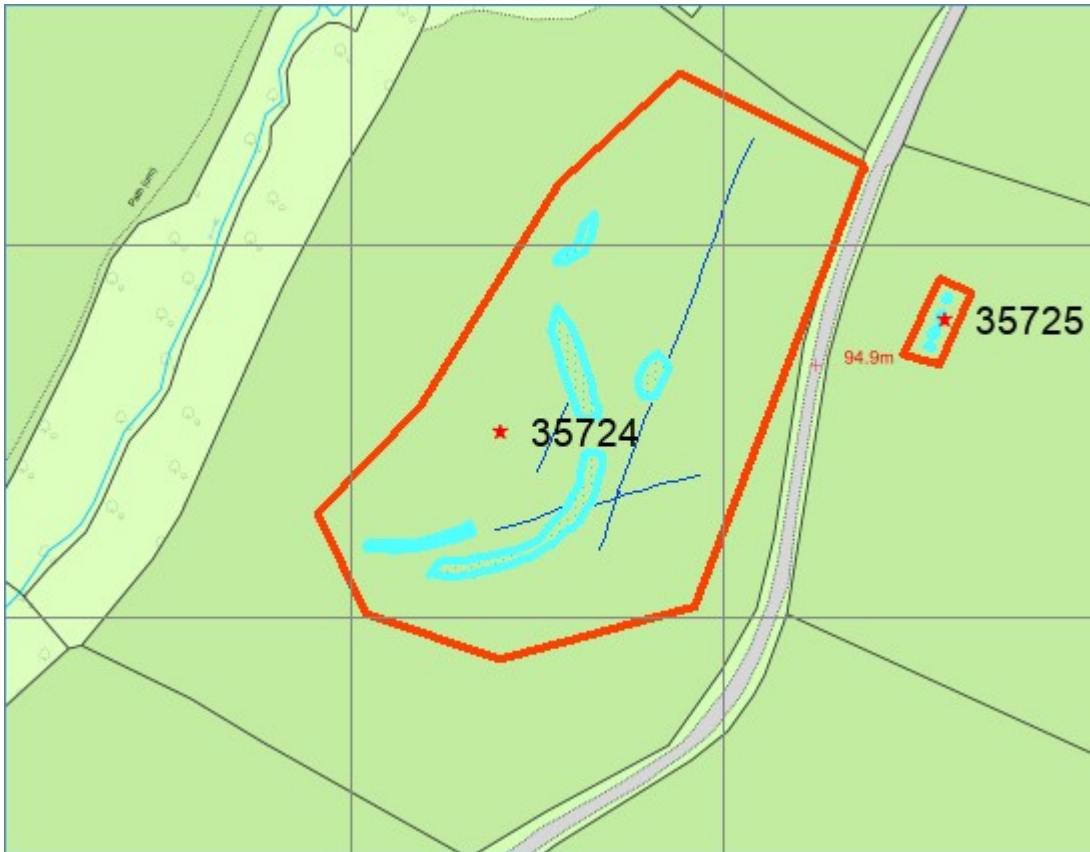
PRN 35714

This is a cropmark enclosure with no earthwork or other surface evidence. The site lies on a gentle west-facing slope, towards the head of a small valley, at approximately 90m above sea level. To the west the land falls away by 5m - 10m to a stream in the valley floor. The slope is undulating, and the southern side of the site occupies a small subsidiary valley or hollow a few metres deep. The site is overlooked from most sides. Aerial photographs show a curving arc of a cropmark ditch defining the eastern and southeastern sides of an enclosure, with a possible concentric ditch inside on the southeast side and splodges outside the ditch possible marking the site of pits. However, much of the field is marked by unresponsive vegetation which masks the site.

In 2005, a geophysical survey detected the curving line of ditch visible on aerial photographs with a entrance mid-way along its eastern side. The northern corner of this ditch turns a sharp right angle to the west, the southern corner is a gentle curve. Within the ditch a second (concentric) ditch springs from its northern side. This, too, has an entrance in its east side. Its south corner turns a sharp right angle to the west. This then is a bivallate enclosure, possibly of two phases, sub-rectangular in plan, approximately 60m by 60m.
