DYFI ESTUARY FLOOD RISK APPRAISAL

Landscape Baseline Site Visit Notes

Project no. 4020938

Natural Resources Wales

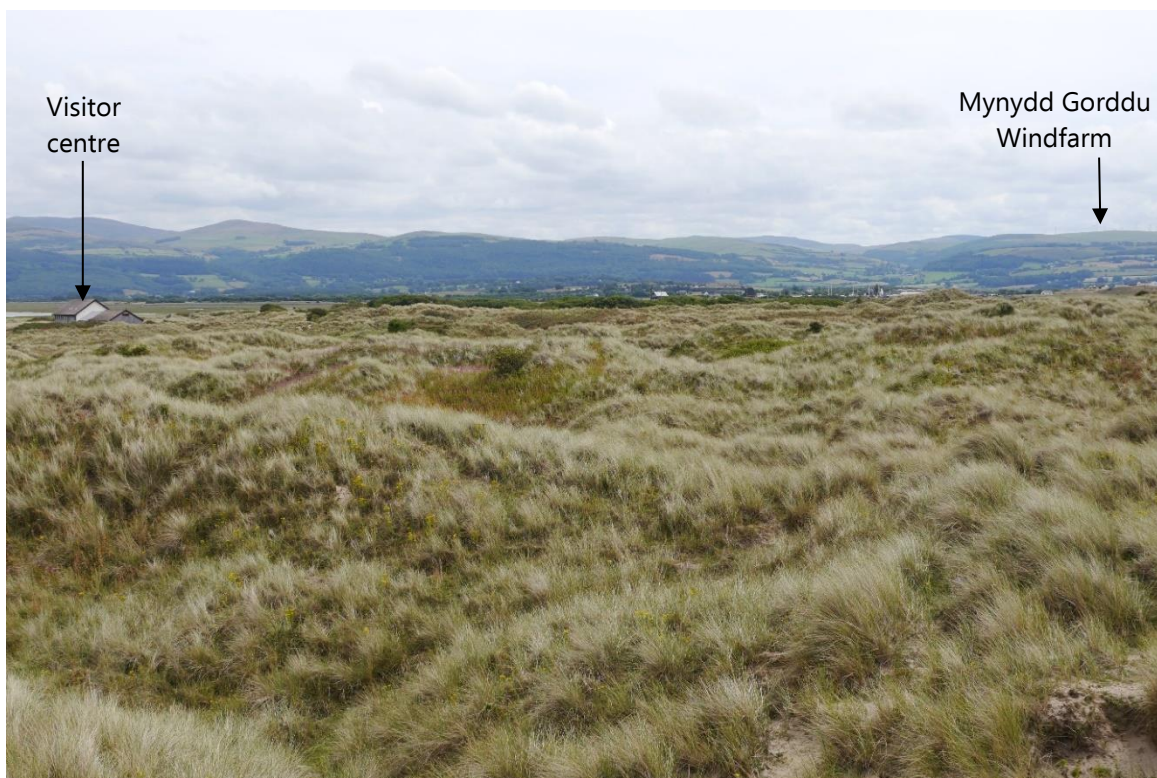
View 1: View from high ground on informal path through Ynyslas dunes looking south east.

The dunes at Ynyslas rise approximately 4-5m high, with a few trails through the dunes including a waymarked trail as part of Dyfi NNR. The Dyfi NNR visitor centre at Ynyslas can be seen in the left of the view in the middle distance and the Cambrian Mountains in the far distance. Due to the flat, low-lying nature of the study area, it is largely hidden from view by the dune system, and the eye is drawn to the Cambrian Mountains beyond. Scattered buildings can be seen, and Mynydd Gorddu Windfarm is visible on the hilltop in the far right of the view. The character of the surrounding mountains can be seen to change from the Cambrian Mountains in the left of the view (east) which have wooded lower slopes and open heathland on the peaks; and the lower hills towards the coast at Borth in the right of the view (south), which are covered by irregular agricultural fields. The area is quiet despite the popularity of the beach.

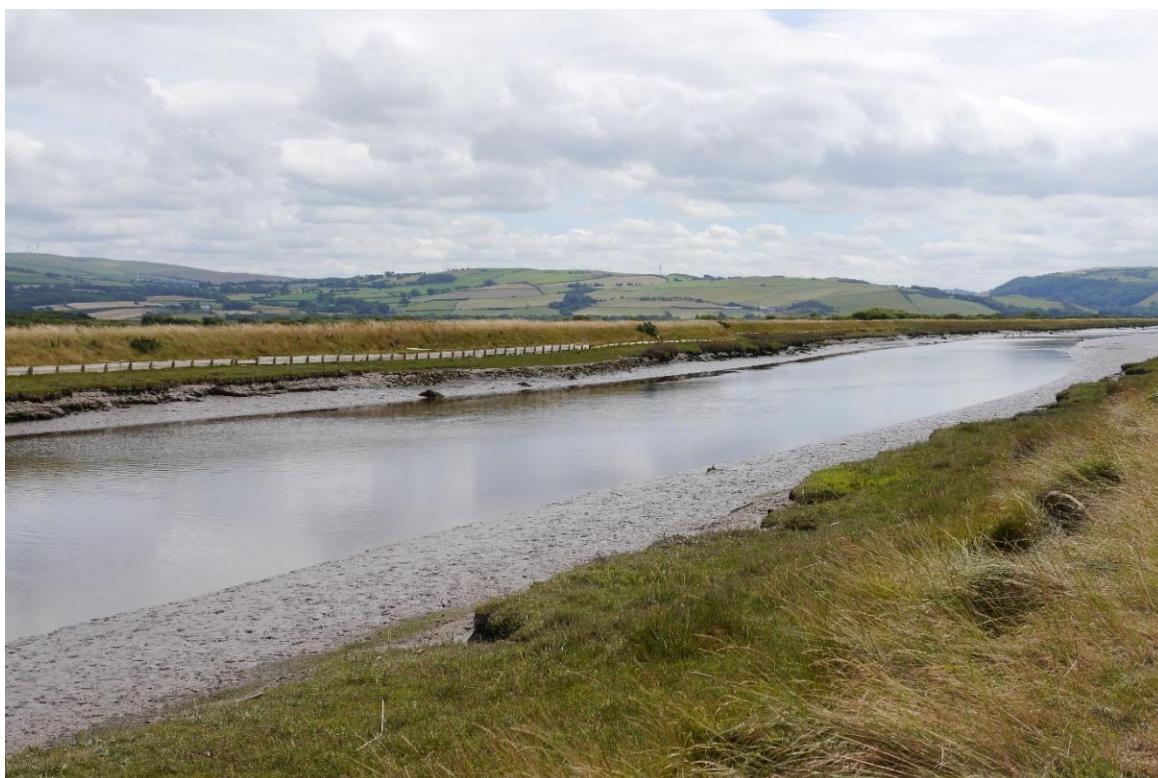
View 2: View from public footpath along the Afon Leri left hand (west) bank, looking south east.

Whilst the channel of the Afon Leri is artificially straight, it does have an element of a natural feel in the way that the water meanders slightly within its channel, and the banks are of mud and grass, without the use of hard materials to shape the channel such as concrete or sheet piles; this gives the channel a 'softer' feel.

From the footpath along the left hand bank, views of Cors Fochno, on low-lying flat land on the opposite side of the channel, are blocked by the right hand bank of the Afon Leri, and views over the bank are instead of high ground beyond.

Views are less enclosed towards the west (not visible in image above); Borth and Ynyslas settlements as well as caravan parks along the coast are visible, beyond which is the open expanse of the sea. Although the sea itself cannot be seen due to the coastal flood defence wall to the rear of Borth Sands, the lack of visible ground beyond the flood wall leads to an open, expansive feel when looking west, which is in contrast to the more enclosed feel when looking towards the mountains.

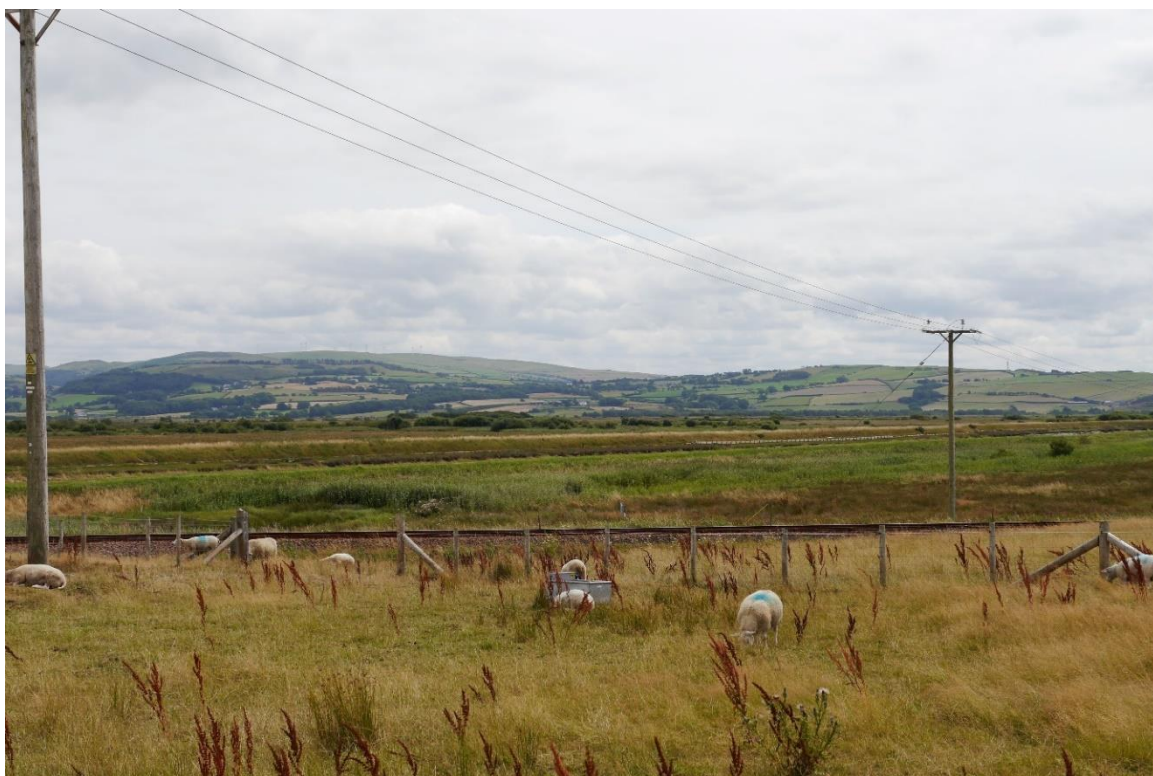
View 3: View from B4353 between the Afon Leri and Ynyslas, looking south east.

The landscape is very open and has a wild, desolate feel. This is despite, or perhaps partly because of, small scale infrastructure being visible in the landscape. Small pylons, a railway line with infrequent trains and occasional small settlements show that this landscape is used, but not busy. Due to this slightly elevated viewpoint, the low-lying ground of Cors Fochno can be seen before the hills rise to the south. As Cors Fochno is a homogenous land type however, the eye is still drawn over it towards higher ground.

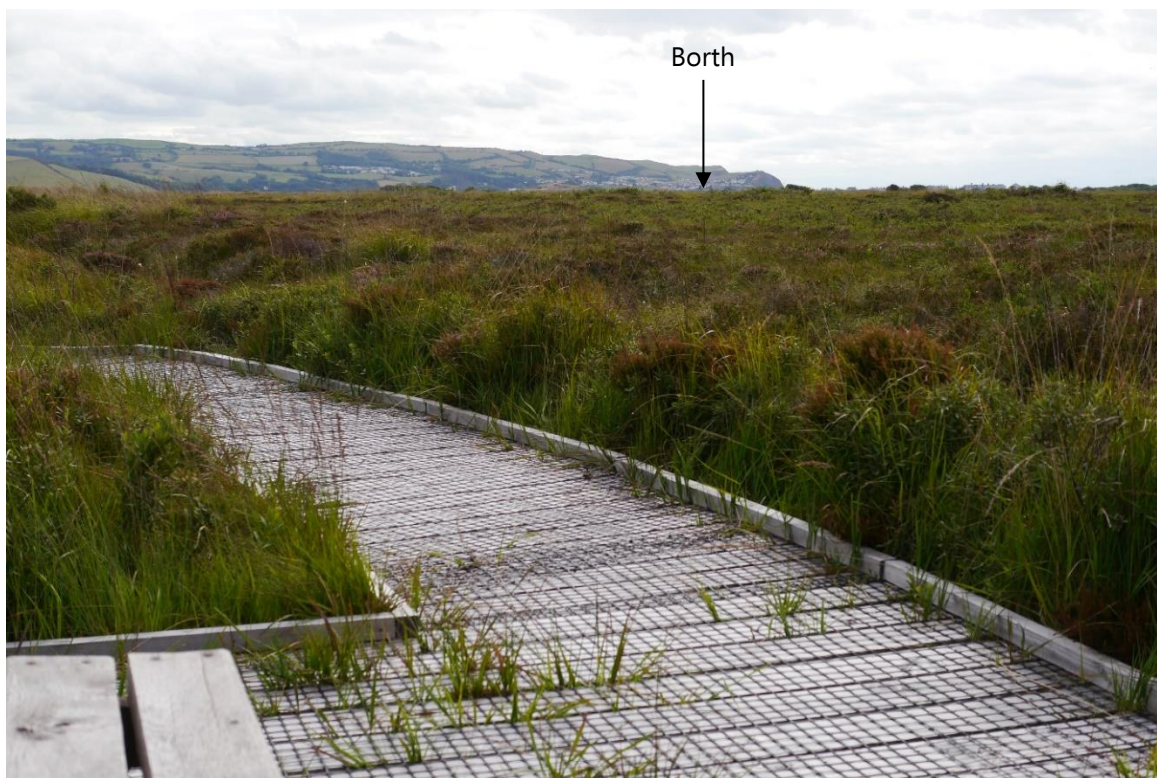
View 4: View from boardwalk at Cors Fochno, looking south west towards Borth.

Cors Fochno is protected as part of Dyfi NNR and access is only permitted via a boardwalk in the north. Cors Fochno is expansive and flat, with a homogenous appearance. Once again, the hills to the south create a backdrop, leading to a partial sense of enclosure, and Borth settlement is visible in this otherwise rural-feeling landscape. Cors Fochno is quiet, the sounds of the B4353 road having been shielded from the nature reserve by trees.

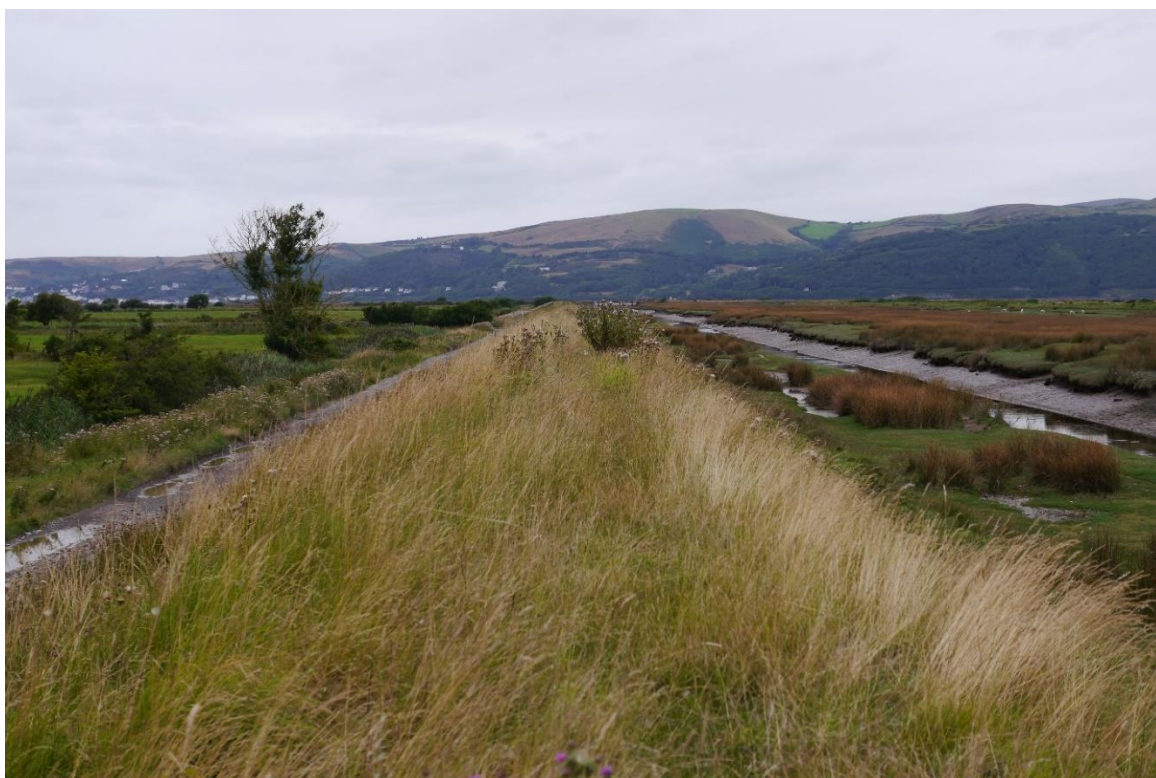
View 5: View along Afon Clettwr left hand (west) bank, looking north towards Snowdonia.

Although the landscape is flat, long-range views are blocked by river embankments and boundary hedgerows. The left hand Afon Clettwr embankment divides the land into farmland which is visible to the left (west), and marshy grassland within a washlands area to the right (east). Both landscape types are only visible in conjunction from the embankment crest; from either side the embankment blocks the other from view. The Afon Clettwr is made up of a primary and secondary (higher flow) channel, surrounded by marshy grassland consisting of short grass and rush, within which were grazing sheep, and has a desolate feel. On the other side of this washlands area, the right hand (east) Afon Clettwr embankment is visible in the distance on the right of the image and, as with the left hand embankment, rises above the surrounding land blocking views beyond it to the east. The mountains of Snowdonia and Ceredigion are visible as a backdrop.

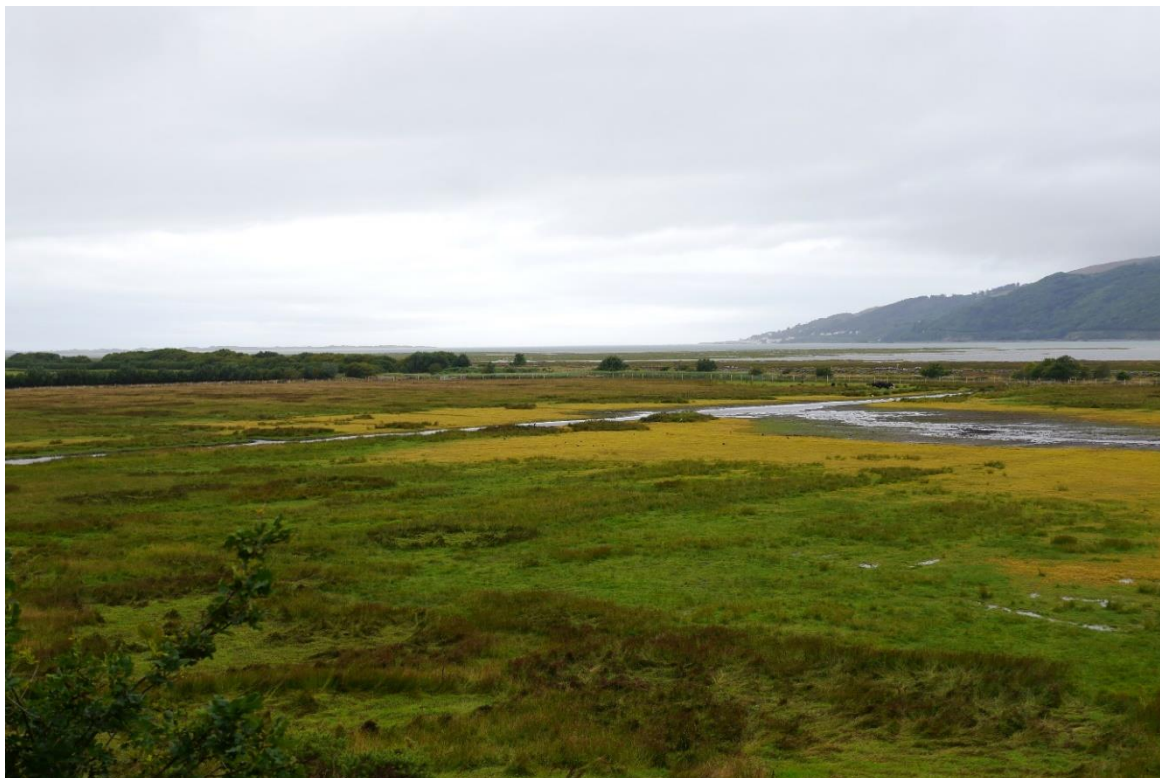
View 6a: View west from Ynys Feurig hide at Ynys-hir RSPB nature reserve, looking over the Dyfi estuary, saltmarsh and hinterland.

This is an open, exposed, large scale, flat expanse with the Snowdonia mountains as a backdrop, and Aberdyfi visible on the opposite side of the estuary channel. The landscape is peaceful and undisturbed, in which the sounds of the wind and birds can be heard, and there are long range views down the estuary towards the sea. Although the railway line runs from east to west through the centre of this flat landscape, it is not substantially raised above the level of the estuary and from this viewpoint the flat land either side of it appear to merge into a single landscape type; the railway line, although visible, is not obvious and does not from this viewpoint form a visual barrier.

The landscape character within the publicly accessible areas of the RSPB nature reserve at Ynys-hir varies. The above image shows the character of the northern edge of the RSPB reserve overlooking the Dyfi estuary; other land types include woodland, scrub, wetland, reedbed, and raised bog which has been reclaimed from conifer plantation. The woodland, including some oak woodland, is found on the steep foothills of the Cambrian Mountains and the rolling hills between the mountains and the flat hinterland. The character of the woodland is sheltered and enclosed, in sharp contrast to the open saltmarsh and hinterland, although there are some glimpses outwards towards the estuary to the north. An interpretation board within the reserve described the bog reclamation work as clearing conifer plantation, rhododendron and scrub, and installing dams and a sluice to raise water levels and encourage peat to form. There is a boardwalk along the edge of this area.

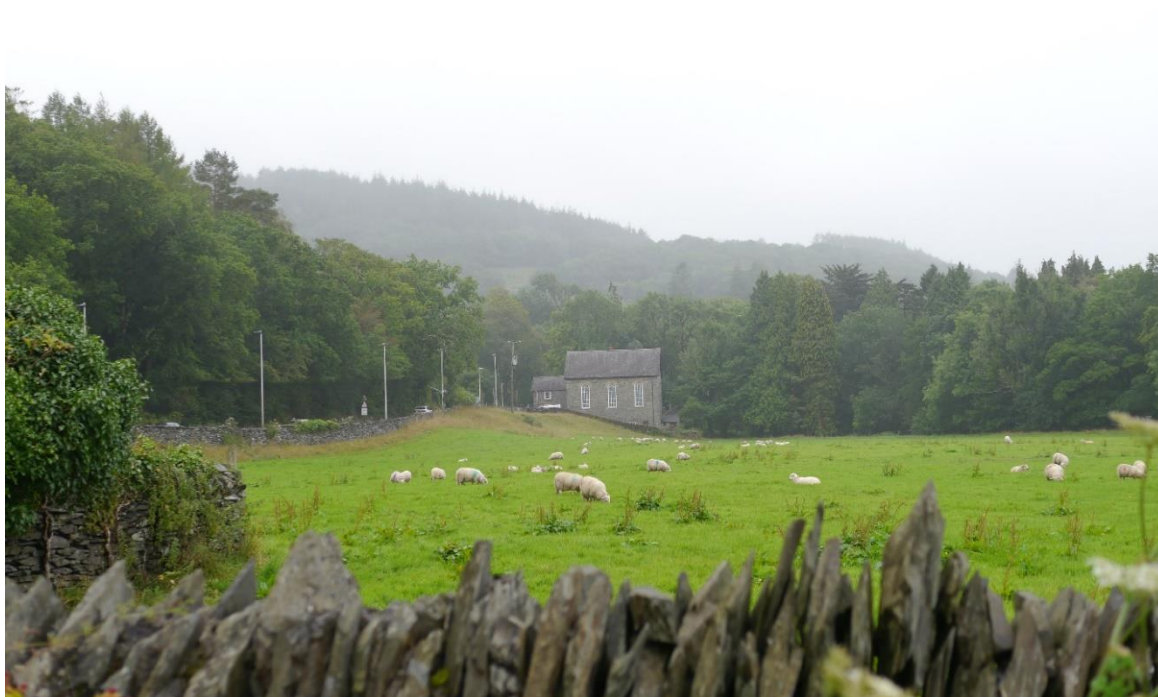
View 7: View south-west from St Michael's Church at Eglwys Fach.

This view is within the rolling hills between the flat estuary/hinterland and the mountains which border the study area. The land is pastoral, with drystone wall boundaries and enclosed by wooded hill slopes. The predominant building material is stone, but not whitewashed. In this area the wooded hills limit views and there is no indication that the estuary and sea are close by. Hedgerows and trees along roadsides largely block views to/from roads.

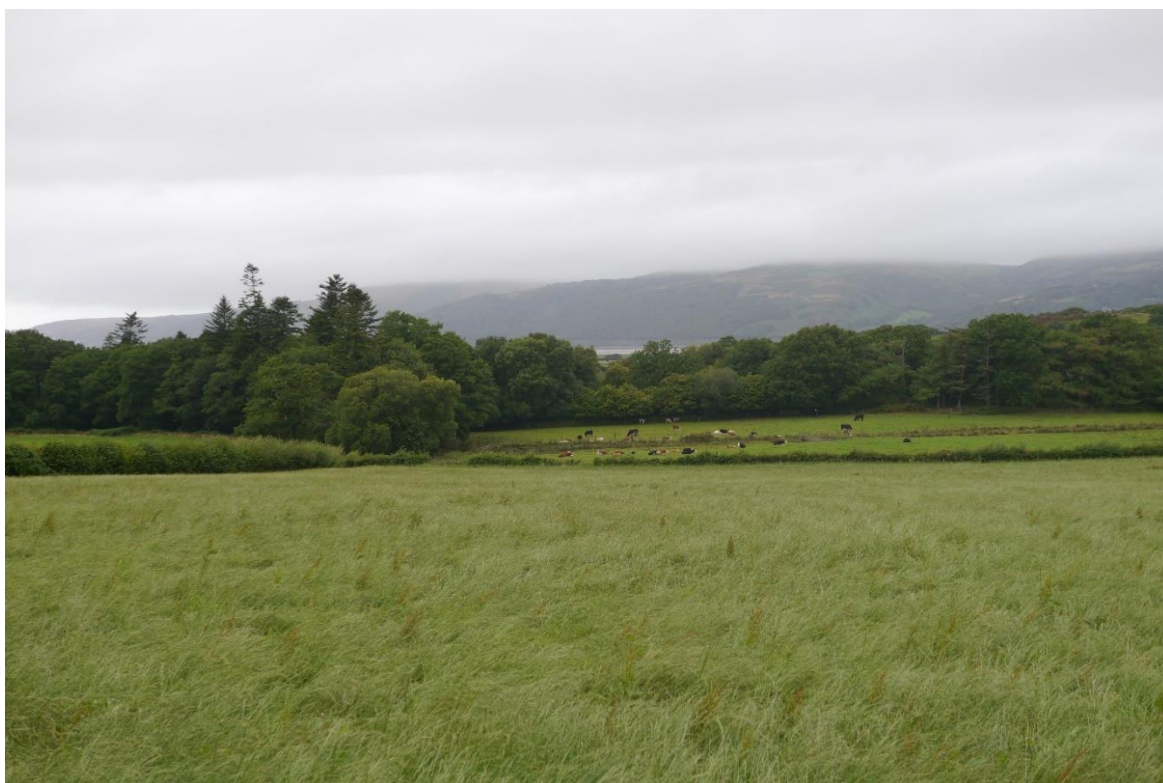
View 8: View north-west from A487.

The A487 at this point is passing through the rolling hills and provides an elevated viewpoint. The land use is pastoral with boundary hedgerows and clumps of trees. The estuary is barely visible through the trees, though the mountains of Snowdonia are still visible as a backdrop.

(NB: due to the poor visibility due to weather on the day, the full height of the Snowdonia mountains may not have been visible).

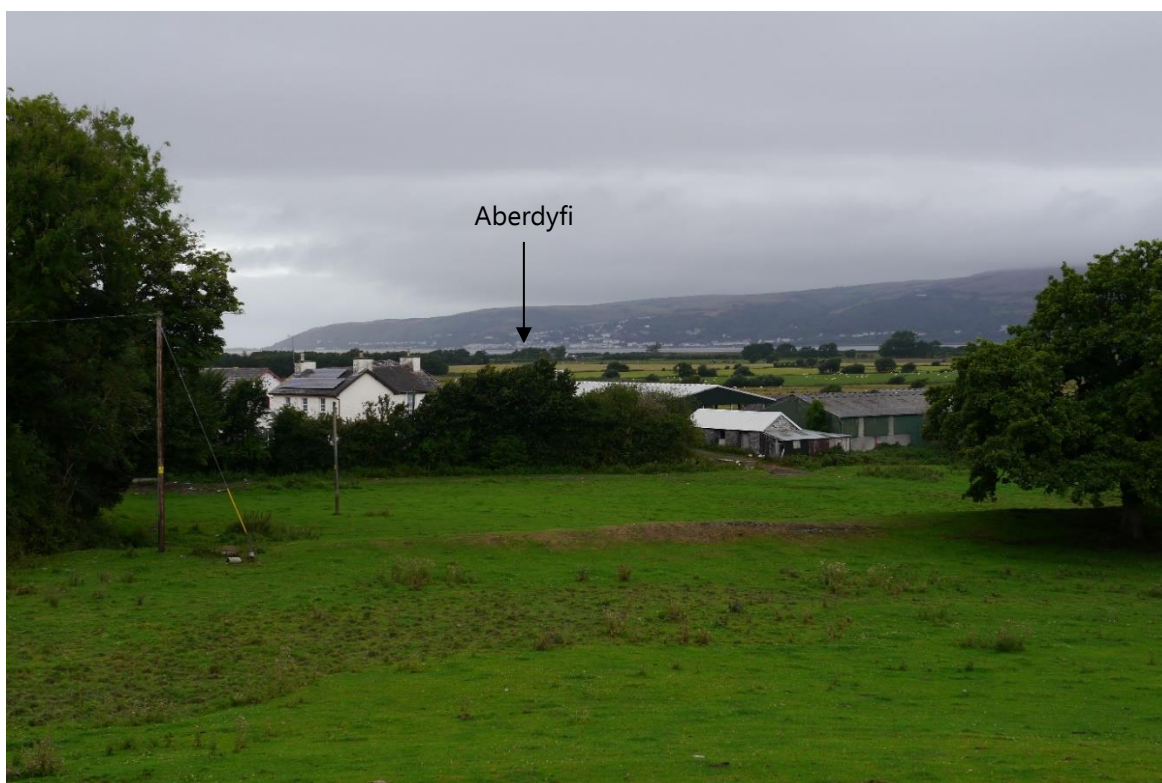
View 9: View north-east from B4353 at Llancynfelyn.

Llancynfelyn has its own very localised character as it occupies a small hill overlooking the flat estuary and hinterland. Pastoral fields are less well defined here than elsewhere within the study area, with an absence of hedgerow boundaries which are replaced by post and wire fences, and individual trees scattered or in clumps. The grass is tussocky and the ground level irregular, giving a wild appearance. The regular fields of the hinterland can in contrast be seen in the middle distance. There are views of the Dyfi estuary, Aberdyfi and Snowdonia from this elevated viewpoint, although these are limited from the B4353 due to hedgerows alongside the road. This is a working landscape with small scale infrastructure visible including farm buildings and small pylons.

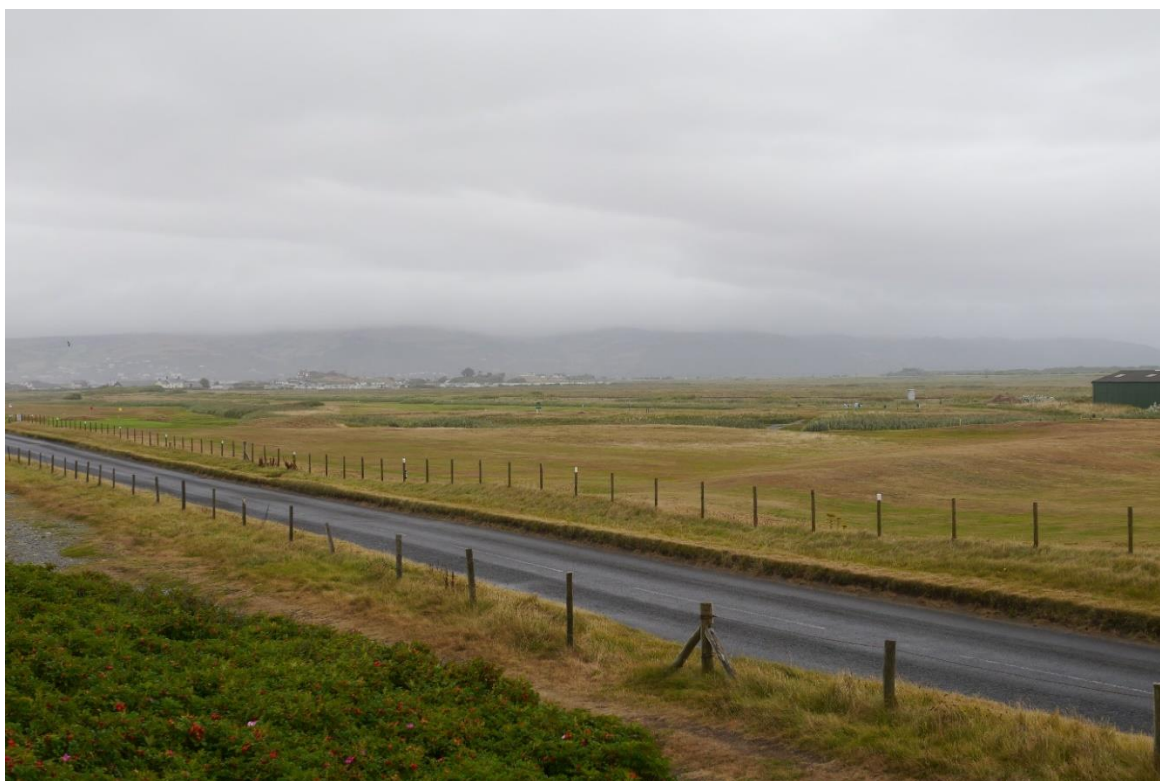
View 10: View north-east from Borth sea defence embankment, looking across Ynyslas golf course to Ynyslas.

Unlike most other roads within the study area which are bounded by hedgerows, the B4353 between Ynyslas and Borth is open, and separated from Ynyslas golf course by only a post and wire fence. Views across the golf course are therefore plentiful from the road and the sea defence embankment, but the golf course blends in well with the surrounding landscape and does not appear incongruously artificial. The golf course largely consists of gently undulating short grassland and drainage ditches containing reeds. There are views of Ynyslas and associated caravan parks to the north, with a backdrop of the Snowdonia mountains, and (if the viewer looks southwards) Borth can be seen to the south (Borth is not visible in image above). The area has an open, exposed feel, particularly if facing the sea to the west, but not a rural feel due to the presence of the settlements of Ynyslas and Borth.

(NB: due to the poor visibility due to weather on the day, the full height of the Snowdonia mountains may not have been visible).

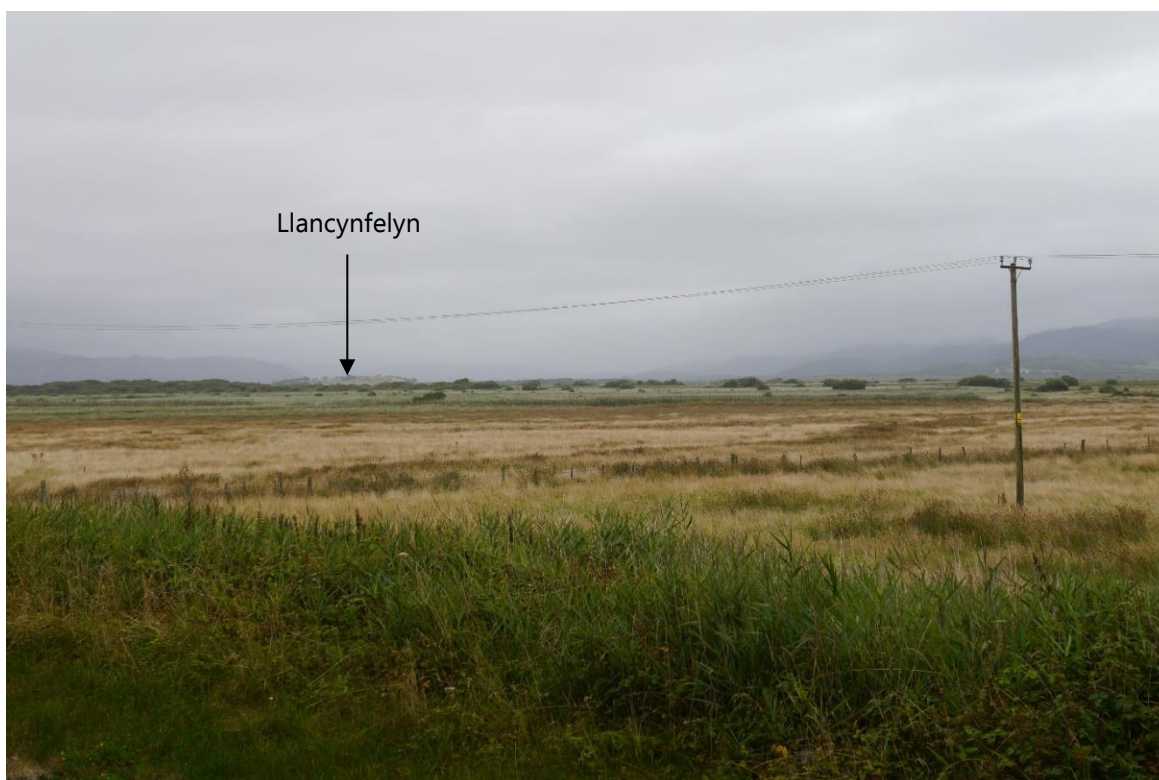
View 11: View north-east from Borth railway station platform.

Borth railway station has only one platform, which offers uninterrupted views eastwards from the slightly elevated position on the platform. Flat grassland can be seen in the foreground, interspersed with straight, reed-filled drainage ditches, post and wire fences, and trees and shrubs in clumps or scattered individually. The flat landscape has an expansive feel, although at this point the viewer is aware that they are immediately adjacent to the settlement of Borth (which is behind the viewer), and therefore the landscape is not as tranquil as it would appear in this image. Small scale infrastructure is visible in the form of lines of small pylons, the railway line (off the front of this image), and the buildings of Llancynfelyn. From this position, to the right (south-east) and left (north) of the image above, there are views of further built elements including isolated farm buildings and dwellings, St Matthew's Church, caravan parks and the settlements of Borth and Ynyslas. Buildings are often painted white or limewashed and are therefore prominent within the landscape. Llancynfelyn is situated on a small hill which is a prominent feature in this flat landscape, although difficult to make out on the image above due to the poor weather conditions at the time of the site visit. The Cambrian mountains form a dramatic backdrop, although again these are difficult to see in the image above due to the weather at the time leading to poor visibility. It should be noted that although the viewer is looking in the direction of both the Afon Leri channel and Cors Fochno bog, neither the channel or the bog can be seen as, due to the flat nature of the land, they are hidden from view by any elements with minor vertical elevation including the embankments of the Afon Leri channel and any intervening vegetation.

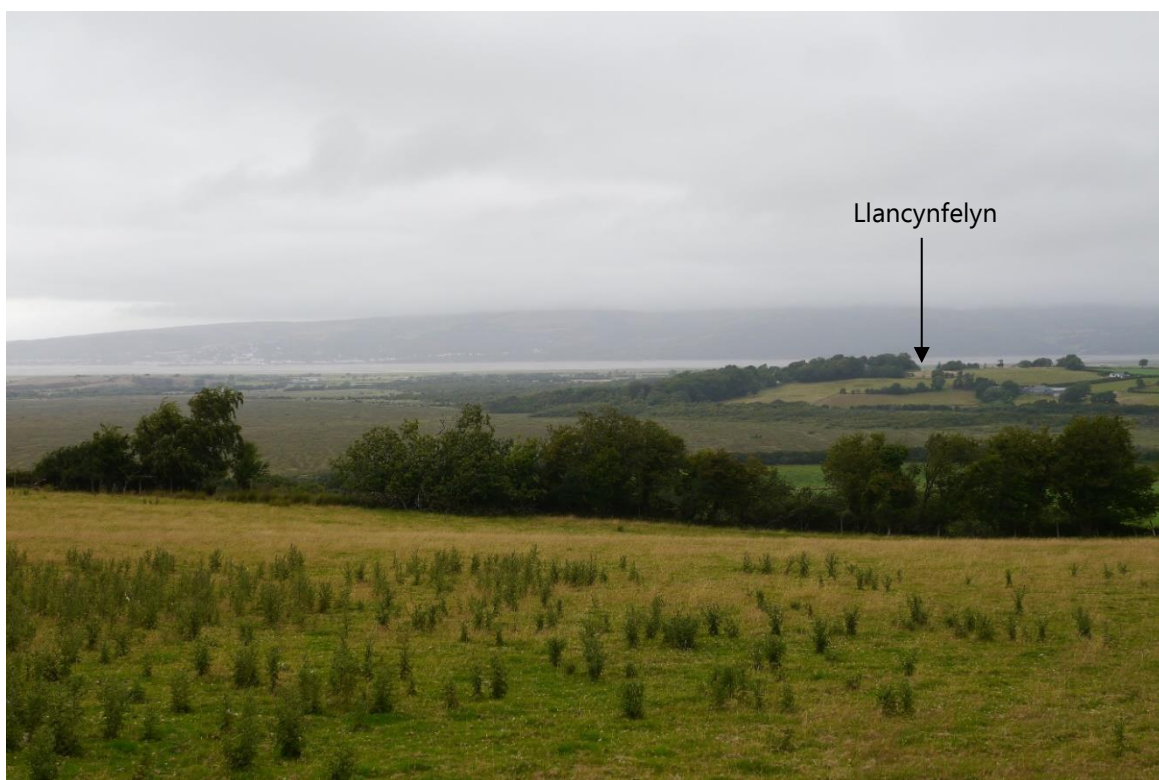
View 12: View north-west from unnamed road near Staylittle.

From this viewpoint on high ground in the hills to the south of the study area, the various landscape types that make up the study area can be seen. The flat land of Cors Fochno is visible in the centre-left of the image, with a homogenous, flat brown appearance. Towards the east, scrub and woodland can be seen encroaching onto the bog habitat of Cors Fochno, before the land rises at Llancynfelyn. The pastoral fields with hedgerow boundaries of the hinterland can be seen behind Cors Fochno, and the expanse of the Dyfi estuary behind that. As a backdrop, the Snowdonia mountains rise behind.

Due to the flat nature of the land within the study area, the various elements which make up the landscape cannot all be seen in conjunction when standing within the study area itself and are only visible from surrounding high ground.
