Assessment of Welsh Raised Bogs LIFE Project works and their proximity to known historic features.

This document is a brief assessment undertaken by Jake White, WRB LIFE Project Officer, to understand whether the planned WRB LIFE Project actions may impact known historic features. This investigation has used Arc GIS desktop application, with the known historic feature layer, overlain with planned WRB LIFE Works. Particular attention is paid to those actions which involve ground works.

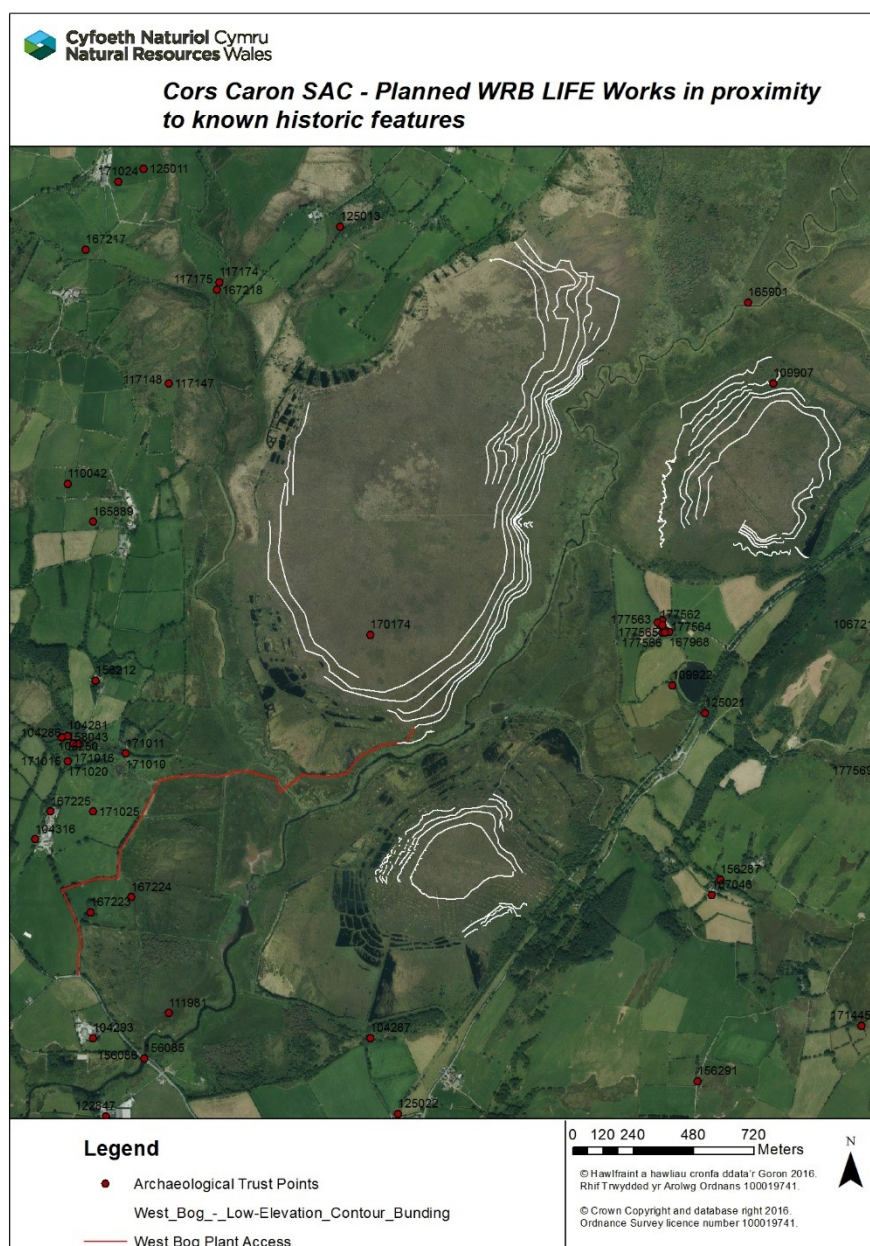
Cors Caron SAC

Low elevation contour bunding planned throughout the WRB LIFE Project is due to impact the following features.

PRN	Trust	Community	Unitary Authority	NGR	Site Type	Status	Link to feature profile
114048	Dyfed	Ystrad Fflur	Ceredigion	SN696640	N/A - Landscape	N/a	CLICK HERE
8420	Dyfed	Ystrad Fflur	Ceredigion	SN6800063000	N/a – Peat Bog	N/a	CLICK HERE

Feature 114048 is a landscape scale feature, rather than a specific historic feature, importance for this historic landscape feature is to maintain the peat's record of vegetative cover and climate change. This has been covered already within the Habitats Regulations Assessment, under the SSSI feature table "Raised Mire Stratigraphy" – [CLICK HERE FOR DOCUMENT](#).

Feature 8420 is a habitat feature recognising the peat bog, rather than a specific historic feature. A full assessment of WRB LIFE action impacts to this habitat has been made through the Habitats Regulations Assessment – [CLICK HERE FOR DOCUMENT](#).

Risk to historic features is though to be low, the WRB LIFE Works aims at improving the wildlife, habitats and carbon capture ability of the raised bogs at Cors Caron SAC. Also accurate locations of ground penetrating interventions will be recorded so prevent confusion with any future paleo-ecological studies.

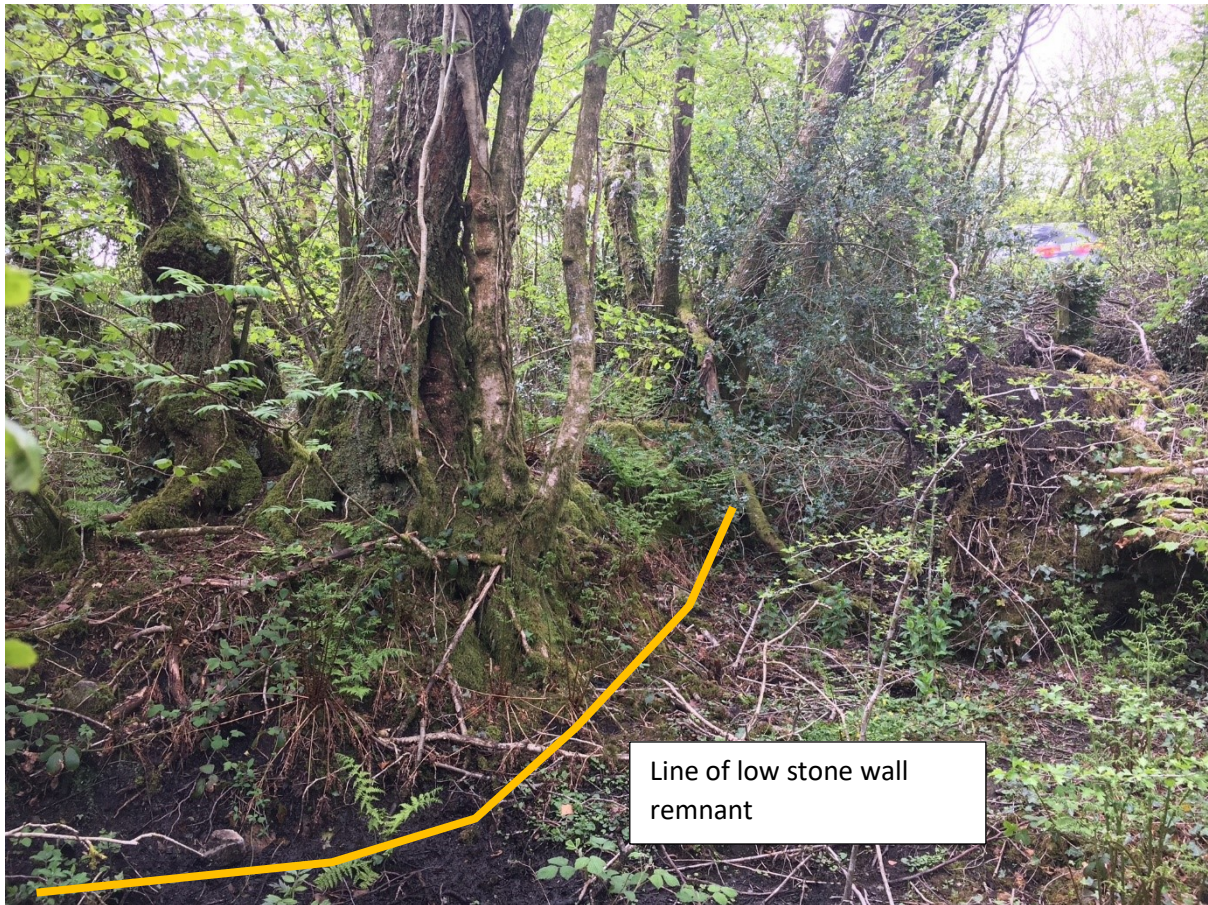
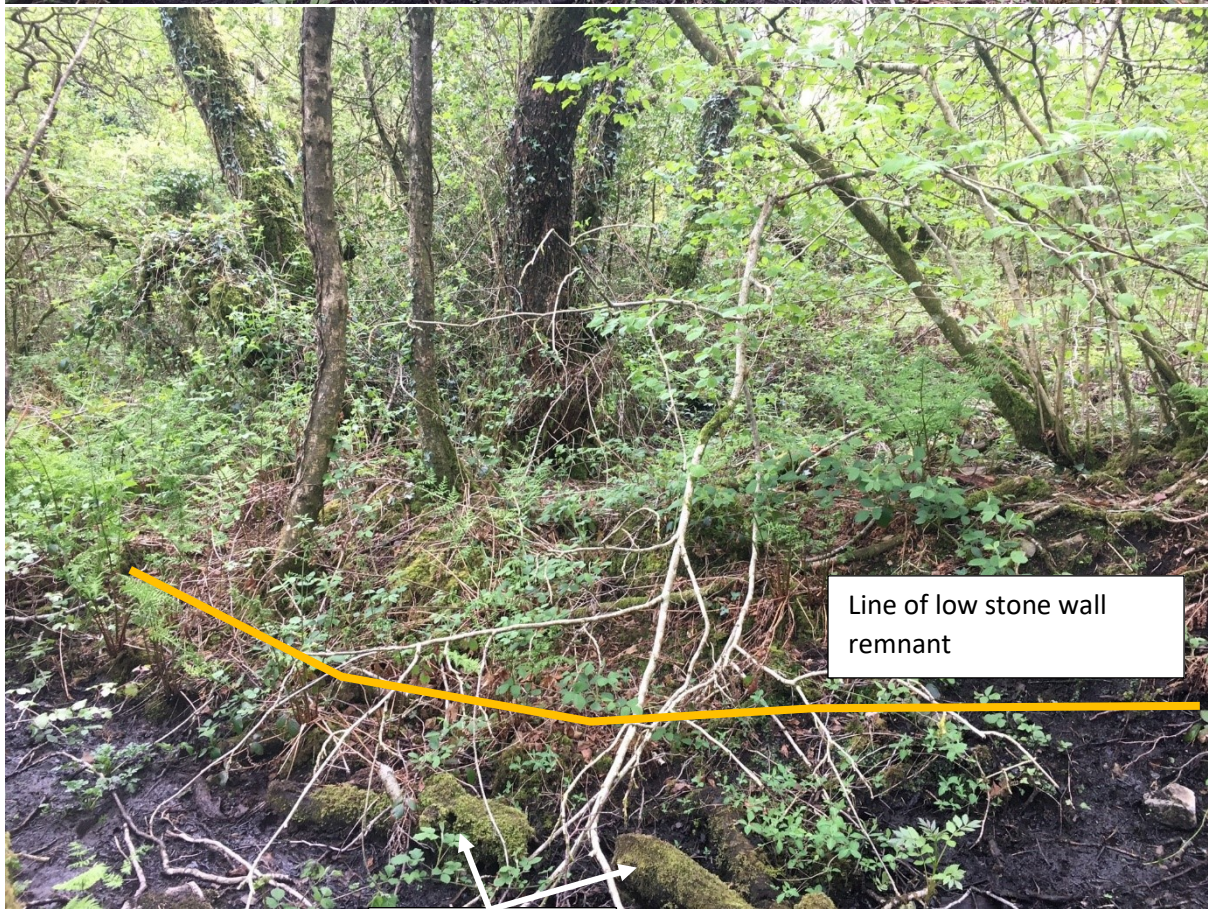
Site visit to ascertain presence of feature 122252 – Post -medieval mill.

On Tuesday 18th May, Jake White (WRB LIFE Project Officer) attended site at Cernydd Carmel SAC to assess the presence of historic feature 122252. As mentioned above, an investigation undertaken by Cadw in 2012 could not find any evidence of the mill first recorded in 1983. Arc GIS online was used to accurately find the location of the archaeology layer feature point, and then a walkover was undertaken of a 20m radius around the location.

The site is very wooded, but observations of some linear features were made, what looks like some stone walls – now degraded to about 0.8m above ground level – with loose stones found at the base. Whether this was a mill or simply an old animal enclosure is unclear. However, efforts will be made to avoid these structures, and keep all works at least 10m from them. NRW staff can also mark out the walls on the ground using bamboo canes and red tape throughout the duration of the works.

Risk to historic features is though to be low.

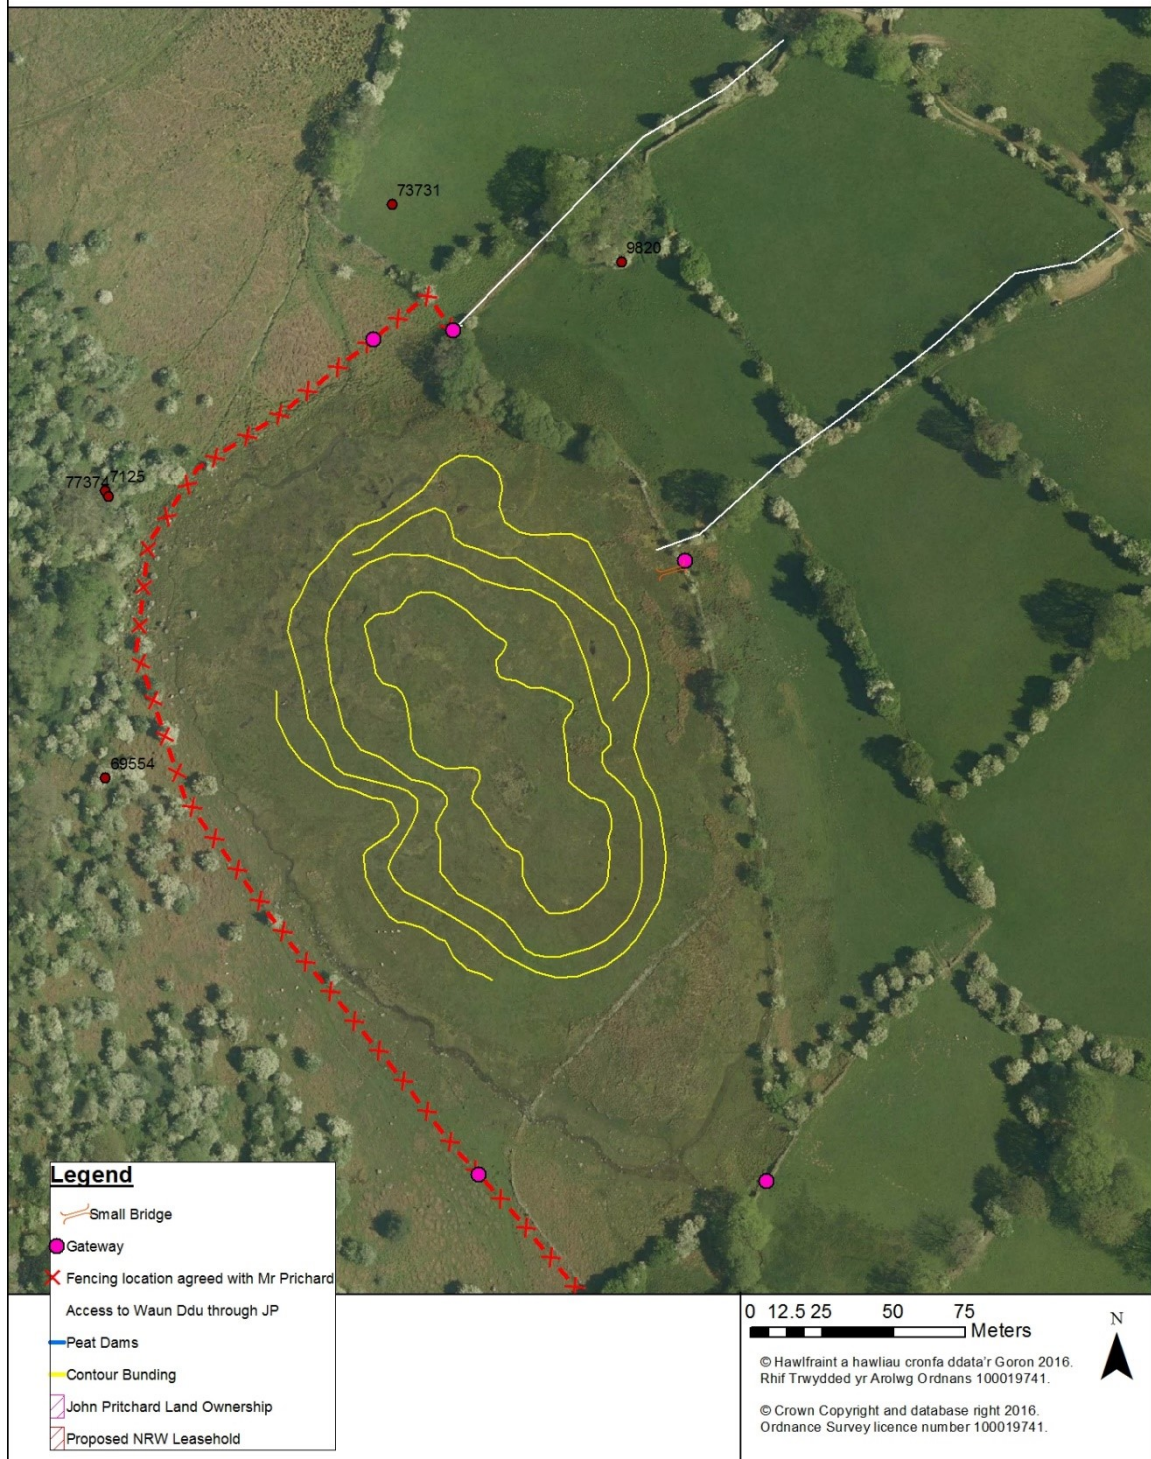
Waun-Ddu WRB LIFE Project Actions Proximity to known historic features

PRN	Trust	Community	Unitary Authority	NGR	Site Type	Status	Link to feature profile
58804	Clwyd Powys	Llangattock	Powys	SO185165	MULTIPERIOD ENVIRONMENTAL DEPOSIT	N/a	CLICK HERE
5314	Clwyd Powys	Llangattock	Powys	SO185166	POST MEDIEVAL LIME KILN	N/a	CLICK HERE
125405	Clwyd Powys	Llangattock	Powys	SO1850116598	POST MEDIEVAL BUILDING	N/a	CLICK HERE

Feature 58804 is recorded as Multiperiod Environmental Deposits – this is due to its importance as an historic pollen sampling site for understanding historic vegetative and climate change. WRB LIFE works are going to be disturbing and inverting the upper 1-2m layer of peat along c0.80m wide peat bunds. These works are designed to restore the condition of the SAC for the long term, and the large majority of the pollen record retained within Waun-Du will remain intact.

Feature 5312 is recorded as a post medieval lime kiln and is visible as a stone walled structure, it is located 20m away from the proposed fence line. The installation of the fence can easily avoid any damage to the feature – however the feature will be included within the contractor information pack, as well as being identified on the pre-commencement meeting, and temporarily taped off to make operatives aware.

Feature 125405 is recorded as a post medieval building, and is located in close proximity to feature 5312, therefore the same mitigation measures will be taken to ensure no damage comes to the feature during the installation of WRB LIFE actions.

Risk to historic features is low.

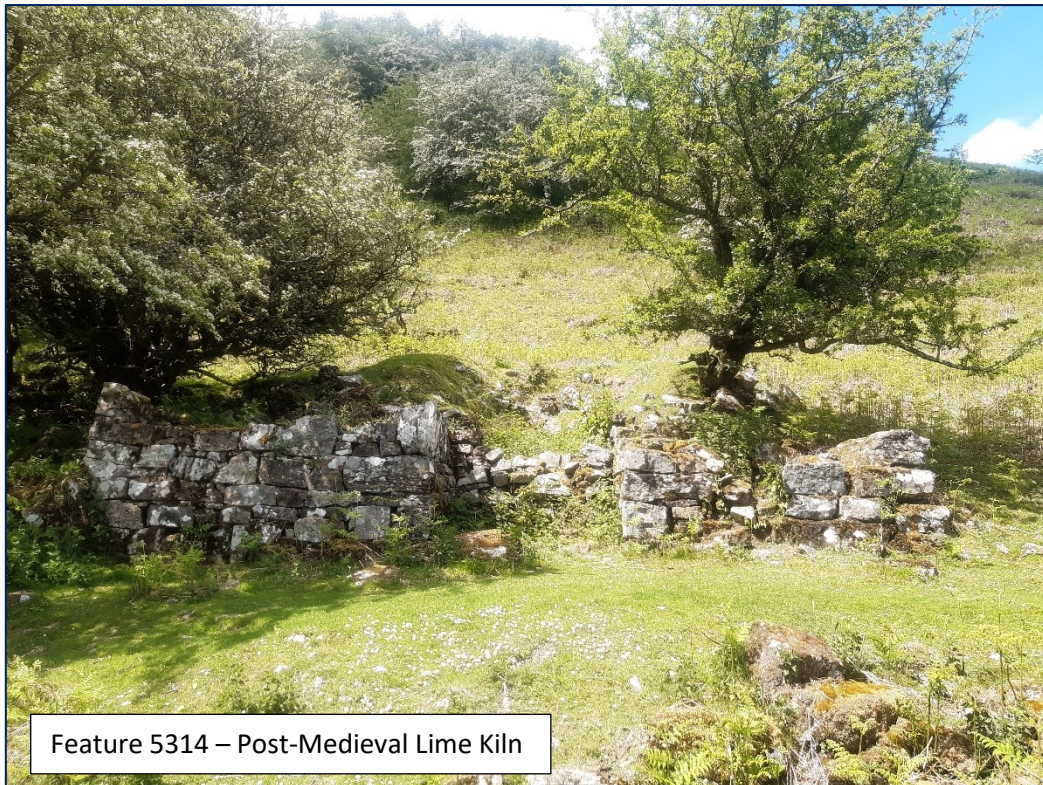
Feature 5314 – Post-Medieval Lime Kiln

On 03.06.21 Jake White, Project Officer, visited Waun-Ddu to investigate the historic features 5314 (Post Medieval Lime Kiln) and 125405 (Post medieval building). Both features were observed. Due to heavy grazing in the area preventing scrub colonisation they were both easy to find. The proposed fence line that is due to be installed within 20m of the lime kiln will not impact the feature directly. Also there is already an existing well used path used by walkers and livestock next to the lime kiln, so the fence wont be introducing any new pathways.

There are trees growing out of both features, so with advice from the local archaeological trust, there is the opportunity to undertake some restoration work of these historic features through scrub removal.
