LITTLE DIBLEY, CRINOW, NARBERTH PEMBROKESHIRE: ARCHAEOLOGICAL EVALUATION 2017

RHIF YR ADRODDIAD / REPORT NO. 2017/14
RHIF Y PROSIECT / PROJECT RECORD NO. 110330

LITTLE DIBLEY, CRINOW, NARBERTH, PEMBROKESHIRE: ARCHAEOLOGICAL EVALUATION 2017

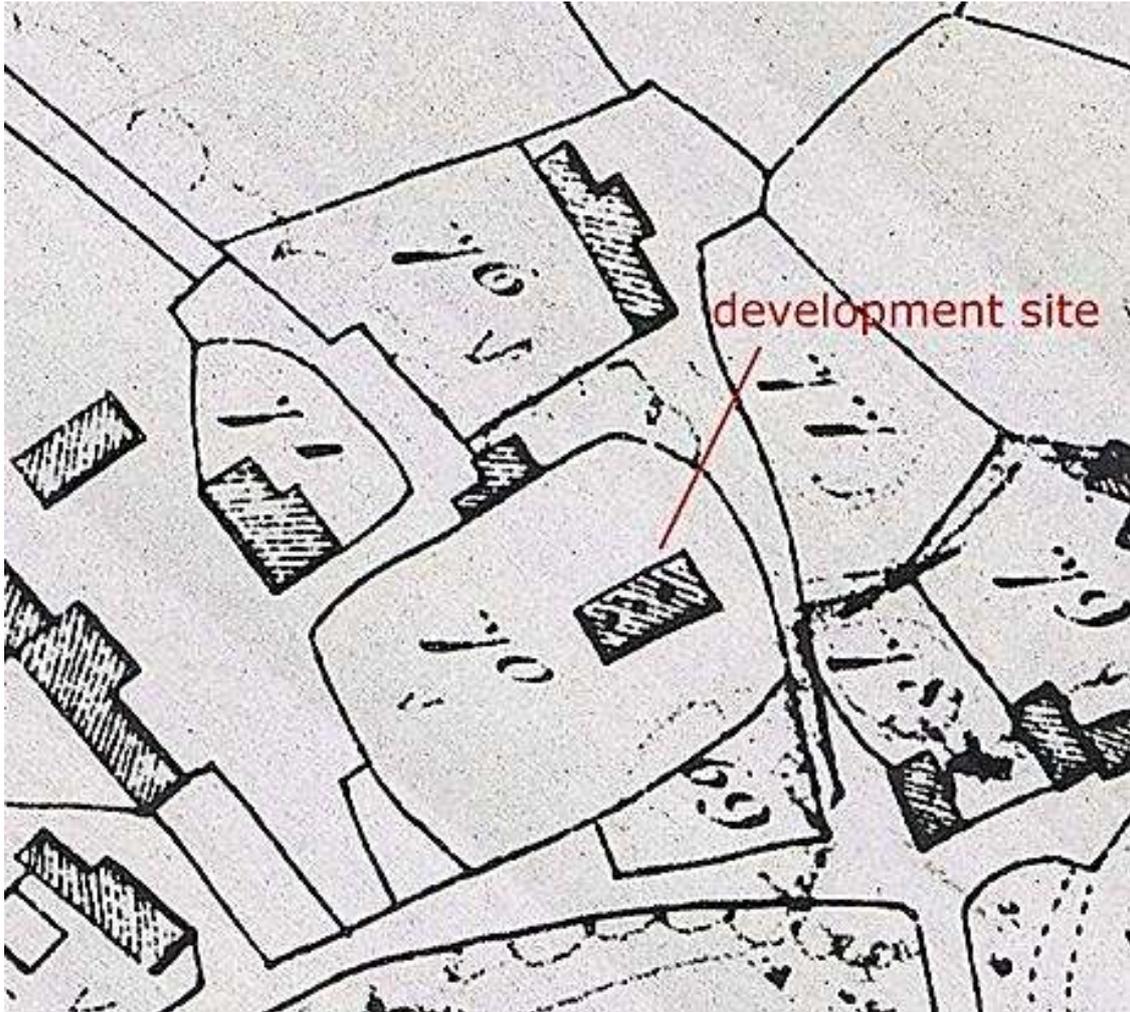
Figure 2: Extract from 1840 parish tithe map.

- 2.2.7 A review of earlier maps shows that the shape of the churchyard was previously more rectangular, with rounded corners, as shown on both Tithe Map of 1841 (Figure 2) and the 1889 First Edition Ordnance Survey map (Figure 3). By the 1908 Ordnance Survey map (Figure 4), a former garden area to the southeast had been incorporated into the churchyard.

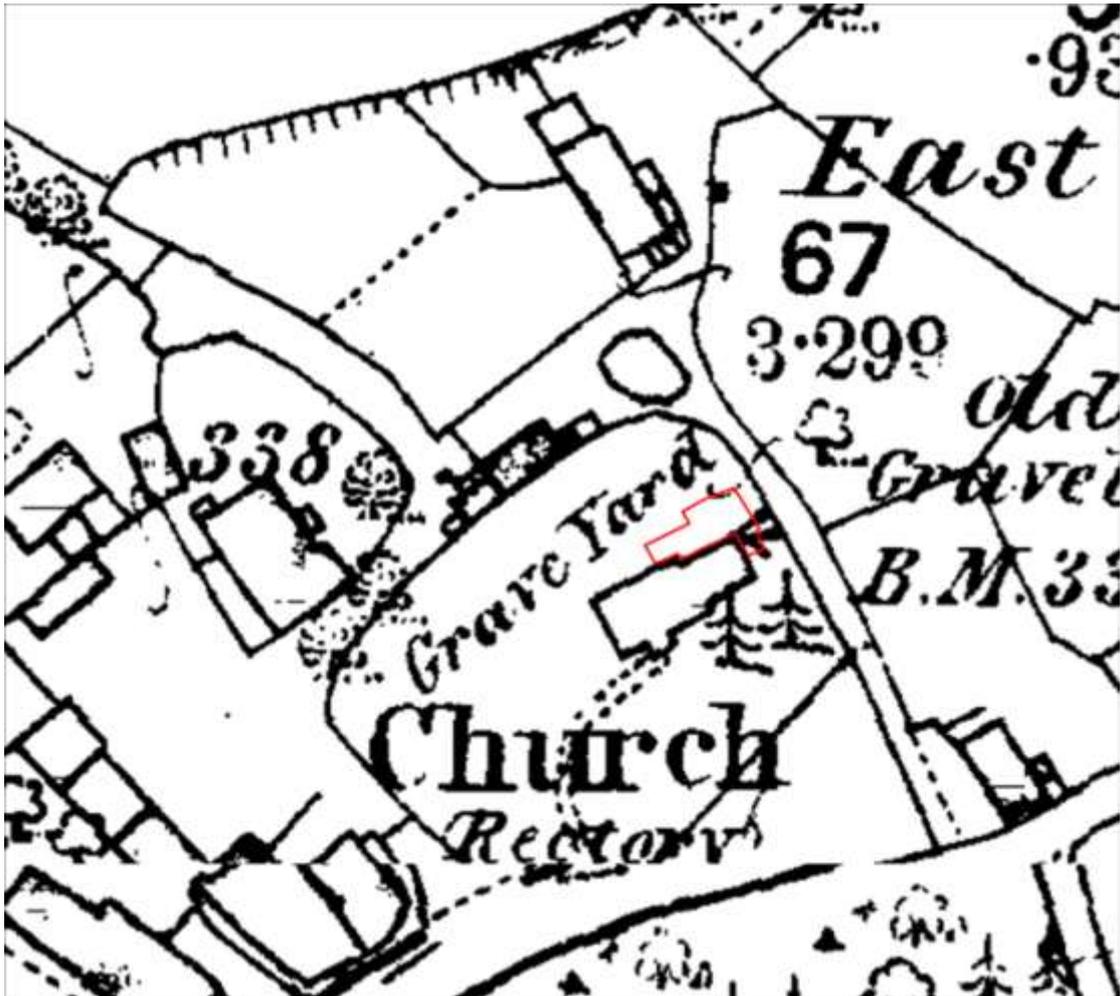
Figure 3: Extract from 1889 1st Edition OS 25" map. Evaluation trench in red.

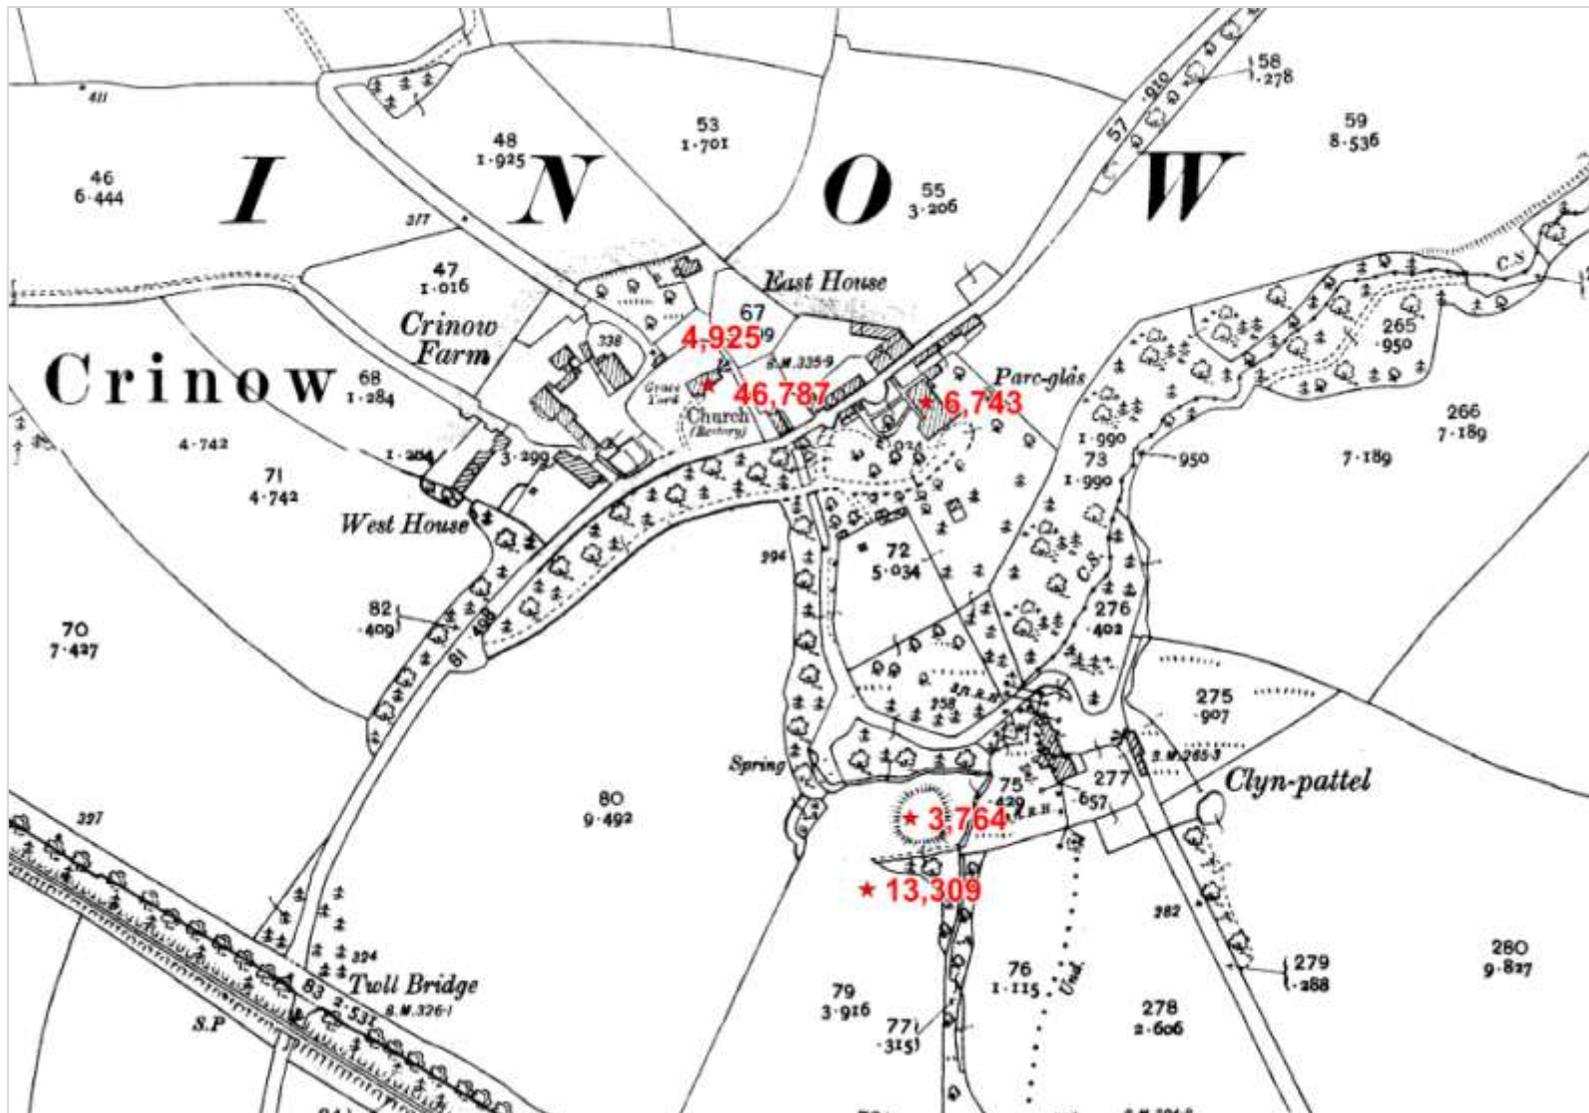
Figure 4: Extract from 1908 2nd Edition OS 25" map showing the archaeological and historical sites recorded on the regional HER lying within 250m of the proposed development; listed in Table 2.

Table 2: Archaeological and historical sites recorded on the regional HER lying within 250m of the proposed development; illustrated in Figure 4.

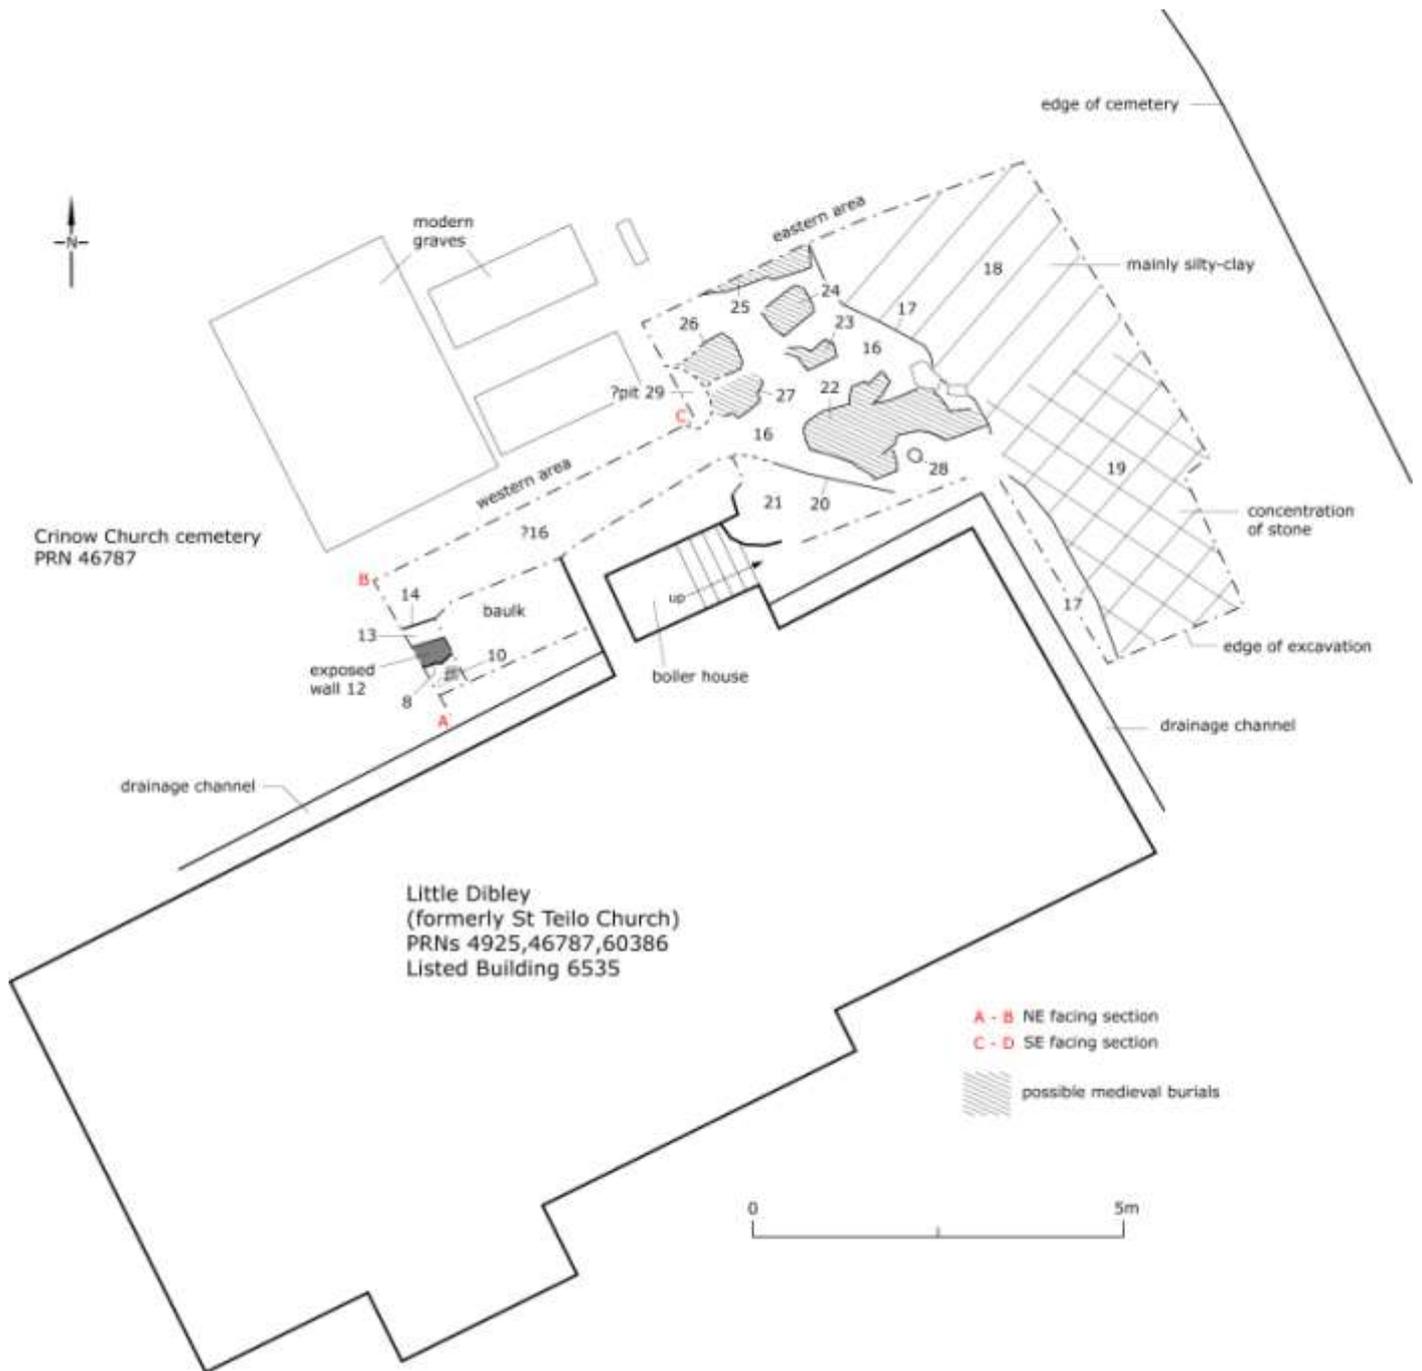
Figure 5: Plan of archaeological features within evaluation trench

4.1 An evaluation trench corresponding to the foot print of the proposed extension was excavated along the eastern half of the north wall of the church. It measured 11m long and its width ranged from 2.1m at the west end to 7.6m at the east end. It extended 3.3m beyond the east wall of the church. For the purpose of this report the trench has been divided into western and eastern areas (Figure 5).

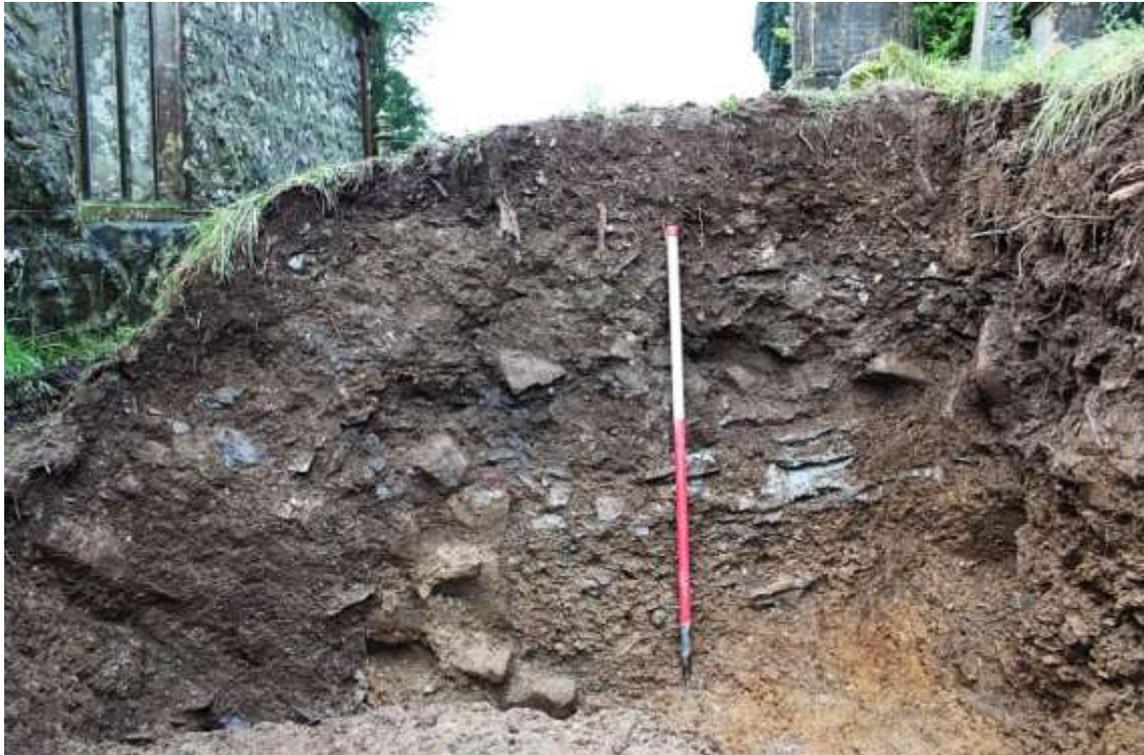
Photo 1: Northeast facing section. 1m scale.

4.2.2 The top of the east-facing section sloped down gently towards the south, but 1.2m from the church wall it turned sharply down (Photo 1, Figure 6). The topsoil (1) was a medium-brown, silty-clay containing occasional small stones, brick and roots. It was cut on the south side by feature (02) the fill of which (3) was a dark-brown almost stone-free, silty-clay. This cut was probably associated with the construction of a concrete drainage channel that runs alongside the church wall.

- 4.2.4 The most salient feature in the section exposed in this area was wall (12) (Photos 1 and 2). It was 0.55m high and approximately 0.35m wide at the base, narrowing to 0.15 at the top. The top of the wall lay 0.9m below the present ground surface. It was of rubble construction and utilised lime mortar (cream coloured mix containing small shale fragments). The north face was relatively undisturbed, but the south face has been truncated by grave cut (8). Whether the top of the wall had also been truncated was not certain. The short (0.35m) length of wall visible in plan between the east facing section and the baulk showed an alignment similar to the church (Photo 3, Figure 4). Whether the wall was part of a building or for revetting purposes is unknown. There was no indication in the south facing section of any corresponding structure, therefore it is reasonable to assume that if there was a angle it would turn towards the church. If the wall continued beneath the boiler house it is unlikely that any remains would survive, as the floor of the boiler house was c.1.7m below the top of the surviving wall and would almost certainly have completely removed any remains or footings.

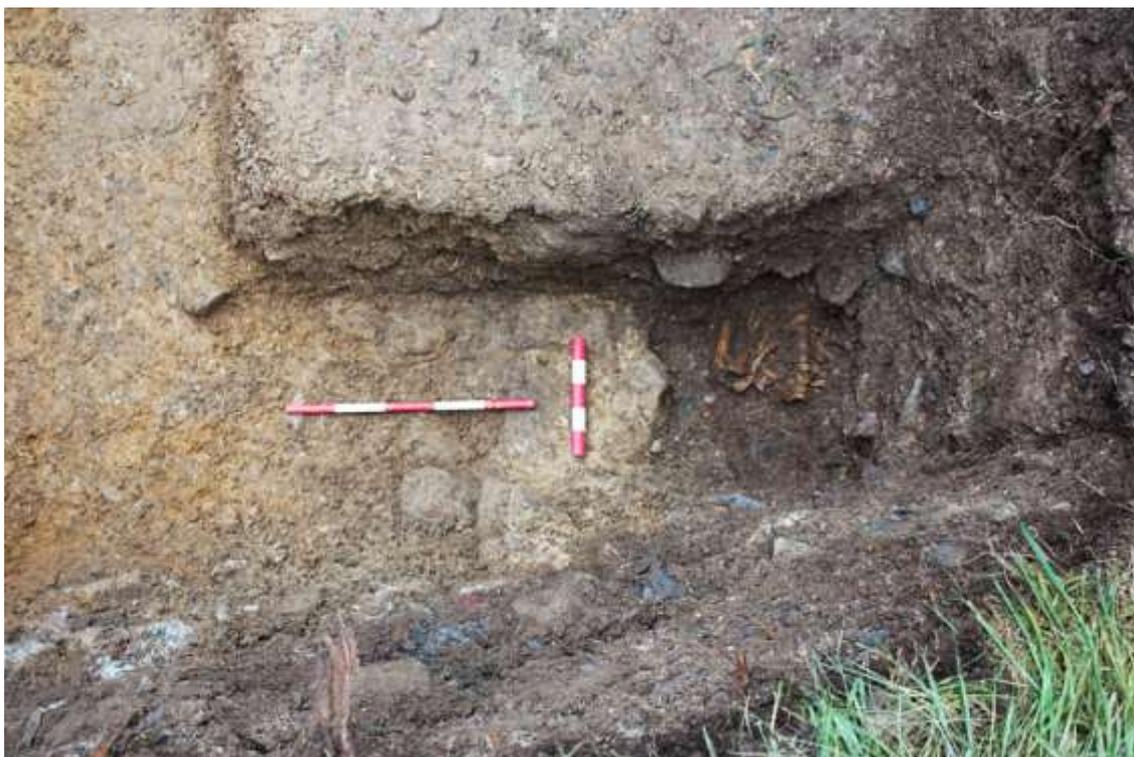
Photo 2: View East of wall (12) in sondage. Grave (8) right of wall (skull having been removed). 0.5m scale

- 4.2.5 The south facing side of wall (12) is ragged, having been truncated by the grave cut (8) to accommodate burial (10). When investigated the grave was found to contain articulated skeletal remains buried in an east-west alignment. Green stains, typical of copper shroud pins were visible on the cranium and mandible (Photo 3). Four coffin nails with small pieces of timber attached were retrieved from the upper fill of the grave. The grave-fill was a dark brown, silty-clay containing mortar/plaster flecks and small pieces of slate.

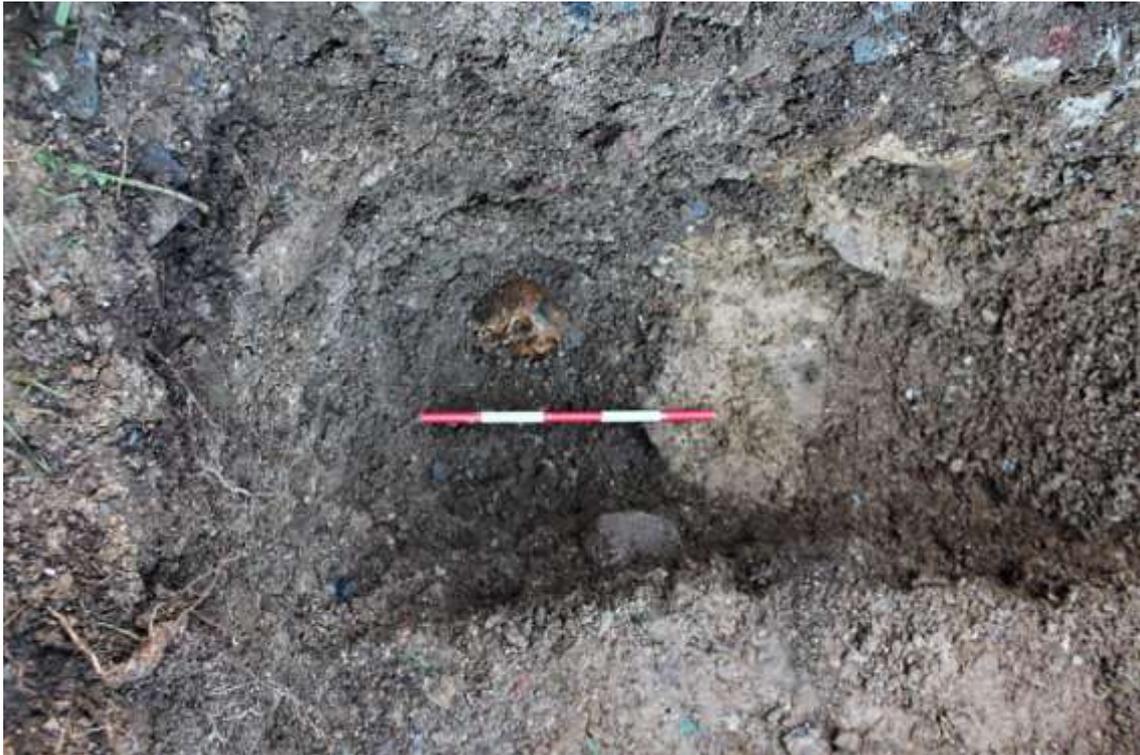
Photo 3: Green stain on skull produced by copper shroud pin. 0.5m scale.

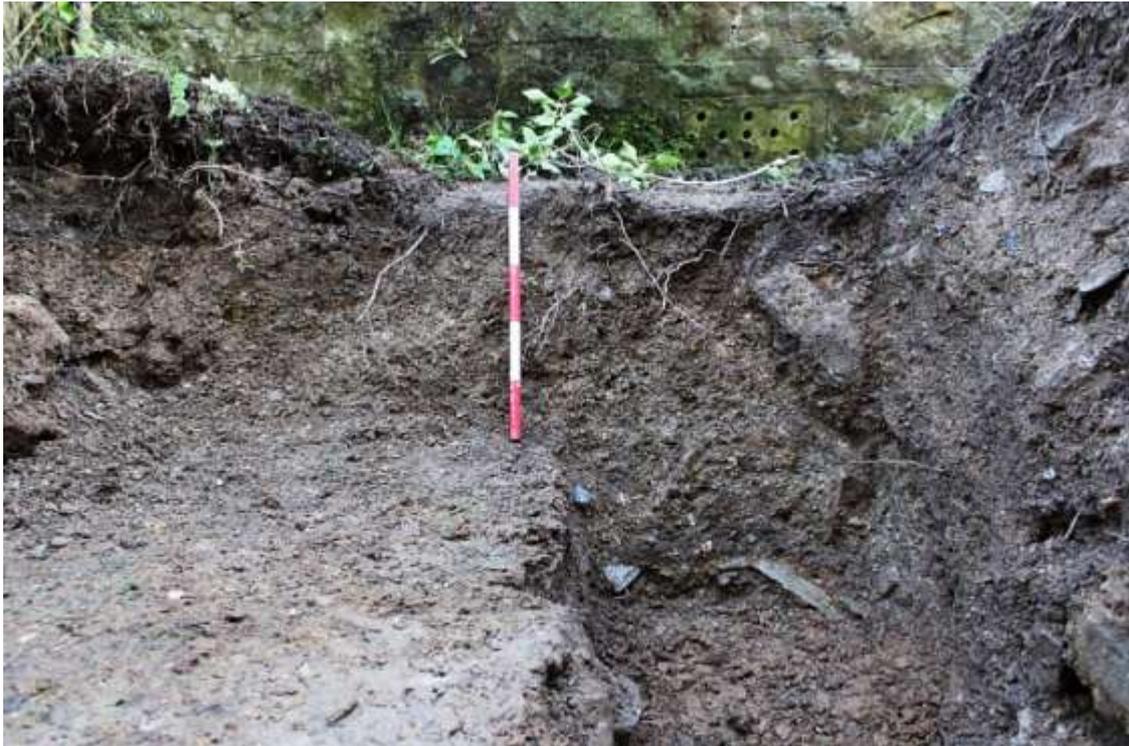
Photo 4: North facing section showing tip-lined ash deposit (07). 0.5m scale

- 4.2.6 The top of the burial was capped with medium sized pieces of broken slate (09) (Figure 6). Above the slate, was a layer of c.0.8m depth comprising ash (07) - presumably wood ash, as no cinder or coal was observed. The tip-lined ash butted up against the truncated south side of the wall and was visible in the east and north facing sections (Photos 1 and 4; Figure 6). It is probable that during the time that the boiler room was operational, a pit was excavated to dispose of the ash it produced, and whilst excavating the lower levels of this pit, burial (10) was discovered. The top of the burial was probably exposed and to protect it a layer of slate (09) was then placed over it. The dimensions of the pit are not known as it extended beyond the limits of the evaluation area (footprint of the proposed extension) to the east and continued under the southern and western sections. To the north it was bounded by wall (12). It is uncertain whether the upper half of grave cut (08), which is more jagged, is a recut associated with excavating the pit or the original grave cut for burial (10).

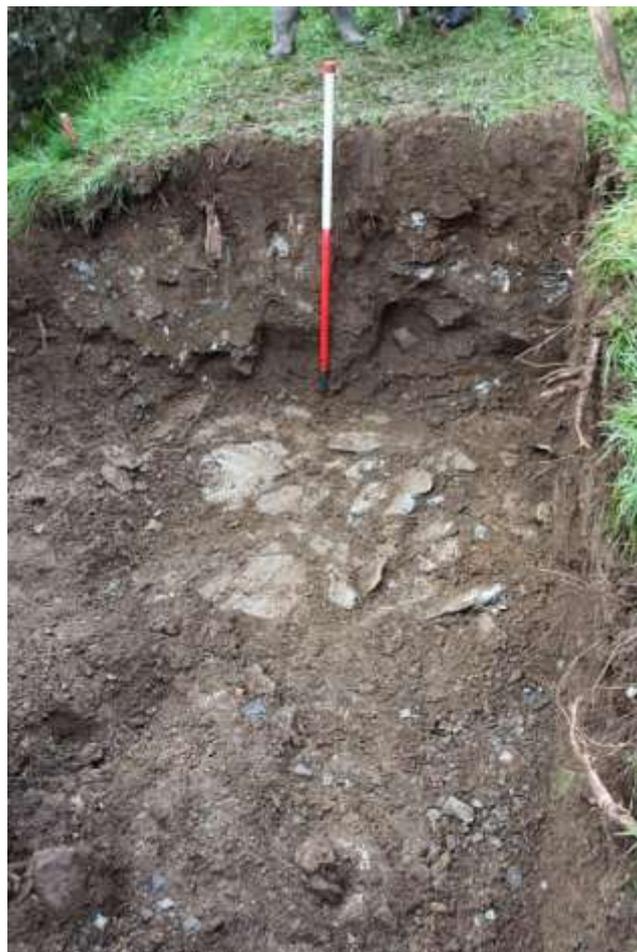
Photo 5 : View Southwest; slate layer (13) covering burial prior to removal.
1m scale.

- 4.2.8 Above (13) in the east facing section was a layer of broken, clean slate up to 0.35m thick. This layer butted up to the wall. It was also visible in the south facing section but only as a very thin layer extending for approximately 1m. This probably represented dumped material, but a surface of some kind cannot be ruled out (Photos 1,5 and 6; Figures 6 and 7).

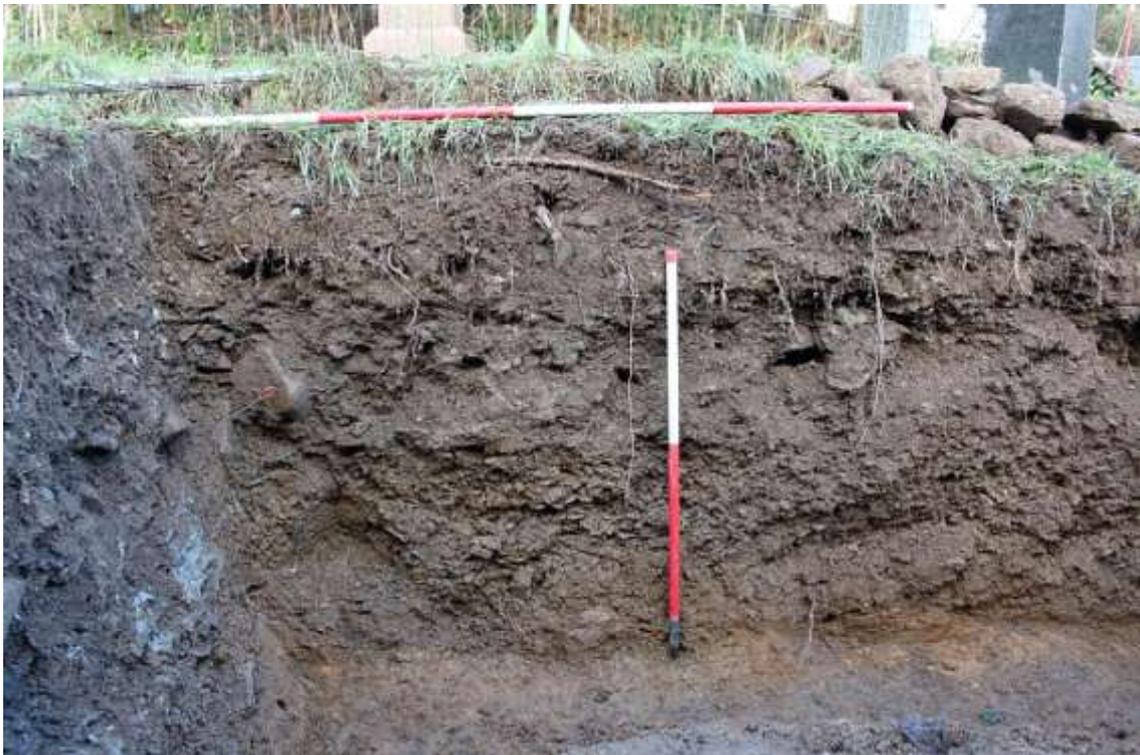
Photo 6: West end of southeast facing section (see Figure 7).

- 4.2.7 Cut (14) was visible in what is what was probably the undisturbed natural substrat (15), a hard, clean, orangey-brown, silty-clay containing small to medium stones. The cut seemed to be part of the construction trench for wall (12). The trench was filled by (13) a deposit of mainly small angular stones, also containing some large stone and boulders up to 0.4m long. This deposit butted up to wall (12), and continues along the south-facing section for approximately 4m. This could be levelling material possibly derived from the groundworks associated with the building of the wall. (Photos 6 and 7; Figures 6 and 7).

- 4.2.9 Layers (1), (4), (5), (6), (13), and (15) were also visible in the south-facing section (Photos 6, 7 and 8; Figure 7) with (1), (4), (5) representing a later phase of backfilling and levelling. It is unclear whether context (6) belonged to the earlier or later phase.

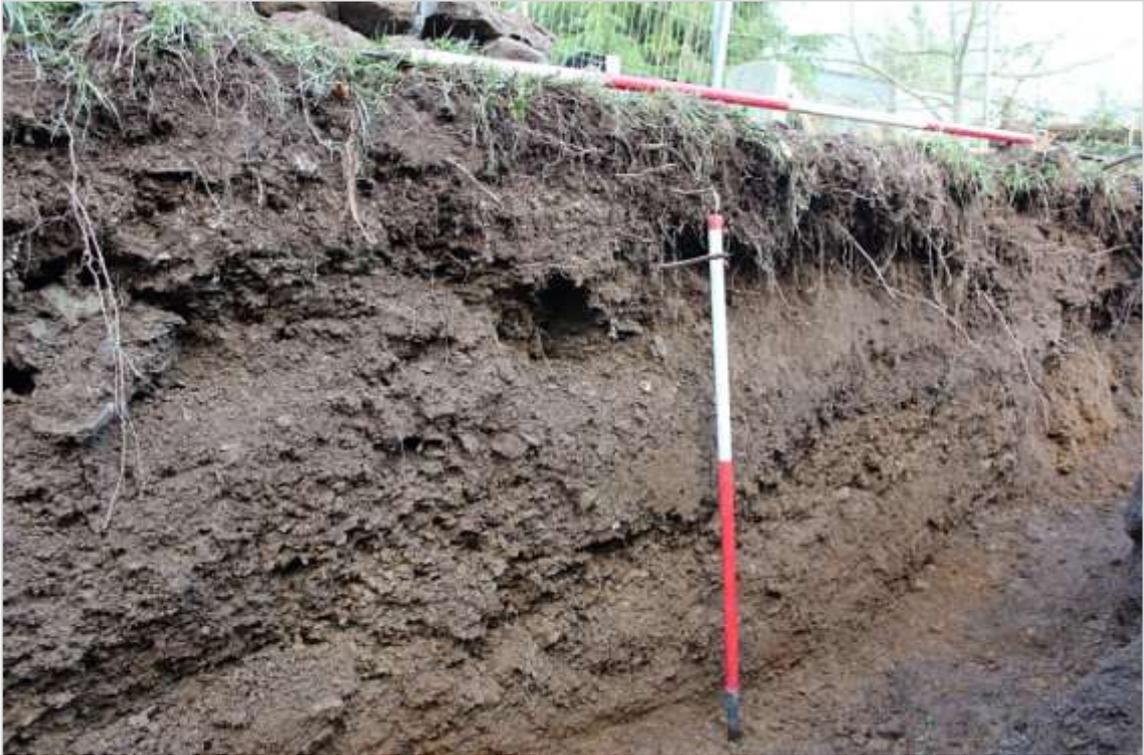
Photo 7: Central area of southeast facing section (see Figure 7).

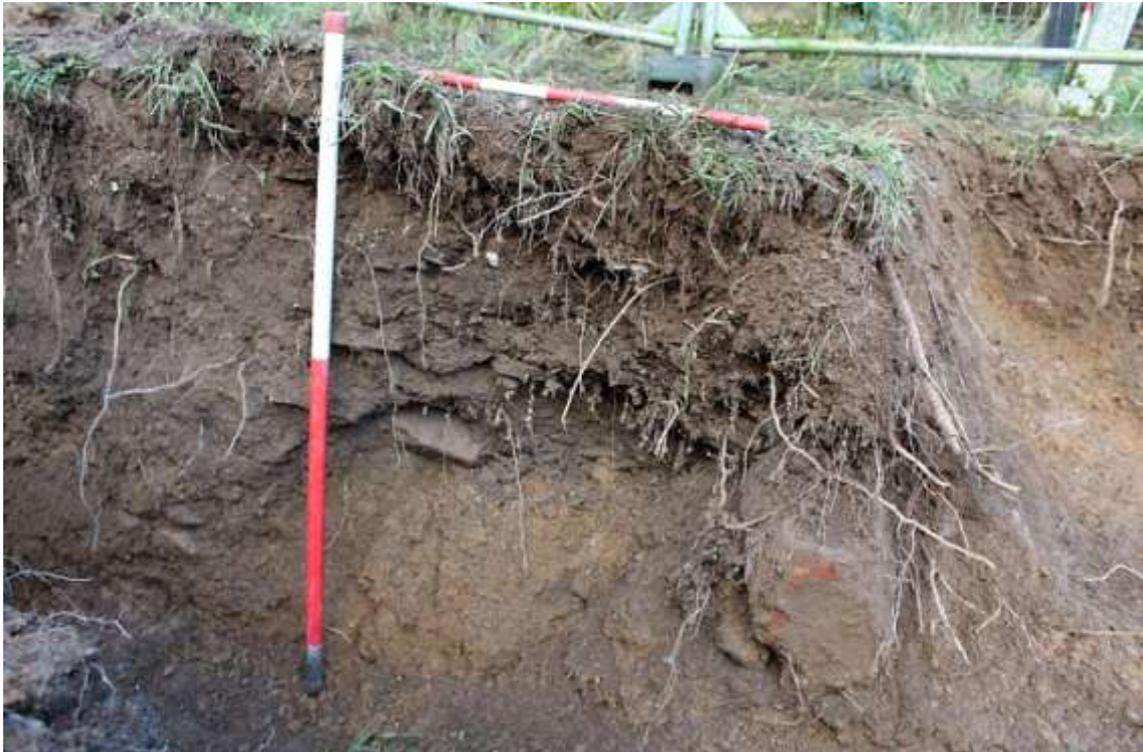
Photo 8: East end of southeast facing section (see Figure 7).

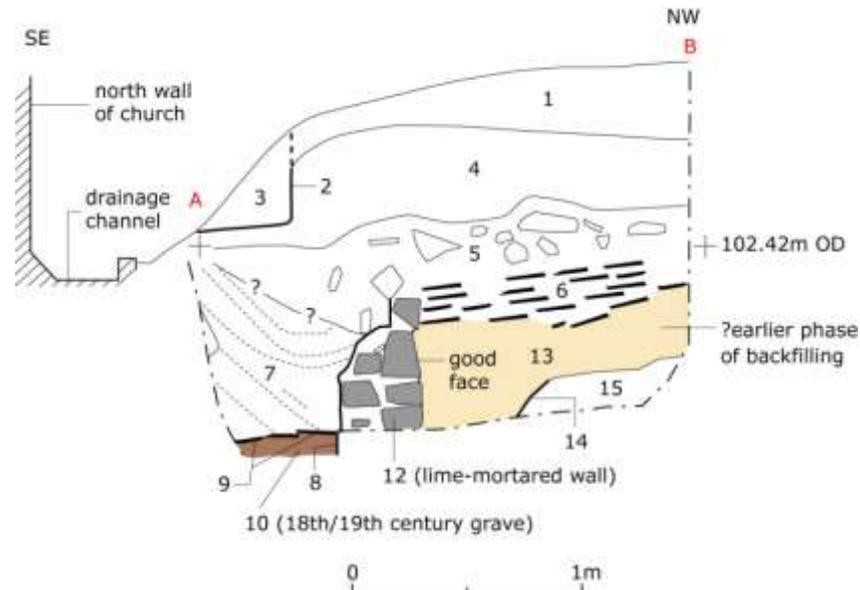
Figure 6: Northeast facing section at west end of site.

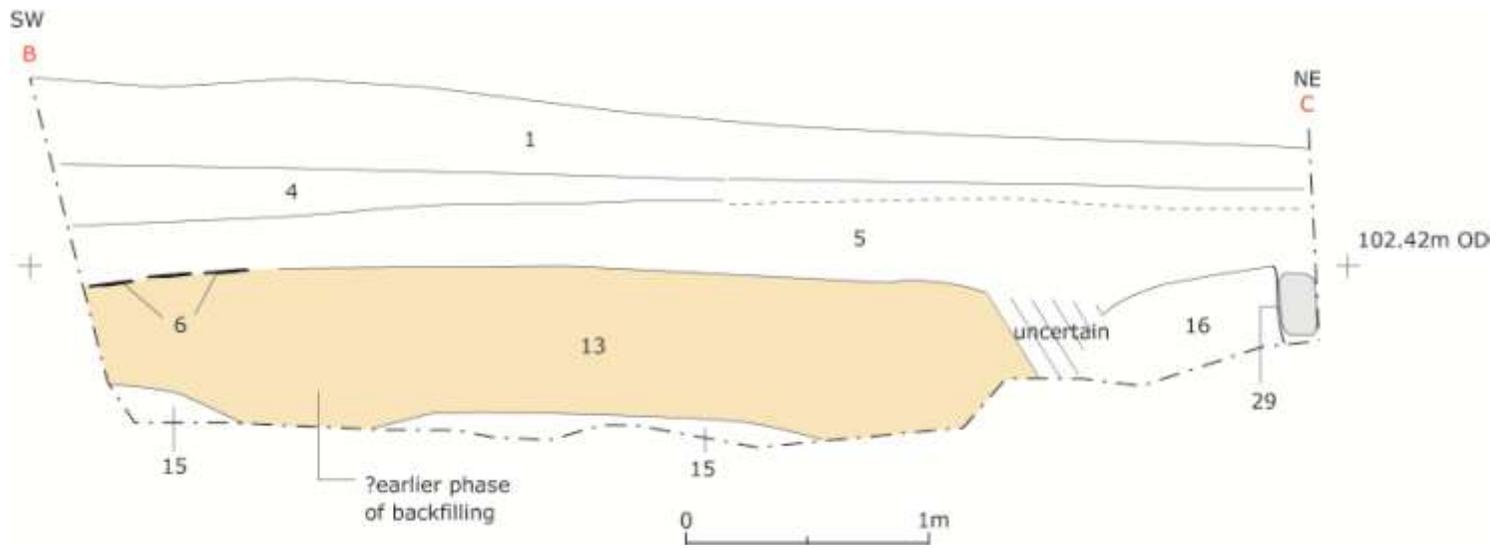
Figure 7: Southeast facing section in western half of site.

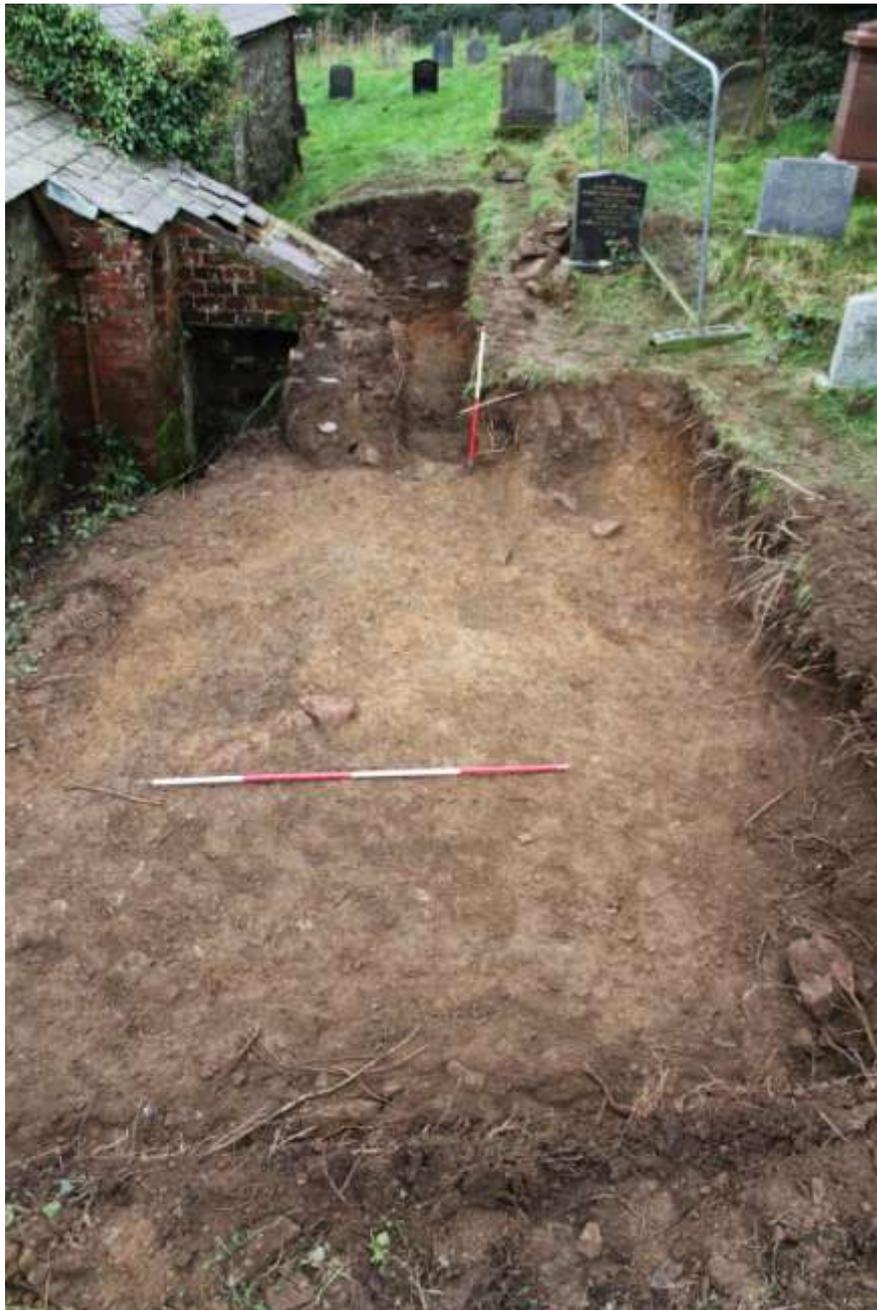
Photo 9: View Southwest across eastern half of site. Possible medieval graves in middle ground; features (18) and (19) in foreground. 2m and 1m scale.

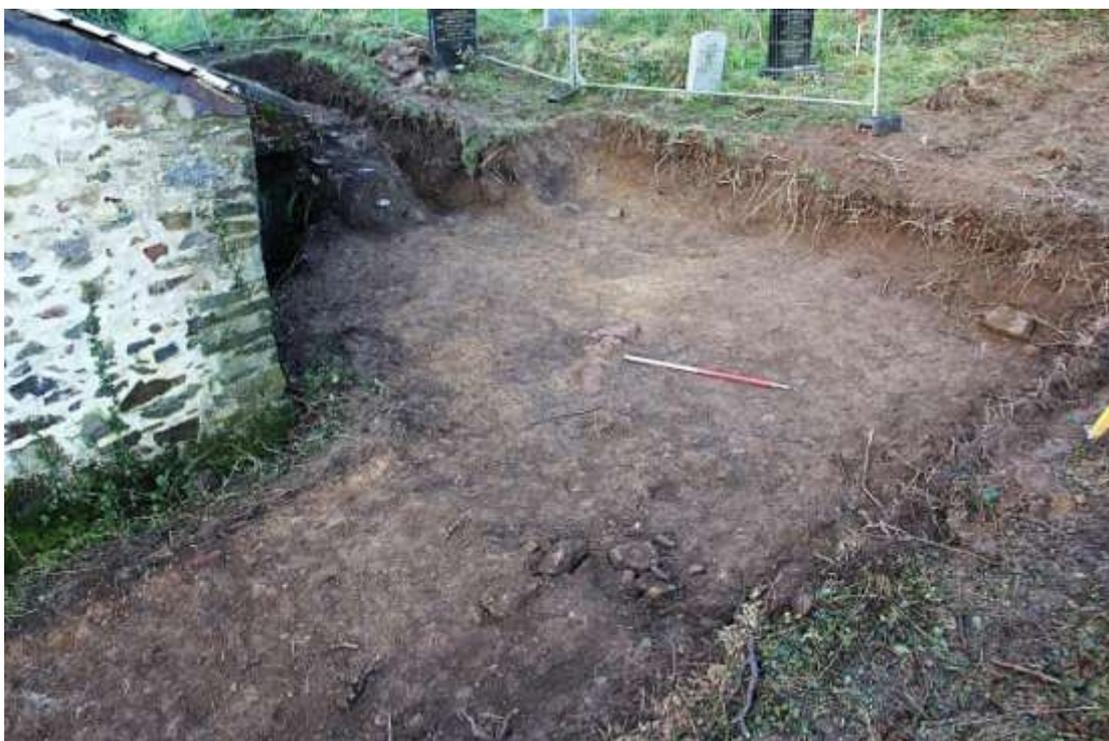
Photo 10: Looking northwest across eastern half of site; possible graves cut into orange natural; (18) and (19) in the foreground. 1m scale

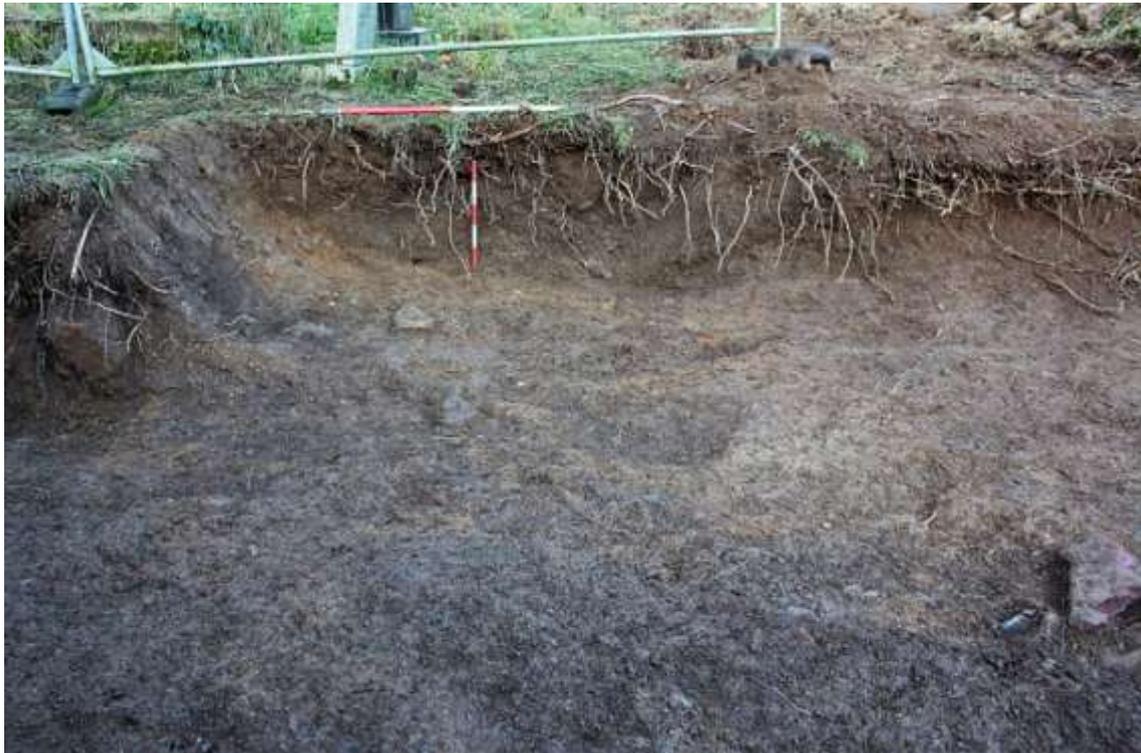
Photo 11: Looking northwest at possible graves [26] and [27].
1m and 0.5m scale.

- (22) 1.9m x 1.35m. Probably contains several inter-cutting elements.
- (23) 0.45m x 0.3m.
- (24) 0.65m x 0.4m
- (25) 1.55m long; width under section. Probably composed of two inter-cutting elements.
- (26) c.0.58m x 0.45m. Unclear at west end.
- (27) c.0.75m x 0.35m. Unclear at west and north sides.

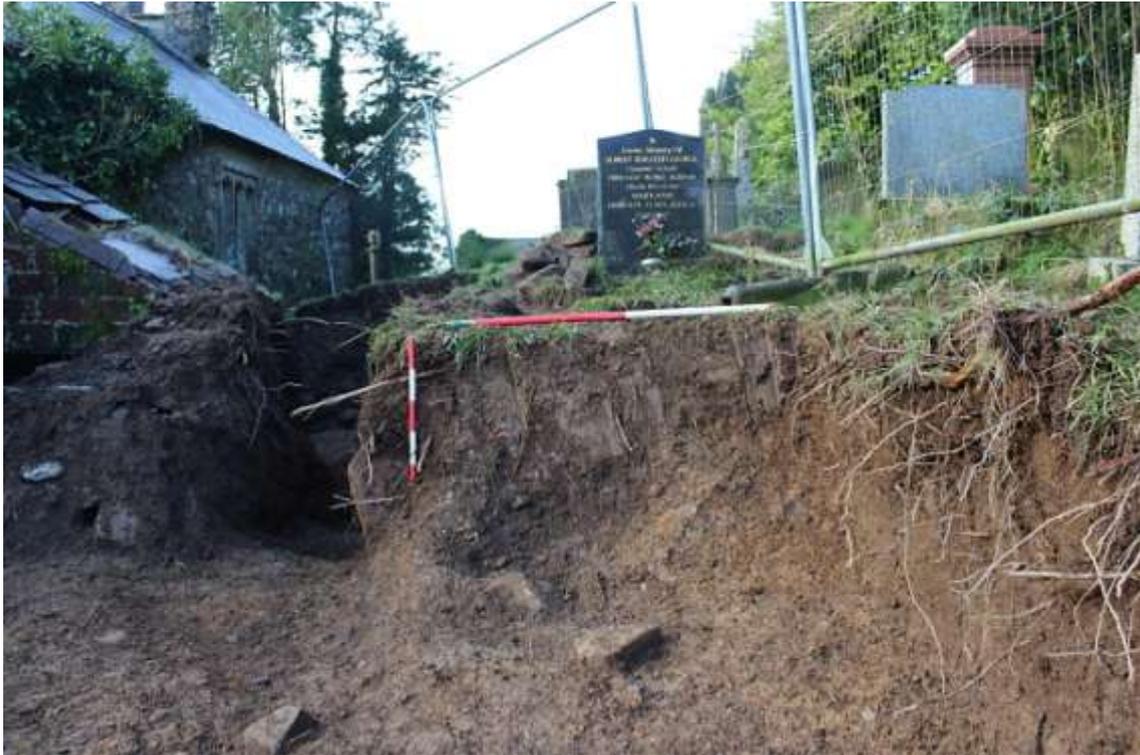
Photo 12: Looking southwest at ?pit (29). 1m and 0.5m scales

4.3.10 A later ?pit/treehole (29) filled during the period of ground levelling, was observed in section and plan, intruding into features (27) and (28).

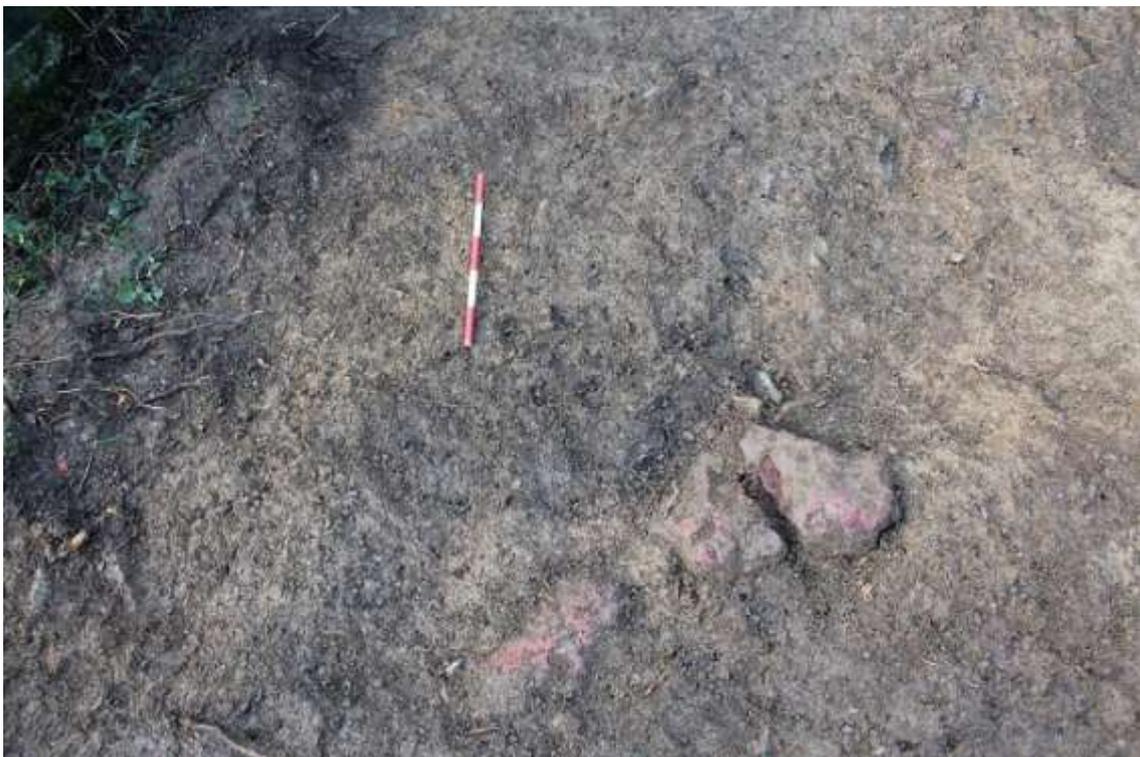
Photo 13: Looking SW towards possible grave (22). 0.5m scale

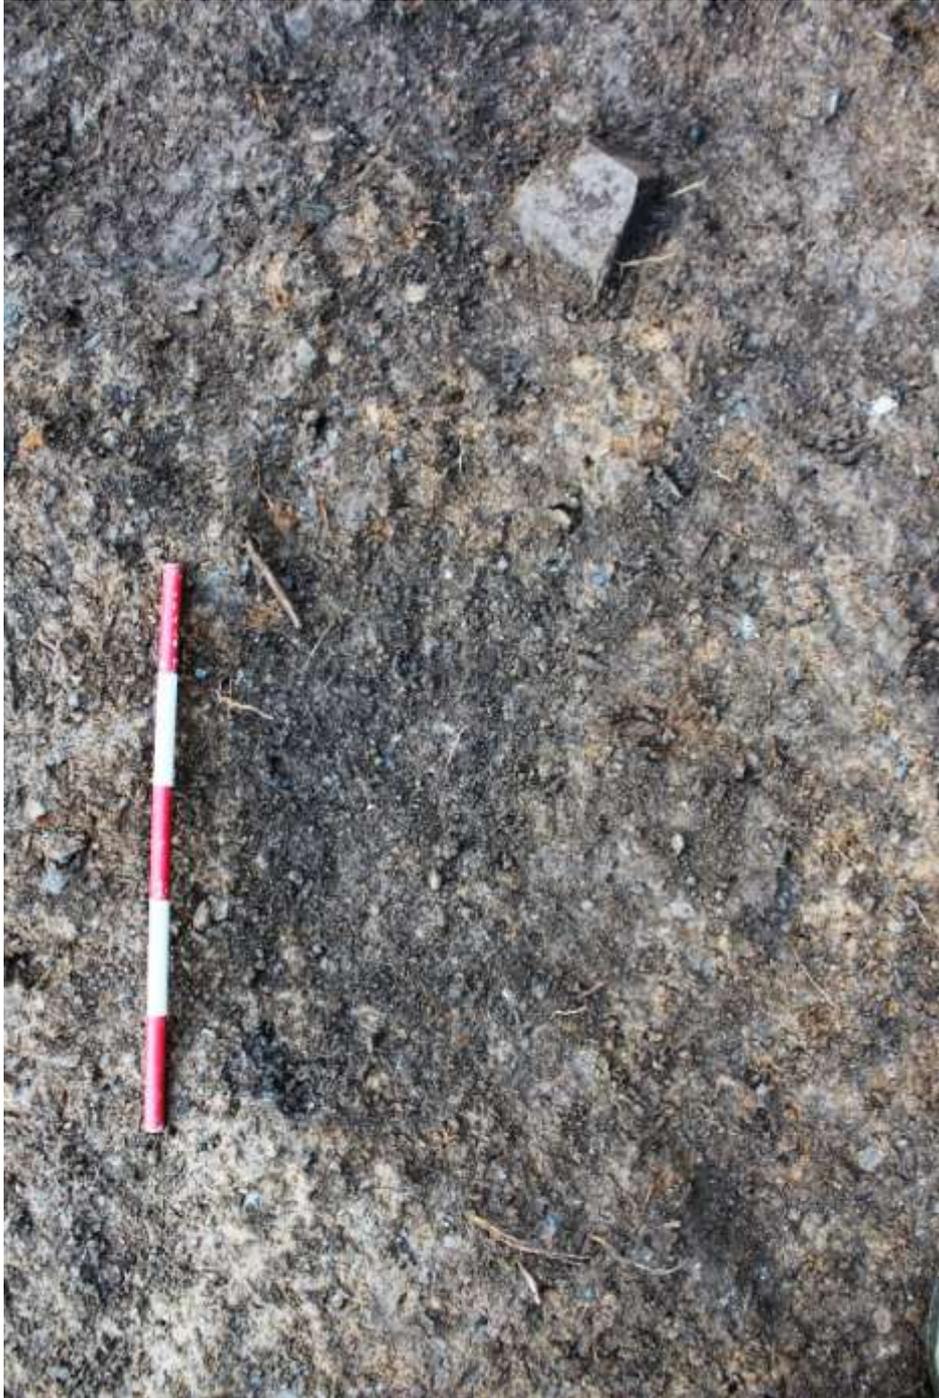
Photo 14: Looking SW along possible grave (23). 0.5m scale
