LITTLE DIBLEY, CRINOW, NARBERTH PEMBROKESHIRE: ARCHAEOLOGICAL EVALUATION 2017

RHIF YR ADRODDIAD / REPORT NO. 2017/14
RHIF Y PROSIECT / PROJECT RECORD NO. 110330

LITTLE DIBLEY, CRINOW, NARBERTH, PEMBROKESHIRE: ARCHAEOLOGICAL EVALUATION 2017

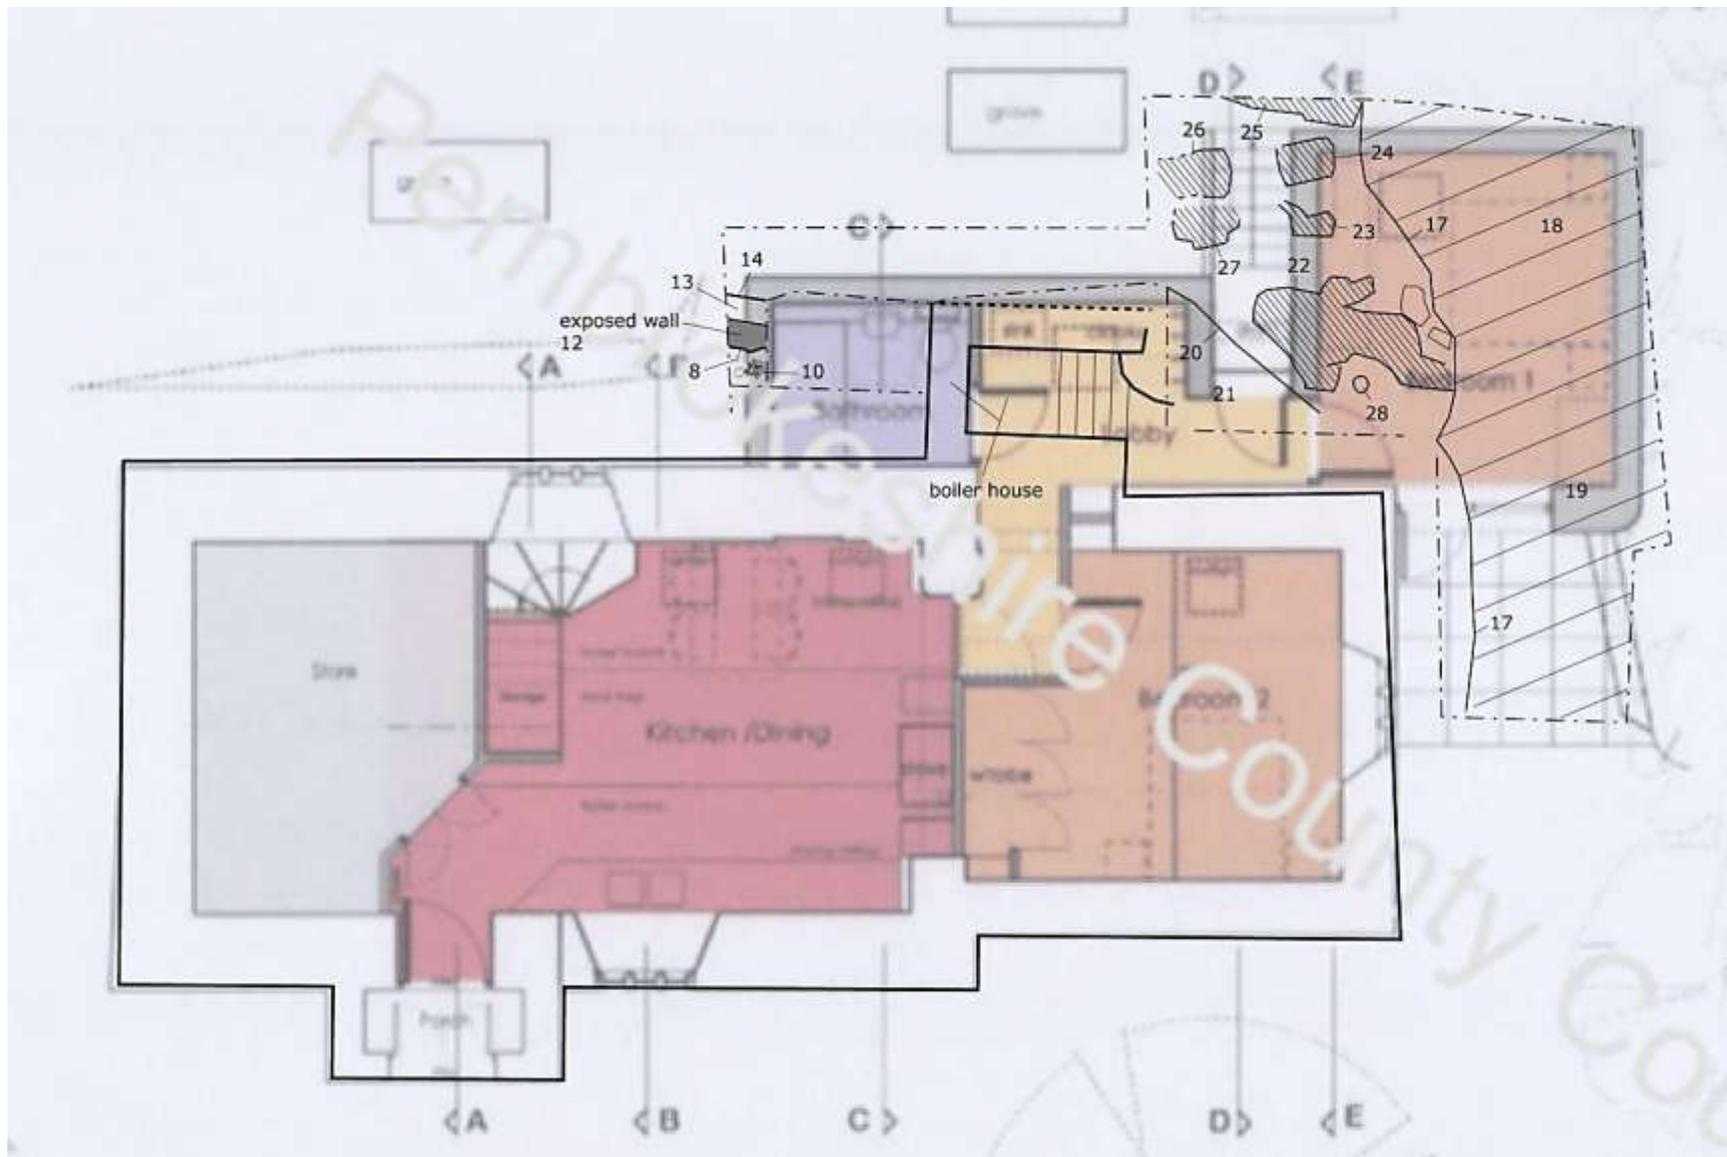
Figure 8: Plan of proposed development with overlay of archaeological features
