Planning Application: A220770

Level 1 Photographic Survey

Cwmceirw, Llanfarian, Aberystwyth SY23 4QG

Survey Prepared and submitted by A O'Regan

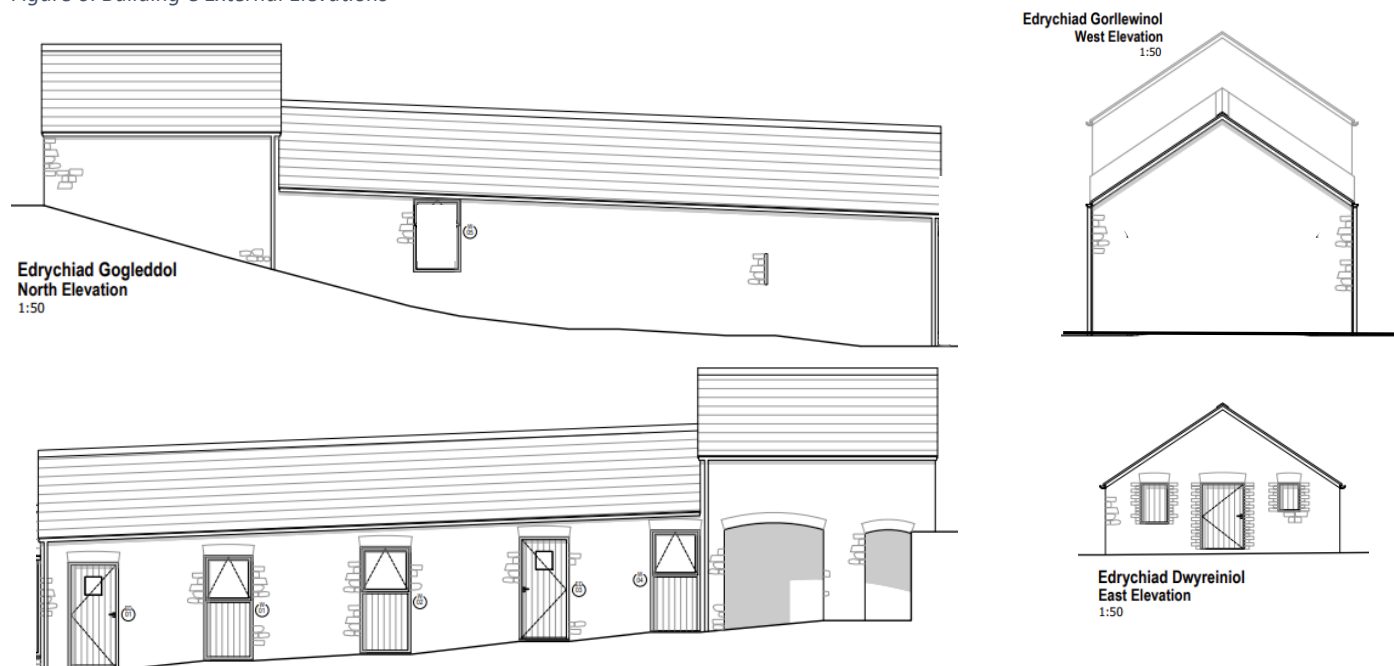
Figure 6: Building C External Elevations

The existing building is constructed from 600mm thick random rubble stone walls and formed in two primary blocks. The eastern end of the building is 2 storey with the first floor being accessed from the eastern elevation, while the western end is of single storey construction assessed from the front (southern) elevation. The eastern section of this building does not form part of the planning application.

The building was gutted and re-roofed +/-20yrs ago. The roof structure is timber raised collar principal trusses supporting purlins and rafters with felt and batten over, the covering is slate. The purlins in both sections of the building have been replaced.
