YSGOL DYFFRYN CONWY, LLANRWST

Archaeological Mitigation report

Project No. G1961

Report No.1184

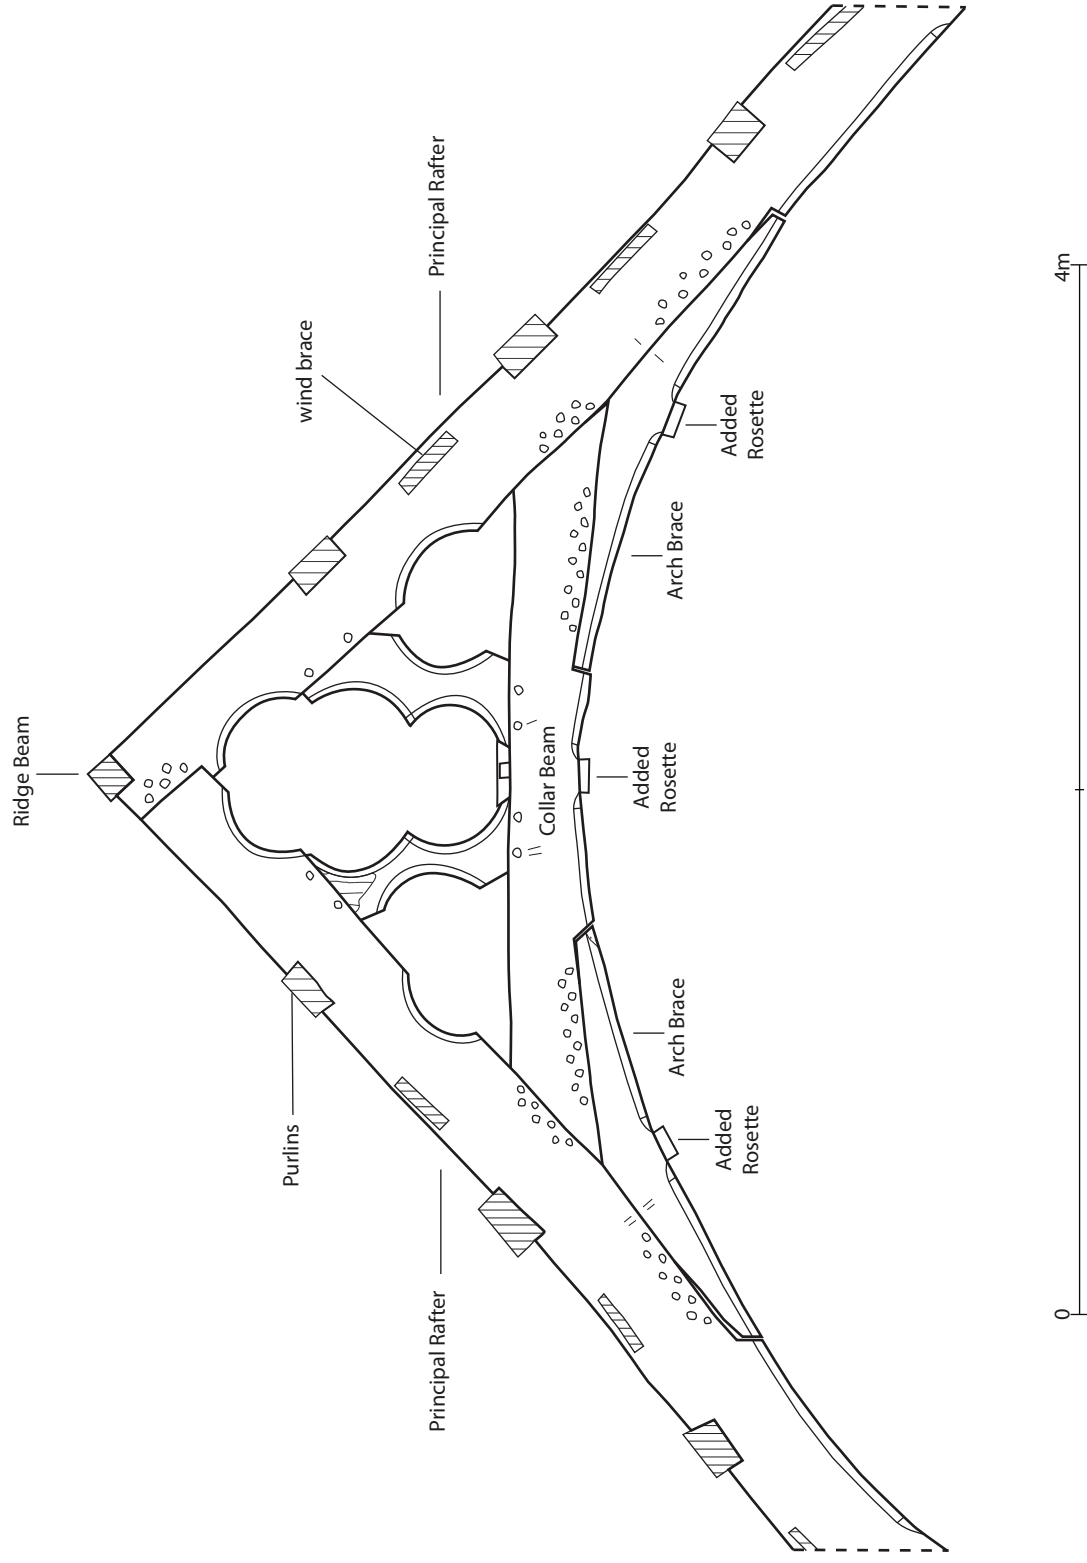
Figure 20 - Old Grammar School Roof Truss 04

The southernmost two trusses (Trusses 4 and 5; Figs. 20-21) have undergone some modification since that date, although when this took place is yet to be identified. There are however 18th century hand-made nails in the timber of Truss 5, and this may indicate that changes have taken place. The decorative bosses had been removed from the southern two trusses, although replaced in more recent times on Truss 4.

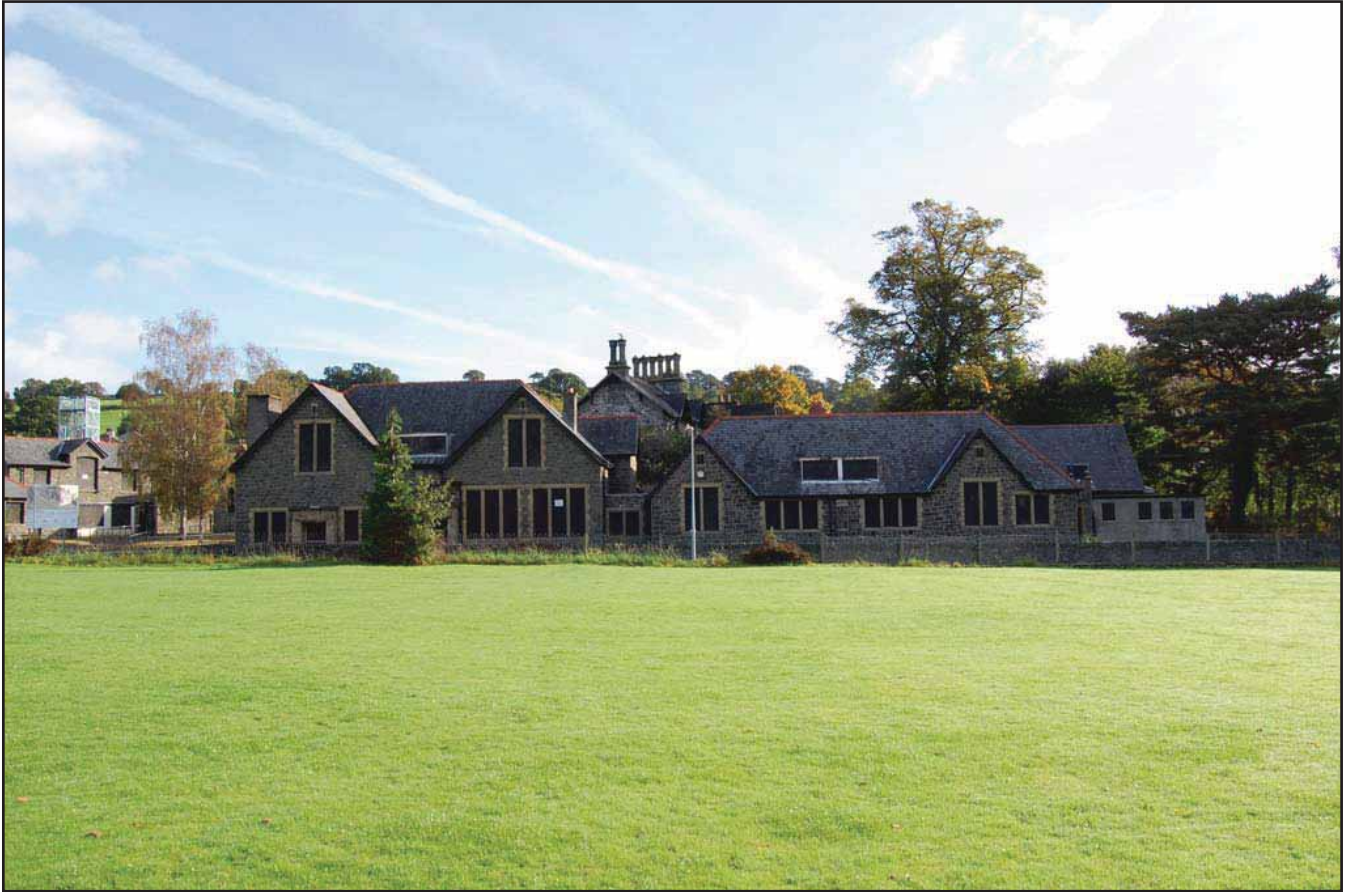
Plate 01: View west of Ysgol Dyffryn Conwy, Llanrwst prior to the renovation and conversion programme (October 2007); these buildings were constructed in the early twentieth century

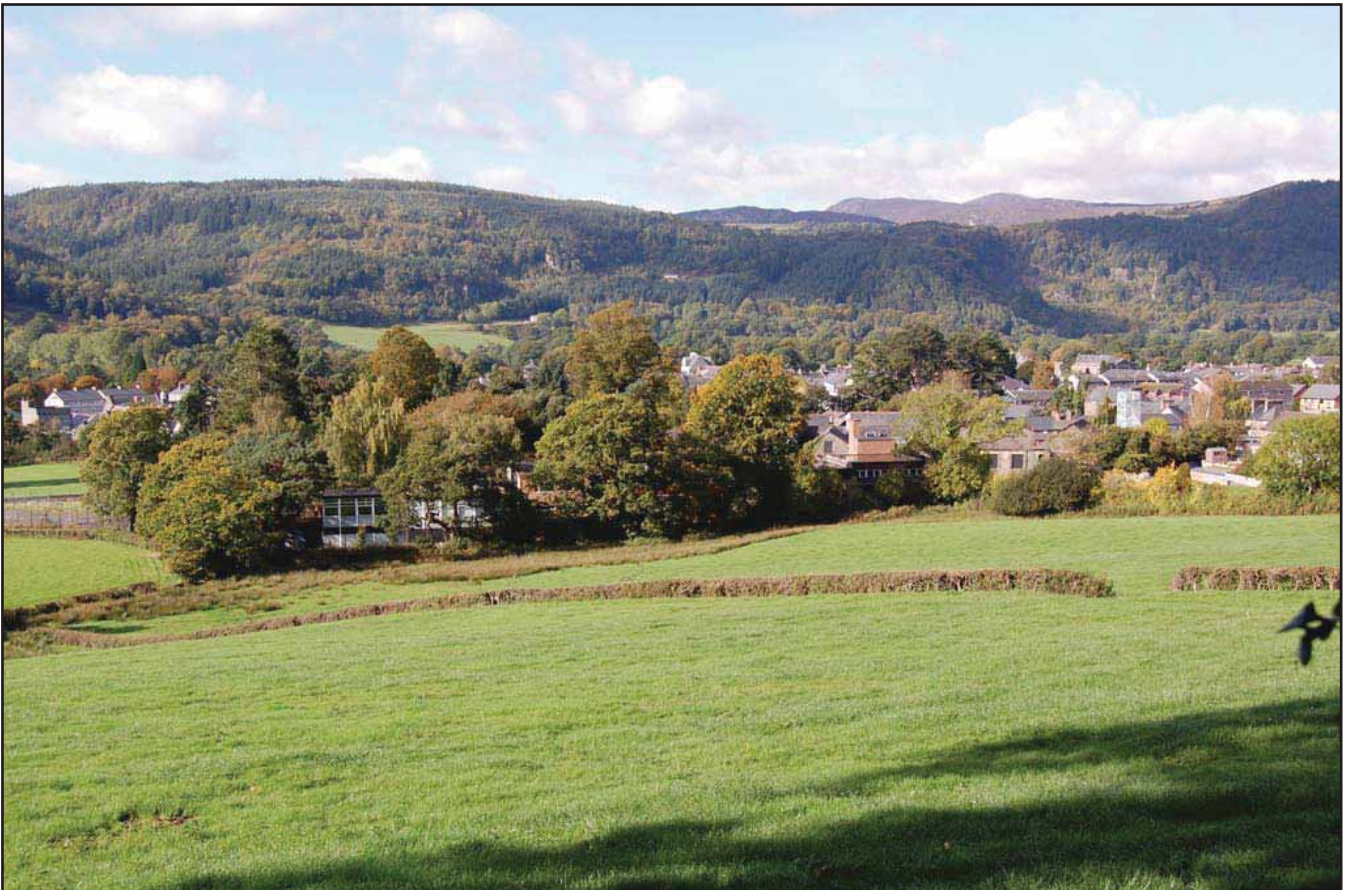
Plate 02: View east of Ysgol Dyffryn Conwy, Llanrwst prior to the renovation and conversion programme (October 2007)

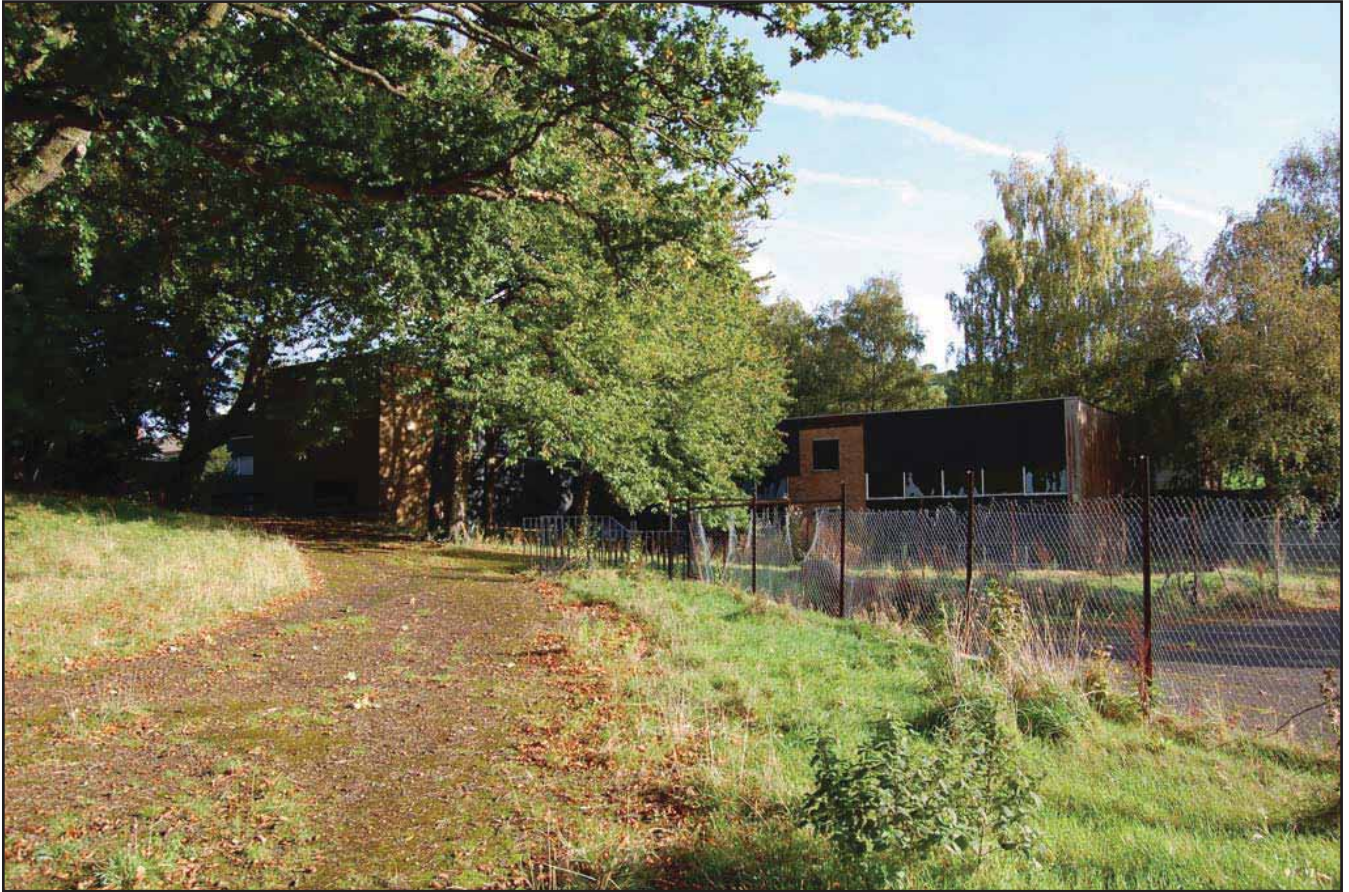
Plate 03: View northeast of the 1960s school block; taken from the school grounds. This was demolished in 2008.

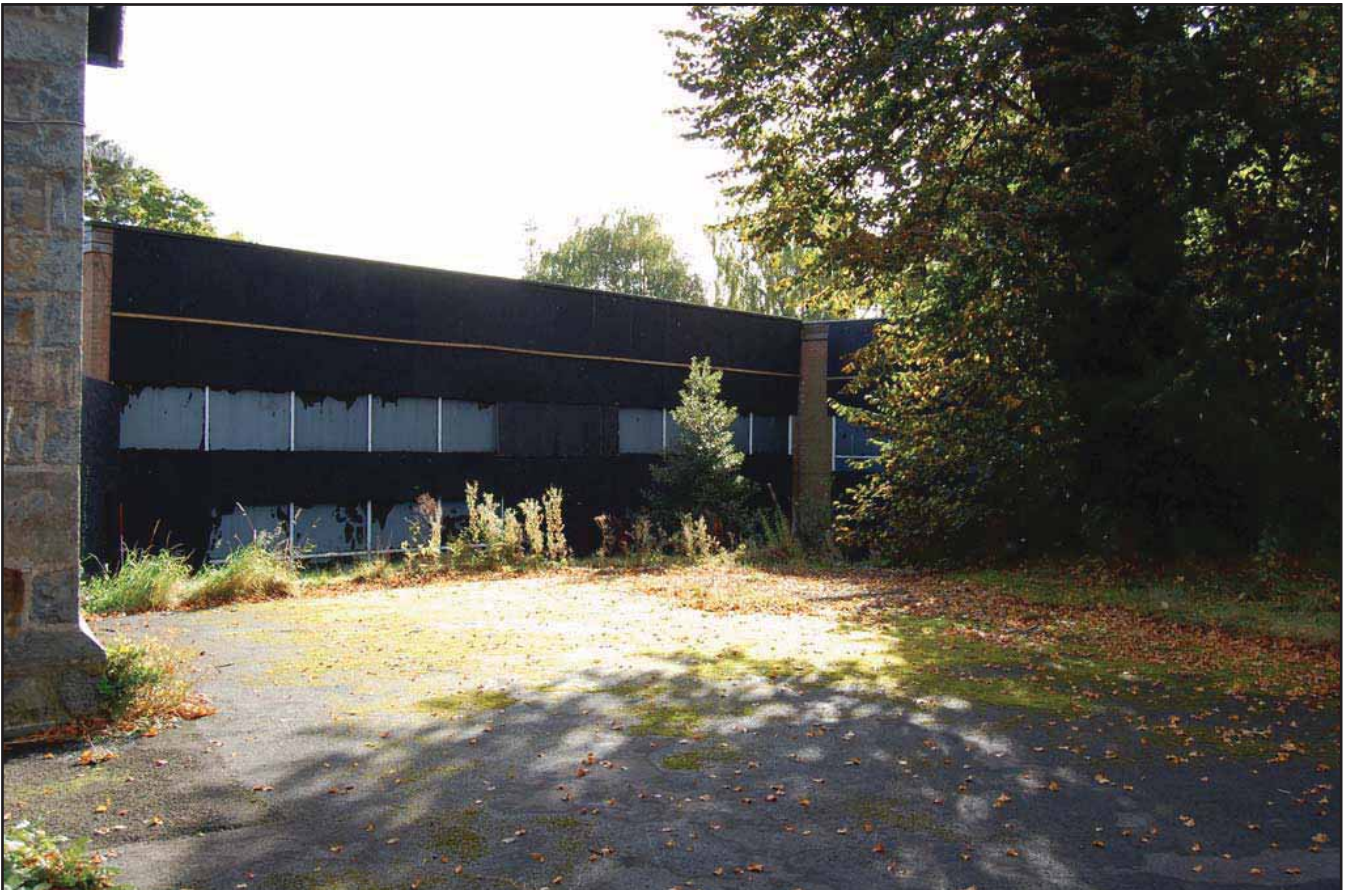
Plate 04: View east of 1960s school block; note the Schoolmaster's House in the left foreground. This was demolished in 2008.

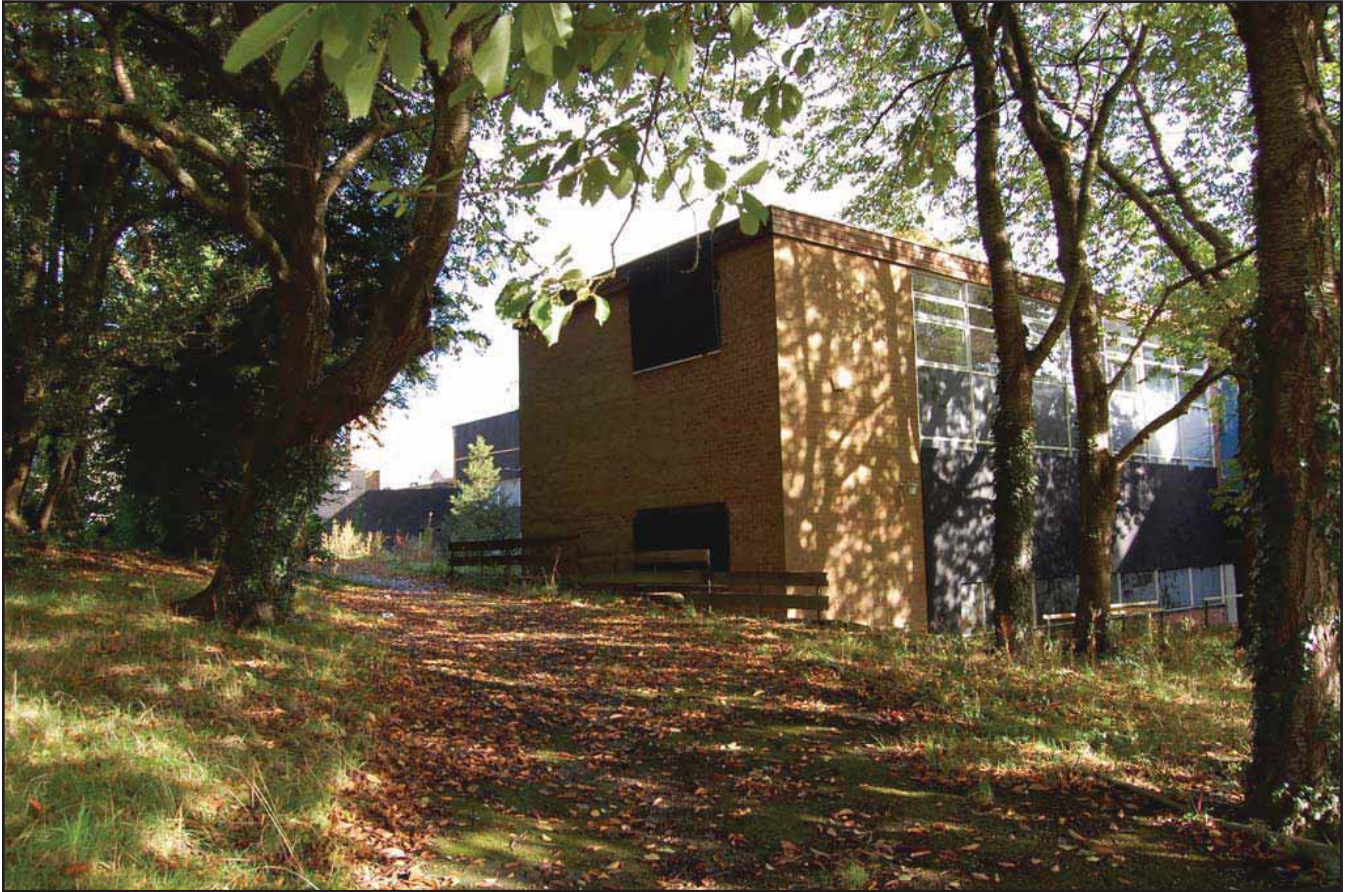
Plate 05: View northeast of west projecting 1960s school block. This was demolished in 2008.

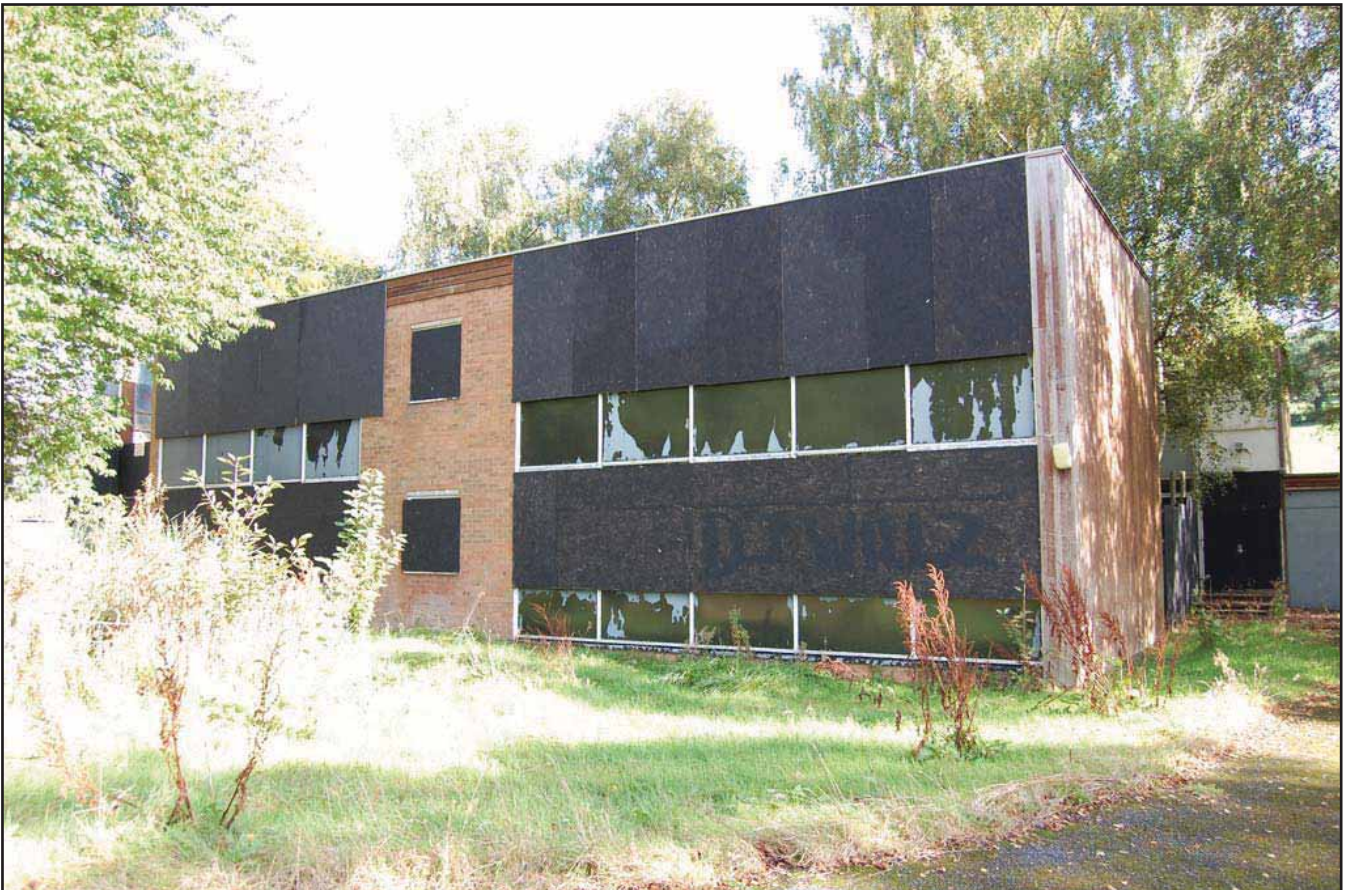
Plate 06: View northeast of south projecting 1960s school block. This was demolished in 2008.

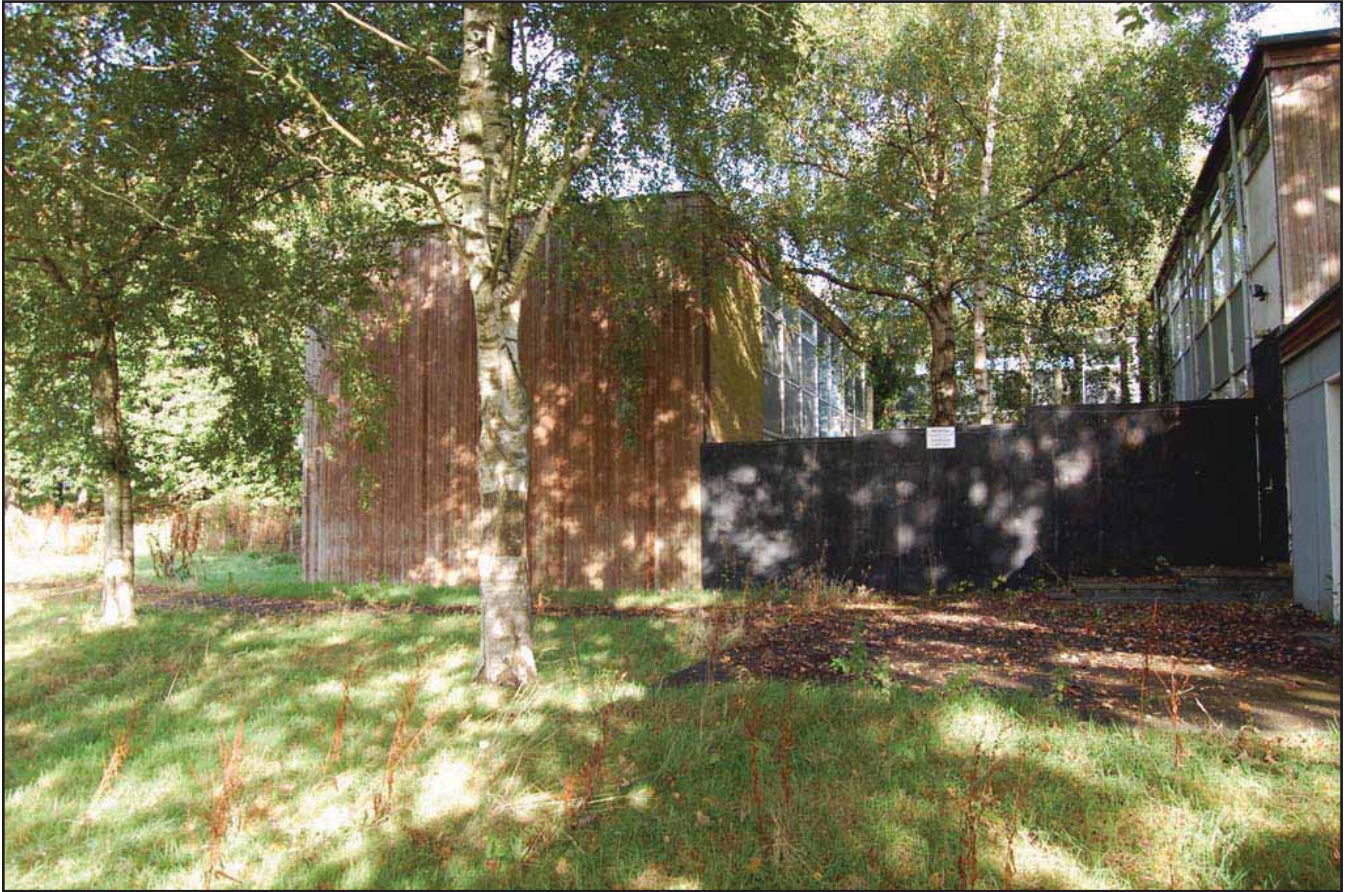
Plate 07: View north of south projecting 1960s block (cf. Plate 06). This was demolished in 2008.

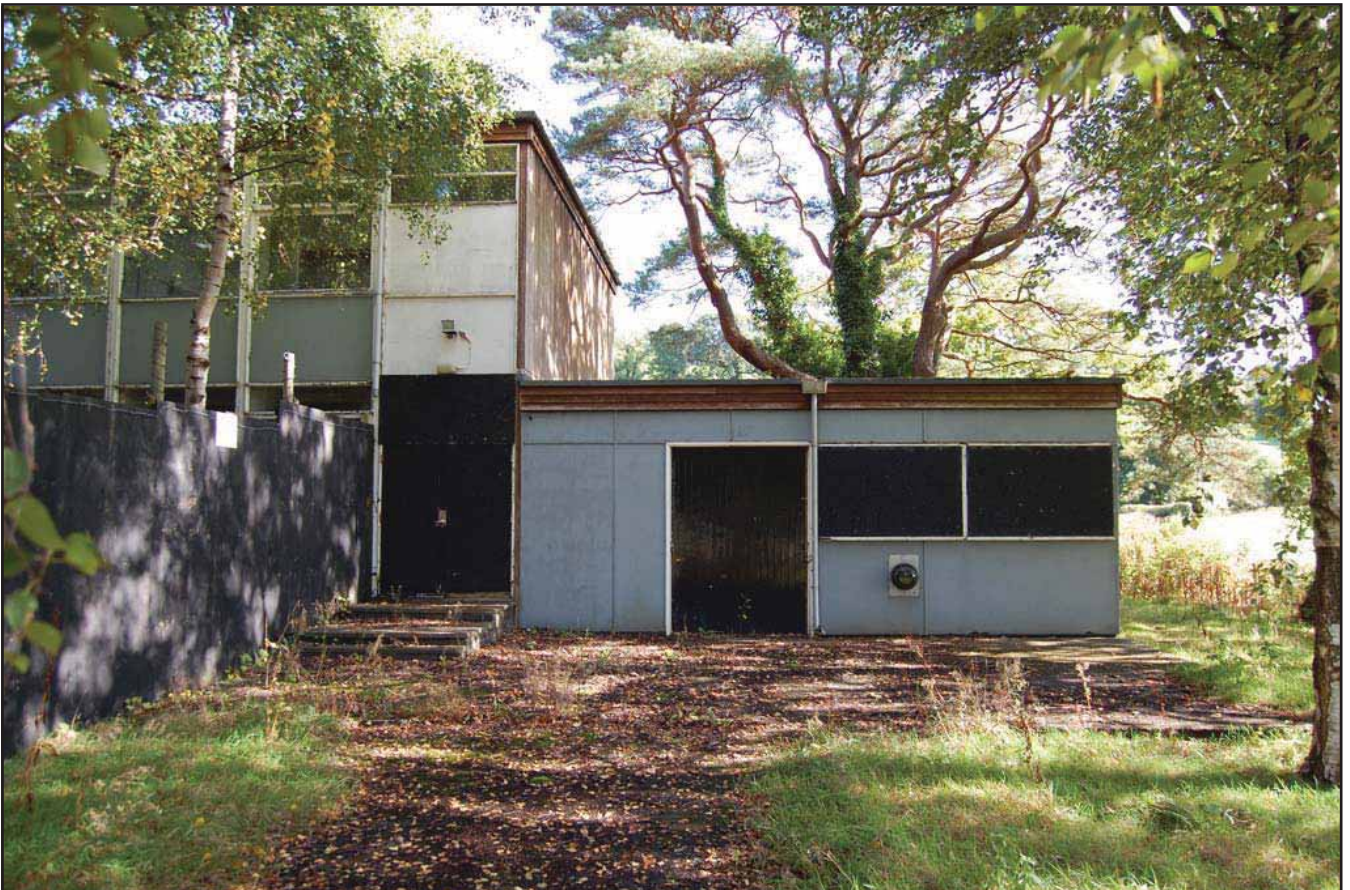
Plate 08: View north of south projecting 1960s block. This was demolished in 2008.

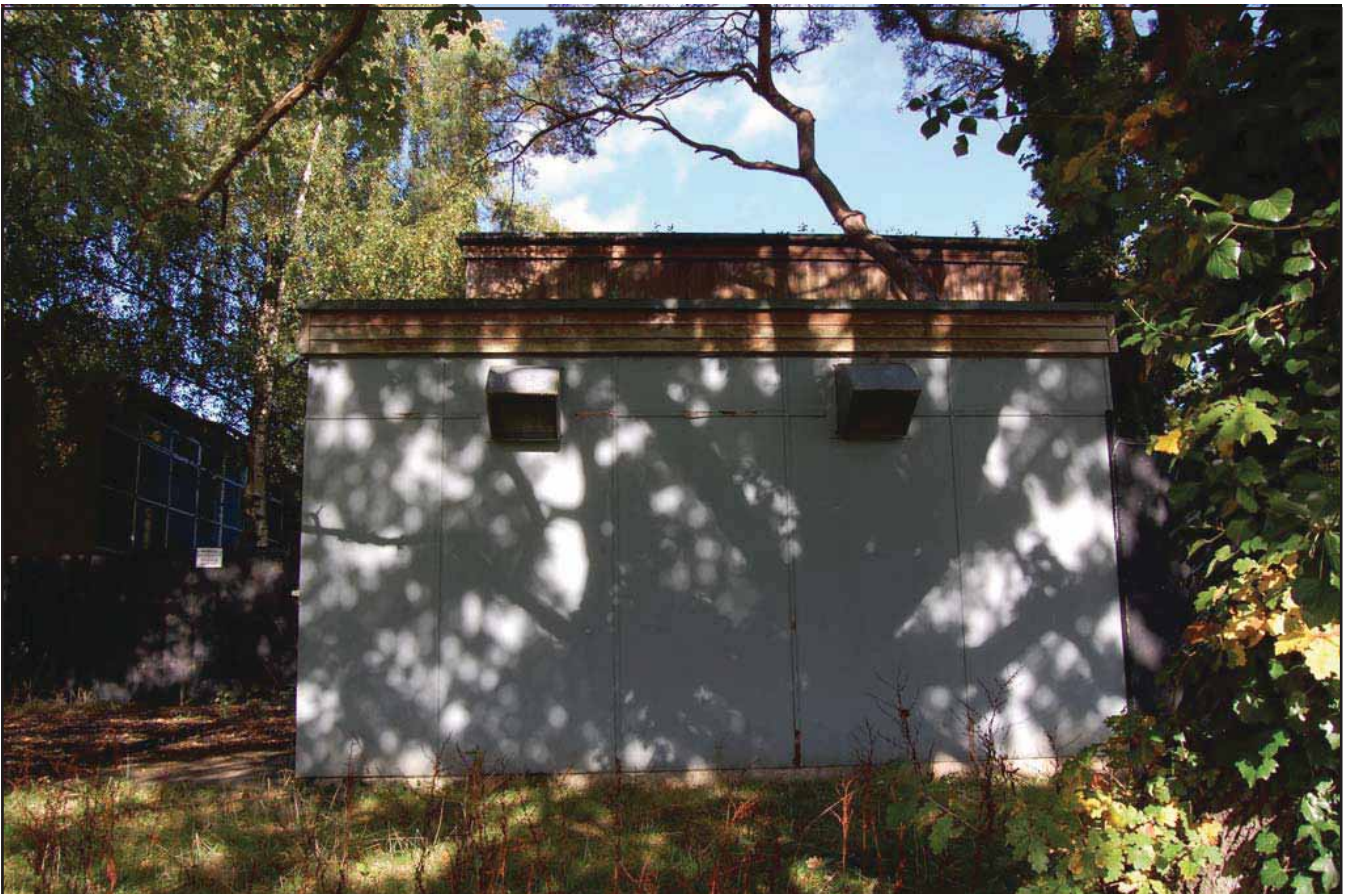
Plate 10: View north of south projecting block (cf. Plate 09); note the larger school block in the background. This was demolished in 2008.

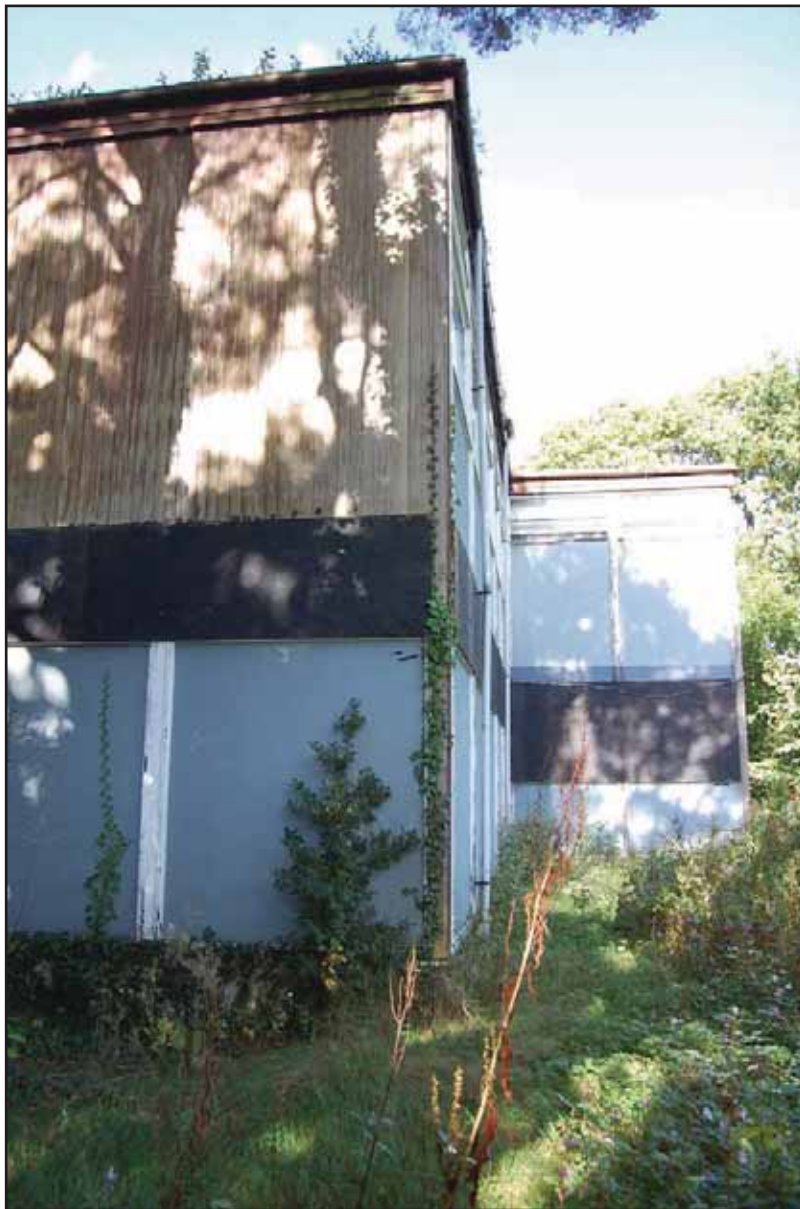
Plate 11: View west of south projecting block (cf. Plate 09). This was demolished in 2008.

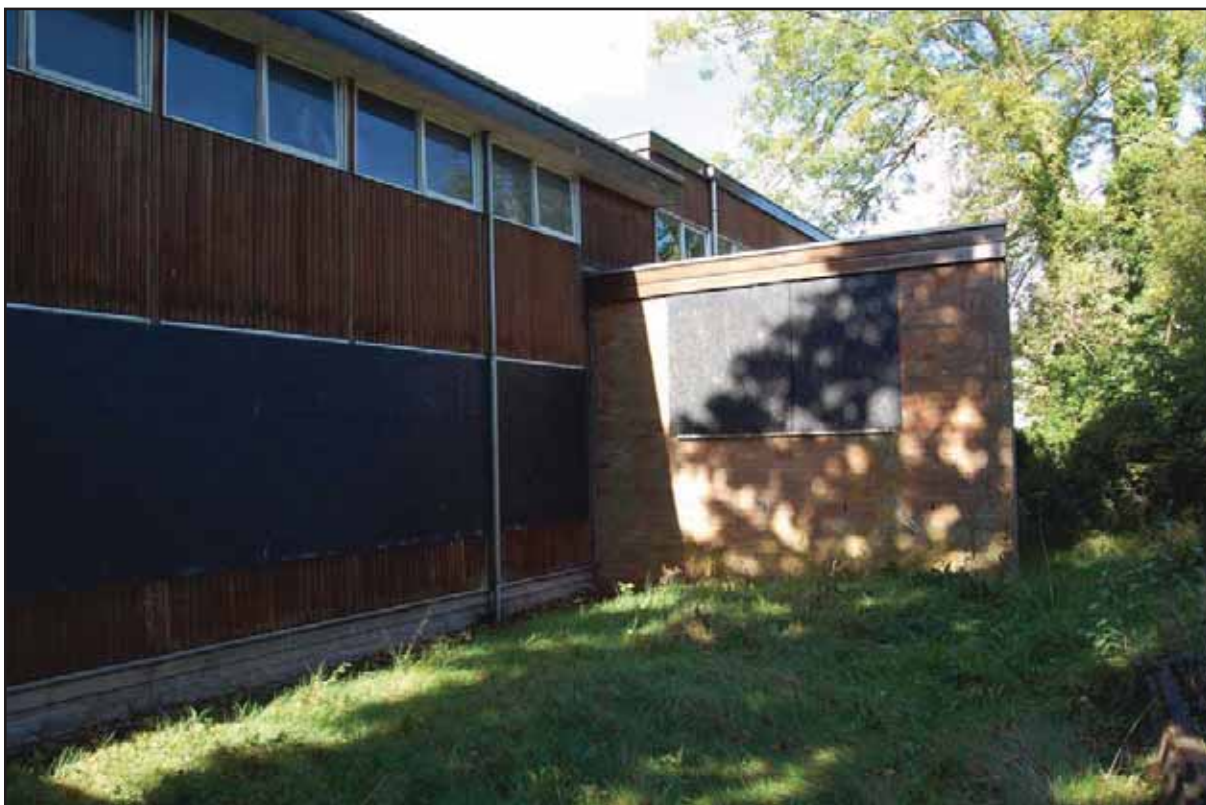
Plate 12: View north of east projecting annexe; note the main school block to the west. This was demolished in 2008.

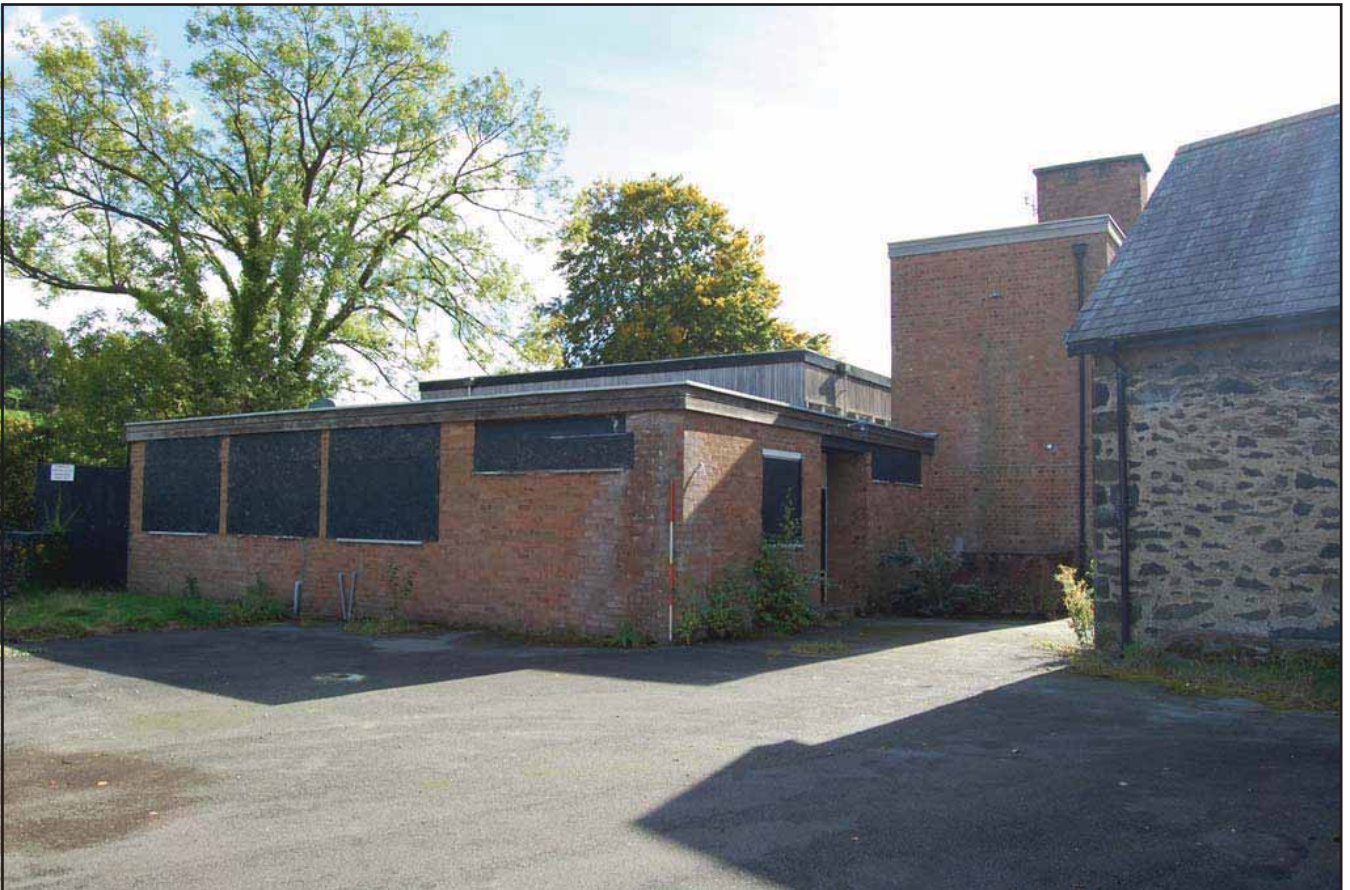
Plate 14: View south of main block. This was demolished in 2008. Note the earlier schoolbuilding in the foreground.

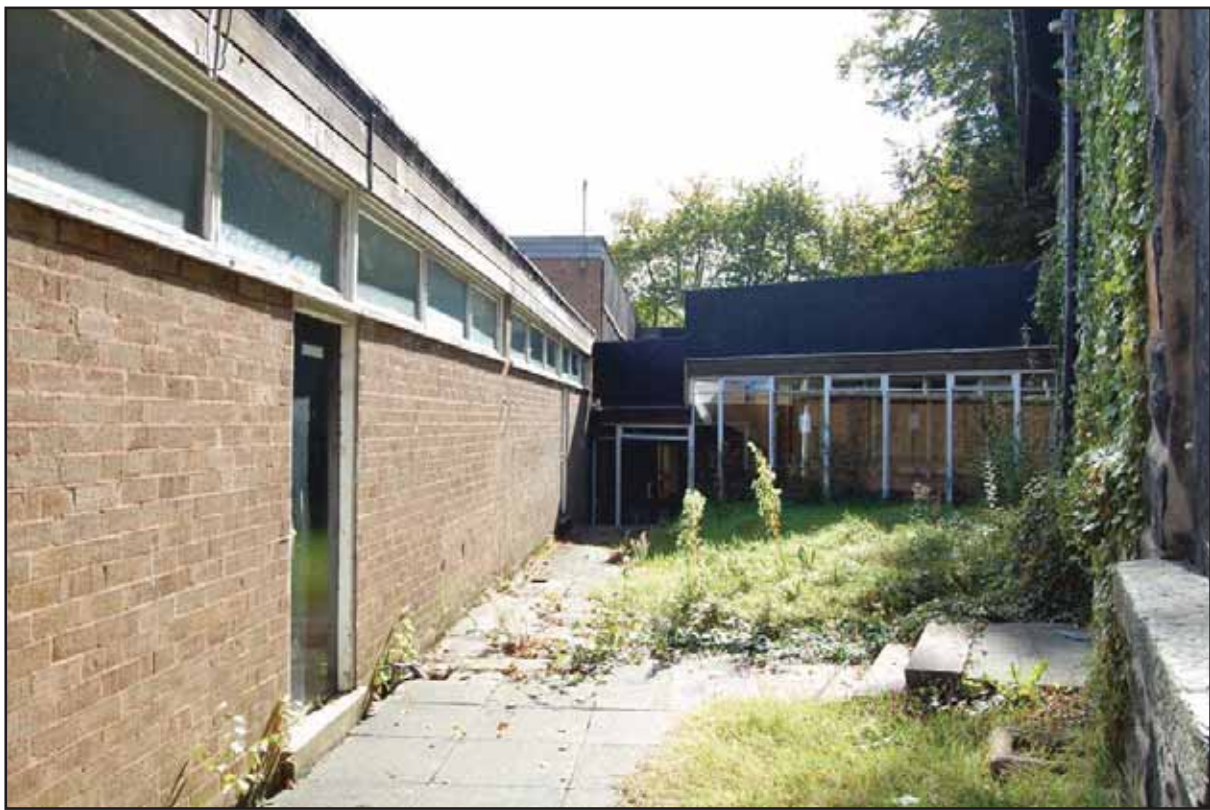
Plate 15: View south of link corridor connecting the 1960s school to the Schoolmaster's House. The link corridor was demolished.

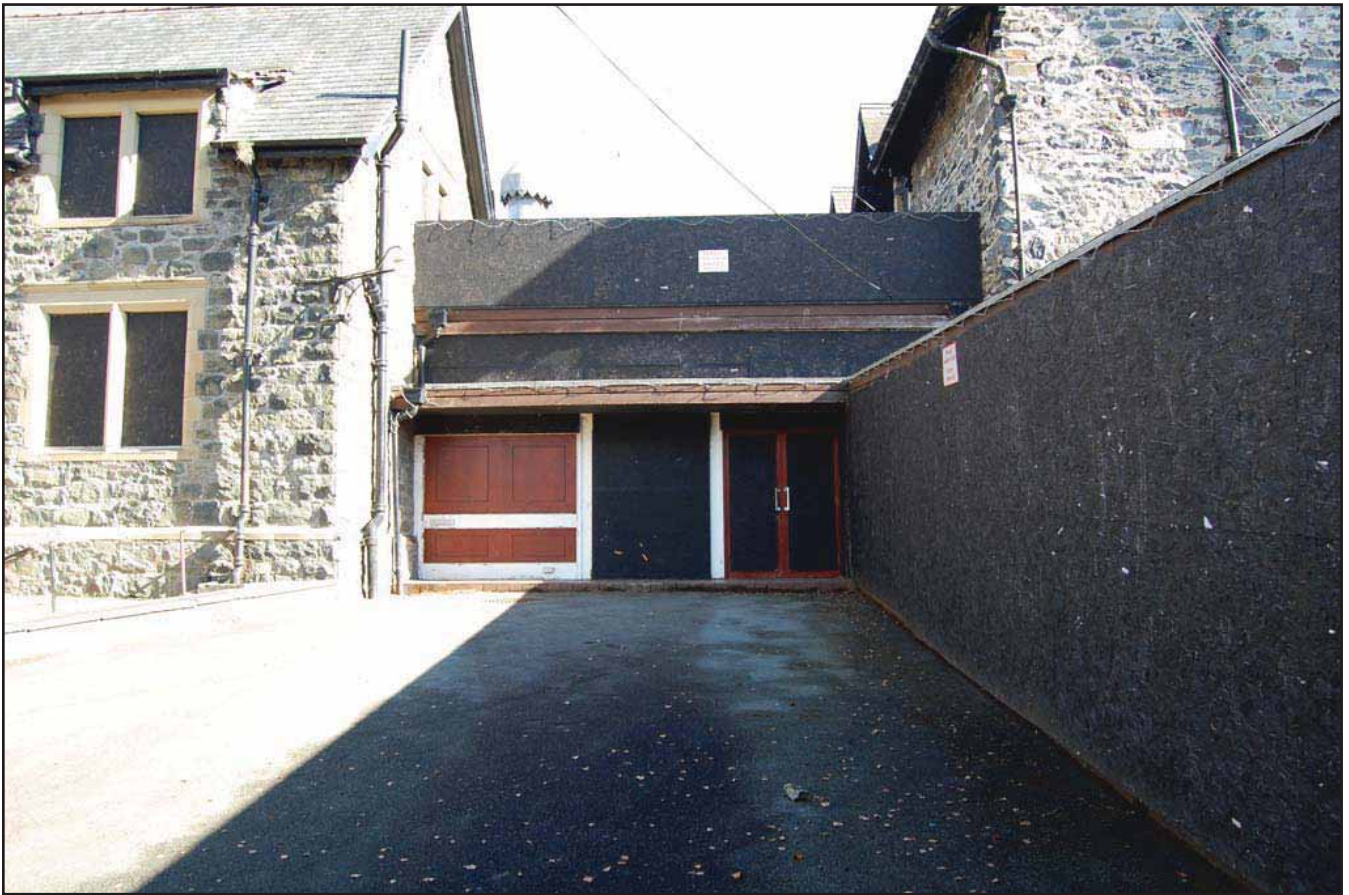
Plate 17: View east of modern entrance lobby. The Old Grammar School block is to the left of image and the Schoolmaster's House is to the right of image. The entrance lobby was demolished in 2008.

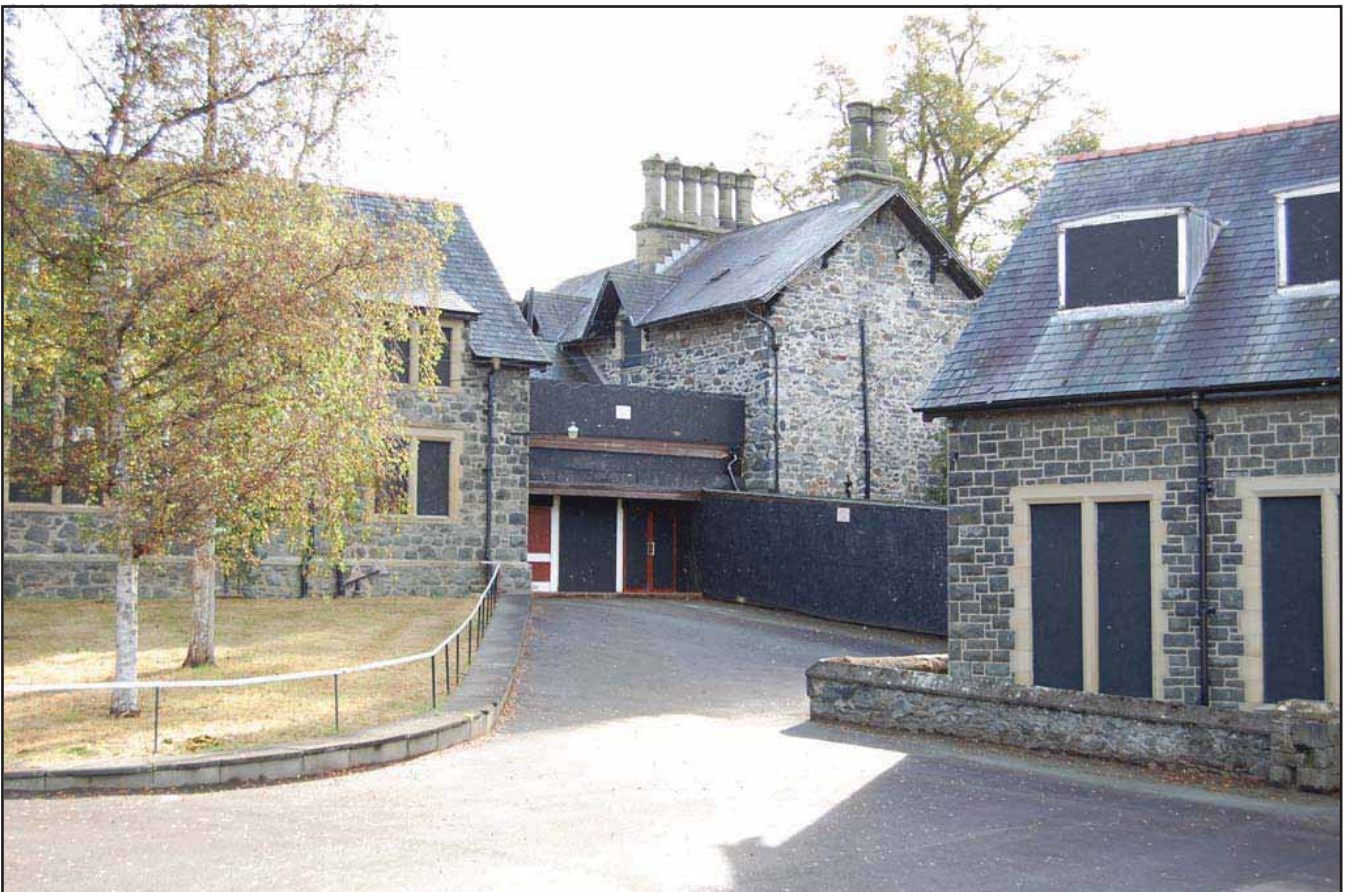
Plate 18: View east of modern entrance lobby (cf. Plate 07), which was connected to the Old Grammar School block and the Schoolmaster's House. The early twentieth century school building is to the bottom left of the image. The entrance lobby was demolished in 2008.

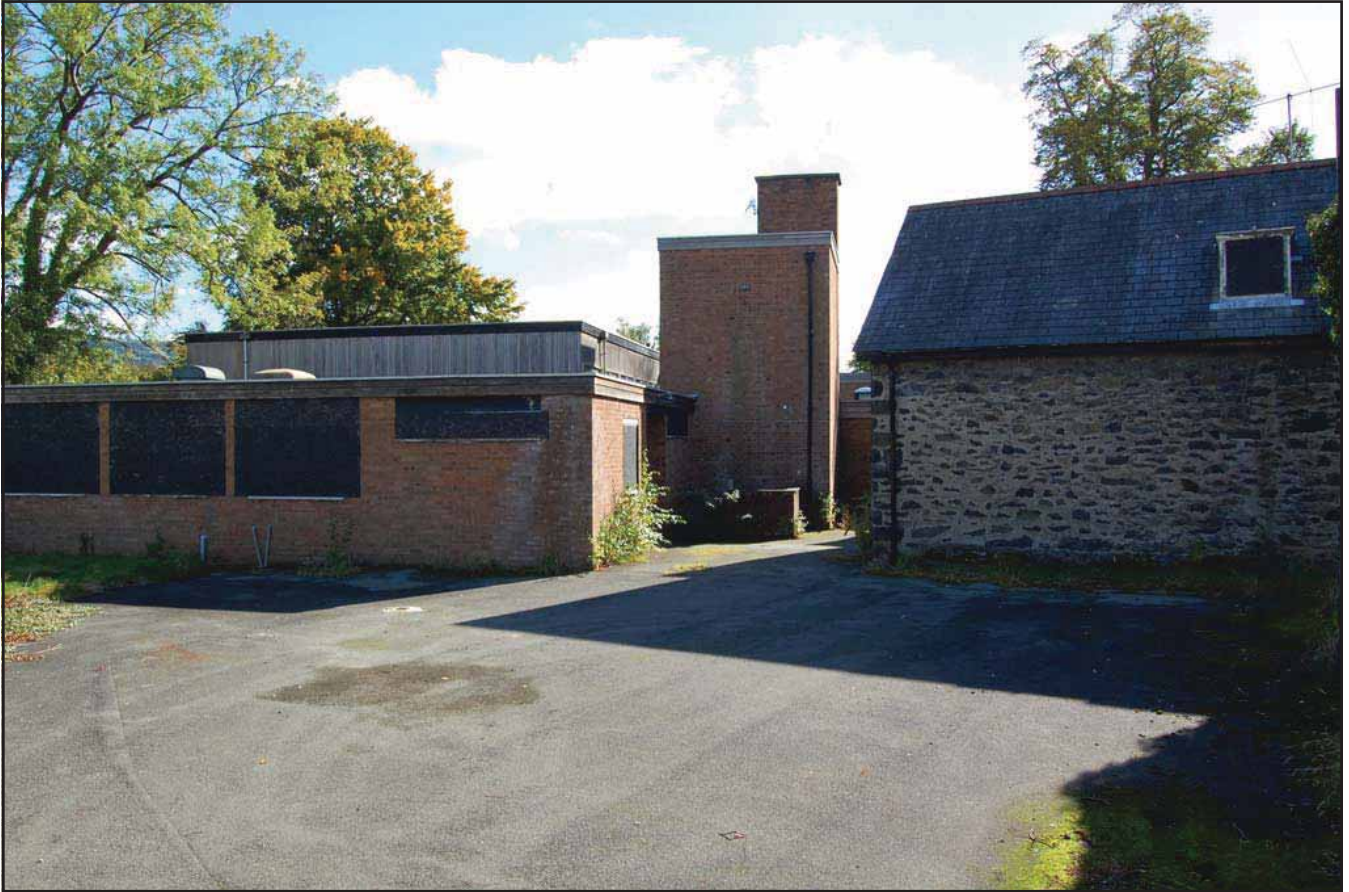
Plate 19: View south of 1960s school block and non-listed classroom extension (stone-built) attached to the Old Grammar School block. Both the school block and the non-listed classroom extension were demolished in 2008.

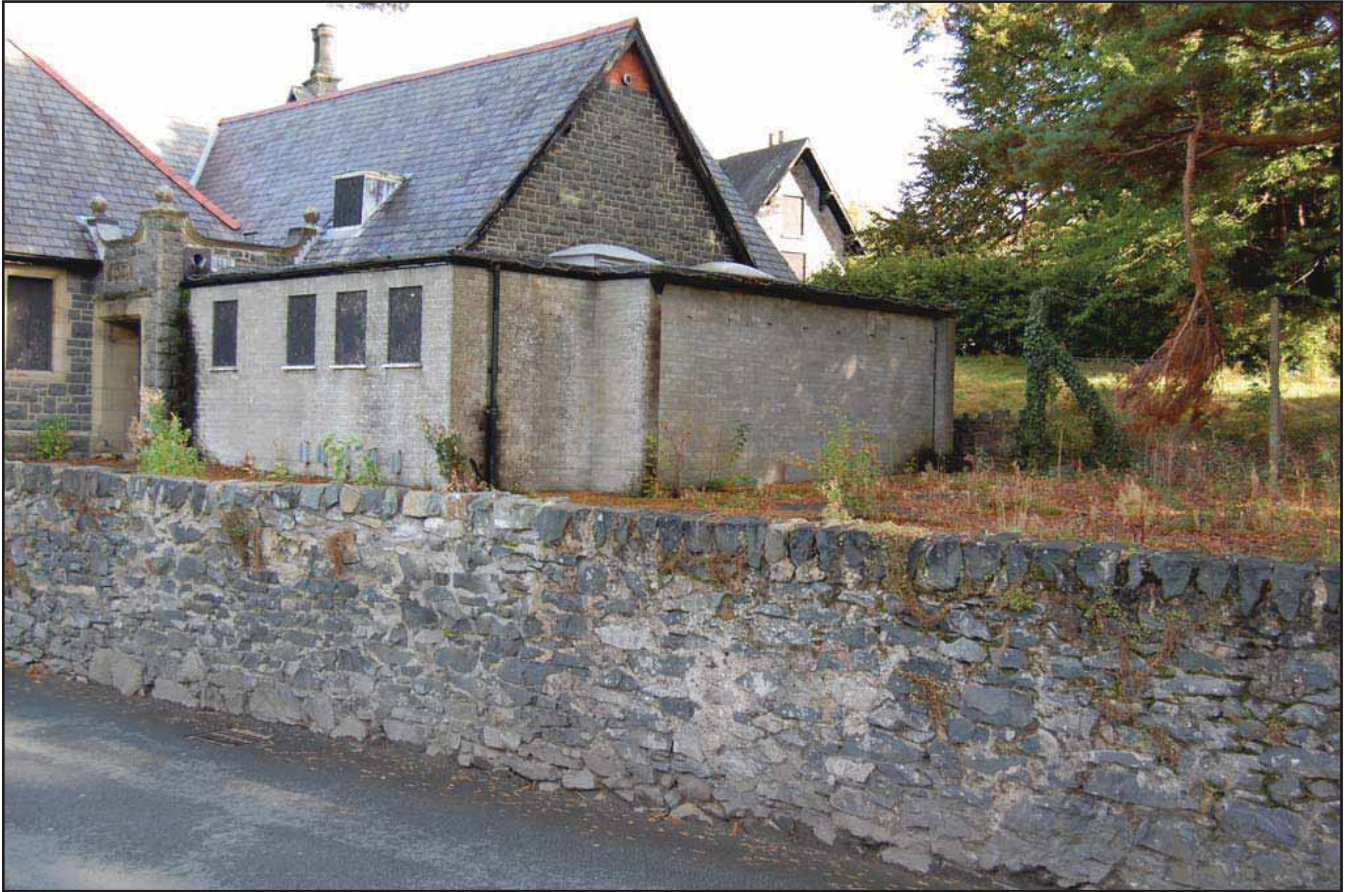
Plate 21: View north of late twentieth century extension added onto the school block facing School Bank Road. This extension was used as a toilet block prior to closure. This extension was demolished in 2008. The School Bank Road block was retained.
