YSGOL DYFFRYN CONWY, LLANRWST

Archaeological Mitigation report

Project No. G1961

Report No.1184

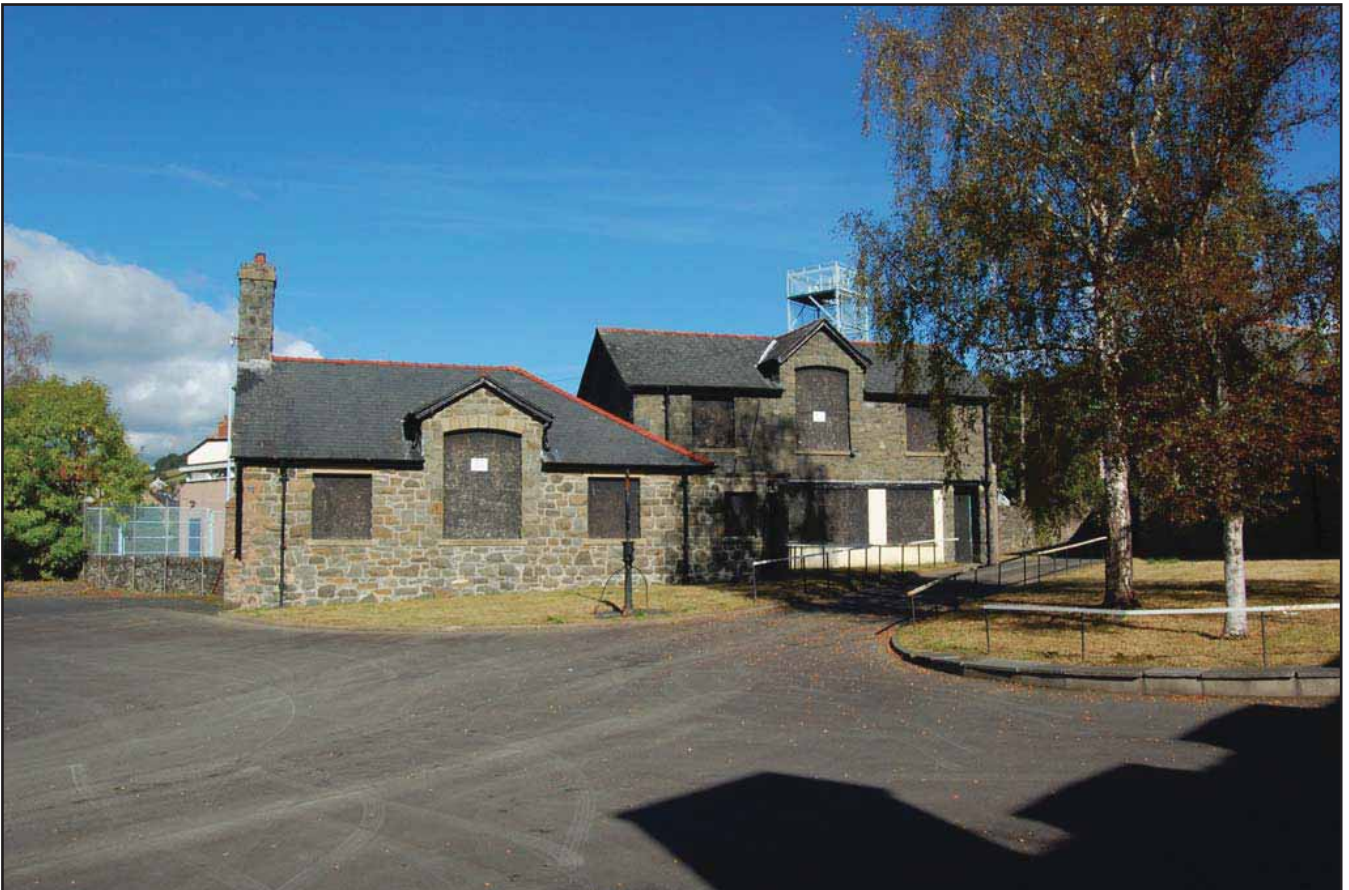
Plate 22: View north of detached block at northern end of site. This block was retained but was not renovated or converted.

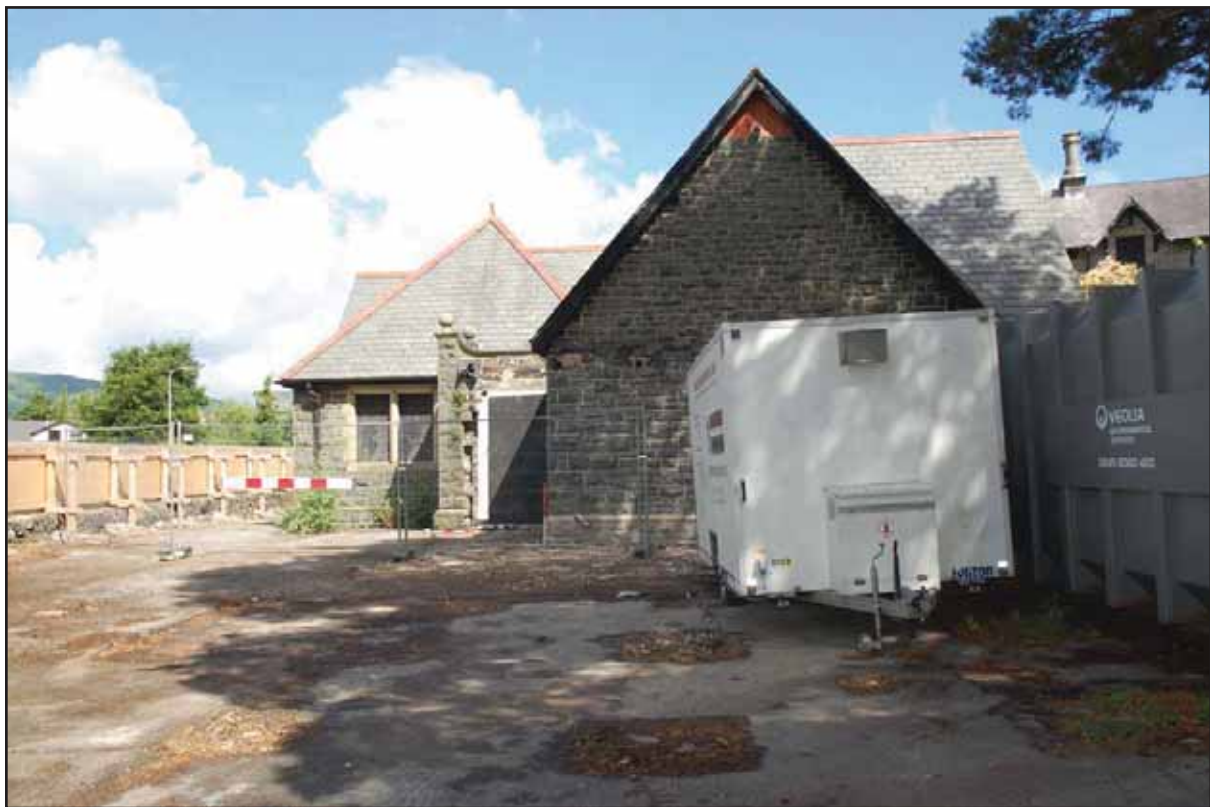
Plate 23: School Bank Road south building south elevation - entrance porch and south gable. Scale: 1.0m

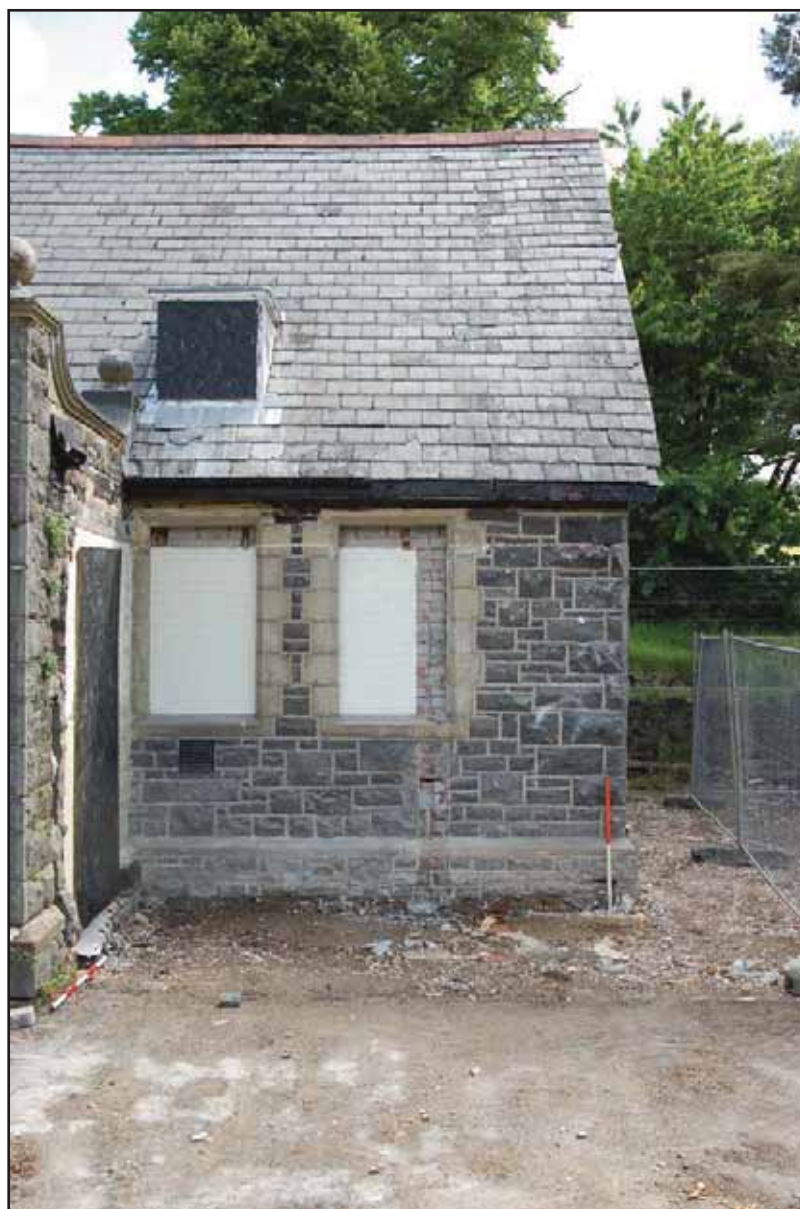
Plate 24: School Bank Road south building west facing elevation- exterior of room G01. Scale: 1.0m

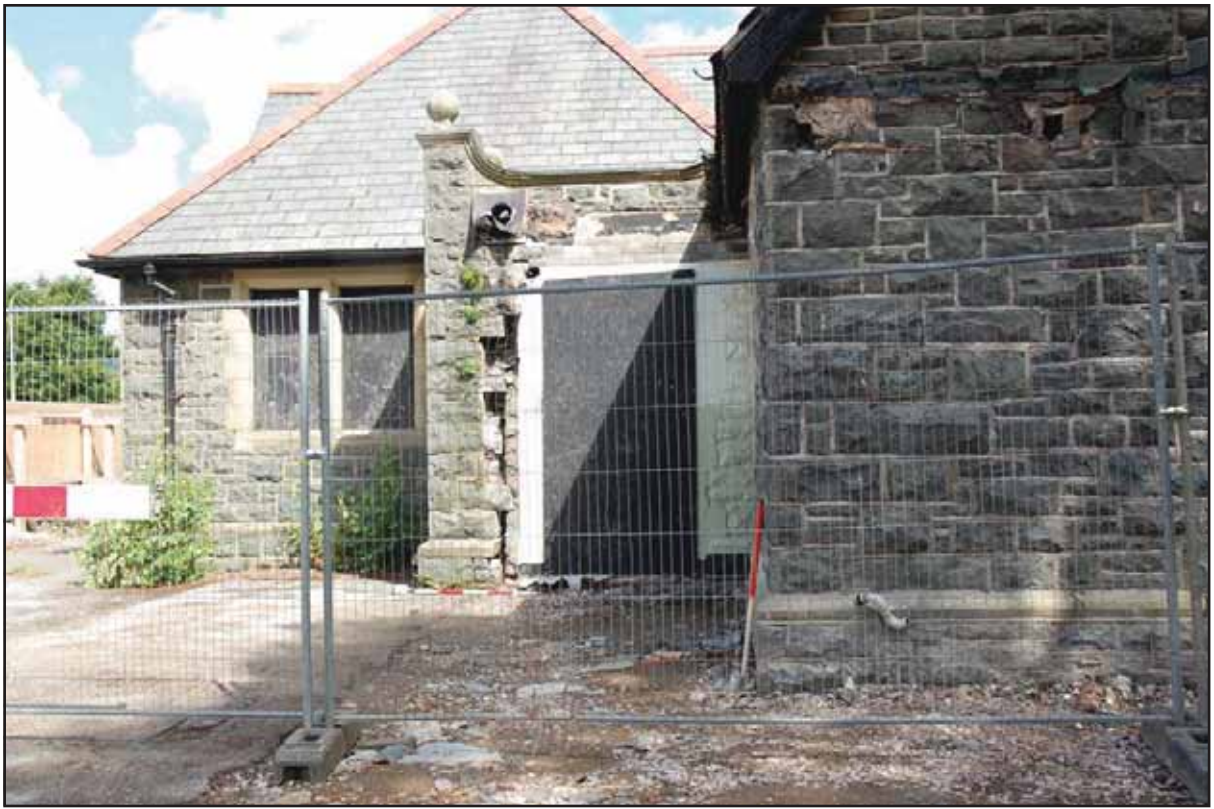
Plate 25: School Bank Road south building south facing elevation- porch detail/former modern extension. Scale: 1.0m

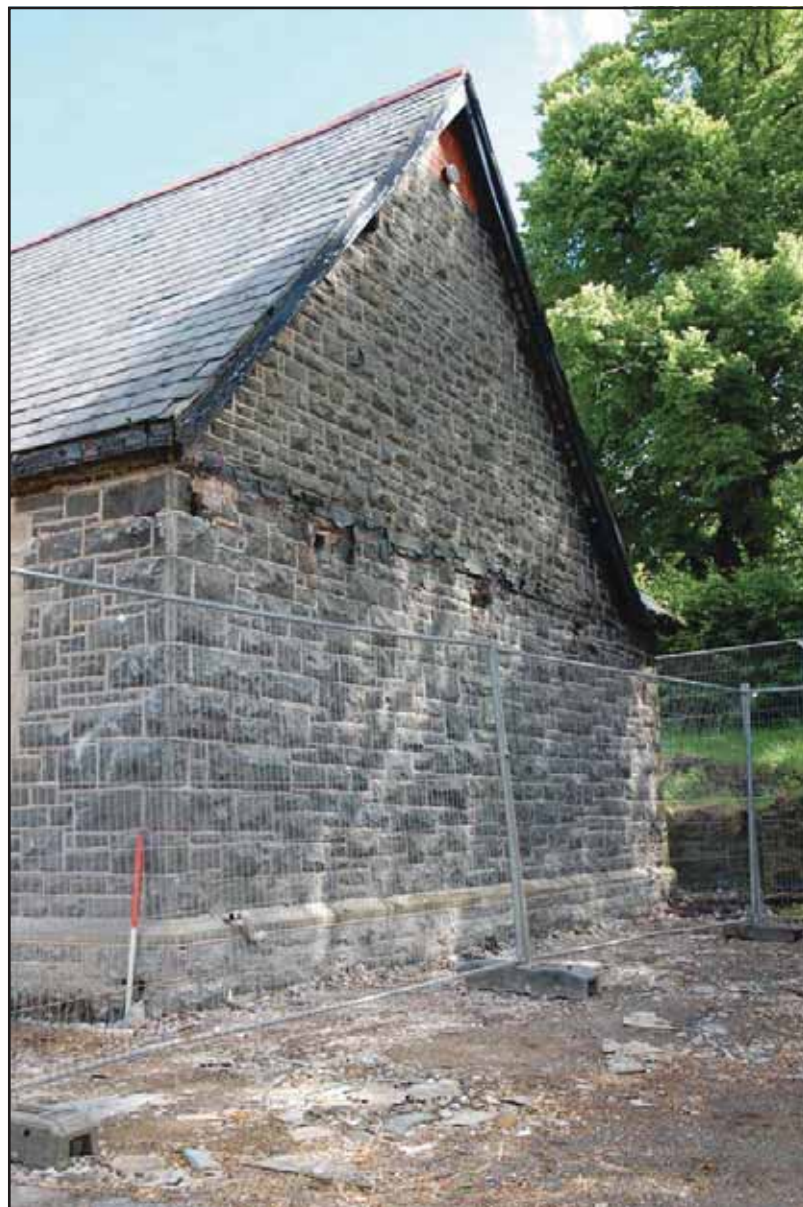
Plate 26: School Bank Road south building south facing elevation- exterior of room G01, detail of construction. Scale: 1.0m

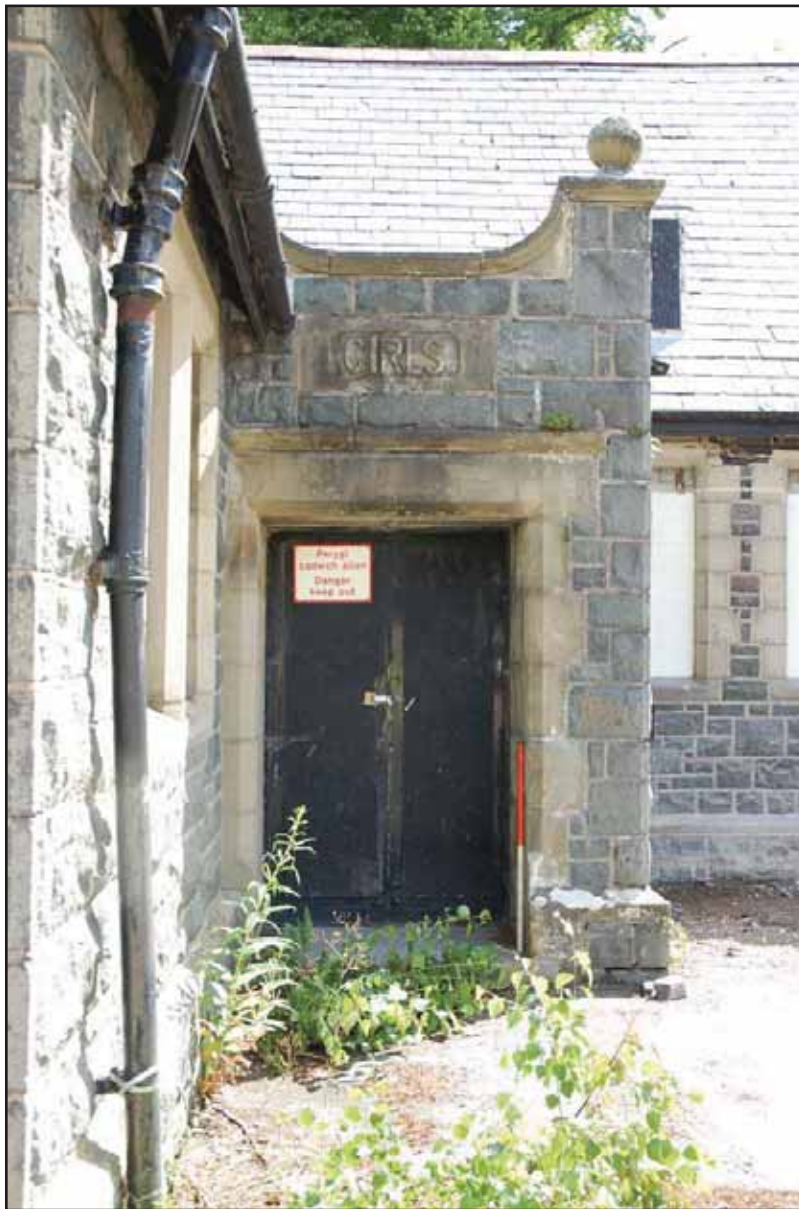
Plate 27: School Bank Road south building west facing elevation- porch detail: note inscribed stone. Scale: 1.0m

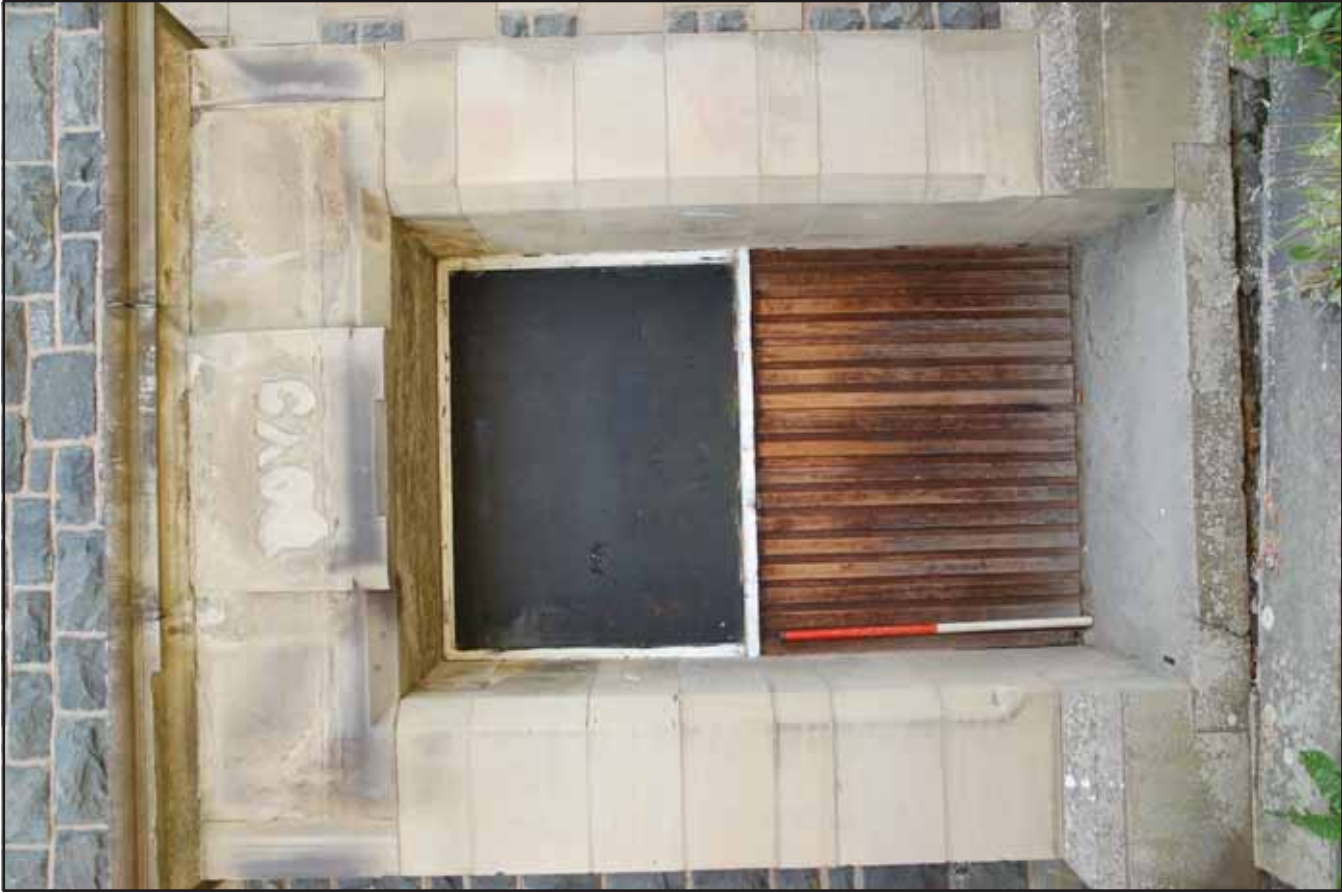
Plate 31: School Bank Road west facing elevation- detail of former "Girls" entrance on north building. Scale: 1.0m.

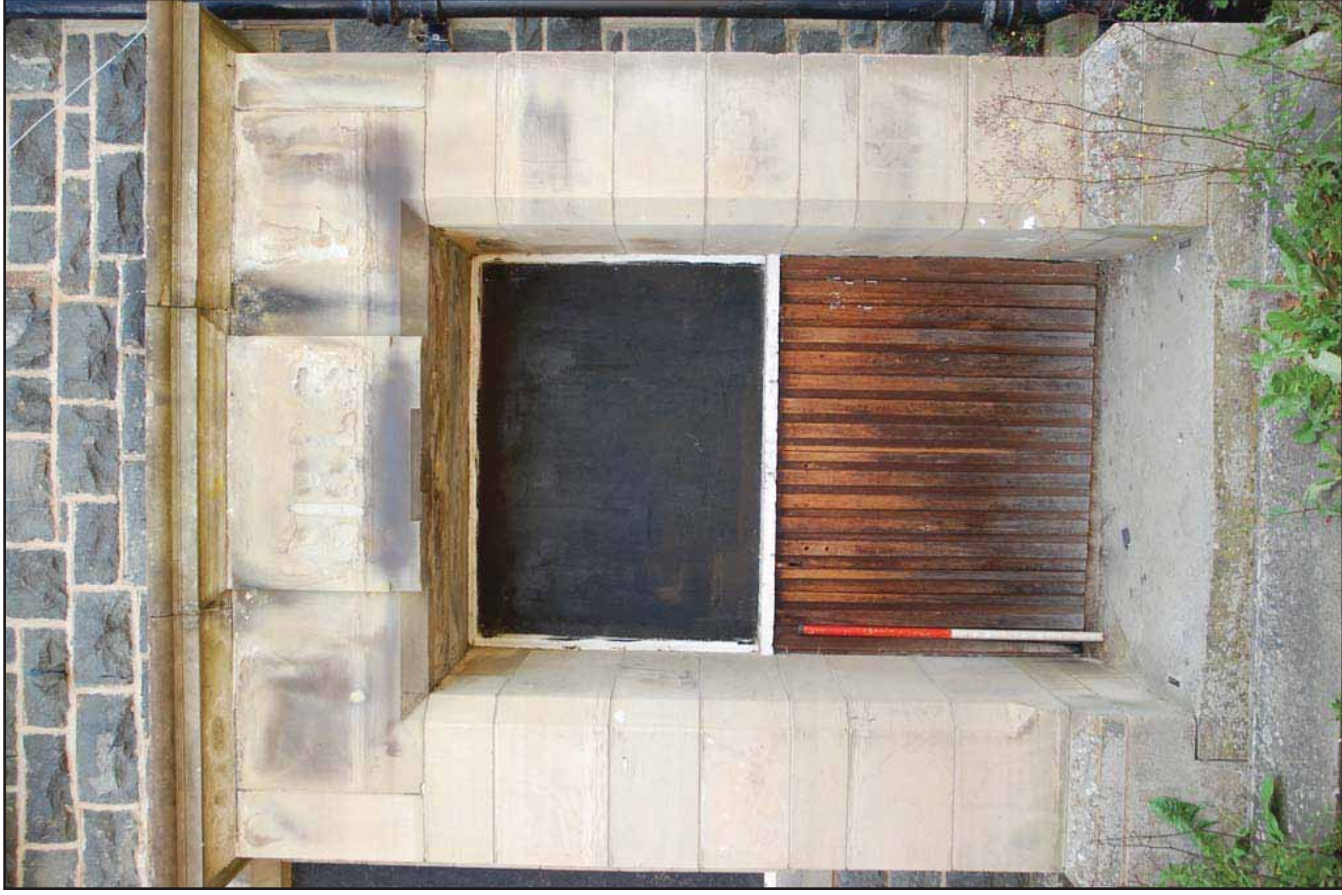
Plate 32: School Bank Road west facing elevation - detail of former "Boys" entrance on north building. Scale: 1.0m.

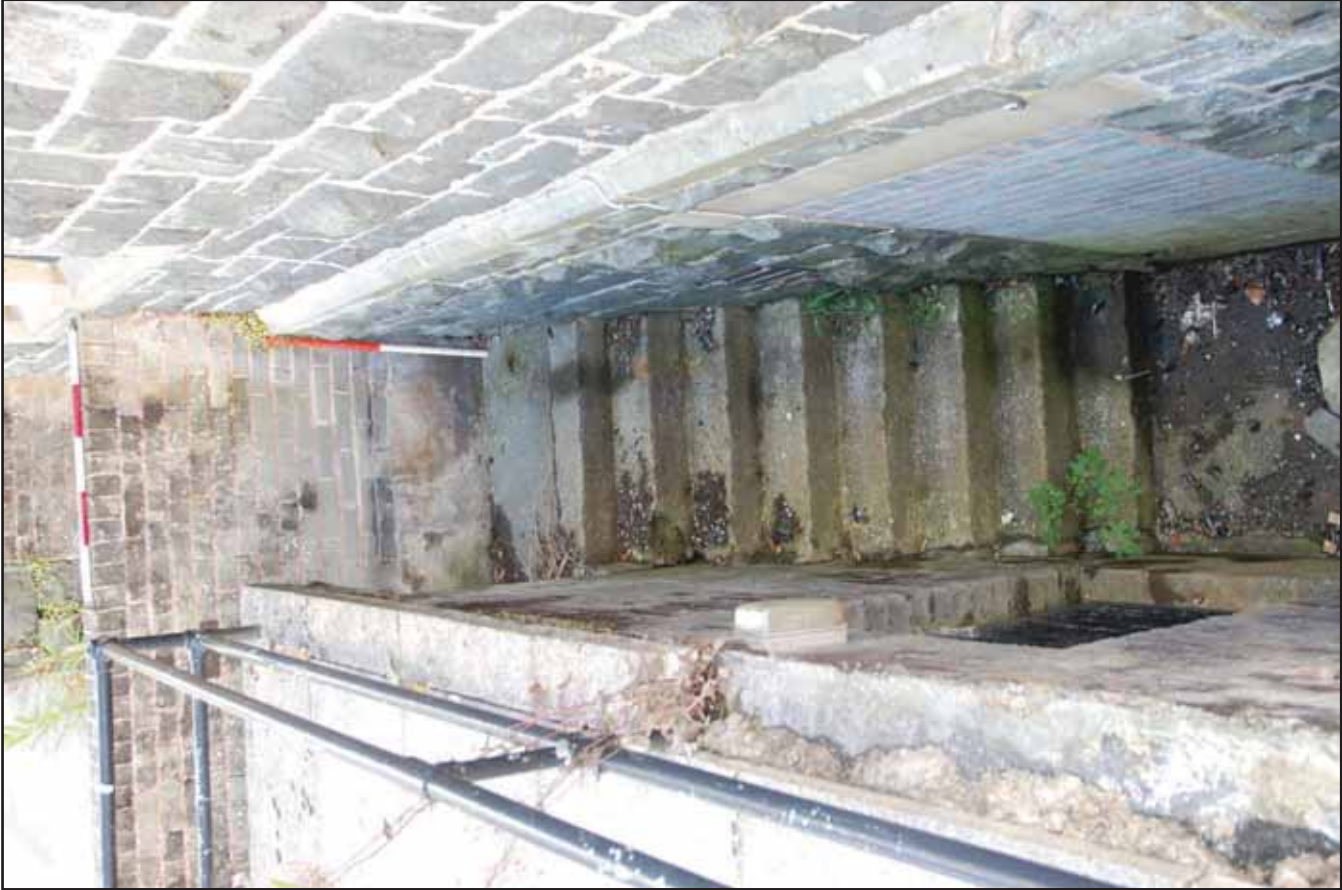
Plate 33: School Bank Road north building north facing elevation - cellar entrance.
Scale: 1.0m.

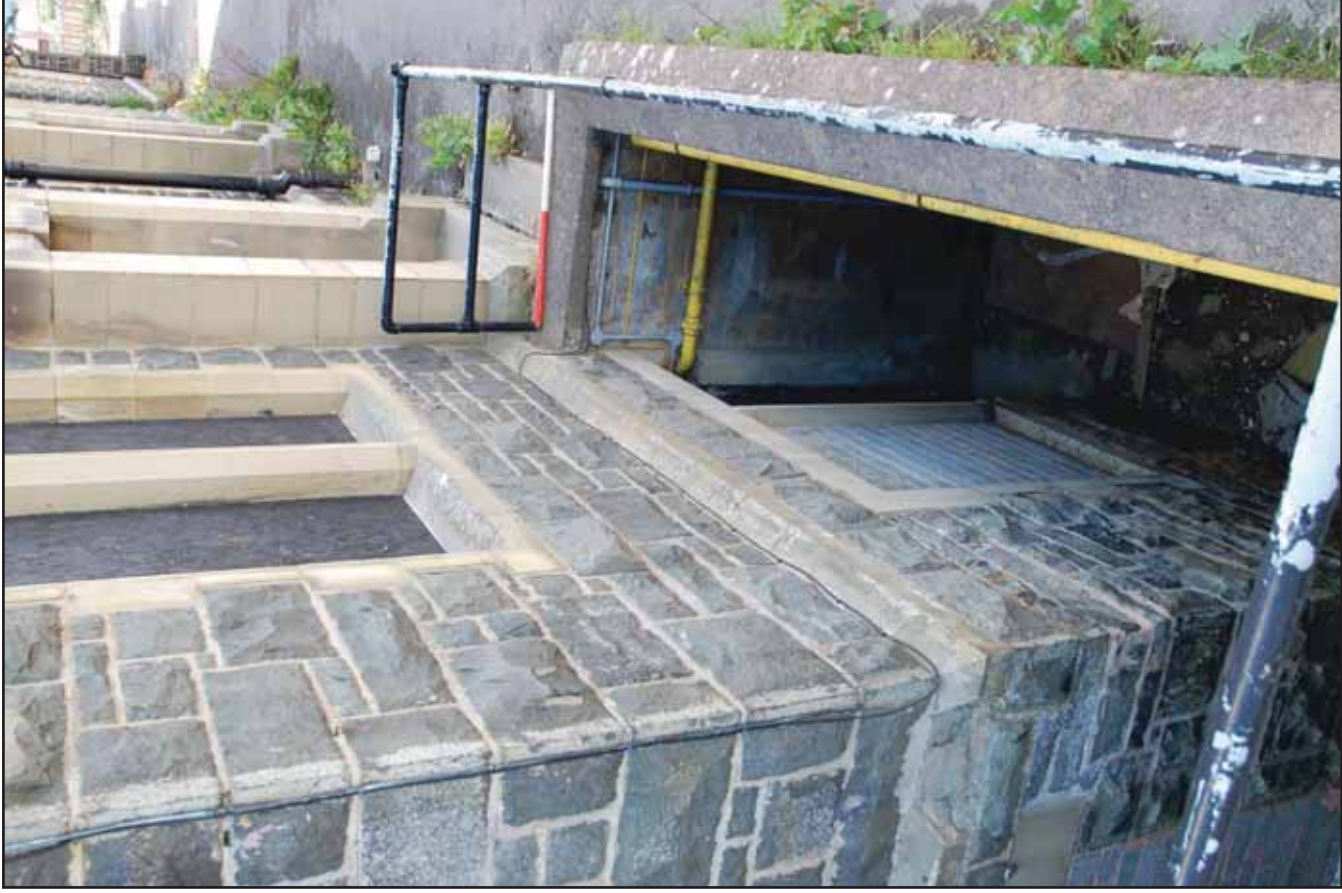
Plate 34: School Bank Road north building west facing elevation - cellar entrance.
Scale: 1.0m.

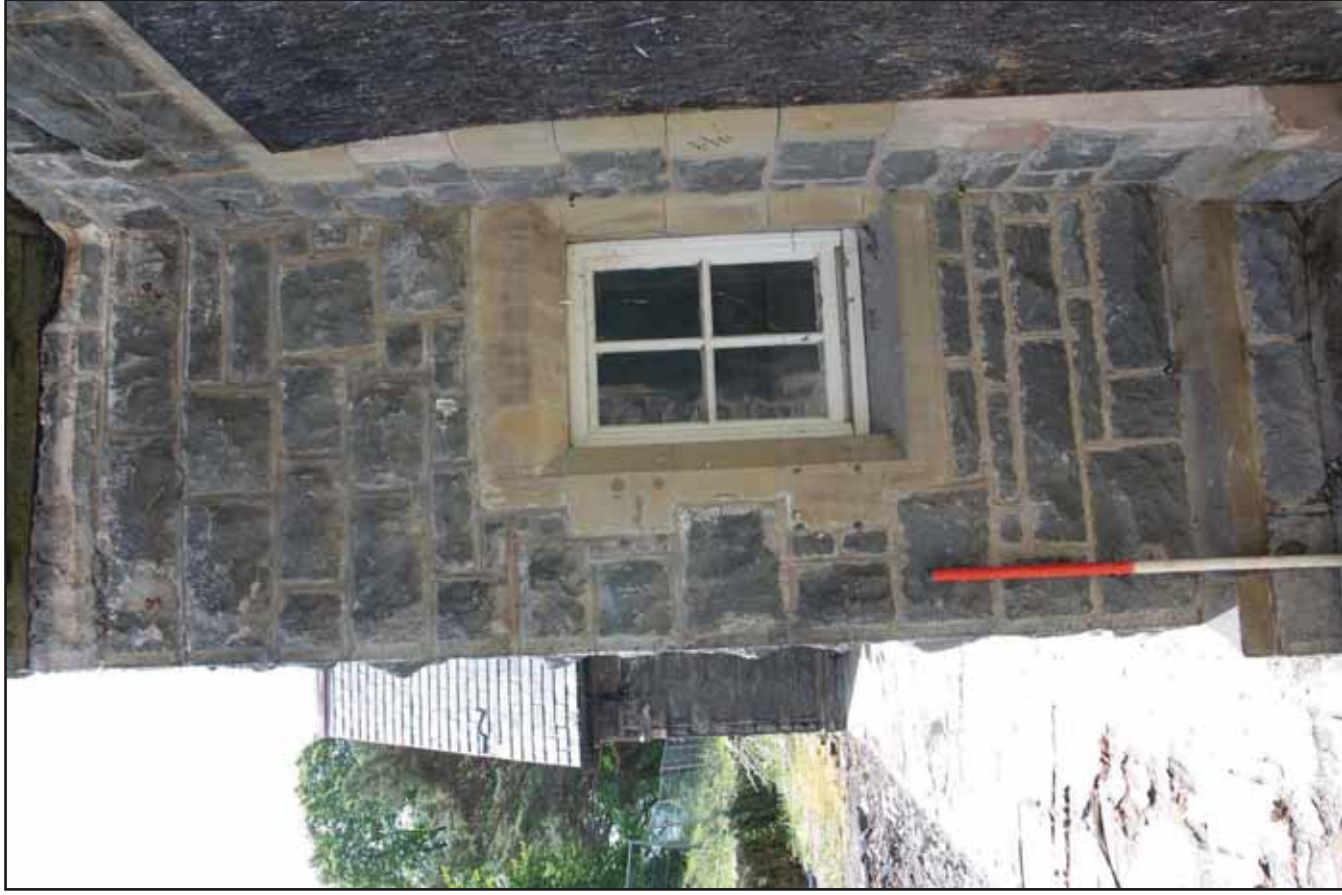
Plate 37: School Bank Road north building east facing elevation entrance point detail.
Scale: 1.0m.

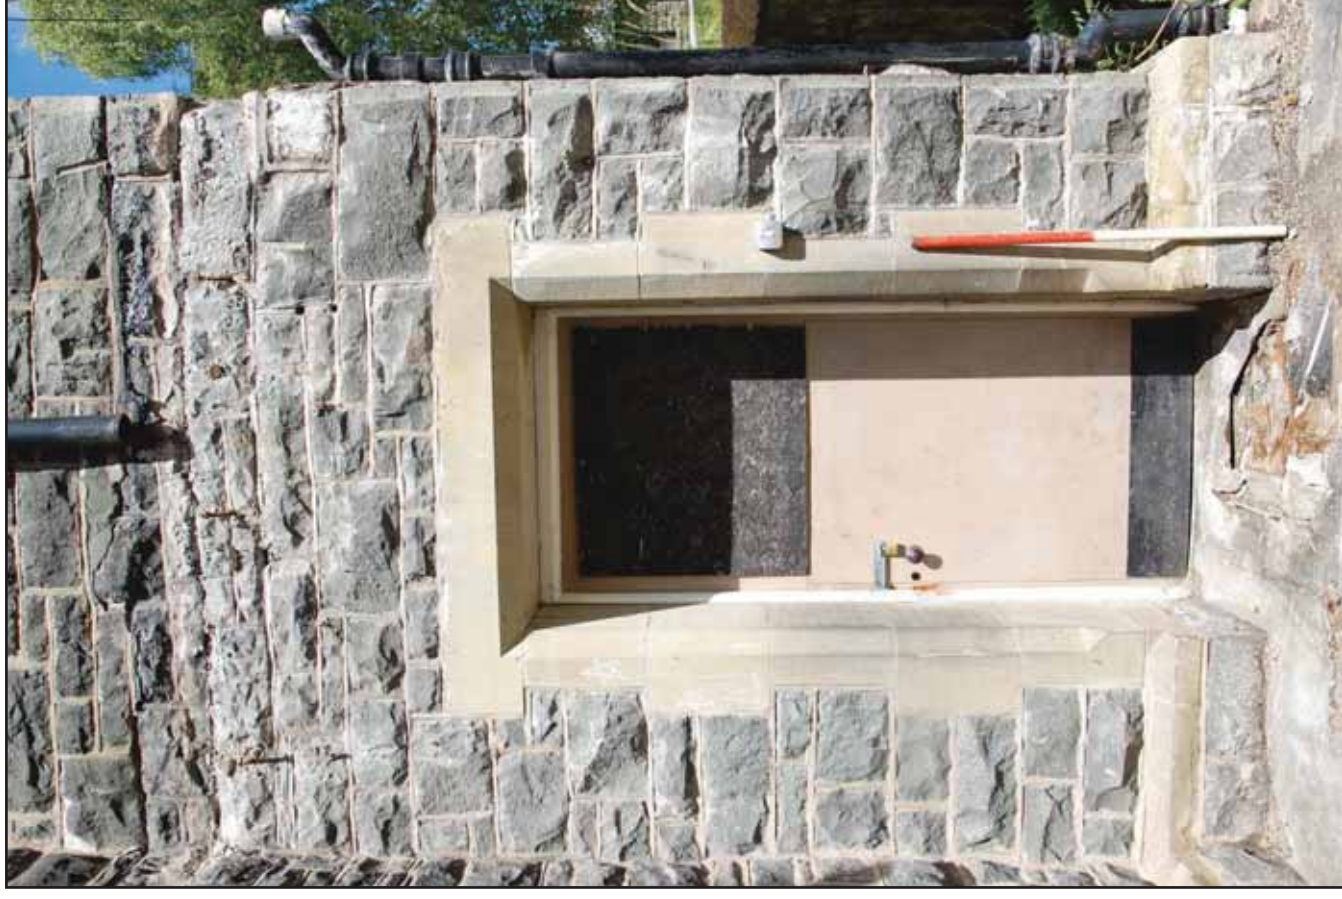
Plate 38: School Bank Road north building east facing elevation - ground floor entrance to room G13. Scale: 1.0m.

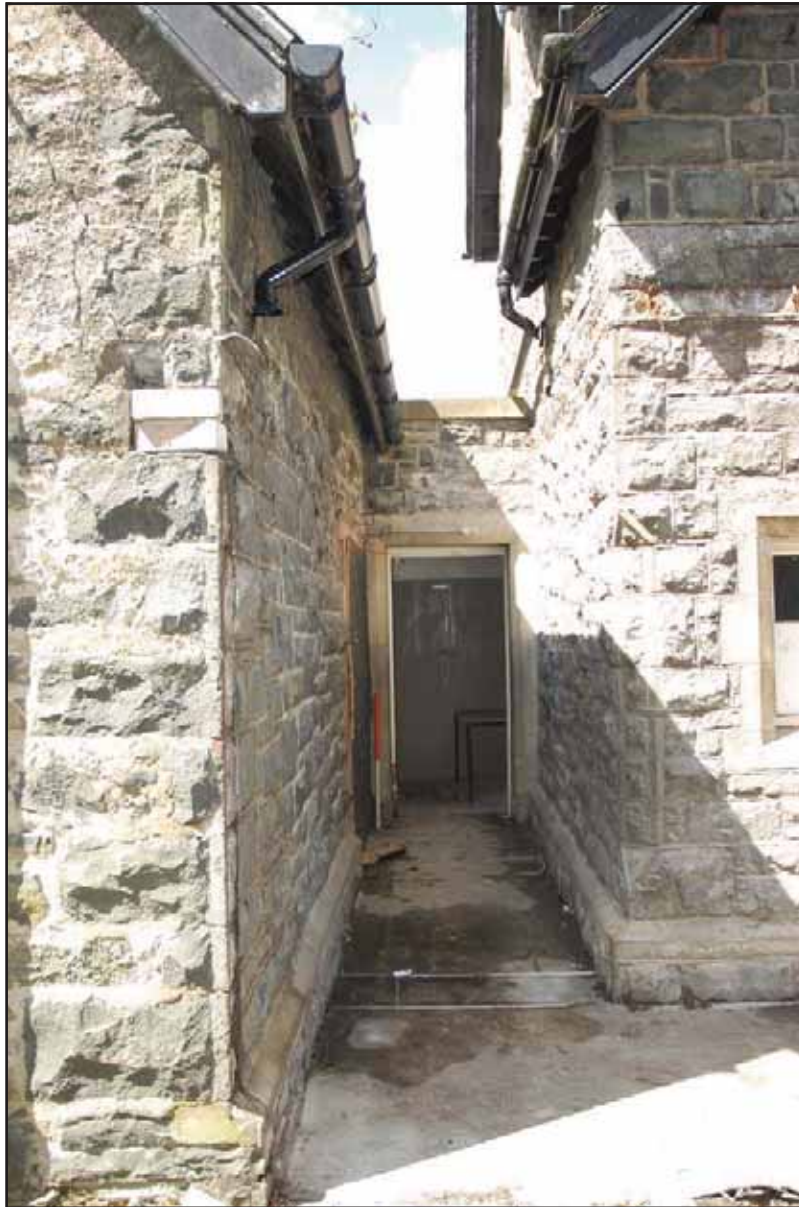
Plate 39: School Bank Road north building east facing elevation. - ground floor entrance for both north and south building. Scale: 1.0m.

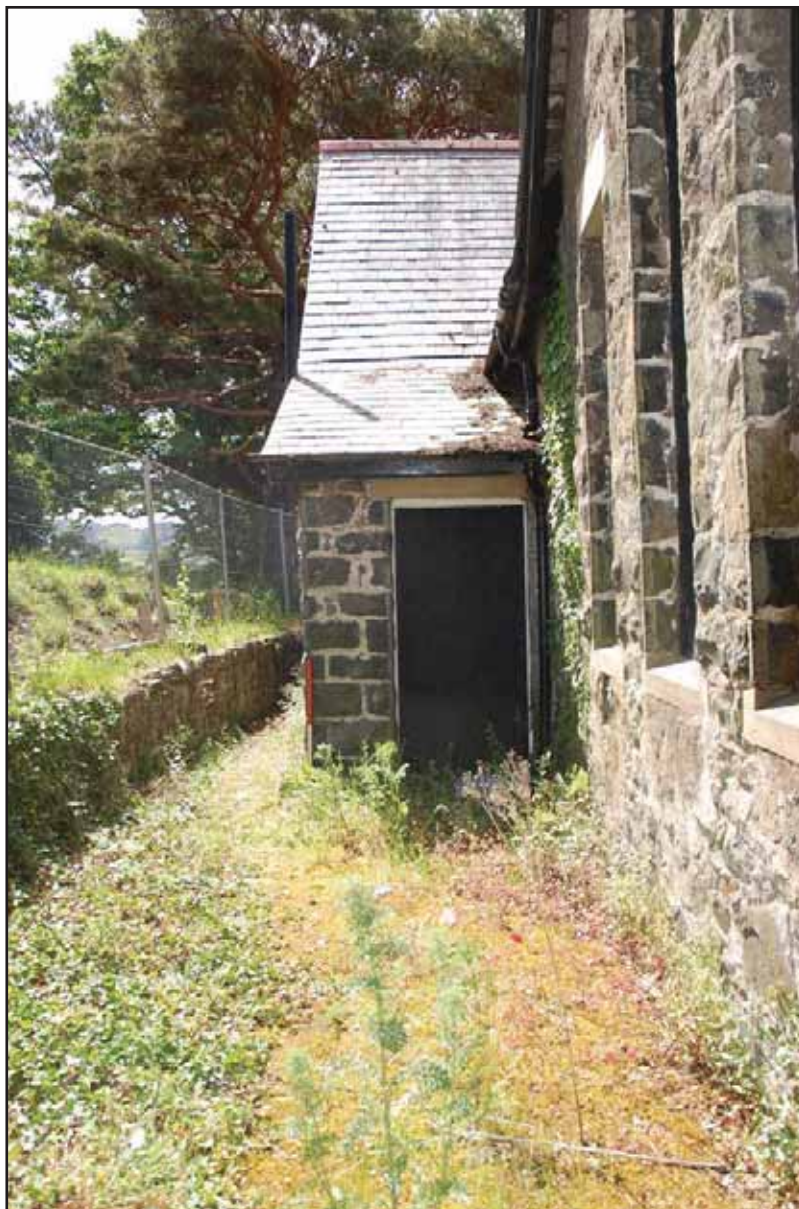
Plate 41: School Bank Road south building east facing elevation - ground floor entrance to room G01 detail. Scale: 1.0m.

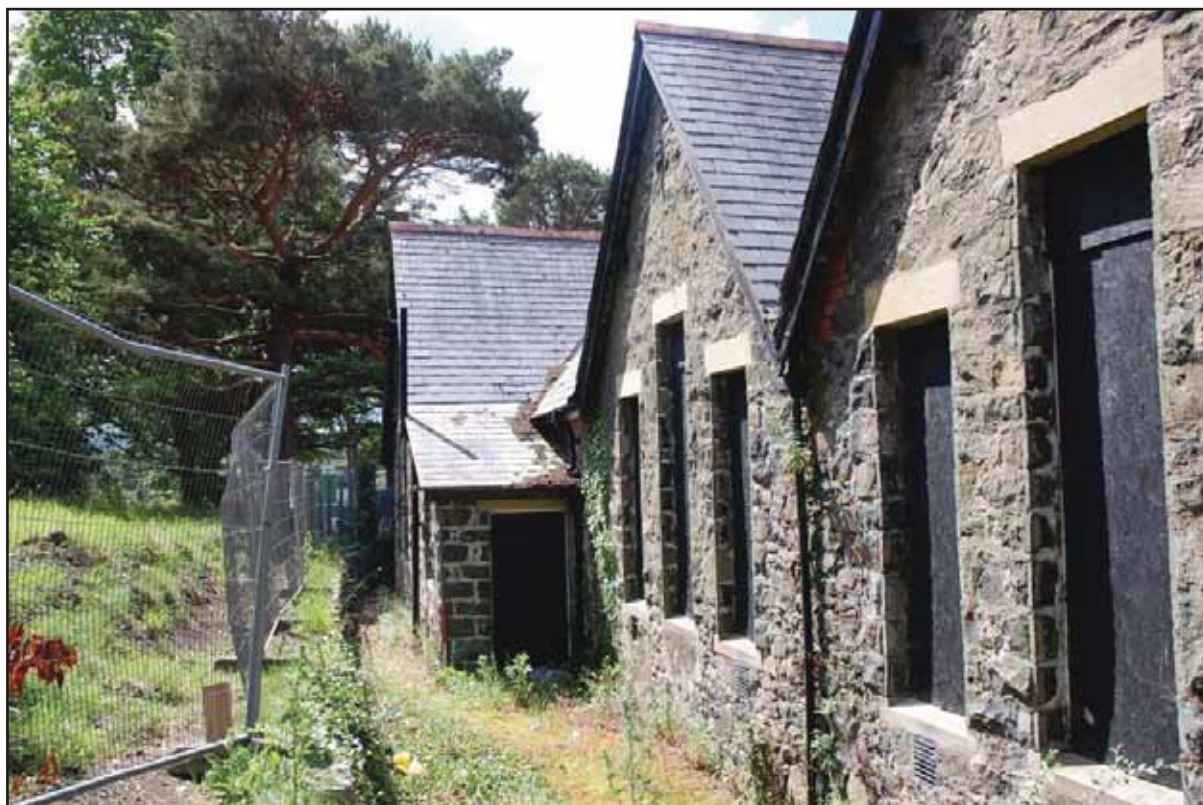
Plate 42: School Bank Road south building east facing elevation oblique view and ground floor entrance to room G01. Scale: 1.0m.

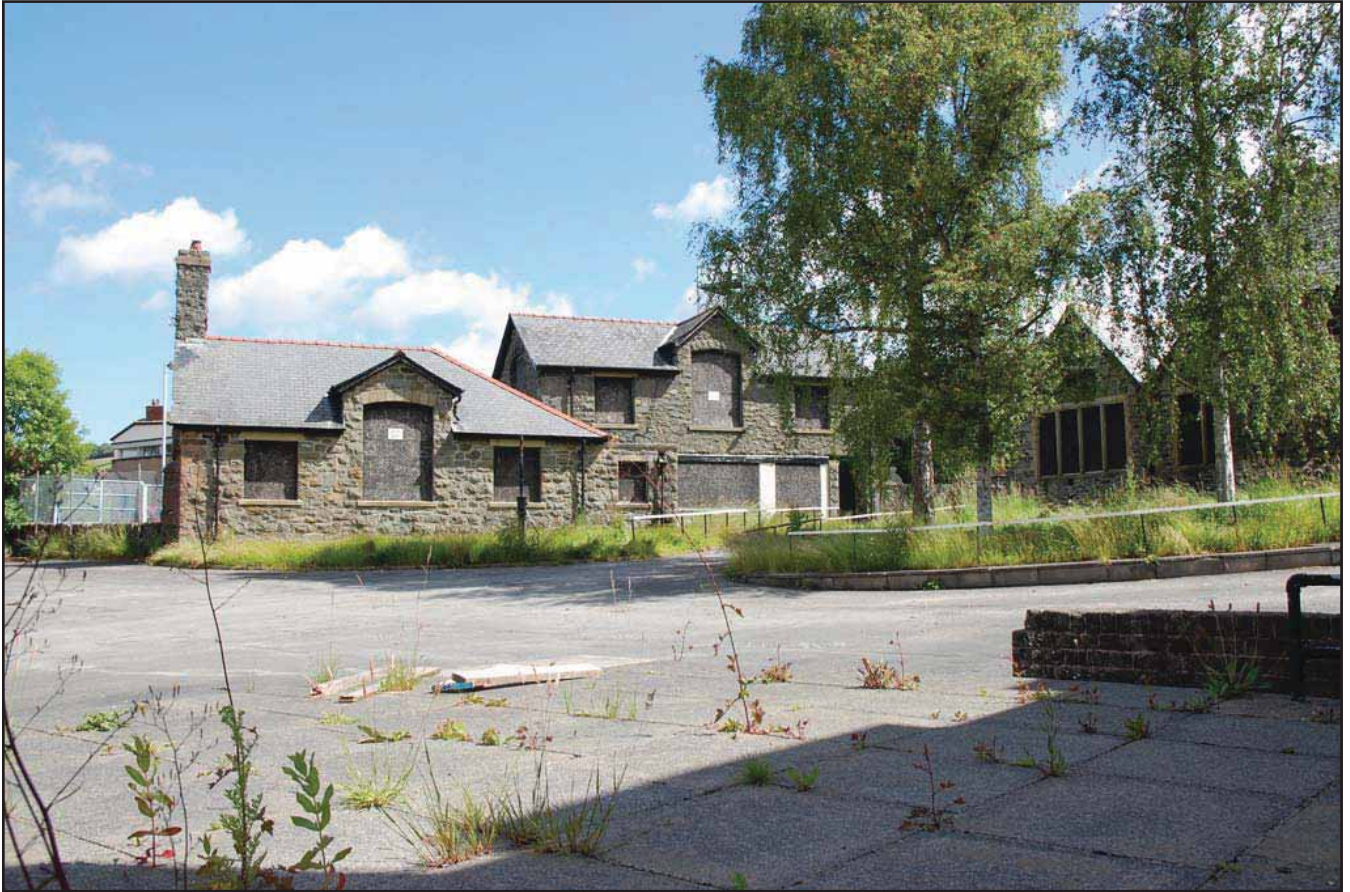
Plate 57 - Detached north building - south elevation

The south elevation (Plates 57 to 59) comprised the single storey section on the western side of the property and the two storey section on the eastern side. Access to the west section was through a flat roofed porch on the east facing elevation. This elevation incorporated matching window styles throughout: there were four windows on the western section (including the porch) and three on the ground floor of the eastern section and three on the first floor. On the west section were two square windows with sandstone lintels and sills, either side of a larger arched dormer window with a sandstone sill and a dressed stone voussoir. The porch window matched the square windows. The ground floor of the east section include modern alterations, with a partial brick rebuild that indicate an extension had been added to this section and subsequently removed. The first floor windows matched the central dormer window and two square windows seen on the eastern section.

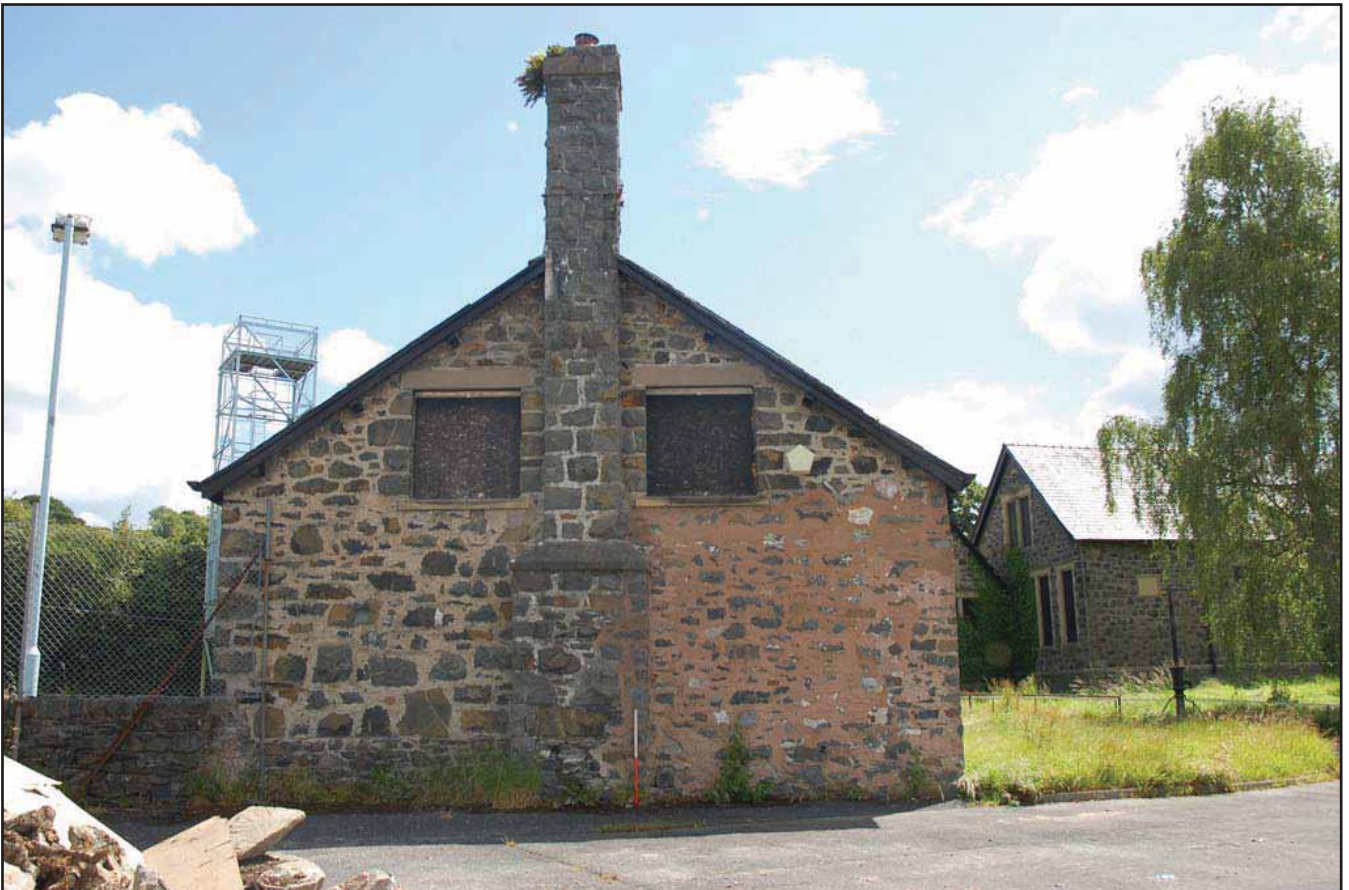
Plate 60 - Detached north building - west elevation

The west elevation (Plate 60) included a gable end with a 9.0m high projecting stone chimney and two small square windows located at 3.2m above ground level. These windows were located either side of the chimney close to the gable apex (apex was 6.0m above ground level); the windows included sandstone sills and lintels. The stone used was more crudely set than the southern elevation and recent repointing was evident.

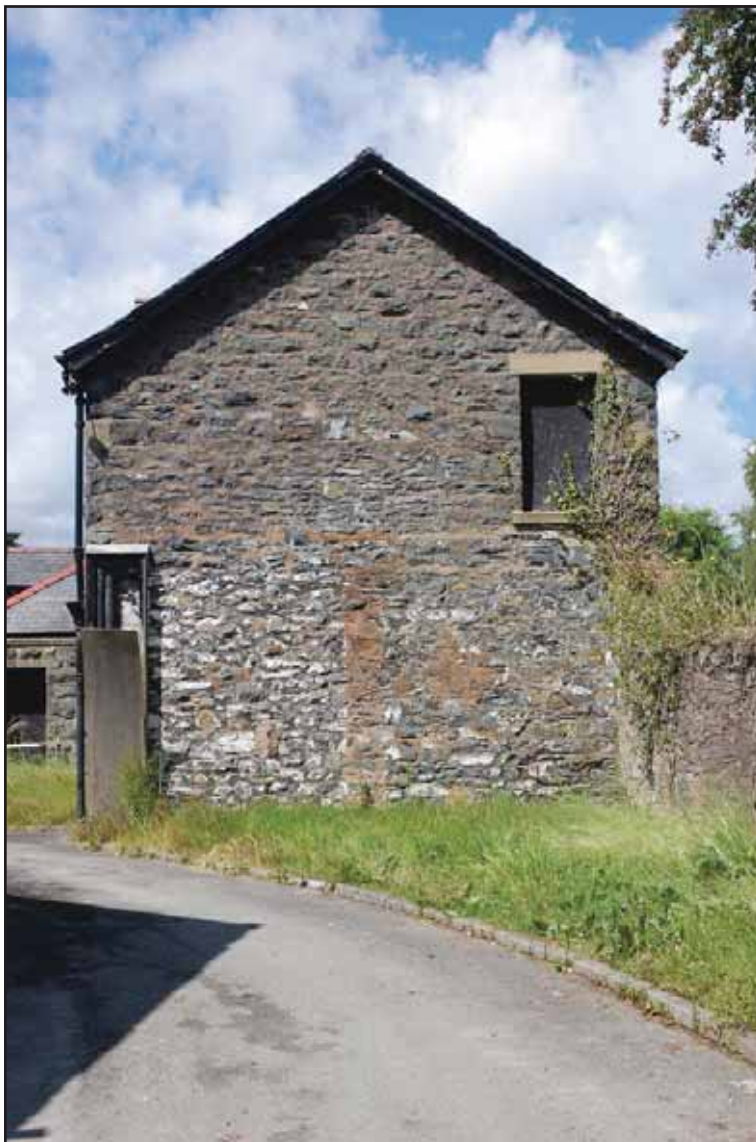
Plate 61 - Detached north building - east elevation

The east elevation (Plate 61) included the porch access to the west section, which included a stone lintel. A first floor rectangular window was located to the northern end of the elevation: the window included a stone lintel and sill and was located 3.4m above ground level; the window would have provided light onto the staircase leading to the first floor. The north boundary wall of the school was built in the elevation. Evidence for repointing was visible.

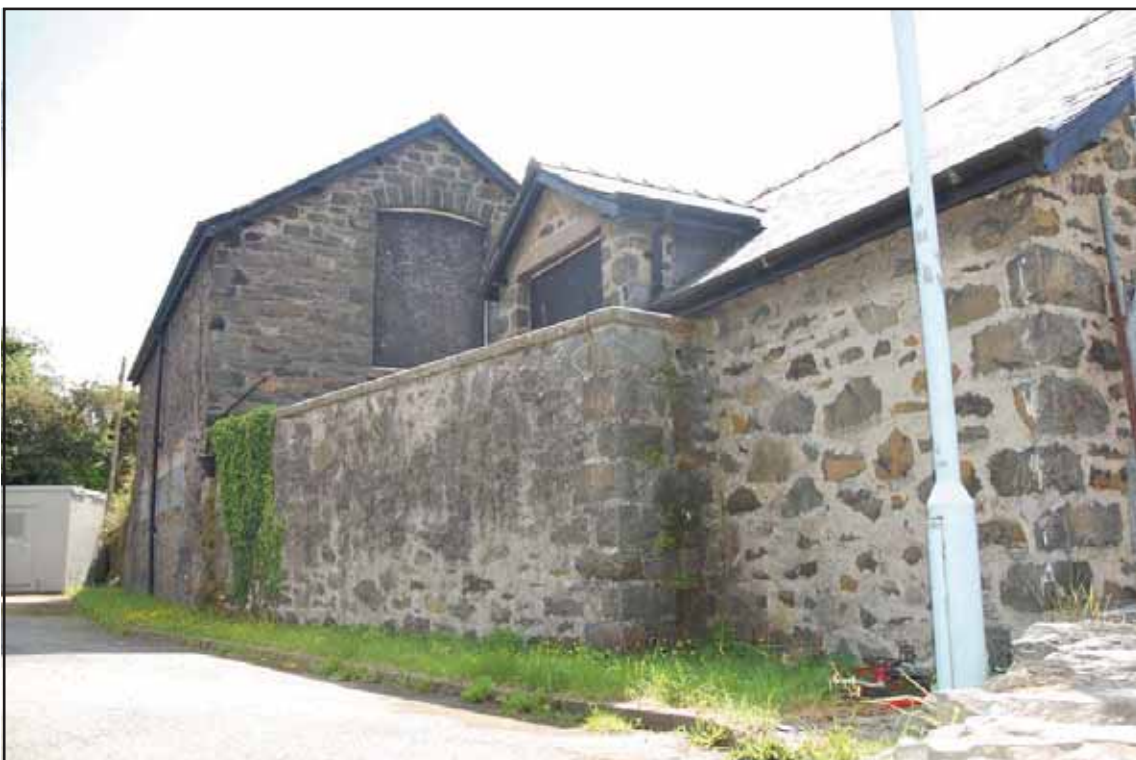
Plate 62 - Detached north building - north elevation oblique

The north elevation (Plate 62) formed the rear of the property and included an 8.0m long and 2.4m high wall that encompassed the west section of the building. Partly visible above the wall was a dormer window part set into the pitched roof, with a stone lintel (sill not visible); this dormer window did not replicate the style of the dormer windows on the south elevation. The west gable of the east section of the building was visible from this elevation: the window matches the style and size of the south elevation dormer windows and included a stone voussoir. The north elevation of the east section was limited in detail but included three sets of 0.8m high windows, elevated 1.8m above ground level; these windows included sandstone lintels but no sandstone sills. The windows had been blocked with modern breezeblocks.

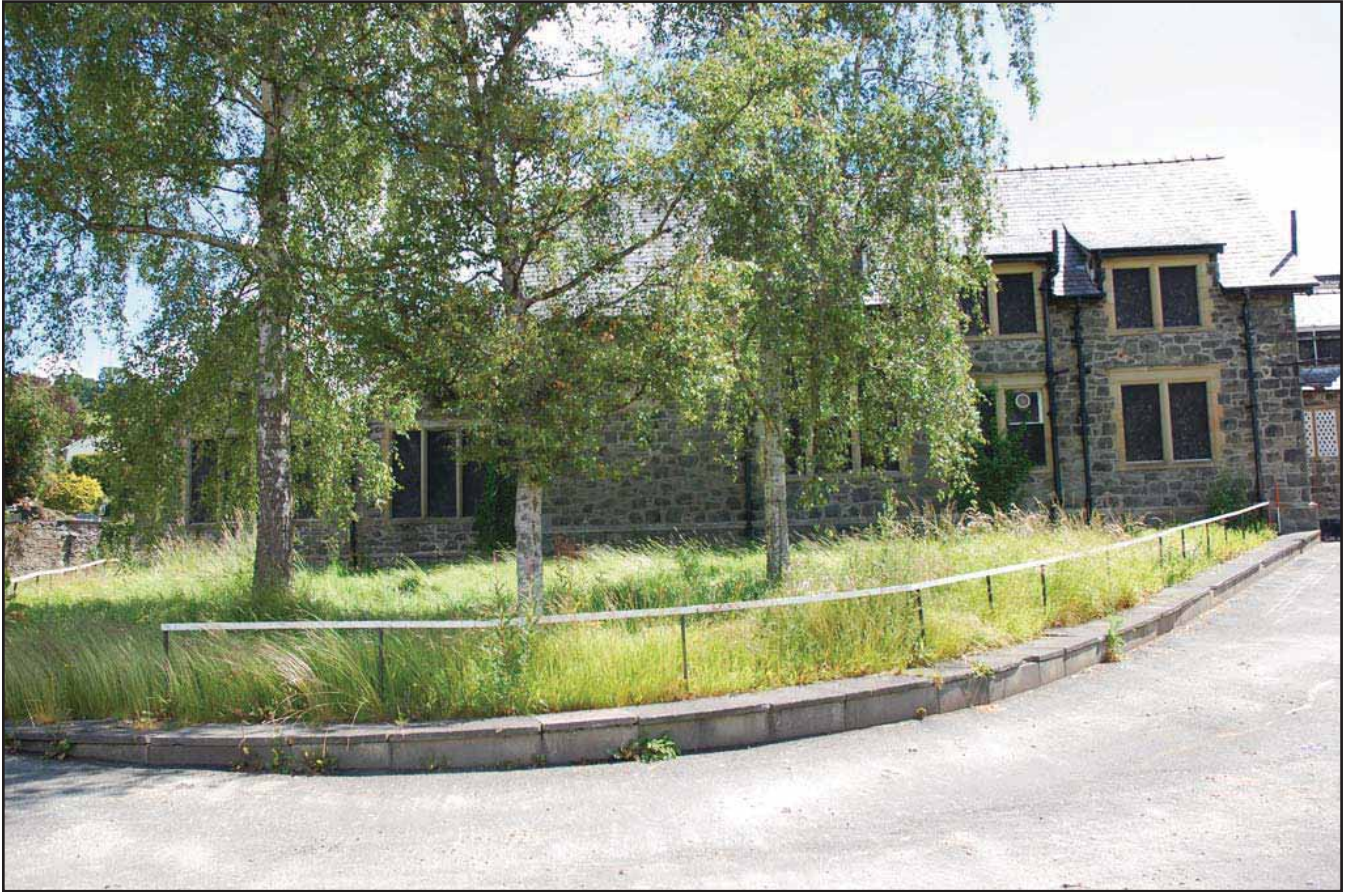
Plate 73 - Extension A (Old Grammar School Block) - west facing elevation

The west facing elevation of Extension A (Plates 73 to 77) comprised three ground floor windows all with dressed sandstone surrounds, mullions, lintels and sills; two the windows were of equal size (2.0m wide and 2.0m high set 1.8m off the ground level), whilst the third, northernmost window, measured 3.0m in width and height (also set 1.8m above ground level). The windows were masked and sealed at the time of the recording. At first floor level were two dormer windows, each 2.0m wide and 1.6m high, set 4.0m off the ground that were above the ground floor square windows. A projecting dormer window was set into the roof pitch above the larger ground floor window. A small square plaque (Plate 76) was located 3.0m above ground level to the north of the ground floor windows that read:
