YSGOL DYFFRYN CONWY, LLANRWST

Archaeological Mitigation report

Project No. G1961

Report No.1184

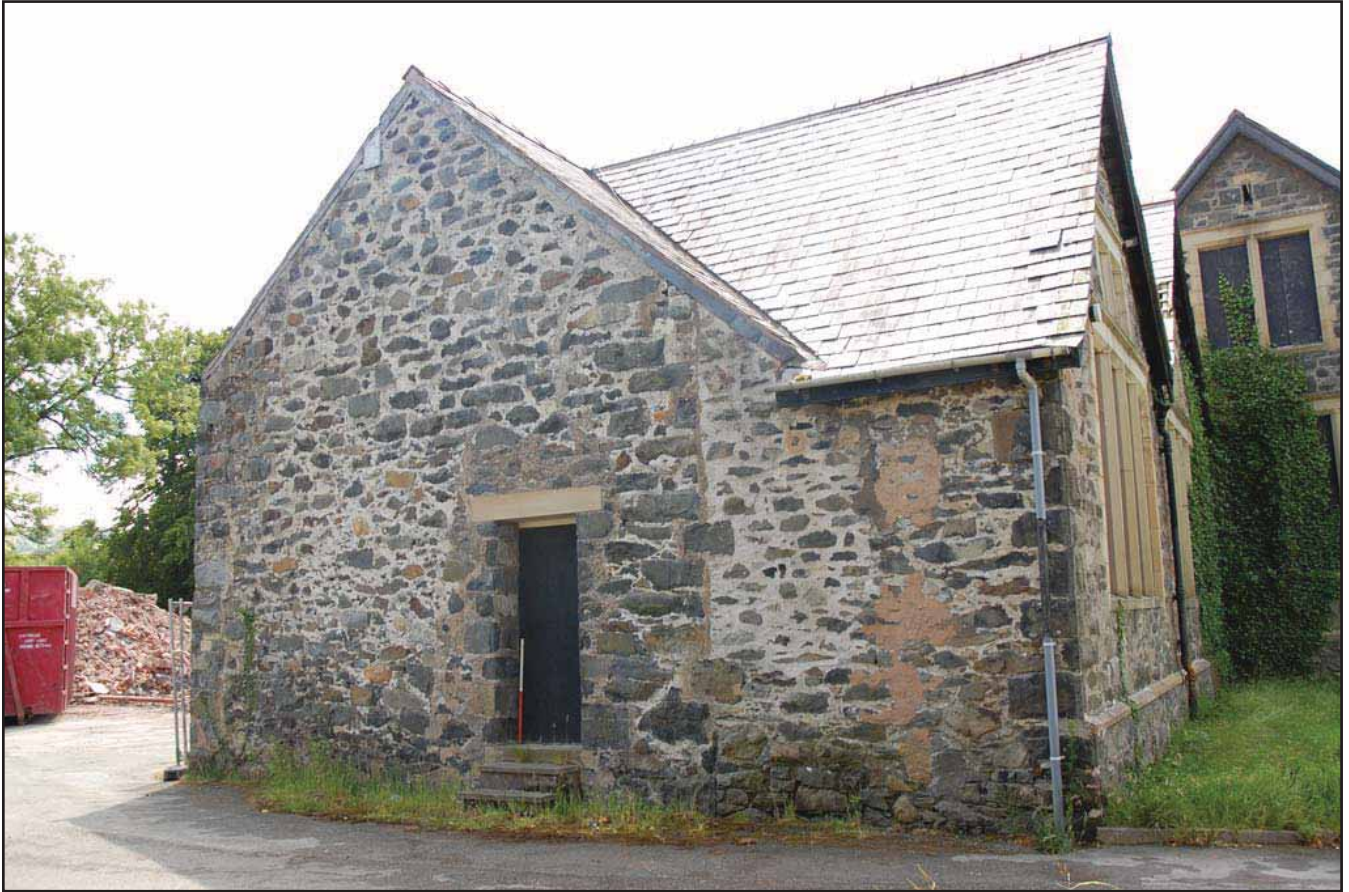
Plate 79 - Extension B (Old Grammar School Block) - north facing elevation; note structural phasing to the left of the door.
Scale: 1.0m

The north elevation (Plate 79) incorporated both the pitch from the west elevation and a projecting gable. An entrance door to room G01 was incorporated at ground level and was accessed by two stone steps with slate capping. The door included a sandstone lintel and measured 1.0m in height and 2.0m in width. The gable apex measured 7.0m from ground level. There appeared to be evidence for structural phasing: a distinctive line ran from the gable pitch to ground level, 1.0m to the west of the door. This appeared to be a former external wall and may have represented the earlier building form visible on the first and second edition Ordnance Survey maps.

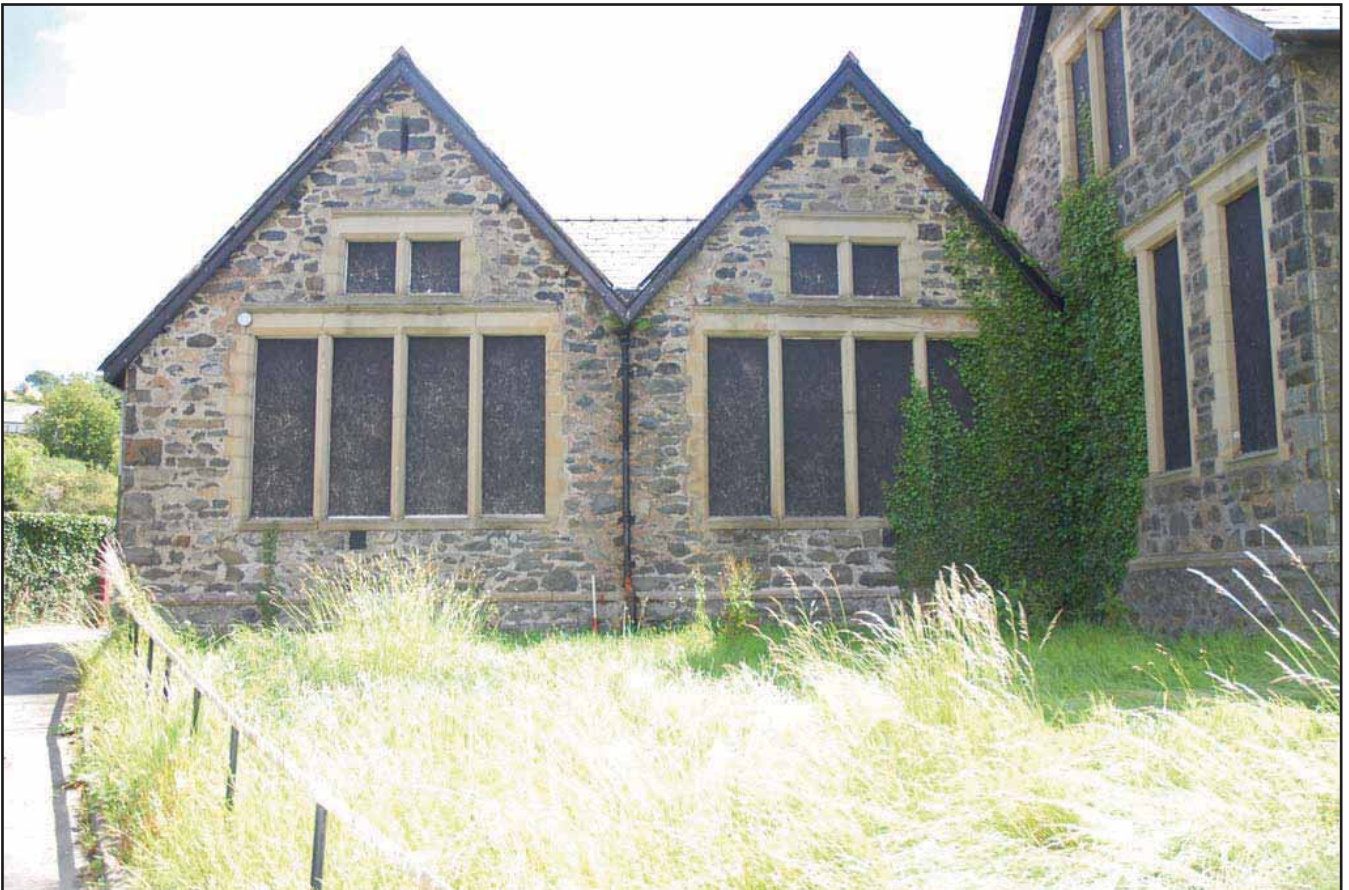
Plate 80 - Extension B (Old Grammar School Block) - west facing elevation. Scale: 1.0m

The west elevation (Plate 80) was a double gable frontage and included two large ground floor windows, with two smaller windows above: the ground floor windows both measured 3.8m in width and 2.8m in height, with four lights each separated by sandstone mullions; sandstone lintels and sills were used throughout. The two smaller windows above each measured 2.0m in width and 1.6m in height; above these were small vents near the gable apexes; the vents did not include sandstone surrounds as found on Extension A. The gable apexes measured 7.0m from ground level.

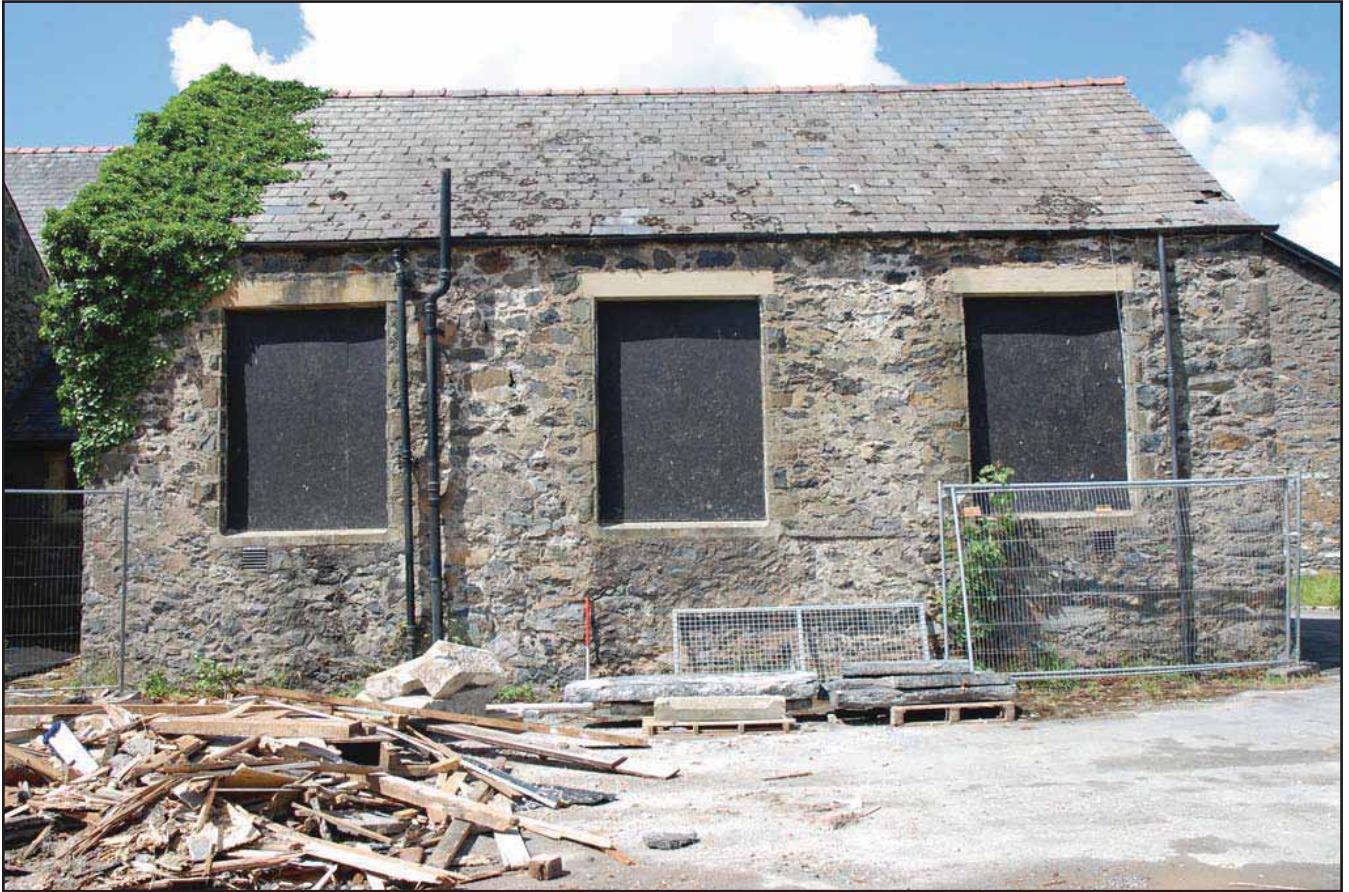
Plate 81 - Extension B (Old Grammar School Block) - east facing elevation. Scale: 1.0m

The east elevation (Plate 81) measured 4.0m in height and 12.0m in width and included three ground floor windows as the main structural detail: these windows were of equal size, each measuring 1.6m in width and 2.0m in height, located 1.6m apart and set 1.4m above ground level. They had sandstone lintels but no sandstone surrounds, sills or mullions.

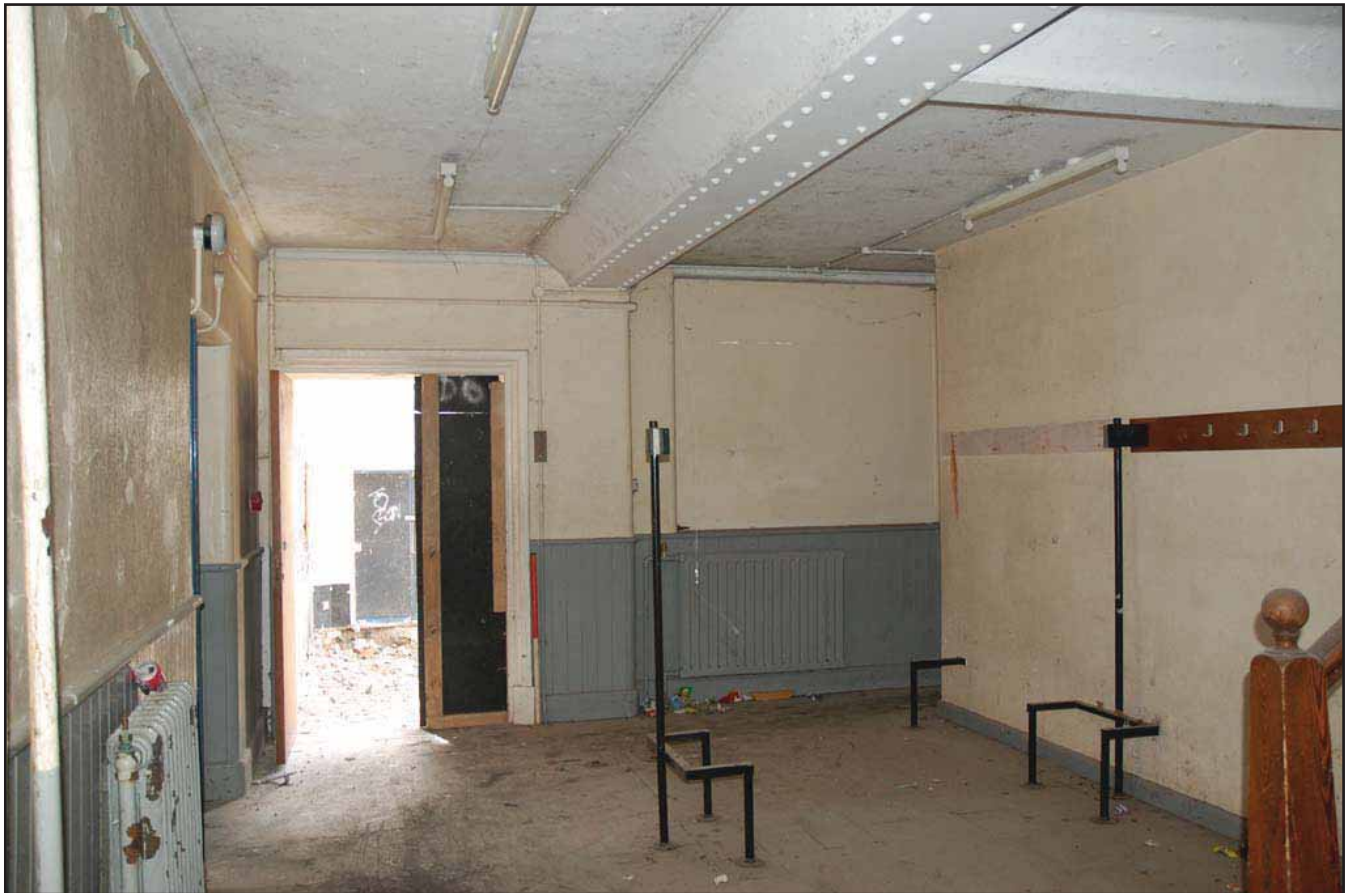
Plate 82 - Extension A (Old Grammar School Block) - Room G01 view south; note cloakroom furniture and ceiling support joist.
Scale: 1.0m

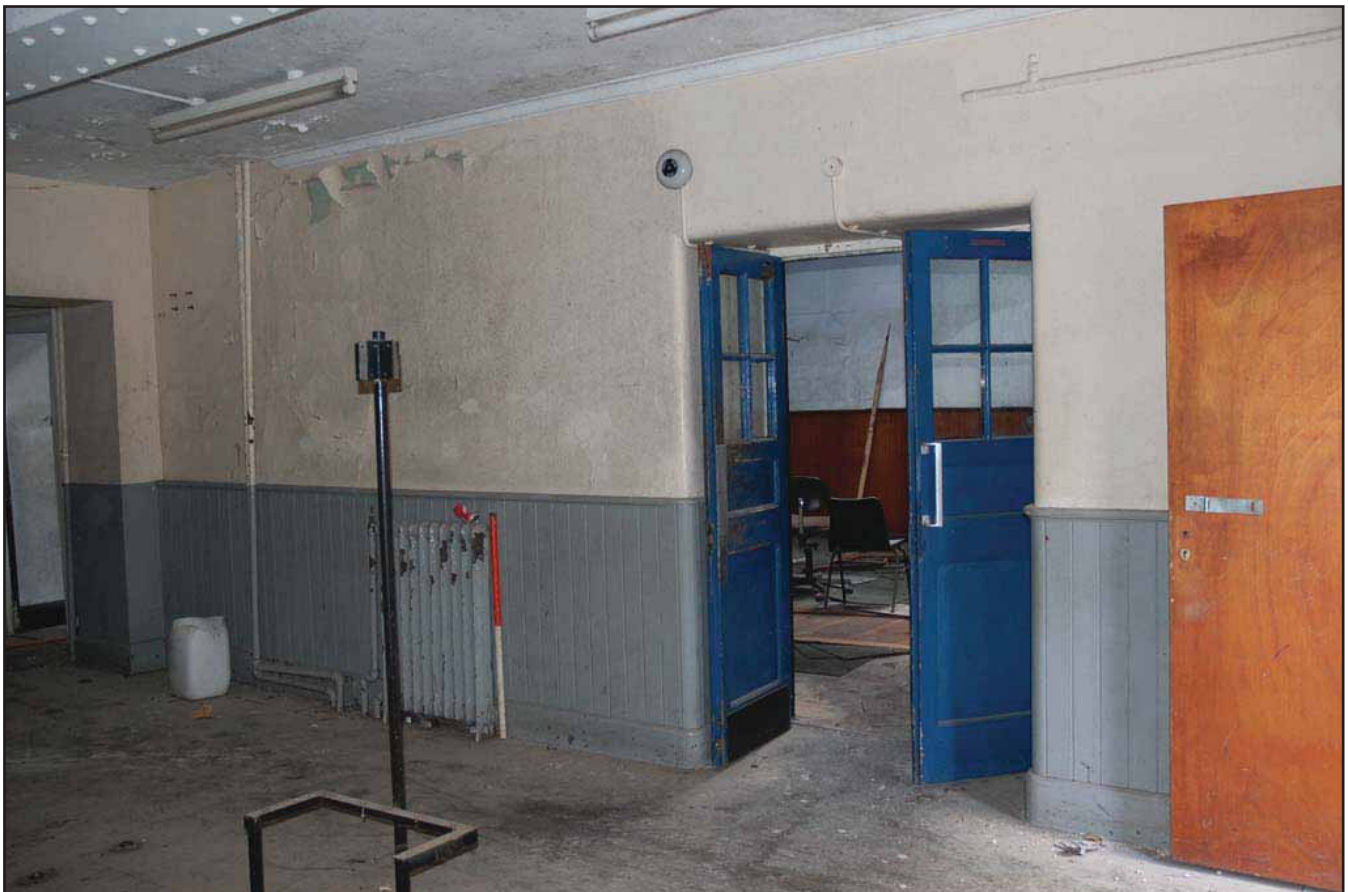
Plate 83 - Extension A (Old Grammar School Block) - Room G01 view east; note cloakroom furniture and ceiling support joist. The double door entrance provides access to the Old Grammar School Hall. Scale: 1.0m

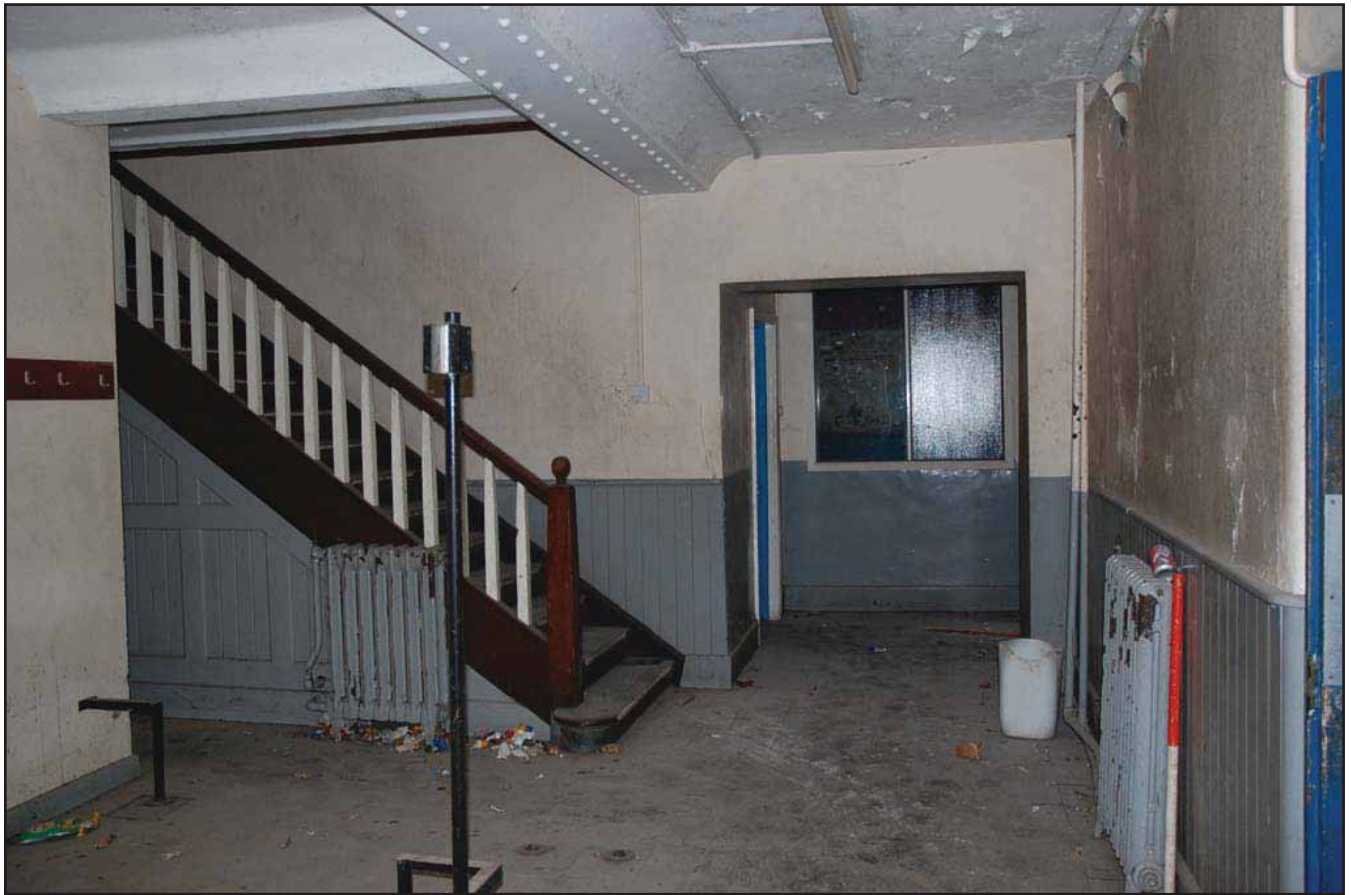
Plate 84 - Extension A (Old Grammar School Block) - Room G01 view north; note cloakroom furniture and ceiling support joist. The staircase leads to the first floor (rooms F01 to F03); the open access leads to room G02

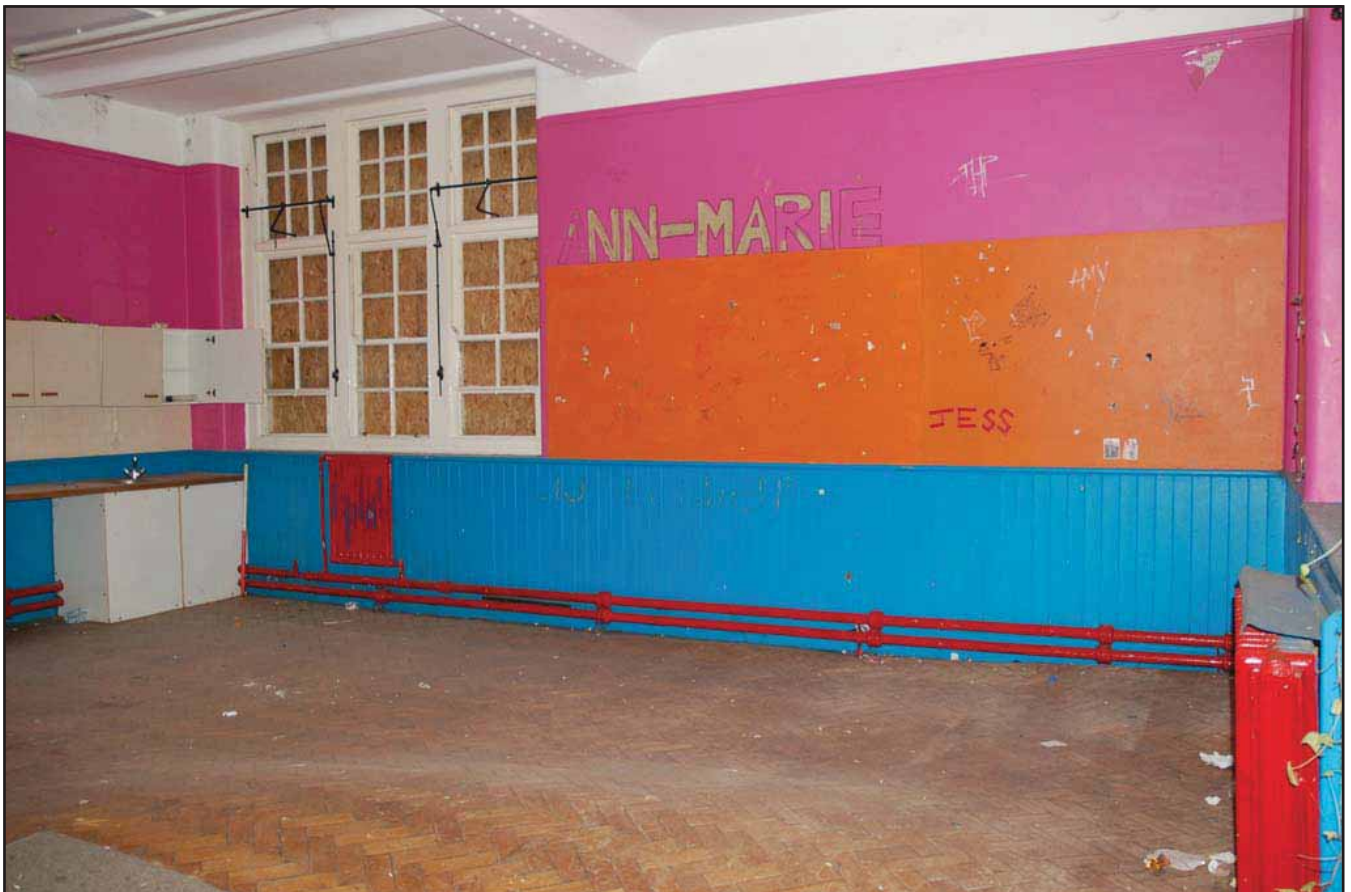
Plate 85 - Extension A (Old Grammar School Block) - Room G02 view west; note ceiling support joist

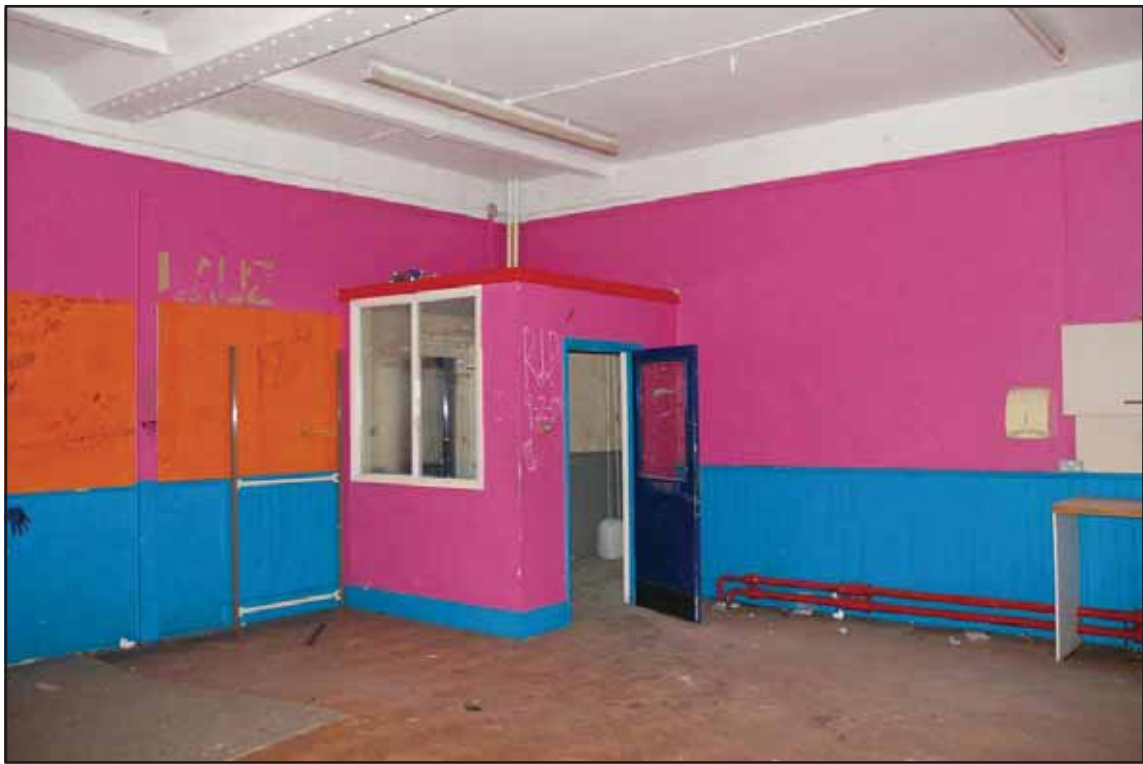
Plate 86 - Extension A (Old Grammar School Block) - Room G02 view south; note ceiling support joist. Access is from room G01

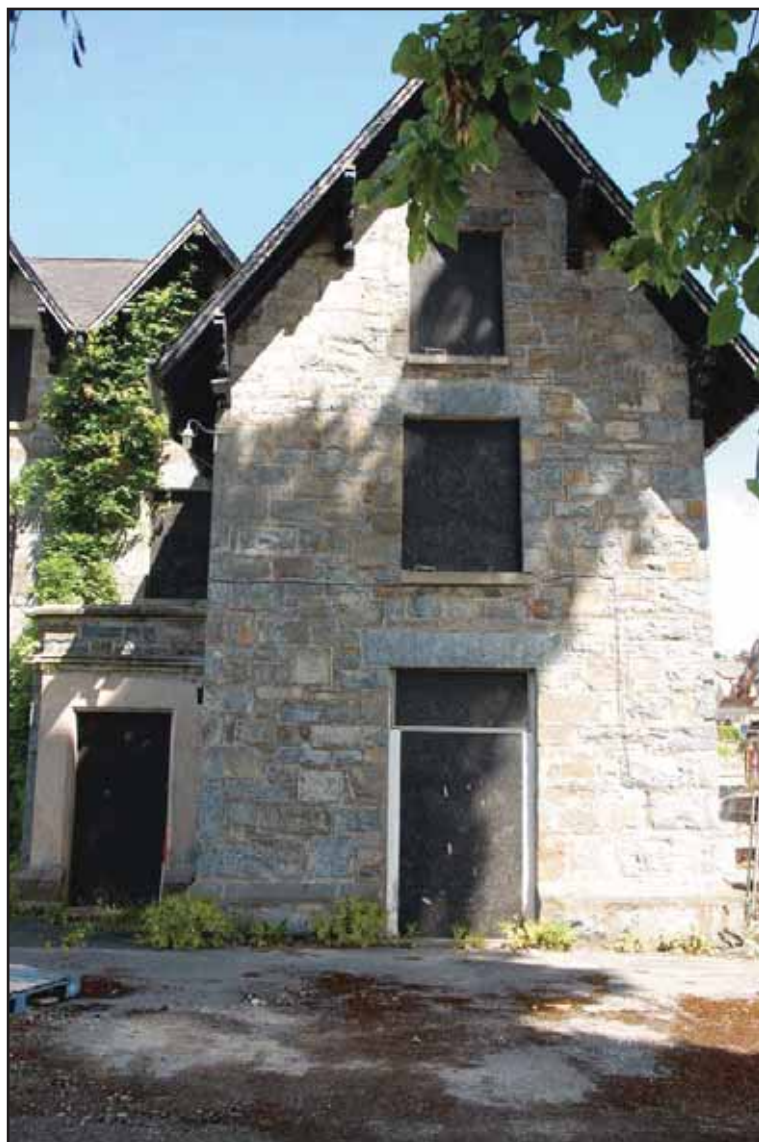
The south elevation (Plates 96 and 97) was the front of the building and measured 19.0m in width and 9.0m in height. The elevation included a projecting gable with an attached porch. The elevation was faced with dressed stone. Three equal sized windows (1.6m each in width and height) ran along the elevation lighting the ground floor; each window had a stone lintel and sandstone sill. The porch entrance measure 2.0m wide and 3.4m high, with the entrance surrounded by dressed sandstone. A second entrance on the projecting gable matched the windows with a stone lintel. The first floor windows were all of equal size at 1.0m wide and 1.6m high and matched the stone lintel/sandstone sill design of the ground floor; including the projecting gable, there were five first floor windows. The second floor windows matched the size and design of the first floor windows, with five also present, directly above their first floor counterparts. The second floor windows were set into dormer projections. Visible on the roof ridge were three sets of chimneys, all with the same dressed style.

Plate 96 - Headmaster's Building - south elevation. Scale: 1.0m

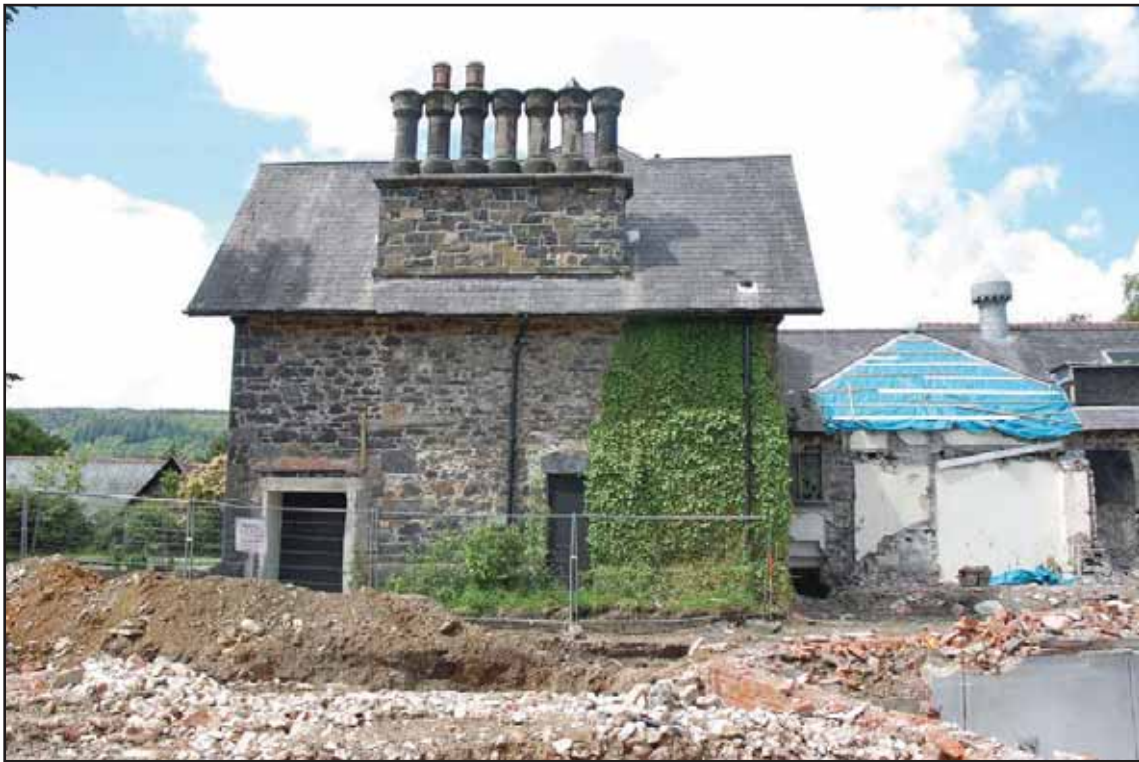
Plate 98 - Headmaster's Building - east elevation. The former link corridor entrance is at the left of image. Note the former building exterior next to the link corridor entrance that was replaced by the projecting gable. Scale: 1.0m

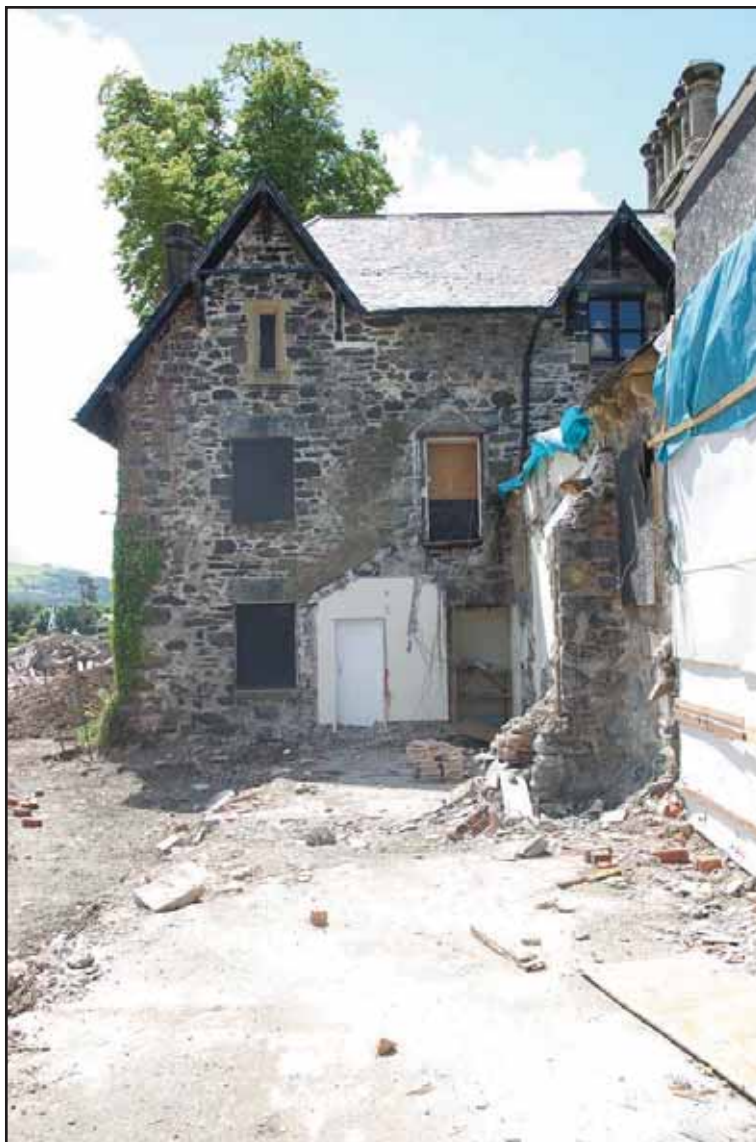
Plate 99 - Headmaster's Building - north elevation east side. Note the former building extension which was demolished in 2008 and the first floor window converted into a door. Scale: 1.0m

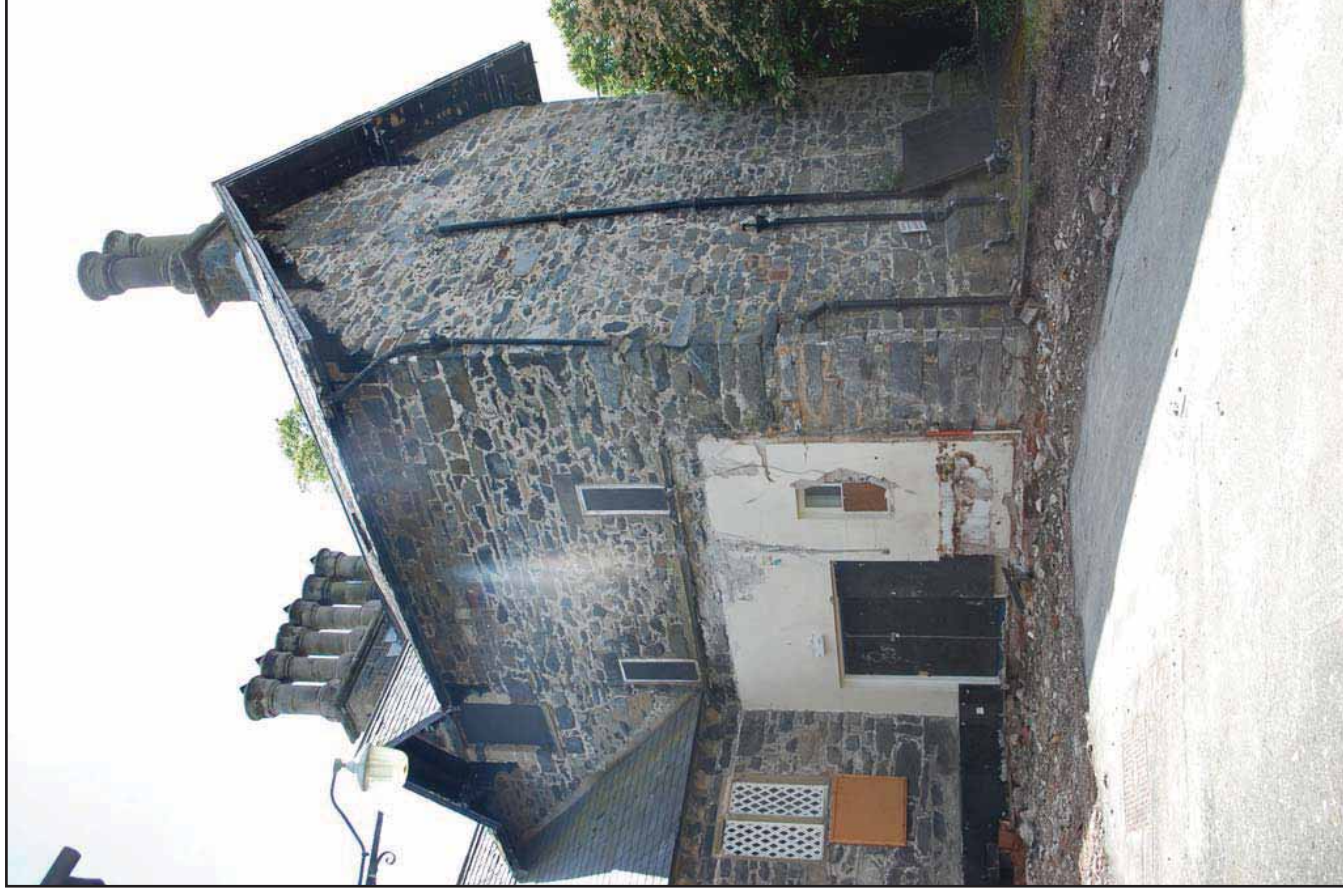
The north elevation was visible as two sections either side of the Old Grammar School: a 6.6m wide section projecting east of the Old Grammar School (Plate 99) and a 5.2m wide section projecting to the west (Plate 100). The west projection included a modern entrance associated with the 1960s lobby; two narrow windows were extant on the first floor and a single dormer window matching those on the south elevation was also visible. The east projection incorporated remnants of the demolished Old Grammar School extensions on the ground floor. A rectangular window with stone lintel was located on ground level that matched in size and construction the windows on the south elevation; an identical window was located above this window on the first floor. To the west of this was a modified window of the same design, but which had been converted into a door for access/egress to the demolished Old Grammar School extension. On the second floor were two dormer windows: the example to the east was a very narrow rectangular window with sandstone surround; the other dormer window to the east was similar to the dormer windows on the south elevation.

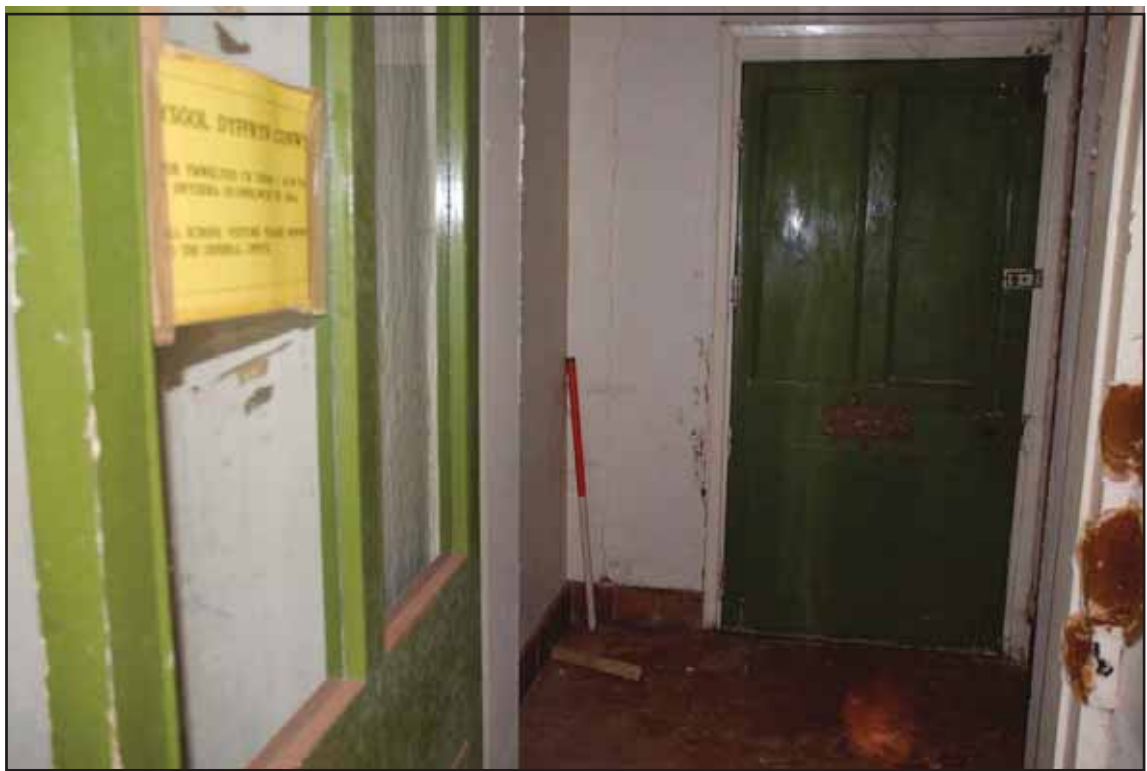
The west elevation (Plate 101) measured 7.4m in width and comprised a gable end, measuring 10.0m high at the gable apex. A chimney with carved stacks was set onto the ridge of the roof. There were no windows or doors on this elevation and it was characterised by irregular shaped stone. The raised roofline was evident on the west elevation with the former pitched roof line still visible.

Plate 101 - Headmaster's Building - west elevation. Note the raised roof line. Scale: 1.0m

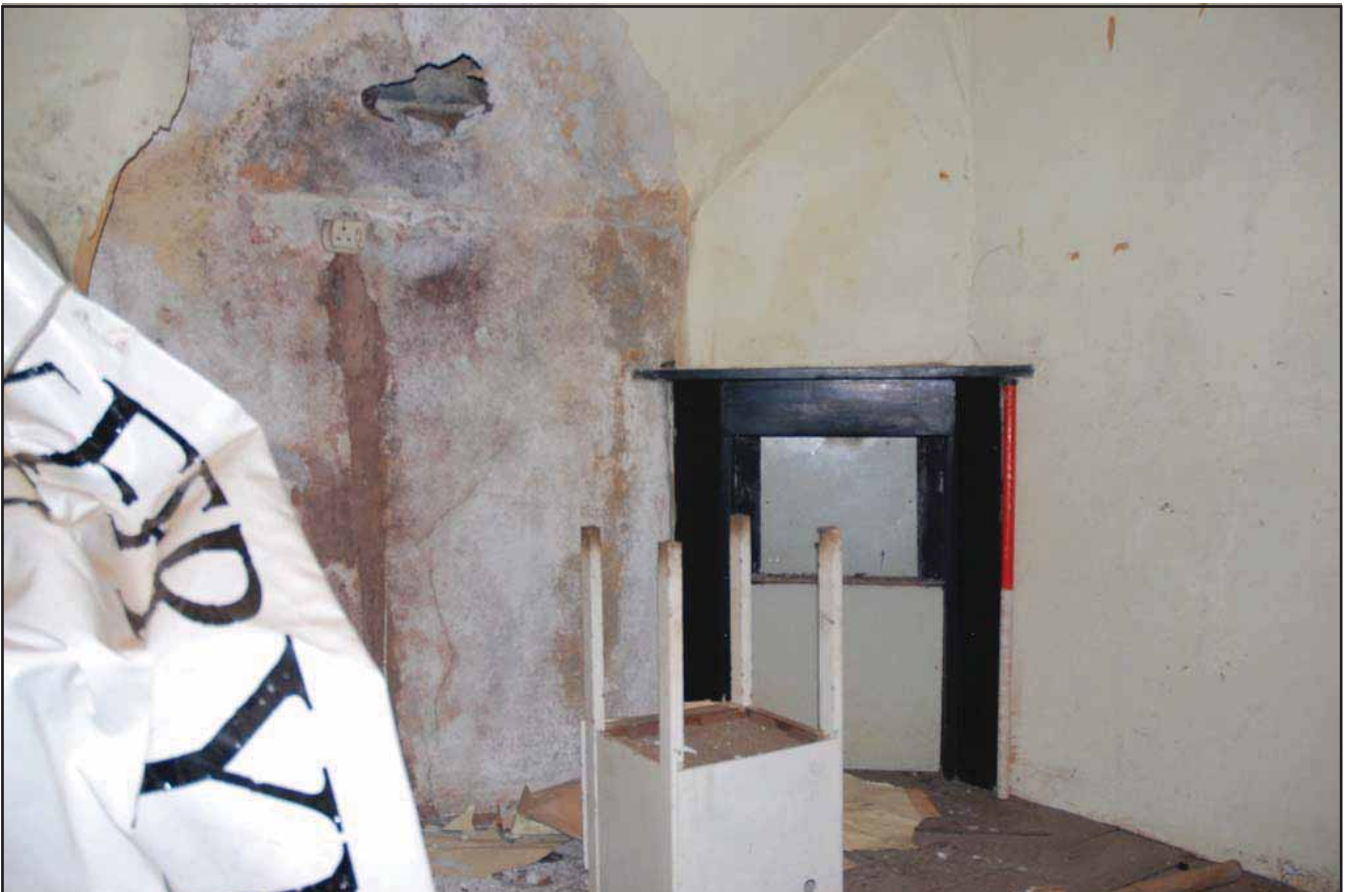
Plate 113 - Headmaster's Building - internal - room S02 view southeast (fireplace detail). Scale: 1.0m

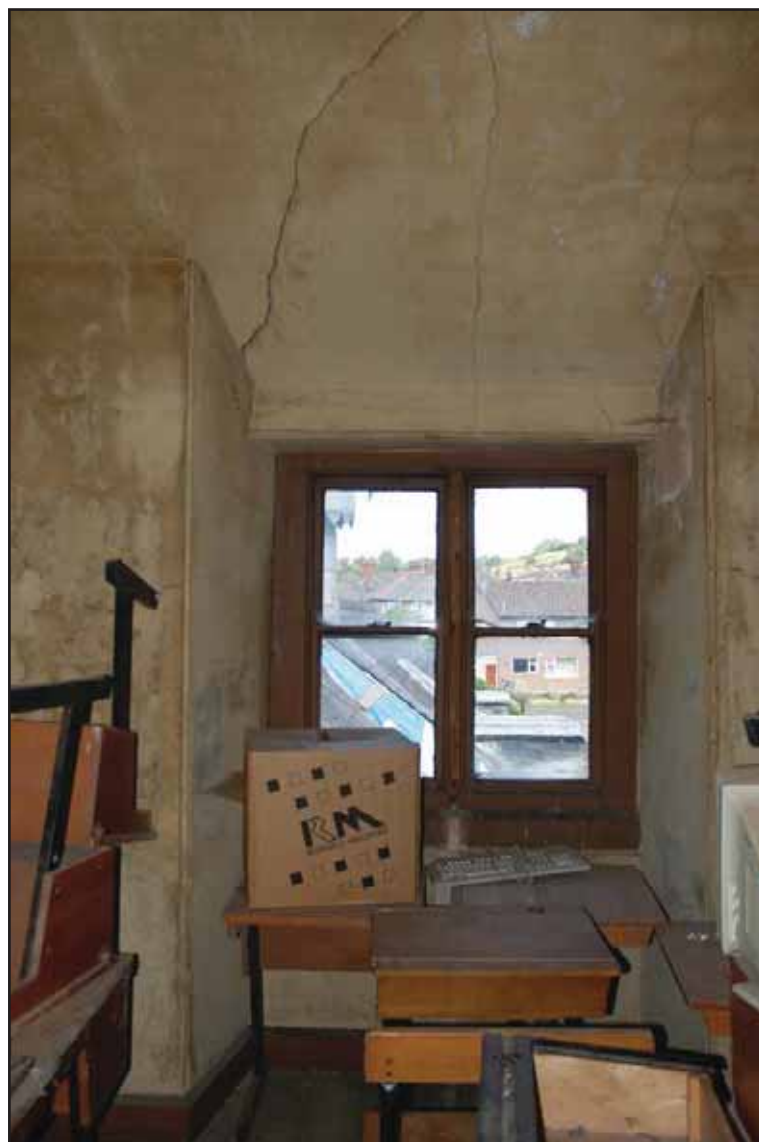
Plate 115 - Headmaster's Building - internal - room S04 view north (window detail). Scale: 1.0m

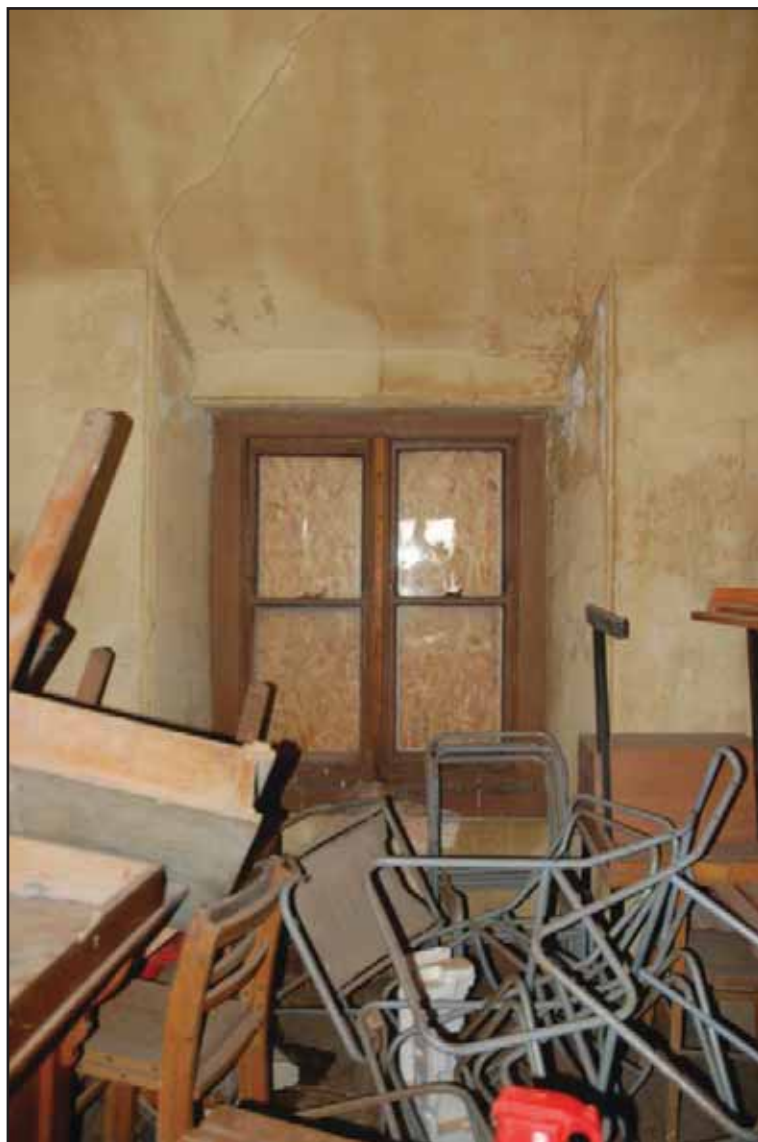
Plate 117 - Headmaster's Building - internal - room S04 view south (window detail). Scale: 1.0m

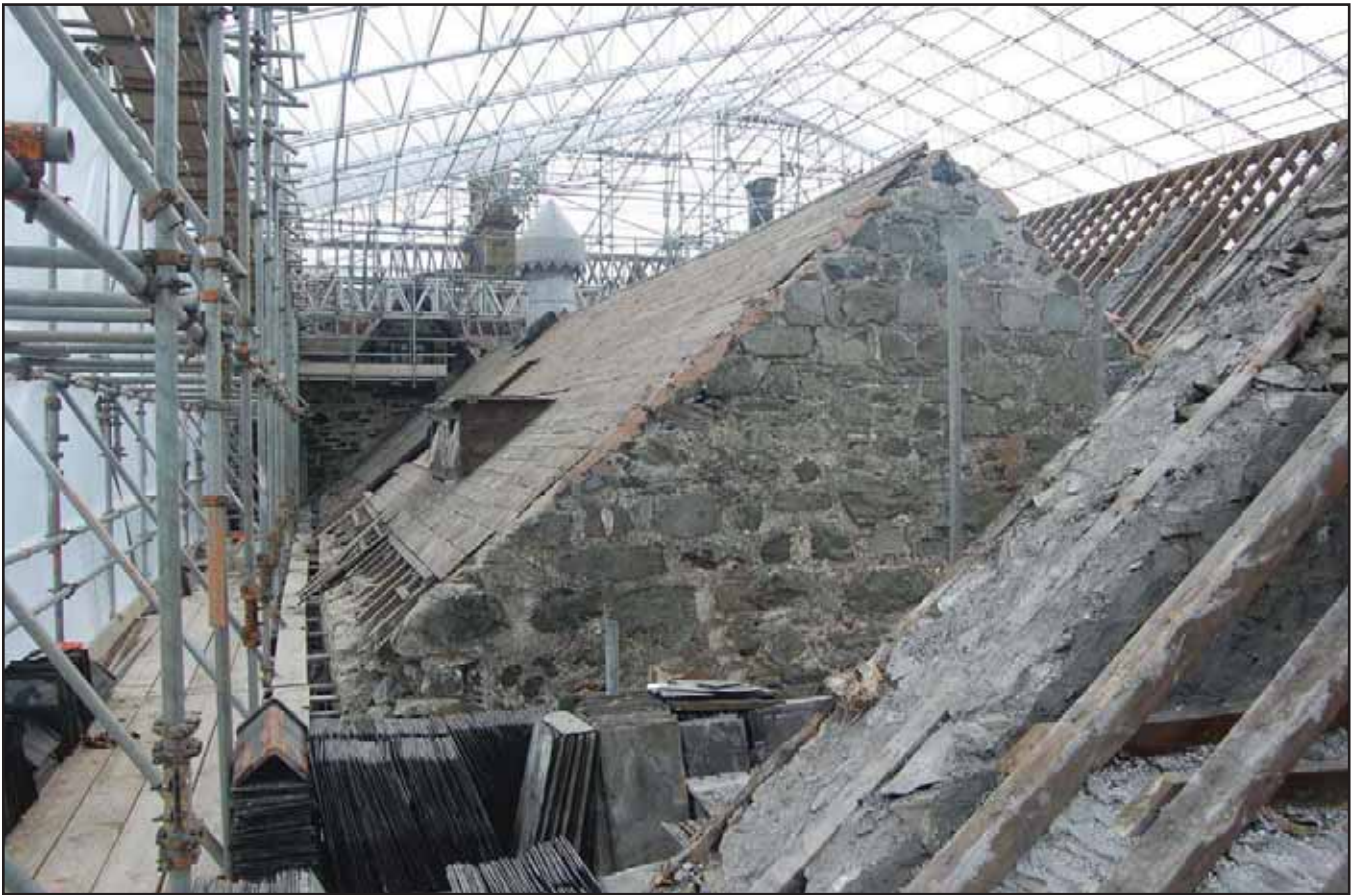
Plate 118 - Old Grammar School External - view south of roof during renovation; note the cupola in the background

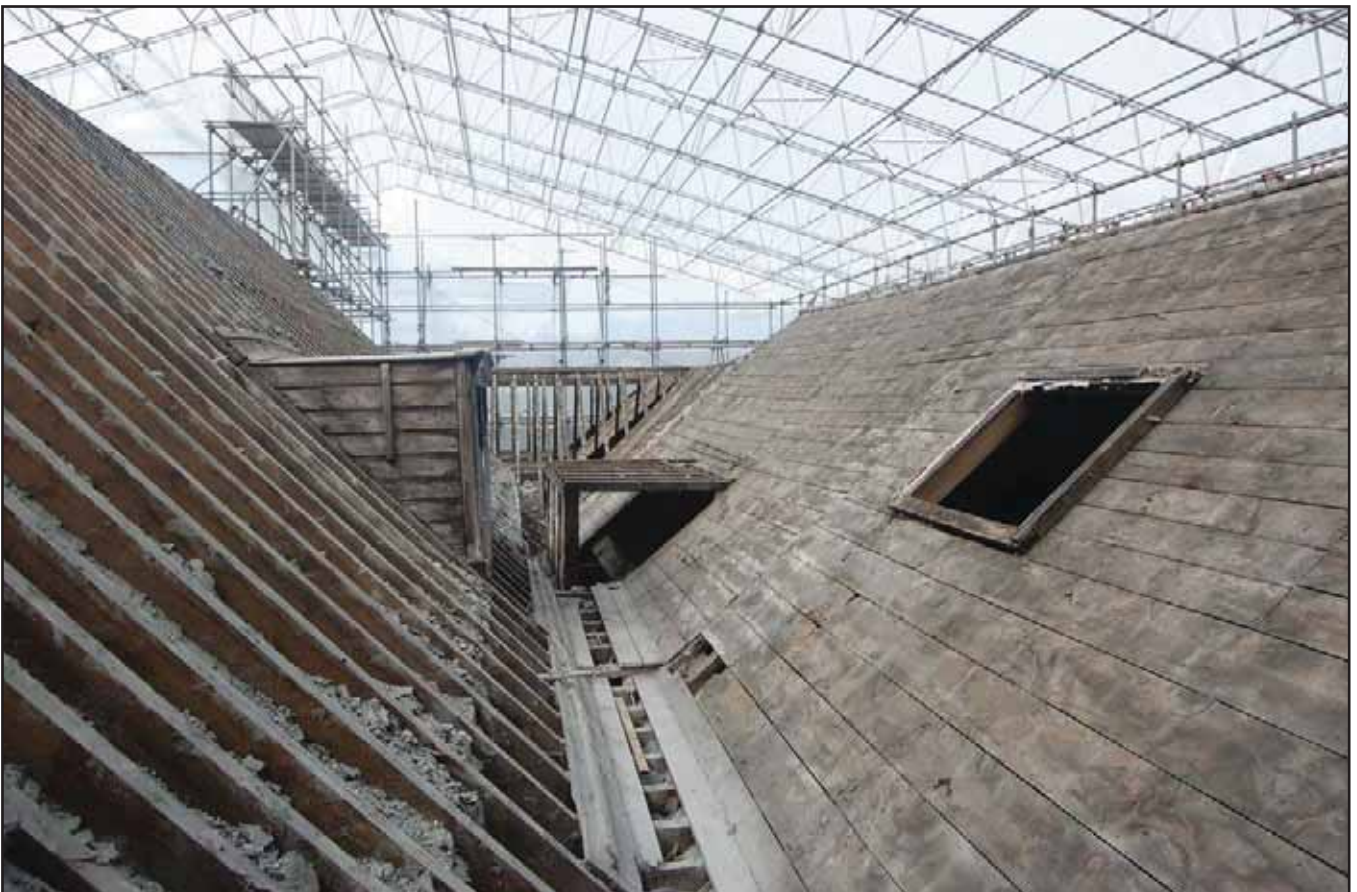
Plate 119 - Old Grammar School External/Extension A - view south of roof during renovation

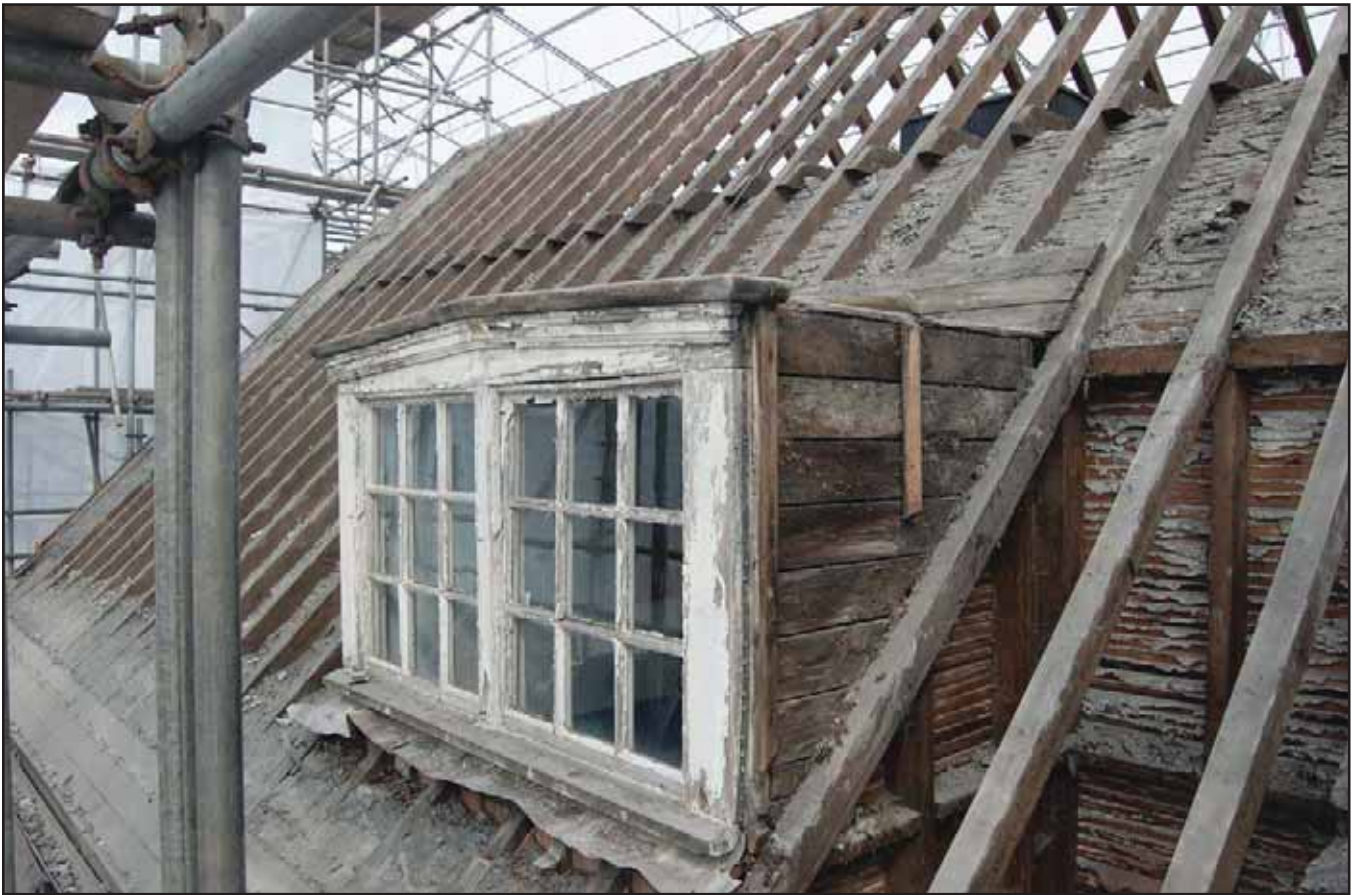
Plate 120 - Old Grammar School External- view west of roof during renovation: dormer light detail
