YSGOL DYFFRYN CONWY, LLANRWST

Archaeological Mitigation report

Project No. G1961

Report No.1184

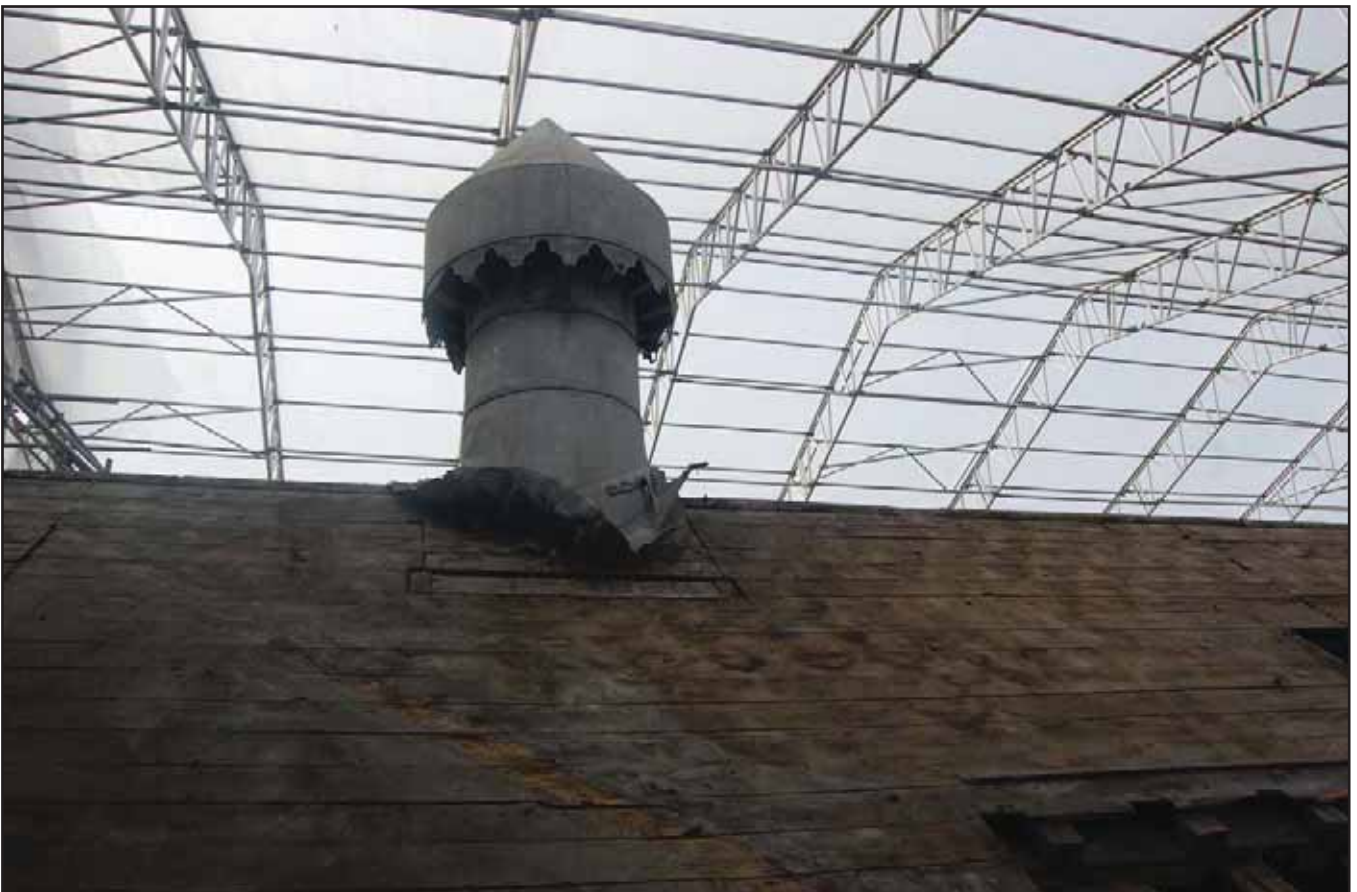
Plate 121 - Old Grammar School External- view east of roof during renovation: cupola detail

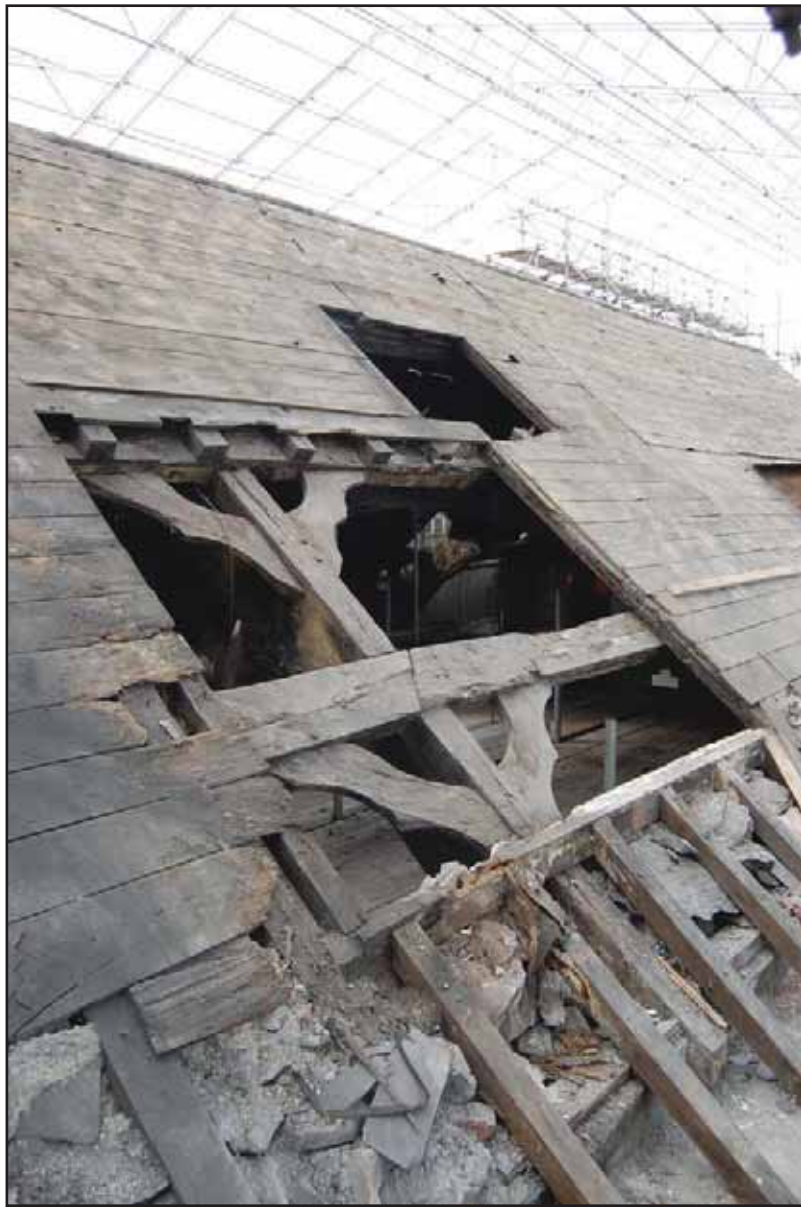
Plate 122 - Old Grammar School External - view east of roof during renovation: wind brace and purlin detail

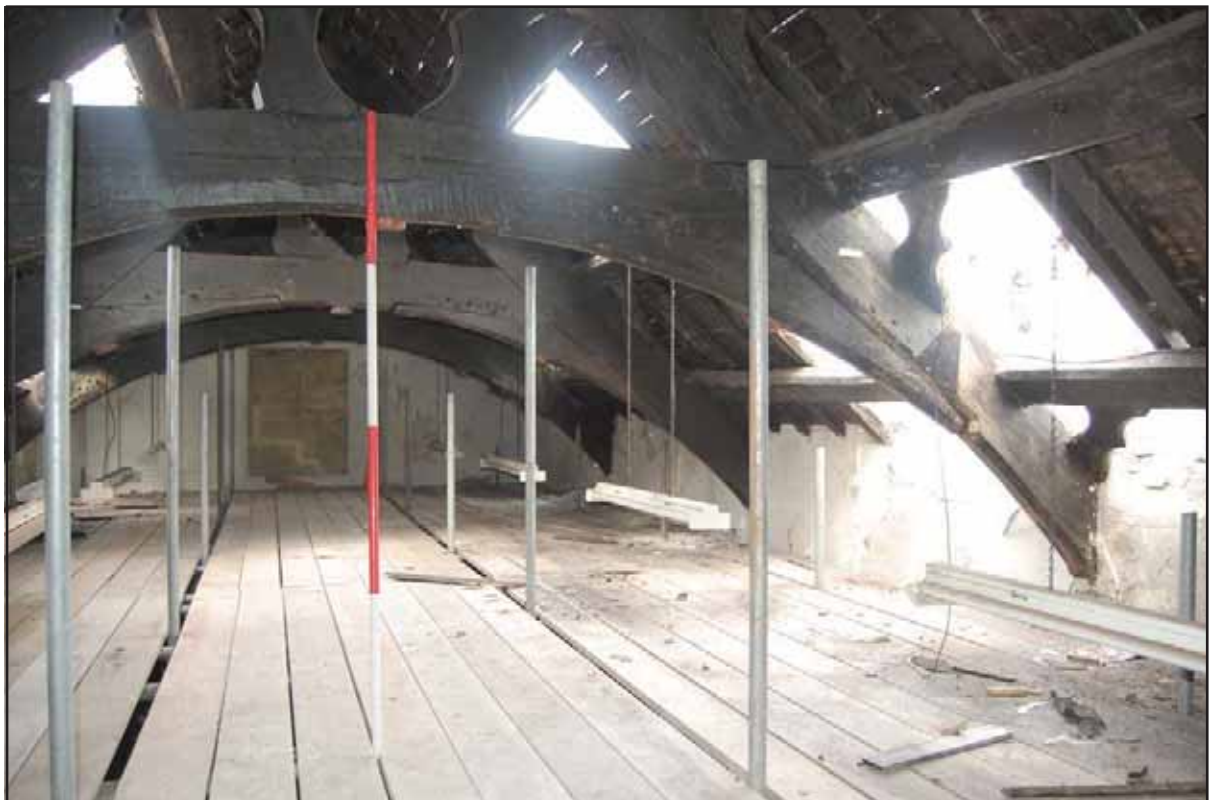
Plate 123 - Old Grammar School internal- view north of roof trusses during renovation. Scale: 2.0m

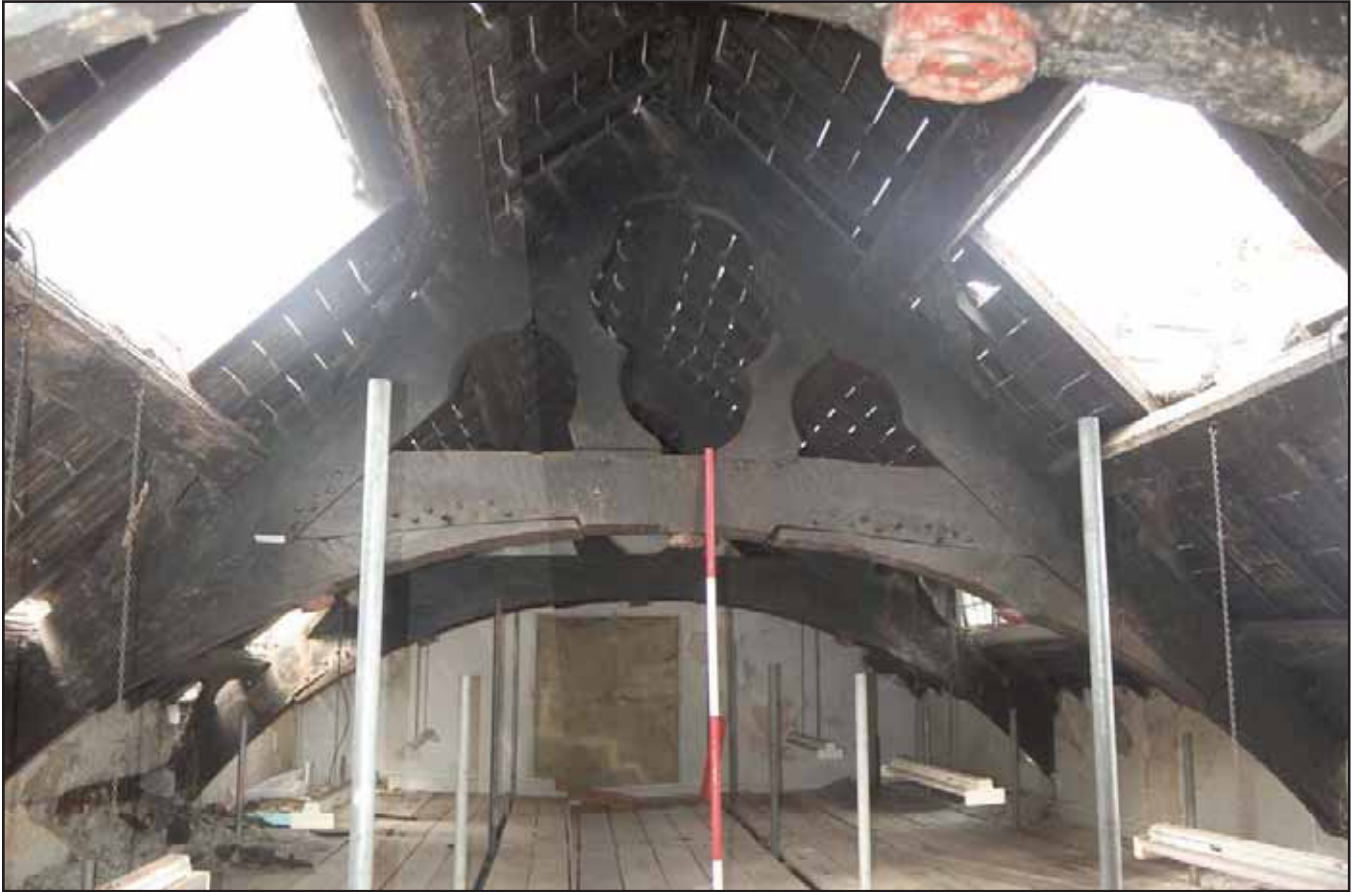
Plate 124 - Old Grammar School internal- view north of roof truss 02 during renovation works. Scale: 2.0m

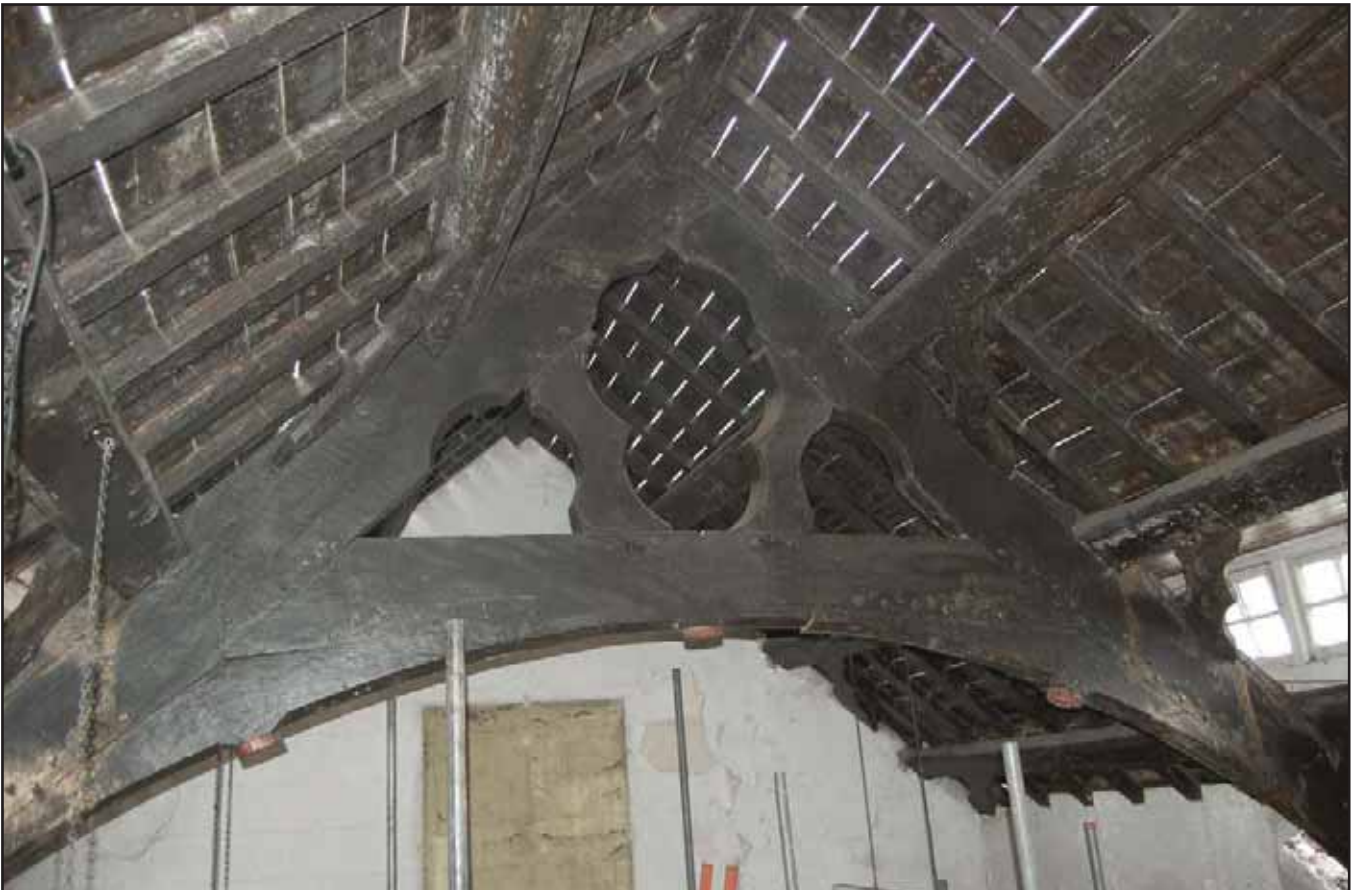
Plate 125 - Old Grammar School internal- view north of roof truss 01 during renovation works. Scale: 2.0m

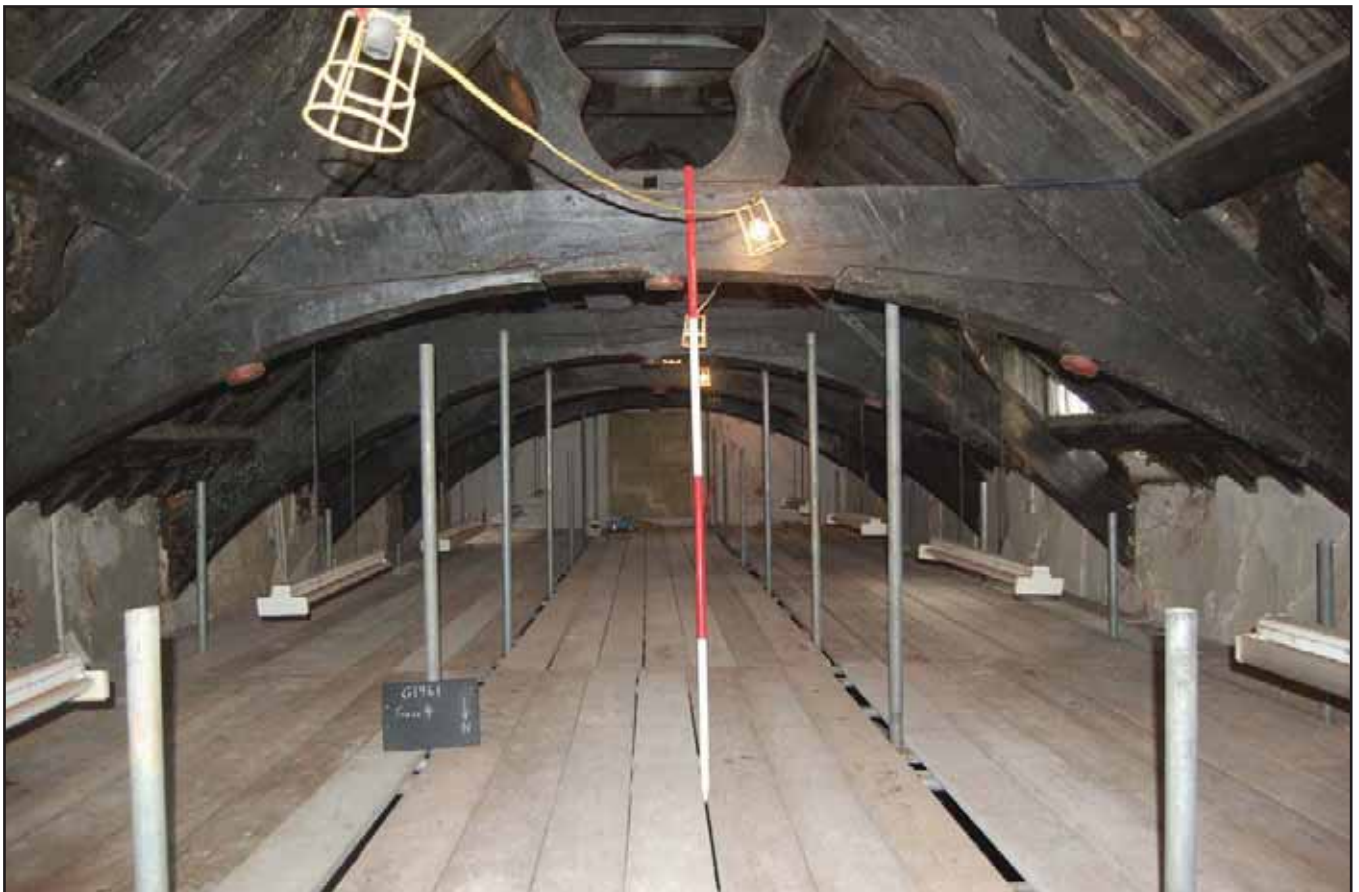
Plate 127 - Old Grammar School internal- view north of roof trusses during renovation works. Scale: 2.0m

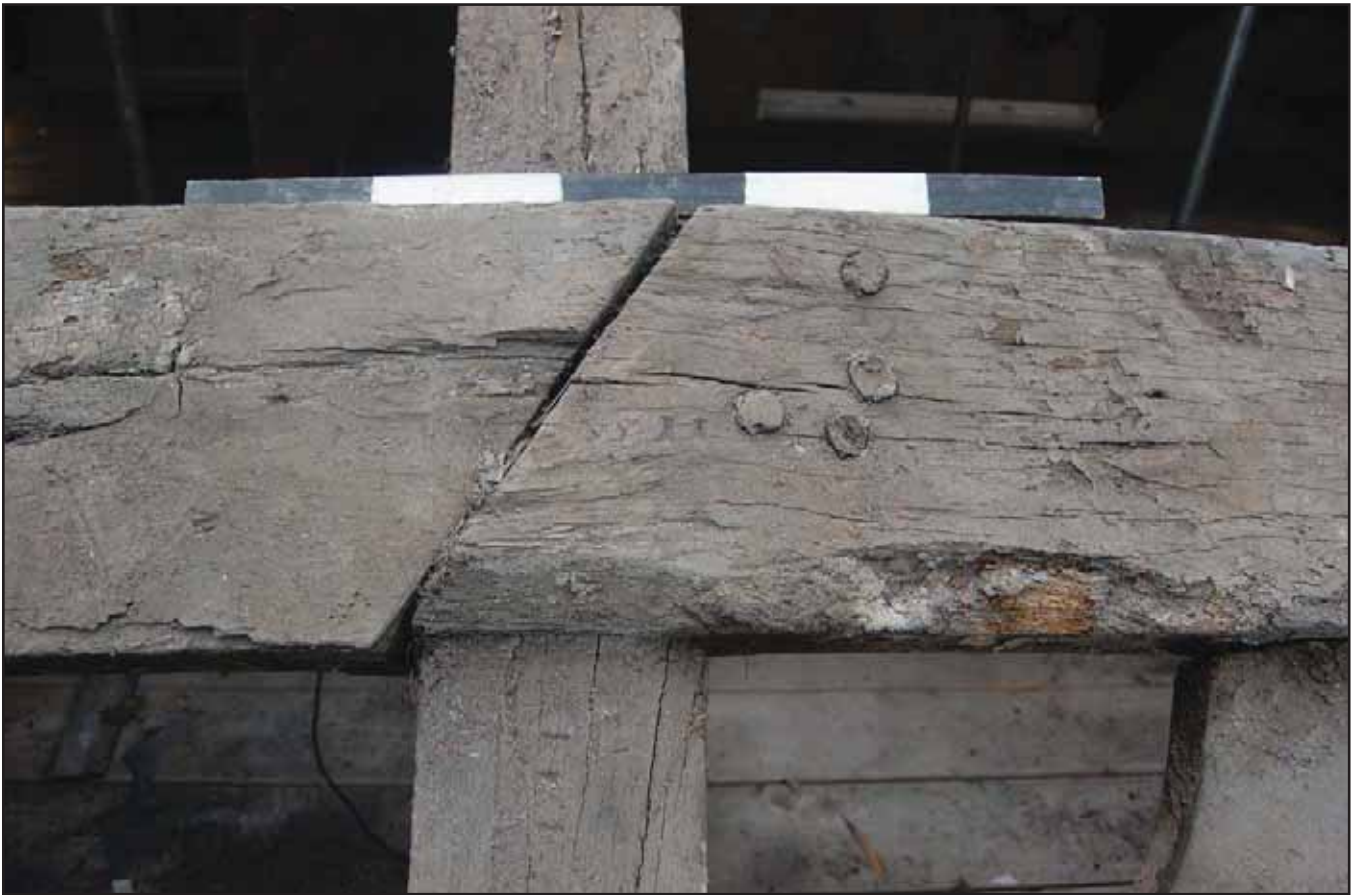
Plate 128 - Old Grammar School internal - detail of join between purlins and associated fixings. Scale: 0.3m

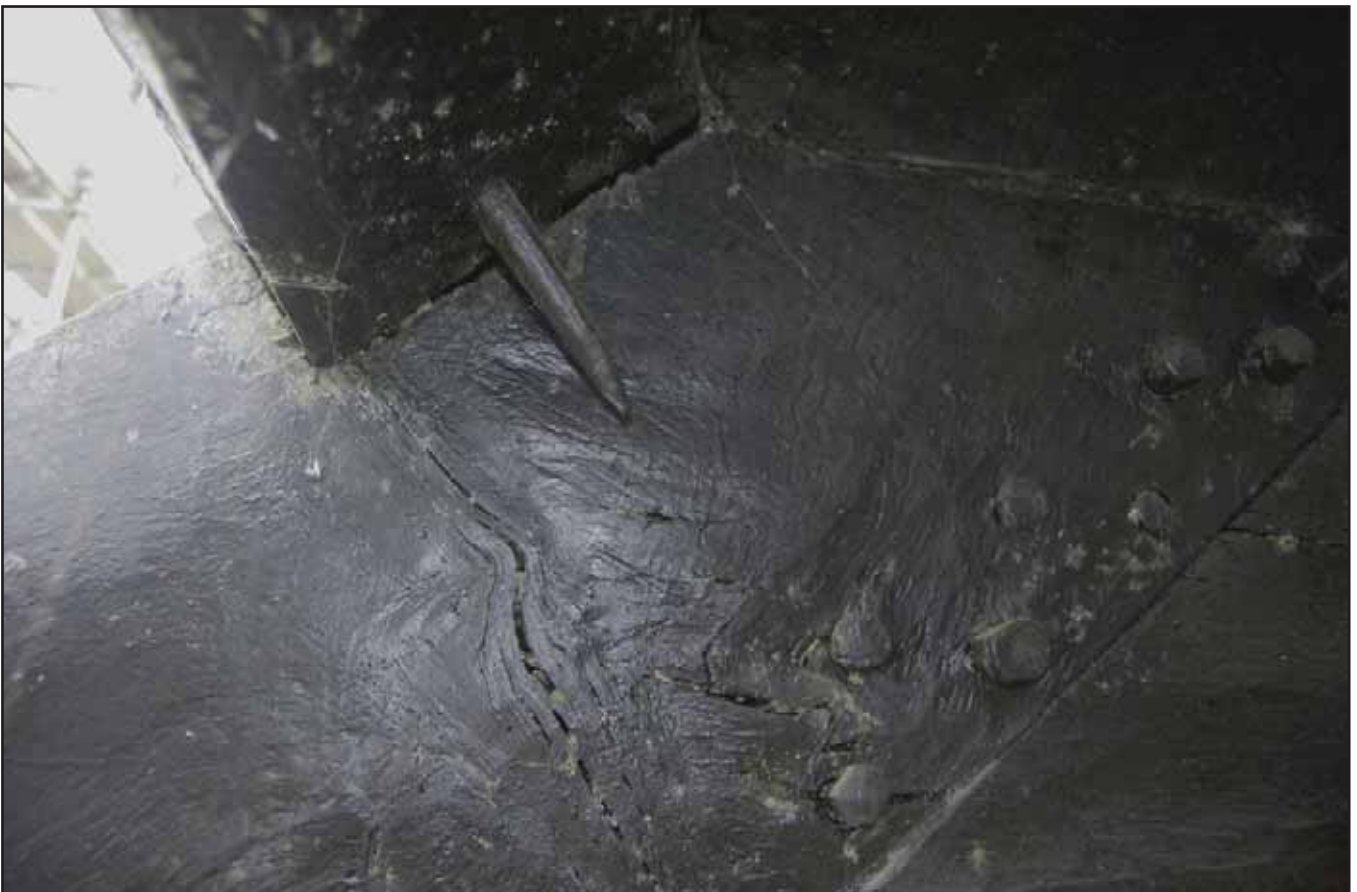
As far as the rest of the roof structure is concerned, some of the chamfered and stopped purlins and some of the wind-braces were of contemporary date with the construction of the building, although the purlins appear to have been re-set. The lower purlin in the fourth bay along from the north has a mortice cut into its upper face, suggesting that this is an original purlin that has been turned around. The removal of much of the later roof as part of the renovation works enabled carpentry joints to be noted within the purlins. Some graffiti was also noted on these, probably dating from the time that the roof was altered in the 19th century (Plate 129).

Plate 129 - Old Grammar School internal - detail of roof construction fixings

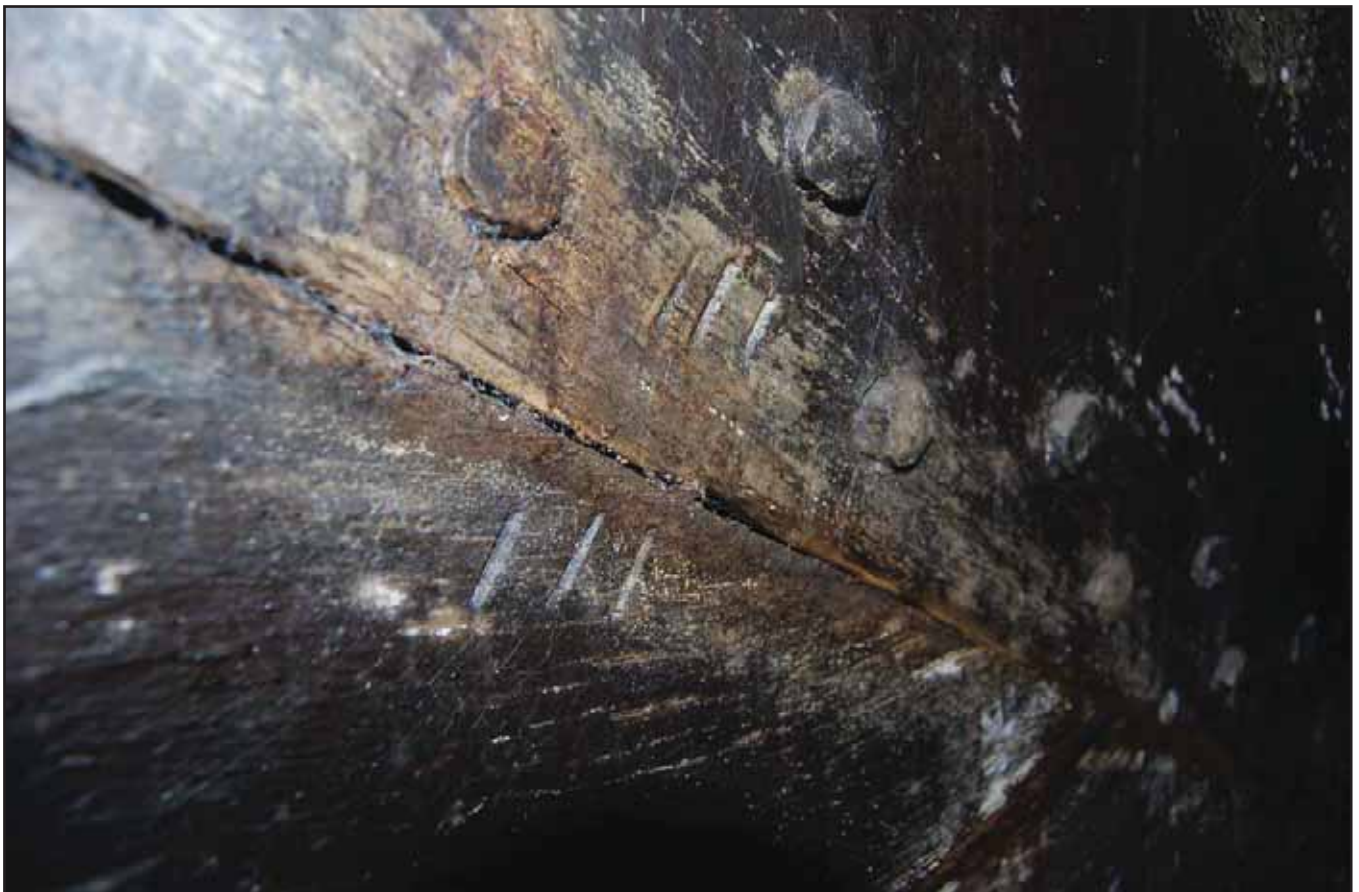
Plate 131 - Old Grammar School internal - detail of carpenter's markings on roof truss 02

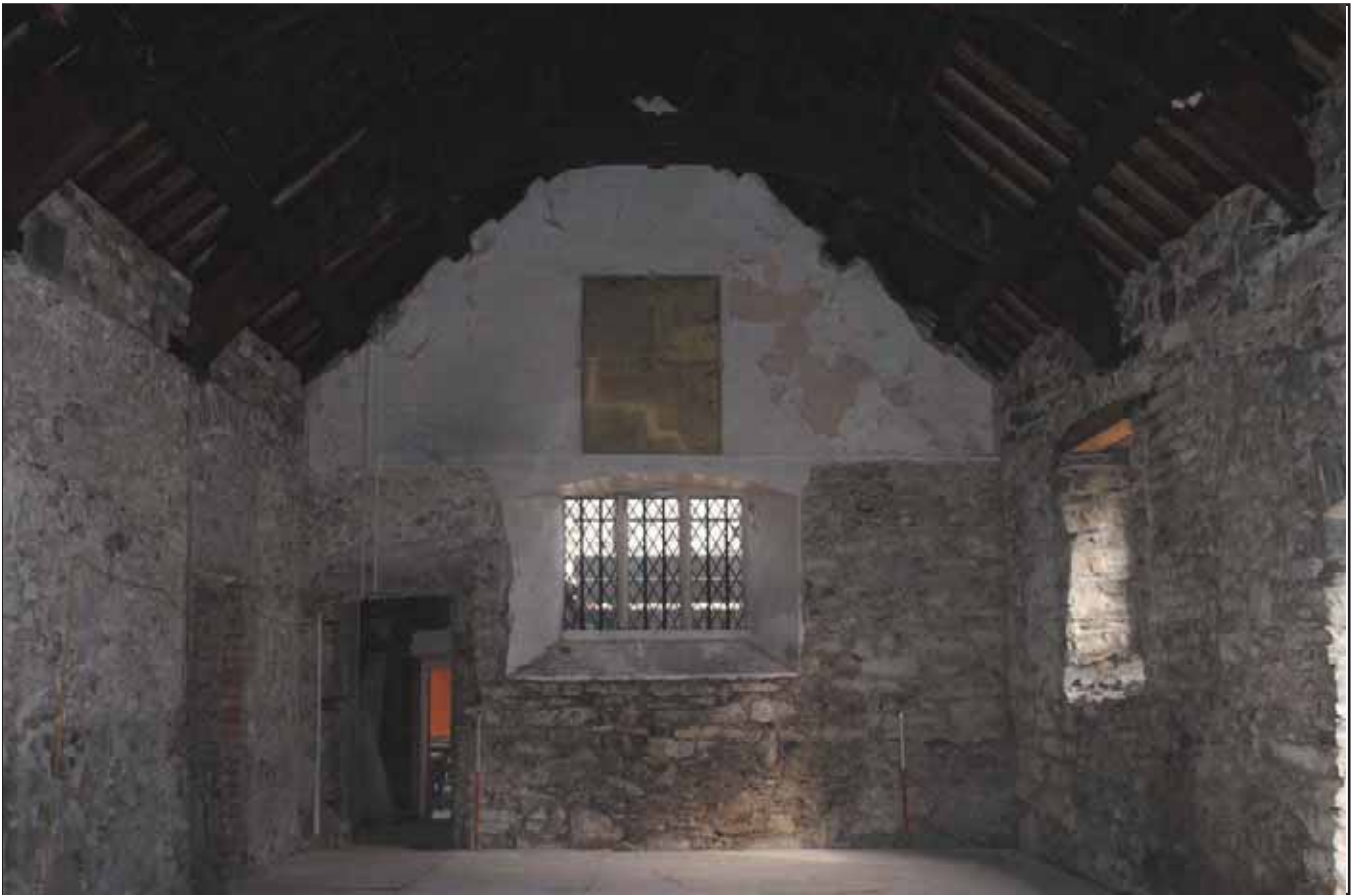
The north facing internal elevation had the modern render removed to a height of about 2.2m. An original window opening at a height of 1.4m and 1.6m wide would originally have lit the dais end of the hall. It consists of an embrasured window recess with two mullions with ovolo mouldings and leaded lights. Even though probably a replacement, the window probably reflects its original form. A door opening, 2.2m high, was cut into the western side of the gable end, with a concrete lintel and edged with brick. This gave access to a hallway and was probably of late 19th or early 20th century date (Figure 22; Plate 133).

Plate 132 - Old Grammar School internal - North Facing Internal elevation of the School Hall. Scales 1m

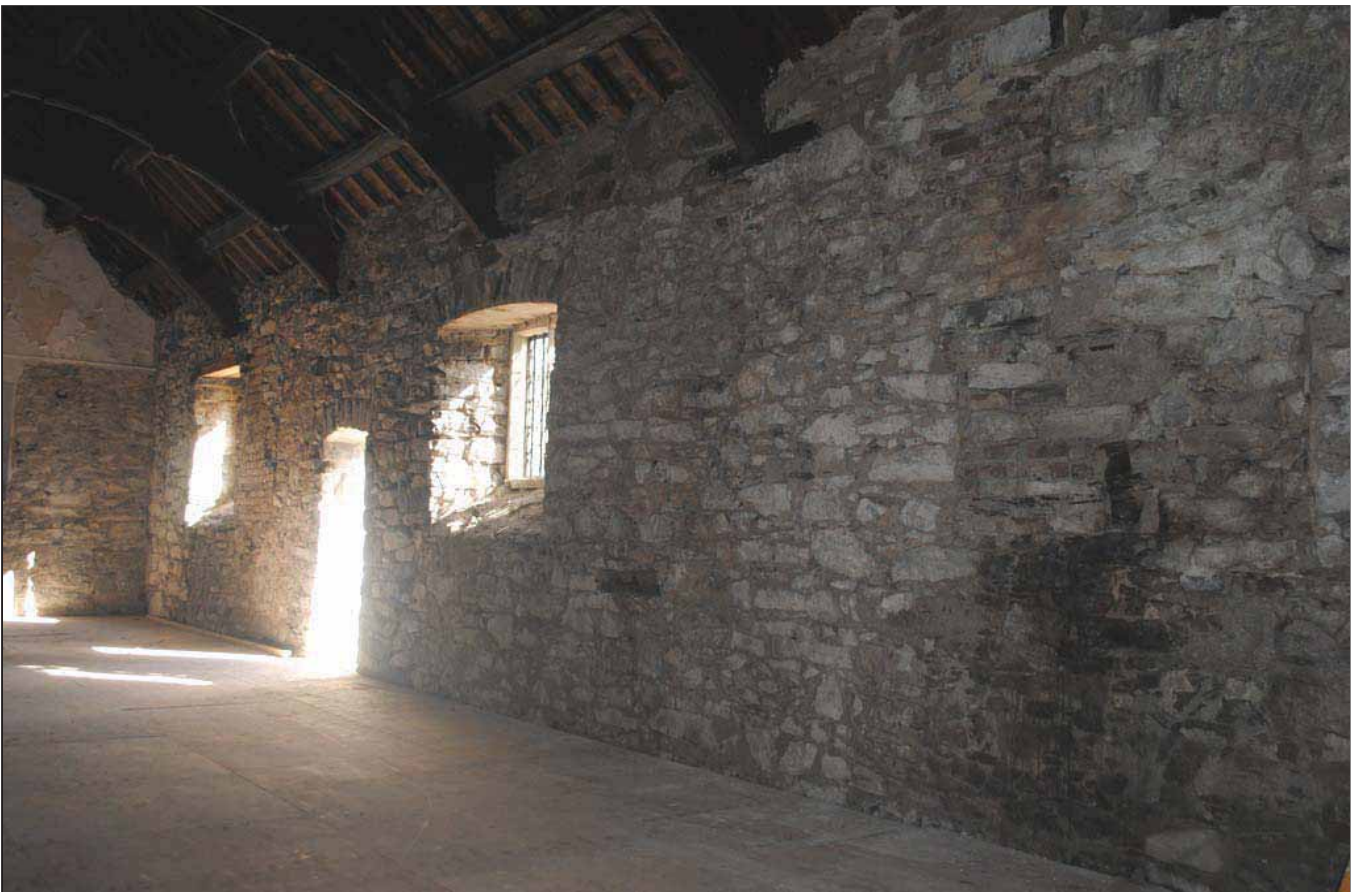
Plate 133 - Old Grammar School internal - West Facing Internal elevation of the School Hall

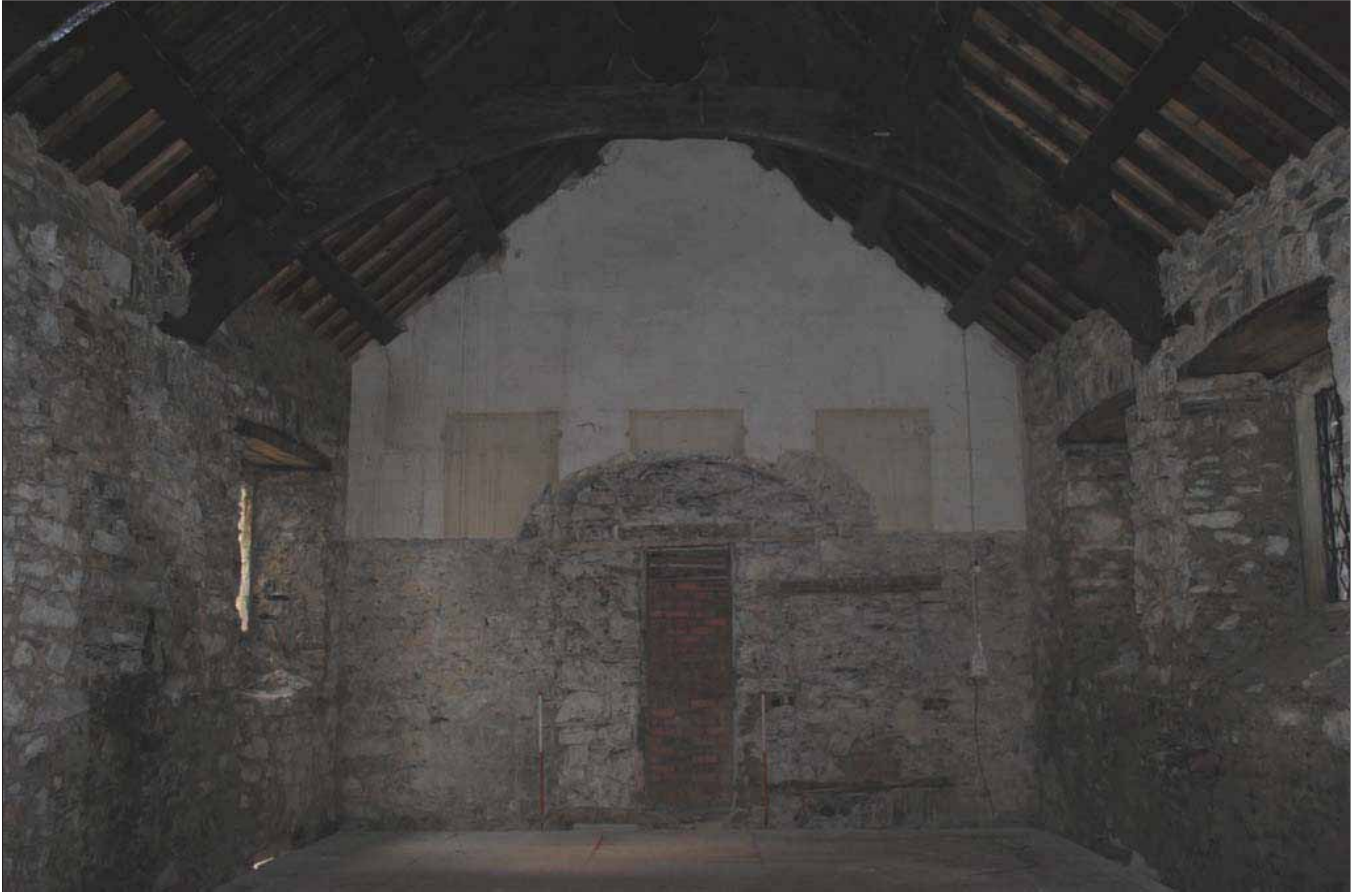
Plate 134 - Old Grammar School internal - South-facing Internal Elevation of the School Hall. Scales 1m

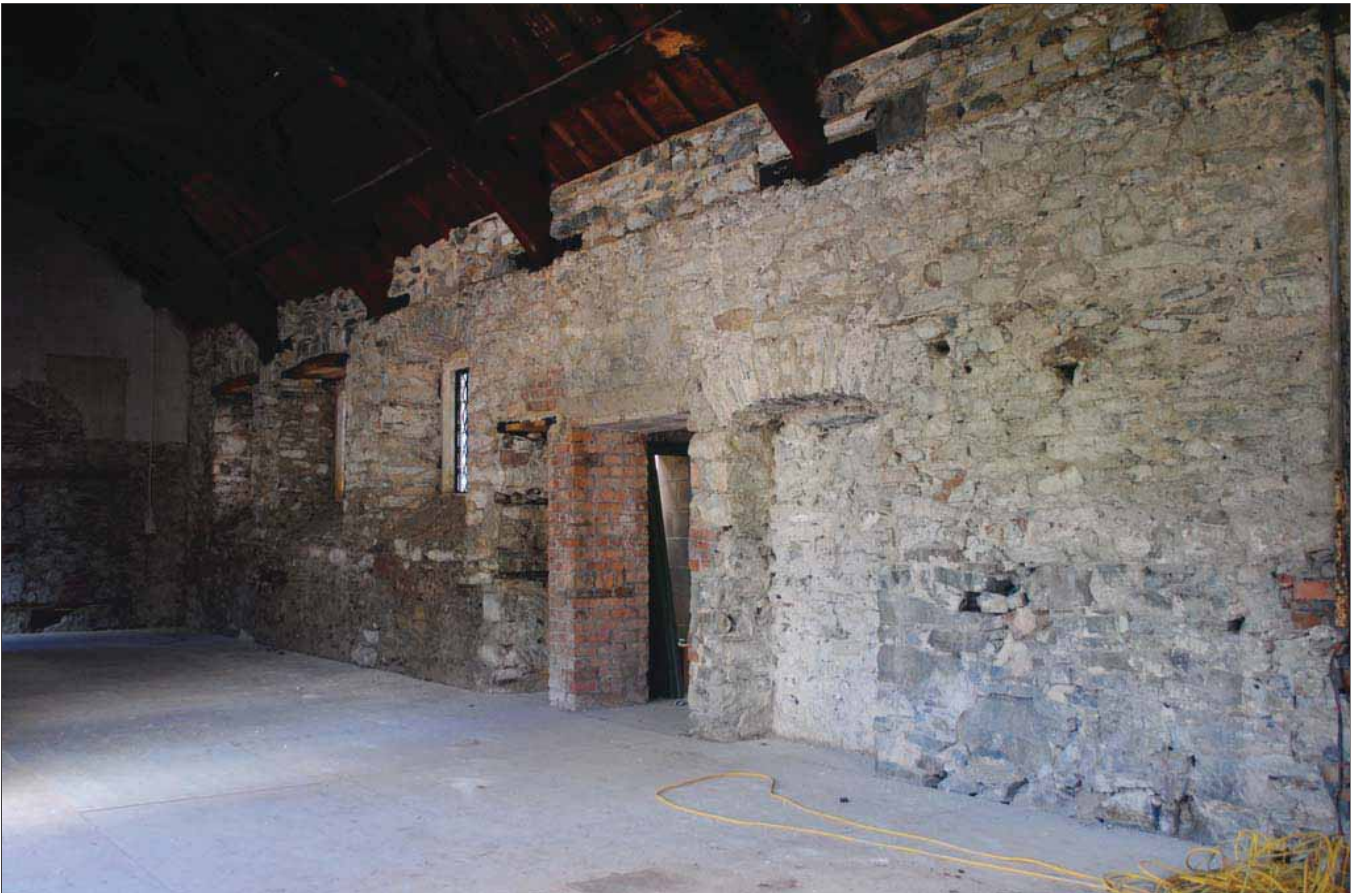
Plate 135 - Old Grammar School internal - East Facing Internal Elevation of the School Hall from the North East

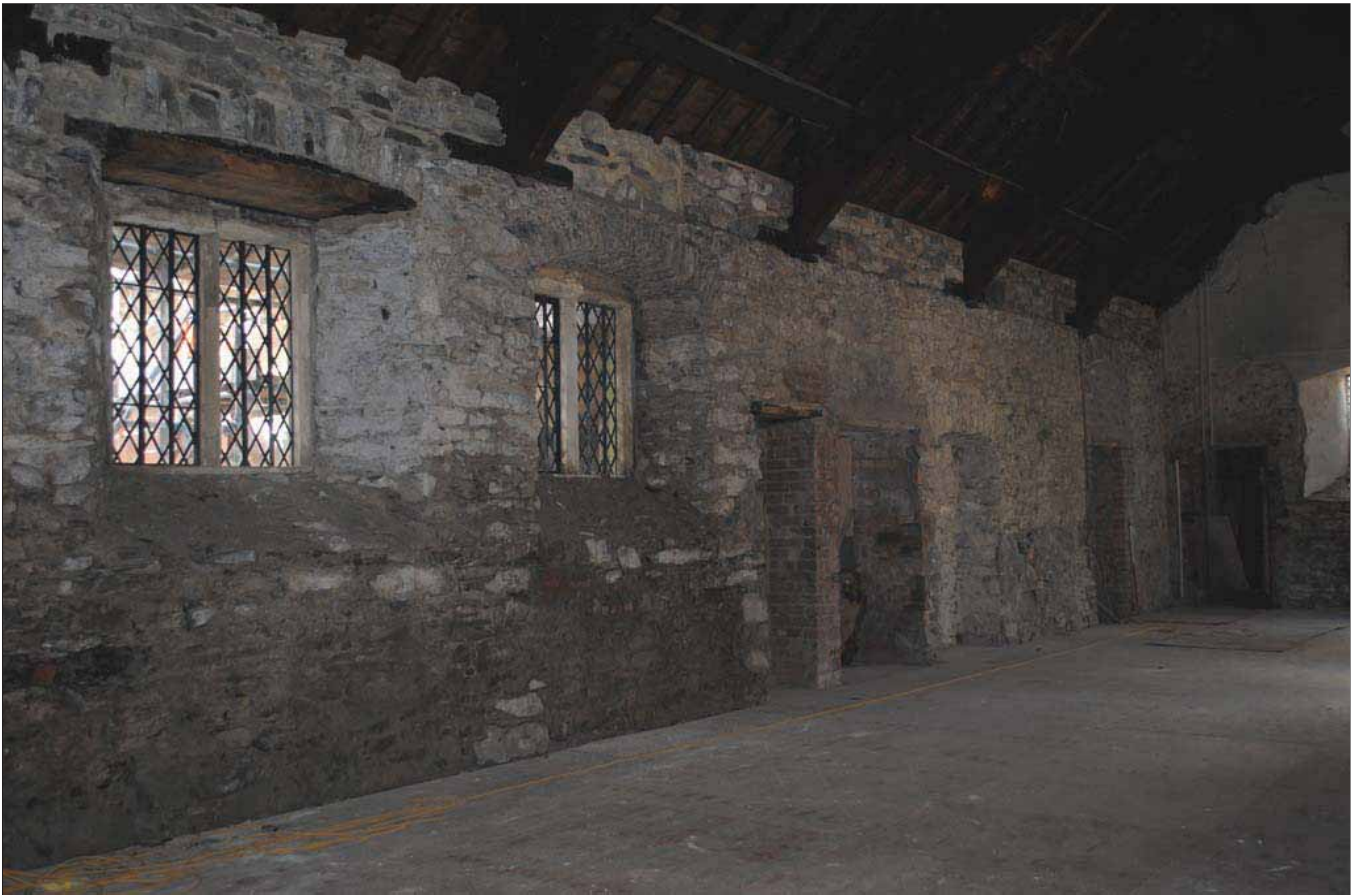
The east facing elevation, which rises in height from 3.1m to 3.4m north to south, constructed of loose rubble masonry (Plate 136). There are currently three window openings, of similar character to those on the western elevation, 1.9m above ground level and 1.3m wide and 0.6m high, and a doorway 0.6m wide and 3.05m high, which formed part of the original cross-passage in the hall. There were originally four windows, three close together to the northern end and one to the south of the cross-passage door. The group of three of these survive although the lintels and voussoirs of the northernmost two have been replaced. The third window opening survives in almost its original condition, and appears to be the only one with its original window tracery. The former cross-passage door has been blocked with

Plate 136 - Old Grammar School internal - East Facing Internal Elevation of the School Hall from the South-West. Scale 1m

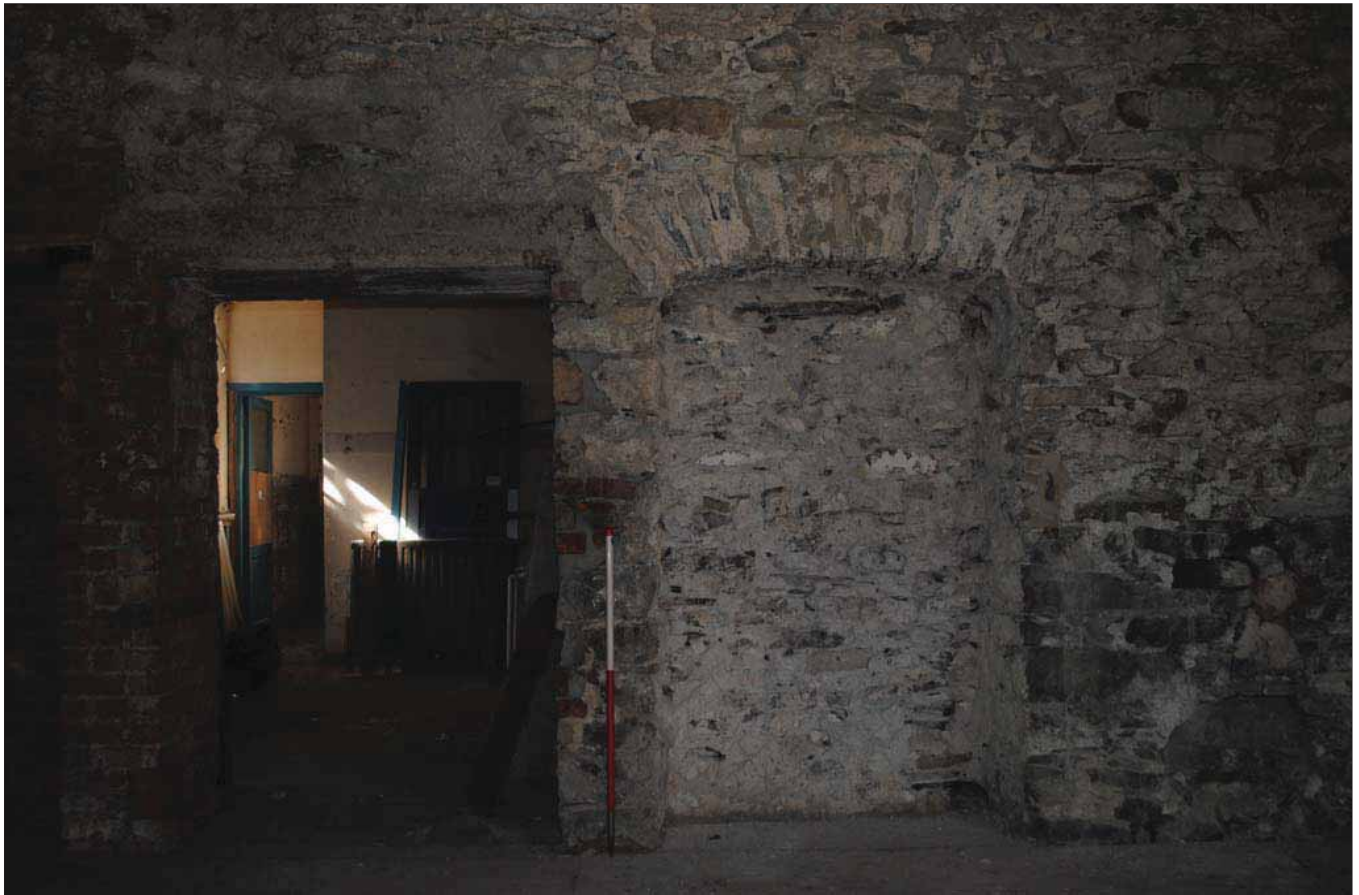
Plate 138 - Old Grammar School internal - Blocked Cross-Passage Door on the East Facing Internal Elevation. Scale 1m

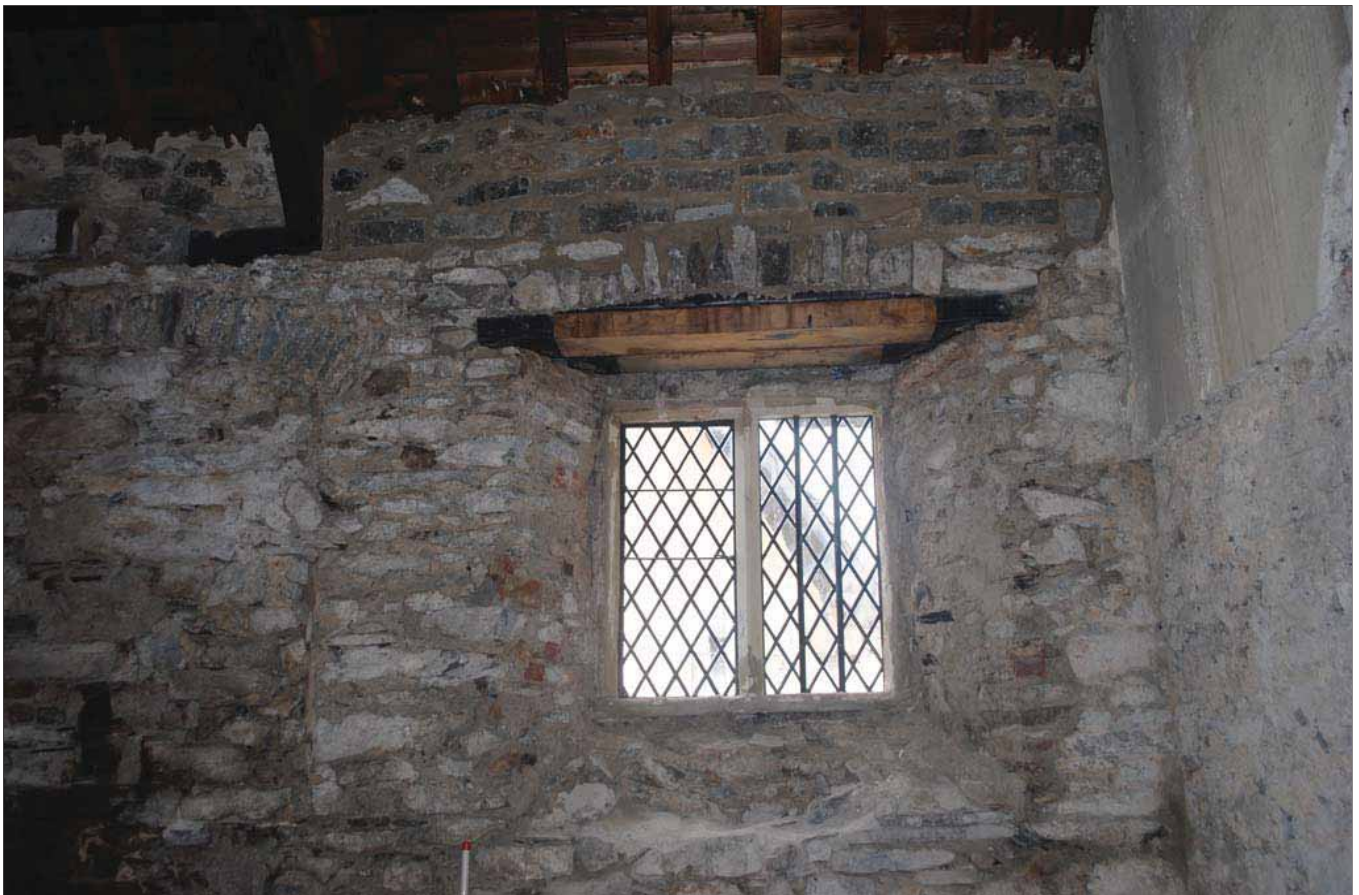
Plate 139 - Old Grammar School internal - Detail of blocked window and renewed window with modern lintel at the Southern End of the West Facing Internal Elevation

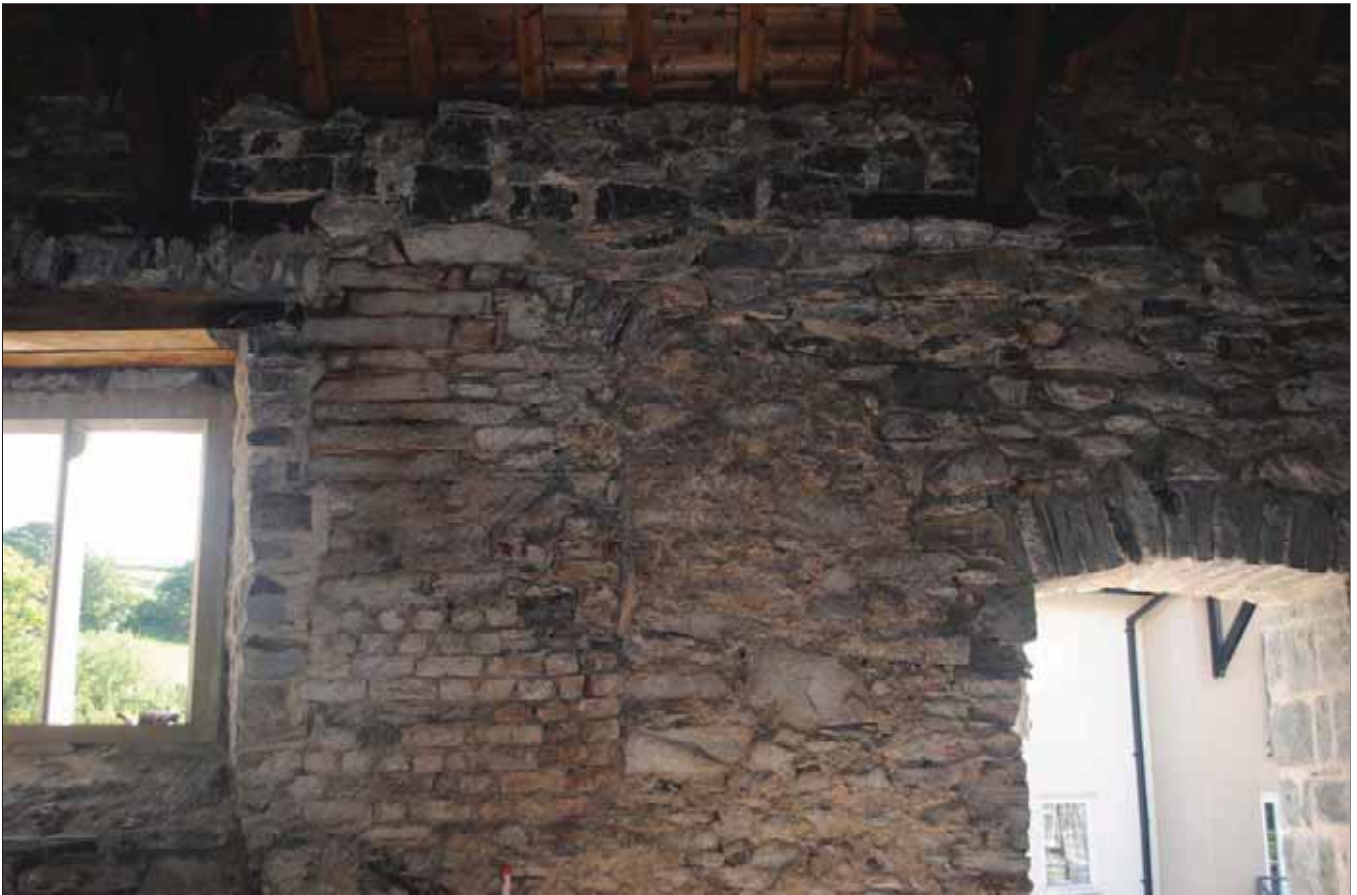
Plate 140 - Old Grammar School internal - Blocked Window on on the West Facing Internal Elevation with Brick Infill

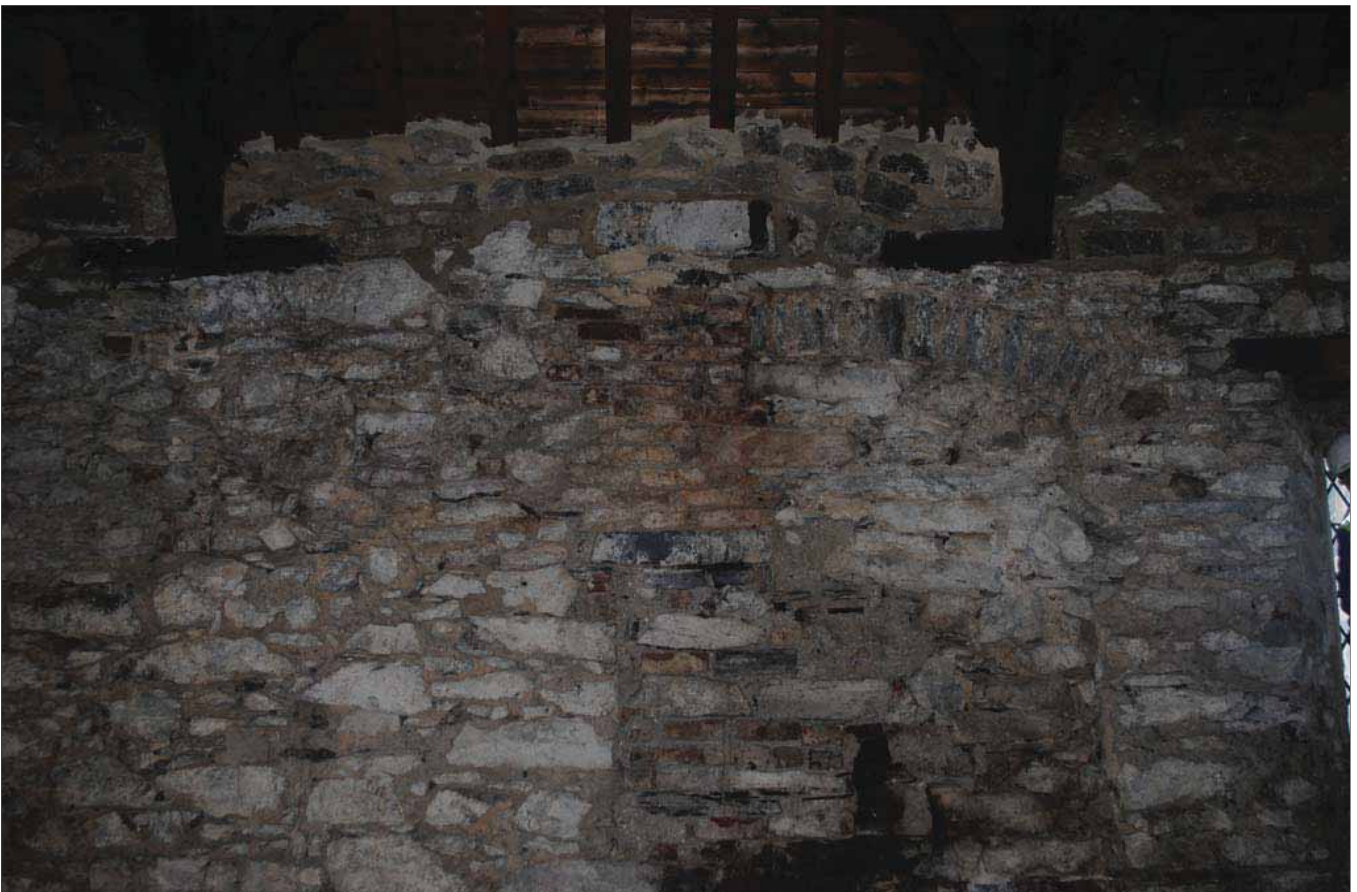
Plate 141 - Old Grammar School internal - Detail of blocked window on the West Facing Internal Elevation, with later brick infill
