YSGOL DYFFRYN CONWY, LLANRWST

Archaeological Mitigation report

Project No. G1961

Report No.1184

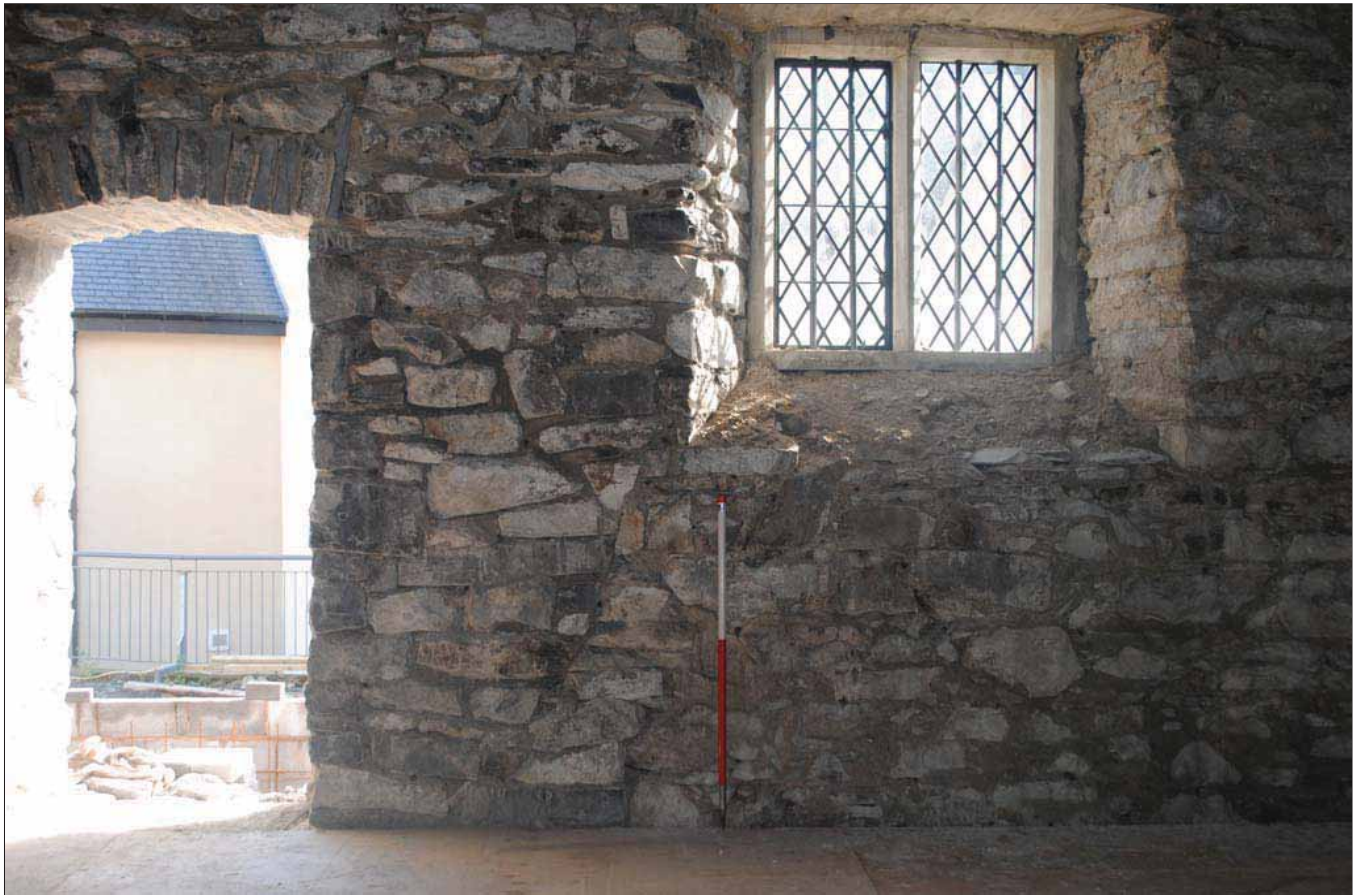
Plate 142 - Old Grammar School internal - Modern Stonework by the Cross-Passage Doorway on the West Facing Internal elevation

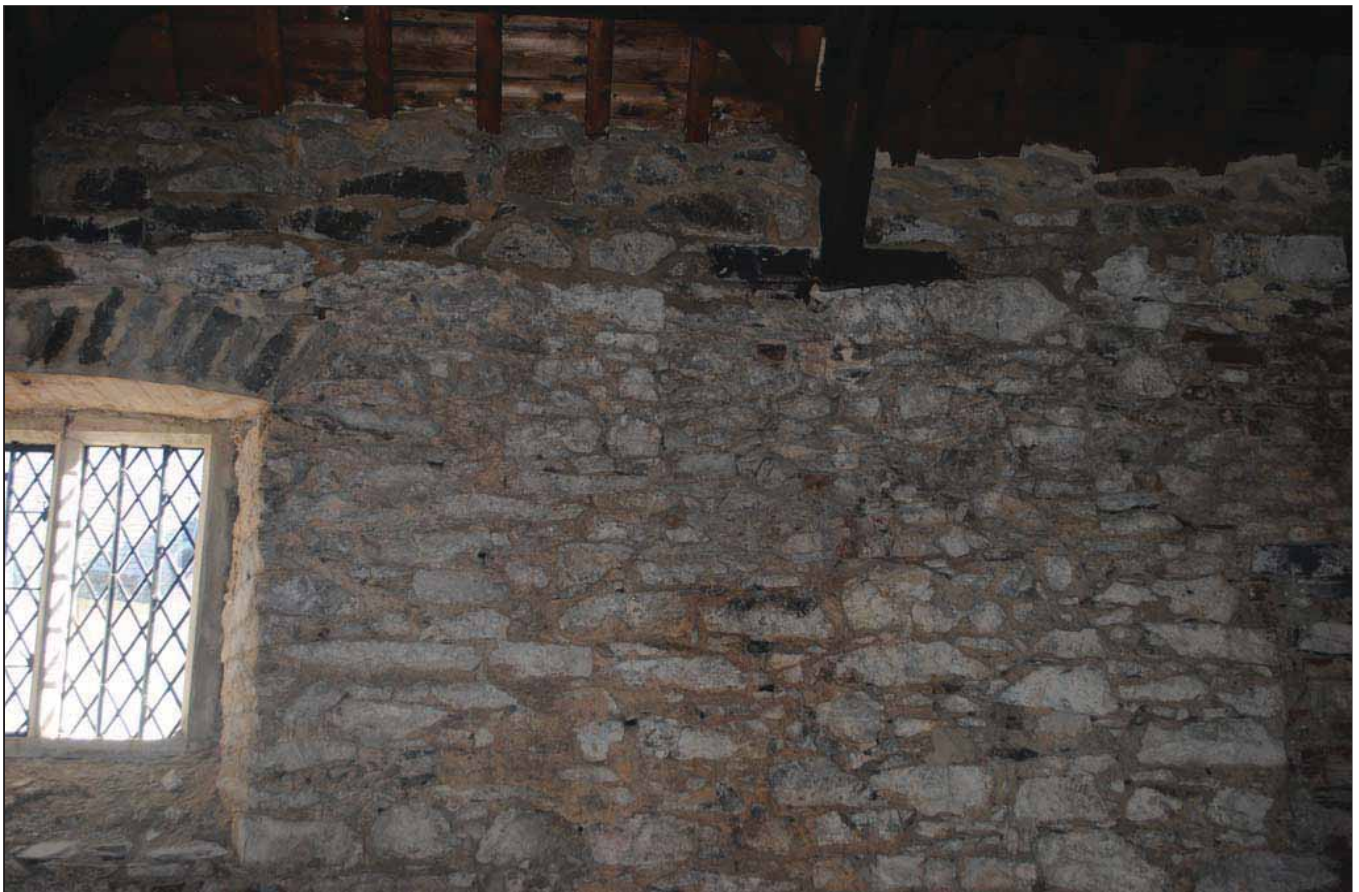
significantly modified, and this is discussed in detail below. Some stonework on the former external hall walls at the north and south ends of the building, and some on the western long wall, apart from some large masonry quoin blocks at the corners, no architectural features were identified, and there was much modern brick infilling, caused by alterations when the classrooms were added to the building to the west and also subsequently (Plates 136, 143).

Plate 143 - Old Grammar School internal - Detail showing modern work on the West Facing Internal Elevation at wall plate level

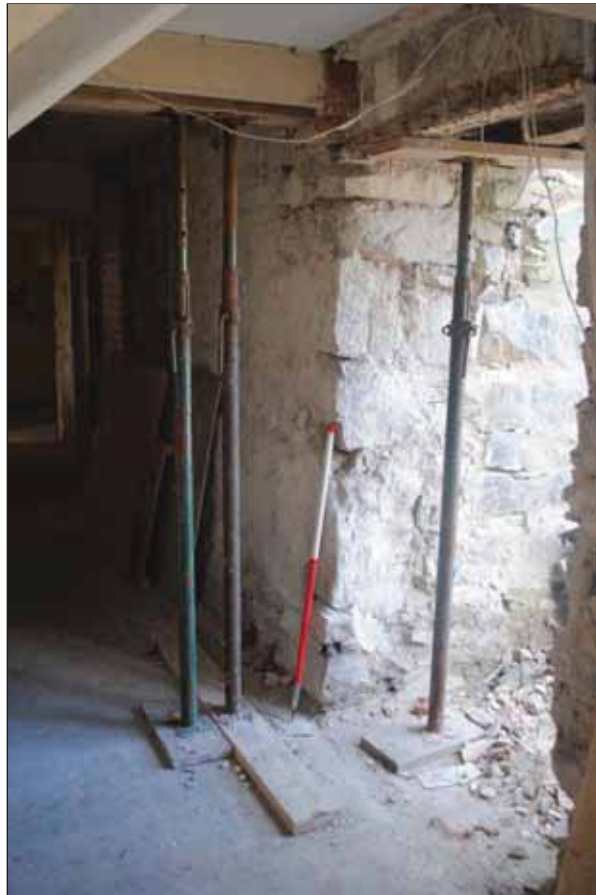
Plate 144 - Old Grammar School internal- View of the Formerly External Quoin Stones at the South East Corner of the School Hall. Scale 1m

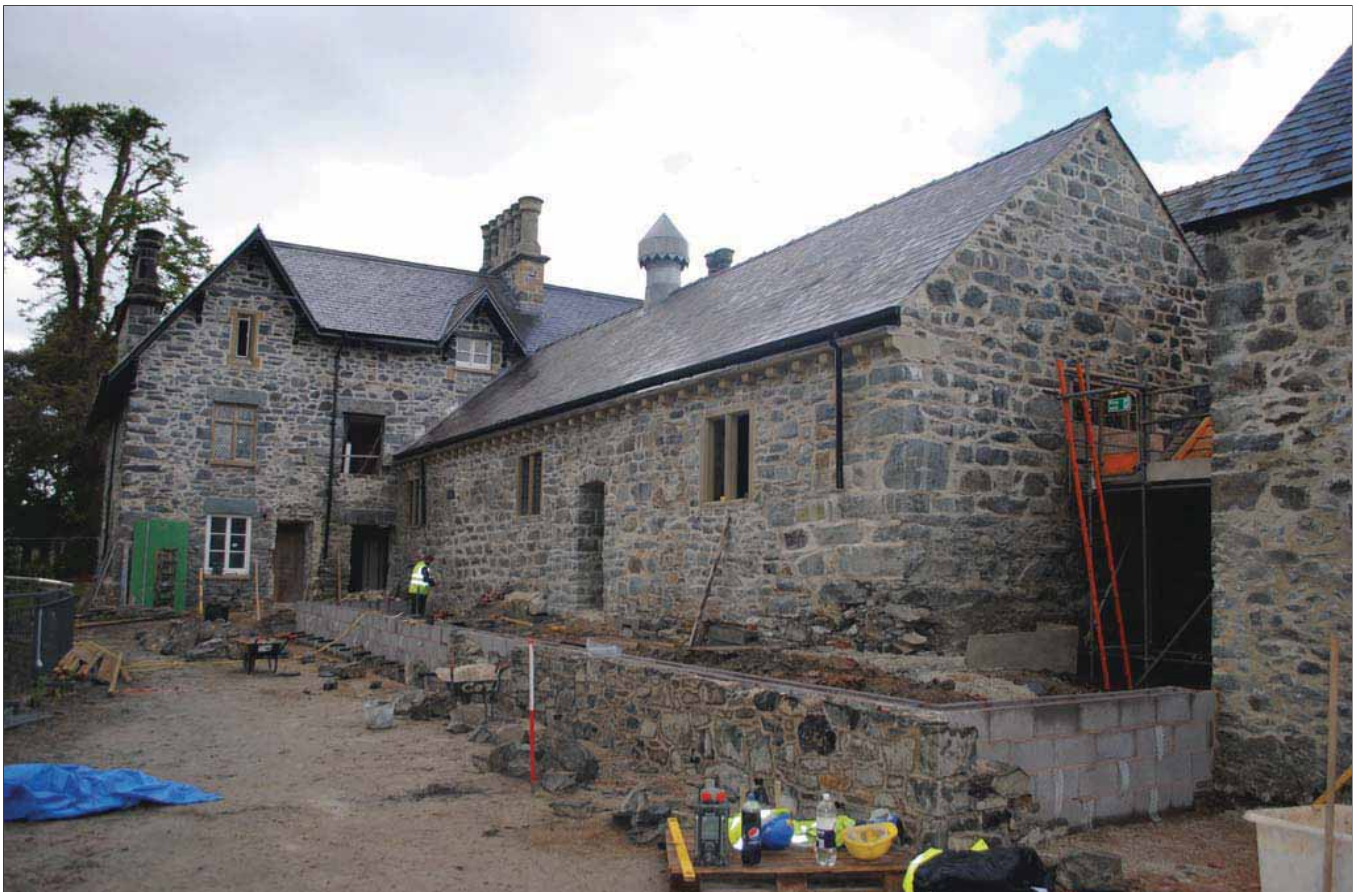
Plate 145 - Old Grammar School External View of the School Hall During the Recent Renovations, View Taken from the North East

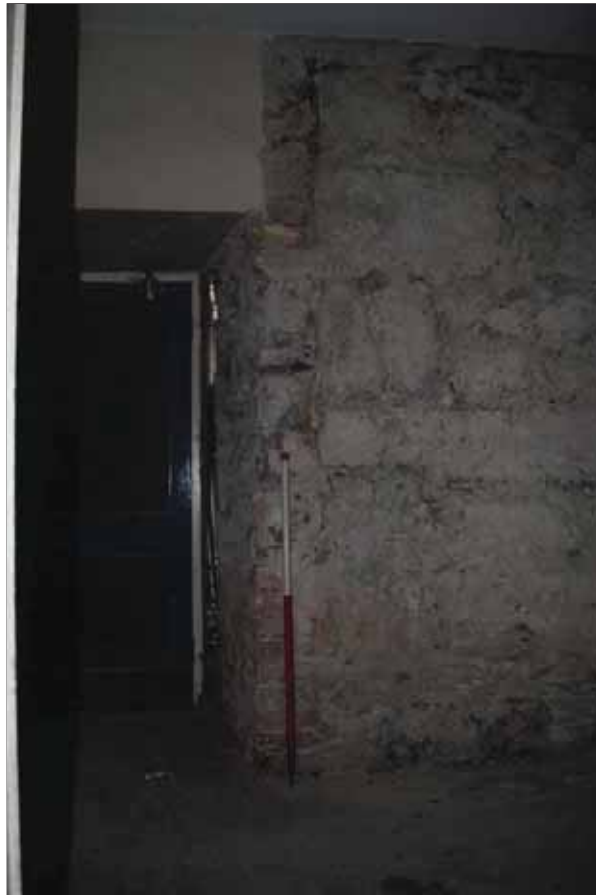
Plate 146 - Old Grammar School internalView of the Formerly External Quoin Stones at the South West Corner of the School Hall, with adjacent Modern Brickwork. Scale 1m

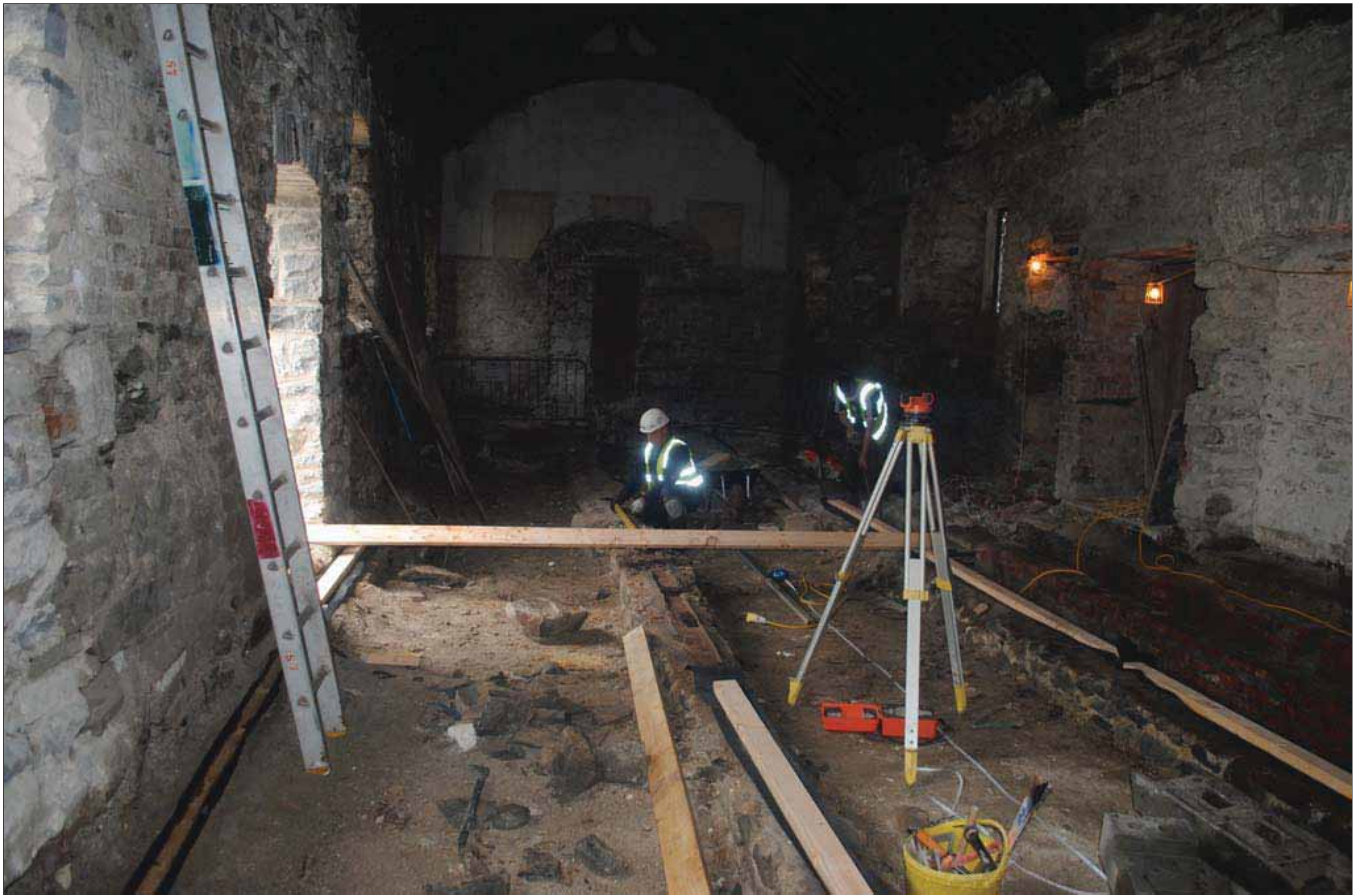
Plate 148 - Old Grammar School internal - View of the School Hall looking north during renovations, showing the sleeper walls beneath the hall floor

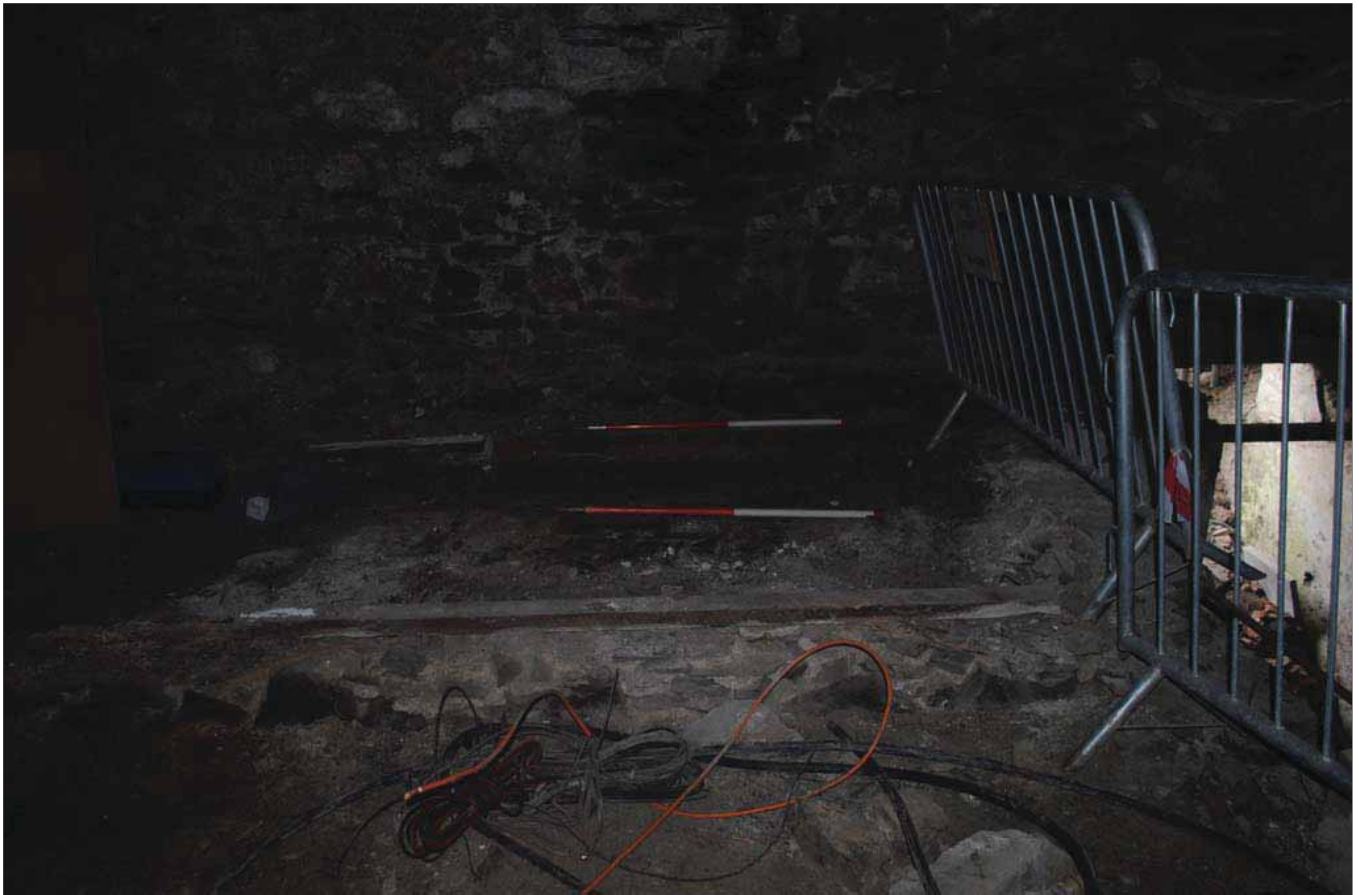
Plate 149 - Old Grammar School internal - View of the Possible Fireplace adjacent to the west facing internal elevation. Scales 1m

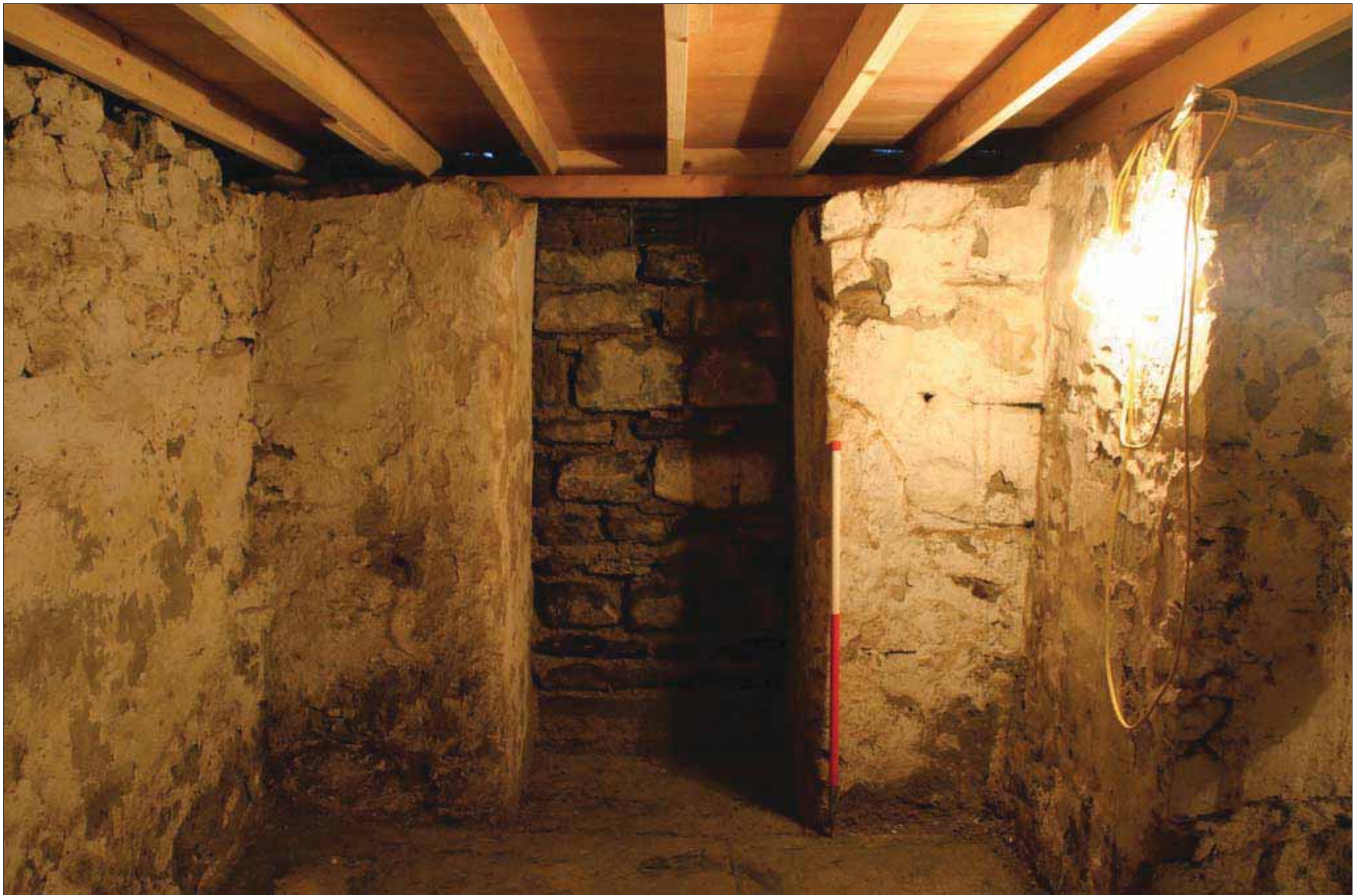
Plate 150 - Old Grammar School internal - View of the cellar beneath the School Hall looking East towards the Modern Doorway Blockage. Scale 1m

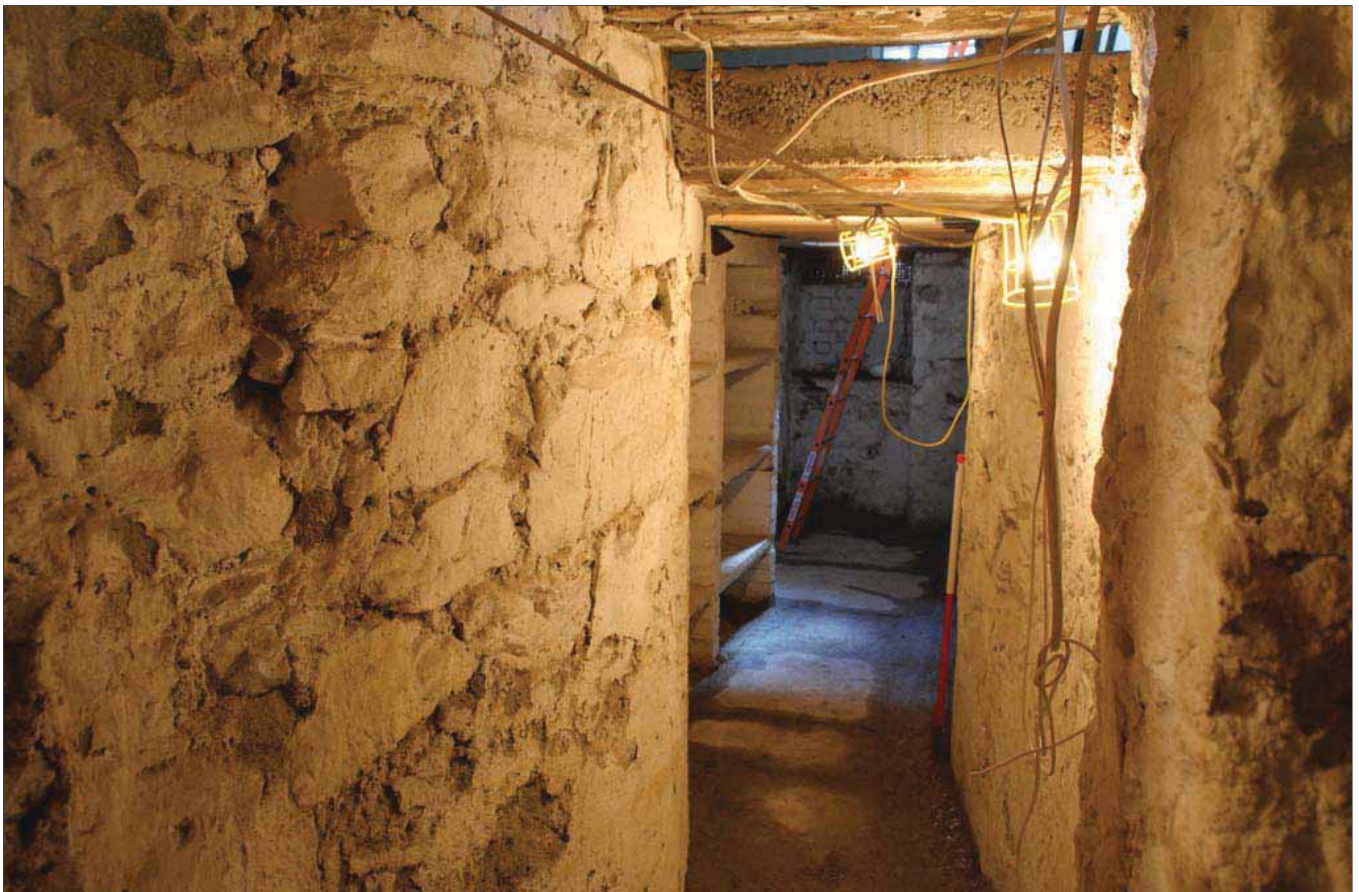
Plate 151 - Old Grammar School internal - View of the cellar looking South showing the passage under the Headmaster's House and Wine racks. Scale 1m

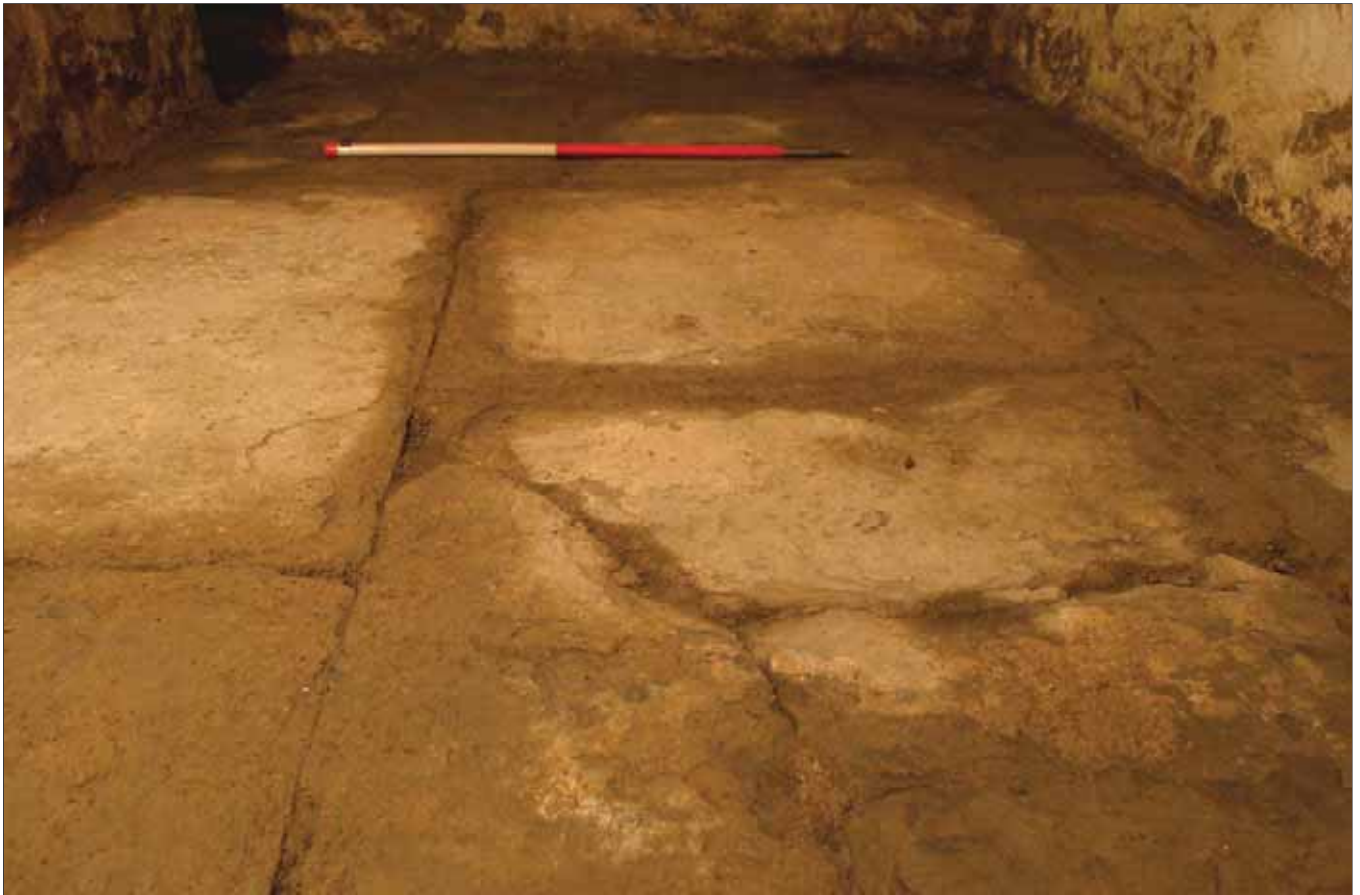
Plate 152 - Old Grammar School internal - View of Flagstone Floor in Cellar area under the Hall Floor. Scale 1m

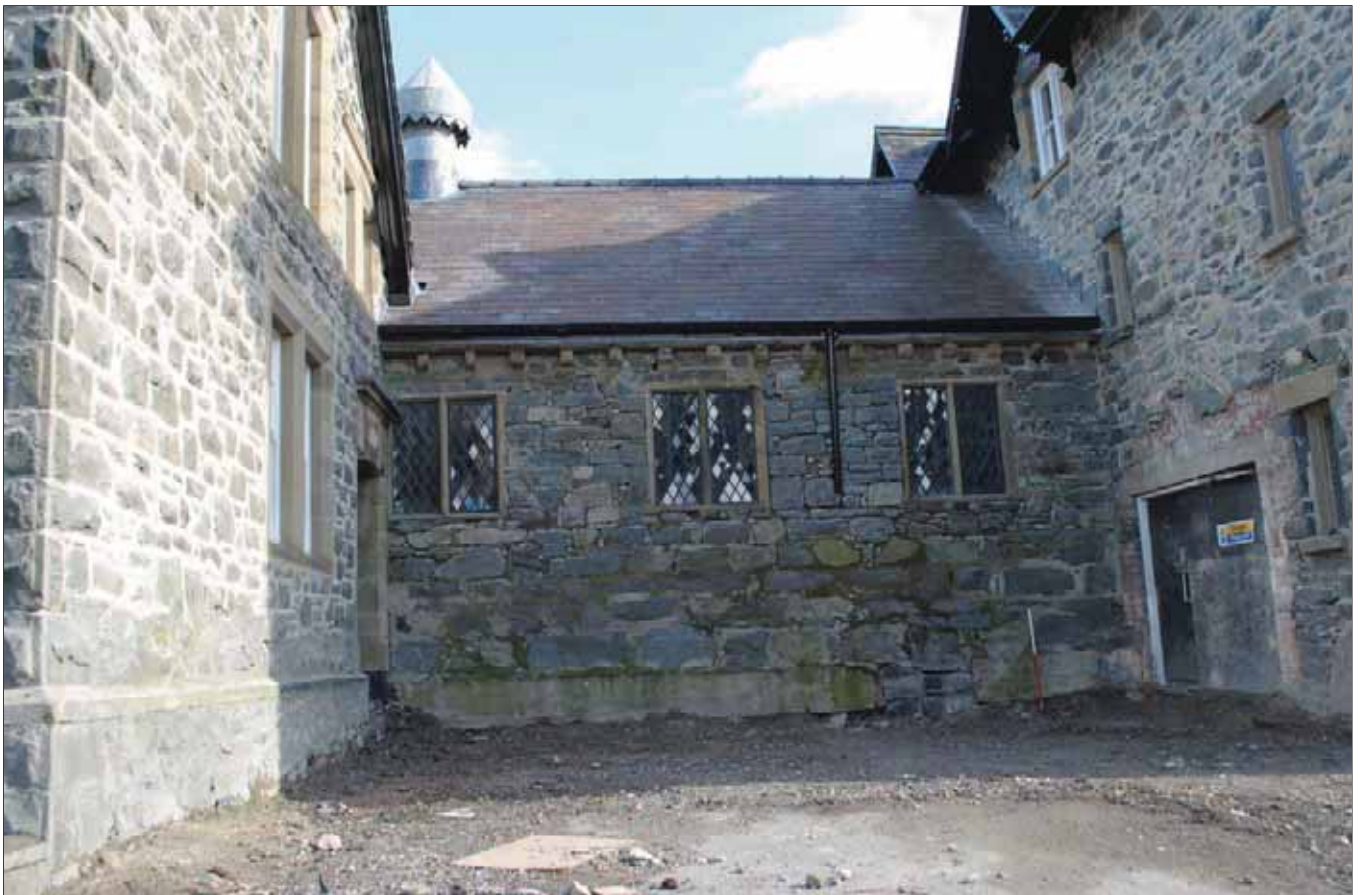
Plate 153 - Old Grammar School external - View of the Visible Portion of the External Western Elevation of the School Hall. Scale 1m

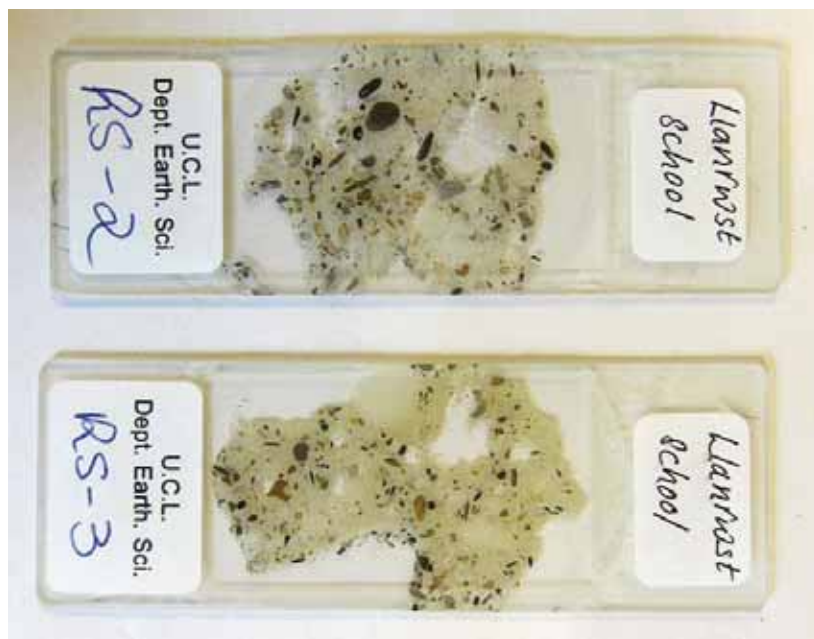
Samples of the School mortar mounted on microscope slides (76 x 26 mm) showing the macroscopic texture of these materials.

Analysis of the School Mortars (Siddall; Report January 2013) characterised the composition of the lime cement and investigated the possibility that pozzolanic additives had been used. The conclusions were that this was a pure lime plaster. Furthermore geological descriptions of the aggregates used was provided which included grain size and shape analysis. A natural, non-sharp sand derived from low-grade metamorphic rocks was used as an aggregate. Analysis using thin sections can overestimate the amount of lime present, but an aggregate : lime ratio of 1:2 was observed.

- Mortars used in the school appear to contain fewer aggregate particles (i.e. were more lime-rich) than those used for the Bridge. No coarse aggregate was observed in the school mortars.
