# Penrhyn Castle Renewable Heating Scheme

## Archaeological Evaluation

Prosiect Rhif / Project No. G2447

Adroddiad Rhif / Report No.1299

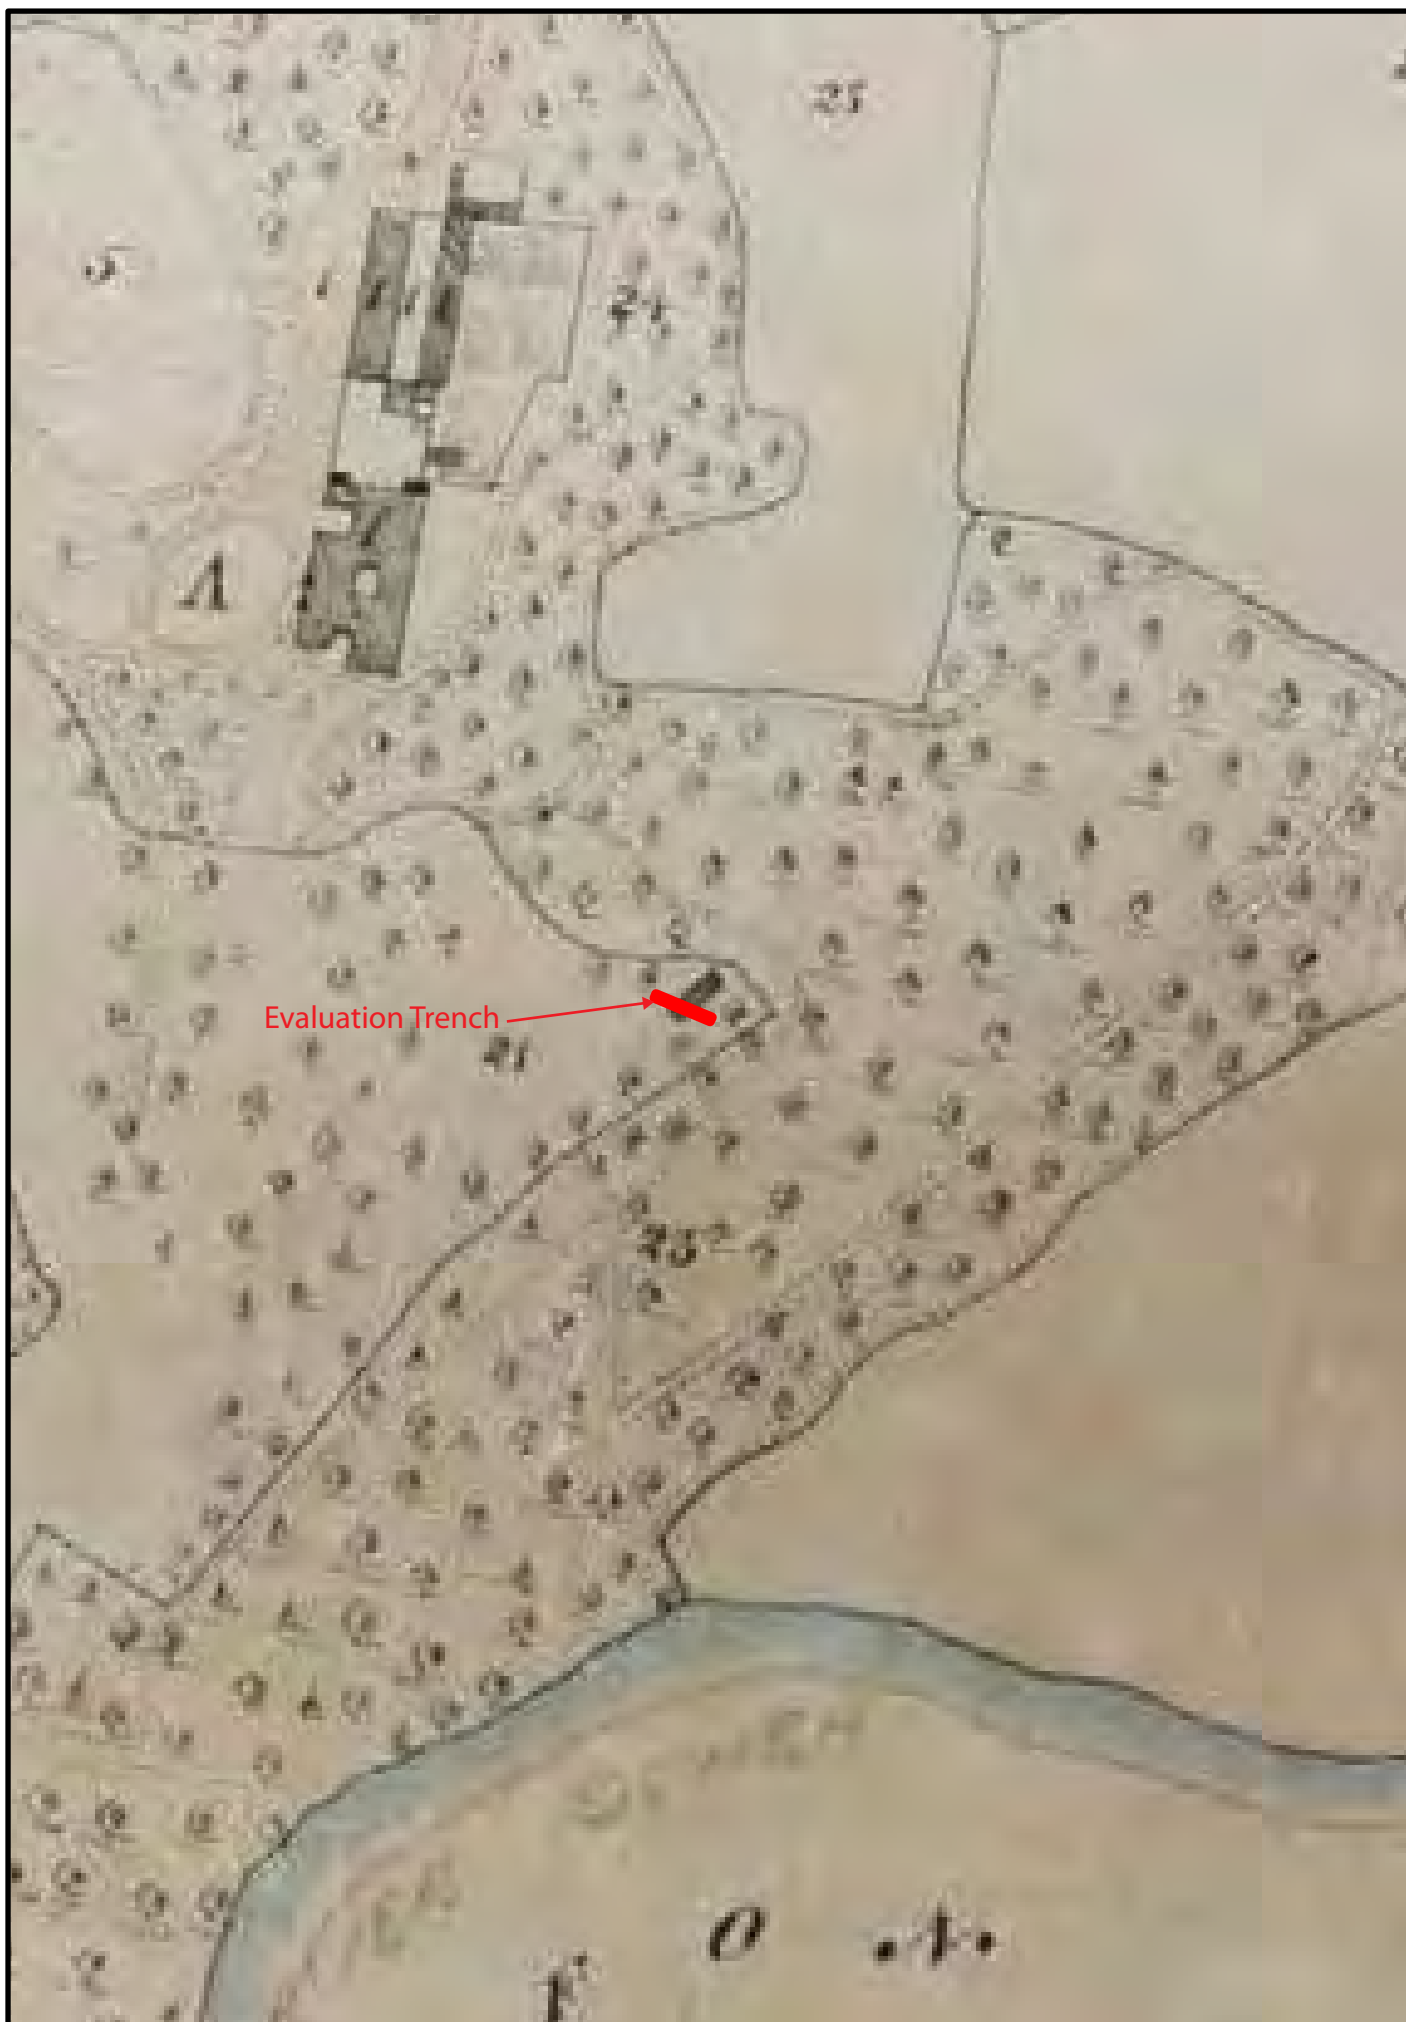
Figure 02: Location of evaluation trench, positioned over GAT Report 1286 Feature 6 (PRN 61232).  
Scale: 1:500@A4; trench size: 20m long & 0.50m wide, centred on NGR SH60337172.

Feature 6 comprises a small rectangular building noted on the 1803 Penrhyn Estate map, orientated northeast-southwest and measuring c.19m in length and 6m in width and located at NGR SH60347174 (Figures 1-2). The evaluation trench targeted the portion of the proposed heat main route that crossed the suspected location of Feature 6.

The trench was centred on NGR SH60337172 (Figures 1 and 2) and orientated northwest to southeast to match the footprint of the heat main. Please note that the trench targeted the heat main route used in application C16/0107/16/LL rather than that used for GAT assessment report 1286 (cf. Figure 2). The revised route is further south than the assessed route; however, it still crossed the suspected location of Feature 6.

The landscaping well have happened in the area of the trench after 1803, as the building noted on the 1803 plan (PRN 61232; Figure 2) appears to have left no trace on the ground. It is likely that any trace of the building was removed as part of the changes from an agricultural landscape to parkland, which appears to have involved substantial landscaping. It is just possible however that the building is not accurately located on the historic map, and is situated elsewhere. In this latter case however the heat main will probably avoid the former building.

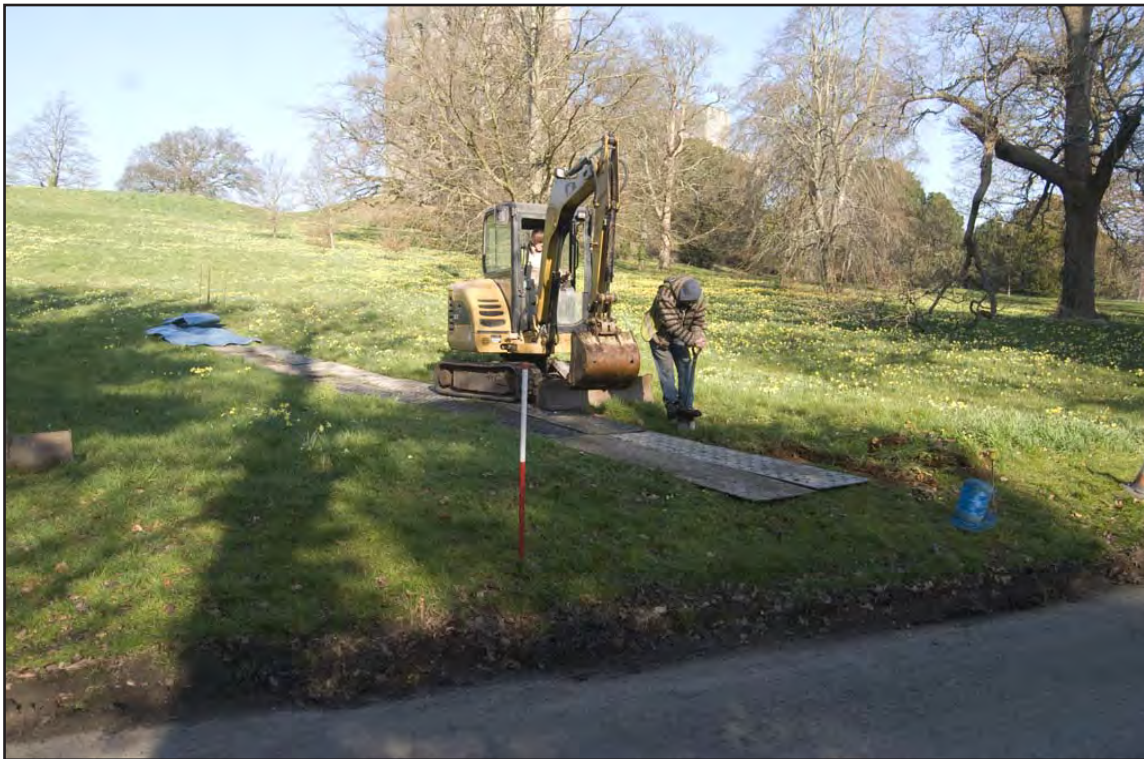
Plate 01: View of the evaluation trench from the south during initial excavation (archive image G2447\_Penrhyn\_044). Scale: 1 x 1m.

The evaluation trench was located to the south east of Penrhyn Castle within Penrhyn Park, just to the east northeast of the track way that runs northwards towards the castle on its eastern side (Figure 1, Plate 1). The trench was orientated northwest-southeast and located over a possible building noted on an 1803 estate map (Figure 2) originally identified in GAT Report 1286 (Evans 2015) as Feature 6 (PRN 61232).

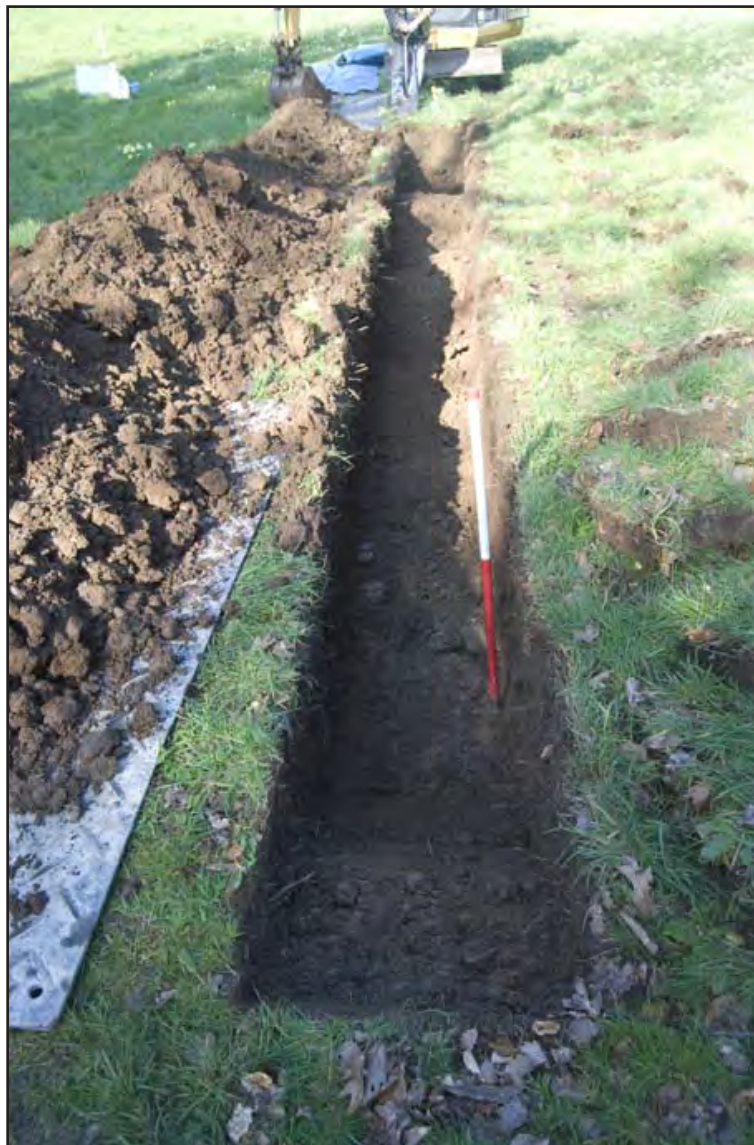
Plate 02: View of the evaluation trench from the southeast during initial excavation (archive image G2447\_Penrhyn\_046). Scale: 1 x 1m.

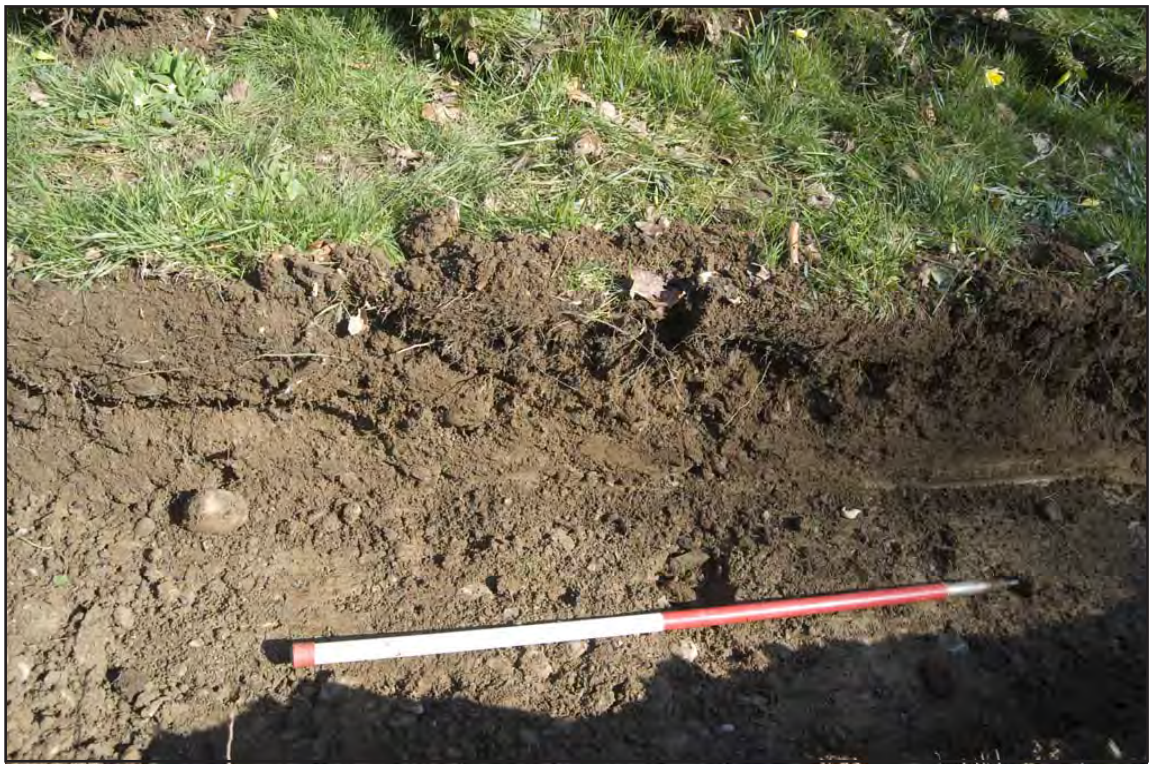
Plate 03: View of the west-southwest facing section within the evaluation trench detailing the topsoil overlying the glacial horizon (archive image G2447\_Penrhyn\_049). Scale: 1 x 1m.

A turf layer up to 0.1m thick was noted to overlie a top soil, which was about 0.4m deep at the higher north-western end and up to 0.8m deep at the south-eastern end of the trench. The topsoil was deeper downslope as it approached the north-south trackway beyond the end of the trench (Plate 2). It consisted of a dark orangey brown silty clay loam with much organic material within it, and contained small rounded and sub-angular stones. The topsoil sealed a light yellowish brown clay, which contained small to large angular stones (up to 0.4m by 0.3m in size). The interface between the topsoil and the clay was noted to be very clear and distinct (Plates 3 to 4).

The clay deposit was interpreted as a glacial deposit. No other deposits or archaeological features or structures were encountered in the excavation.

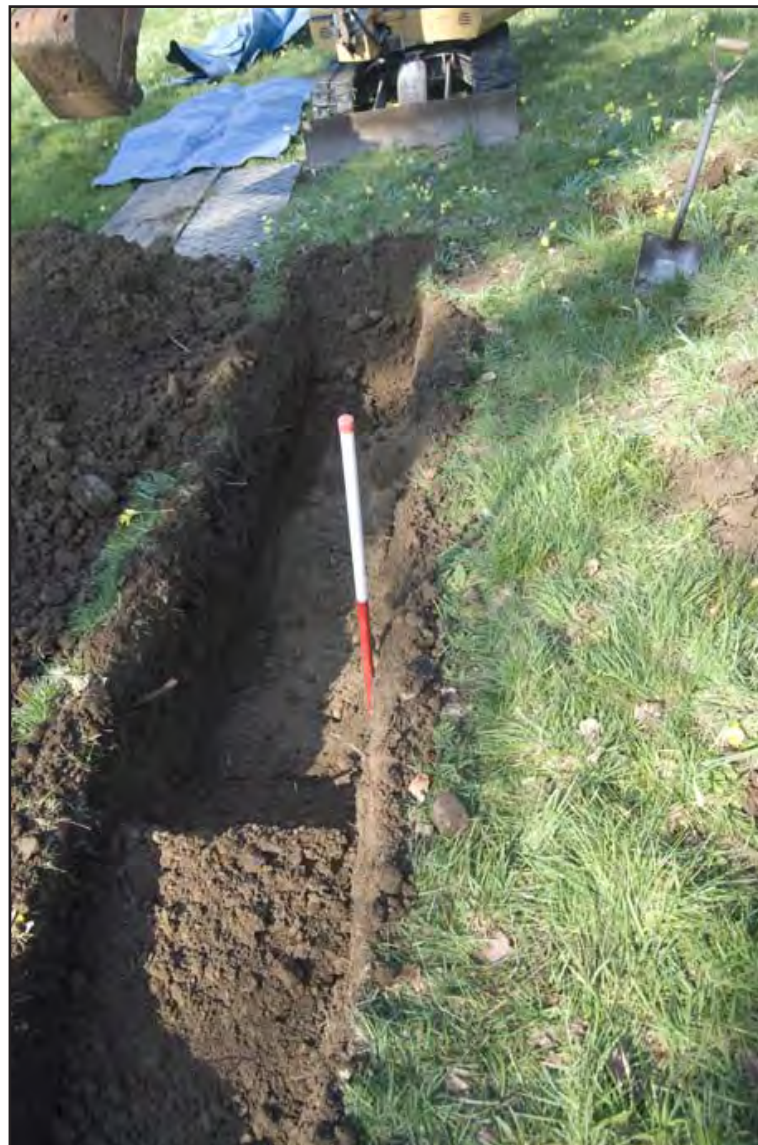
Plate 04: View of the evaluation trench from the east detailing the topsoil overlying the glacial horizon (archive image G2447\_Penrhyn\_047). Scale: 1 x 1m.

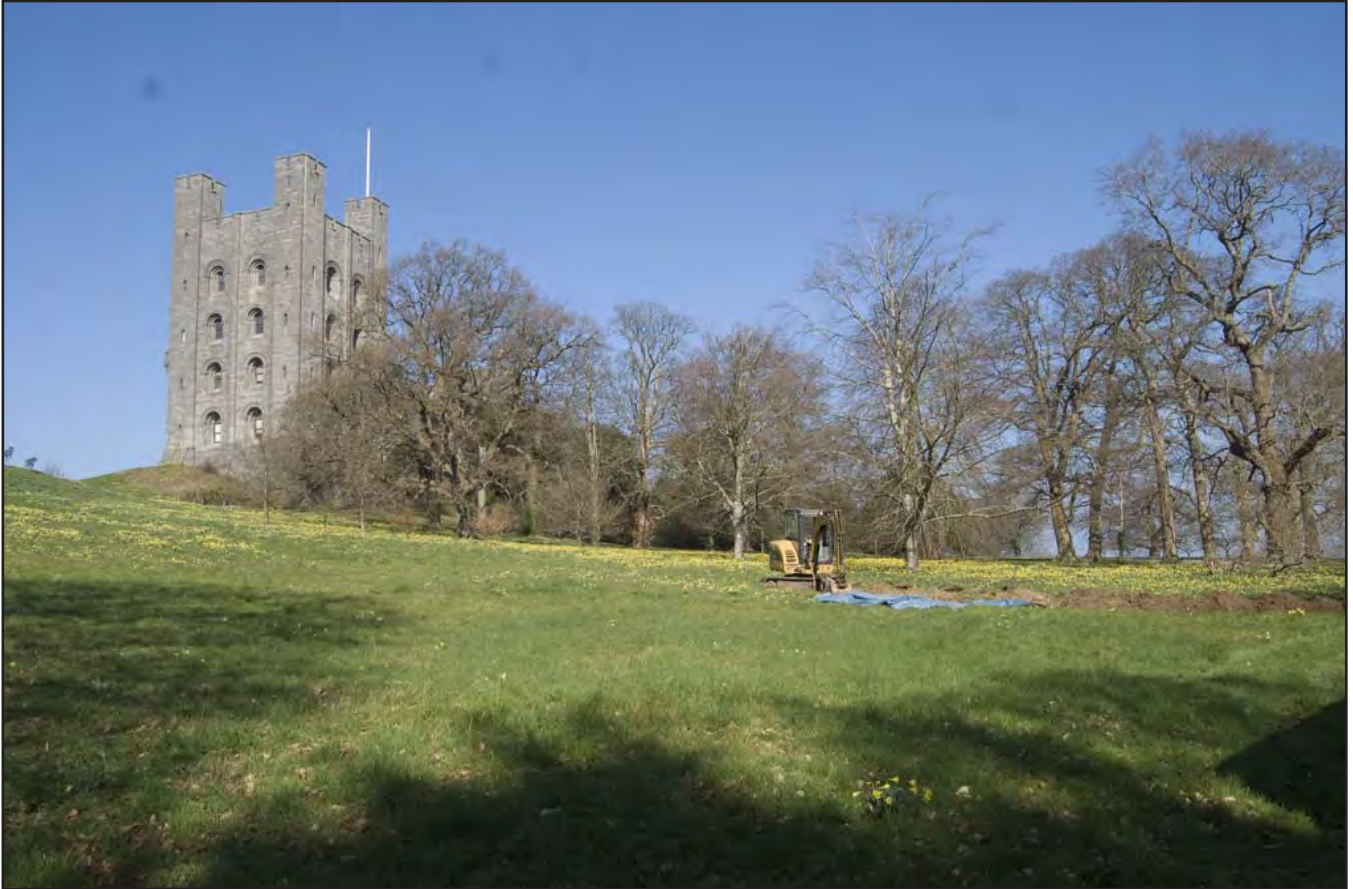
Plate 05: View from the south of the evaluation trench within the estate landscape (archive image G2447\_Penrhyn\_051). Scale: 1 x 1m.

The trench crossed moderately sloping ground, falling about 0.7m from north-west to south-east, and terminated close to the north south trackway. The trench was located within grass parkland and clumps of mature trees, with a significant quantity of daffodils in bloom within the grassland (Plate 5).

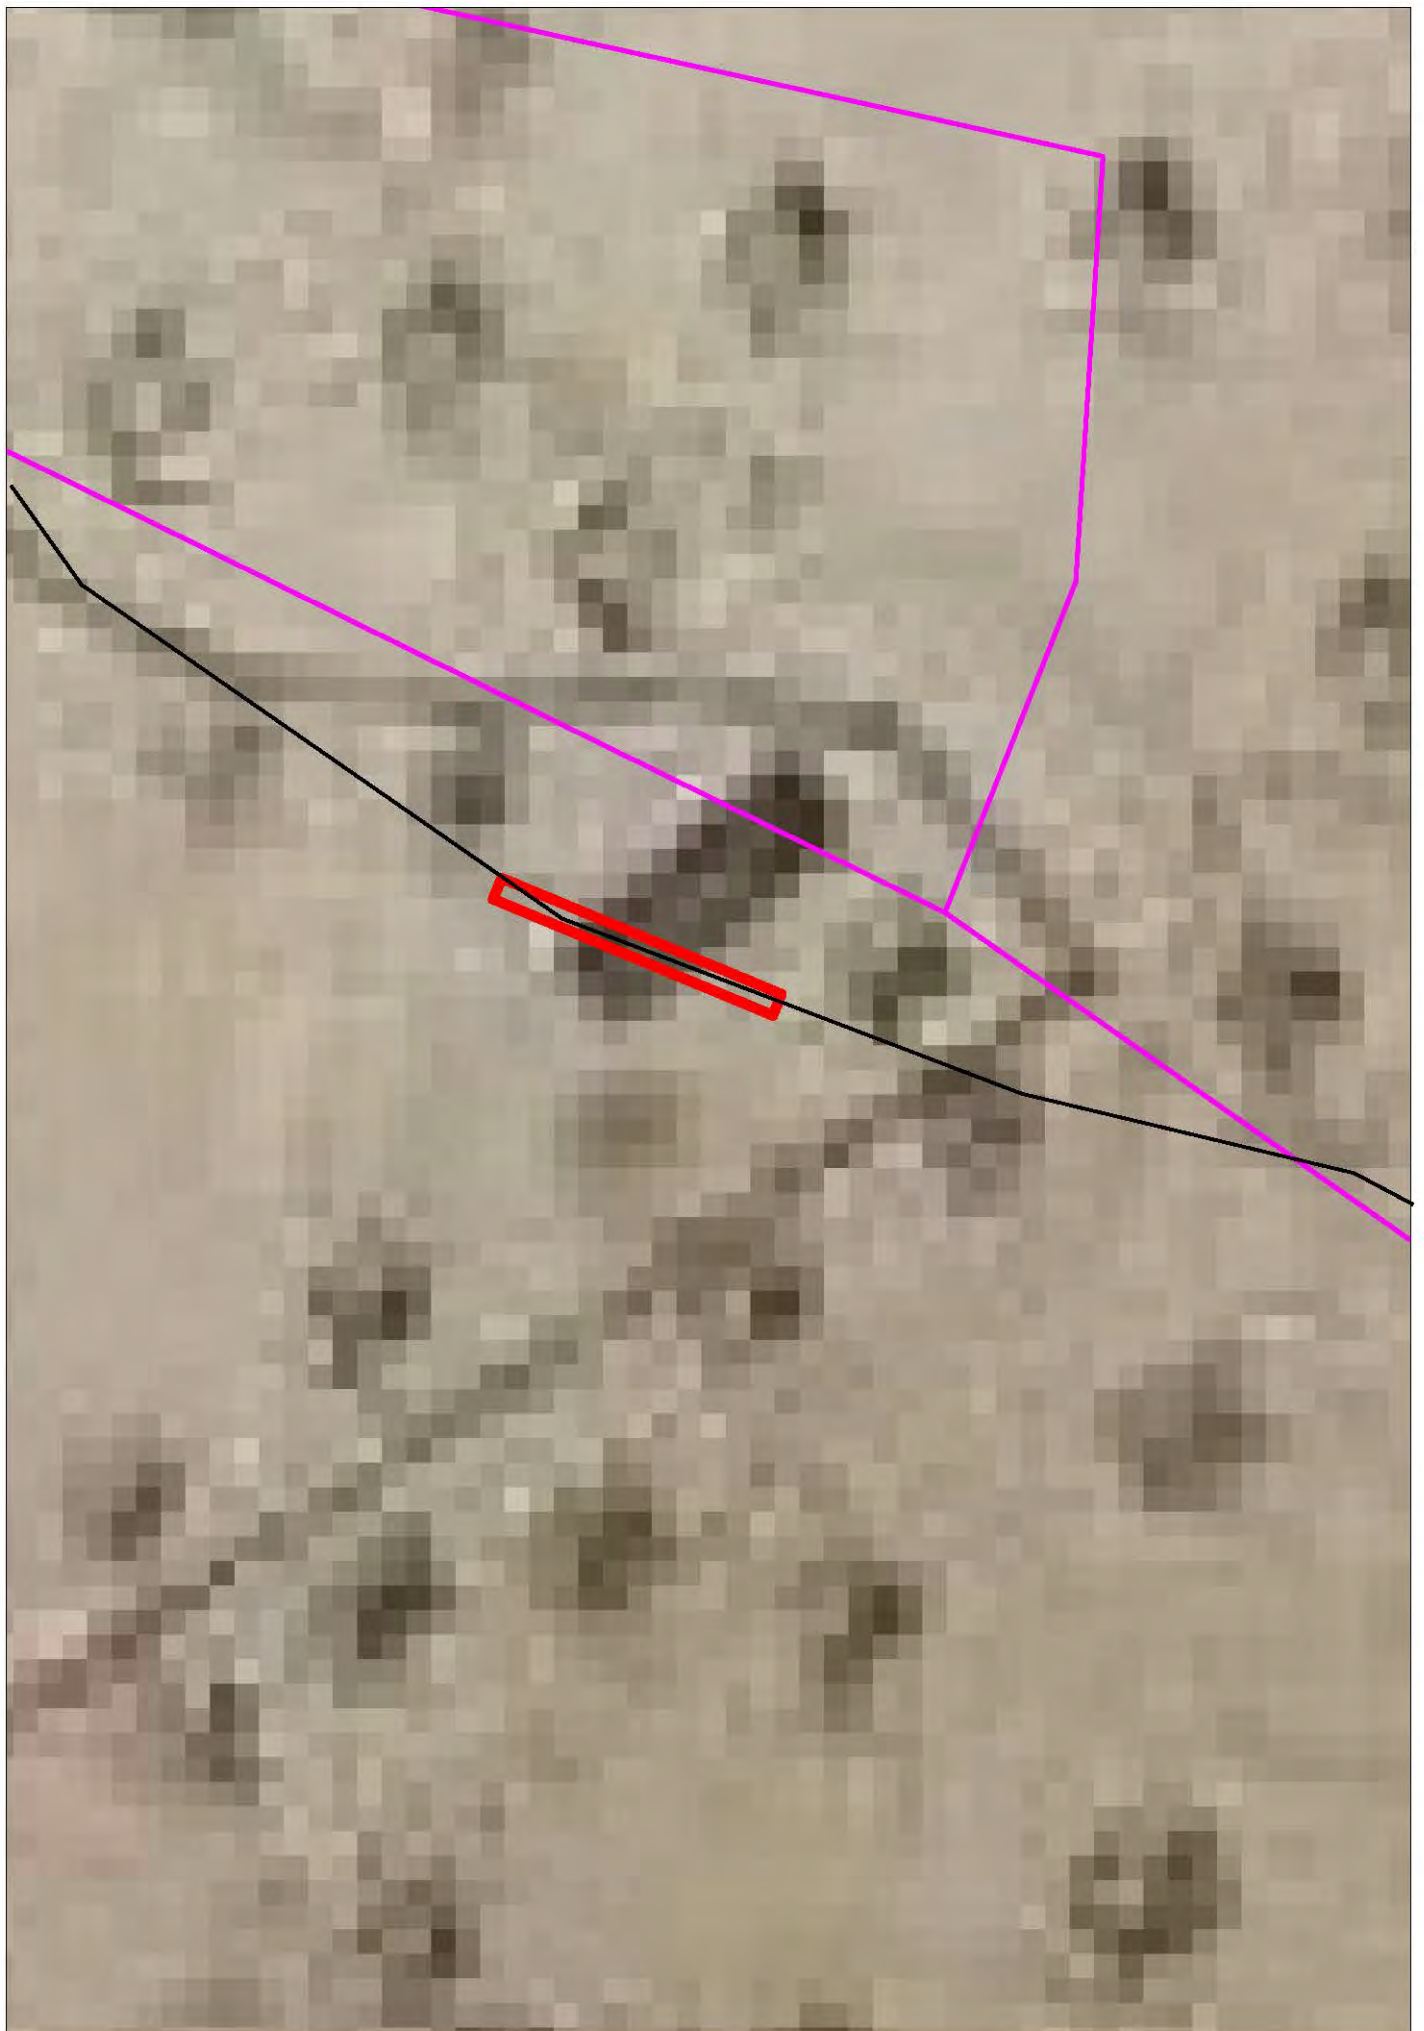
## **FIGURE 02**

Figure 02: Proposed location of evaluation trench, positioned over GAT Report 1286 Feature 6/heat main route.  
Note: the revised heat main route is in black (cf. Figure 1); the route assessed in GAT Report 1286 is in pink.  
Scale: 1:500@A4; trench size: 20m long & 0.50m wide, centred on NGR SH60337172.

Feature 6 comprises a small rectangular building noted on the 1803 Penrhyn Estate map, orientated northeast-southwest and measuring c.19m in length and 6m in width and located at NGR SH60347174 (Figure 2). The evaluation trench will target the portion of the proposed heat main route that will cross the suspected location of Feature 6.
