Esgyryn Site, Llandudno Junction

Archaeological Watching Brief

Rhif Prosiect / Project No. G2374

Rhif Adroddiad / Report No.1326

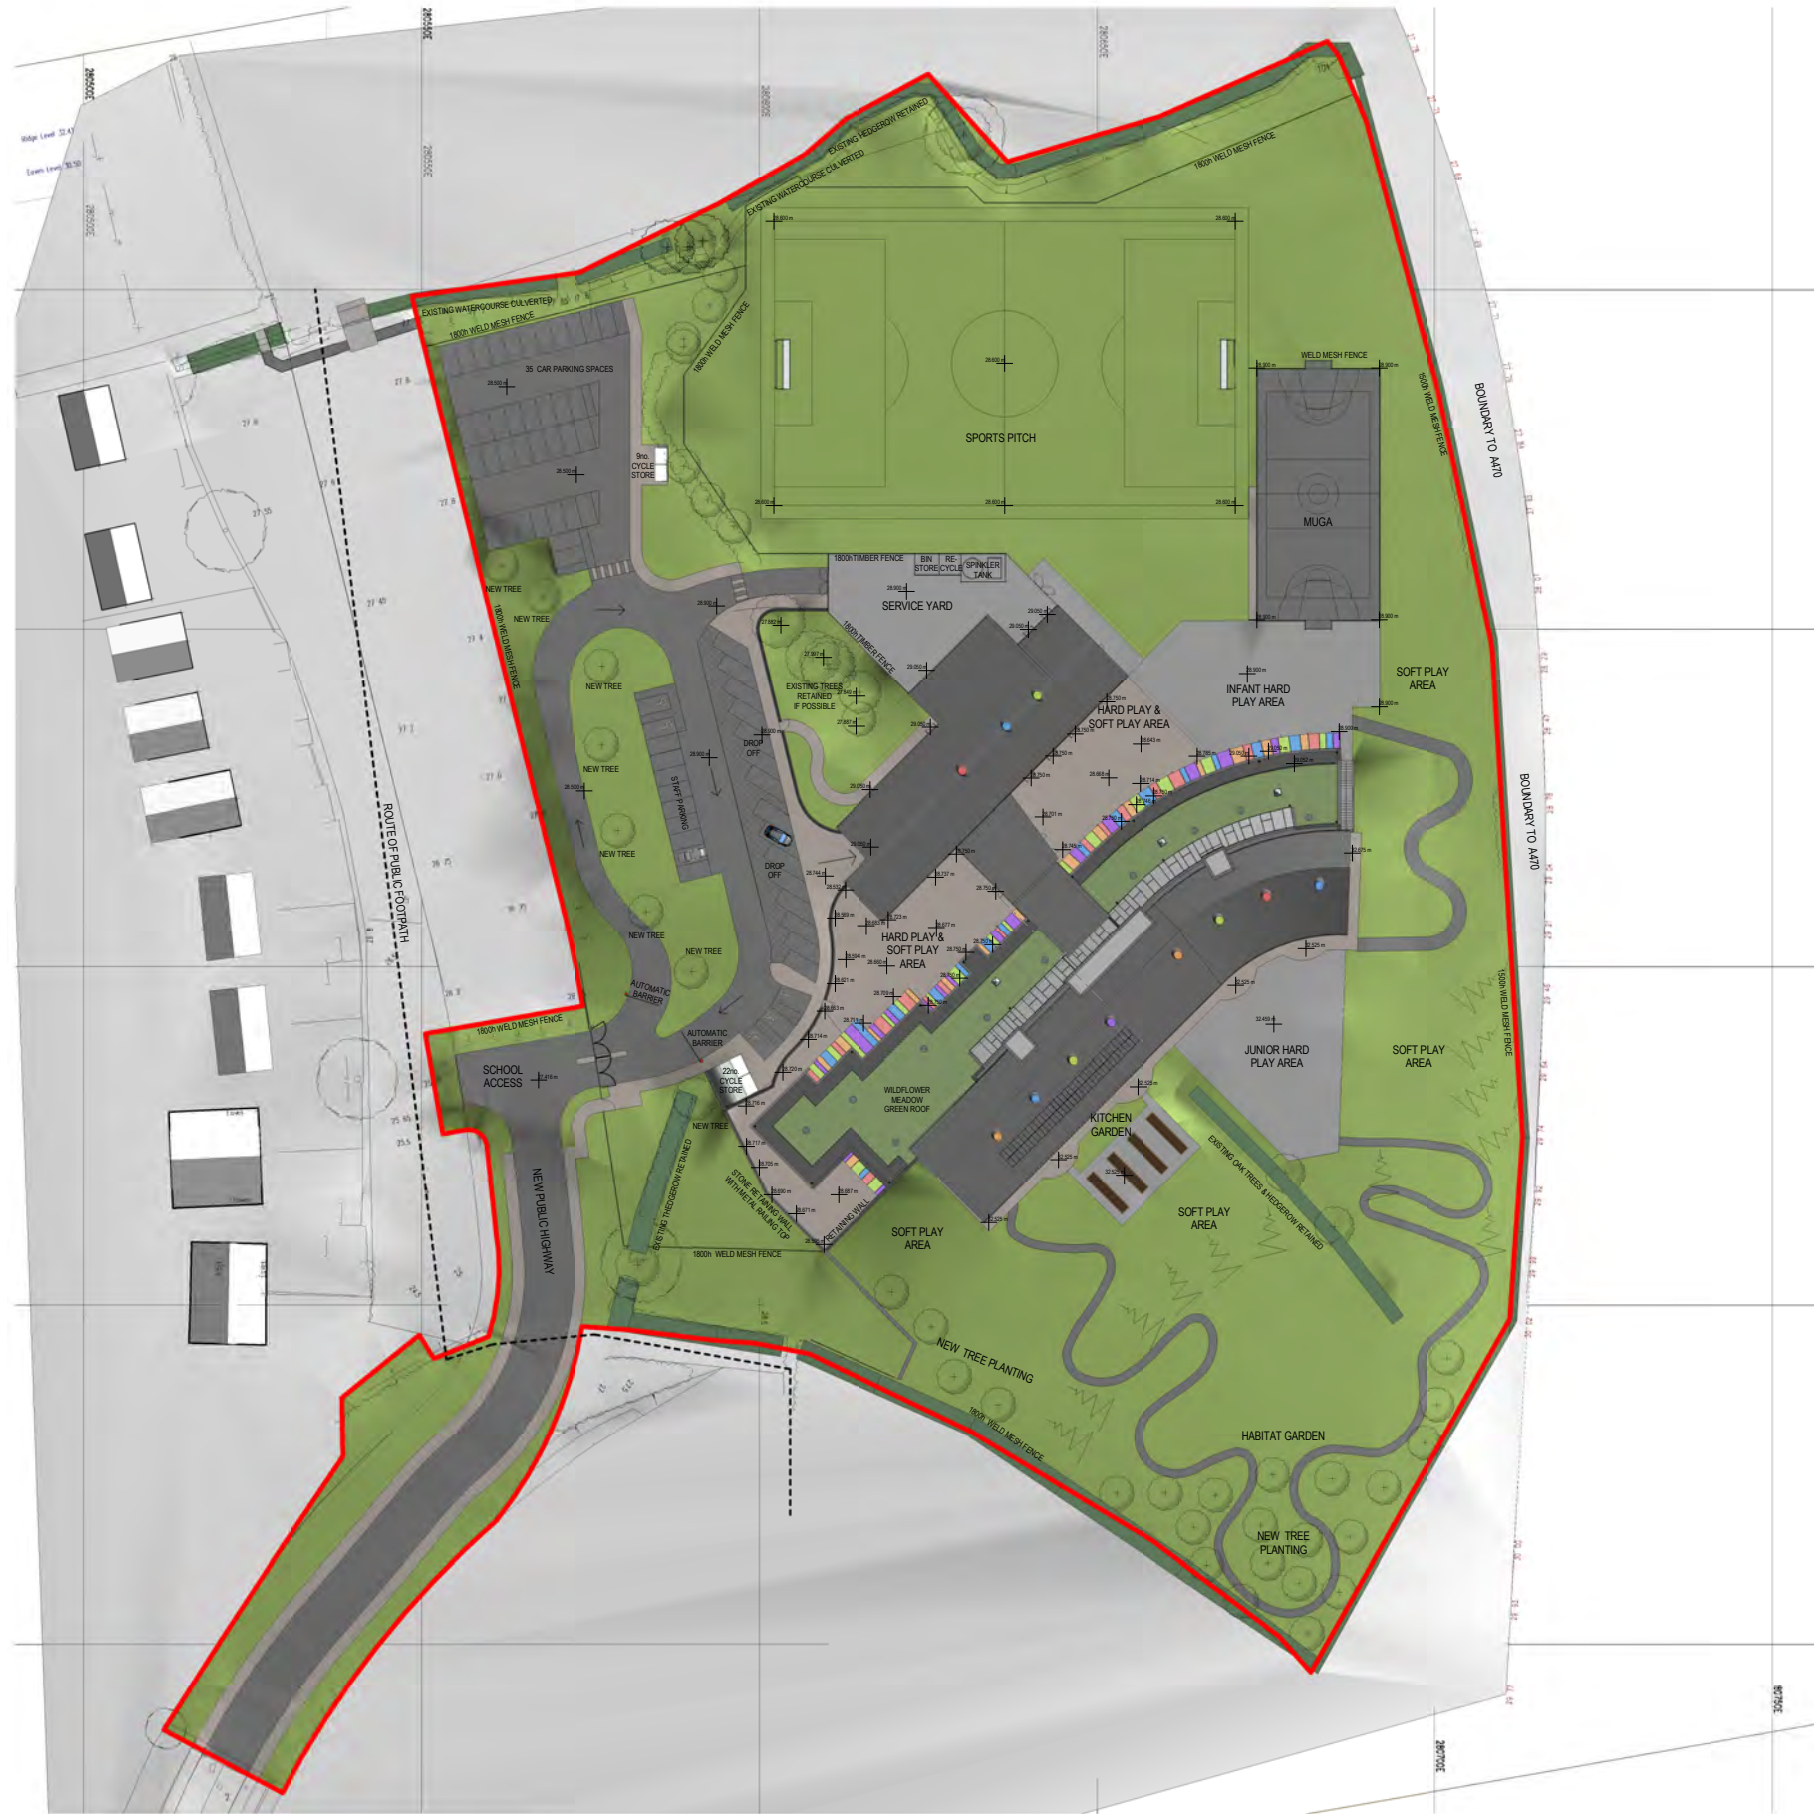
Figure 02:
Reproduction
of client
drawing
C835.808B

PROPOSED SITE PLAN - OPTION 4
1:500

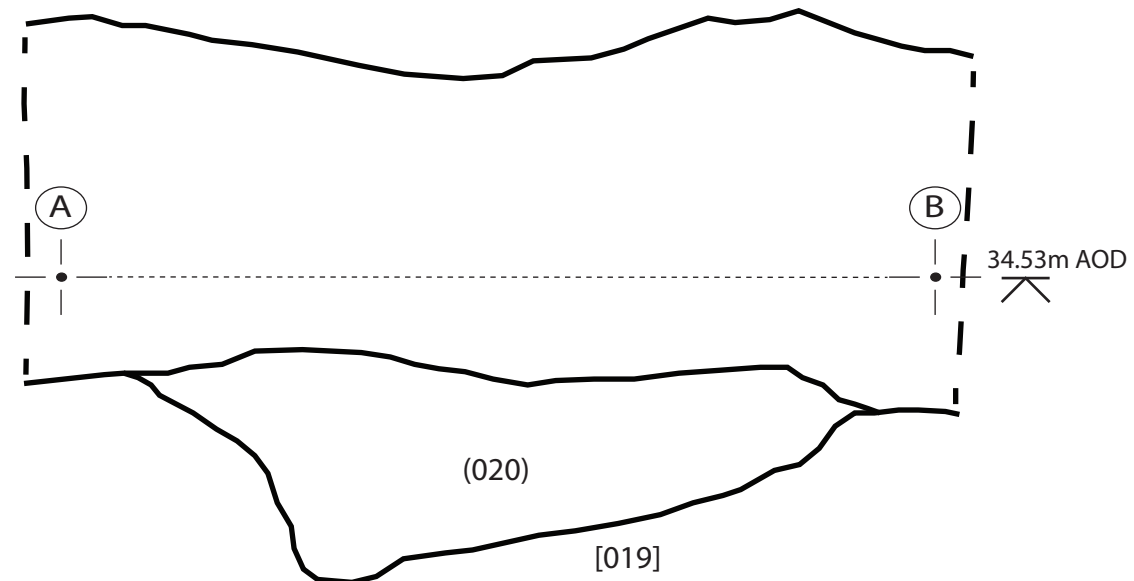
Figure 05 Section and plan of pit [019], Scale 1:10 @ A4

(020) Mid brown sandy loam matrix mixed with infrequent small sub-rounded stones and the occasional medium sized cobble
[019] Cut of shallow circular pit

E 280688.451 / N 377979.065

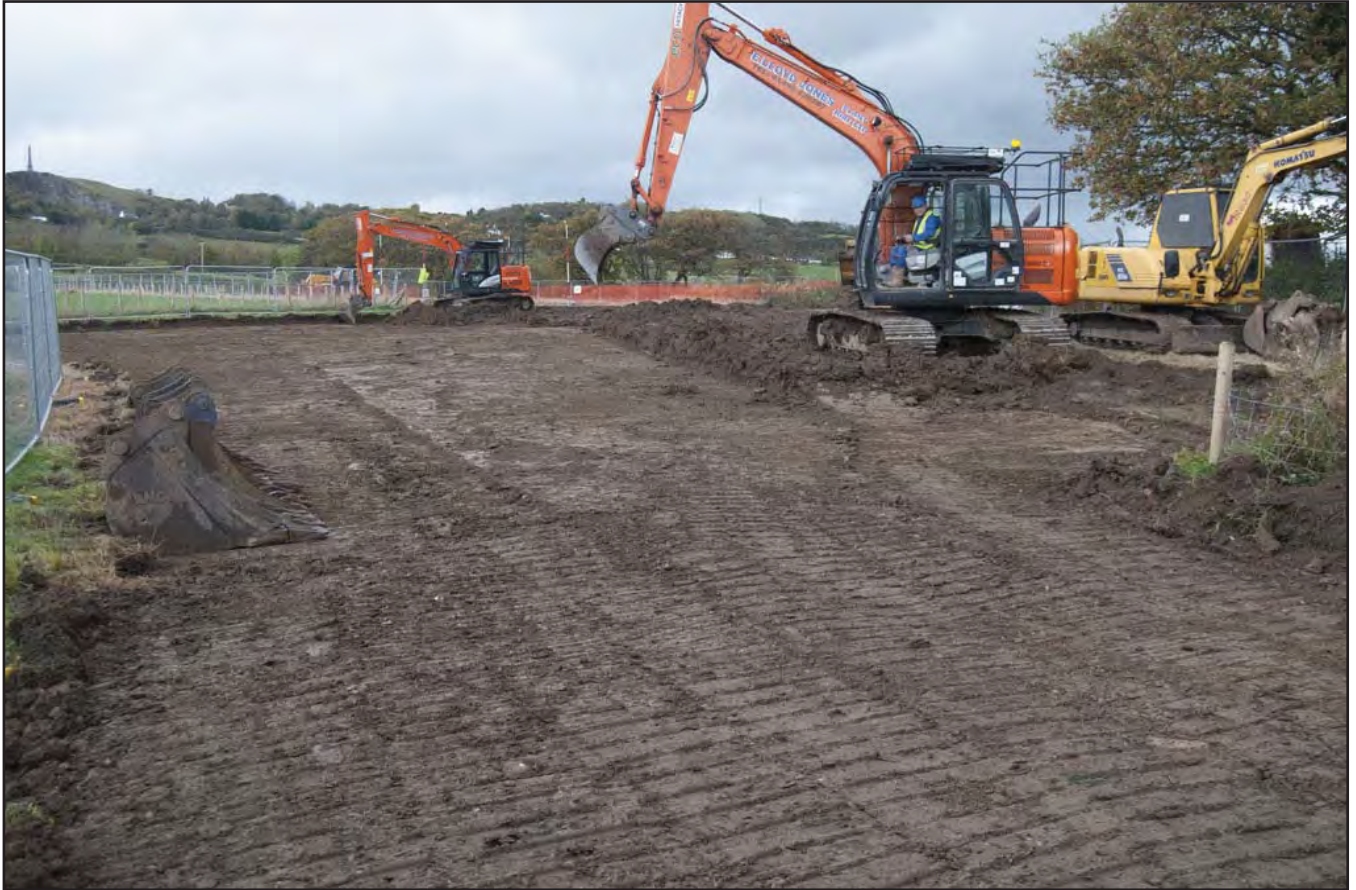
Plate 01: View of topsoil strip at the 'hammerhead' junction. View from the south south east (Photographic archive ref. G2374_Esgyryn_0111.jpg).

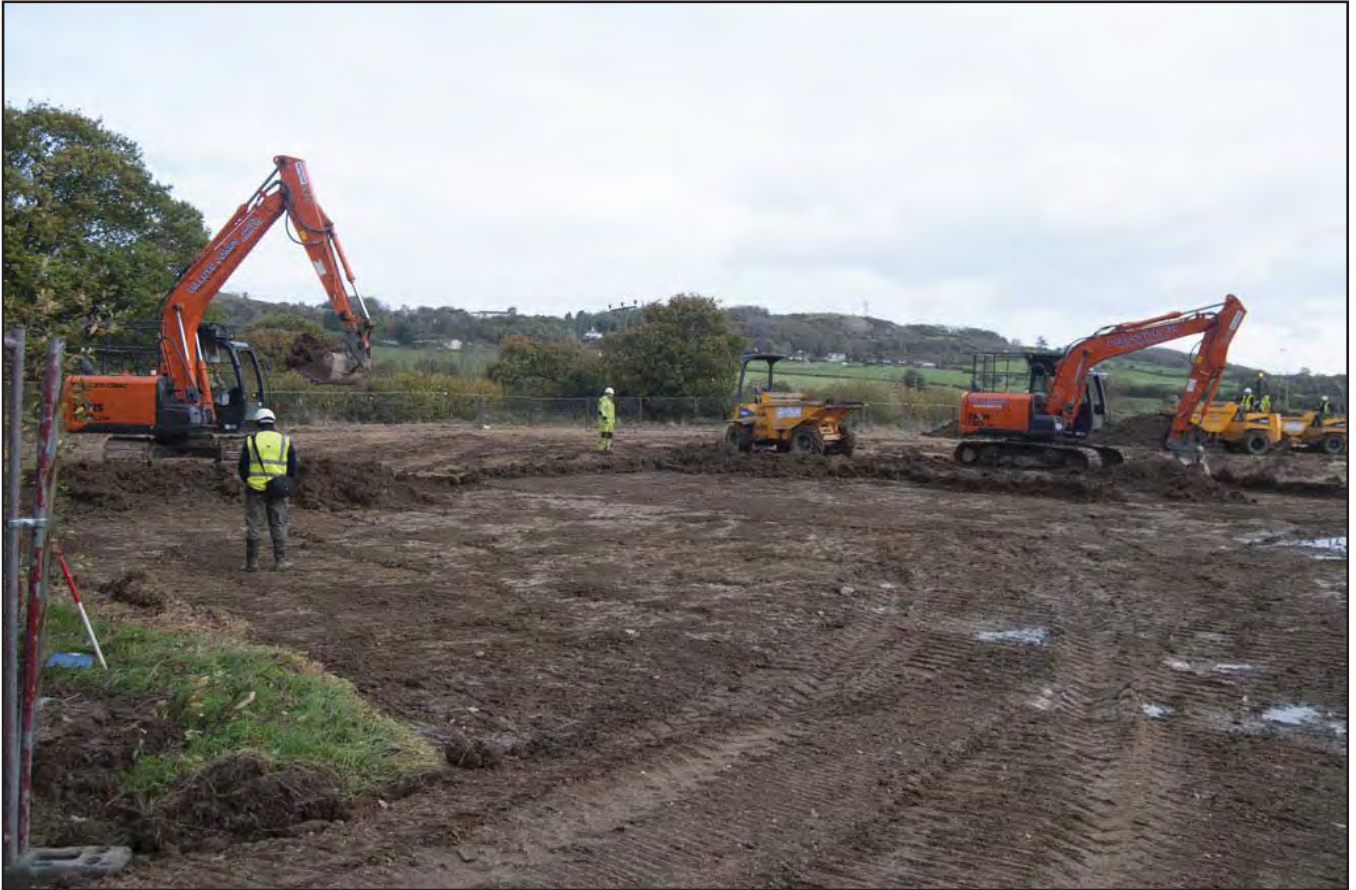
Plate 02: Topsoil strip of sports pitch with 360° excavators & 3 wheeled dumpers. View from the west (Photographic archive ref. G2374_Esgyryn_0116.jpg).

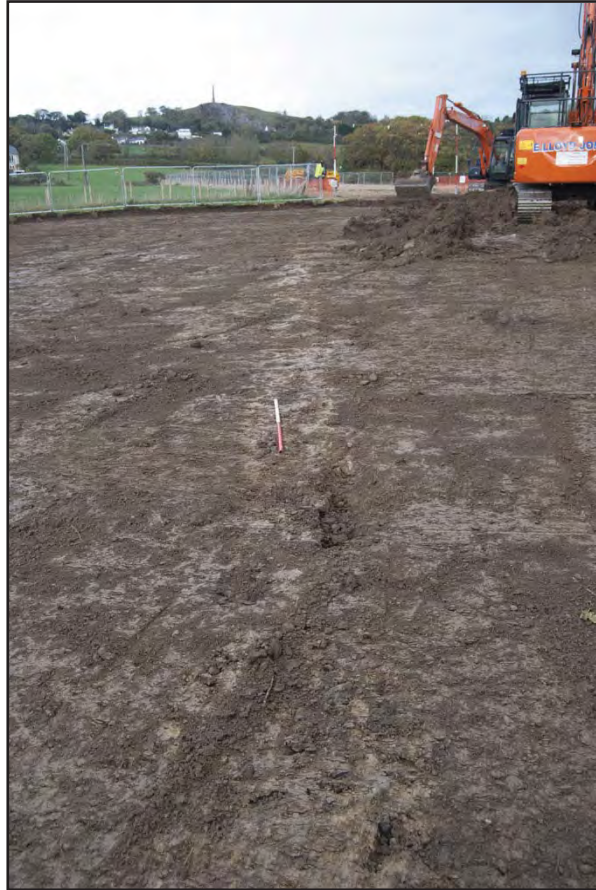
Plate 03: Modern linear cut for 'metallic utility'. 1m x 1m scale. View from the south
(Photographic archive ref. G2374_Esgyryn_0113.jpg).

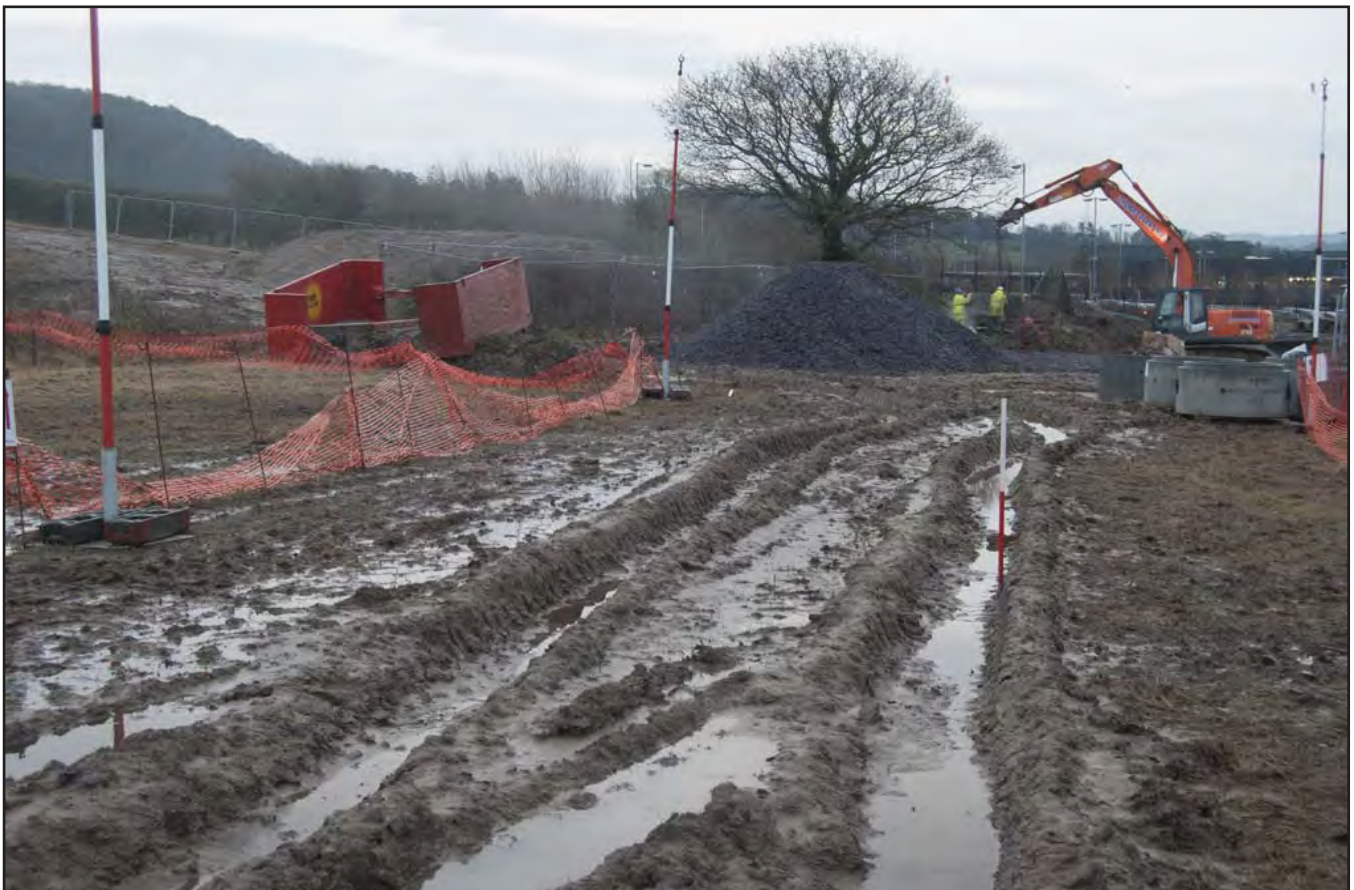
Plate 04: An example of ruts (beneath overhead power cable). 1m x 1m scale. View from the west
(Photographic archive ref. G2374_Esgyryn_0128.jpg).

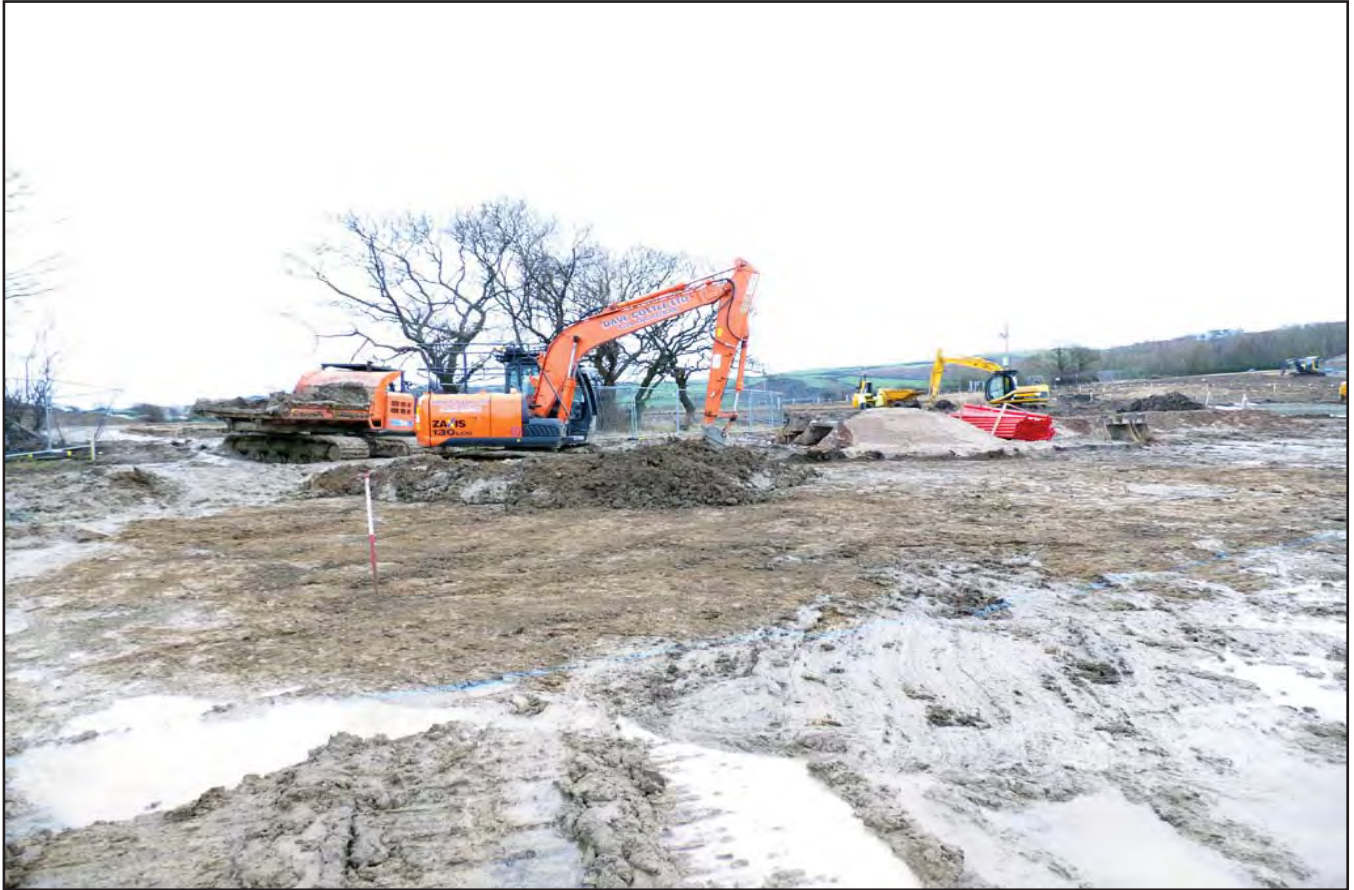
Plate 05: Tracked dumper being used for the saturated ground conditions. 1m x 1m scale. View from the north west (Photographic archive ref. G2374_Esgyryn_0158.jpg).

The topsoil/subsoil strip recommenced in January 2016. Due to the continued saturated ground conditions and poor weather the wheeled dumpers were abandoned in favour of a tracked dumper (Plate 05), to allow for safer transport of spoil across the site and to generate less impact on the potential underlying archaeology.

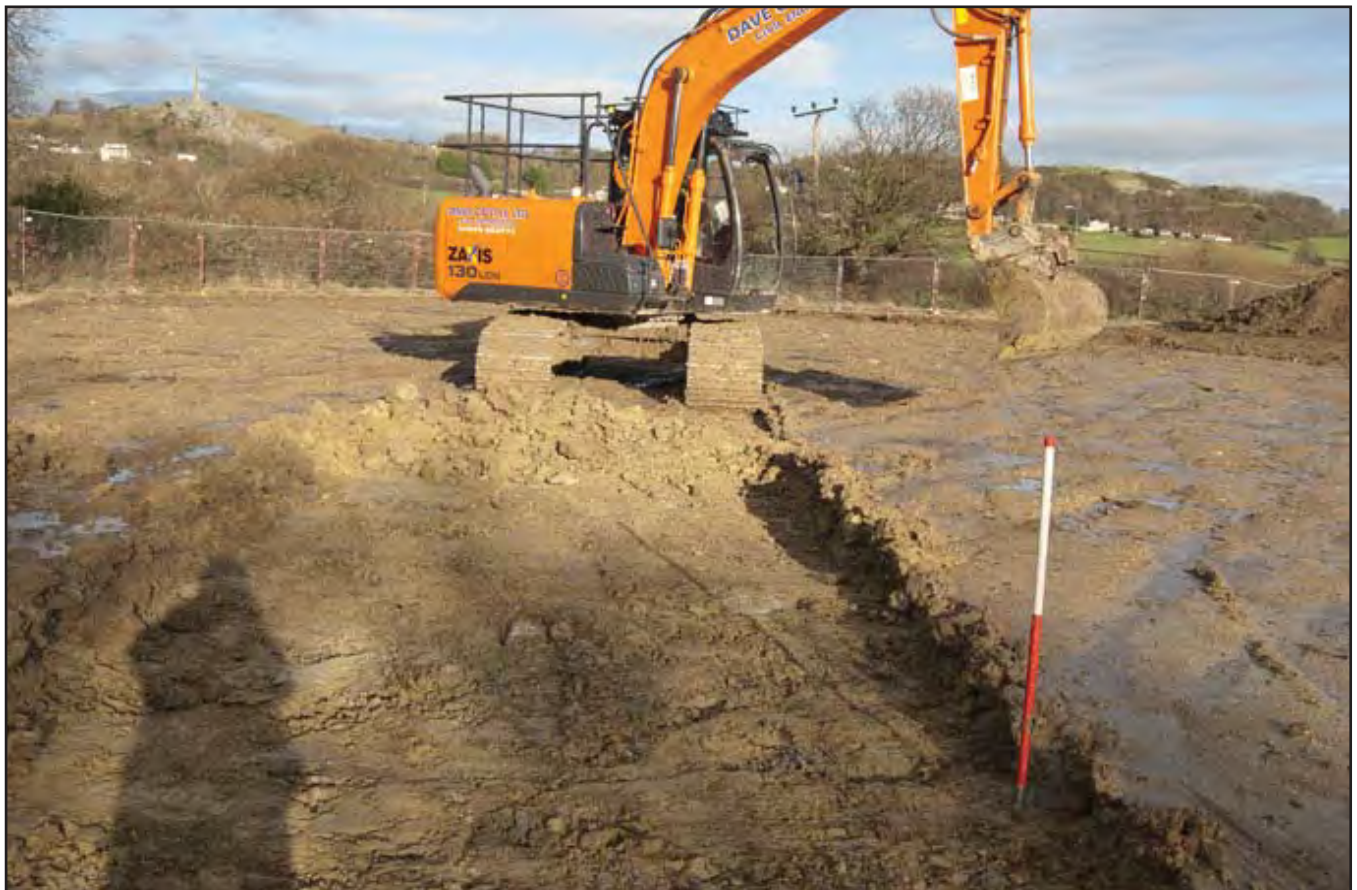
Plate 06: Subsoil strip of tracks in sports pitch. 1m x 1m scale. View from the south west (Photographic archive ref. G2374_Esgyryn_0136.jpg).

In advance of plant crossing the topsoil stripped portion of the sports pitch, two tracks were cleared by 13 tonne tracked 360° excavator fitted with a toothless bucket (Plate 06) under archaeological supervision. The tracks were positioned along the southern edge of the area for a distance of 40m with a width of 4.0m and across it on a diagonal northeast-southwest alignment for a length of 40m and width of 3.2m (Plate 07). The remaining mid brown silty clay subsoil had a depth of 0.15m which overlaid a light greyish yellow boulder clay.

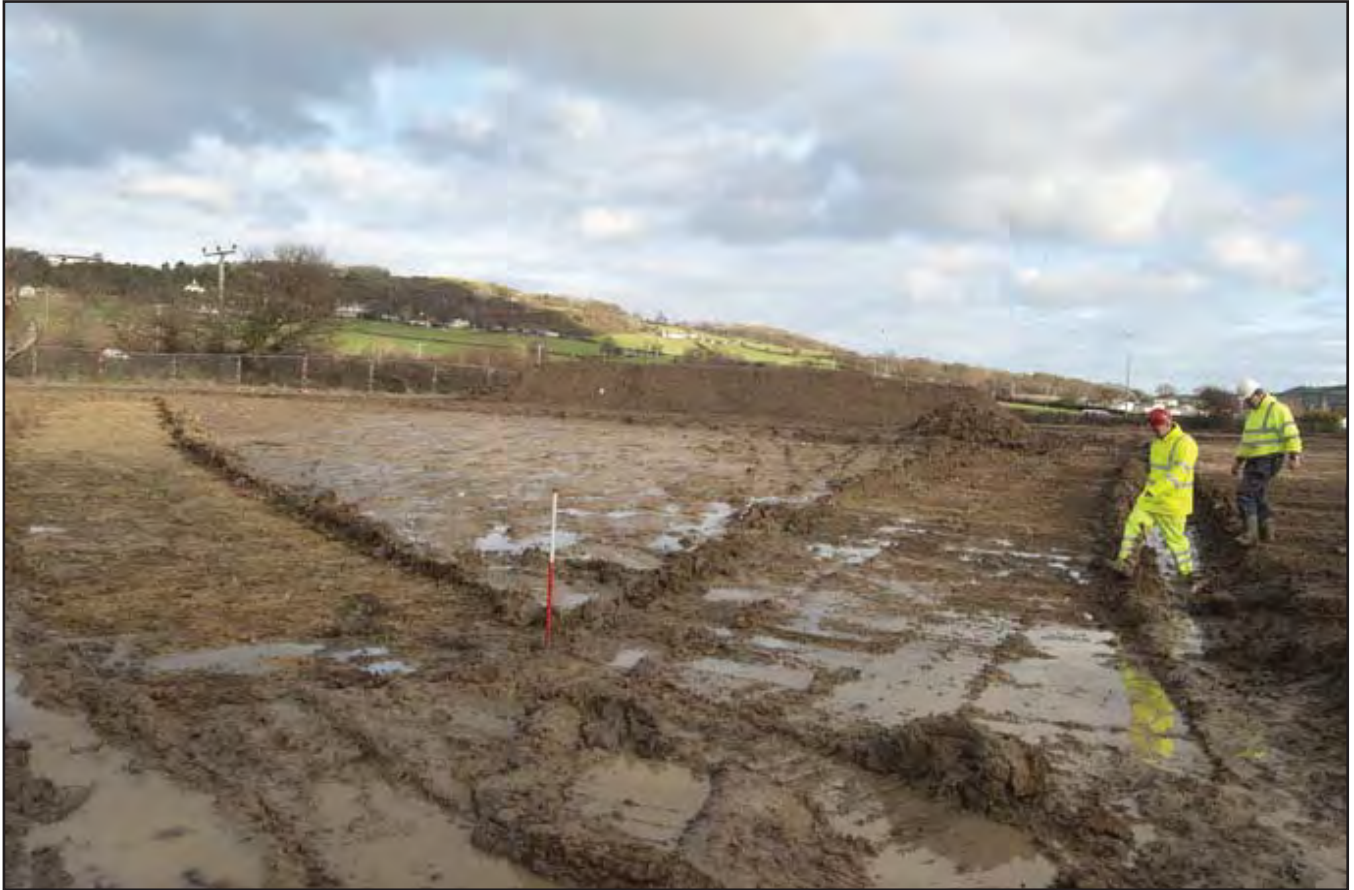
Plate 07: The two stripped tracks across the sports pitch. 1m x 1m scale. View from the west
(Photographic archive ref. G2374_Esgyryn_0138.jpg).

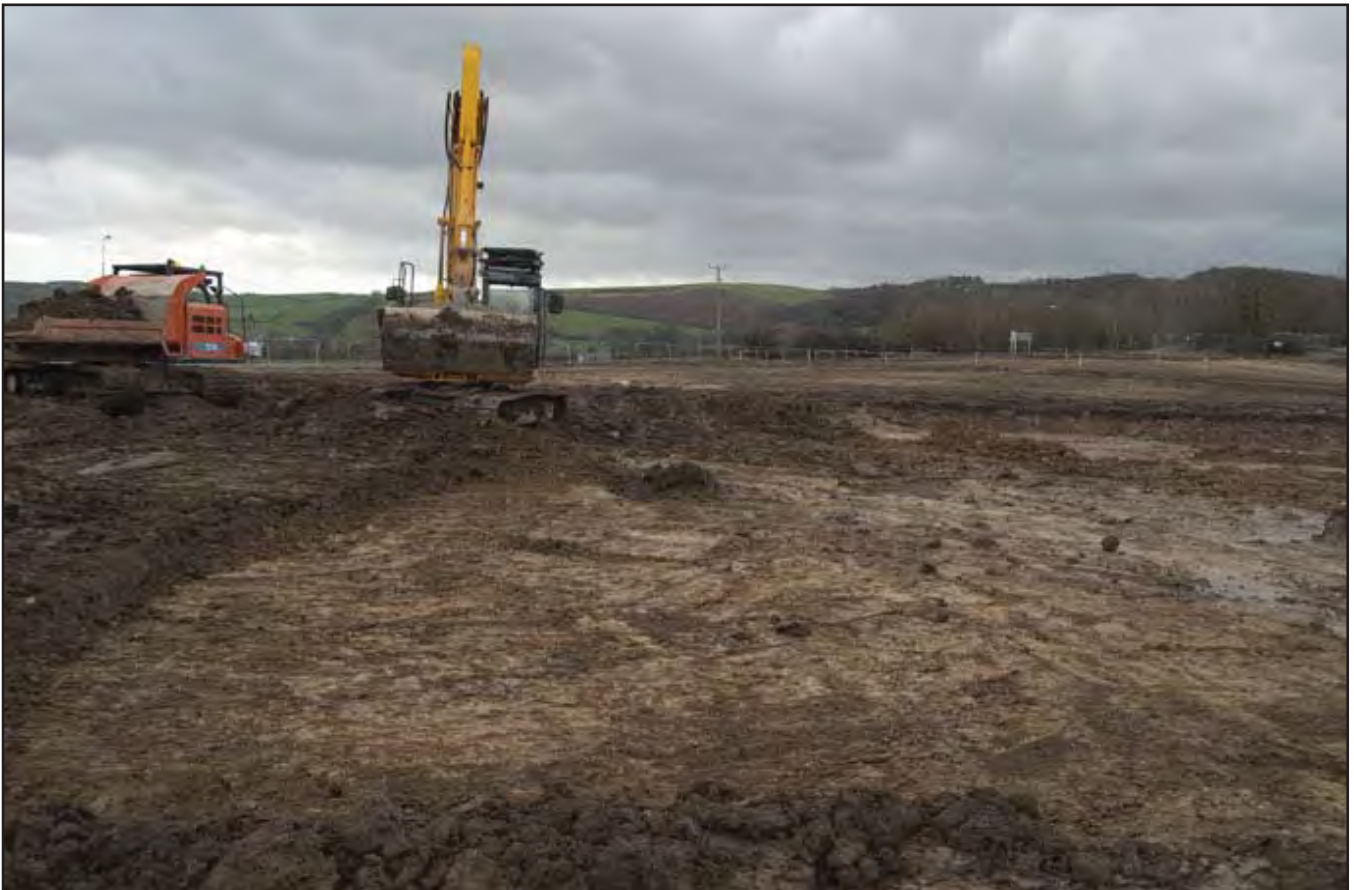
Plate 08: Topsoil/subsoil strip of the 'Hub' as machine worked west to east. View from the north west
(Photographic archive ref. G2374_Esgyryn_0180.jpg).

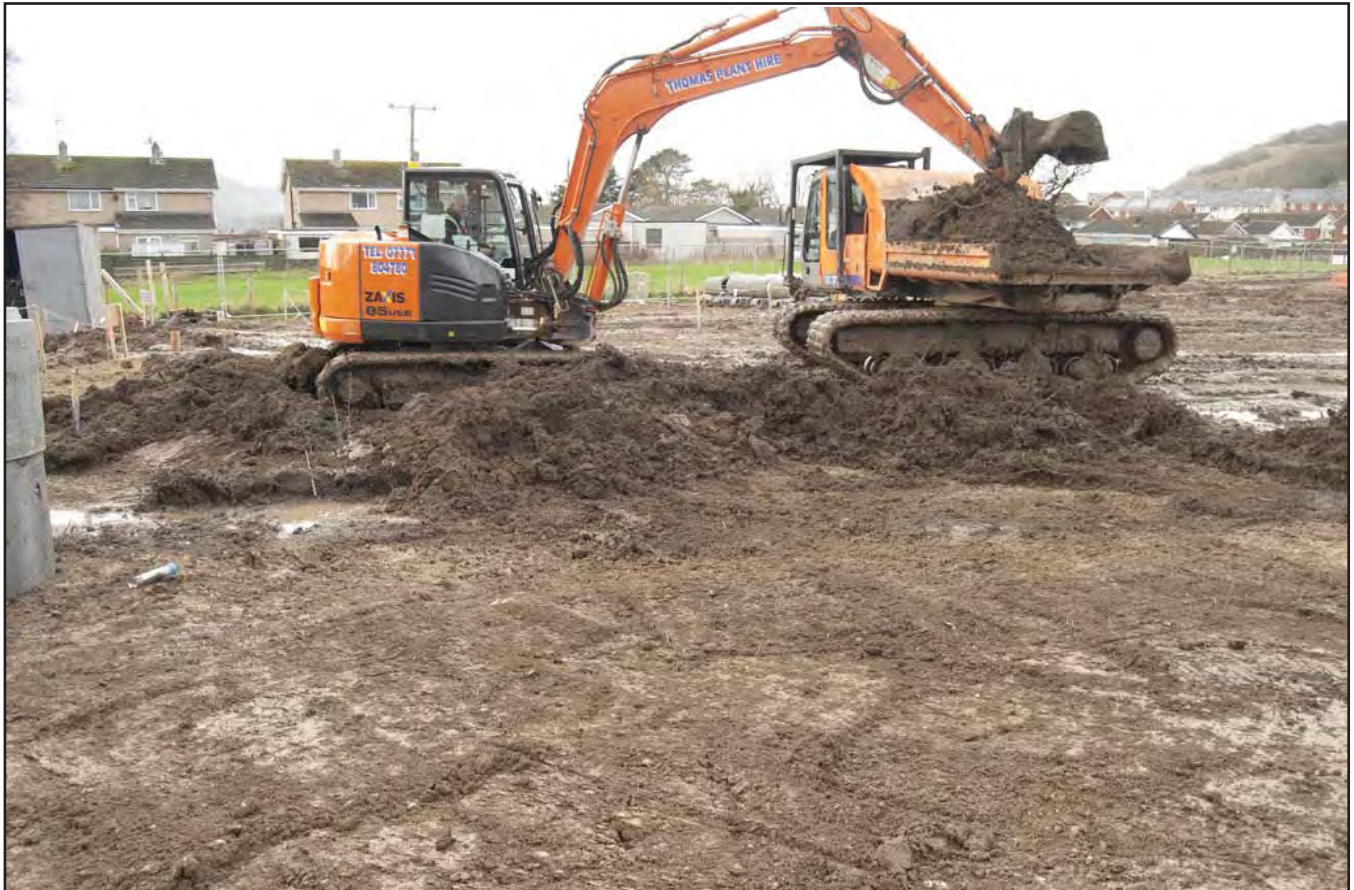
Plate 09: Topsoil/subsoil strip beneath overhead cables. View from the east (Photographic archive ref. G2374_Esgyryn_0150.jpg).

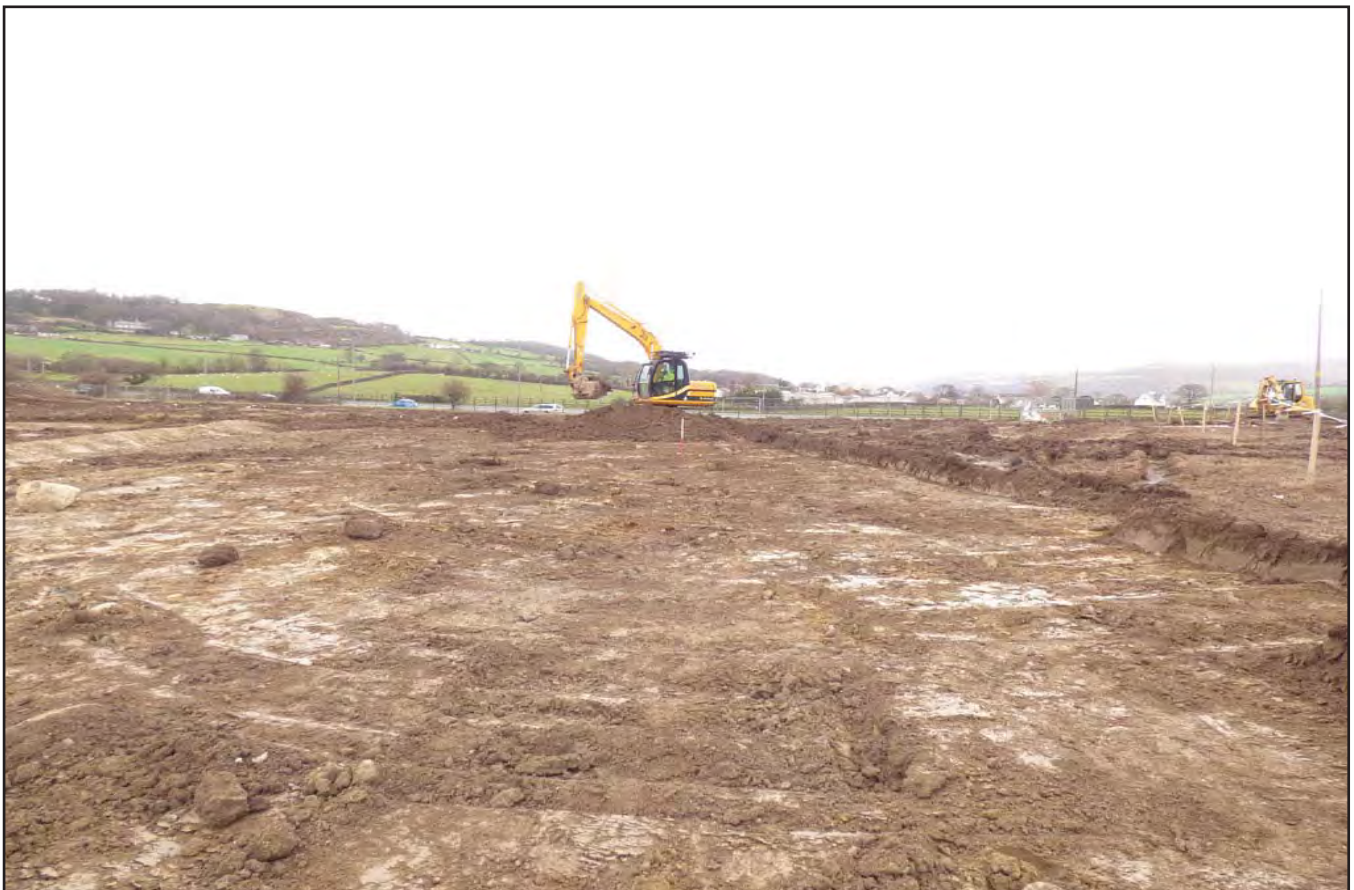
Plate 10: South east corner of site with more boulders. 1m x 1m scale. View from the west (Photographic archive ref. G2374_Esgyryn_0210.jpg).

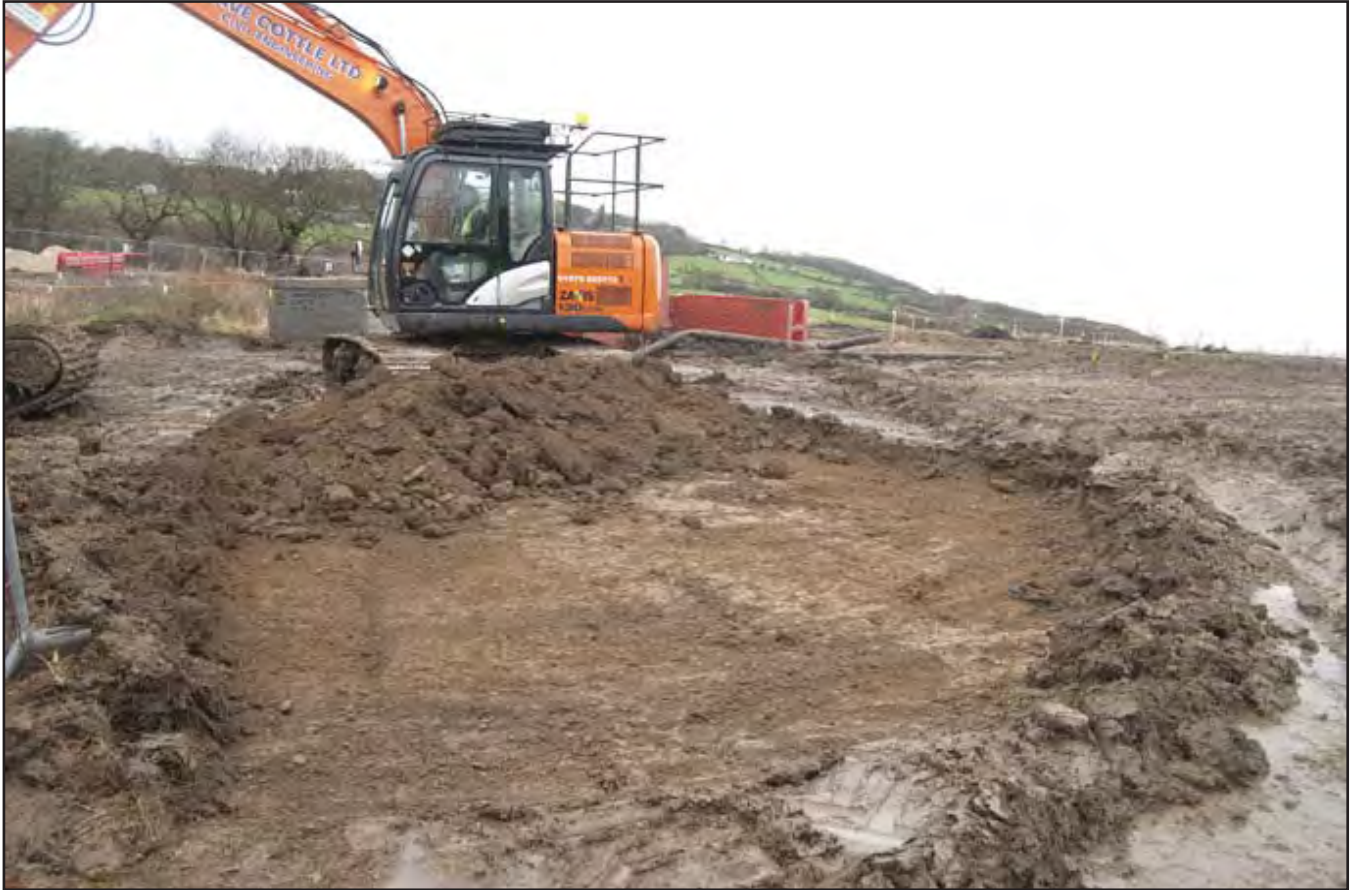
Plate 11: Example of fine red gravelly clay natural. View from the south (Photographic archive ref. G2374_Esgyryn_0146.jpg).

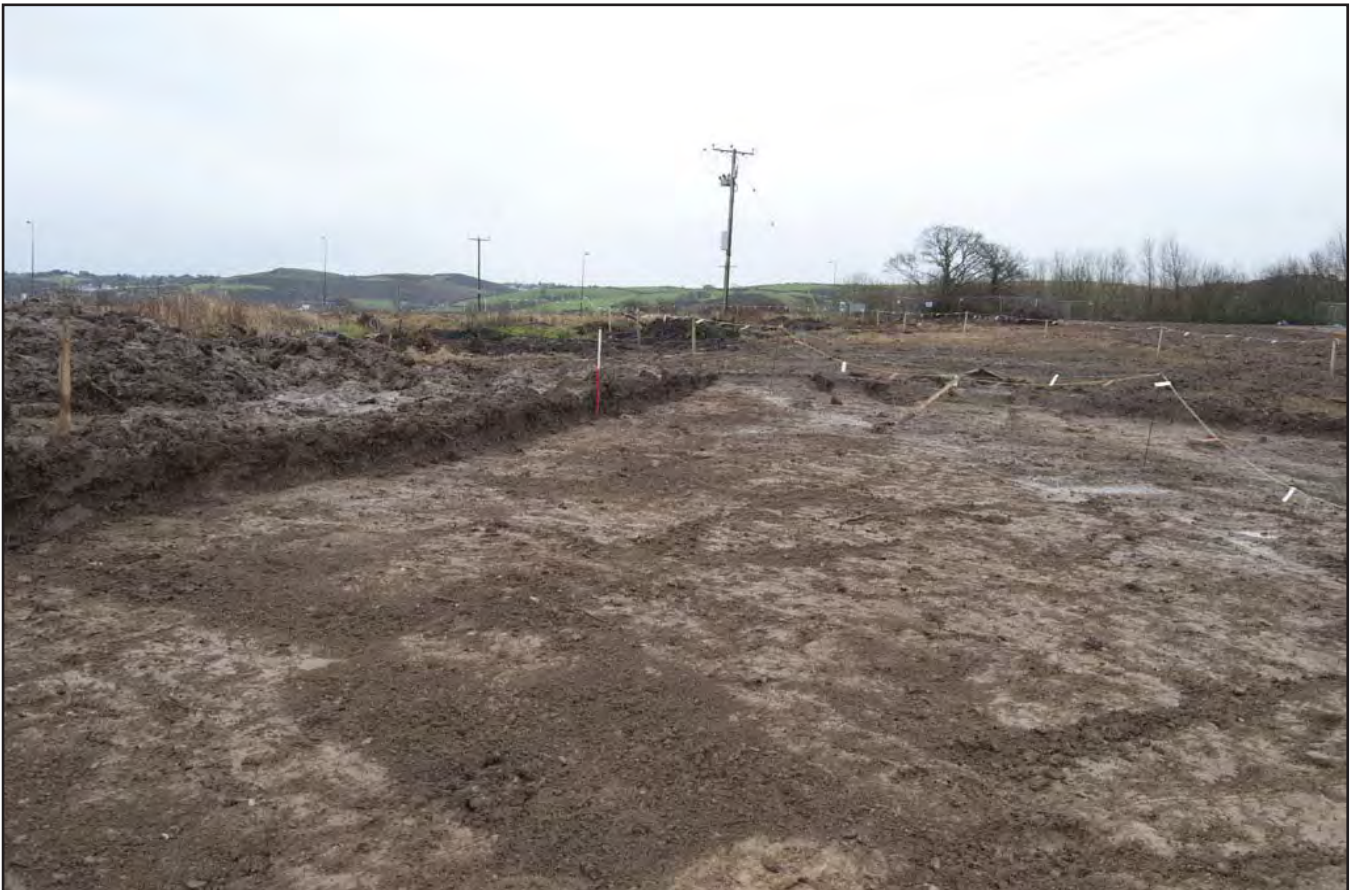
Plate 12: Example of red plasticity clay natural. 1m x 1m scale. View from the north west (Photographic archive ref. G2374_Esgyryn_0155.jpg).

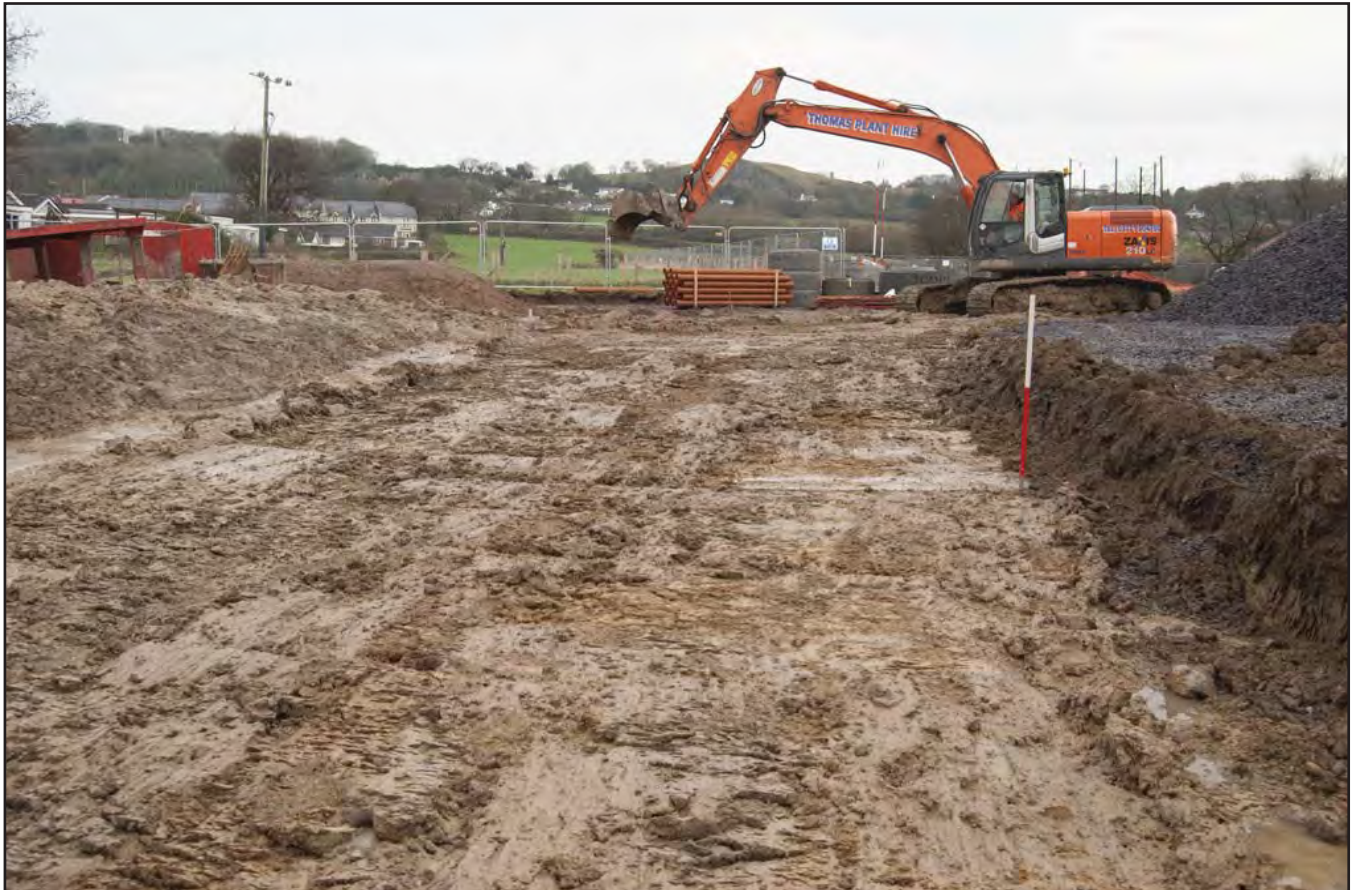
Plate 13: Area stripped of subsoil along access road. 1m x 1m scale. View from the south west (Photographic archive ref. G2374_Esgyryn_0133.jpg).

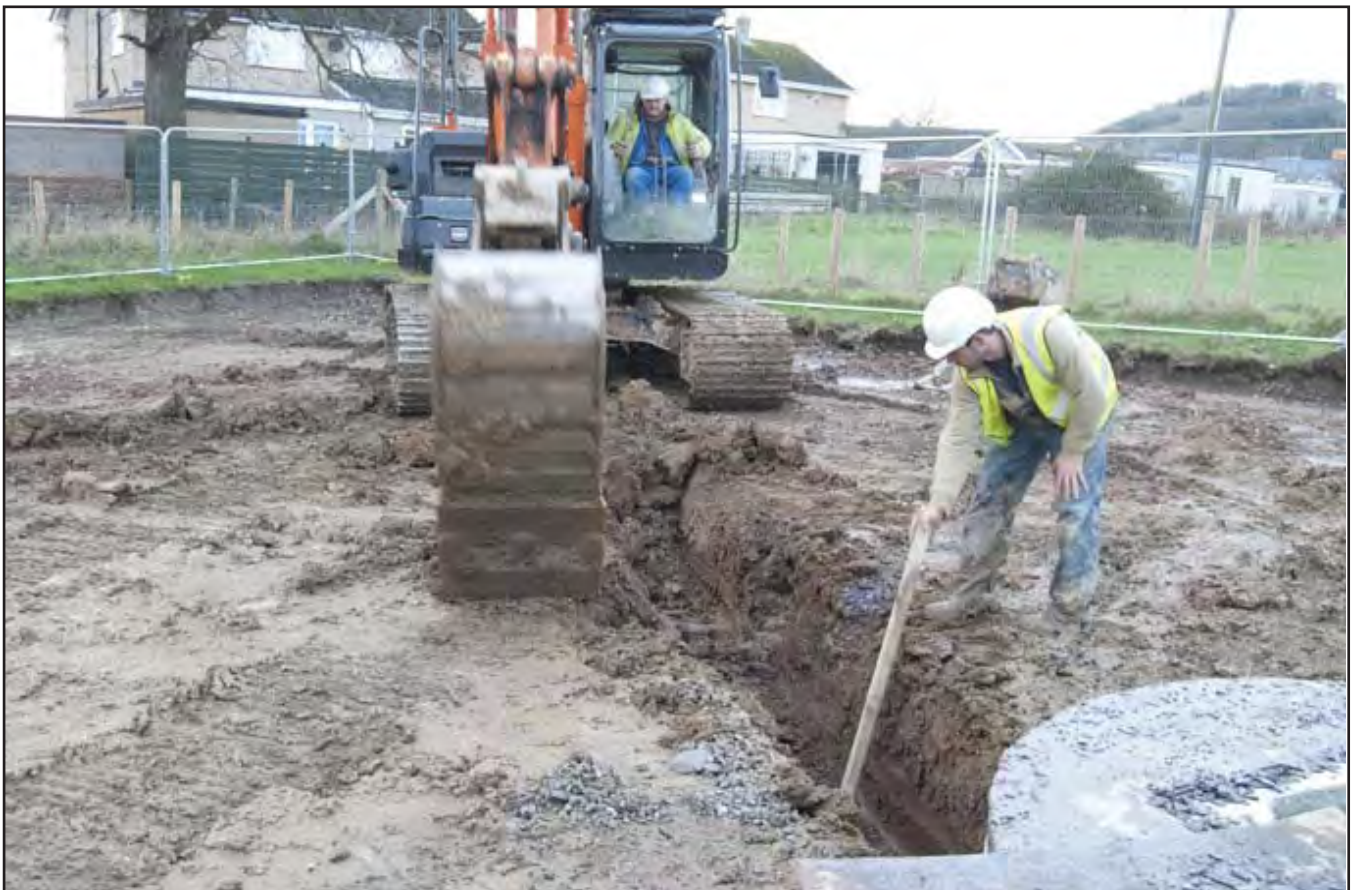
Plate 14: Excavation of drainage pipe trench at hammerhead. View from the south east (Photographic archive ref. G2374_Esgyryn_0140.jpg).

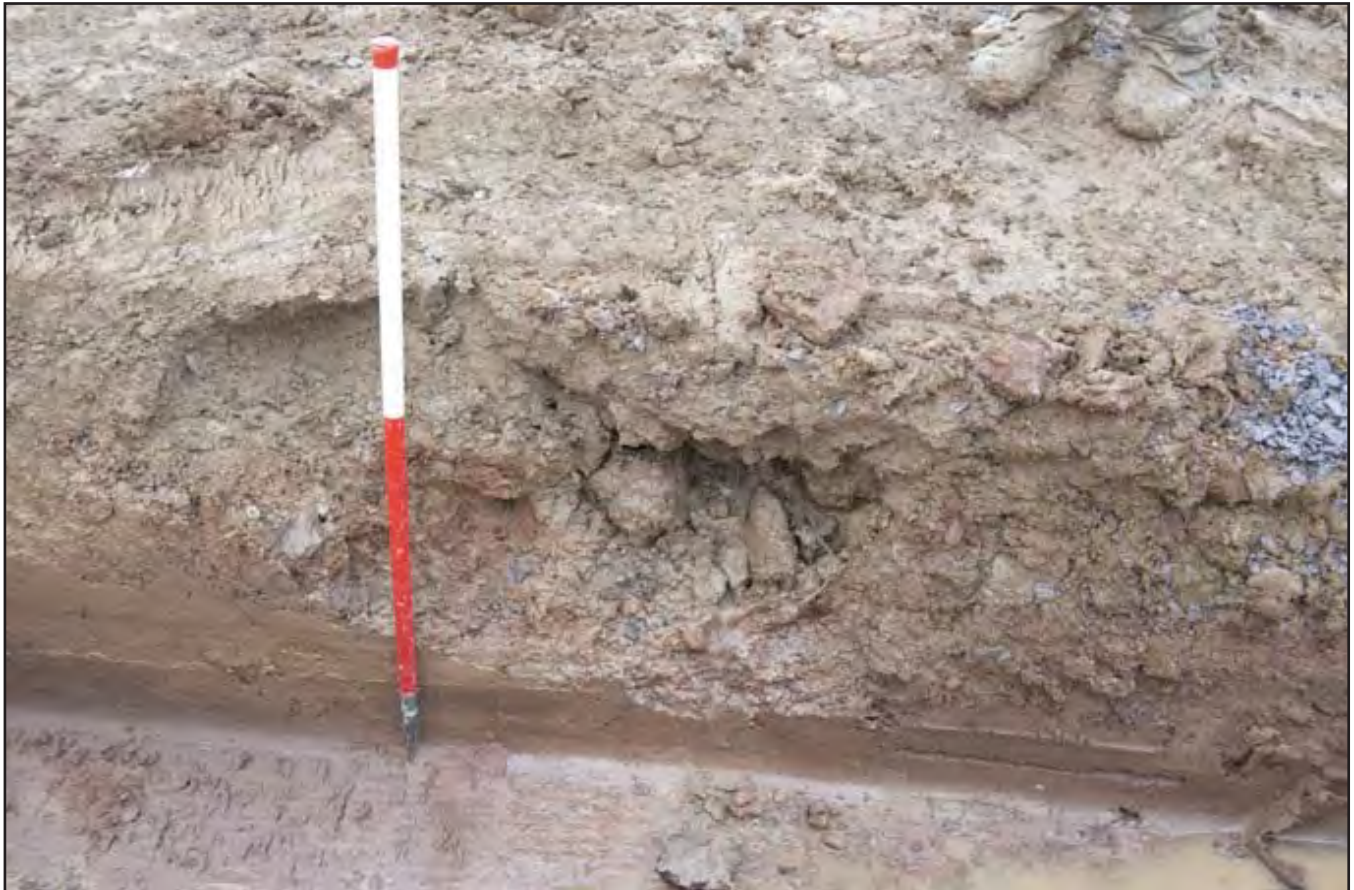
Plate 15: Stone field drain in west facing section of drainage pipe trench. 1m x 1m scale. View from the west (Photographic archive ref. G2374_Esgyryn_0141.jpg).
