Esgyryn Site, Llandudno Junction

Archaeological Watching Brief

Rhif Prosiect / Project No. G2374

Rhif Adroddiad / Report No.1326

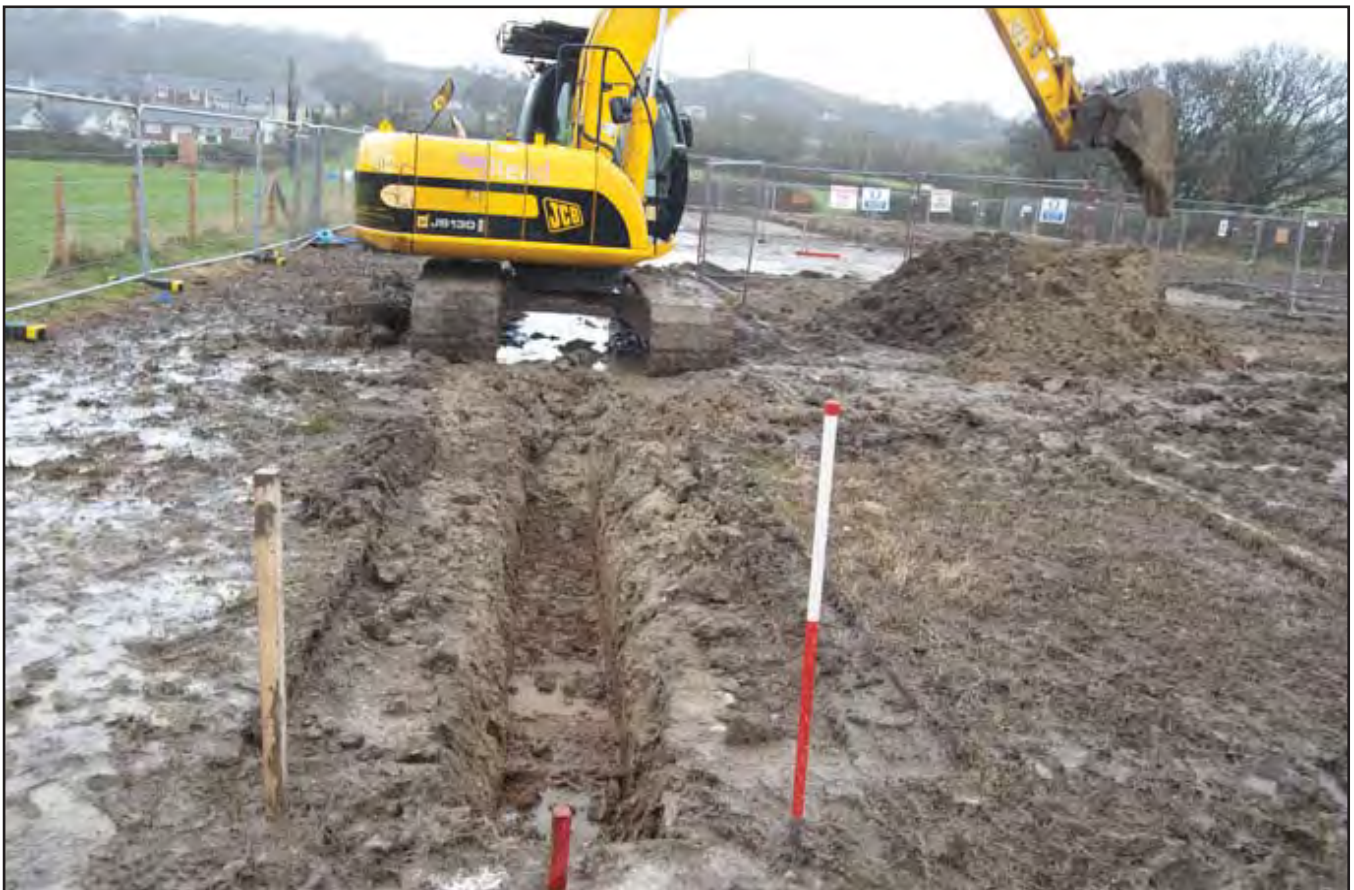
Plate 16: Excavation of duct trench adjacent to main car park. 1m x 1m scale. View from the south (Photographic archive ref. G2374_Esgyryn_0144.jpg).

A duct trench to take the overhead power cable which crossed the southern end of the site was excavated north along the route of the site, east across the width of the main car park and continued east until it reached the A470. It was excavated intermittently depending on ground conditions by a tracked 360° excavator fitted with a narrow toothless trenching bucket (Plate 16). The trench had a depth of 0.80m, and width of 0.50m. The remaining subsoil had a depth of 0.30m that covered a natural thin band (0.20m) of mid brownish yellow silty clay which in turn overlaid a compact plasticity red clay natural (Plate 17). No archaeological deposits were identified during the excavation of this duct trench.

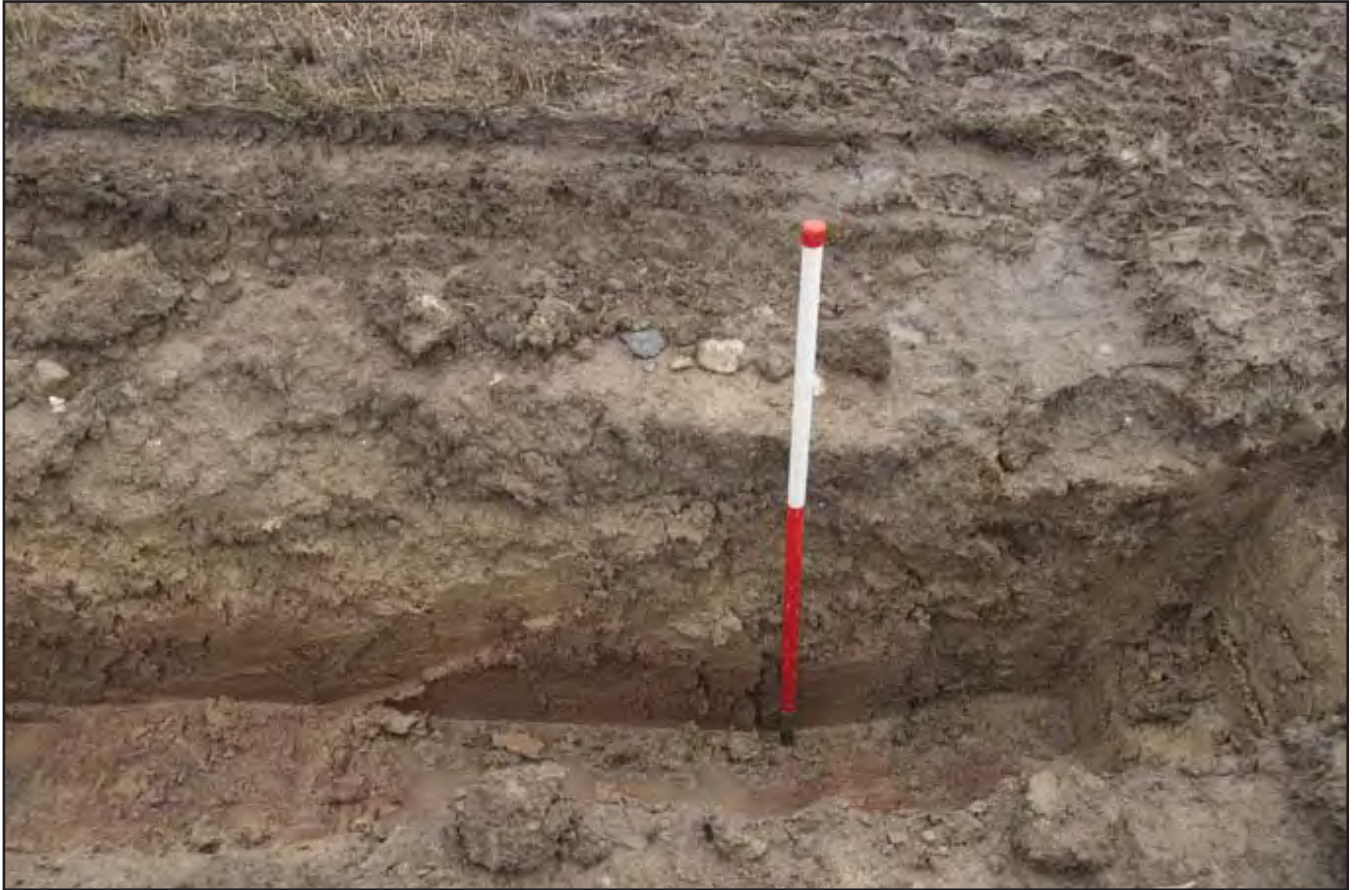
Plate 17: West facing section of duct trench. 1m x 1m scale. View from the west (Photographic archive ref. G2374__Esgyryn_0145.jpg).

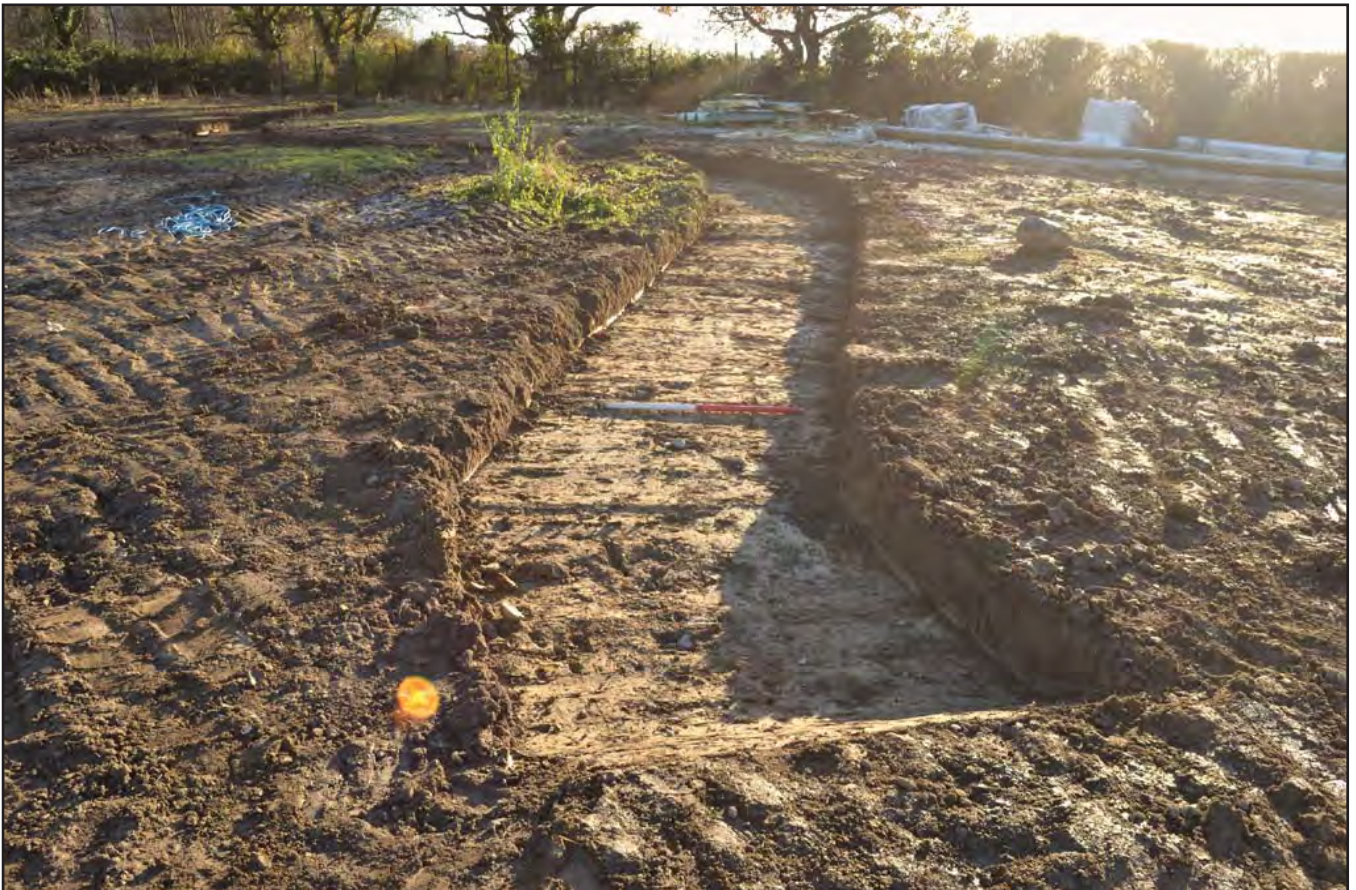
Plate 18: Habitat garden path. 1m x 1m scale. View from the north (Photographic archive ref. G2374_Esgyryn_0249.jpg).

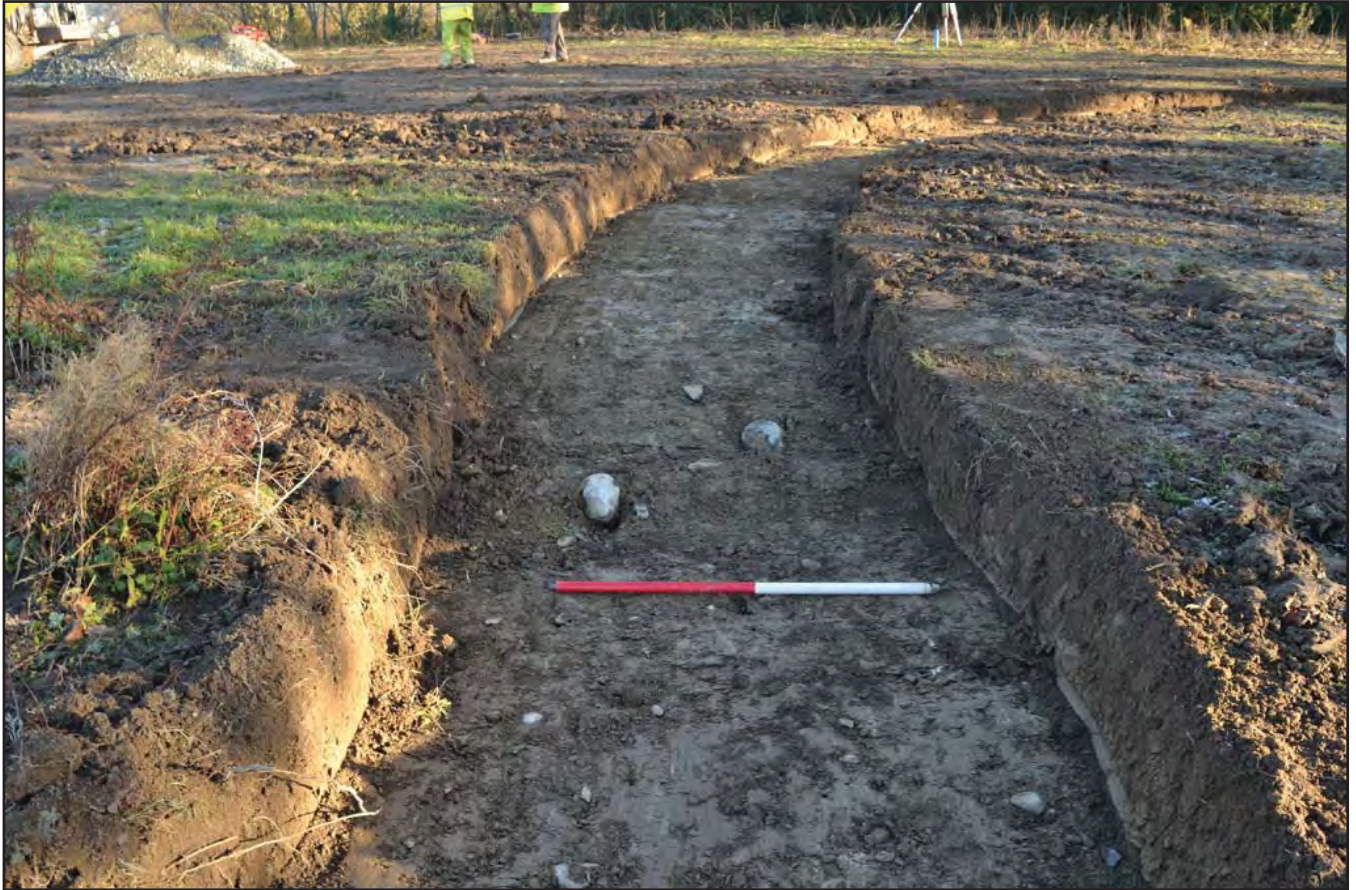
Plate 19: Depth of topsoil and underlying natural clay. 1m x 1m scale. View from the west (Photographic archive ref. G2374_Esgyryn_0251.jpg).

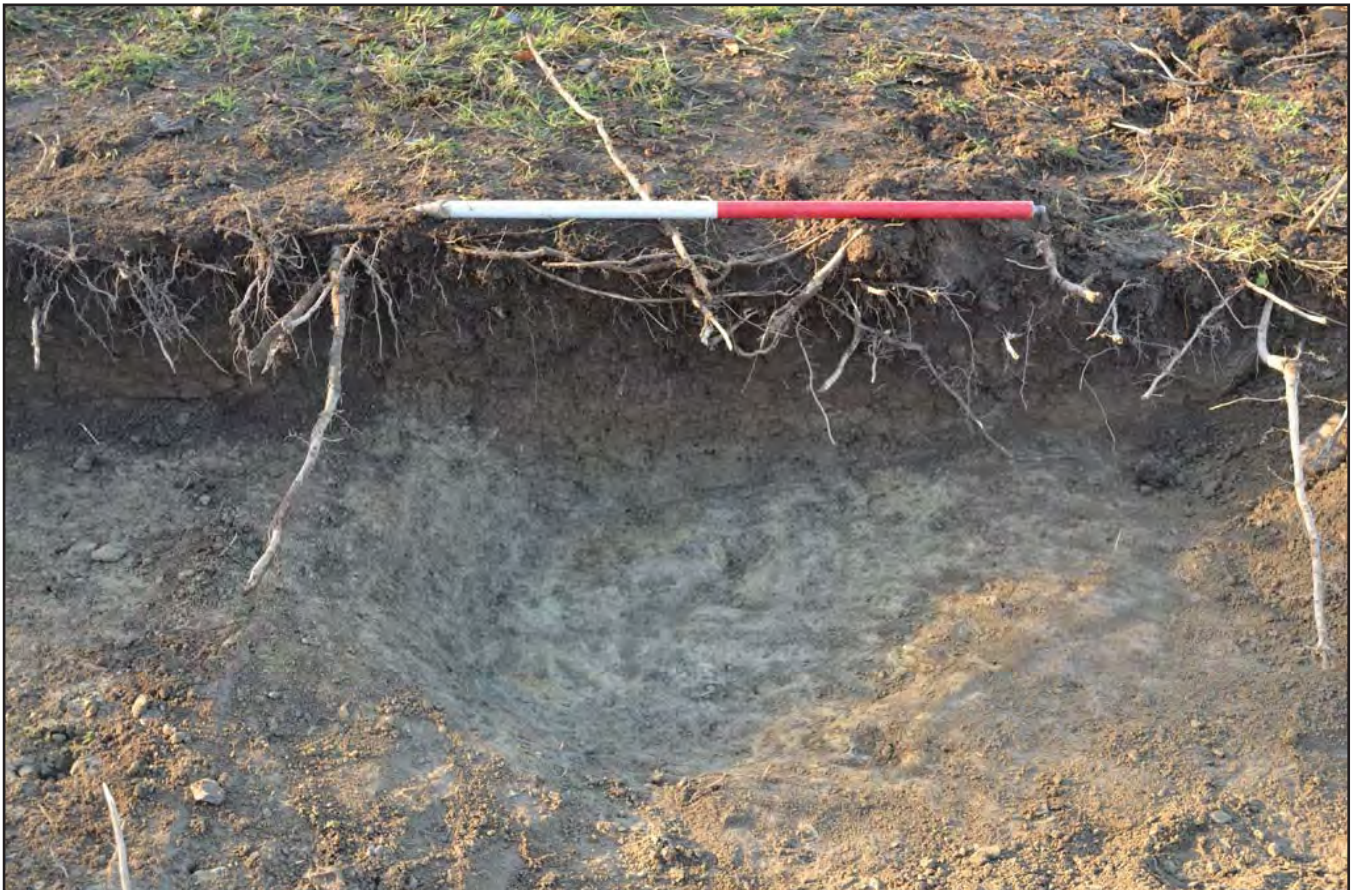
Plate 20: East facing section of pit [019]. 1m x 1m scale. View from the east (Photographic archive ref. G2374_Esgyryn_0257.jpg).

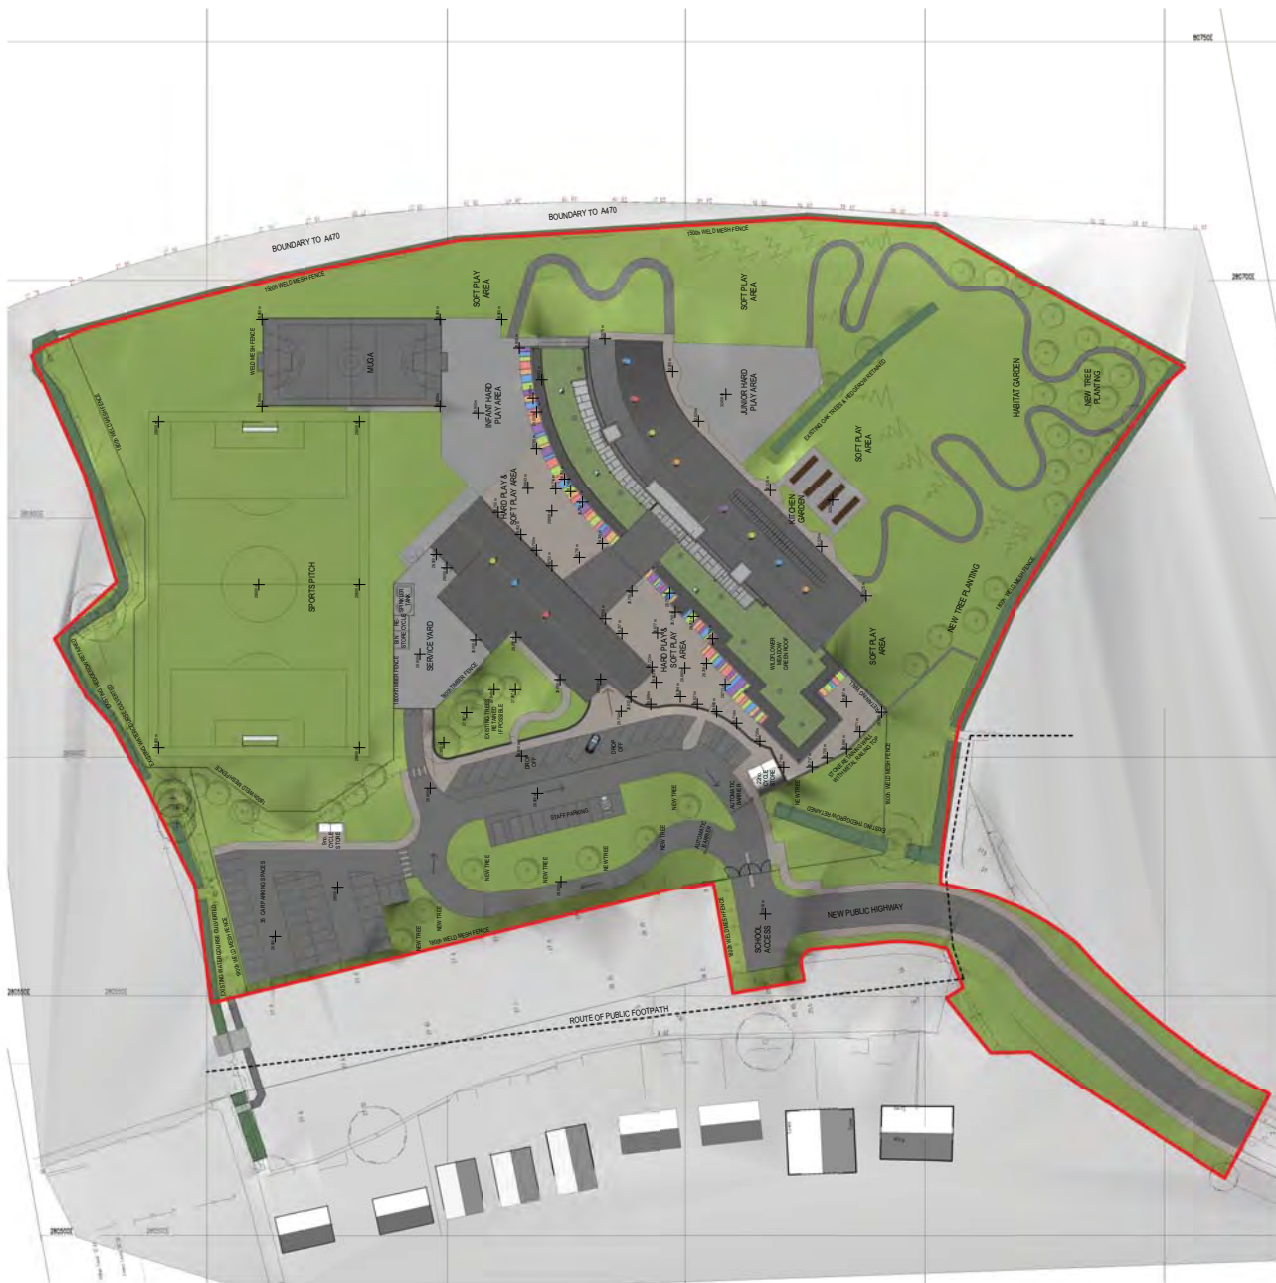
**Figure 02:
Reproduction
of Proposed
Site Plan**

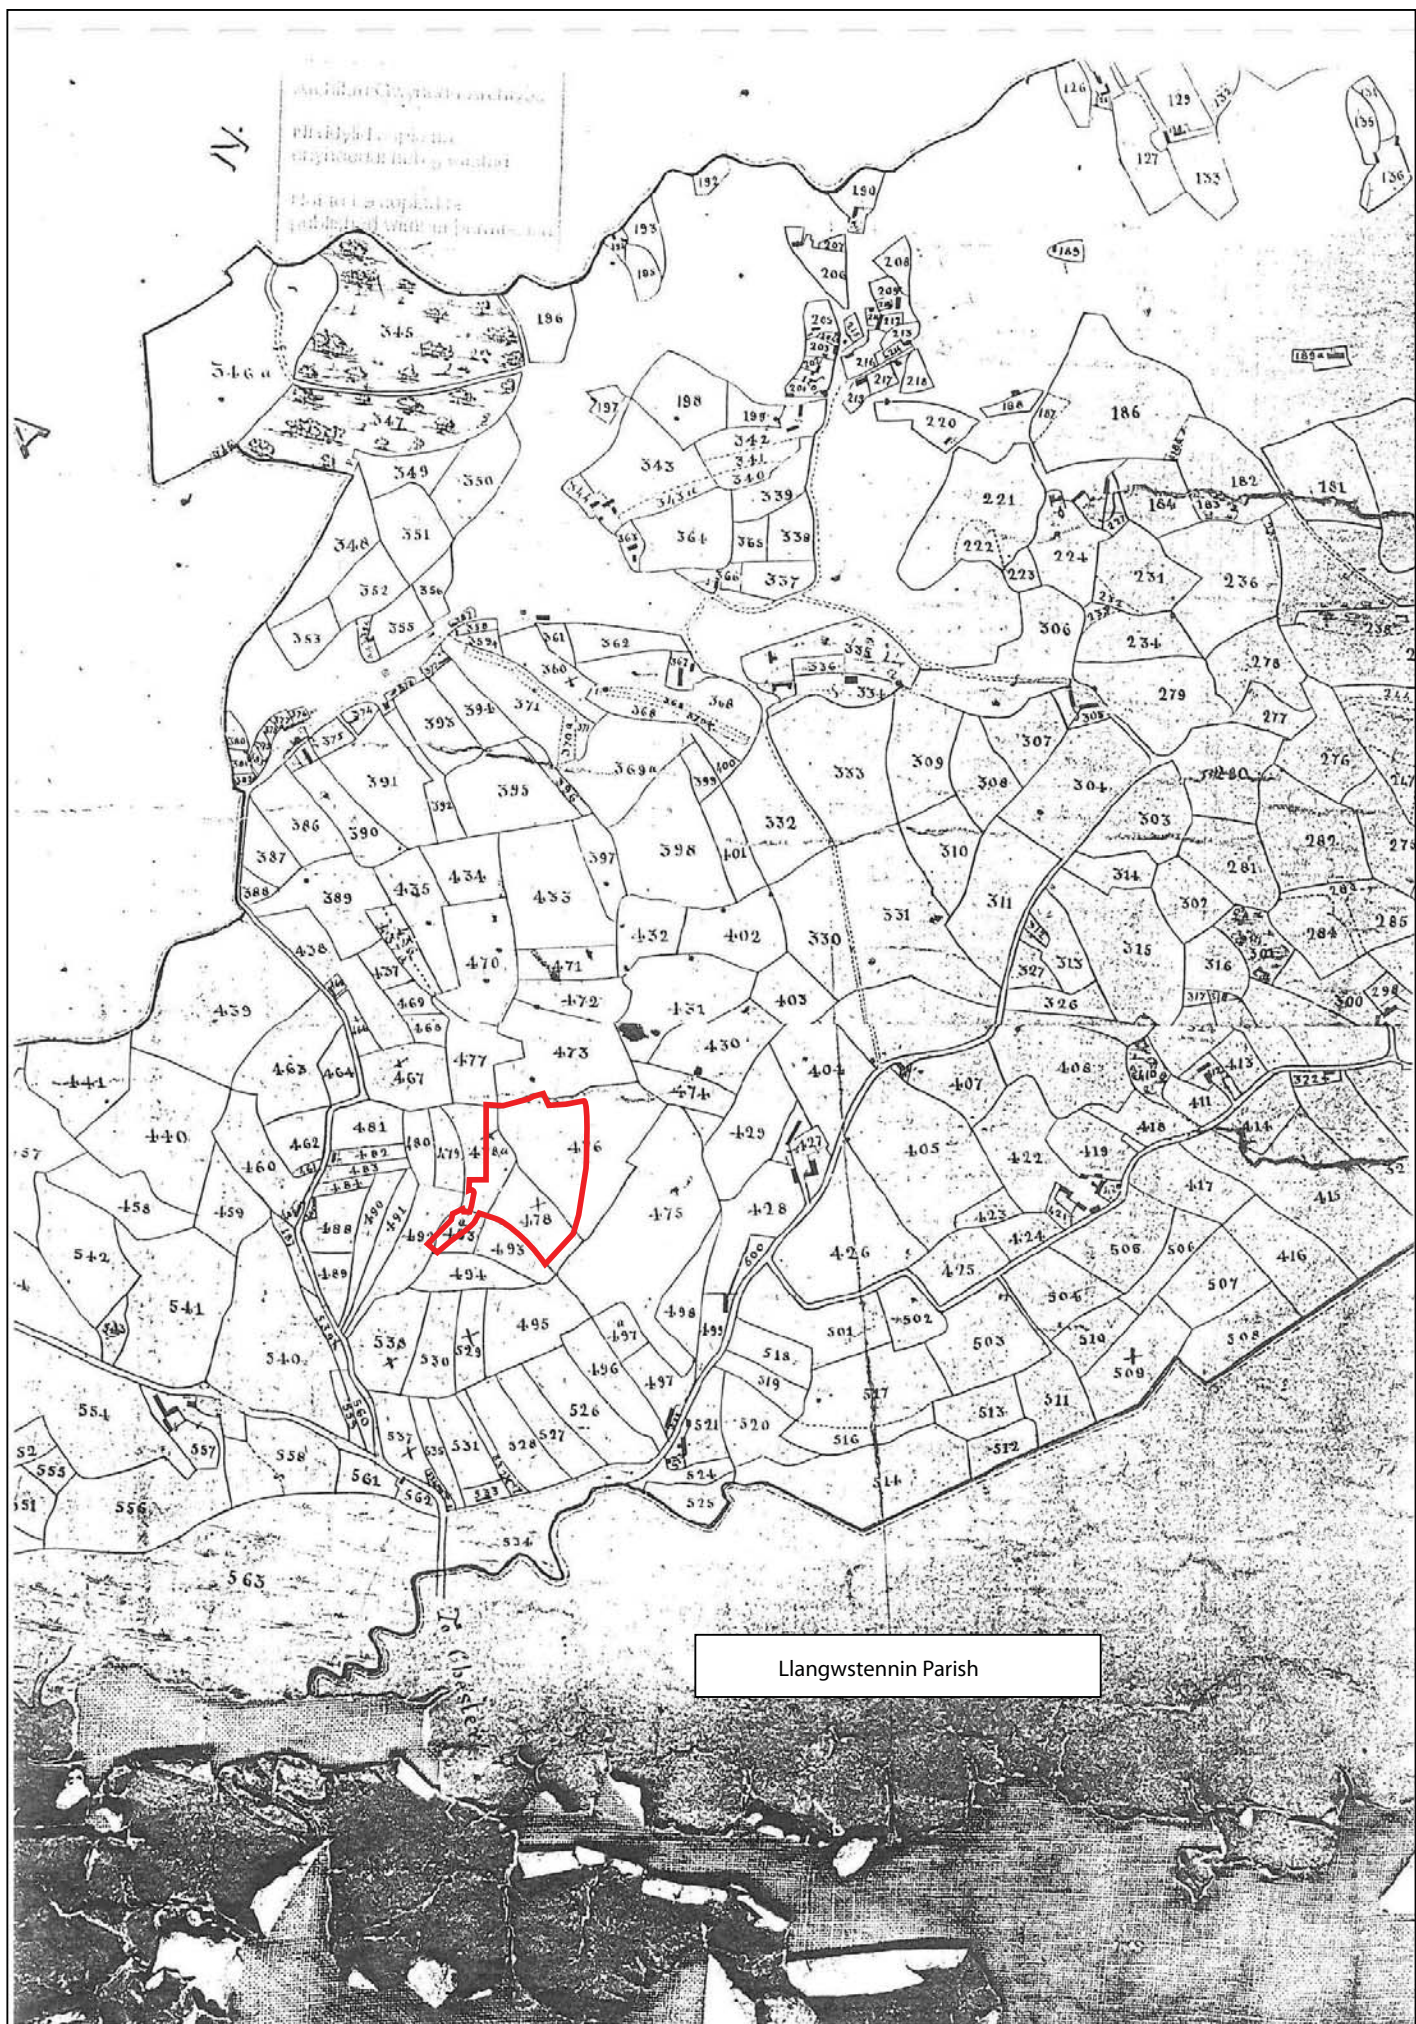
Figure 03

Reproduction of the Llangwstennin Parish Tithe Map 1840, with the proposed development site superimposed in RED.

Figure 03: Reproduction of the Llangwstennin Parish Tithe Map 1840, with the proposed development site superimposed in RED.
Not to Scale
