# Pen y Bryn Barracks Nantlle

Community Excavation and building recording

Project No. G2593

Report No. 1539

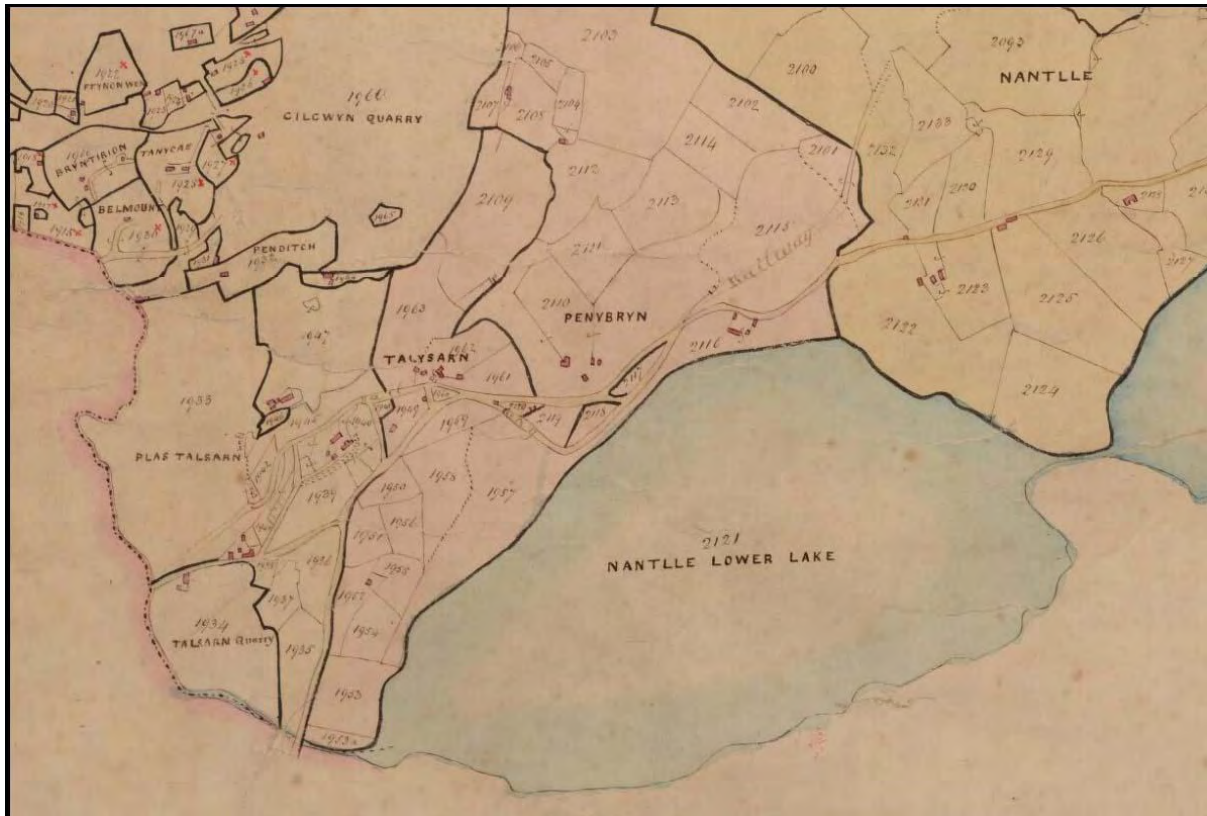
Figure 3. The 1841 tithe map showing Pen y Bryn

The 1846 tithe map shows buildings at Pen y Bryn but it is not sufficiently accurate to allow interpretation. There does appear to be a cluster of buildings including the house and farm buildings, one of which appears to correspond to the earliest phase of the barracks. The schedule lists Dorothea Garnons as the owner. The Garnons family were descended from Robert de Gernon a companion of William the Conqueror. In the 17th century Richard Garnons married Catherine Vaughan of Corsygedol. Richard Garnons of Colommendy in Denbighshire inherited the Pant Ddu and Nantlle Estates from his father in 1803. He was the sheriff of Caernarfonshire in 1805 (Burke 1835). Pant-du is a 17th Century house close to Talysarn and appears to have been the nucleus of the Garnons' holdings in the area. Dorothea quarry was named after Dorothea Garnons

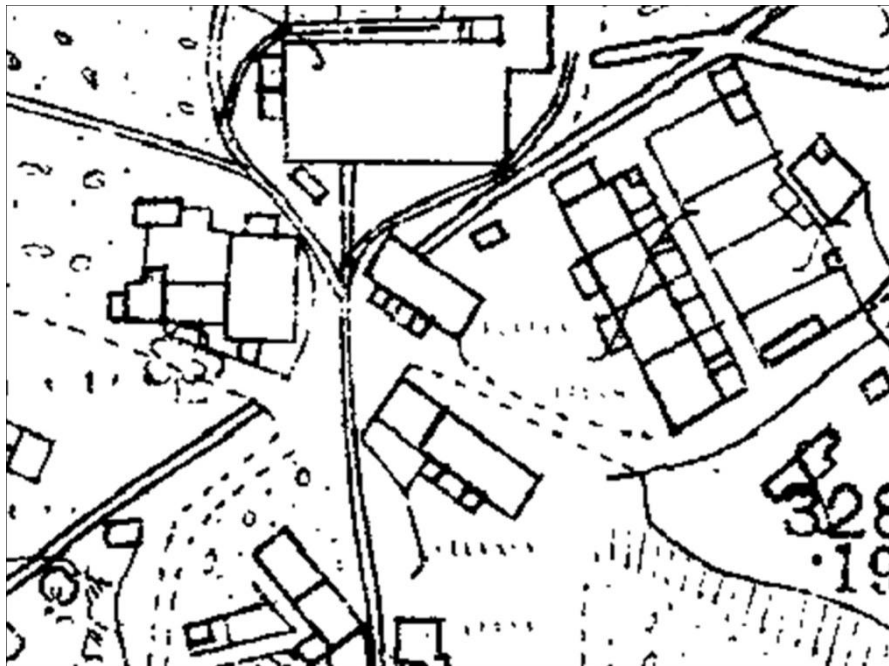
Figure 4. Ordnance survey 25" 1<sup>st</sup> edition 1889

This demonstrates that Pen y Bryn changes from a farm and outbuildings to a farm plus 7 households sometime between 1861 and 1871, presumably as a result of the conversion of farm buildings to dwellings. The dwellings are usually referred to as quarry barracks (e.g. PRN description and Gwyn 2015 191). The makeup of the households show that they were, in fact, cottages housing family units (including one widow and her daughters) as opposed to being worker's barracks. The 1881 census lists 9 households possibly indicating further conversions. The 1891 census lists 9 or 10 buildings with 2 unoccupied. Pen y Bryn Terrace Nos 1 to 4 are named. The 1911 census provides details of the numbers of rooms. There were 8 households, 2 with 2 rooms, one with 3, and 5 with 4.

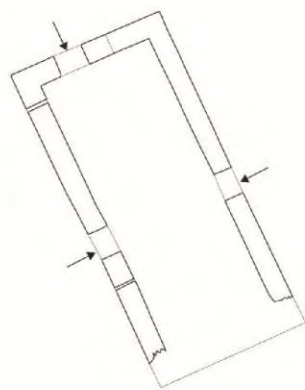
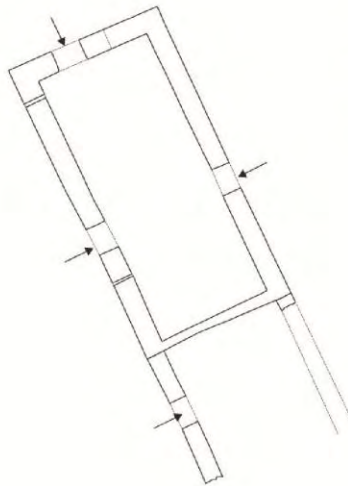
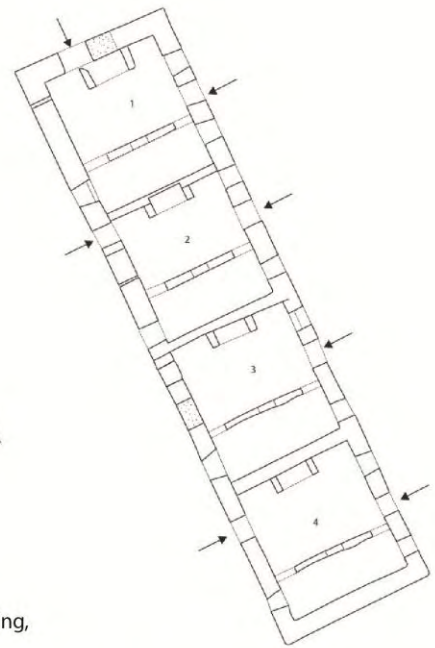
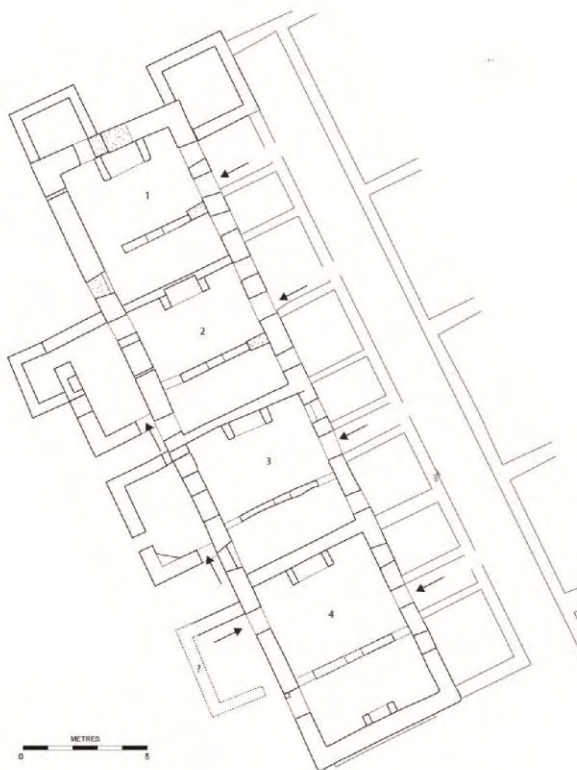
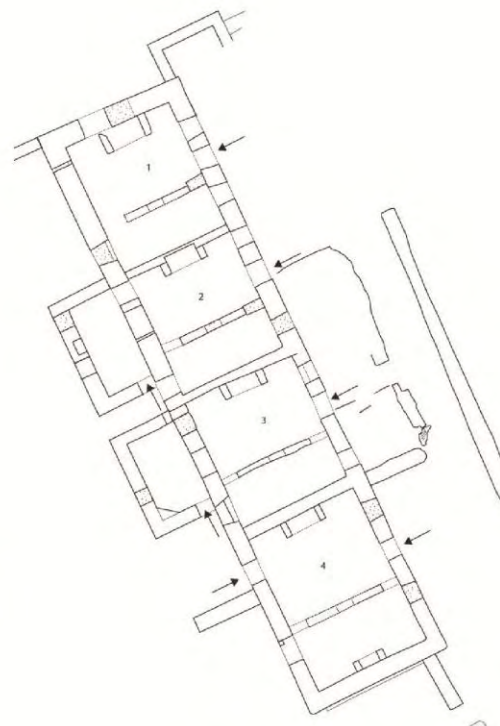
Figure 8. Outline phasing plans

Phase 1 - barn,  
late 17th century

Phase II - additional agricultural building,  
18th or early 19th century

Phase III - conversion to cottages,  
between 1861 and 1871

Phase IV - extensions to cottages,  
1870s to 1913

Phase V - animal pens,  
post 1920s

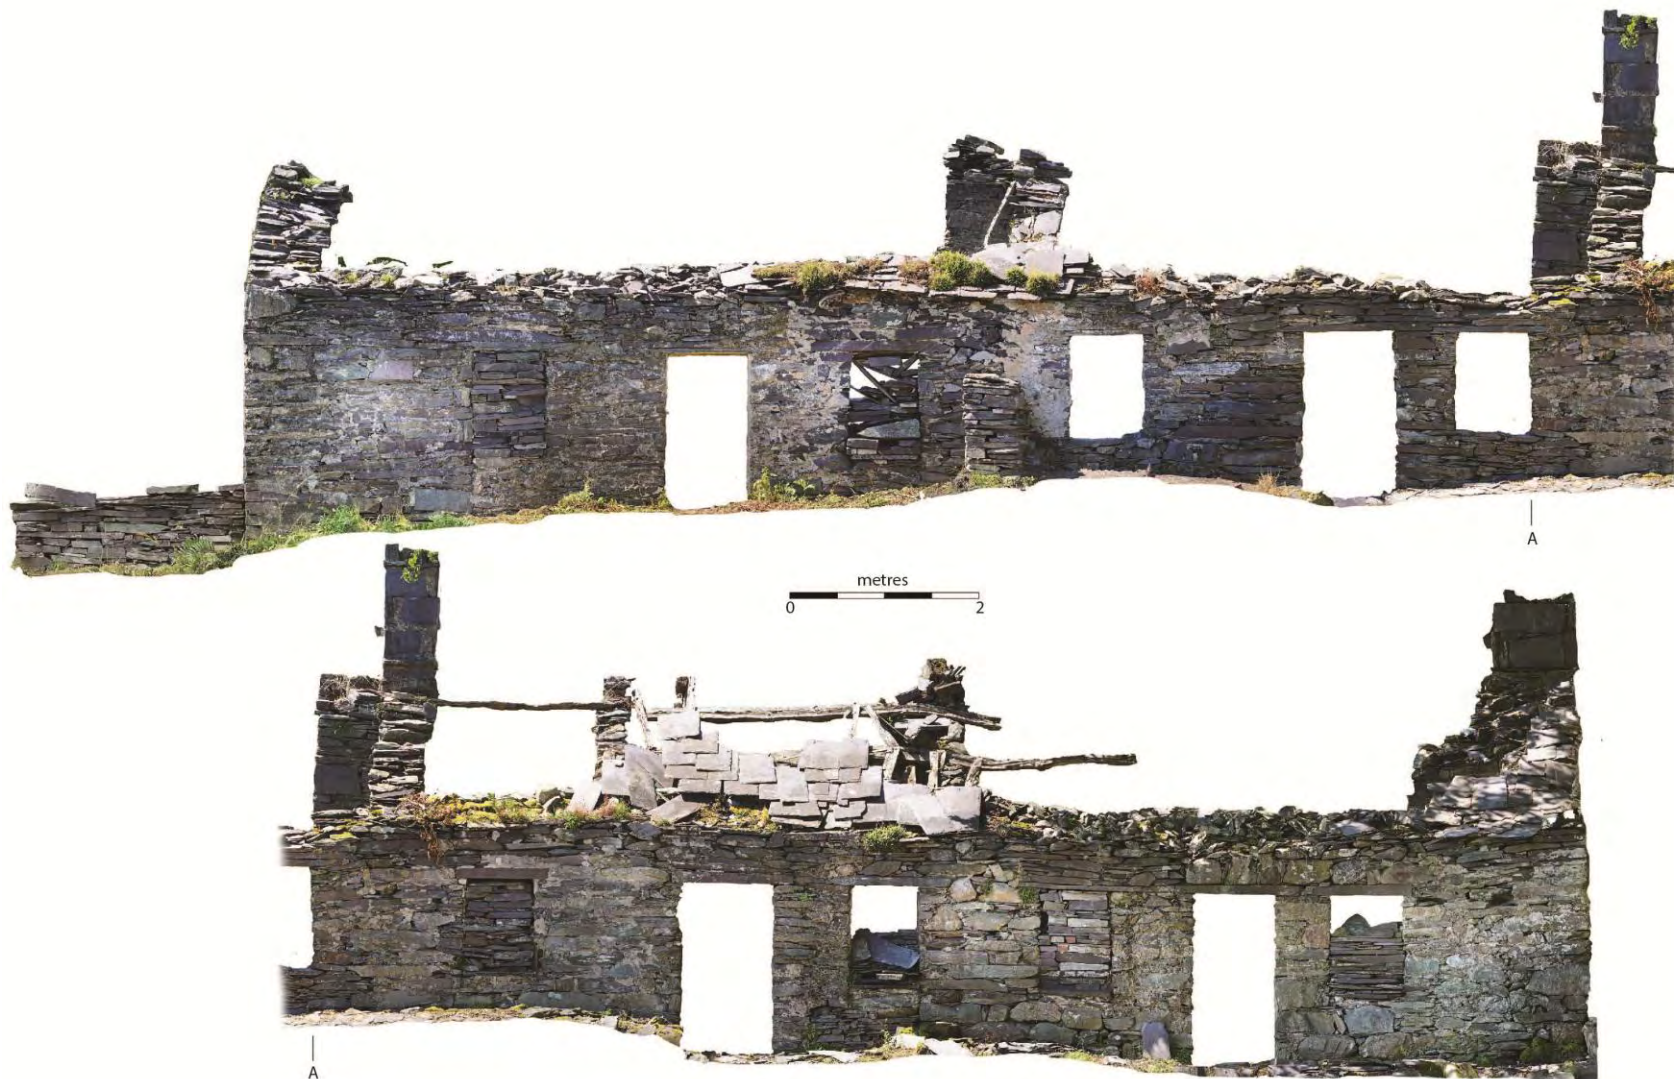
Figure 9. Orthographic projection from 3D model - ENE facing elevation

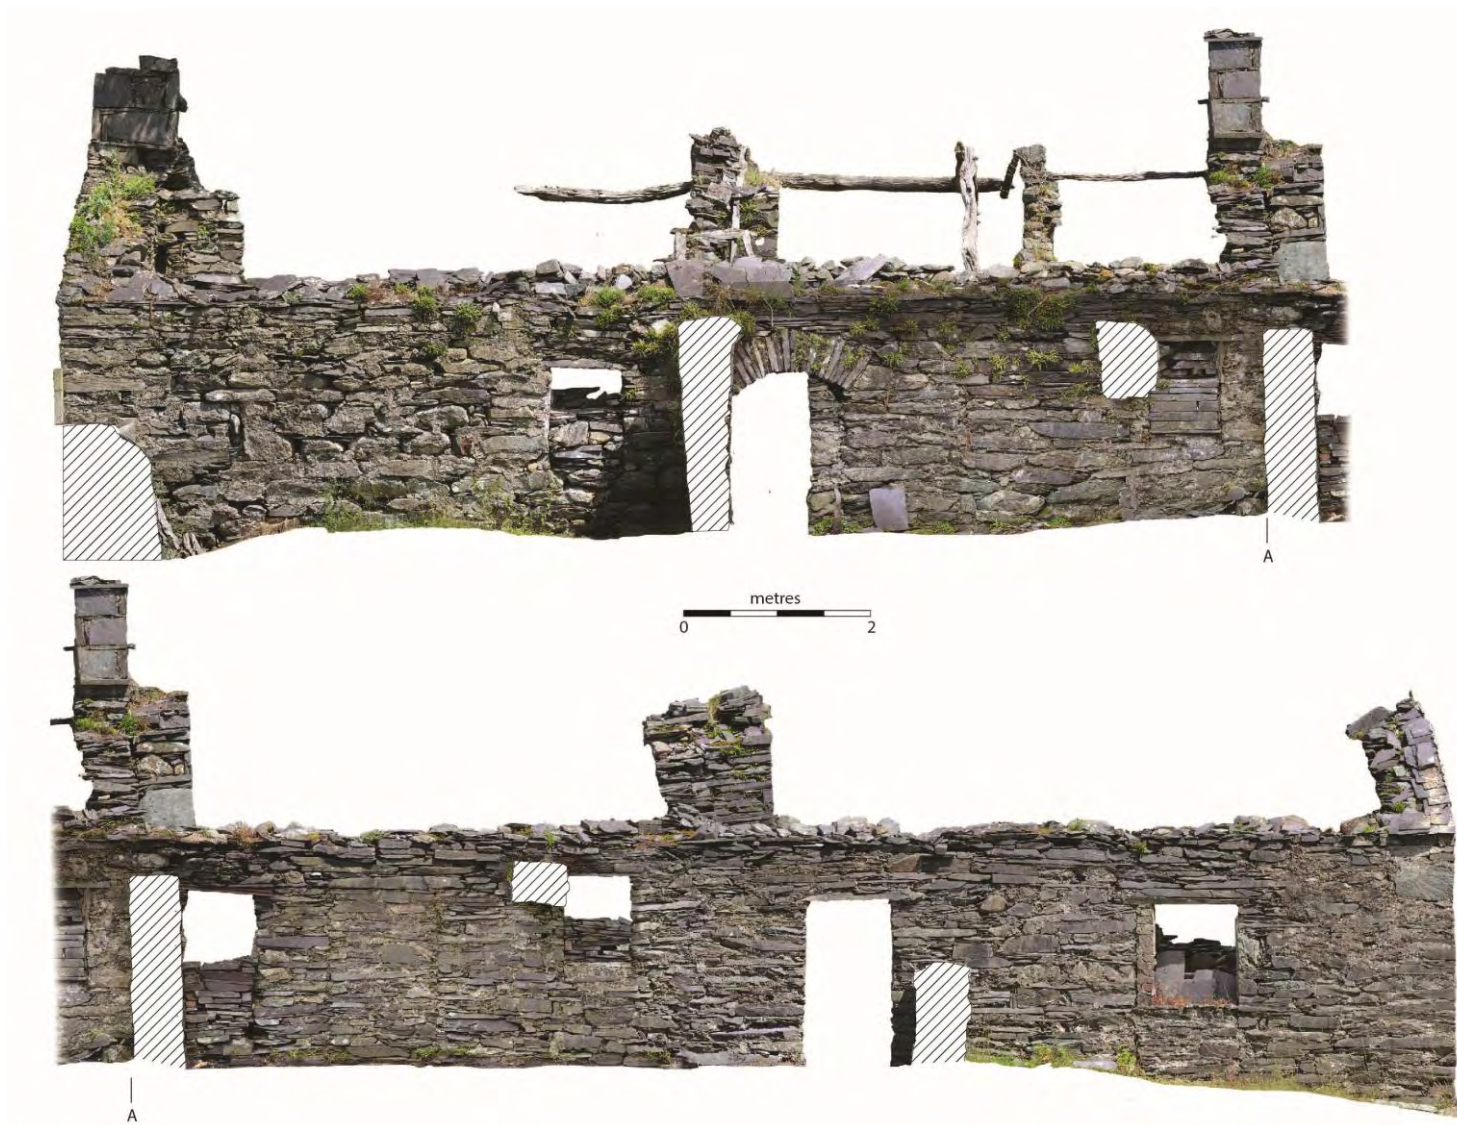
Figure 10. Orthographic projection from 3d model - WSW facing elevation without extensions

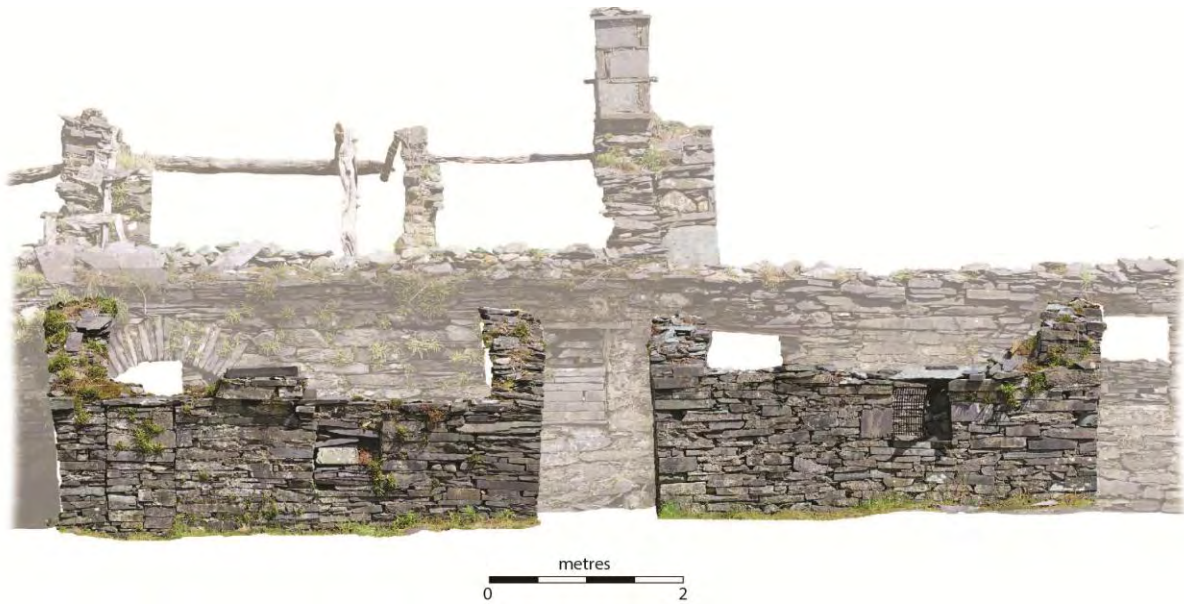
Figure 11. Orthographic projection from 3d model – WSW facing elevation of extensions

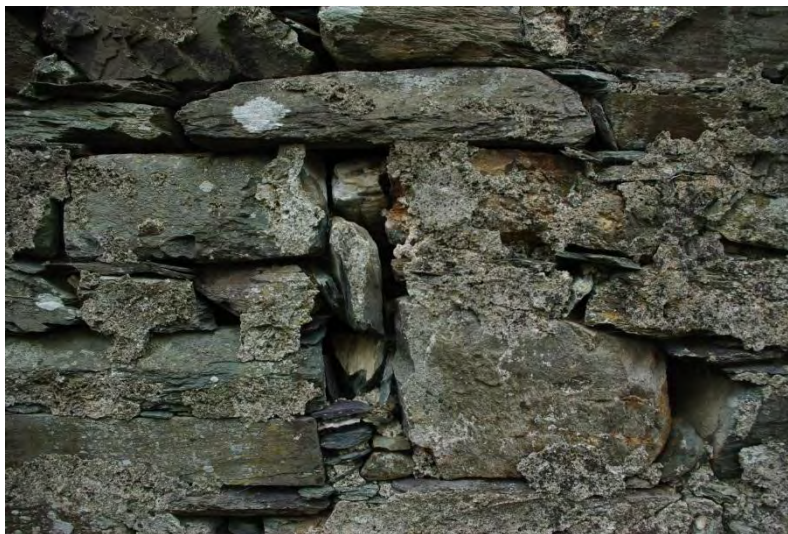
Figure 12. Slit window 1003

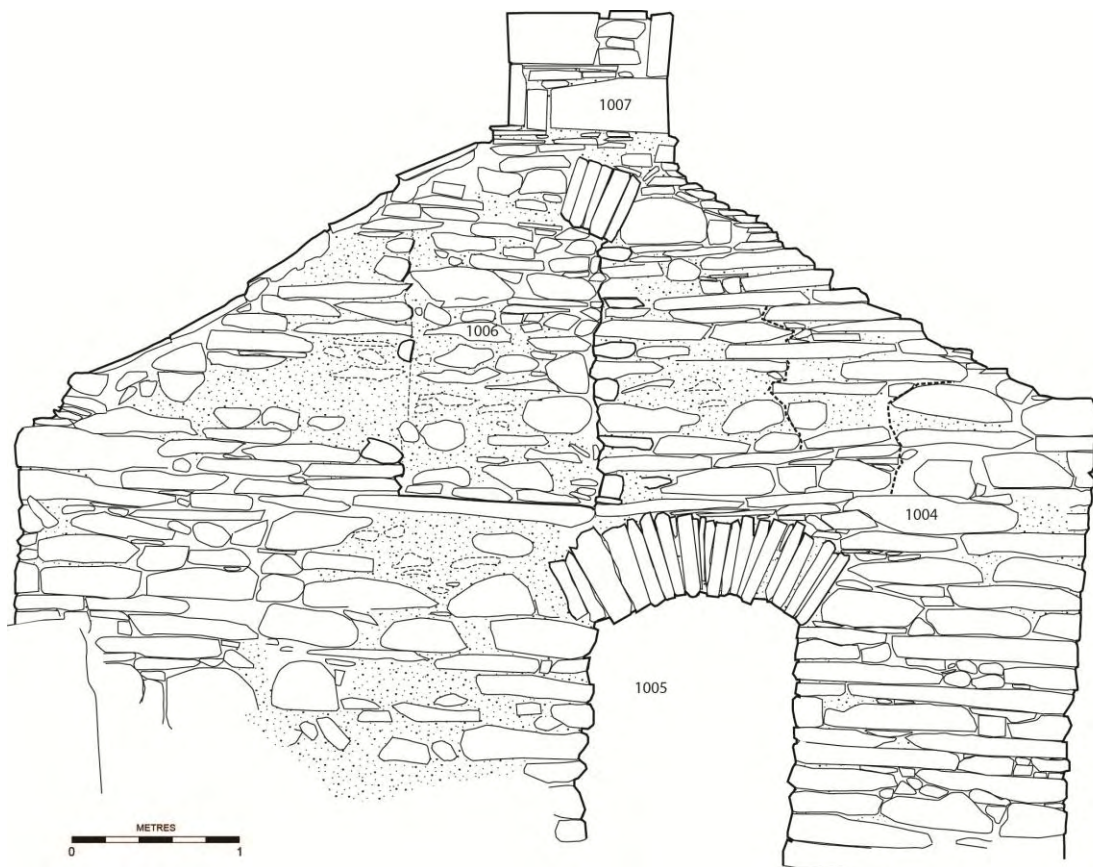
1004 The NNW gable end (Figures 12 and 13). The gable survives to its full height of 5.15m (including chimney) and is 6.8m wide. The gable is slightly asymmetrical with the chimney stack offset to the WSW by about 0.5m. The masonry is mortar bonded field-stone including some large slate slabs. There are two main phases visible. The first are elements of the phase I barn in the form of the majority of the masonry and two arched doorways 1005 and 1006 (see individual descriptions). The first floor doorway has been truncated with much of the arch having been lost. This demonstrates that the roof line was lowered after the door was blocked, probably in the conversion to the phase III barracks. The chimney stack is also a later phase III addition and is constructed from thick squared-off slate slabs and rubble. The first floor doorway is blocked with mortar-bonded field-stone masonry. The ground floor door is open and the ENE side stands behind the fireplace (see discussion in 1005). There has been some subsidence with some parts of the structure leaning to the WSW and cracks in the upper wall.

Figure 13. NNW gable end 1004 showing phase I doorways 1005 and 1006

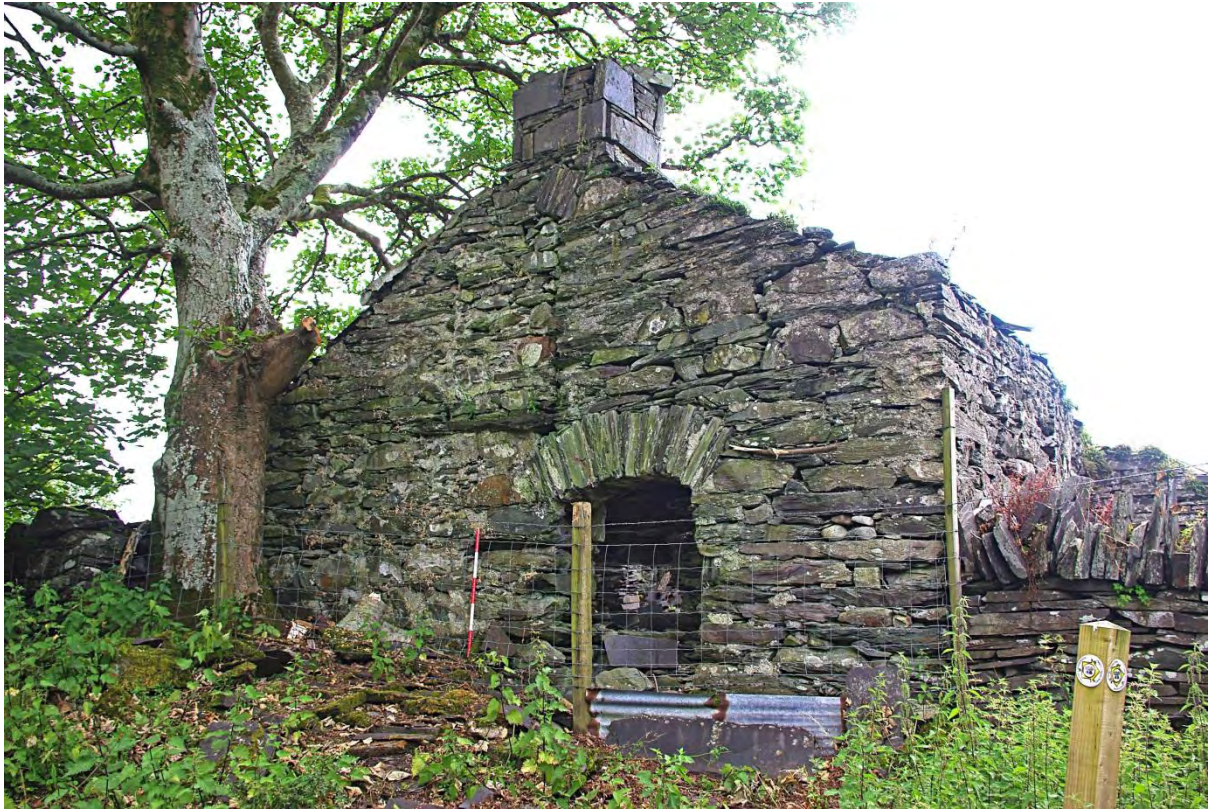
Figure 14. NNW gable-end of cottage 1

1005 Ground floor door in NNW gable (Figures 13-14). The doorway is 1.2m wide and a maximum of 1.6m high. The outside of the wall is supported by a segmental arch of rough slate voussoirs. This does not continue through the width of the wall and the inside is supported by a substantial oak lintel set level with the apex of the arch. Fireplace 1014 stands in front of about a third of the width of the door. Unlike the other cottages, the fireplace and chimney breast were offset to the ENE apparently in order to avoid covering the door completely. It is possible that the door continued in use even though it was partially obscured by the fireplace. This would have provided access to the lane. It may have been partly blocked in a similar fashion to door 2007.

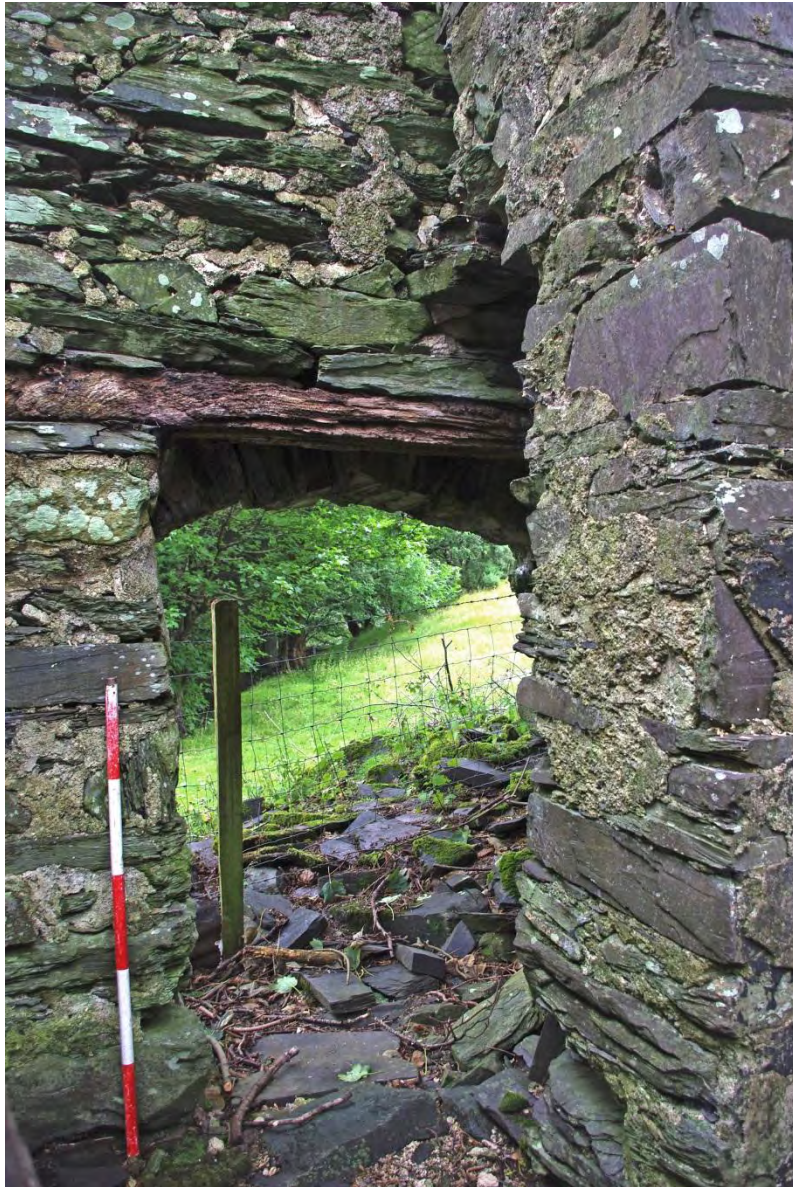
Figure 15. Blocked doorway 1005 showing oak lintel and corner of fireplace

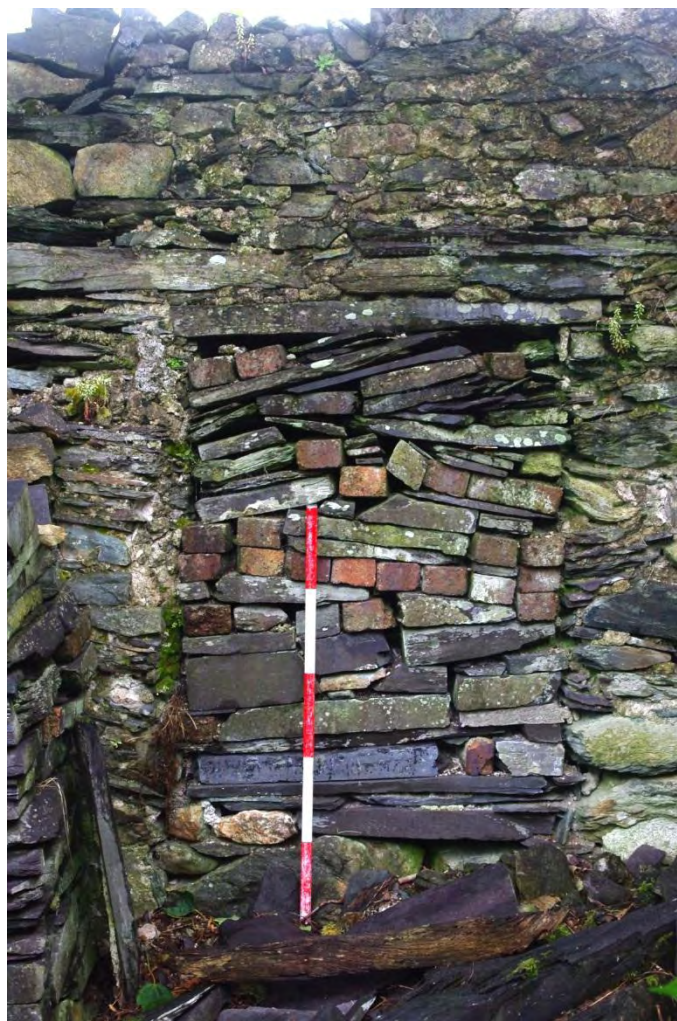
1011 Blocked window 0.77m wide and 1.1m high with slate lintel and sill (Figure 15). Completely blocked with slate waste and bricks (phase V). Patches of infilling around the window with small pieces of slate are an indication that it was inserted in phase III.

Figure 16. Blocked window 1011

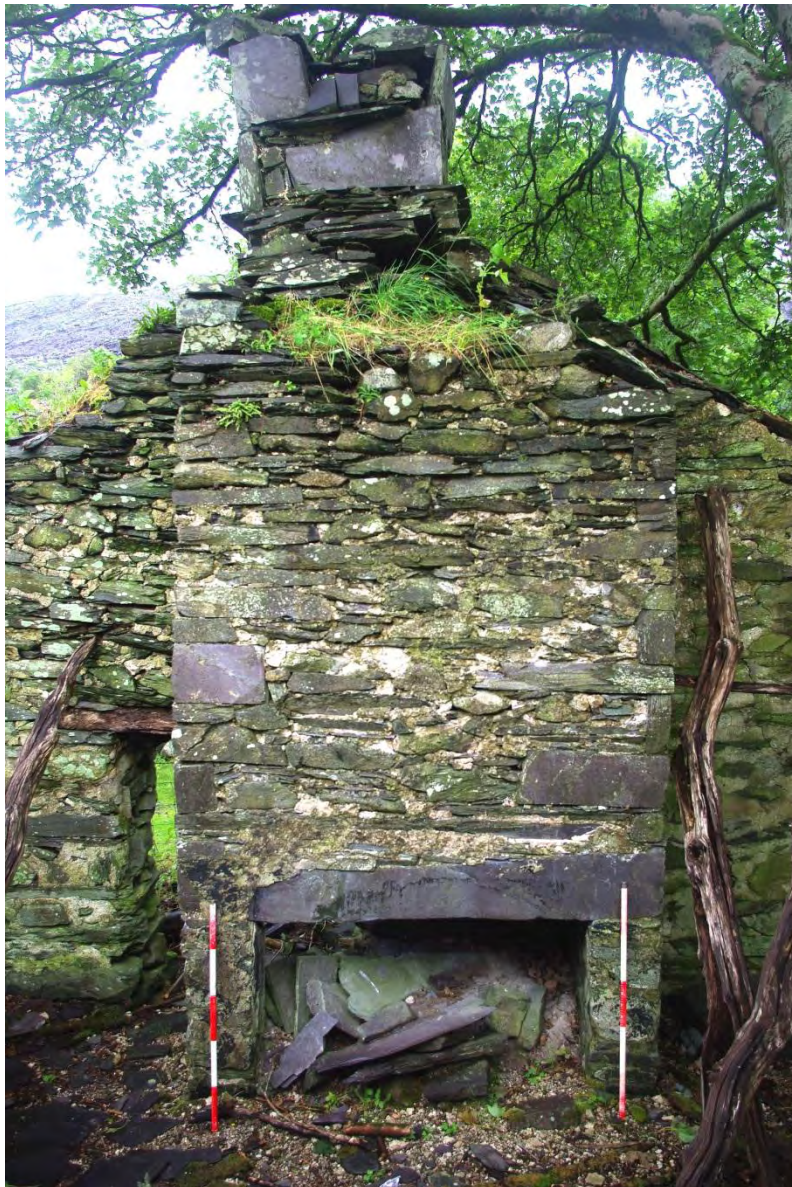
bituminous paint. The chimney breast and flue were built against the existing end wall of the building and were only minimally tied in with occasional stones set into the gable end. The WSW side of the chimney breast has moved forward and away from the wall forming a substantial bulge and appears to be on the point of collapse.

Figure 17. Fireplace 1013 and chimney breast 1014

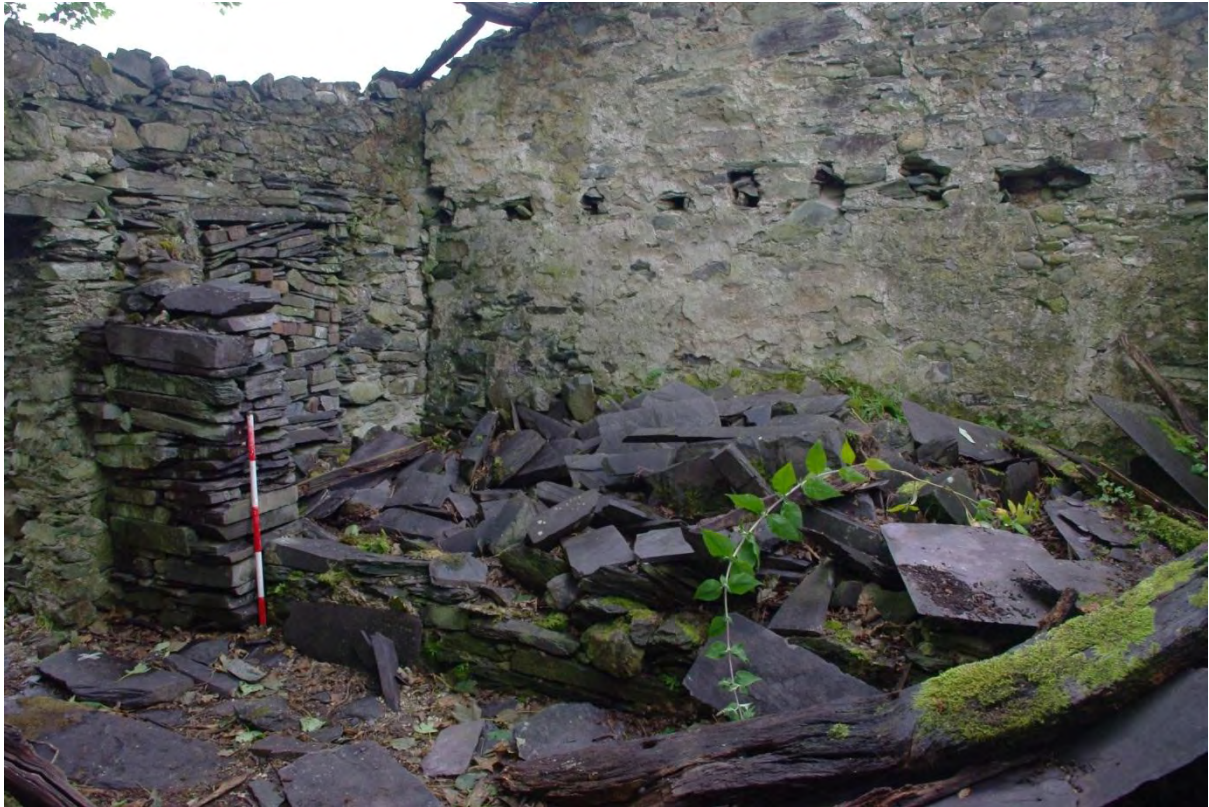
1015 The cottage was divided into two by a narrow slate wall with doorways forming a crog-loft. The wall was lightly built out of small slate slabs and was 0.4m thick. There were 0.8m wide doorways at either end. The wall has collapsed into the SSE end of the cottage leaving a stub up to 0.4m high. The ENE doorway had been blocked (Figure 17).

Figure 18. Collapsed dividing wall 1015. Note sockets for crog-loft joists

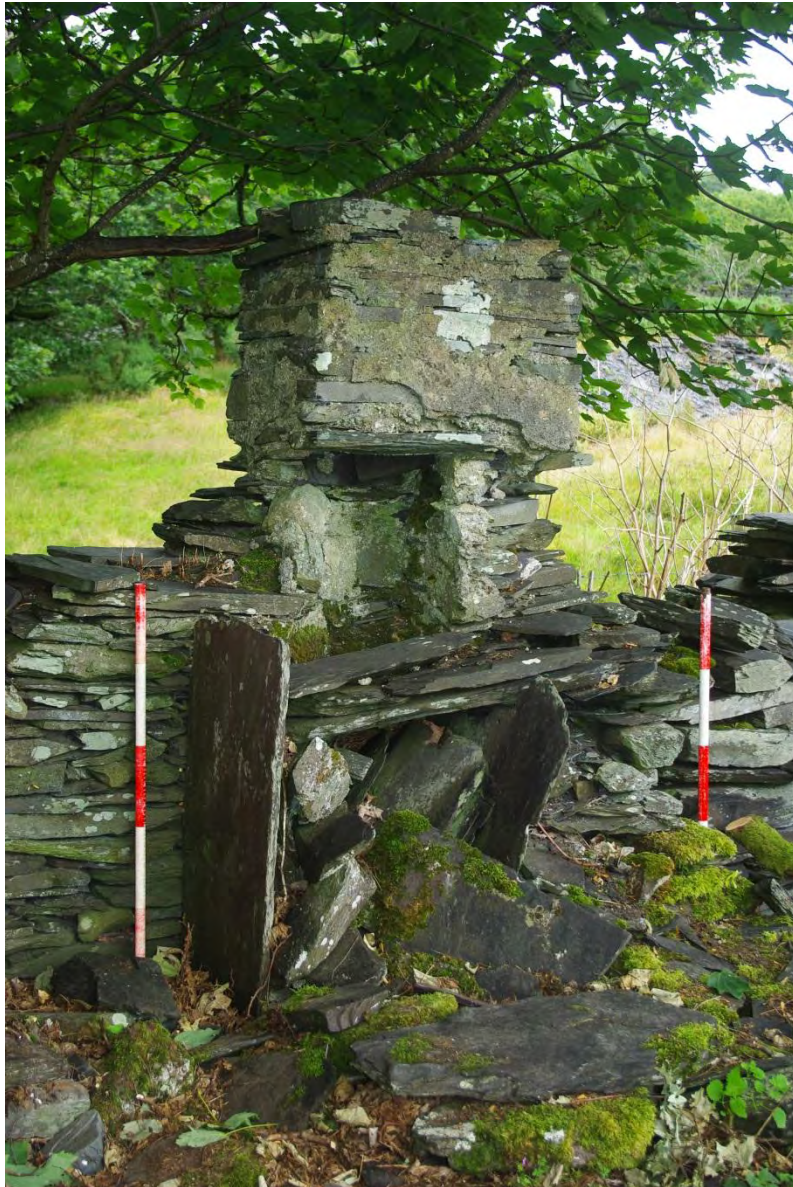
1018 Cottage 1 extension. The kitchen is shown on the 25" county series maps. The NNW wall survives but much of the rest was demolished in the 1950s. The WSW wall to the N of the cottage has been pushed over by a mature sycamore tree. Much of the area was obscured by brash when the site was surveyed.

Figure 19. Cottage 1 extension 1018, showing fireplace 1019 and upright slab 1020

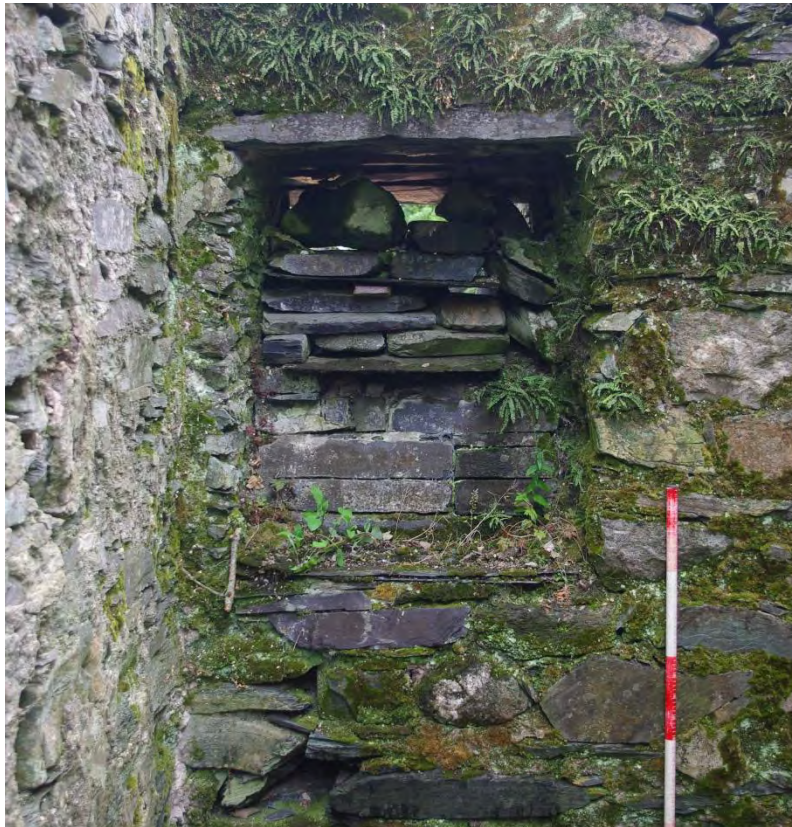
2003 Partly blocked window (Figure 19) in the WSW end of smallest room. It was originally 0.77m wide and 1.38m high. The lower half was neatly blocked with mortared slate blocks leaving a 0.27m wide sill on the inside. Mortar bedding for a window-frame survives in the reduced aperture. This was subsequently infilled with rough slate in phase V.

Figure 20. Partly blocked window 2003

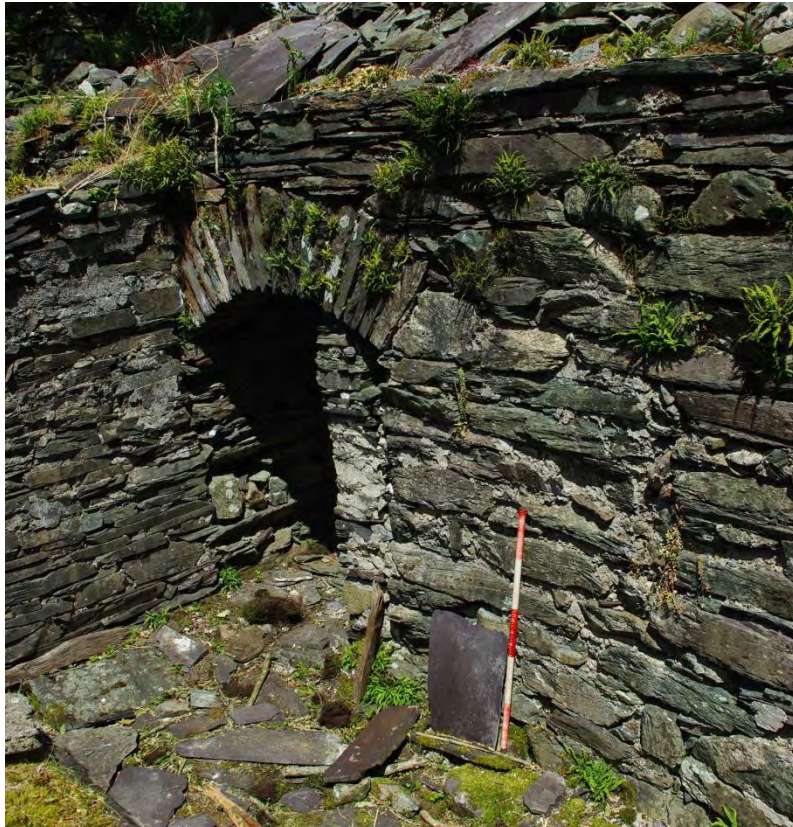
2007 Arched doorway (Phase I, Figure 20) The doorway is 1.32m wide and a maximum of 1.69m high. The outside of the wall is supported by a segmental arch of rough slate voussoirs (photo 079). The arch does not continue through the width of the wall and the inside is supported by a rough slate lintel set level with the apex of the arch. The door is partially blocked by 2008.

Figure 21. Outside of arched doorway 2007

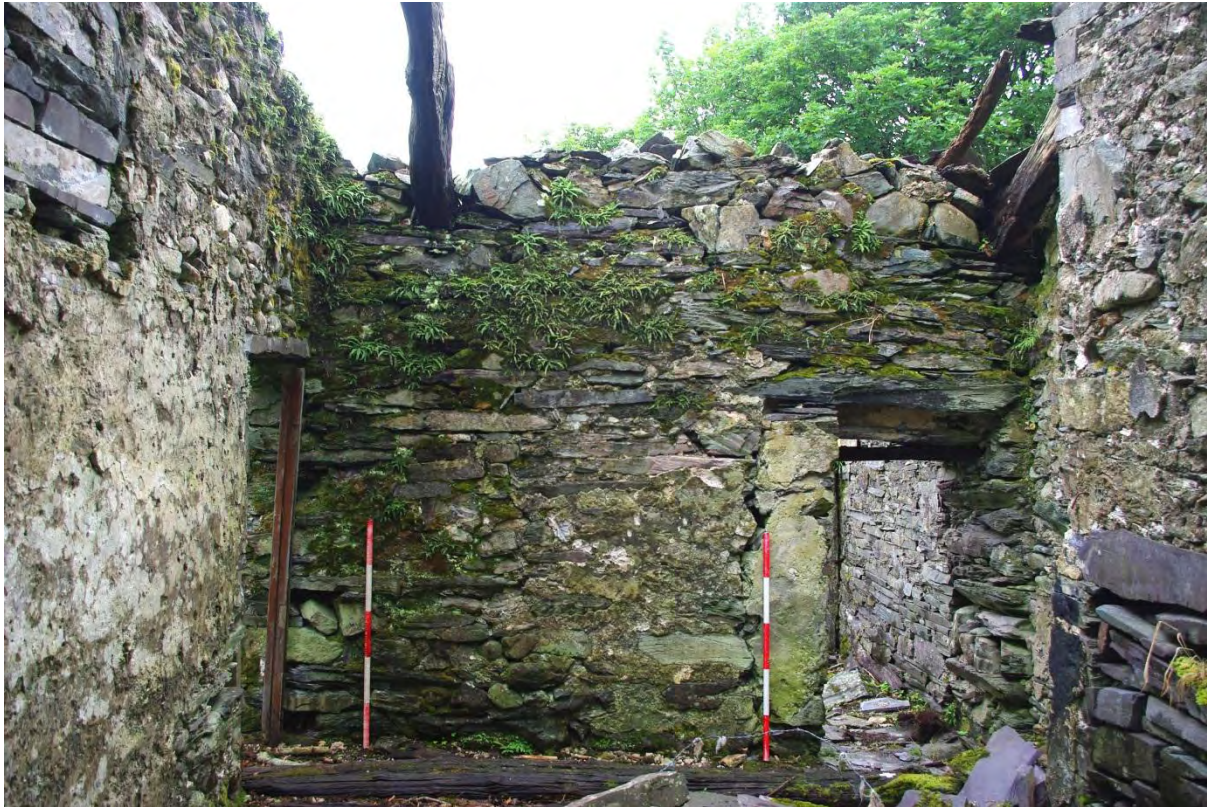
2008 Partial blocking of doorway 2007 (Figures 20 and 21). The SSE side of doorway 2007 was blocked by a narrow wall reducing the width of the doorway to 0.88m. The blocking was constructed from mortar bonded slate and fieldstone. An additional slate lintel and a length of iron rail reduced the height of the doorway to 1.43m. It is presumed that this was constructed at the same time as the phase IV extension.

Figure 22. Inside of arched doorway 2007 showing blocking 2008 and slate lintel

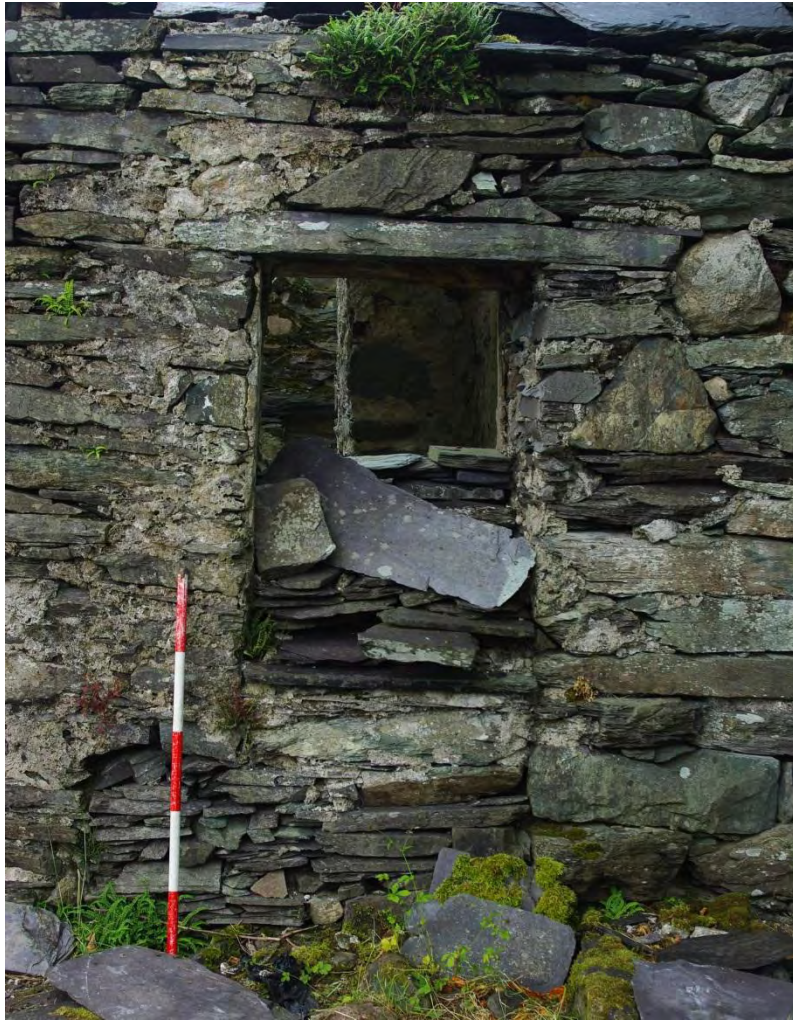
2011 Partially blocked window/doorway (Figures 22 and 23). This is a phase III window 0.75m wide and 1.05m high with slate external lintel and sill and partially blocked with phase V (pigsty) dry-slate. The window retains elements of a phase I feature, almost certainly a doorway. There is a straight joint in the external wall running from the NNW side of the window to the ground (Figure 22). The masonry to the SSE side of the window is partially rendered and includes a crude, apparently recent repair to the lower wall. The inner face (Figure 23) retains an oak lintel, similar to that over doorway 1005, that extends to the SSE of the window and corresponds to a straight joint in the lower wall 0.4m from door 2014. It seems likely that this is the remains of a phase I door with the lintel intact but with the arch over the outside of the door having been removed in the conversion to cottages.

Figure 23. Remains of phase I doorway 2011 in ENE wall. Note straight joint below window

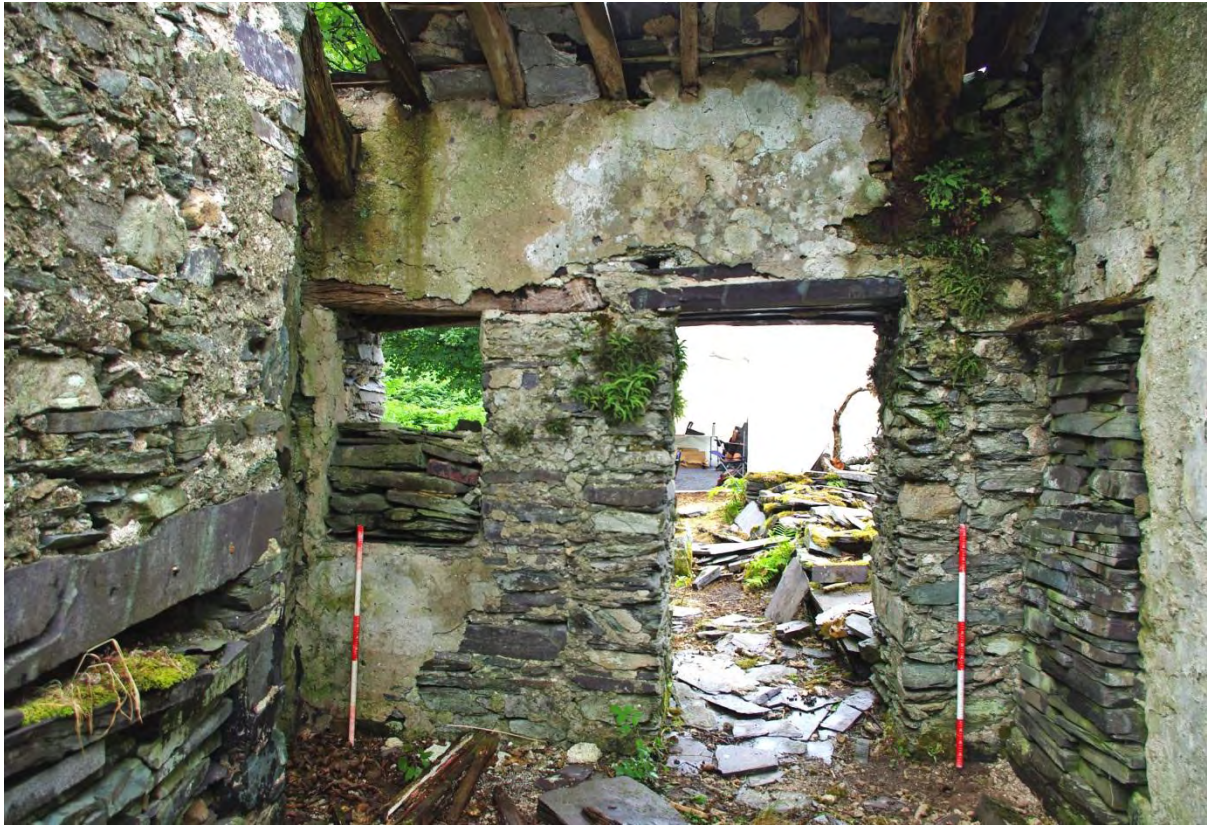
Figure 24. Interior of ENE wall of cottage showing blocked phase I doorway and oak lintel

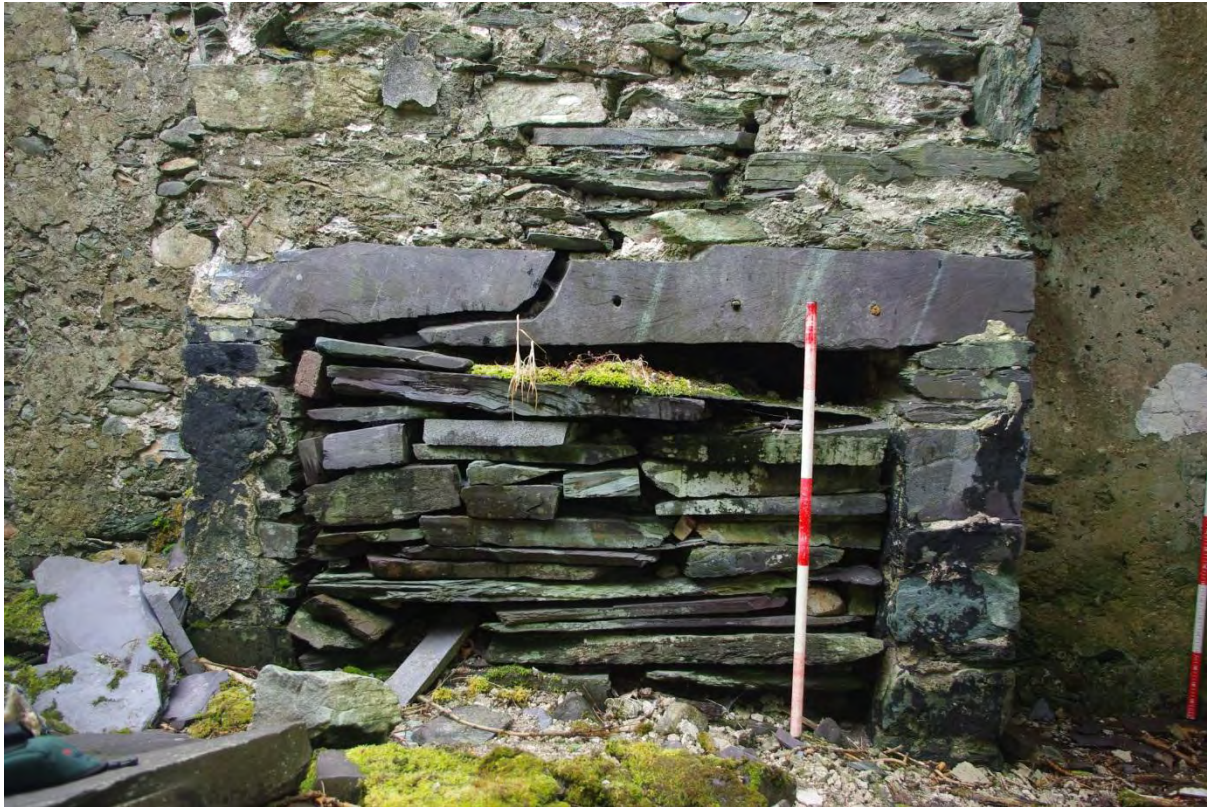
2016 Fireplace in cottage 2 (Figure 24). A fireplace with a vertically set slate-slab lintel which has broken into two. The lintel has three drill holes set asymmetrically into it that presumably held either a decorated fascia or apparatus over the range. The uprights are plastered and covered with black paint. The opening for the fireplace is 1.5m wide and 1.0m high and has been blocked with unmortared slate slabs, presumably to prevent the lintel from collapsing. The blocking appears to be a phase V addition. The chimney breast is of field stone and slate and appears to be of one build with the wall of the cottage (2015). The chimney stack has mostly collapsed.

Figure 25. Fireplace 2016

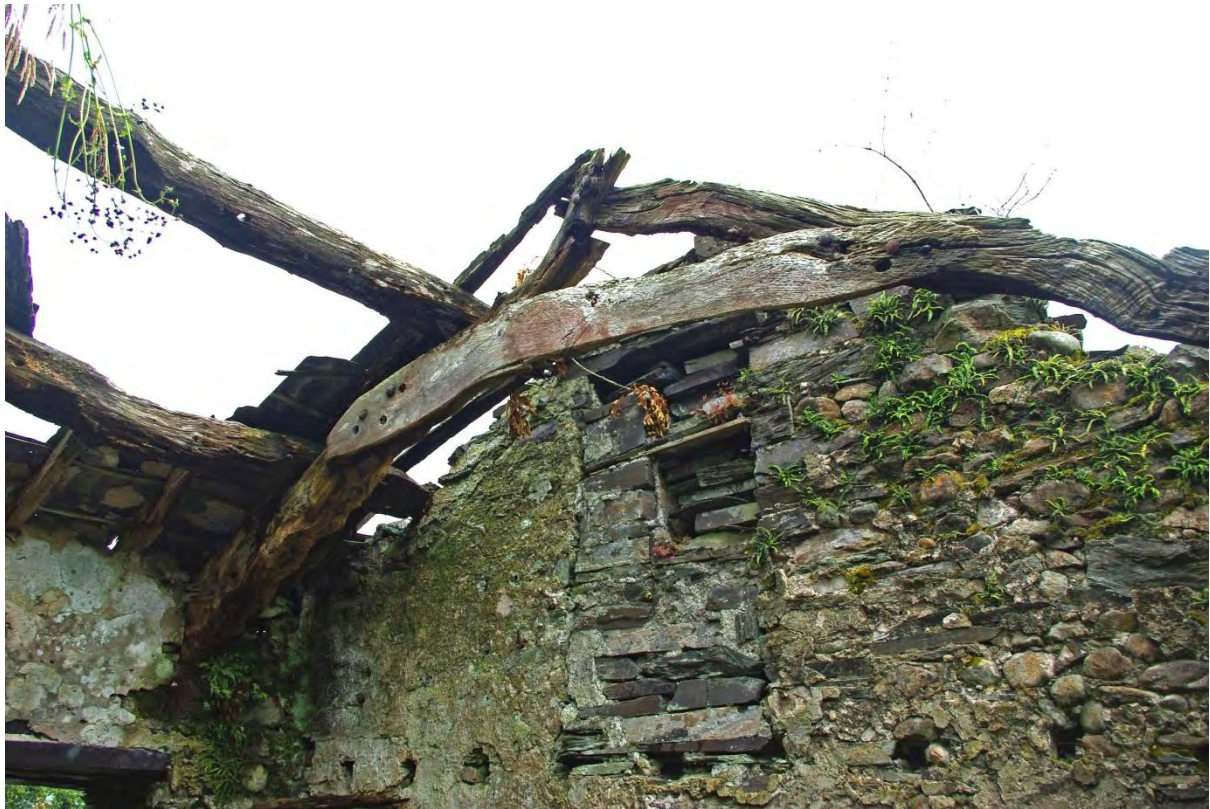
2022 Roof timbers (Figure 25) - Some roof timbers survive in cottage 2. A much modified oak truss survives in the SSE end of the main room. The bases of the rafters spring from about 0.7m from the top of the wall but appear to have been reset and are bolted together at the apex. A tie beam is bolted onto the rafters to form a simple A frame. Purlins run to two rafters at the opposite end of the room that have been incorporated into the chimney-breast. A few fragments of common rafters and battens support slates on the lower part of the roof. The underside of the slates show evidence of lime torching. The bolts tying the roof timbers together are hand-forged and threaded.

Figure 26. Roof timbers 2022 and blocked crog-loft door 2020
