# Pen y Bryn Barracks Nantlle

Community Excavation and building recording

Project No. G2593

Report No. 1539

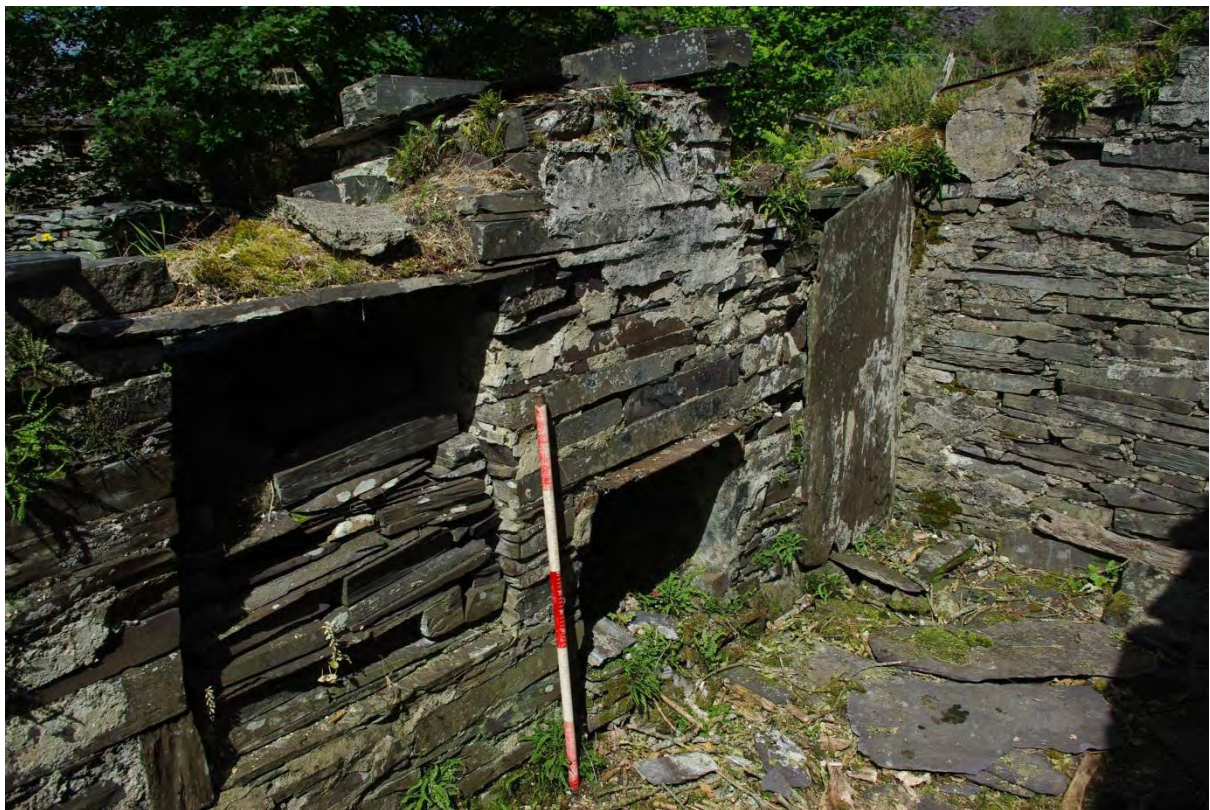
Figure 27. WSW wall of extension 2006 showing fireplace 2006 window 2002 and blocked door 2001

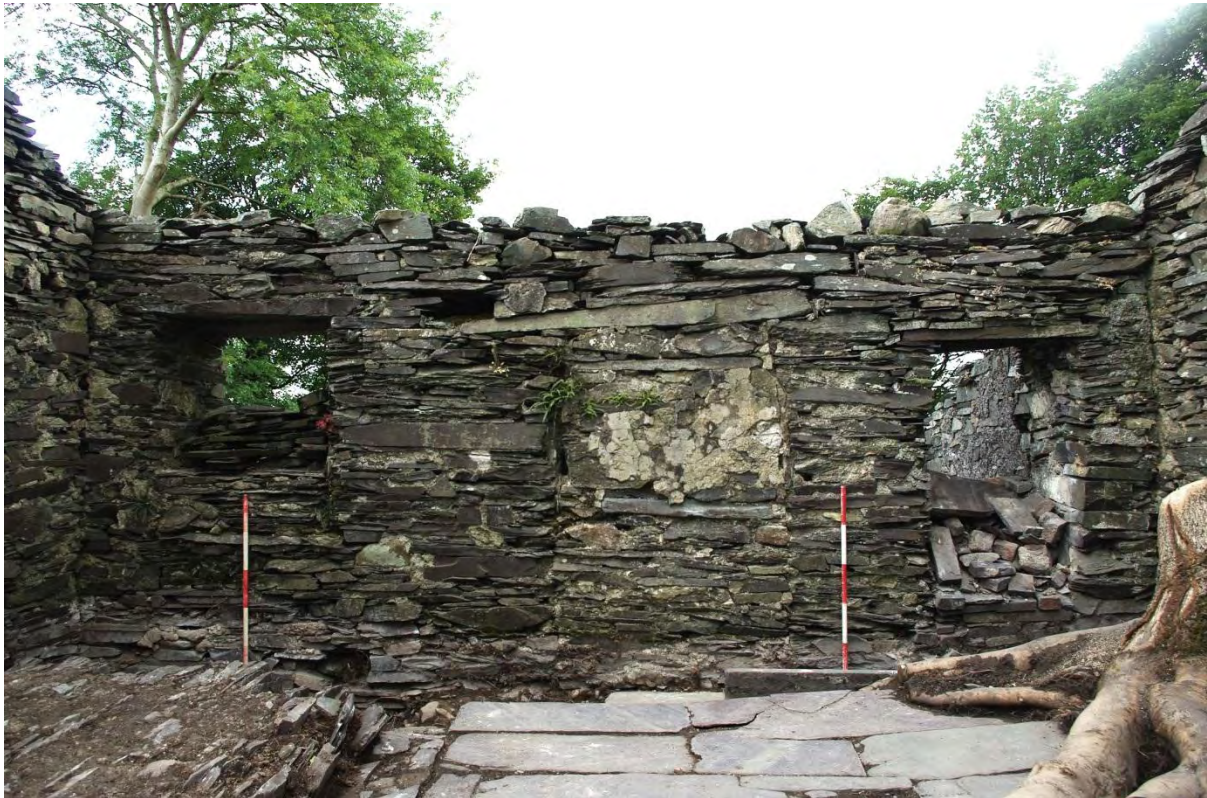
3014 Partially blocked door leading to extension (Figure 28). The doorway is 0.73m wide and 1.73m high with a slate lintel in the interior and lengths of bridge-rails in the exterior. The blocking is phase V piled slate and brick to a height of 1.05m, well preserved on the exterior but collapsed and failed from close to the base in the interior. The collapsed material contained several pieces of slate with incised initials and one small piece with concentric circles. These were presumed to have come from the fireplace. There were also iron fire-bars in the blocking.

Figure 29. Blocked phase II doorway 3015 centre and doorway 3014 (R) and window 3016 (L)

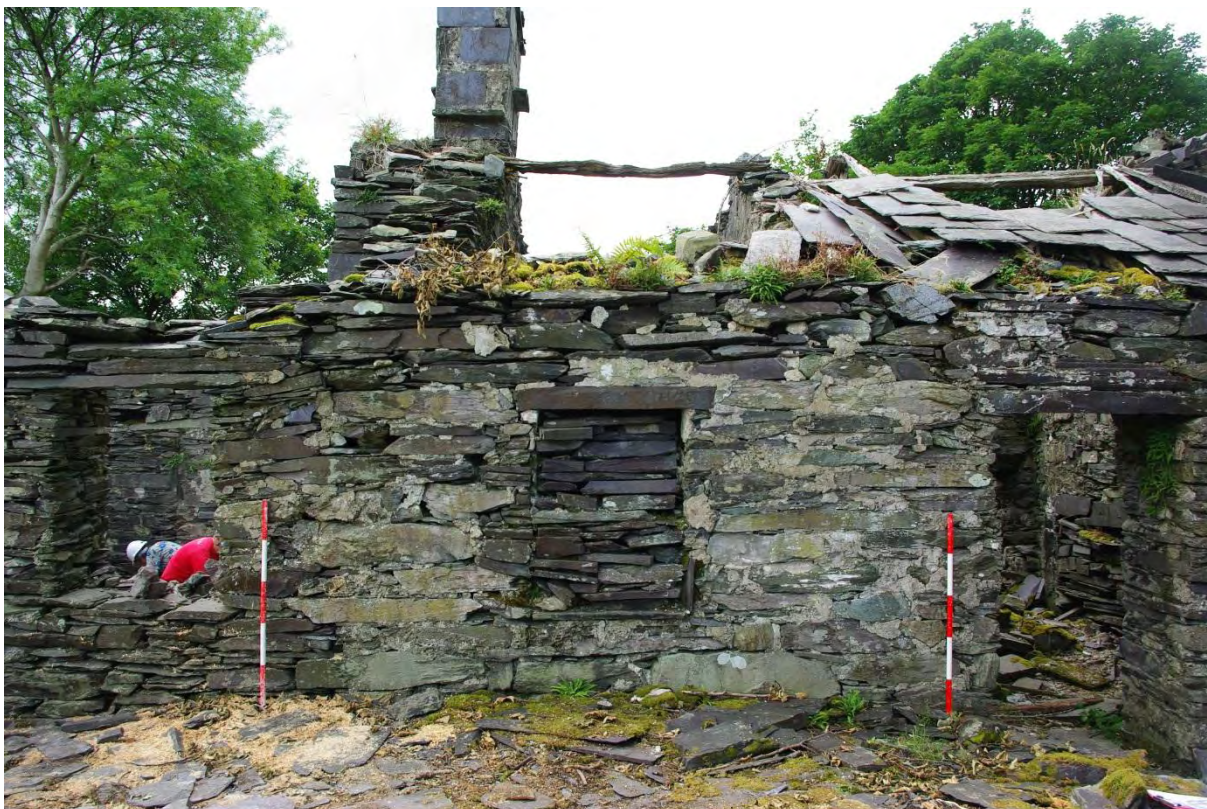
Figure 30. ENE wall of cottages 2 and 3 showing change from field-stone masonry to slate (at L scale)

3032 The ENE wall of the cottage. The wall, in contrast to the fieldstone masonry of the phase I barn, is constructed almost entirely from slate that appears to be waste from the quarry. It is mortar bonded and of one build with cottage 4. The inner face of the wall abuts the dividing wall between cottages 2 and 3. There is however no corresponding joint in the outer face. Here the phase I masonry is bonded with the phase II or III slate masonry photo 141 or elevation. The wall contains phase III inserted windows 3026 and 3031 and doorway 2039.

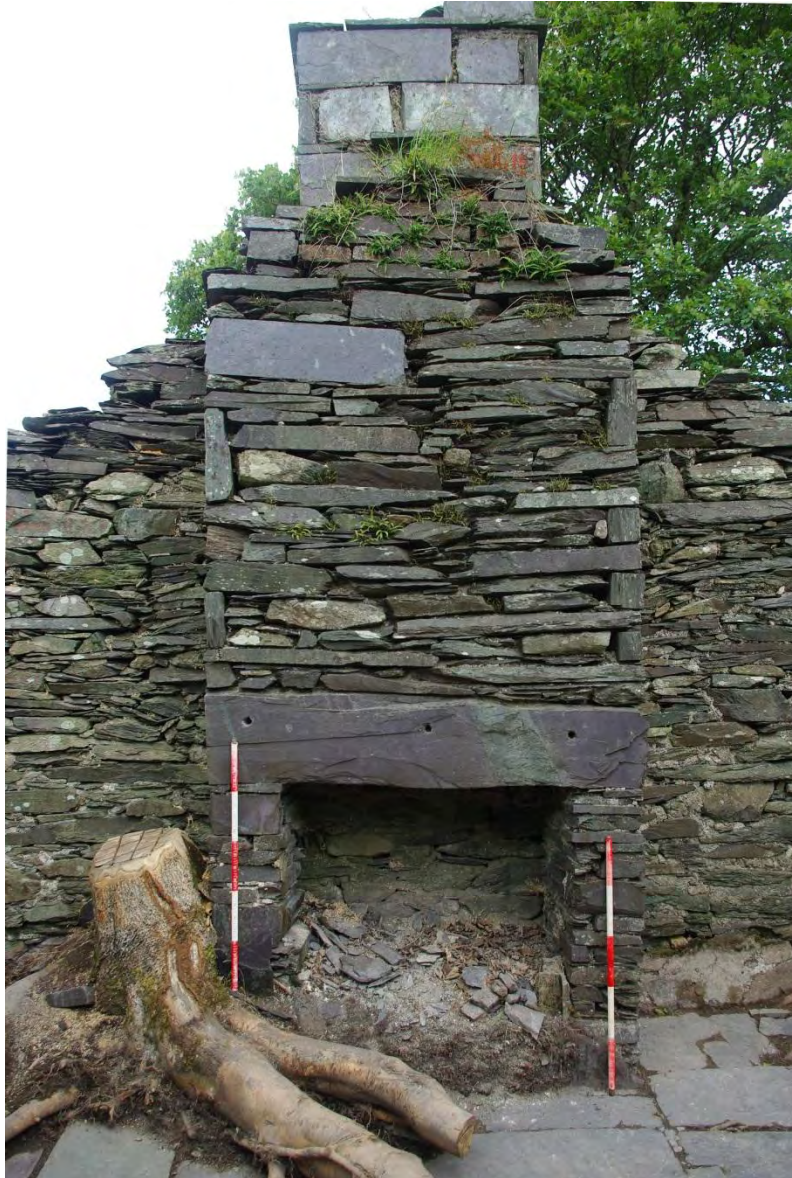
Figure 31. Fireplace 3041

3041 Fireplace cottage 3 (Figure 30). The fireplace and chimneybreast and chimney appear to have been built against the dividing wall 3050. The fireplace and chimney-breast are 1.7m wide and set centrally against the dividing wall. The opening for the fireplace is 1.15m wide and 1.15 high. The lintel is a large, thick edge-set slab of slate with three holes drilled in it. The fireplace had a decorative slate slab surround. Broken off stubs remain on both sides along with an iron fixing on the left upright and the holes in the lintel. Several fragments of incised and carved slate slabs were found in the material blocking door 3014 and John Williams recalls that there was a decorated

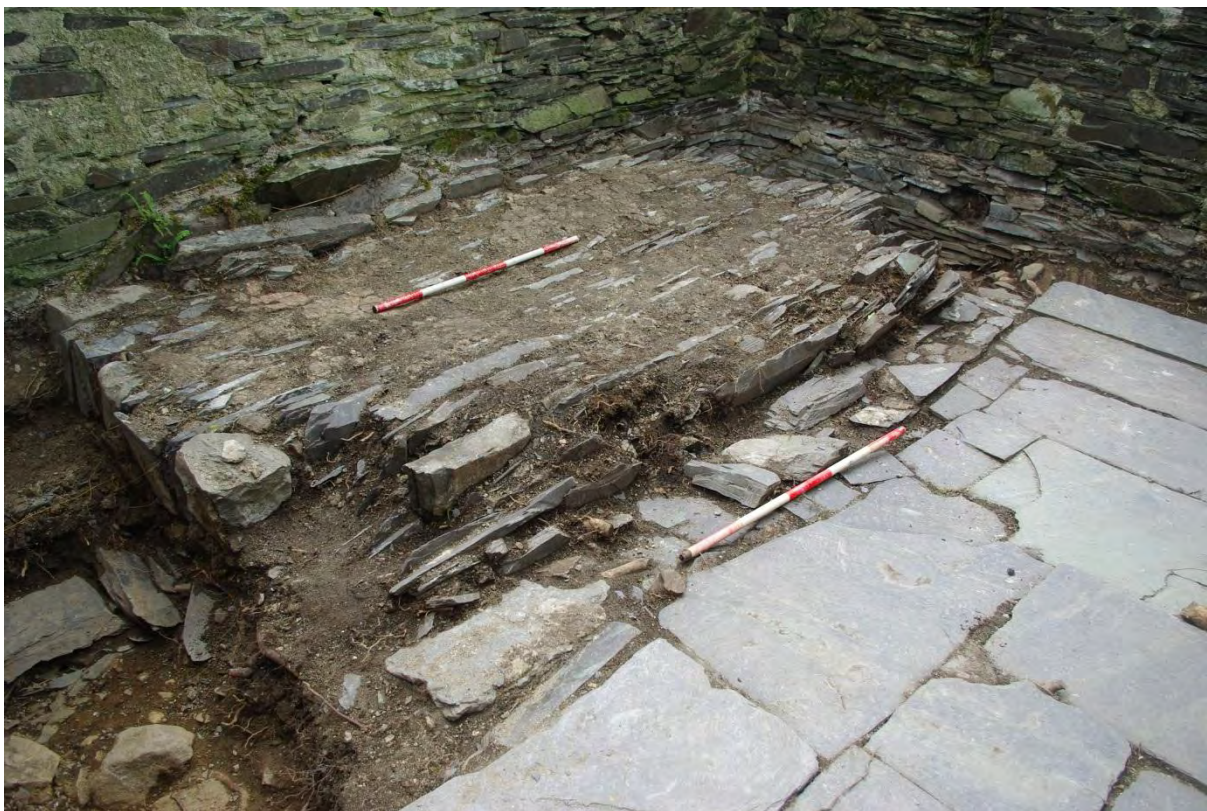
Figure 32. Fallen dividing wall 3006

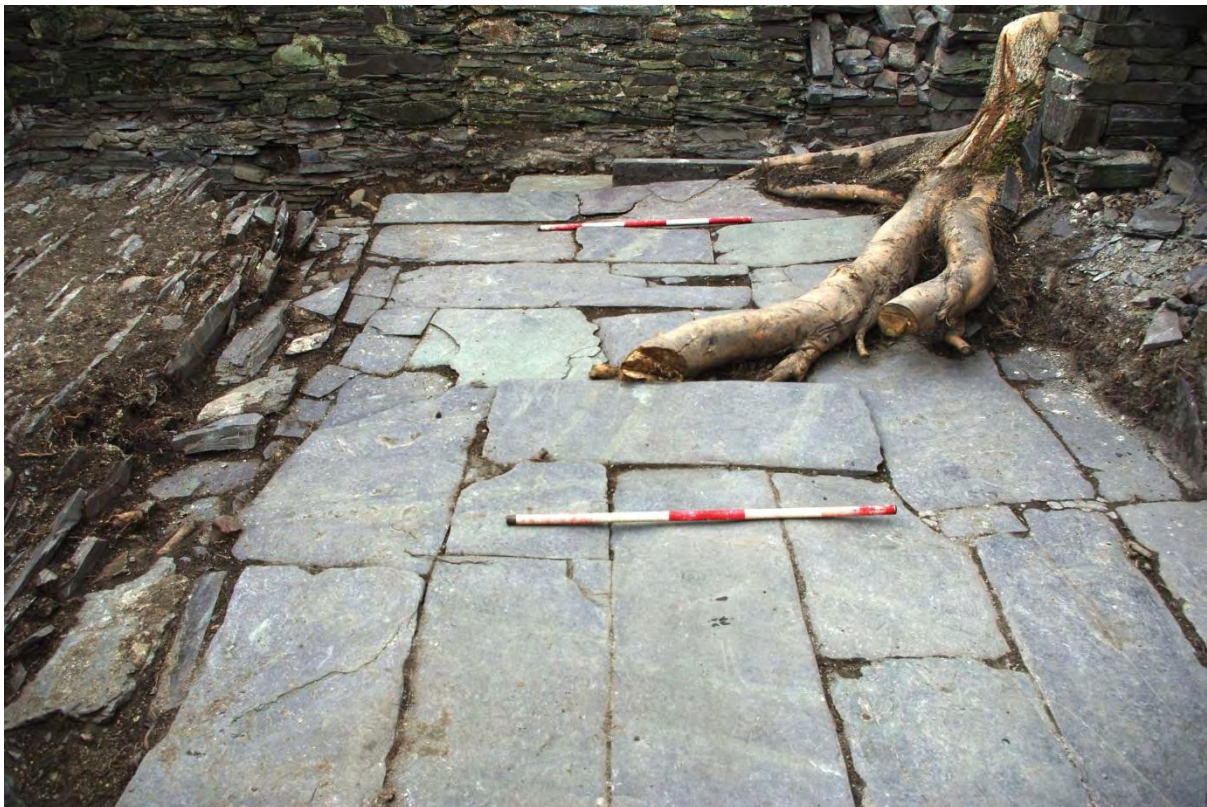
3007 The cottage floor in the main room at the NNW end of cottage 3 (Figure 32). This was an almost intact floor of large mostly blue slate slabs but including one purple slate and two green slates similar to the phase II slab (3036). The slabs are mostly rectangular with dimensions of up to 1.7m x 0.6m. Irregular or broken slates are infilled with smaller fragments. The floor does not continue as far as the WSW wall and the associated features along the wall.

Figure 33. Slate floor 3007

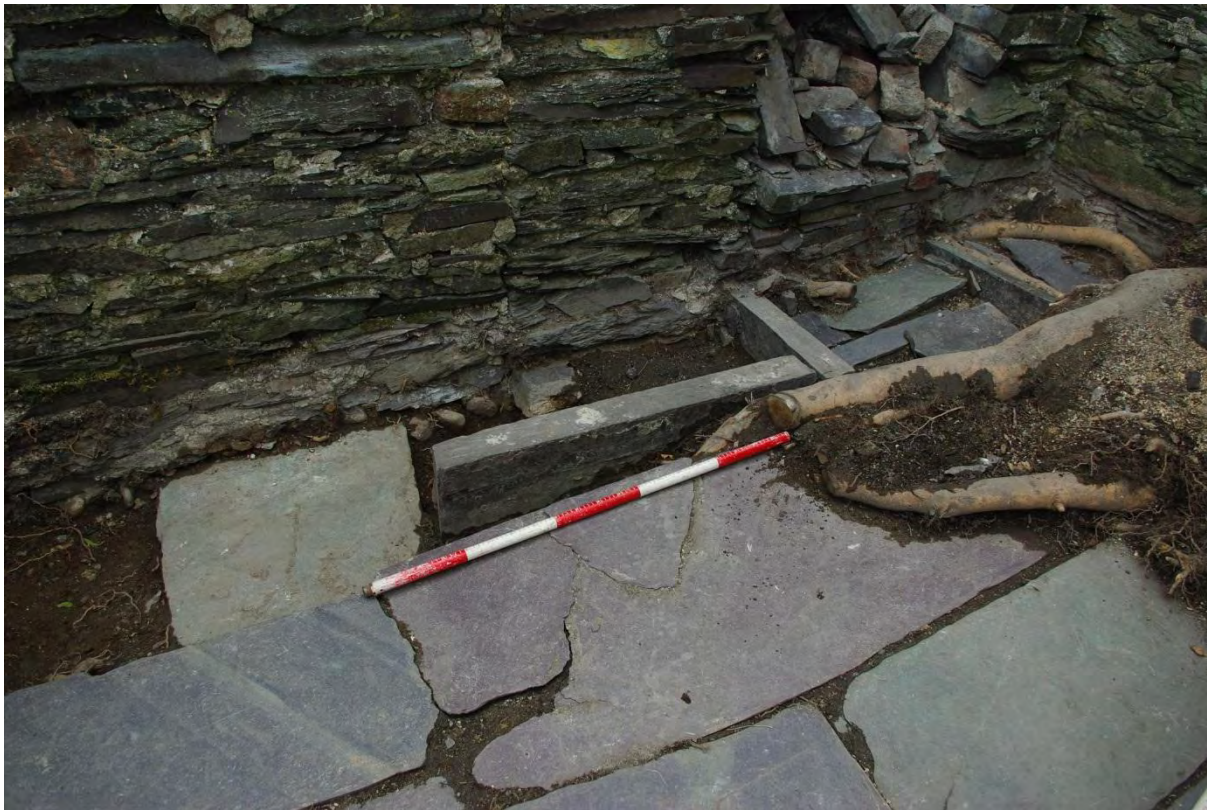
Figure 34. Phase II slab 3036, slate base 3022 and remains of steps 3037

3036 A large greenish slate slab runs beneath both the blocking in door 3015 and the slate cottage floor. This is part of the phase II floor (see Figure 33).

3037 Two edge-set slates and a series of roughly horizontal slabs are aligned with door 3014. This appears to be the remains of steps down into the extension (Figure 33).

3022 A 0.095 wide and 1.0m long carefully squared-off edge-set slab abuts the edge of the side of the steps at a right-angle (Figure 33). This and the side of the steps were clearly set at the same height and set level about 5cm above the floor as evidenced by paint on the side of the slab. The function of this feature is not clear but it might be suggested that it formed part of a level base for a piece of furniture or other item of household equipment, perhaps in order to lift it above the damp floor. The hollow against the wall was filled with cinders and household rubbish (3027 and 3013). There are presumably missing phase III/IV elements here as it is unlikely that there would have been a large hole in the cottage floor.

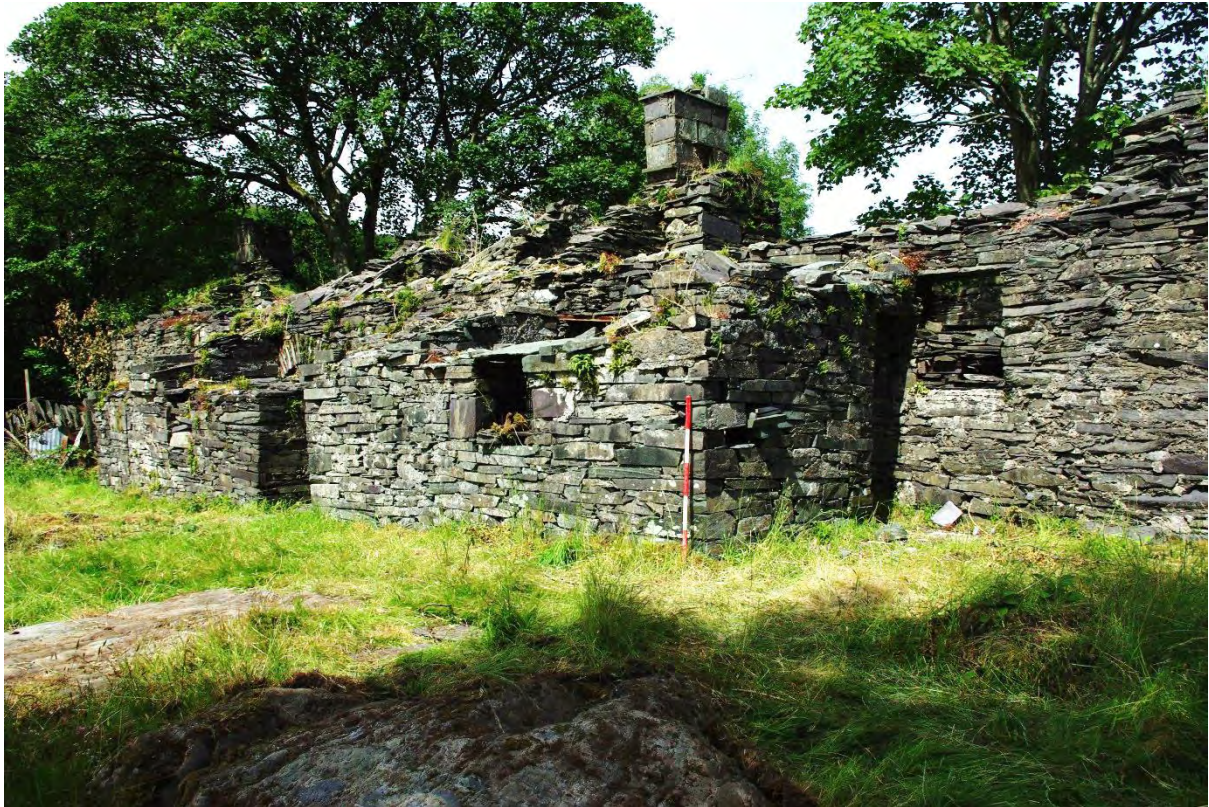
Figure 35. General view of the extensions to cottages 2 and 3

A monopitched lean-to extension 3.6m x 2.3m internally (Figure 34). Walls 0.6m thick of roughly mortared slate slabs and blocks. The interior and yard to the SSE were excavated by hand revealing slate flooring and paving.

3008 A blocked window set into the WSW wall. The window is 0.63m wide and c. 0.64 m high. No lintels survive. The window has been blocked with a plastic coated wire crate or basket and roughly piled stone. Several slabs have been placed on top of the blocking but the original upper wall has been lost (Figures 10 and 34).

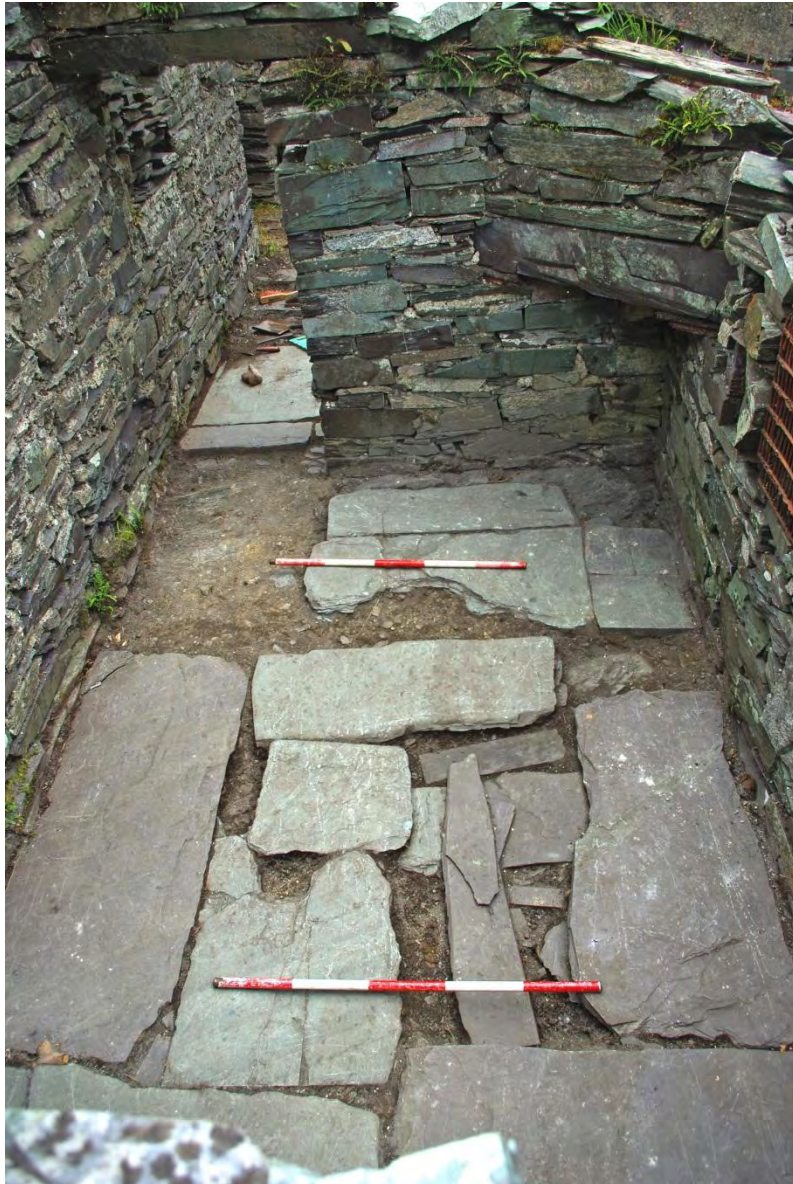
3009 A fireplace set into the corner of the extension. A 1.0m long slate lintel cuts the corner of the building with the wall carried above it to form the chimney. Rusted metal bars can be seen beneath the lintel. John Williams reports that there was a boiler in this corner in the 1950s (Figure 35).

3025 Slate floor of extension (Figure 35). Slab floor of sub-rectangular green and blue slates. There are several slates missing. Two slates have rough semi-circular holes in their edges, possibly deliberately made although their purpose is unclear. The surfaces of the slates were worn and pitted possibly as a result of slates or other objects falling on them.

Figure 36. Cottage 3 extension showing slate floor 3023 and corner fireplace 3009

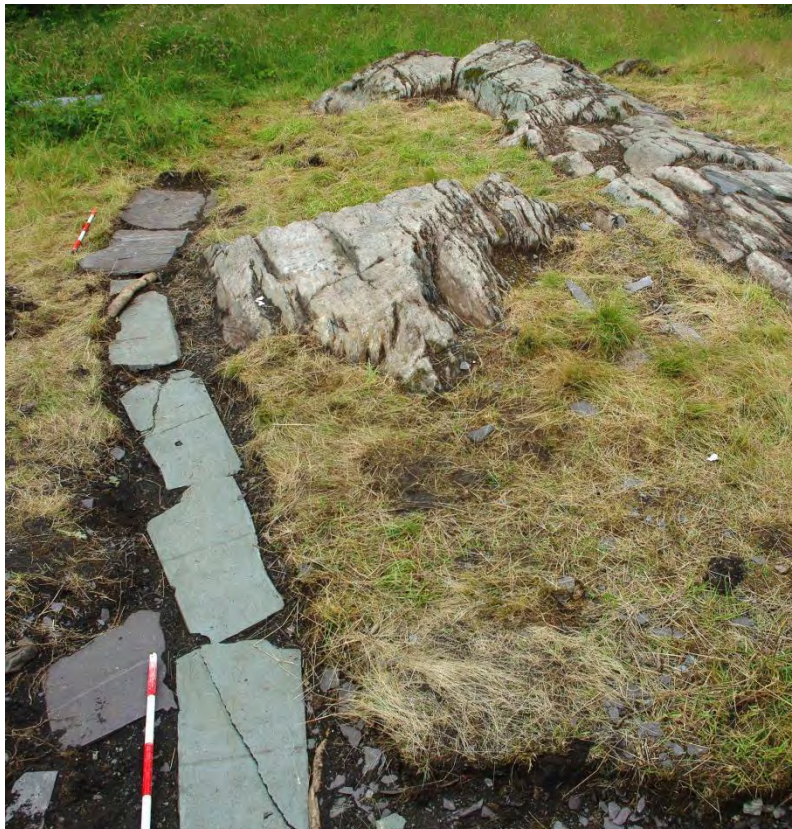
Figure 37. Slate path 3045 leading to outcrop 5000

3045 Slate path. A curvilinear line of six substantial slate slabs were traced as far as the outcrop/rock cannon 5000 (Figure 36). It is not clear if the path continues beyond this point, probing suggests it might but further investigation is needed. The path was laid directly on soil and had been

covered by turf. The north-eastern slabs are green slate possibly all split from the same block. The remaining slabs are blue slate.

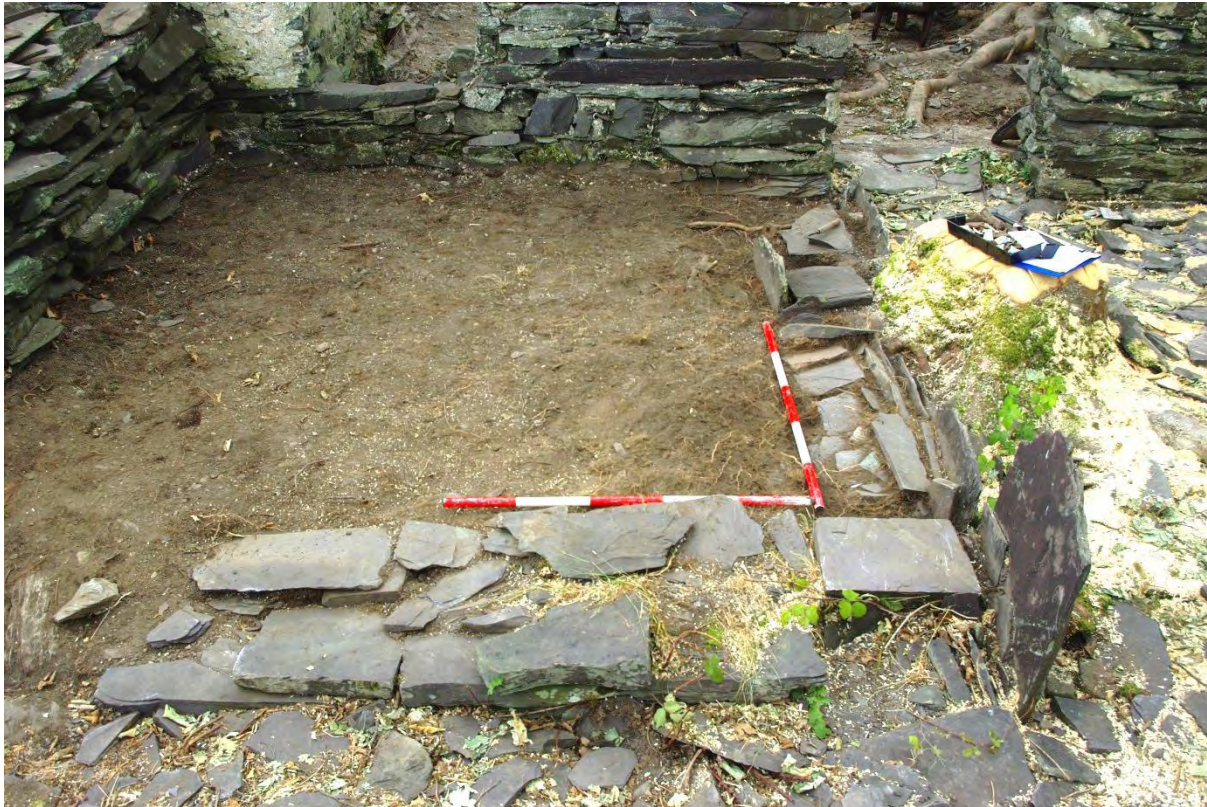
Figure 38. Garden plot (3030, 3023 and 3053)

A raised area presumed to be a garden plot was excavated in front of the SSE end of cottage 3. A layer of broken roofing slates and other debris (3020) were cleared from the area revealing a raised garden plot (Figure 37). The plot was bounded by edging/wall 3030 and walls 3053 and 4010. The latter was a later addition (phase V) and the map evidence suggests that the plot continued as far as the pathway from cottage 4. The excavated contexts are as follows:

3023 a. A parallel alignment of an edge-set slate and two iron pegs define the inner side of the edging, and may have supported a wooden plank. This was subdivided by an edge-set slate running at right angles between the inner and outer edges. The two parallel edges appear to have formed an earth-filled subdivision of the garden plot, 0.35m wide, perhaps for decorative plants. The space between the two edges was subsequently filled by a low, rough wall of slate that was sitting on top of garden soil 3018.

3053 The ENE edge of the garden plot is defined by a slate wall the foundations of which are at the same level as the base of soil 3019. The wall is 0.5m wide and roughly-built from slate slabs. The SSE end had collapsed and had been sitting on uneven bedrock.

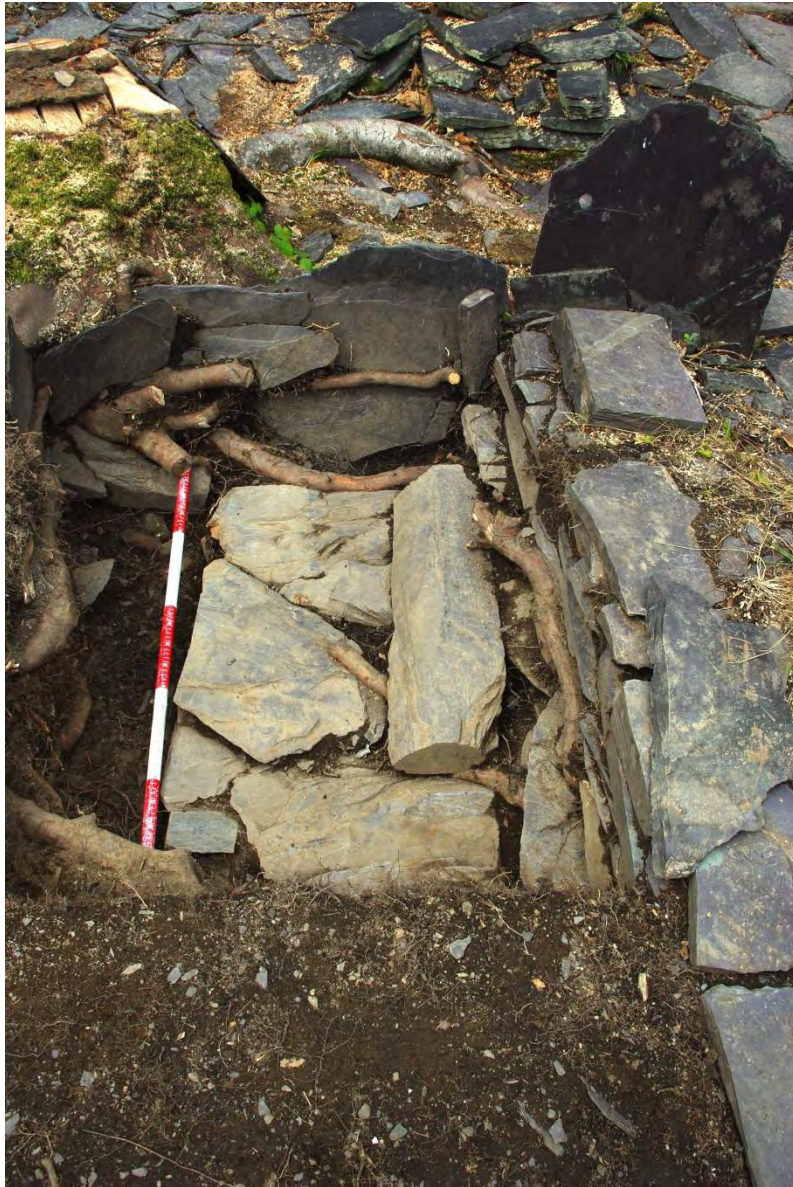
Figure 39. Buried wall 3024

3024 The base of a slate wall was underlying buried soil 3023 and sitting directly on the glacial substrate (Figure 38). The wall was of dry-slate and was 0.6m wide and two to three courses high. It could be traced for 1.1m and continued to the SSE. This must have predated the cottages and was probably associated with the earlier phase I or II agricultural buildings.

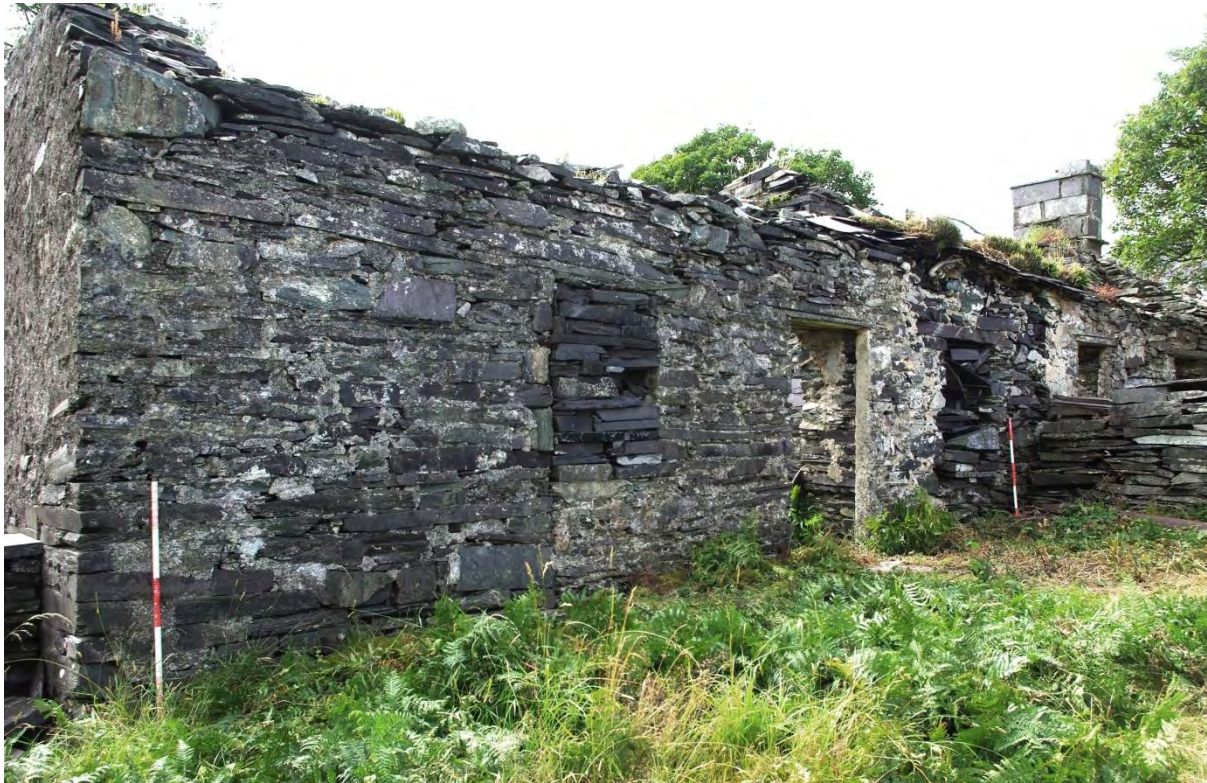
Figure 40. ENE wall of cottage (4009) showing straight joint beneath window 4008

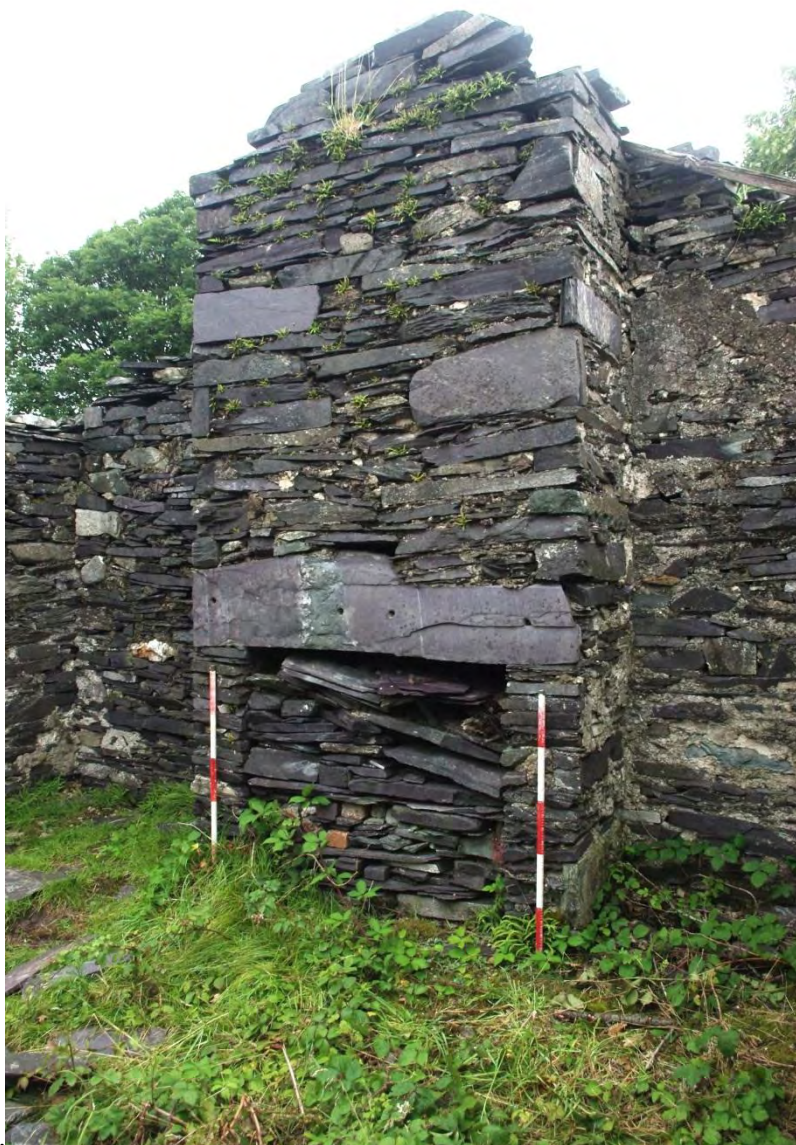
4016 Fireplace at NNW end of cottage 4 (Figure 40). The fireplace and chimney-breast are built against the dividing wall 3052 possibly as one build. The fireplace and chimney-breast are 1.85m wide and 0.65m deep and are set centrally against the dividing wall. The opening for the fireplace is 1.20m wide and 1.05m high. The lintel is a large, thick edge-set slab of slate with four holes drilled in it presumably in order to support a mantle or decorative slate surround. The chimney breast is of mortar-bonded slate slabs and includes some large slabs set upright as quoins. The fireplace has been blocked with rough piled slate masonry (phase V)

Figure 41. Fireplace 4016

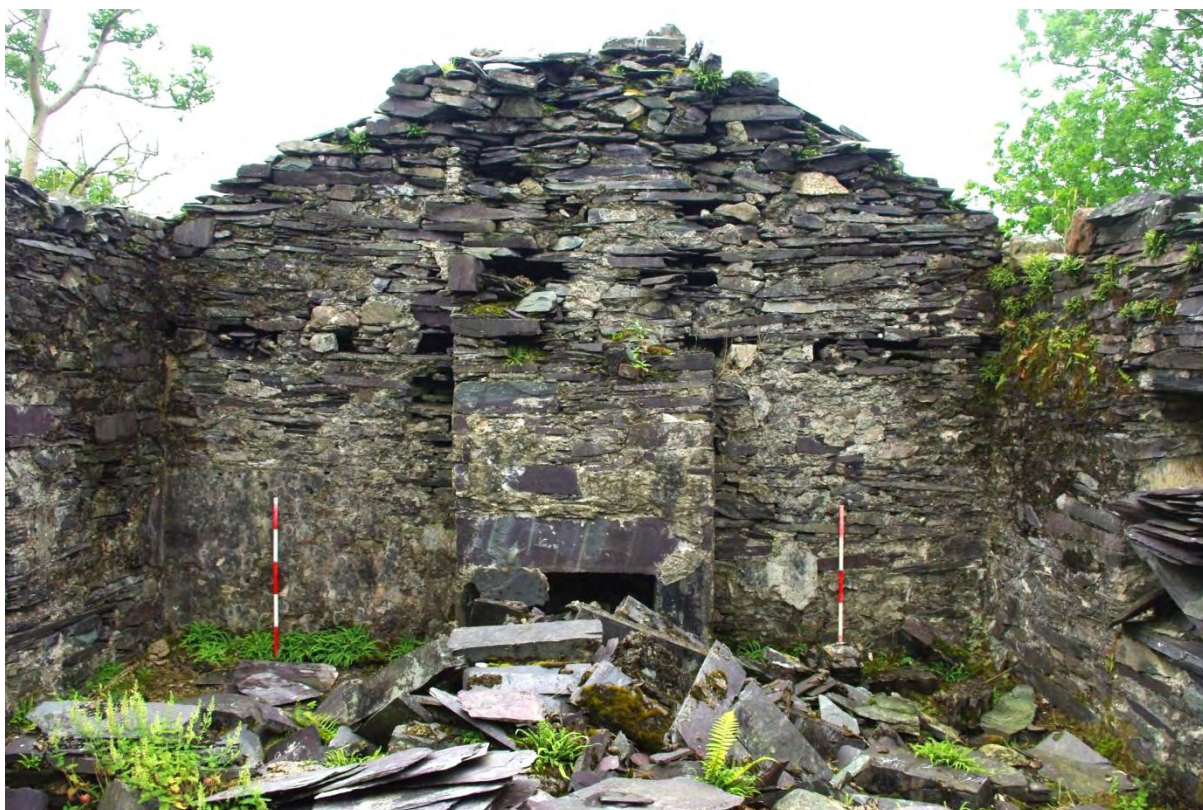
4018 Fireplace at SSE end of cottage 4 (Figures 41 and 42). The fireplace and chimney-breast are built against the gable end and were tied in by some large stones that run into the wall. The chimney breast has tilted away from the wall. The upper part has collapsed and the rest is very unstable. This is the only fireplace in the smaller room in Pen y Bryn cottages. The fireplace and chimney-breast are 1.45m wide and 0.4m deep and are set centrally against the wall. The opening for the fireplace is 0.85m wide and 0.6m high. The lintel is a large, thick edge-set slab of slate.

Figure 42. Fireplace 4018

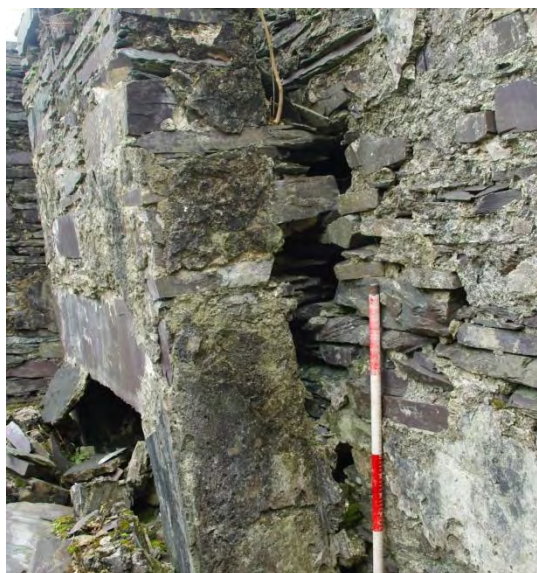
Figure 43. Fireplace 4018 showing collapse

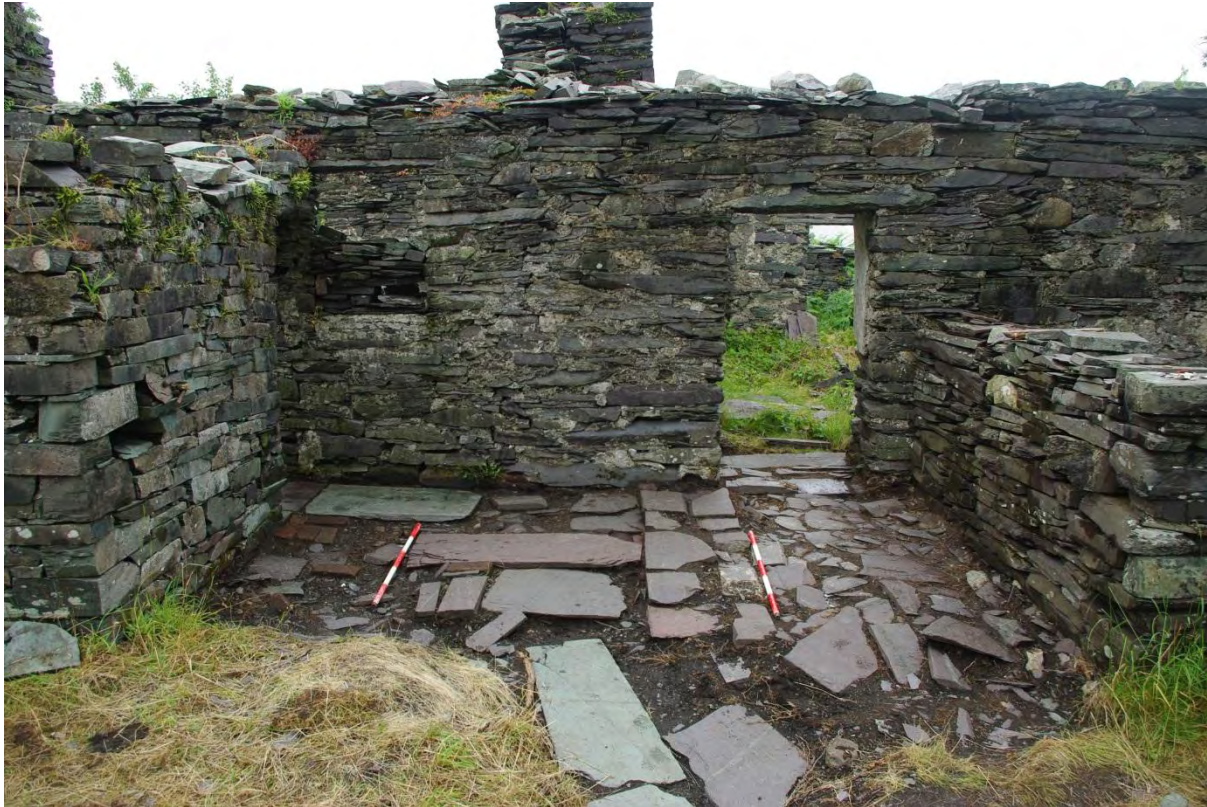
Cottage 4, yard. The area outside door 4002 was cleared of turf and fallen slates (4013) revealing further debris along with the remains of a threshold (4012) for the door and the base of a wall 4014 (Figure 43).

Figure 44. Cottage 3 and 4 yard and wall foundation 4014

4014 Wall foundations. The base of a 0.55m wide slate wall that abutted the outer face of the cottage was uncovered at the same depth as the nearby slate paving. This could be traced for 2.33m before being lost in rubble. It is in a comparable position to the NNW walls of the extensions to cottages 2 and 3 and could be interpreted as the remains of a similar structure built on to cottage 4.

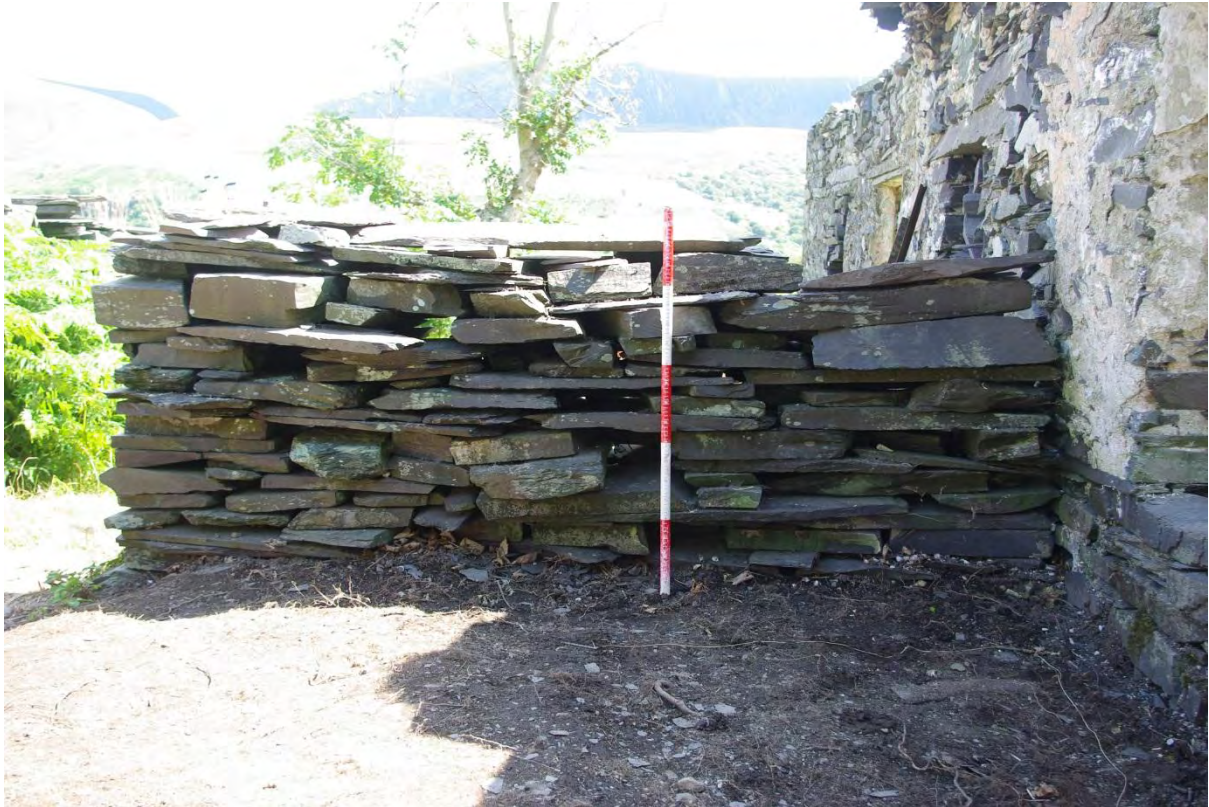
4010 A somewhat roughly built dry-stone slate wall 2.63m long, 0.62m wide and 1.25m high. Phase V wall added in the 1950s as part of reuse of the cottages as farm buildings (Figure 44).

Figure 45. Wall 4010

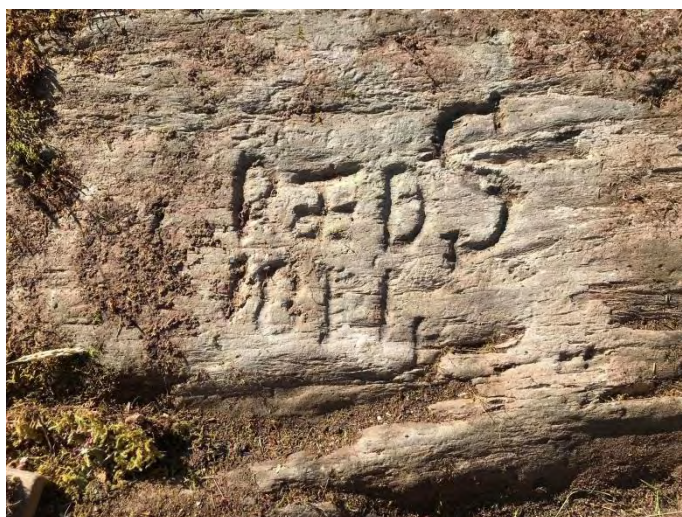
Figure 48. Graffiti with quarryman's 'J' symbol uncovered by Unloved Heritage participants.

By participating in the excavation it also allowed the young people to gain a broader understanding of Dyffryn Nantlle’s history during the slate quarrying period. Prior to this experience the young people had no knowledge of what a Marriage Stone was and had not come across the symbol known as a quarryman’s ‘J’ (Figure 47). By the end of their time on site they had learned about the Marriage Stone’s function and the sites significance during the 19<sup>th</sup> and 20<sup>th</sup> centuries.
