Archaeological Recording and Watching Brief at Cerrig Gwyddel, Llangristiolus

GAT Project No. G1843

Report No. 538

ARCHAEOLOGICAL RECORDING AND WATCHING BRIEF AT CERRIG GWYDDEL, LLANGRISTIOLUS (G1843)

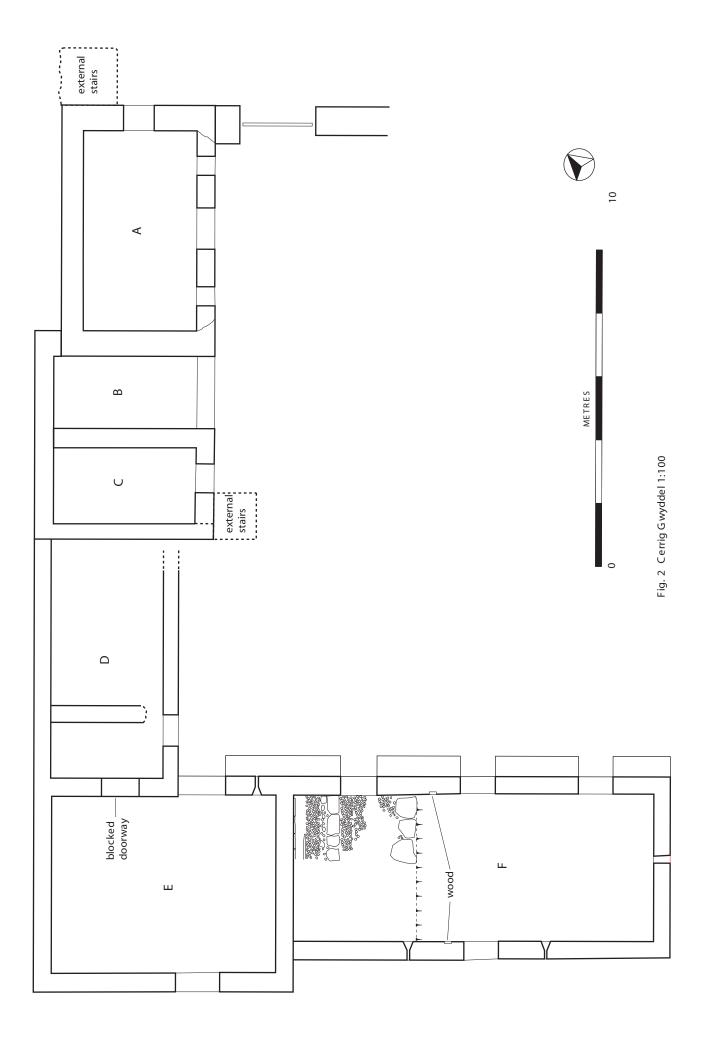
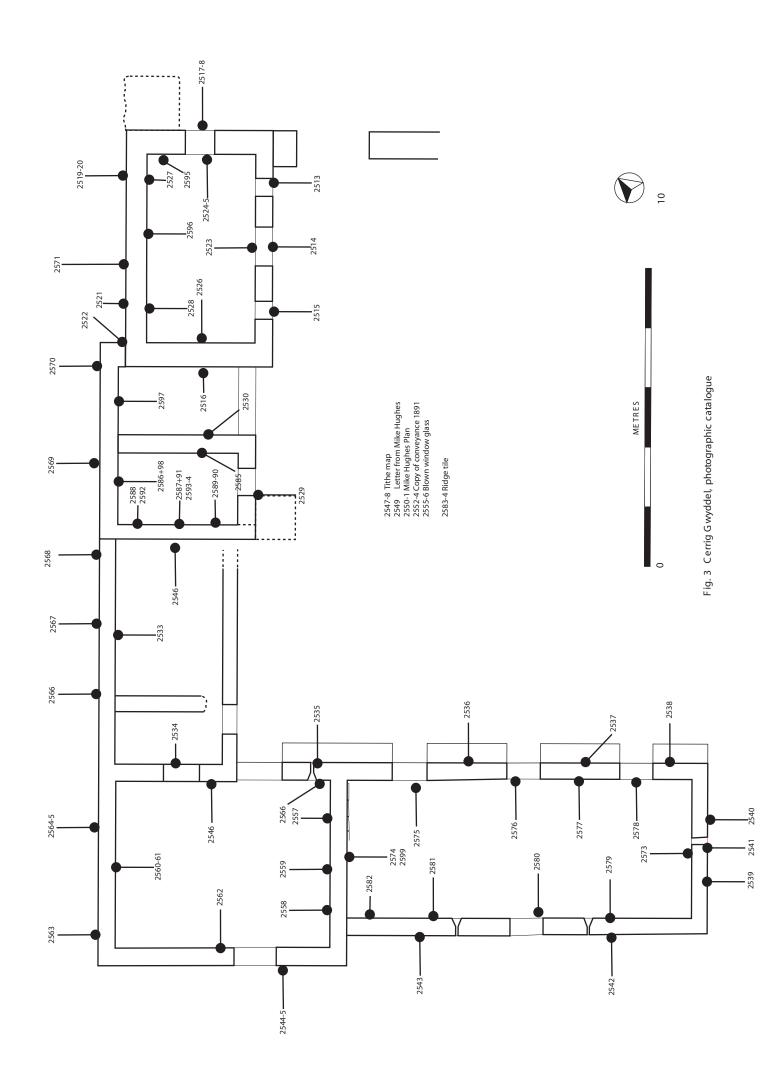
This appears to incorporate three phases of masonry and has internal dimensions of 6.0m x 3.6m. The NW and SW walls are earliest, being constructed from large irregular field stones bonded with clay. The building style in the NE gable is more regular and incorporates somewhat unusual irregular galleting (small stones pressed into mortar joints). A door to the upper storey is located centrally. A somewhat indistinct masonry base presumably indicates the position of the base of external steps originally running up to the door. The front (SE) elevation has clearly been rebuilt and consists of coursed masonry bonded with lime mortar. The window headers are constructed from regular commercially produced bricks probably produced in the late 19th century. The internal elevation retains sockets for floor joists for the upper floor although it is possible that this was an addition relating to the later phases of building. A small opening low in the NW wall (photo 2596) may indicate the position of a water supply. The floor was in reasonably good condition, consisting of well-set cobbles on natural subsoil along with bedrock in the northern corner.

steps. The building is later than and abuts the stable (building A) and is constructed from irregular lime mortared local stone. Compartment B has internal dimensions of 2.25m x 5.3m. The second storey wall was carried over the full width of the compartment by a wooden lintel. The floor was found to be very roughly paved with irregular undressed local stone slabs. The width of the opening suggests that this was a cart shed.

Compartment C has internal dimensions of 2.4m x 5.3m with a 0.9m wide doorway in the SW wall on the ground floor and a similar door in the upper storey. The NW internal elevation was rendered with lime plaster and showed signs of sooting. There was however, no sign of a hearth and this could perhaps be the result of a fire after the buildings fell out of use. The floor was of compacted clay.

This building has internal dimensions of 7.5m x 3.6m and abuts the NW wall of building B/C. The SW wall and an internal division had mostly collapsed. The building appeared to be one storey high. The floor level was poorly defined but appeared to be packed earth.

Building E (internal dimensiona $7.2m \times 5.6m$) appeared to belong to the same phase as building F as there was no visible joint or change in masonry style visible in the NE wall. This again appeared to be a single storey structure. There are doorways, capped with dressed sandstone segmental arches, in the NW and SE walls and a further blocked doorway into building D. The floor was found to be mainly concrete.

Building F has internal dimensions of 11.7m x 4.6m and is again a single storey construction. There are three doors in the SE wall, similar in style to those in building B. There is a single door and two ventilation slots in the NW wall. The opposite positioning of the doors in the SE wall suggests that this building was used as a threshing barn. Remains of timbers in the wall on the SE side of the central doors could indicate an internal partition.

Parts of the flooring of building F had survived. A drain and a fairly ornate pattern of cobbles and stone slabs were uncovered at the north eastern end. The building had been built lengthways into the slope and the floor at least at the NE followed the natural slope. The south western two thirds was less well preserved with occasional patches of cobbles and rough stone flagging remaining. The poor state of preservation may be the result of an attempt to level the floor in this part of the building. A possible crude step was recorded at the point where the floor began to deteriorate. Buildings E and F exhibited a higher standard of building than elsewhere on the site utilising dressed sandstone for the door headers and rectangular blocks of local stone at the corners of the buildings.
